NATIONAL TRANSPORTATION SAFETY BOARD

AIRWORTHINESS FACTUAL ADDENDUM LIGHTBULB RE-EXAMINATION AND STUDY

- A. **ACCIDENT:** DCA08MA098
- LOCATIONS:** Columbia, South Carolina
- DATE/TIME:** September 19, 2008
- AIRCRAFT:** Learjet Model 60, N999LJ, S/N 60-314

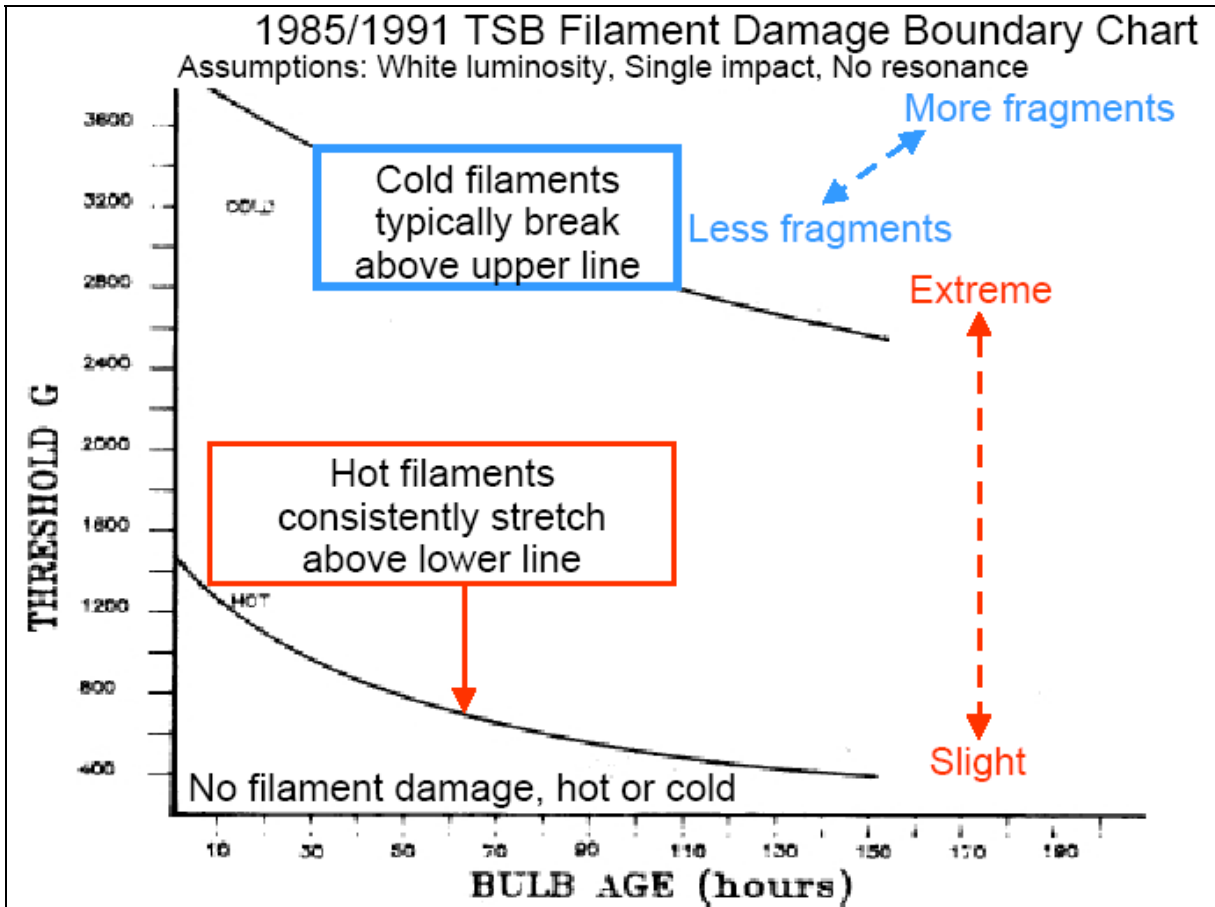
With respect to loads required for filament deformation, hundreds of bulb test specimens had been intentionally damaged by impact at known loads to create the three references. These tests are the source for the chart of probabilistic damage boundaries that is shown in Figure 1. The Australian "Guide to Impact Behaviour" provided further definition to these boundaries.

Chart: TSB Report TP6255E, A Guide to Light Bulb Analysis In Support of Aircraft Accident Investigation, Rev 1991, Poole & Vermij
 Figure 1. Transportation Safety Board of Canada chart with colored items added to illustrate text that accompanied the original chart. Note that the accident airplane had approximately 110 hours. (Reference value only, refer to Airworthiness Factual Report for airplane history.)

Military tests and research providing deceleration loads survivable for humans were consulted as reference values.² As long as the human and bulb were able to experience the same deceleration loads, the probability curves that describe the minimum boundaries for filament deformation (Figure 1) exceed the reference loads for human survival.

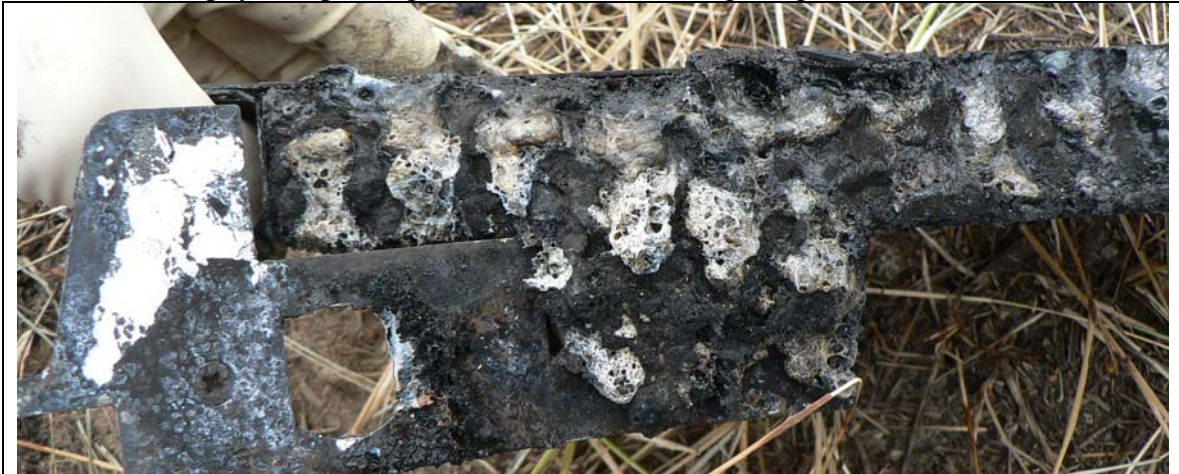
The bulbs were encased in plastic that had melted and resolidified or charred. (See Figures 2A and 2B) Extraction of the bulbs required softening of the plastic with chemicals and physical probing that resulted in breaking the glass of some bulbs.

Figure 2A. Left portion of annunciator panel from accident airplane, showing melted and charred annunciators prior to excavation and removal.

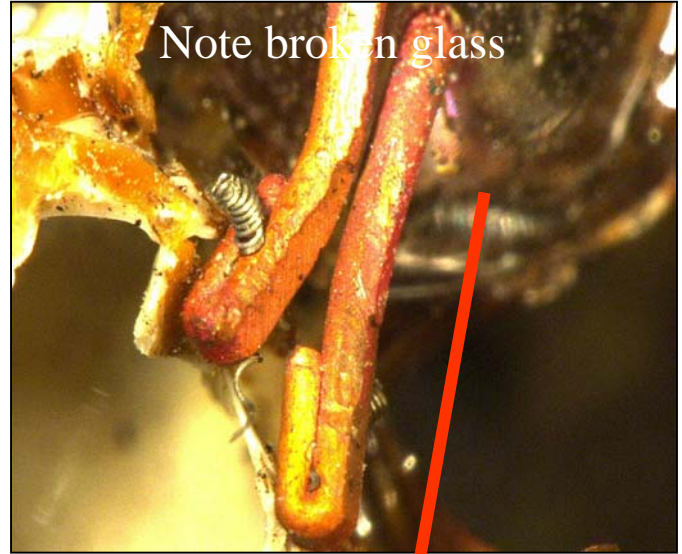
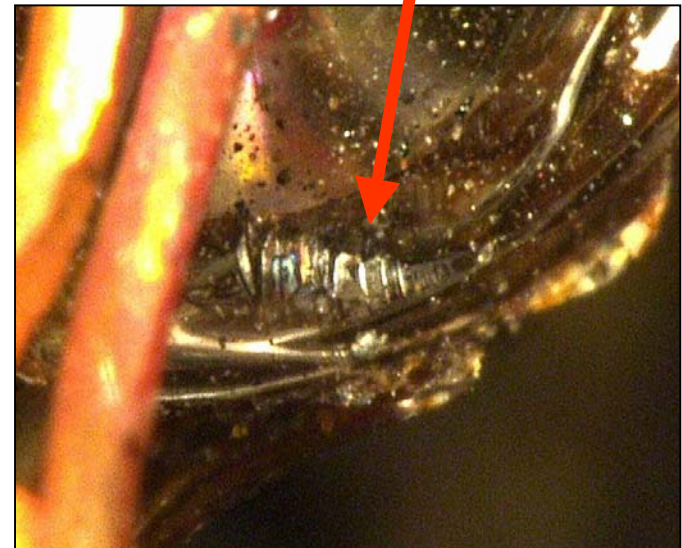
A1R, RIGHT OIL PRESS

To the right is detail of bulb A1R,
RIGHT OIL PRESS,
showing fragment of
filament within the broken glass.

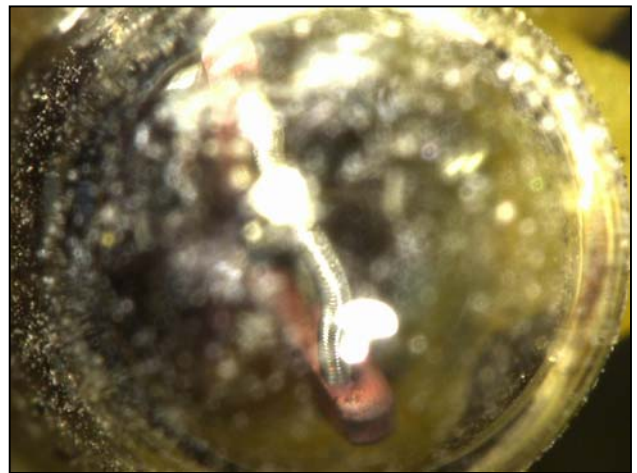
B7R, WSHLD HEAT 2nd fragment

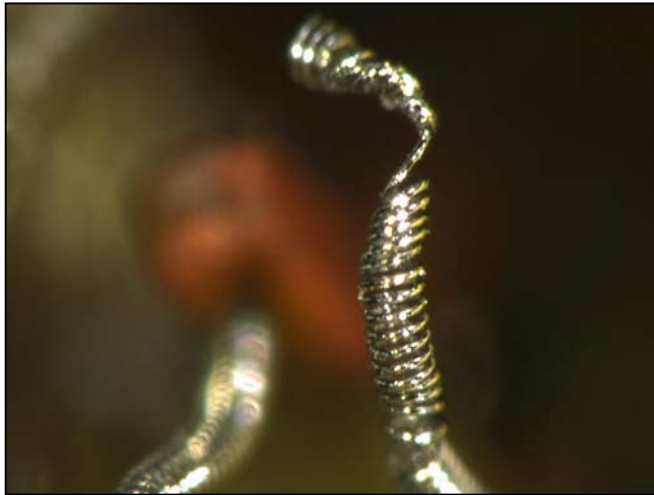
A9L, PITOT HEAT closeup

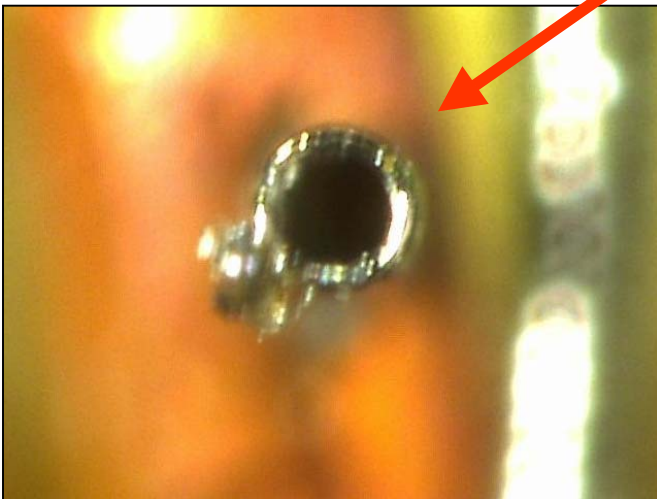
A12R, closeup 1

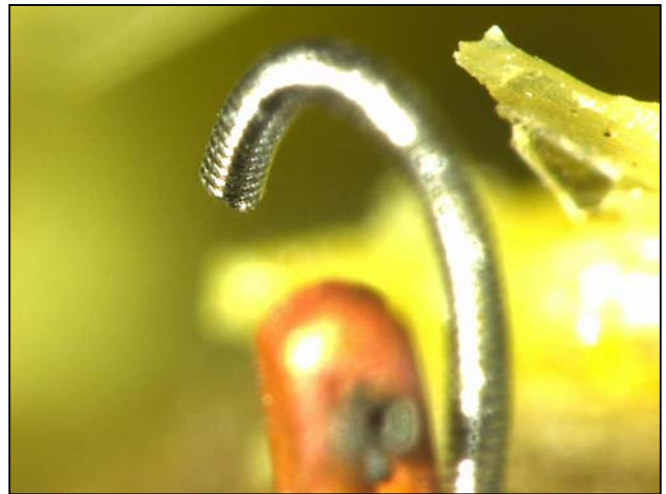
A12R, closeup 2
