K & I FIELD SERVICES, LLC

Observations of N606SP Wreckage during Salvage

6/25/2009

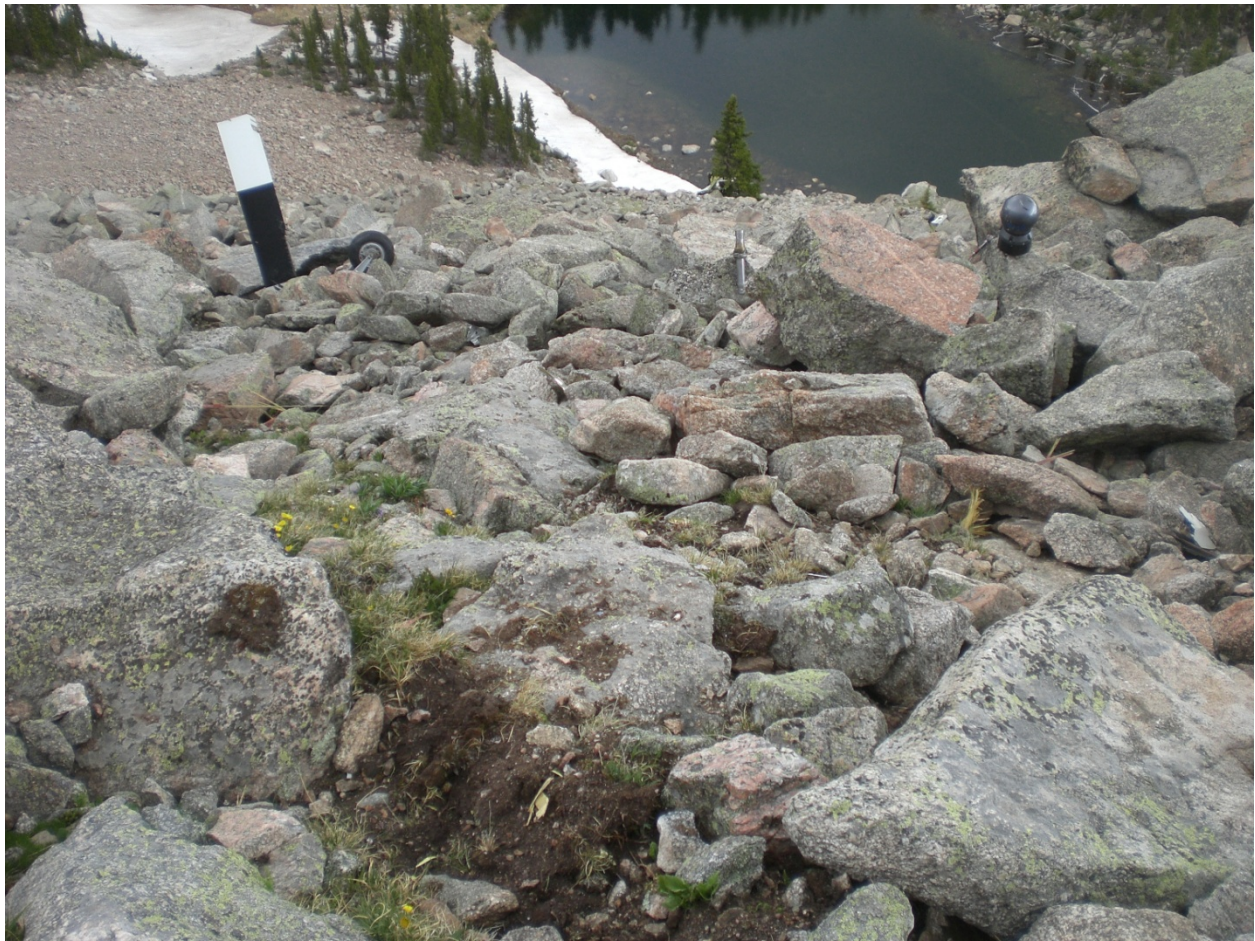
Point #2 is the uppermost (also most southerly) ground strike point observed. Numerous ground strikes were observed downhill from this point. Only a limited amount of time (estimate 40-minutes) was spent looking further uphill for additional ground/tree strikes as the focus of this effort was to recover crash debris. The most commonly noticed ground strike was a divot in soil or talus up to 5" deep, approximately 12" along the fall line of the slope and approximately 30" across the fall line of the slope. Point #2's characteristics fit these descriptions. Despite the predominance of large rock over exposed soil on the slope, paint and metal scrape on rock was noticed only at one location near point #2. The paint scrape was approximately one-square-inch and included parts of a NMSP decal.

In the photograph below, the ground strike divot is visible in the bottom of the field of view with a main rotor blade section, landing gear, landing gear strut (just below tree), and FLIR visible in the upper field of view. The aircraft parts are shown within inches of where they came to rest, but were set atop rock to make them visible for this photograph. The landing gear was approximately 30' downhill from point #2. The FLIR was approximately 30' downhill and 12' east of point #2. The tree with the tail boom is visible between the wheel and the FLIR, just above the wheel strut. A brake caliper was also retrieved from the downhill edge of point #2, and may be the part that is visible in the far right edge of mid-field of view.

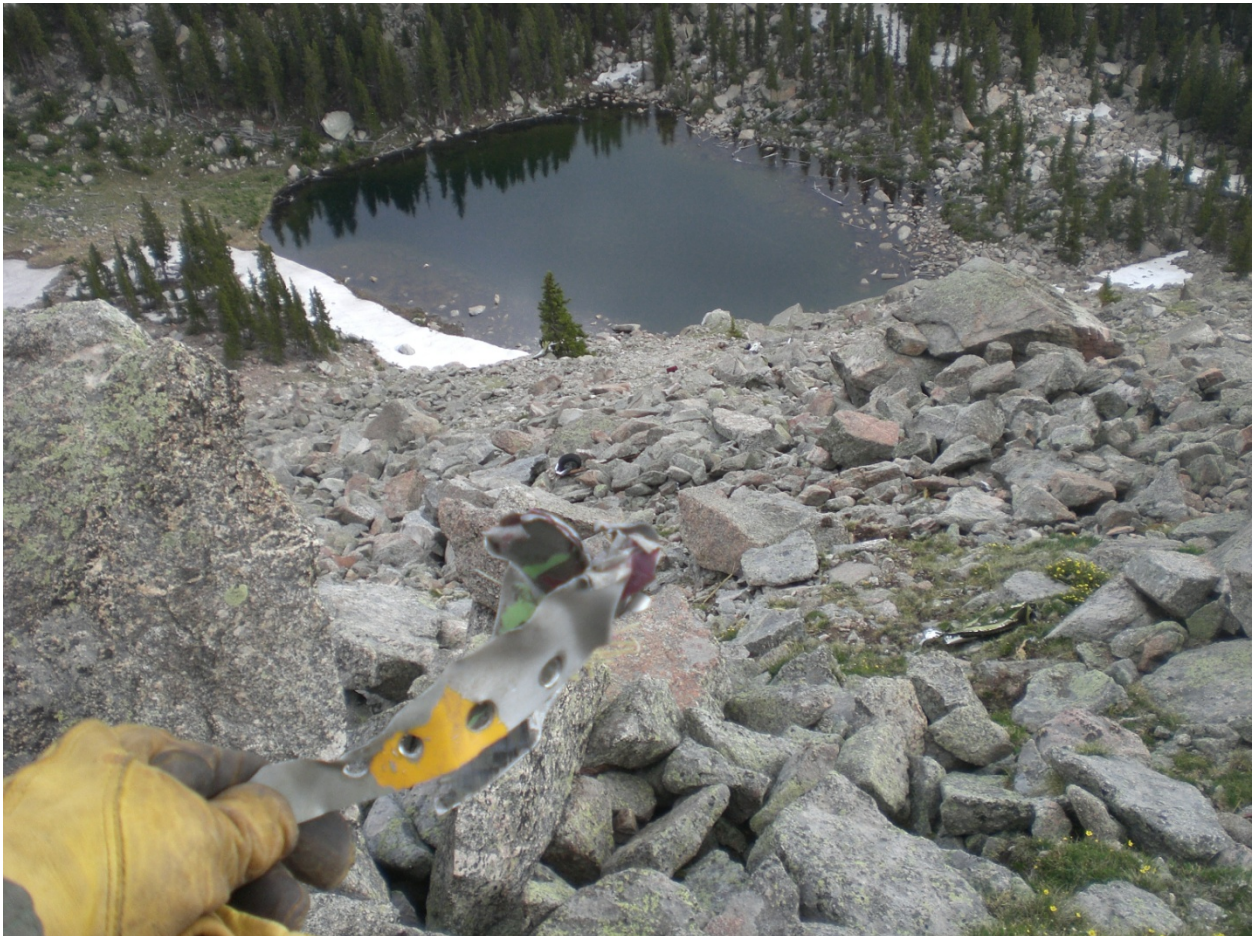
Just uphill from point #2 is point #1, the furthest uphill piece of aircraft debris recovered. It is an aluminum piece with yellow striping, approximately 8" long, shown in the photograph below. It was found approximately 23' uphill (south) of point #2 and approximately 10' west of point #2. In the same picture, the undisturbed landing gear is visible—same gear as shown in the picture above—just left of the middle of the field of view. The tail boom and the tree upon which the tail boom rests are located just above the landing gear. Just right of a line between the landing gear and the tail boom is the black and red bag presumed to be a tool bag. In the vicinity of the black and red bag, we recovered a significant amount of aircraft maintenance materials such as rags, shop towels, a can of fluid, and wheel chocks. In the same general area of the red and black bag, other notable pieces recovered include: the cabin door, aircraft flight manual, ammo clip from semi-auto pistol, semi-auto pistol, chest pouch, green helmet bag, satellite phone, aircraft pre-flight and other checklist pages, both landing gear, FLIR, at least two pieces of main rotor blade over 3' long, numerous pieces of composite fiber material and honeycomb, and the aircraft battery.

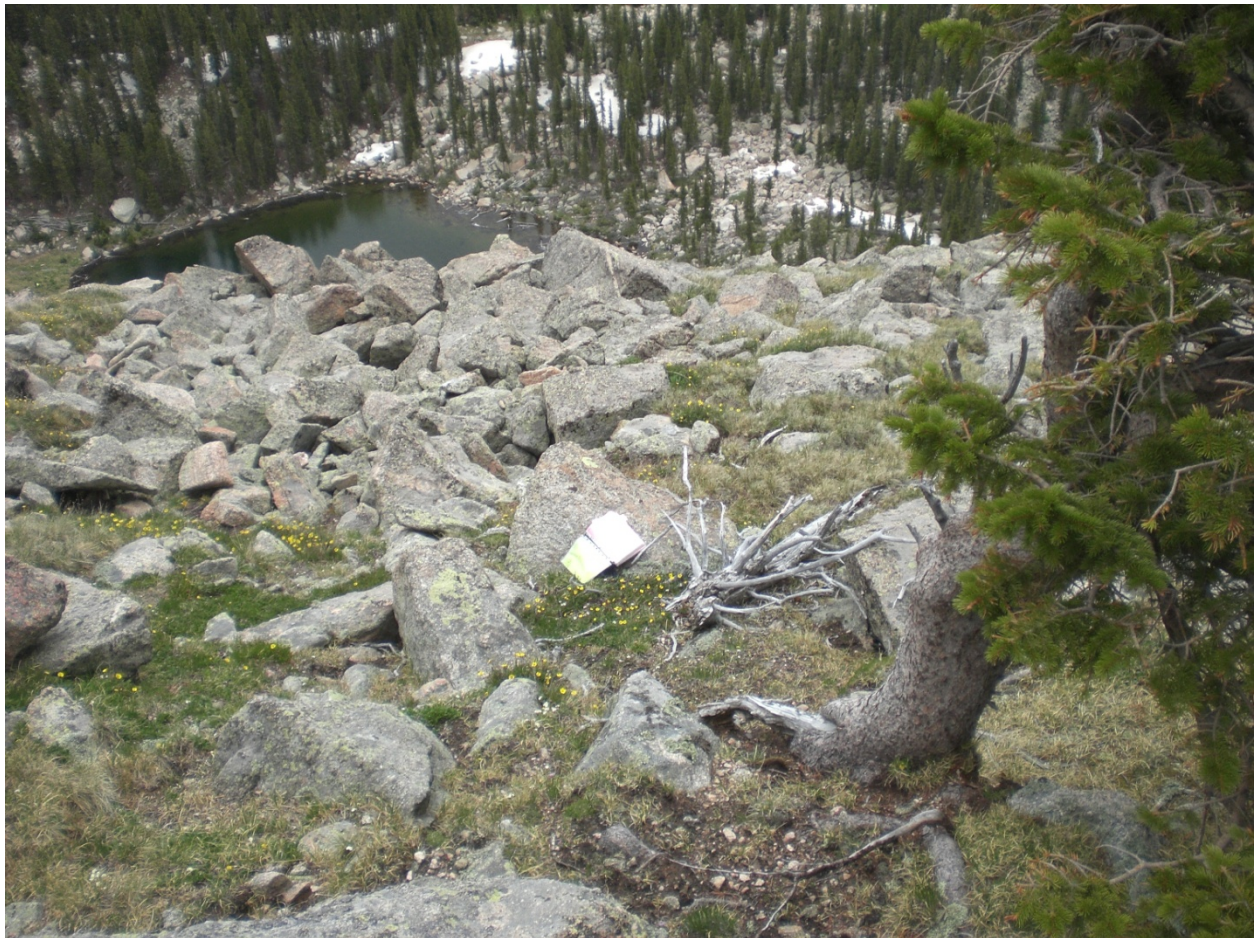
The picture below shows point #4--the furthest uphill piece of related debris found that is not an aircraft part. It is the blue kneboard with local area checklist pages and is the only piece of related debris found uphill from (south of) point #1, with the possible exception of a climbing rope. Roughly 1/3 of the way uphill from point #1 towards point #4, we recovered a climbing rope—unknown whether it is related to the crash, but was packaged with wreckage debris.

Approximately 5-minutes were spent scanning the surrounding trees and rocks within 150' of point #4 for signs of a ground strike—none was found. This point is near the top of the sloping ridgeline that runs downhill to the northeast from the major ridge south of the crash site. The lake in the background is the same lake near which the fuselage came to rest, approximately 500' vertically below the elevation of point #4.

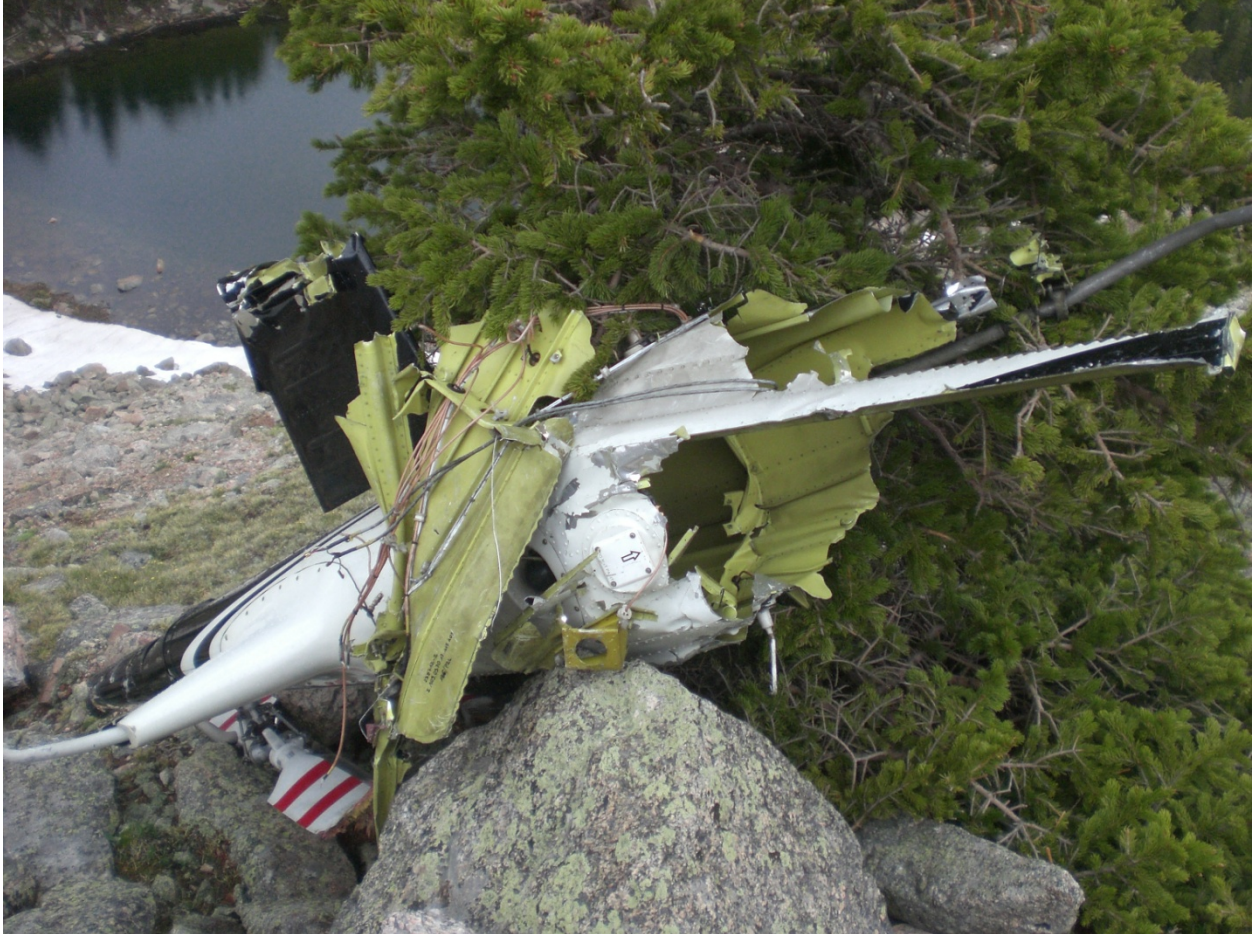
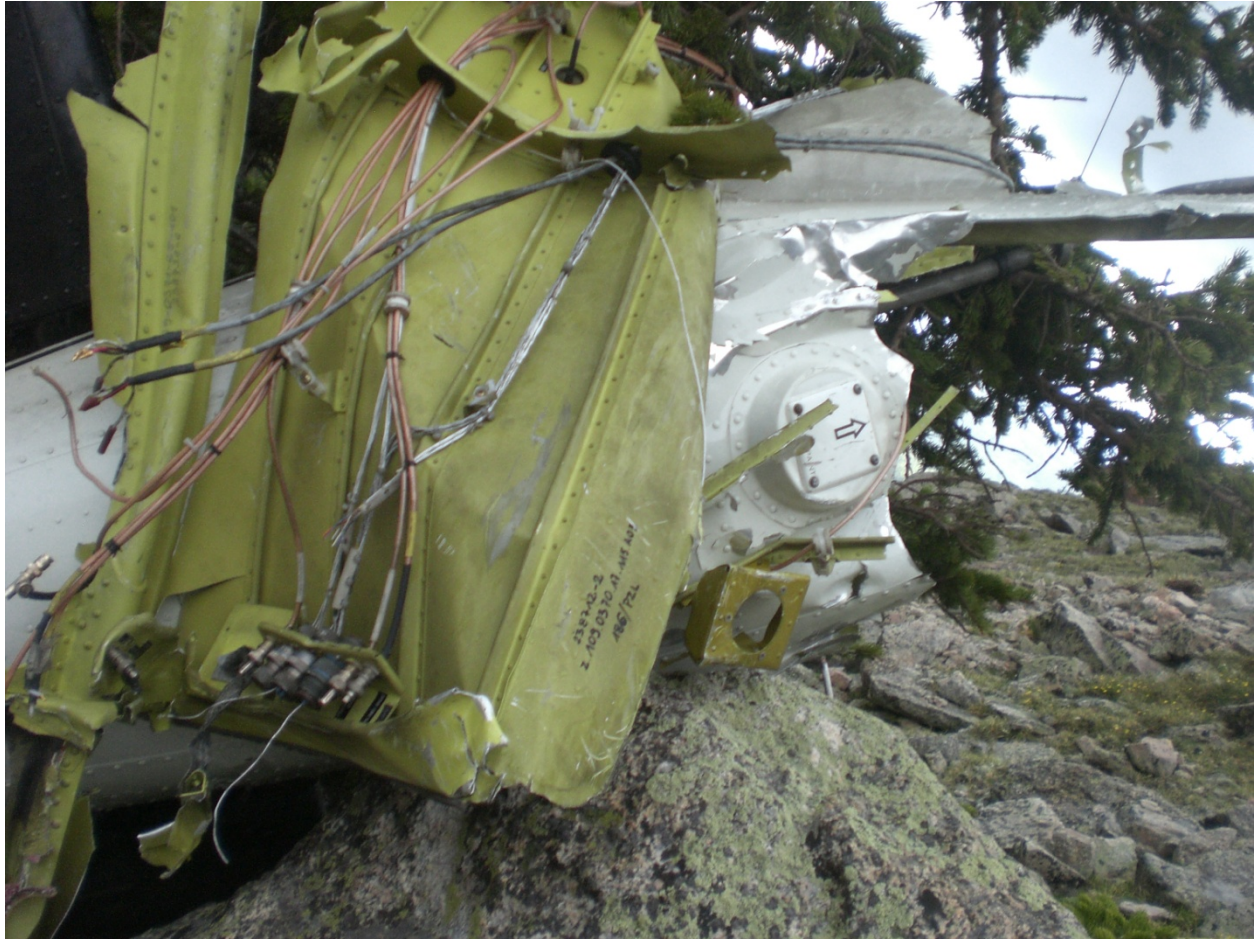
At point #3, we photographed the tail boom prior to disturbing it—seven following photographs. There was no indication the tail boom had been disturbed since the crash. (If it is important to definitively determine that the tail boom was undisturbed between the crash time and this photo, I recommend contacting Mr. Rich Seemer, Atalaya SAR, who was first on the scene of the tail boom and turned off the ELT located within the tail; ask him if the photos depict the condition in which he found the site.) The tail boom lies on the west side of the tree.

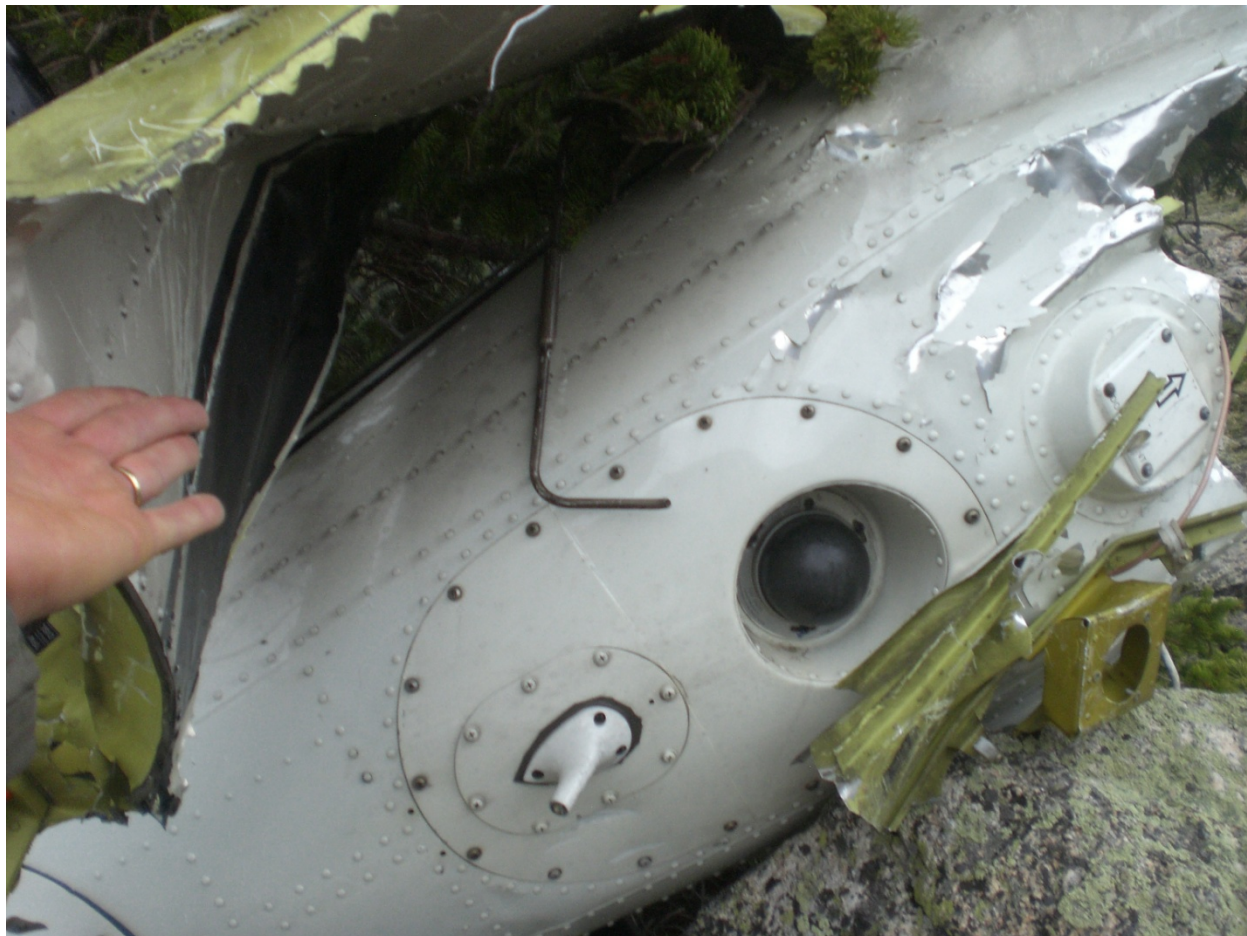
The antenna missing from the fairing shown in the picture below was recovered within 20' of the tail boom.

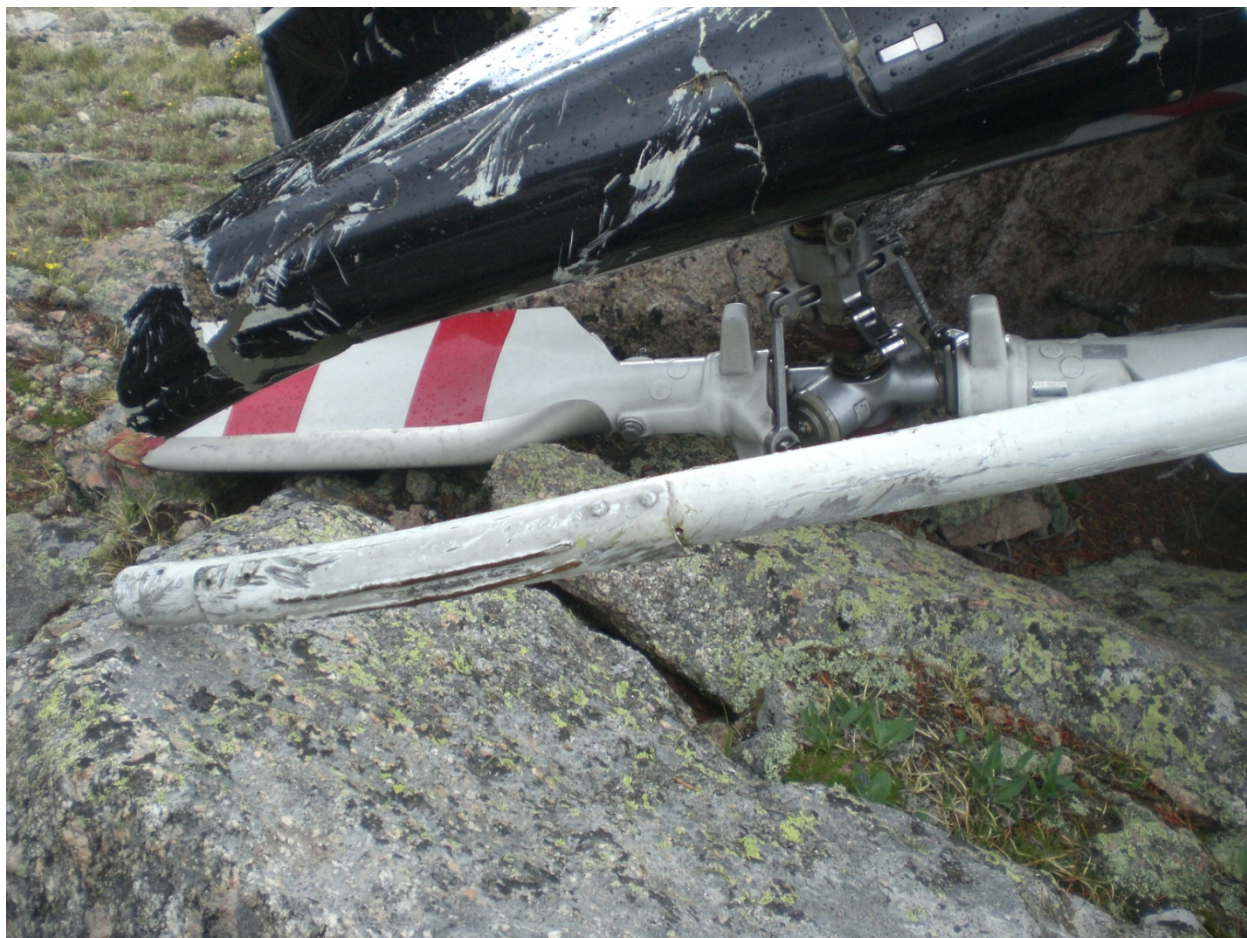
In this photo of the tail boom, you can see that the tail cone is missing. The tail cone was recovered approximately 90' uphill from the tail boom.

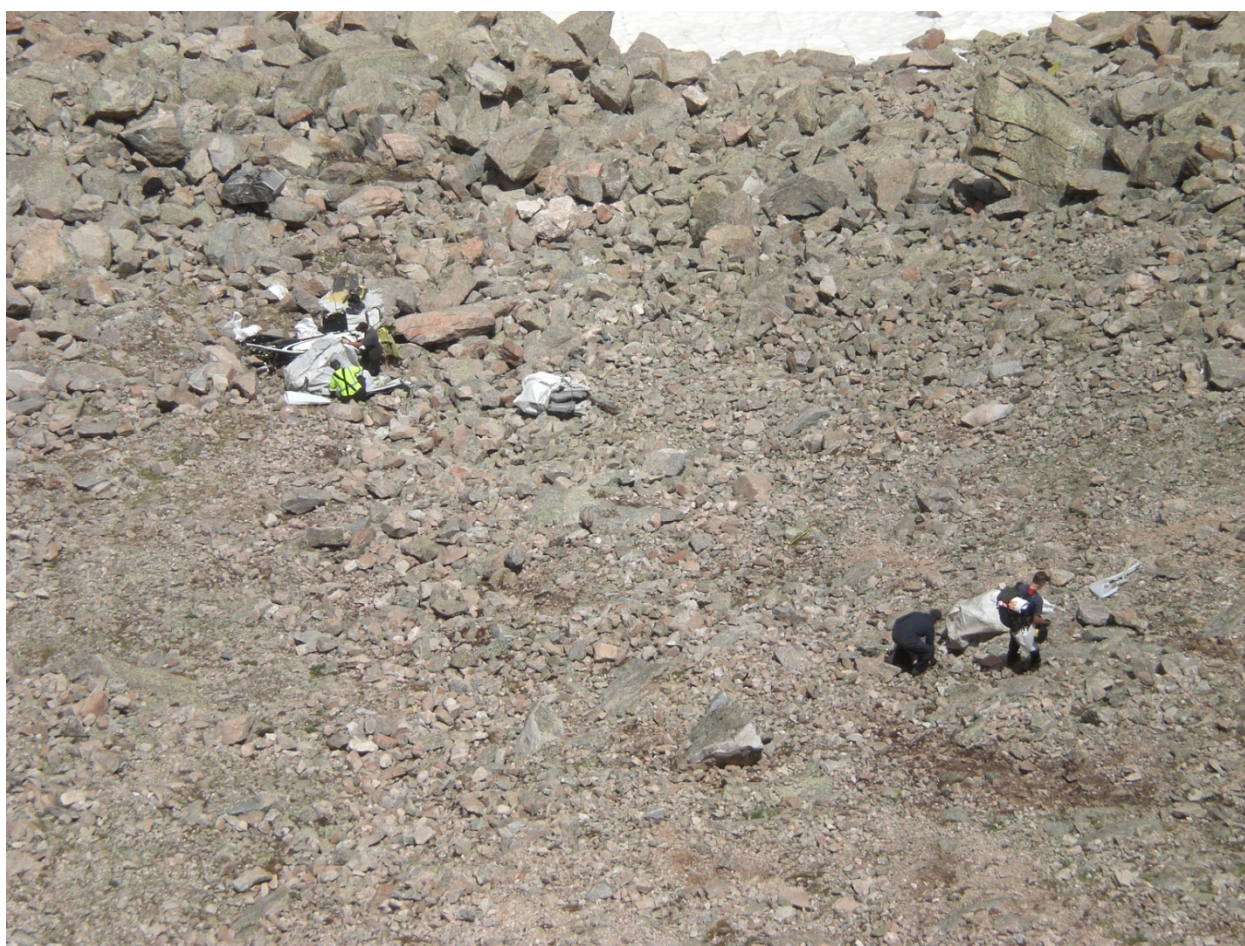
During our attempts to move the tail boom (at point #3) approximately 15' to consolidate with bags of recovered debris for a single sling pickup, we lost control of the tail boom on the slope. Without any flight-path vector, once dislodged from the tree it was resting on, the tail boom rolled downhill to within approximately 50' of where the fuselage was resting (approximately point #5). The picture below shows the tail boom in the upper left field of view strapped to bags of debris recovered from the lower part of the wreckage line after the fuselage had already been sling-loaded out of the site. The perspective for this photograph is from the top of the estimated 50' tall cliff approximately 150' down slope from point #3.
