NATIONAL TRANSPORTATION SAFETY BOARD
Office of Aviation Safety
Washington, D.C. 20594

Airworthiness Group Chairman's Factual Report

NTSB No: CEN13FA121

Operator: Air Methods
Aircraft: Eurocopter EC130 B4, Registration N334AM
Location: Seminole, Oklahoma
Date: January 2, 2013
Time: 1245 Central Standard Time (CST)

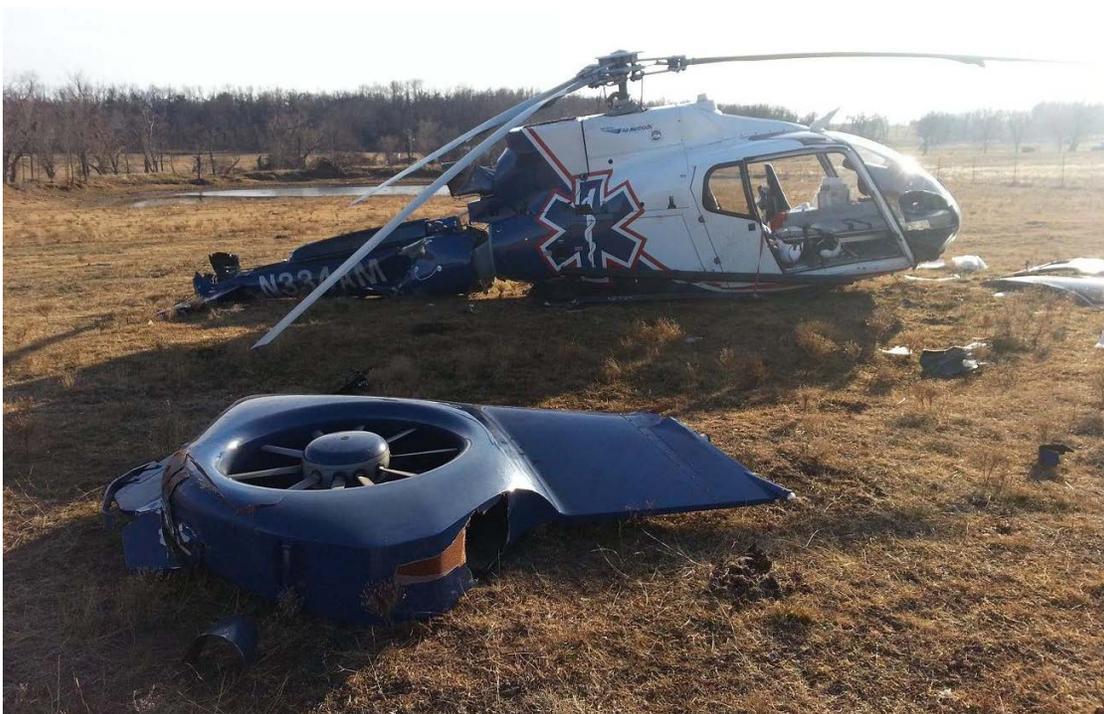
The Airworthiness Group, comprised of members from AEC, Turbomeca, the local FAA FSDO, and the NTSB, convened at the accident site in Seminole, OK from January 3 – 4, 2013 to perform documentation of the aircraft and the accident site. The aircraft came to rest upright on a magnetic heading of 262 degrees. The Fenestron had separated from the aircraft and was found approximately 30 feet north of the main wreckage (**Photo 1**). Three primary ground scars near to the aircraft's final resting position were identified as those consistent with contact from the single tail skid and the two landing skids. The location of the ground scars relative to the final resting position of the aircraft was consistent with a clockwise rotation of the aircraft of approximately 180 degrees following initial ground impact of the landing skids and the tail skid (**Photo 2**). A barbed-wire fence was located approximately 16 feet west of the single tail skid ground scar and approximately 54 feet west of the main wreckage.

Photo 1. The accident scene with the separated Fenestron seen in the foreground.

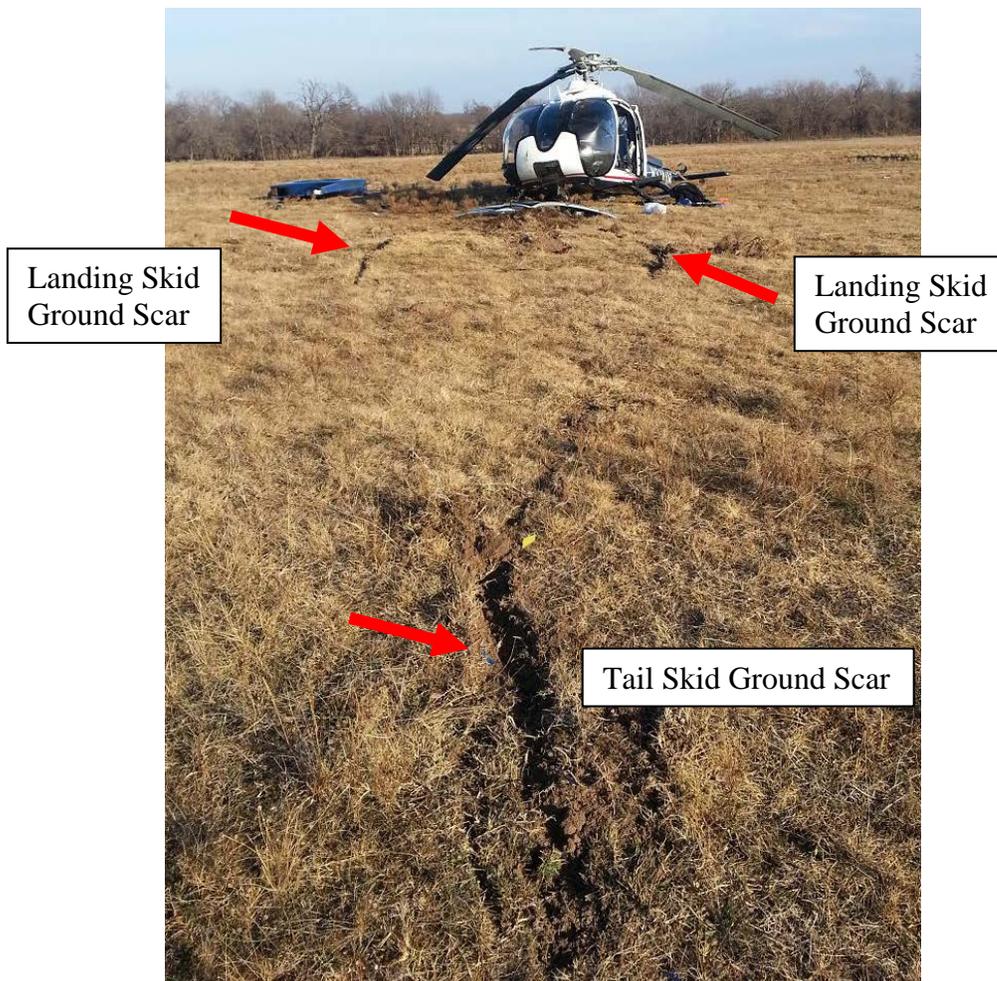
Photo 2. Ground scars observed relative to the aircraft.

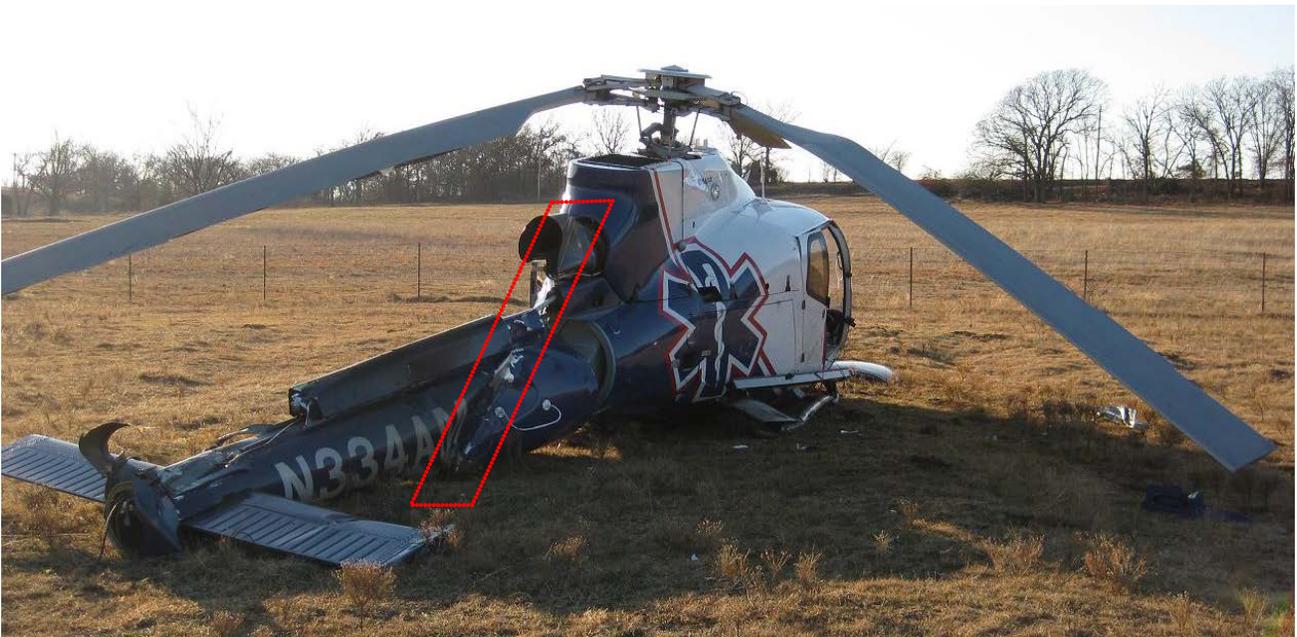
All three main rotor blades remained attached to the main rotor head. The red main rotor blade exhibited trailing edge separation adjacent to the blade cuff. The damage along various points on the leading edge of the 'red' main rotor blade matched that of a 45° straight-lined impact mark to the tailboom and engine exhaust duct on the right side of the aircraft (**Photo 3**). The 'blue' main rotor blade exhibited impact damage on the bottom of the blade approximately 50 inches from the blade tip end; light blue paint transfer marks were observed on some of the edges of the damaged area. The 'blue' main rotor blade also exhibited trailing edge separation along various points of the entire length of the blade. The tip of the 'blue' main rotor blade exhibited damage that was matched to damage found on the Fenestron stators. The 'yellow' main rotor blade exhibited an area of damage on its trailing edge, beginning from 51 inches from the blade tip and extending approximately 58 inches inboard. Light blue paint transfer marks were observed on the bottom side of the blade at approximately 6 inches from the tip end of the 'yellow' main rotor blade and extended inboard approximately 46 inches. Blue paint transfer marks were observed on the leading edge of the 'yellow' main rotor blade, beginning from 32 inches from the blade tip extending approximately 4 inches inboard.

Photo 3. Straight-lined impact damage seen on the tailboom and engine exhaust.

The tailboom separated from the main fuselage at its primary attachment point. The right side of the tailboom exhibited a large, 45° impact mark approximately 23 inches from main fuselage separation point and was matched to an impact by the red main rotor blade. The right horizontal stabilizer exhibited impact damage adjacent to the leading edge approximately 20 inches from its outboard end. The left horizontal stabilizer exhibited no substantial damage.

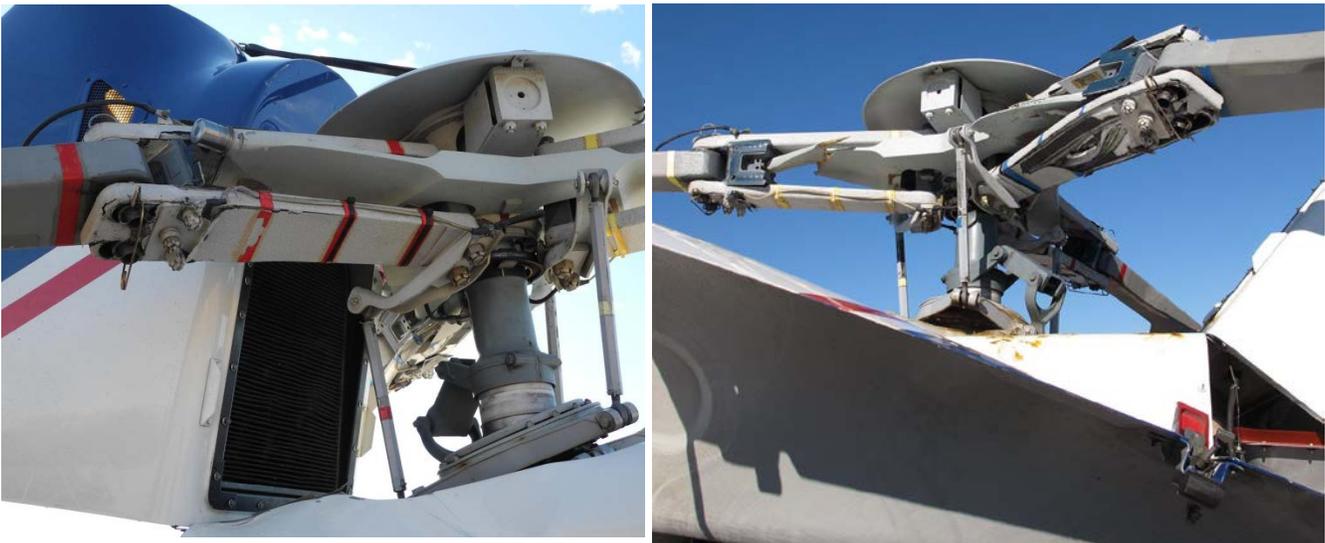
blade Starflex arm was not connected to the ball joint within the elastomer block located at the outboard end of the sleeve assembly (**Photo 4**). No evidence of fractures was observed on the 'red' Starflex arm. The 'blue' and 'yellow' main rotor blade Starflex arm exhibited fractures approximately midway outboard of the Starflex arm flexure point; the fractures were relatively perpendicular to the arm (**Photo 4**). Both 'blue' main rotor blade sleeve assemblies were fractured and twisted consistent with lateral overstress forces. All three main rotor blade pitch change rods (PCR) remained installed to their respective pitch horns and the rotating swashplate with no evidence of substantial damage to the pitch horn and the PCRs.

Photo 4. Damage seen on the 'red', 'yellow', and 'blue' Starflex arms.

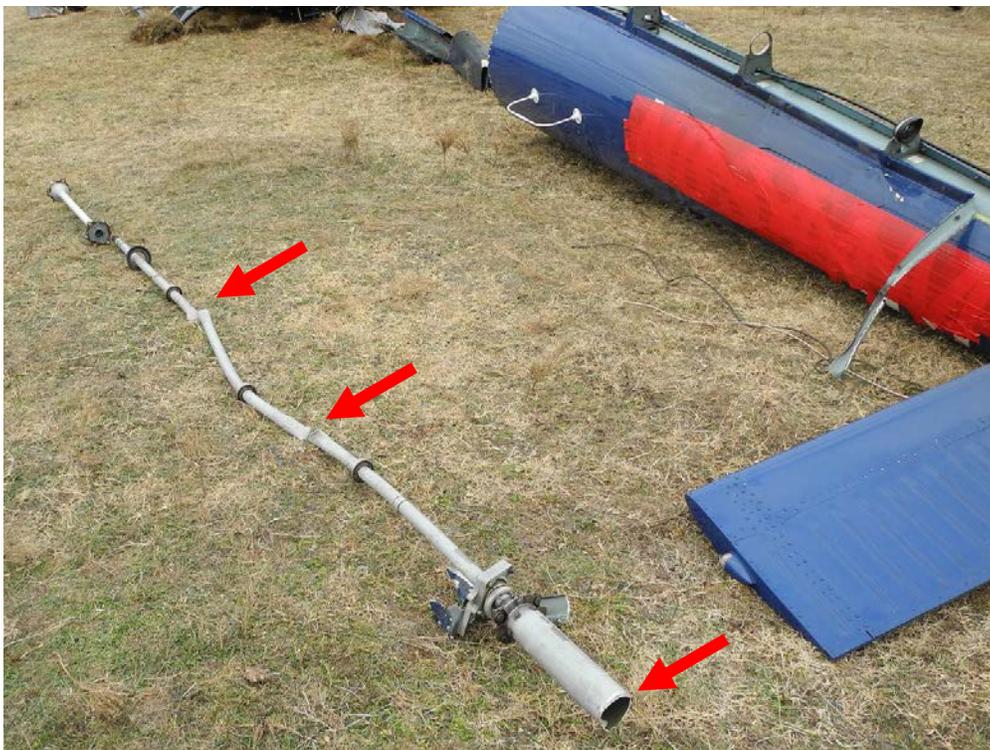
The tail rotor drive shaft had fractured in two locations while the Fenestron drive shaft had fractured in one location (**Photo 5**). The first break was approximately 36 inches aft of the forward splined connection to the engine output shaft. The second break was approximately 36 inches aft of the first break. The remainder of the tail rotor drive shaft remained continuous for another 48 inches until the last break at the Fenestron drive shaft. All drive shaft hanger bearings were accounted for and exhibited no evidence of seizure when turned by hand. All observed fracture surfaces exhibited signatures consistent with overload.

Photo 5. The Fenestron drive system reconstructed after removal from the helicopter. The upper two arrows mark the breaks in the tail rotor drive shaft and the lower arrow marks the break in the Fenestron drive shaft.

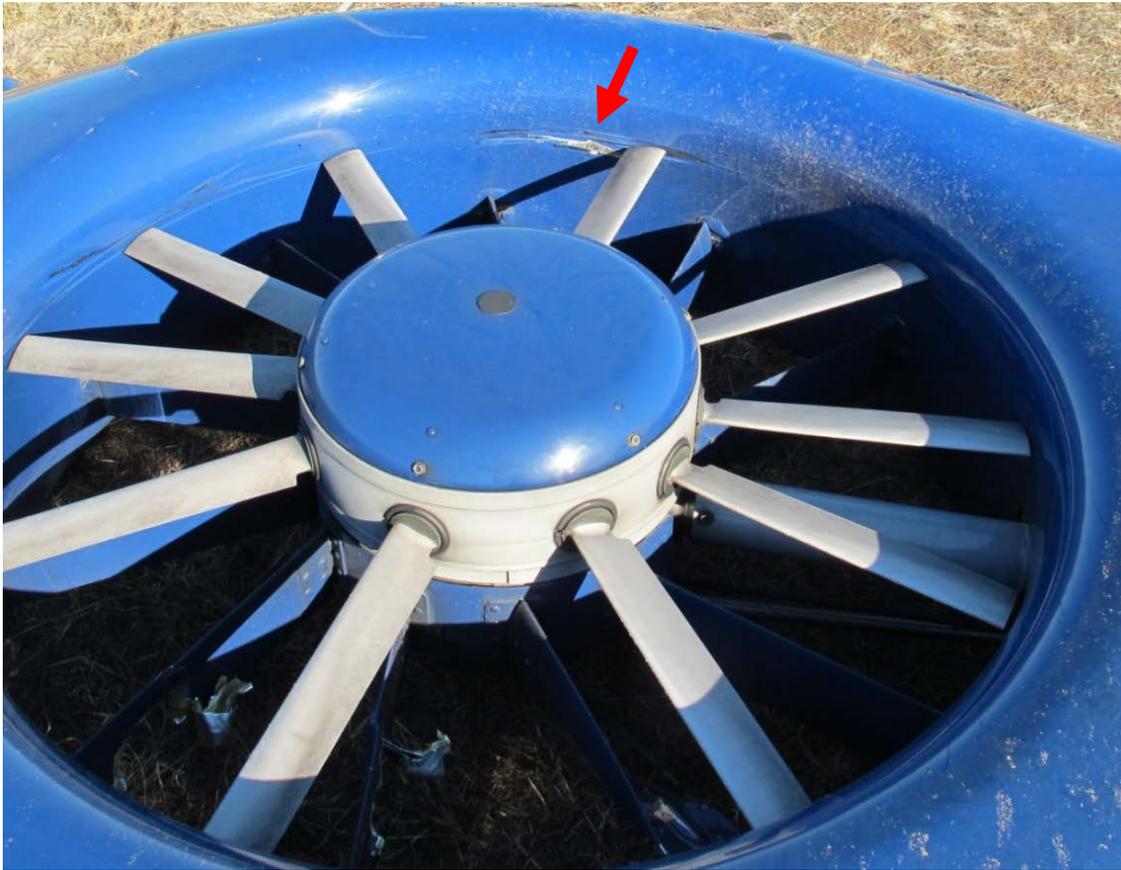
The flexible coupling from the Fenestron drive shaft to the tail gear box exhibited signatures of warping. Fenestron blades showed no evidence of rotational damage. Scuff marks in the path of tail rotor blade tip travel was observed on the Fenestron shroud adjacent to the blades, with a significant scuff mark found near the 6 o'clock position of the Fenestron (**Photo 6**). Three Fenestron stators exhibited impact damage that was matched to impact damage found on the tip of the 'blue' main rotor blade (**Photo 7**).

Photo 6. A significant scuff mark found on the Fenestron shroud.

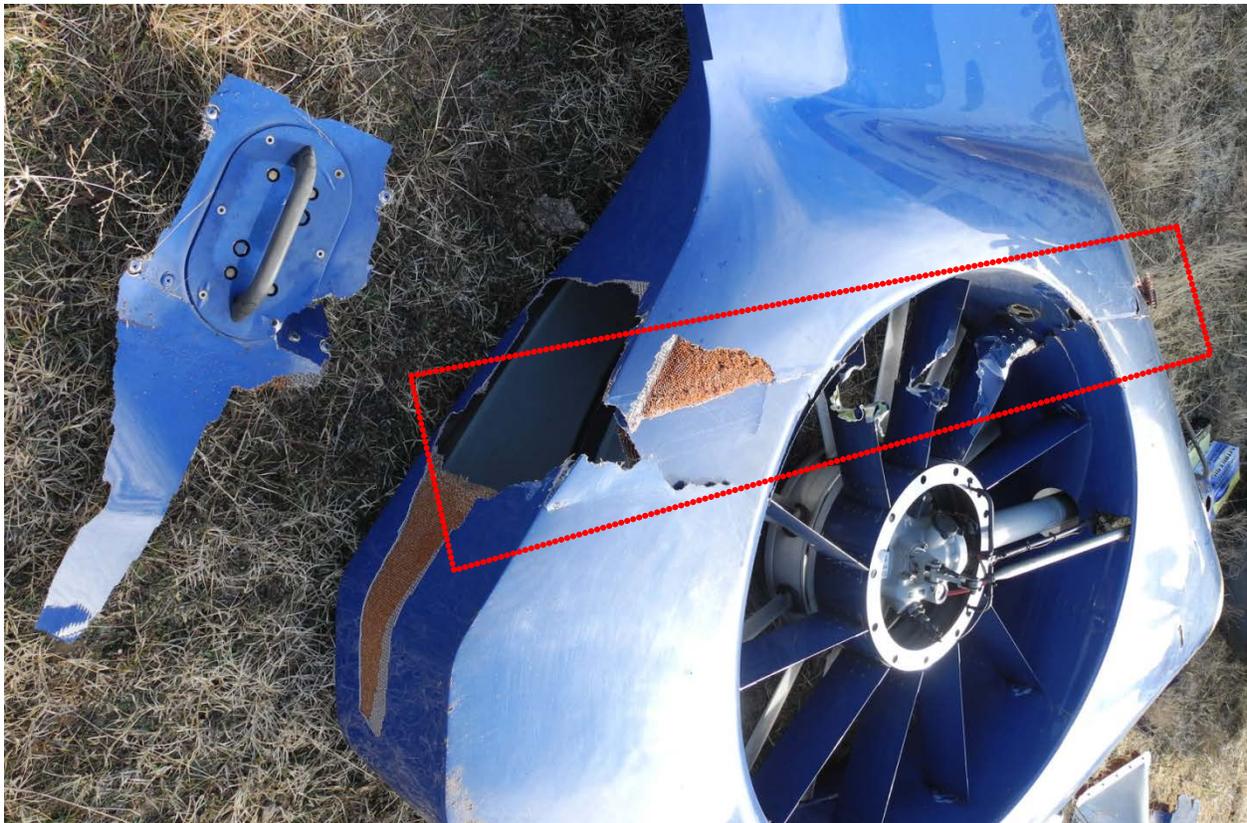
Photo 7. 'Blue' main rotor blade impact mark seen on the Fenestron.

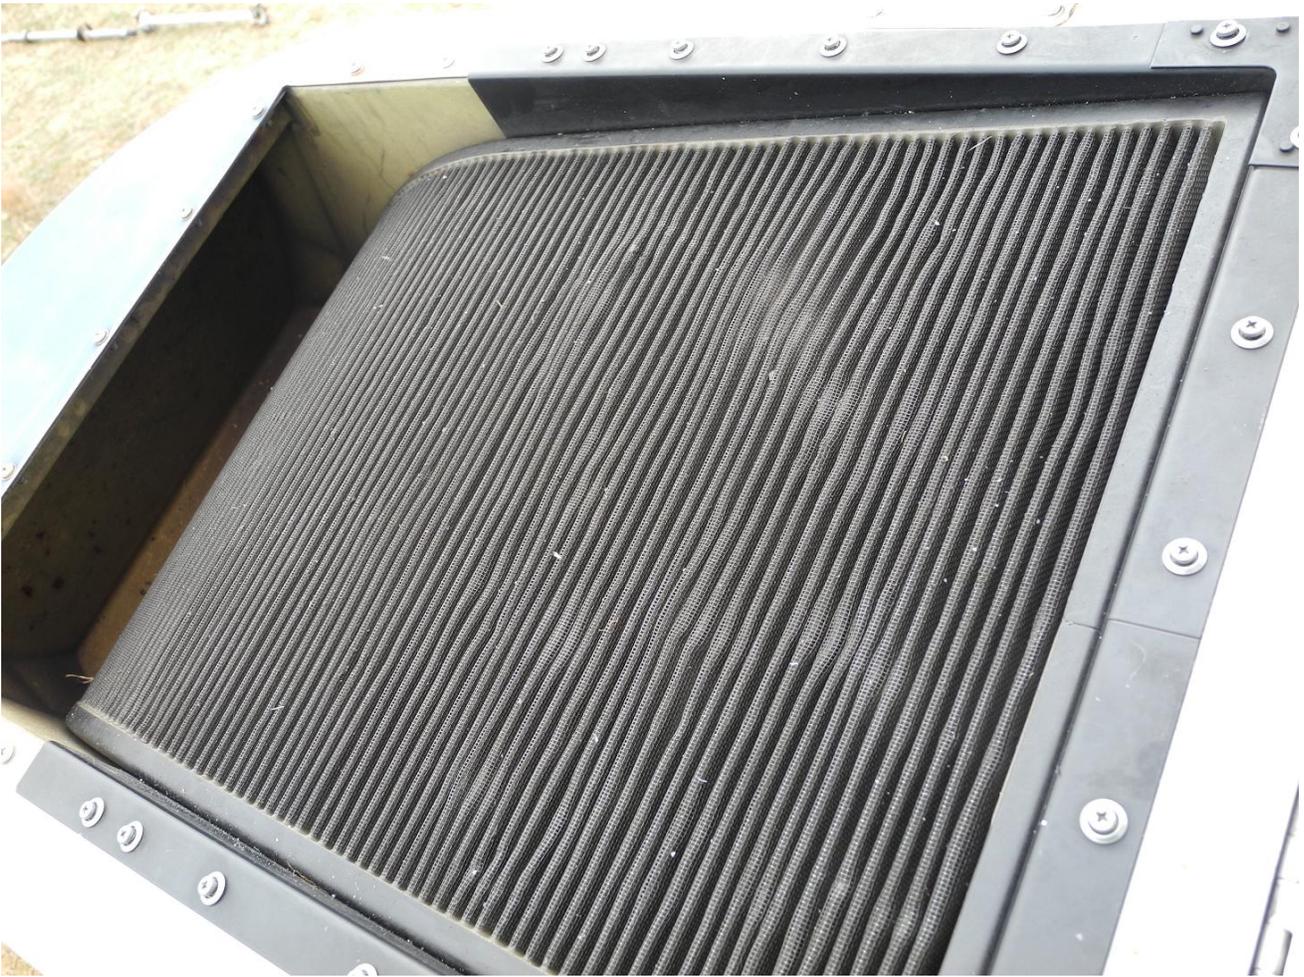
The air filter installed was observed to be the FDC/aerofilter air inlet barrier filter system. The air filter showed no evidence of major damage. No blockages or large pieces of FOD were observed on either side of the air filter (**Photos 8 and 9**). The air intake duct remained attached to the engine and showed no evidence of cracks or fractures. The drain hole in the air intake duct showed no evidence of blockages.

Photo 8. The outside surface of the FDC/aerofilter installed on the aircraft.

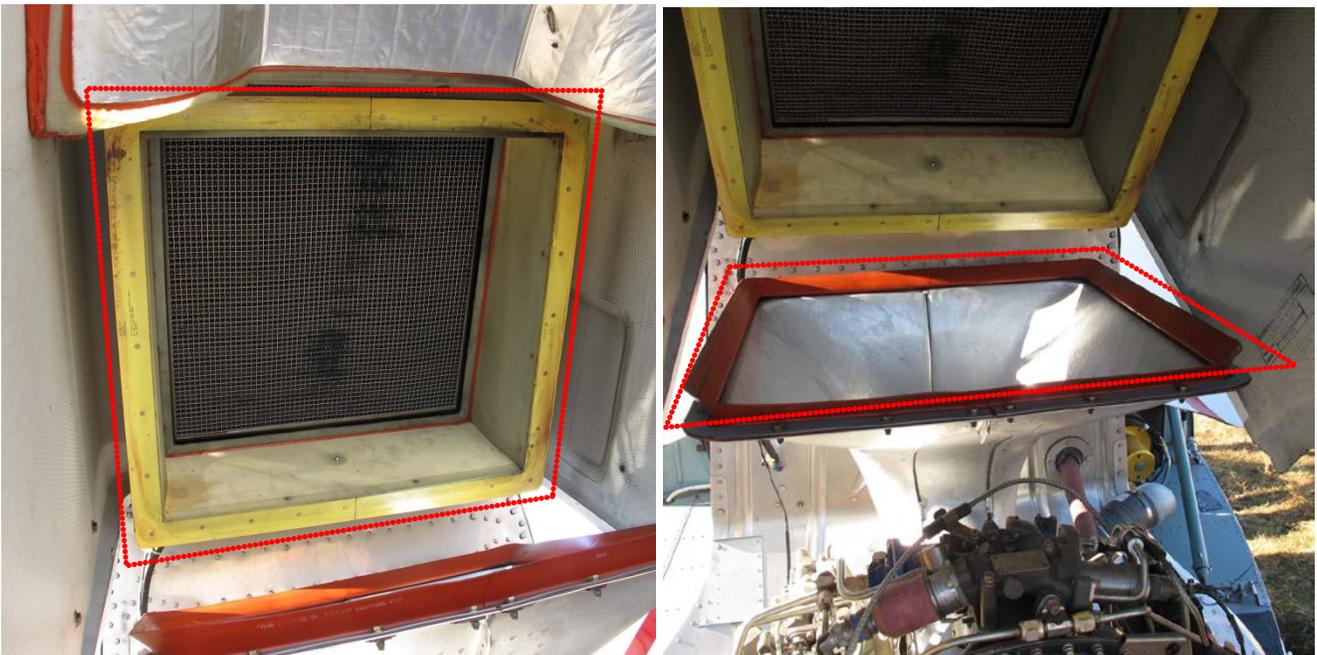
Photo 9. The underside of the air filter (left) and the air intake duct (right).

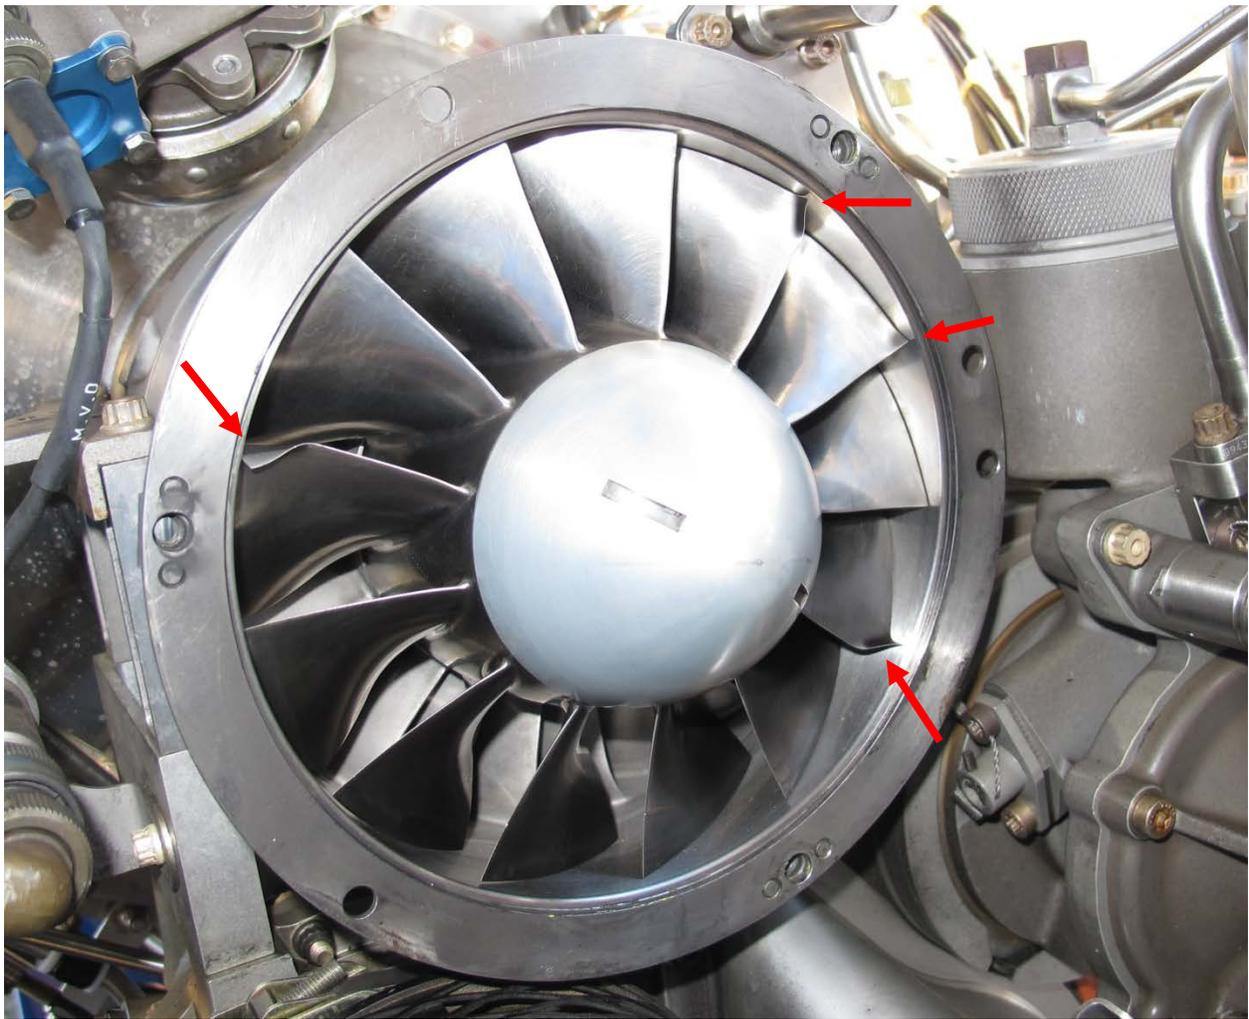
The engine remained installed on the airframe. The engine's fuel, oil, and electrical connections remained intact. The presence of fuel in the engine's HMU was confirmed. A sample of fuel was tested for the presence of water; the fuel exhibited no suspended water. Removal of the air intake duct exposed the axial compressor (the first stage of compression). Four axial compressor blades exhibited significant deformation on the outboard tips of their leading edges; the deformation was observed to be in the direction opposite of normal rotation (**Photo 10**). Deformation observed on the four axial compressor blades was consistent with ingestion of soft body FOD. Ice is an example of soft body FOD. The power turbine blades were observed to be undamaged (**Photo 11**).

Photo 10. Deformation found on the first-stage axial compressor blades.

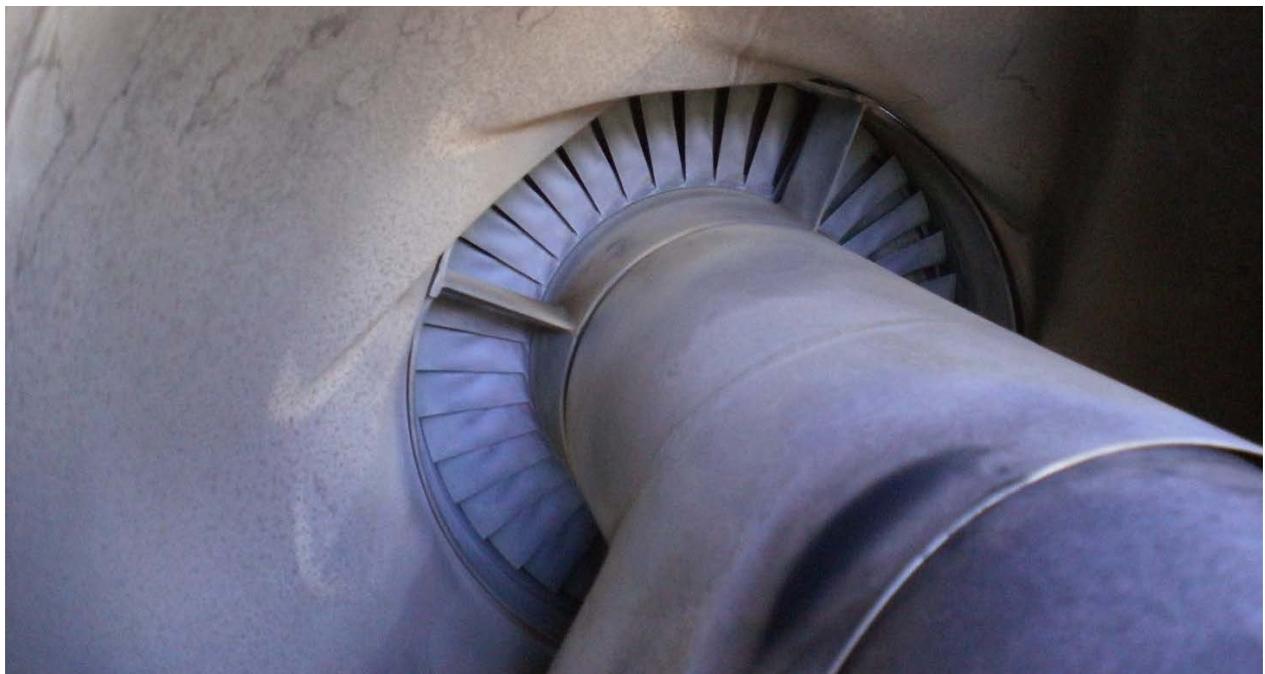
Photo 11. The power turbine blades (seen through the exhaust duct).

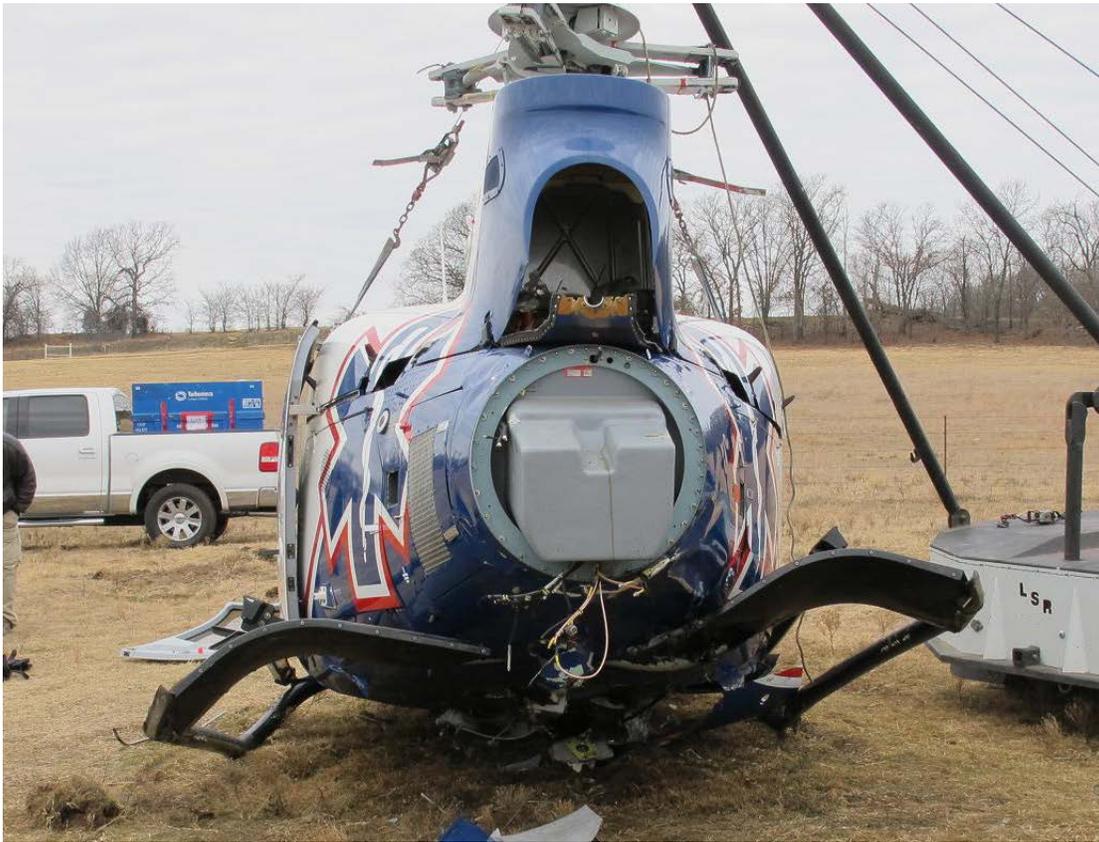
The main fuselage exhibited no signatures consistent with fracturing prior to ground impact. The landing skids remained attached to the main fuselage. The aft-left corner of the landing skid was observed to have dug itself into the ground. The landing skids exhibited significant deformation consistent with a hard impact to the ground (**Photo 12**).

Photo 12. Deformation seen on the landing skids.
