**NATIONAL TRANSPORTATION SAFETY BOARD
Office of Aviation Safety
Washington, D.C. 20594**

Airworthiness Group Chairman's Factual Report

NTSB ID No.: LAX08PA259

Location: Weaverville, California
Date: August 05, 2008
Time: About 7:41 PM Pacific Daylight Time (PDT)
Aircraft: Sikorsky S-61N Helicopter

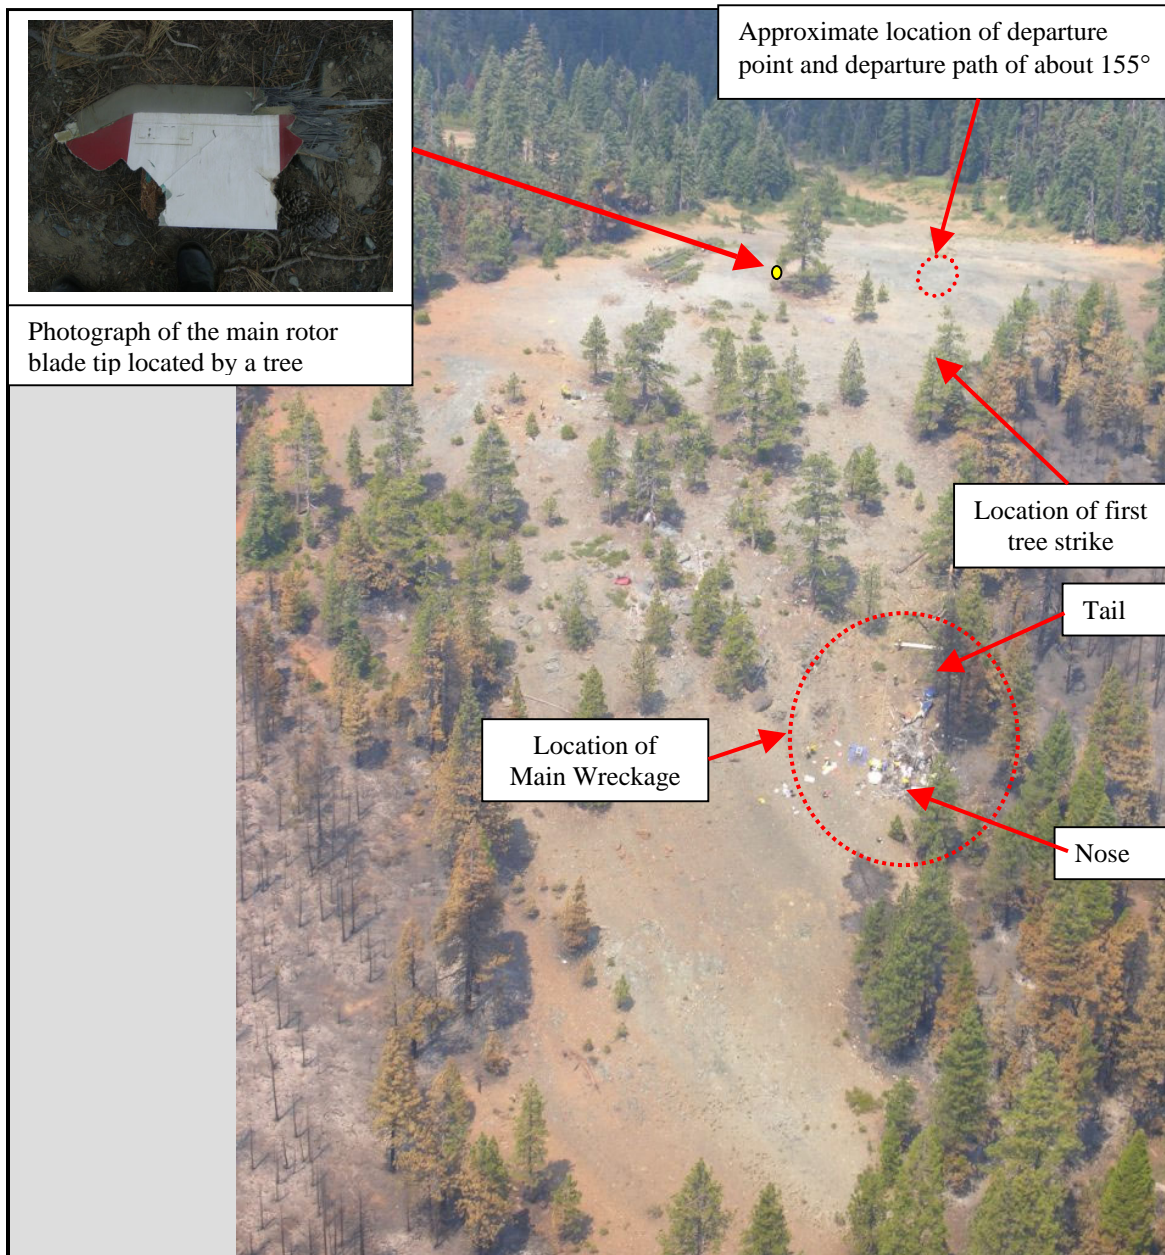
Information from the SkyConnect Tracker AFF system indicates that on August 5, 2008 at 19:39:17 local (about two minutes prior to the accident) the helicopter was located at a GPS position of Longitude 40.9142, Latitude 123.2522 traveling at a ground speed of zero knots on a heading of 138 degrees at an altitude of 5,955 feet mean sea level (MSL). It is not known if the helicopter was fully positioned on the ground when the SkyConnect Tracker AFF system transmitted the data. Investigation of this location revealed marks in the rocky soil that were consistent in size to the helicopter's tail wheel and also consistent with a witness statement of the helicopter's position just prior to takeoff. The ground elevation at this location was determined by the surveyor to be about 5,945 feet (Figure 2).

Figure 2 Photograph of Helispot 44 showing departure location and the main wreckage

The location of the main wreckage was surveyed⁵ and found to be located about 150 yards south-southeast of the helicopter's reported departure point at an approximate GPS position of Longitude 40.91302, Latitude 123.25163. The last data transmitted by the SkyConnect Tracker AFF system installed on N612AZ occurred on August 5, 2008 at 19:41:25 local and located the helicopter at a GPS position of Longitude 40.913, Latitude 123.2517, which is consistent with the location of the main wreckage as determined by the surveyor.

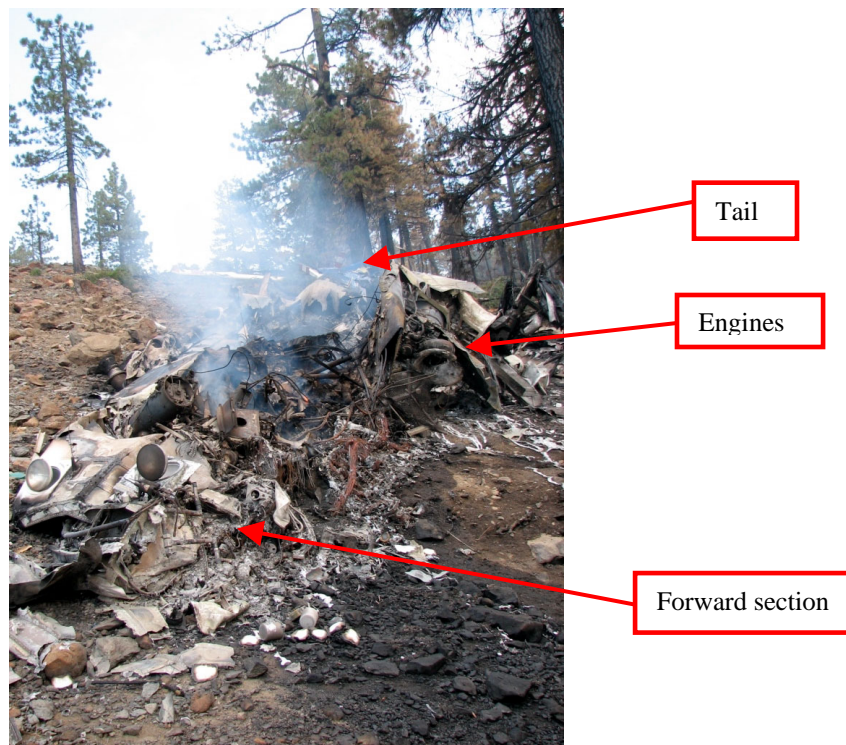
The helicopter was found resting on its left side with its nose lower than its tail boom. A post-crash fire had consumed most of the helicopter's airframe and structure forward of station 640. Resolidified molten metal was noted in several areas of the wreckage and in the impact area. The magnetic heading of the wreckage was about 155°. The helicopter came to rest in an area that was estimated to have about a 15 to 20 degree slope. Sections of the helicopter's lower fuselage structure including all fuel tank cells and the cabin flooring were found consumed by the post-crash fire. Most of the forward fuselage including the cockpit and the electronics compartment were found inverted and consumed by fire (Figure 3).

Figure 3 Photograph showing the forward fuselage section of the helicopter.

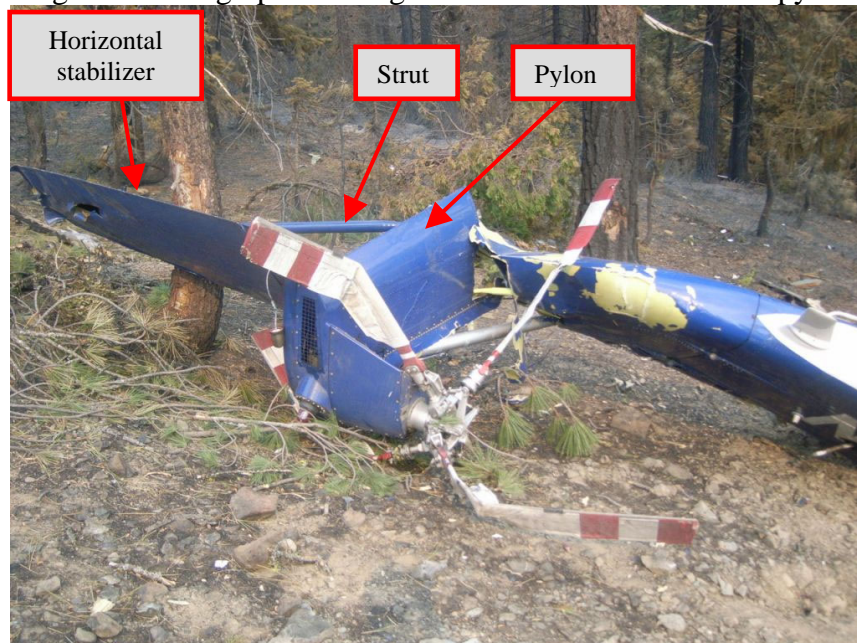
An on-scene assessment revealed that the horizontal stabilizer and its strut remained attached to the vertical pylon via their attachment hardware. The aft section of the pylon was found mostly separated from its mating section of the pylon just forward of the strut attachment (Figure 4).

Figure 4 Photograph showing the horizontal stabilizer and pylon

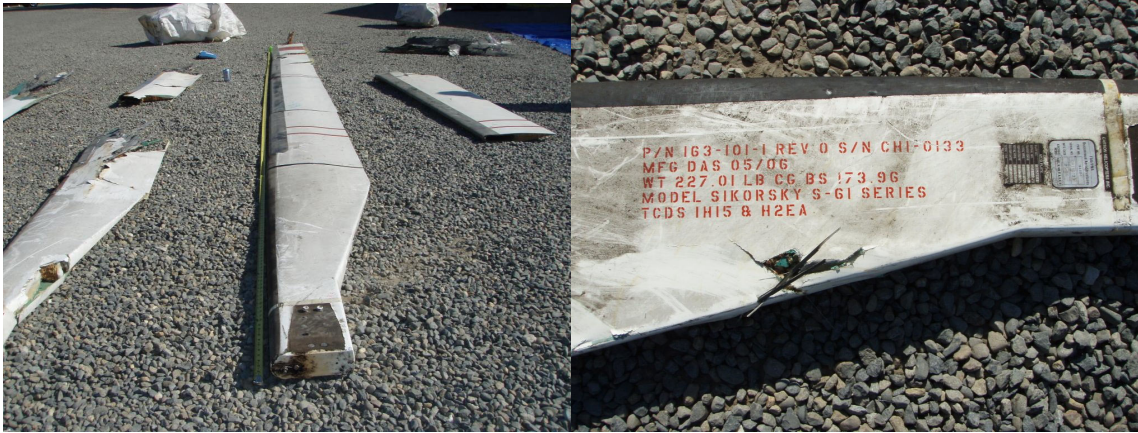
Blue paint transfer, (consistent with paint on the horizontal stabilizer), was noted between BS 118 and 142. Surface contamination (black ash or soot) inboard of about BS 90 was noted on both the upper and lower airfoil surfaces, more heavily along the leading edge (Figure 5). The contamination was sandpaper-rough in appearance, and there was evidence of some streaming in a combined chordwise and radial outward direction. The contamination could be removed by fingertip pressure and was not apparent on any of the other blades. For example, the Black blade inboard section had a dirty film appearance, but was not raised or rough in appearance as was the contamination on the White blade. The Black blade 'dirty film' could also be removed by fingertip pressure. During recovery, the White blade was saw cut at BS 66, 118, 190, and 264.

Figure 5
Photograph of the White main rotor blade showing evidence of contamination.

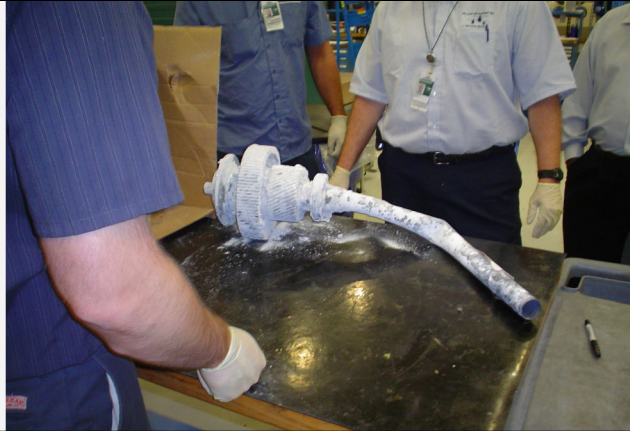
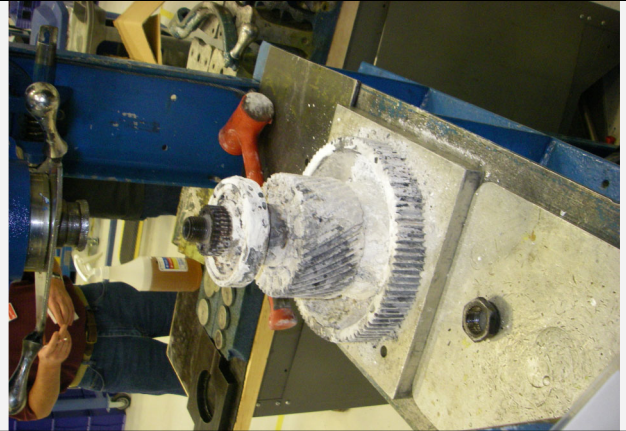
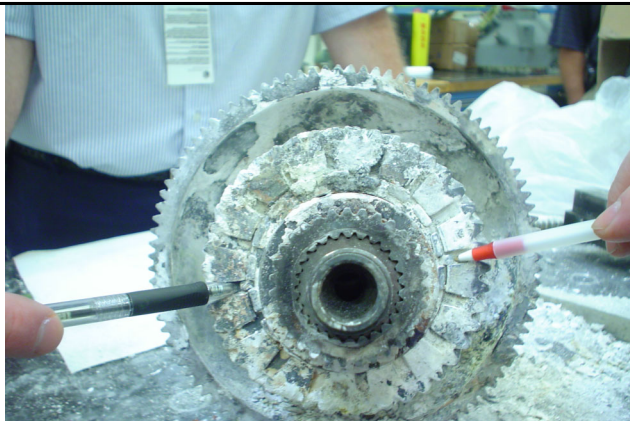
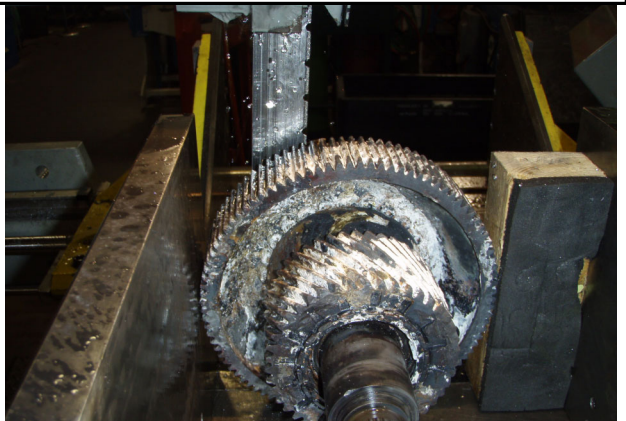
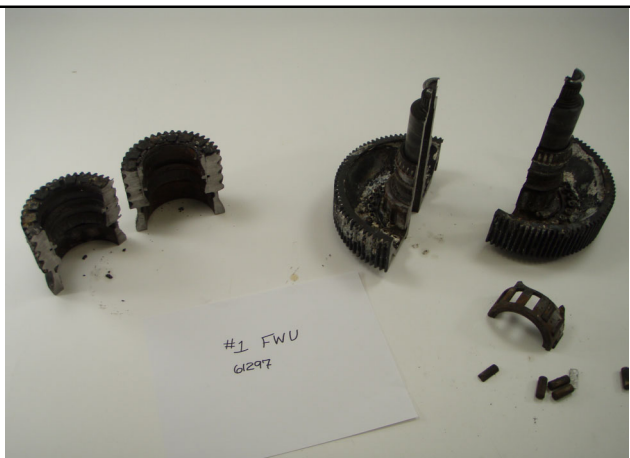
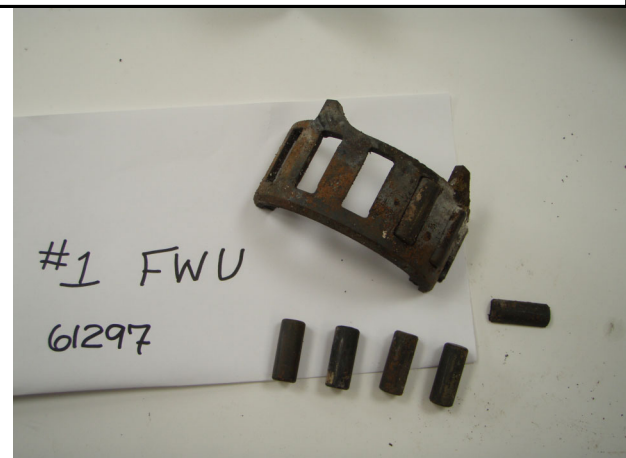
Figure 6
Photographs of the Number 1 IFWU

Prior to disassembly, visual examination revealed that the IFWU was heavily coated in a material consistent with magnesium oxide (Figure 6). A representative from HSI removed the shaft from the input spline and found the gear housing nut-locking tab in place and secured. After removing the camshaft aft lock nut, the camshaft aft roller bearing was examined and found to rotate smoothly, with no visible scoring. An attempt to remove the gear housing from the camshaft was unsuccessful. The Airworthiness Group determined that to inspect the internal mechanisms of the IFWU, the unit should be cut in half. The IFWU was re-packaged and hand carried to the Sikorsky Aircraft Corporation located in Stratford, Connecticut. Utilizing a band saw at the Sikorsky Aircraft Corporation fatigue lab machine shop, the IFWU was sectioned into two pieces along its axial centerline.

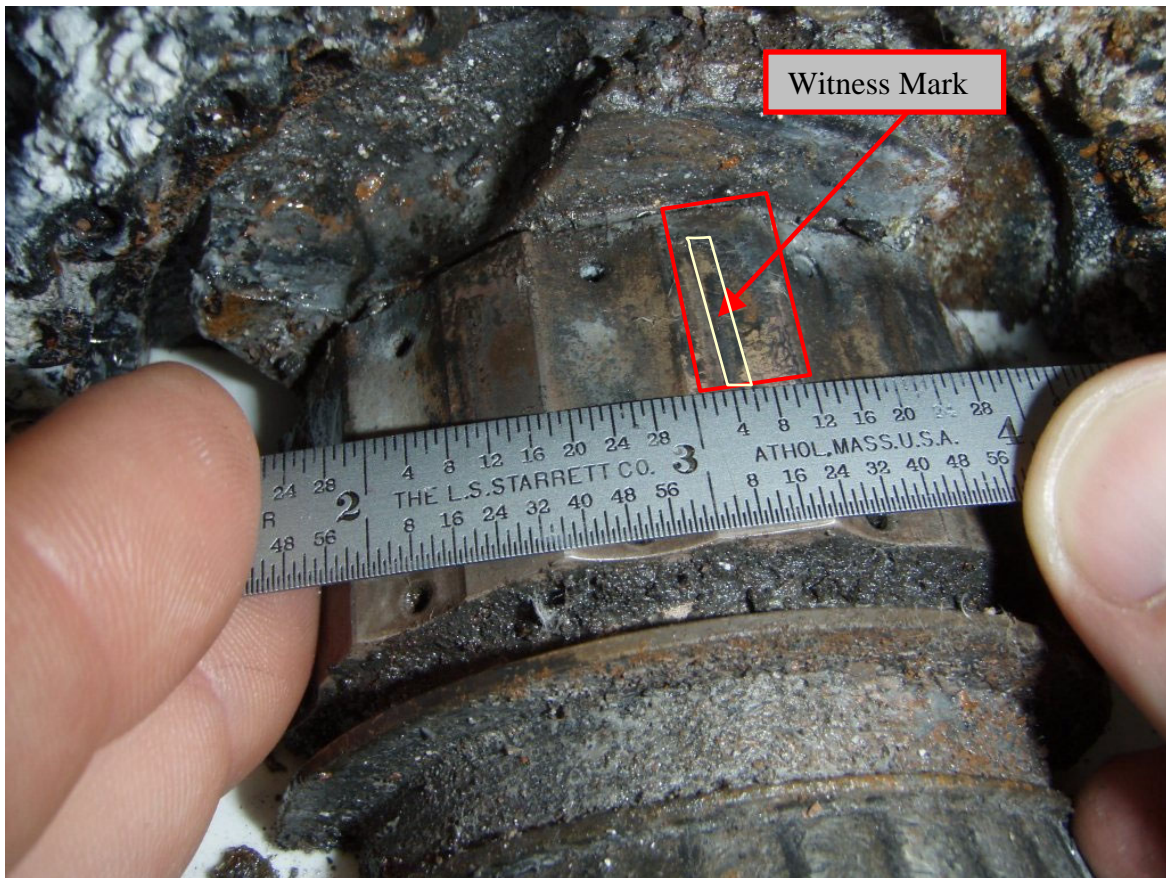
The group inspected the unit's camshaft flats for witness marks and noted marks approximately 0.050" wide at approximately 0.125" to 0.187" up from the beginning of the ramp (Figure 7). An inspection of the cam flats indicated no visible wear depressions, evidence of skidding, impact marks, contamination or any other indications of improper operation on the cam flat surface or on the gear housing. Visual examination of each of the 12 bearing rollers found no excessive wear, flat spots, contamination or deformations. The bronze Oilite bushings (two each) were found thermally destroyed; however, remnants of the bushings were visible in the exposed channel.

Figure 7 Photograph of the Number 1 IFWU showing the approximate 0.050" witness mark positioned at approximately 0.125" to 0.187" up from beginning of the ramp

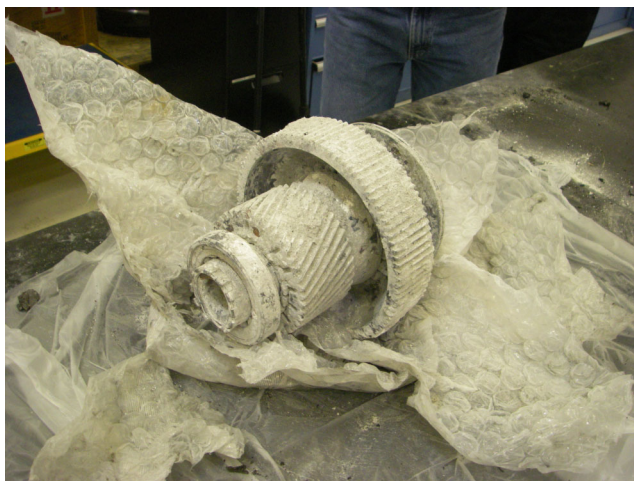
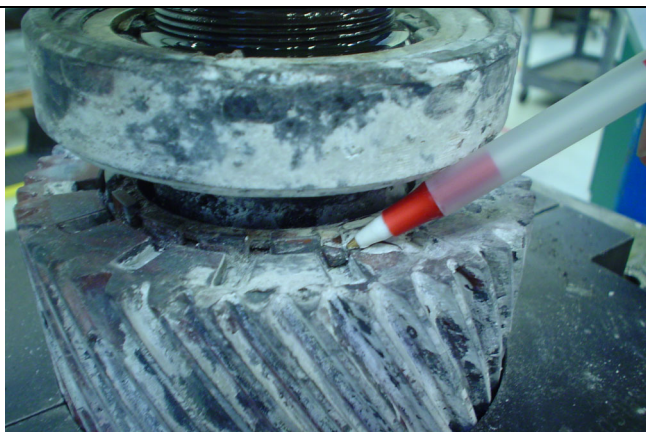
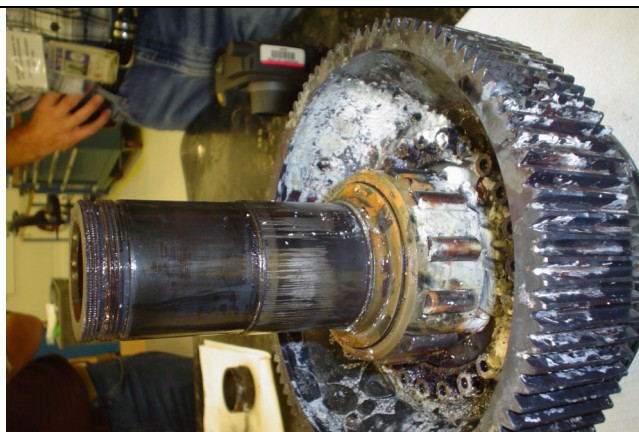
Figure 8
Photographs of the Number 2 IFWU

Prior to disassembly, visual examination revealed that the IFWU was heavily coated in a material consistent with magnesium oxide (Figure 8). A representative from HSI removed the camshaft aft locknut and found the gear housing nut-locking tab in place and secured. After removing the camshaft lock nut, the camshaft aft roller bearing was examined and found to rotate smoothly, with no visible scoring. The gear housing was separated from the camshaft successfully after about 16 tons of pressure was applied to the shaft. Upon inspection, three sequential rollers were found heat-welded to the camshaft,

preventing removal of the roller retainer. The Airworthiness Group determined that to inspect the internal mechanisms of the roller retainer; the retainer should be cut in half. The IFWU was re-packaged and hand carried to the Sikorsky Aircraft Corporation. Utilizing a band saw at the Sikorsky Aircraft Corporation fatigue lab machine shop, the roller retainer was cut into two pieces with two diametrically opposed cuts through the retainer. The less heat-damaged section of the roller retainer was tapped off the camshaft using a brass drift, and the cam flats and rollers were evaluated.

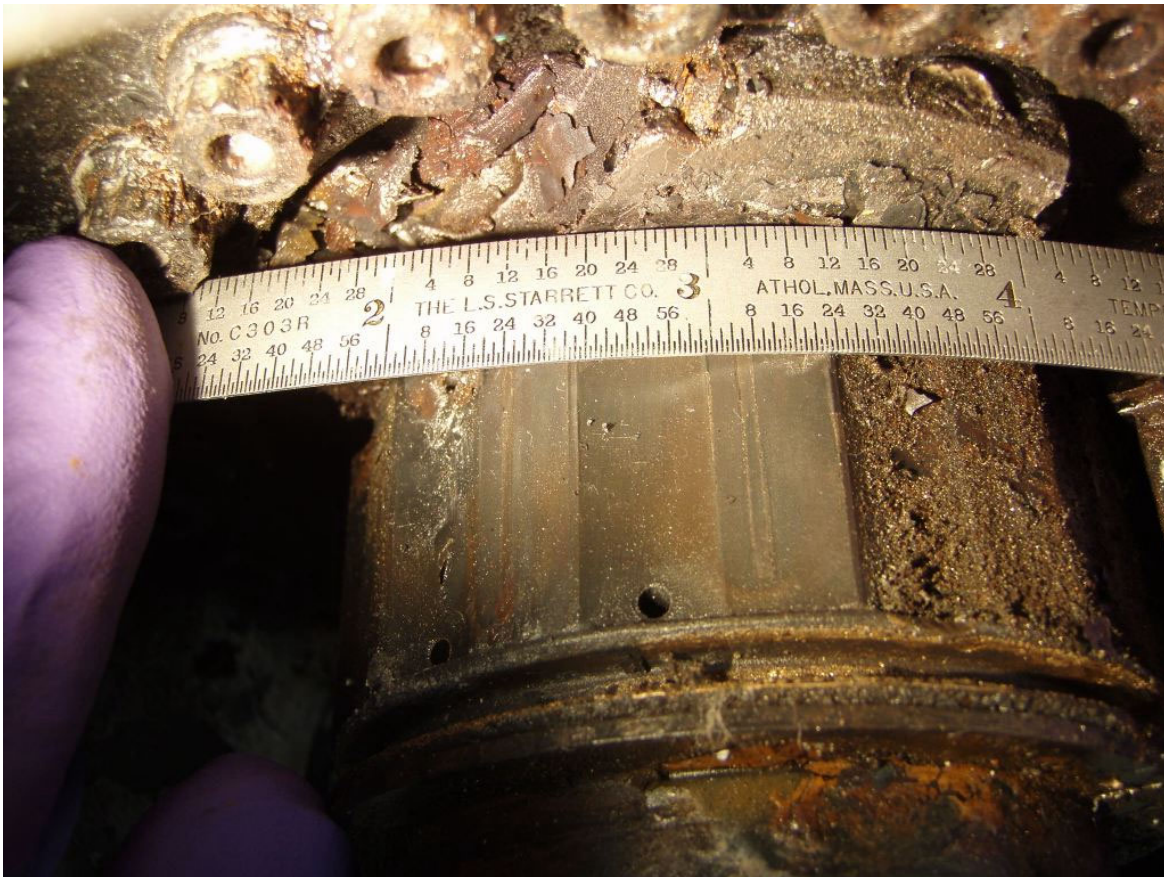
The group inspected the cam flats for witness marks and noted marks approximately 0.050" wide at approximately 0.078" to 0.140" up from the beginning of the ramp (Figure 9). An inspection of the cam flats indicated no visible wear depressions, evidence of skidding, impact marks, contamination or any other indications of improper operation on the cam flat surface or on the gear housing. Visual examination of each of the 12 bearing rollers found no excessive wear, flat spots, contamination or deformations. The bronze Oilite bushings (two each) were found thermally destroyed; however remnants of the bushings were visible in the exposed channel.

Figure 9 Photograph of Number 2 IFWU showing the 0.050" witness mark positioned at approximately 0.078 to 0.140" up from beginning of ramp

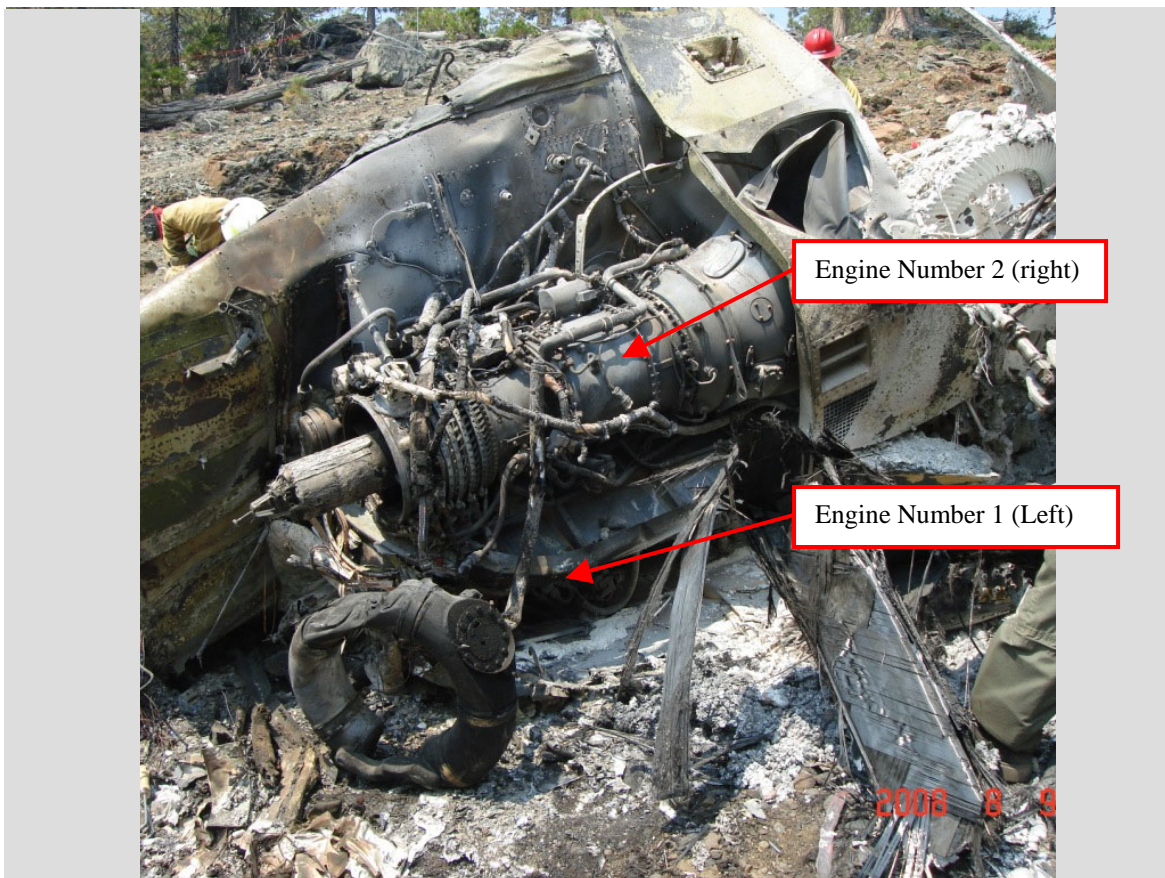
Figure 16 Photograph of the engines at wreckage site

Both engines exhibited widespread heat/fire damage on their external components and there were no visible “burn through” areas on any of the engine casings. For each engine, the engine speed control flex cable assembly remained intact, contained within its clamps attaching it to the engine, and connected to the fuel control unit. The left and right engine speed control flex cable assemblies remained attached to its respective fuel control unit input linkage. To facilitate the removal of the engines from the wreckage, the engine speed control flex cable assemblies were disconnected from the fuel control unit by removing the bolt that attaches the cable to the unit.

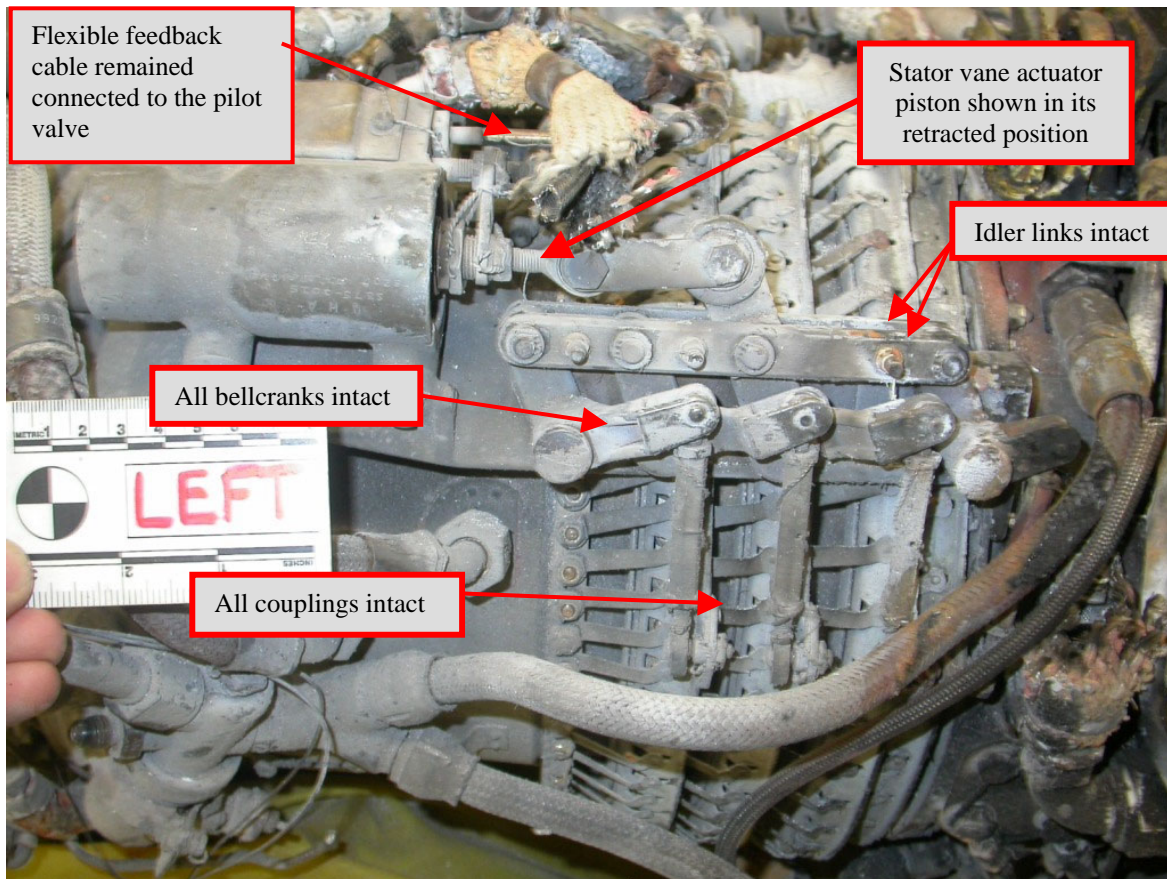
Photograph of the stator vane actuator and support linkage from Engine Number 1 (S/N 295-120C)

The SVA actuator remained attached to the compressor casing and its piston was found fully retracted. The SVAs flexible feedback cable remained connected to the pilot valve (feedback lever) and to the SVA assembly (overspeed control). The feedback cable was observed in position consistent with the SVA in a fully closed position. Under the supervision of the GE representative, a representative from Columbia Helicopter Inc. removed the piston from the SVA actuator and then sectioned the actuator housing into two pieces to allow for an internal visual inspection of the housing and the piston for witness marks. One possible witness mark was observed 1/2 inch from the end on the piston consistent with the piston being positioned at open ($>95\% N_G$) during impact.

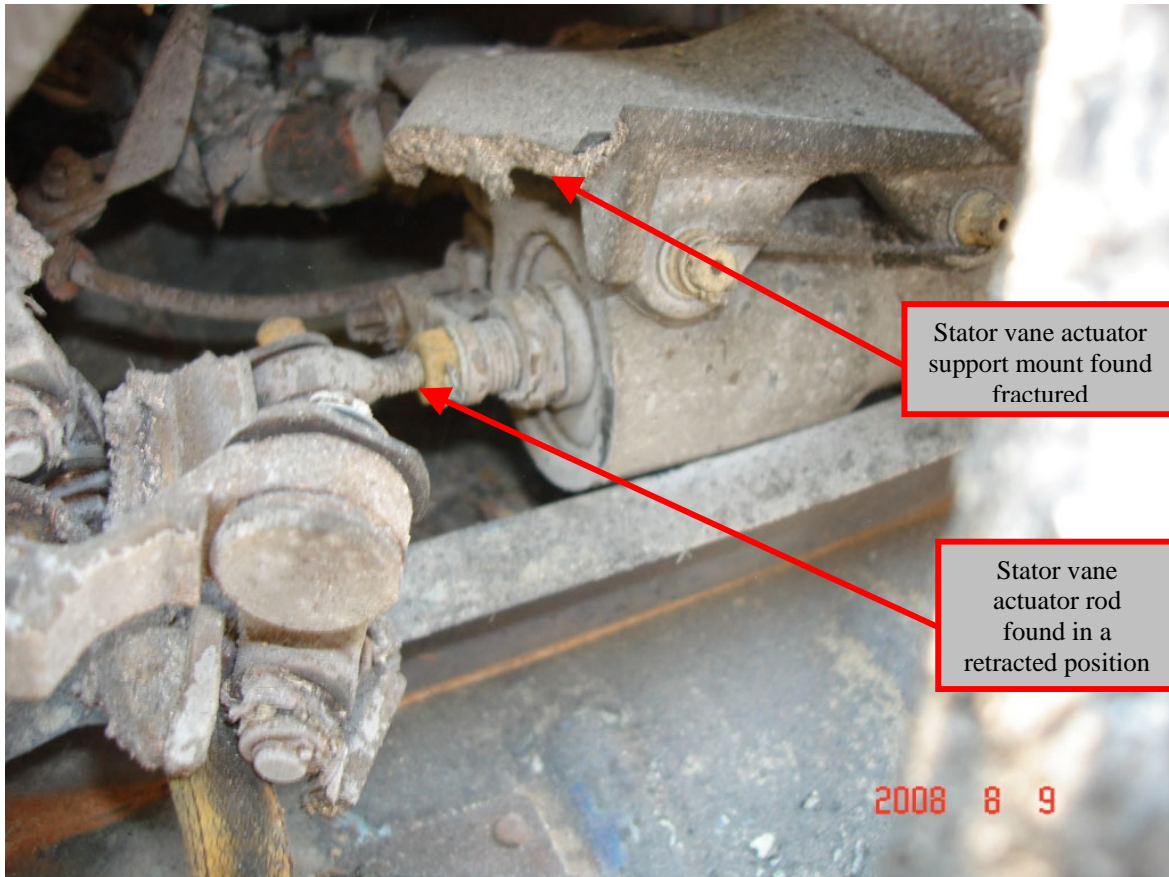
Figure 23 Photograph of the stator vane actuator on Engine Number 2 at accident site

Examination found that the SVA rigging is on the C mark.²⁵ The fuel control's pilot valve linkage remained intact, the pilot valve piston could not be moved and using hand pressure, there was no resistance on the fuel control unit pilot valve arm. The Airworthiness Group submitted the pilot valve to the National Transportation Safety Board Materials Laboratory for metallurgical examination²⁶. Reference NTSB Materials Laboratory Factual Report number 09-019 in the Safety Board's public docket for accident number LAX08PA259.

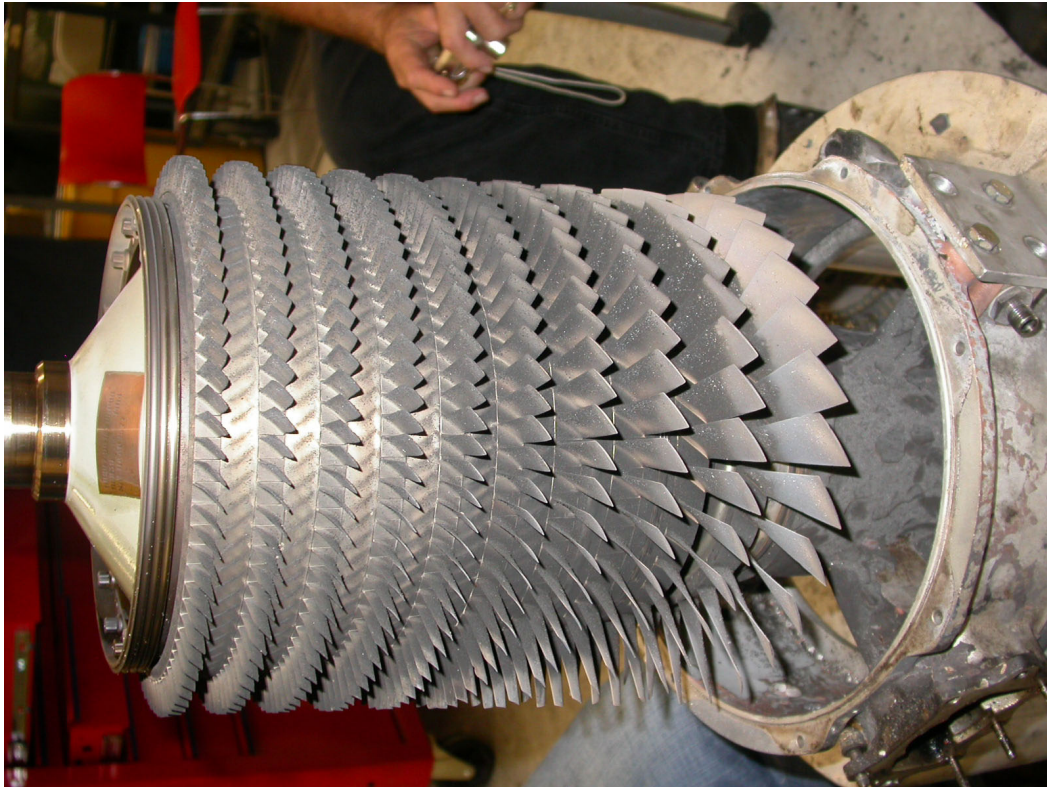
Photograph of the compressor from Engine Number 2 (S/N 296-024D) at Columbia Helicopter Inc.

Examination of the first stage compressor wheel blades revealed that most blades appeared to be undamaged. The leading edges of five blade tips were found bent in the direction opposite of rotation. Two blades were found dented at the leading edge mid-span. The blades and platforms were found coated with a light powdery gray coating. Approximately $\frac{3}{4}$ of the blades have black soot up to the mid-span. There was very light rotational scoring on the blade tips. The leading edge tip of one second-stage compressor blade exhibited a small nick, and rollover and there was very light rotational scoring on the blade tips. The blades and platforms were found coated with a light powdery gray coating. Examination of stages 3 – 10 of the compressor wheel revealed that all the blades were coated with a layer of black soot along the span on the concave and convex side. The platform and drum surfaces are coated with a sooty pattern biased to one side. Approximately 5% of the blades were nicked or torn predominately on the trailing edge tips.

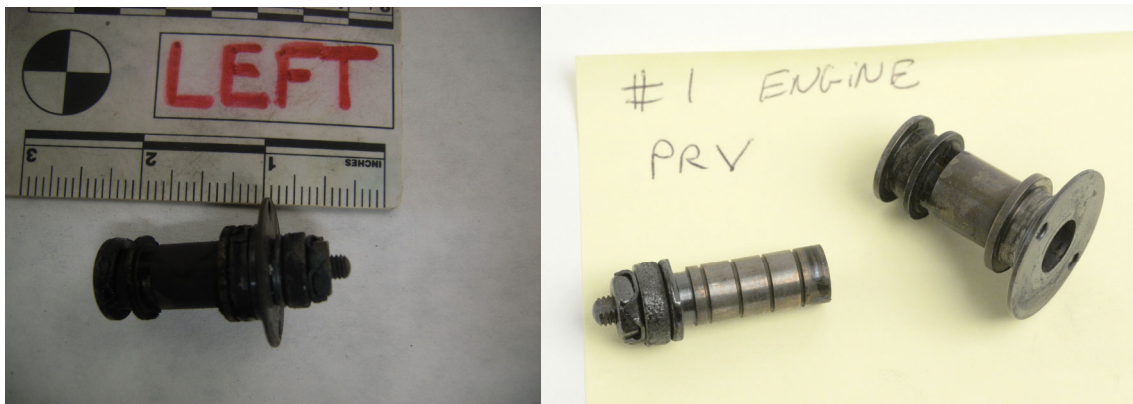
Photograph of the PRV removed from the left engine's FCU, serial number 72835BR

The PRV was further examined at Hamilton Sundstrand at which time its spool and sleeve assembly were separated from each other using an arbor press (very little force was required). After the spool was removed from the sleeve, erosion was observed on the edge of the spool near the metering edge. According to a representative from Hamilton Sundstrand, the erosion appears normal and is indicative of a high time valve spool. No evidence of contamination was observed in the spool's balance grooves and, other than soot, the sleeve appeared clean. Linear scratches were observed on the spool and according to Hamilton Sundstrand these scratches looked like a normal wear pattern. Witness marks of coked fuel were seen on the outer diameter (O.D.) of the spool that matched the opening of the metering windows in the sleeve. The Airworthiness Group

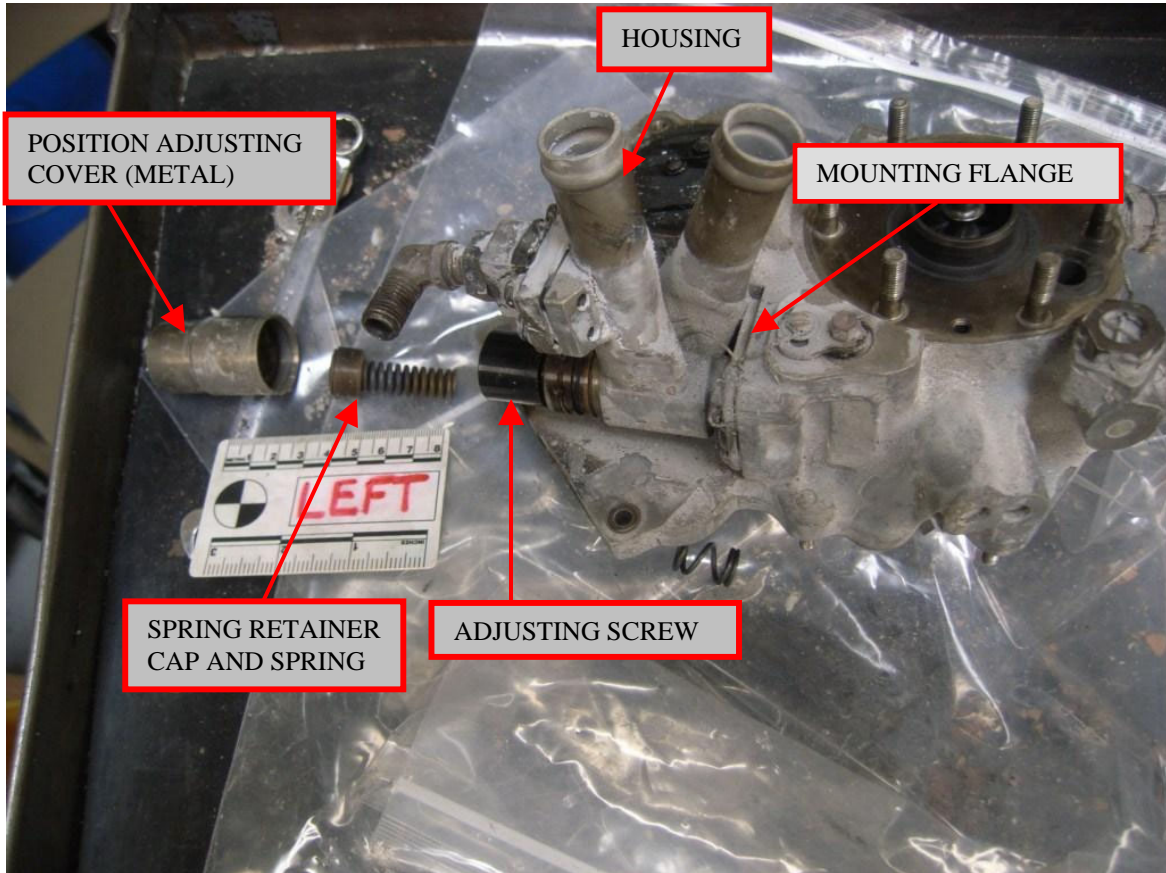
Photograph of the left engine's FCU, serial number 72835BR, showing T2 Servo and Bellows Group

Visual examination at Hamilton Sundstrand revealed that one end of the adjusting screw remained attached to its mating housing assembly; its other end was found fractured 360-degrees around its circumference. The outer lips of the adjusting screw's snap ring grooves appeared to have been extruded as if the snap ring and plug were forced outward. Examination revealed that the T₂ servo assembly-mounting flange appeared warped. When measured with a flat straight edge (machinist's parallel bar) light could clearly be seen between the mounting flange and the FCU housing. The Airworthiness Group submitted the housing assembly (containing the adjusting screw) to the National Transportation Safety Board Materials Laboratory for metallurgical examination of the fracture surface on the adjusting screw and an evaluation of the "warped" mounting flange (Reference NTSB Materials Laboratory Factual Report number 08-121 in the Safety Board's public docket for accident, LAX08PA259).

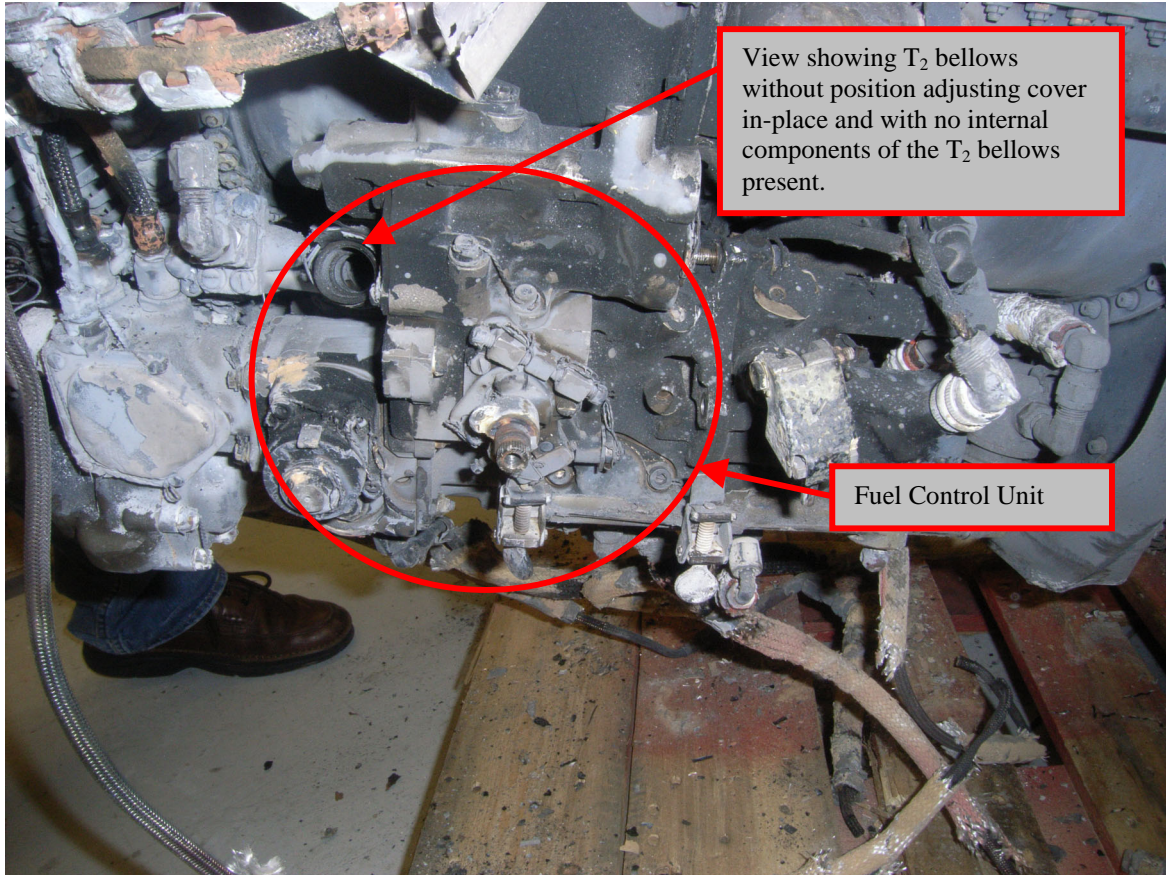
Figure 34 Photograph of the right engines FCU, serial number 49882, as installed on the engine

Overall, the FCU remained intact, all attachment hardware and safety wire were present and secured, and all of its external components (other than the T₂ bellows group) visually appeared to be intact and in place. White oxide residue was present on the exterior of the main housing including within the T₂ aspirator supply tubes. Upon disassembly of the unit, the inside of the FCU was found dry (no fuel present) and coated with a thin layer of black material consistent with residue from coked fuel. Charred remnants of elastomer and polymer seals were found in the areas where the seals would normally be present. No metal contamination was visually observed within the upper or lower control housings and all of the internal components were observed to have no mechanical damage. The machined surfaces of the main housing and internal components were observed with no scoring, galling, scratch marks or mechanical damage.

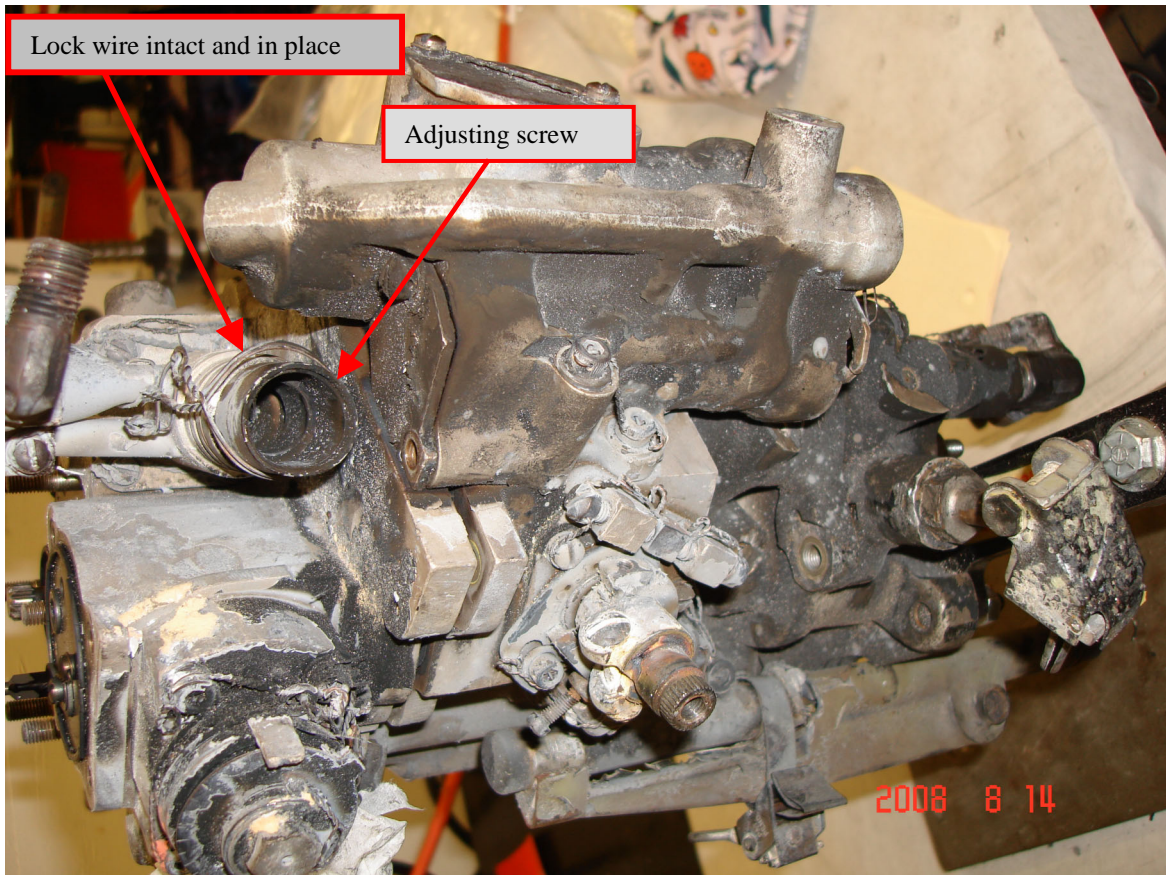
Figure 35 Photograph of the right engine's FCU, serial number 49882, after removal from the engine

Visual examination, at Hamilton Sundstrand, revealed that one end of the adjusting screw remained attached to its mating housing assembly; its other end was found fractured 360-degrees around its circumference. The opening of the adjusting screw appeared oval shaped with sooting consistent with exposure to fire and heat. The outer lips of the adjusting screw's snap ring grooves appeared to have been extruded as if the snap ring and plug were forced outward. Examination revealed that the T₂ servo assembly-mounting flange appeared warped. When measured with a flat straight edge (machinists parallel bar) light could clearly be seen between the mounting flange and the FCU housing.
