# **AIRWORTHINESS GROUP CHAIRMAN'S FACTUAL REPORT OF INVESTIGATION**

November 5, 2011

- A. ACCIDENT ID:** DCA11IA040
- LOCATION:** Louis Armstrong New Orleans International Airport (MSY),  
Louisiana
- DATE/TIME:** April 4, 2011, at about 0725 am (CDT/Local)
- AIRCRAFT:** Airbus Model A320-232, registration N409UA  
Operating as United Airlines Flight 497

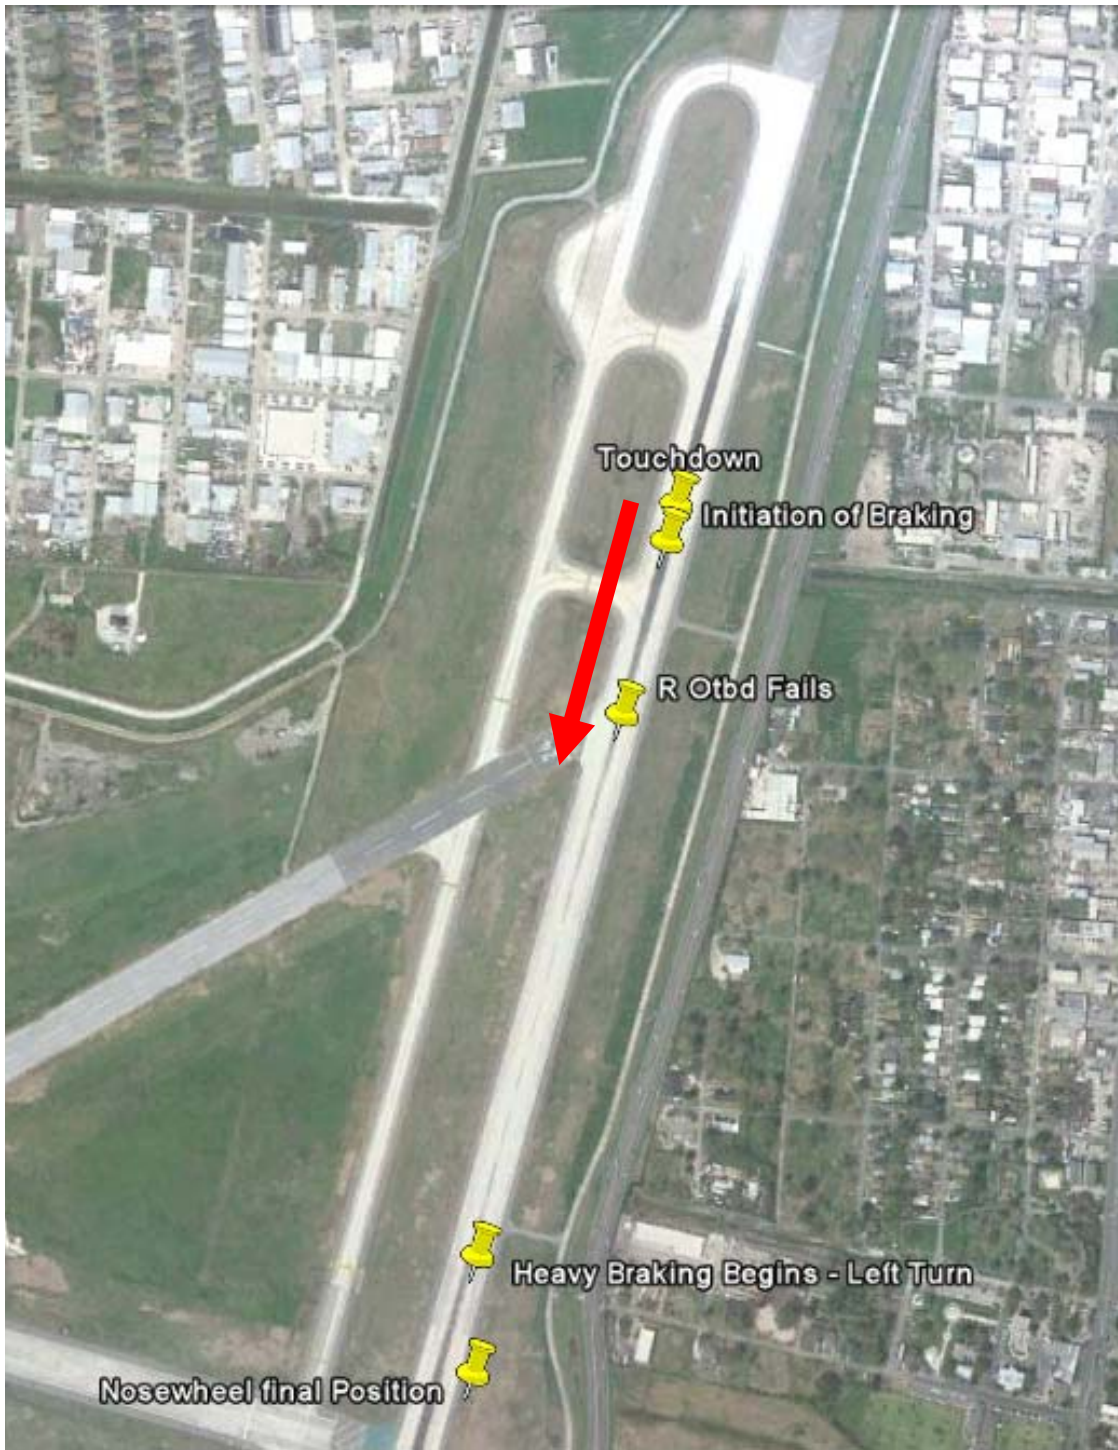
The airplane came to rest with the nose landing gear submerged in soil and the main gear on pavement, east of the intersection of runways 10/28 and 1/19. Black rubber marks led to the main landing gear tires and light gray led to the nose tires. Apart from black rubber marks on the runway and displacement of the grass and soil, the airport was not physically damaged or altered by the landing. (See Figure 1)

Figure 1 Relative locations of points on runway 19. Red arrow denotes direction of landing.

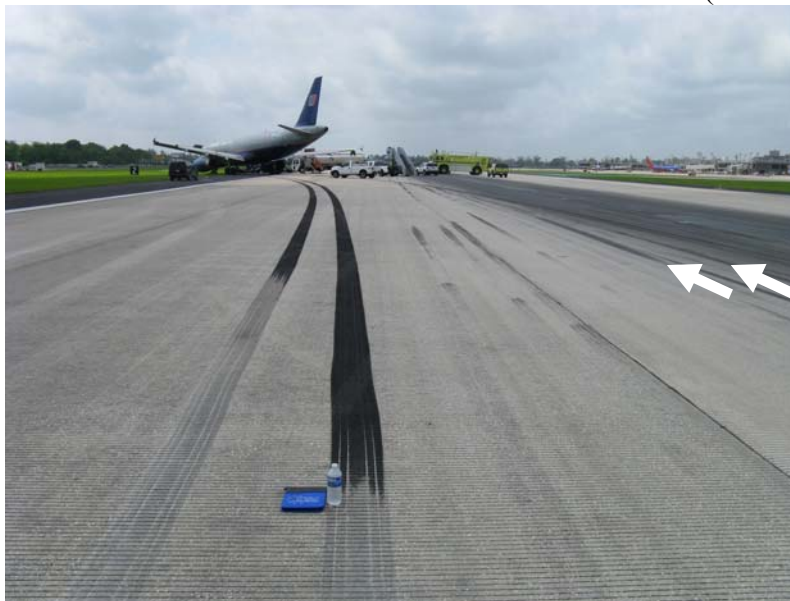
1. N 29 59 54.5 W 090 14 49.2      Approximate touchdown  
201 feet between this location (Point #1) and the next (Point #2)
2. N 29 59 52.5 W 090 14 49.8      Initiation of braking marks  
596 feet between this location and the next
3. N 29 59 46.8 W 090 14 51.5      Failure of right outboard tire  
2075 feet between this location and the next
4. N 29 59 27.0 W 090 14 57.6      Indications of heavy braking begin along  
track of the left tire set (See Figure 2)

Figure 2. The water bottle is where the overhead photo in Figure 1 is labeled “Heavy Braking Begins – Left Turn.” The white pickup truck is parked on the tire marks that lead to the right set of tires, also shown at the pair of white arrows.

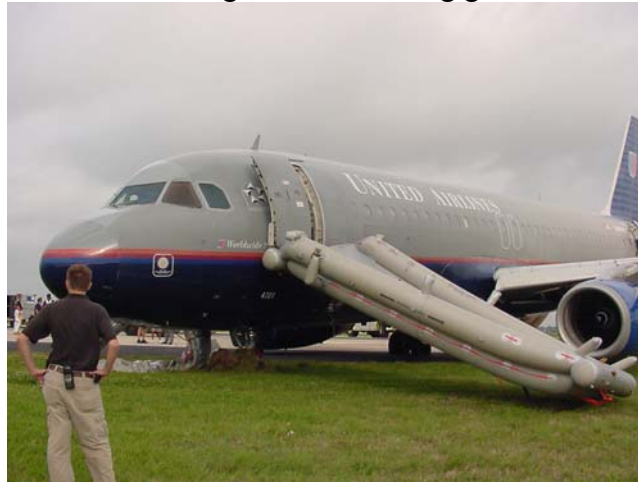
No physical damage was observed to the structures of the fuselage, wings, flight controls, flaps, or fairings and no physical evidence of fire was found. The nose landing gear had been buried before the nose of the airplane was recovered to the runway. (See Figures 3 and 4) During replacement of an electrical conduit and the nose wheels, no visible damage was found to the structure surrounding the nose landing gear.

Figure 3. Nose tire below ground level.

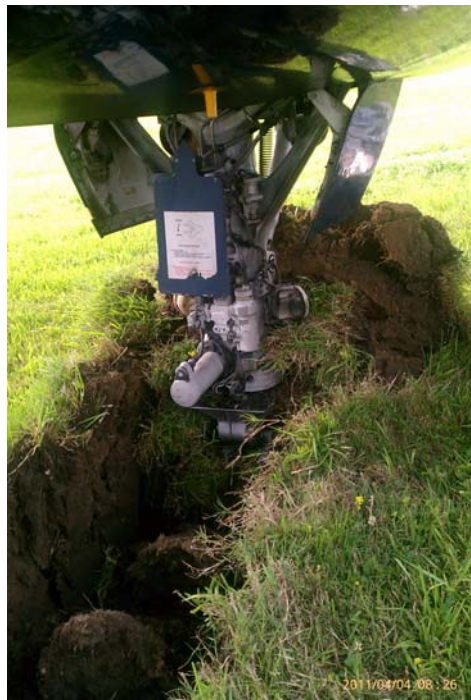
Figure 4. Close up of buried nose landing gear.

Once in a parking area, the group did not have the jacks and other equipment necessary to accomplish the visual inspection requirements specified by the Airplane Maintenance Manual overweight landing or for an off runway excursion. United Airlines subsequently performed these inspections and found no anomalies. United Airlines performed additional inspections in the area of the nose landing gear and found no structural damage.

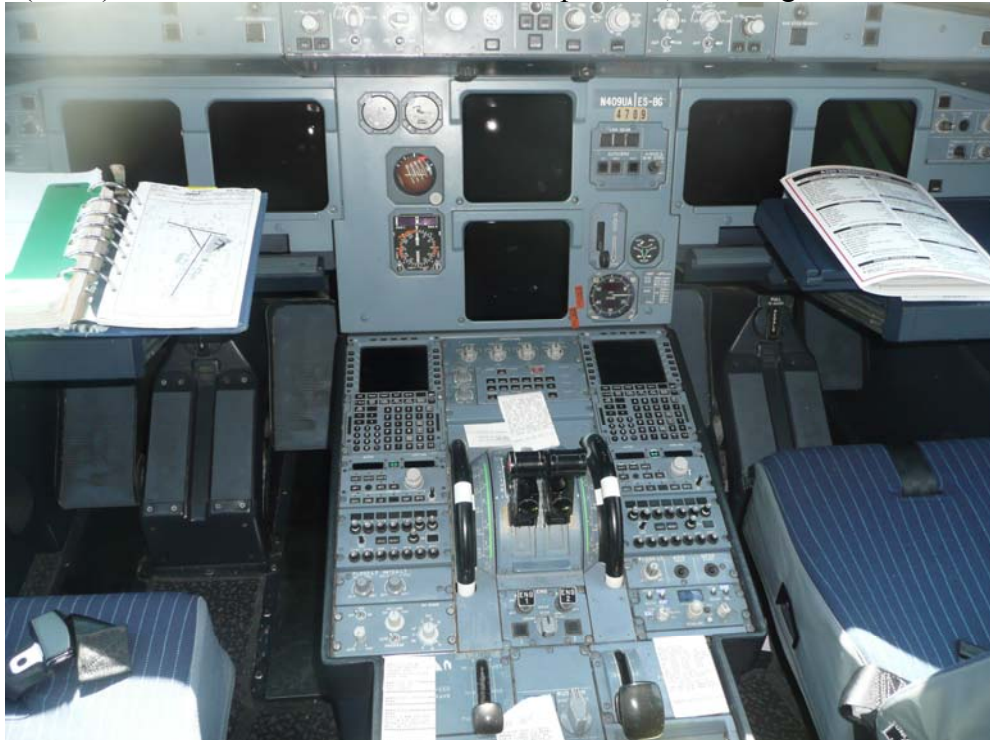
On the Captain's desk was an approach chart for the MSY airport. On the First Officer's desk was a laminated checklist that included A320 EMERGENCY steps. (See Figure 5) The laminated checklist pocket was empty on the First Officer's side of the pedestal and the Captain's laminated checklist was still in the stowage pocket. An airplane flight manual (AFM) was found on the floor behind the pedestal, to the right of center.

Figure 5. Cockpit, as found. The two vertically oriented Engine Centralized Aircraft Monitoring (ECAM) displays are in the center.

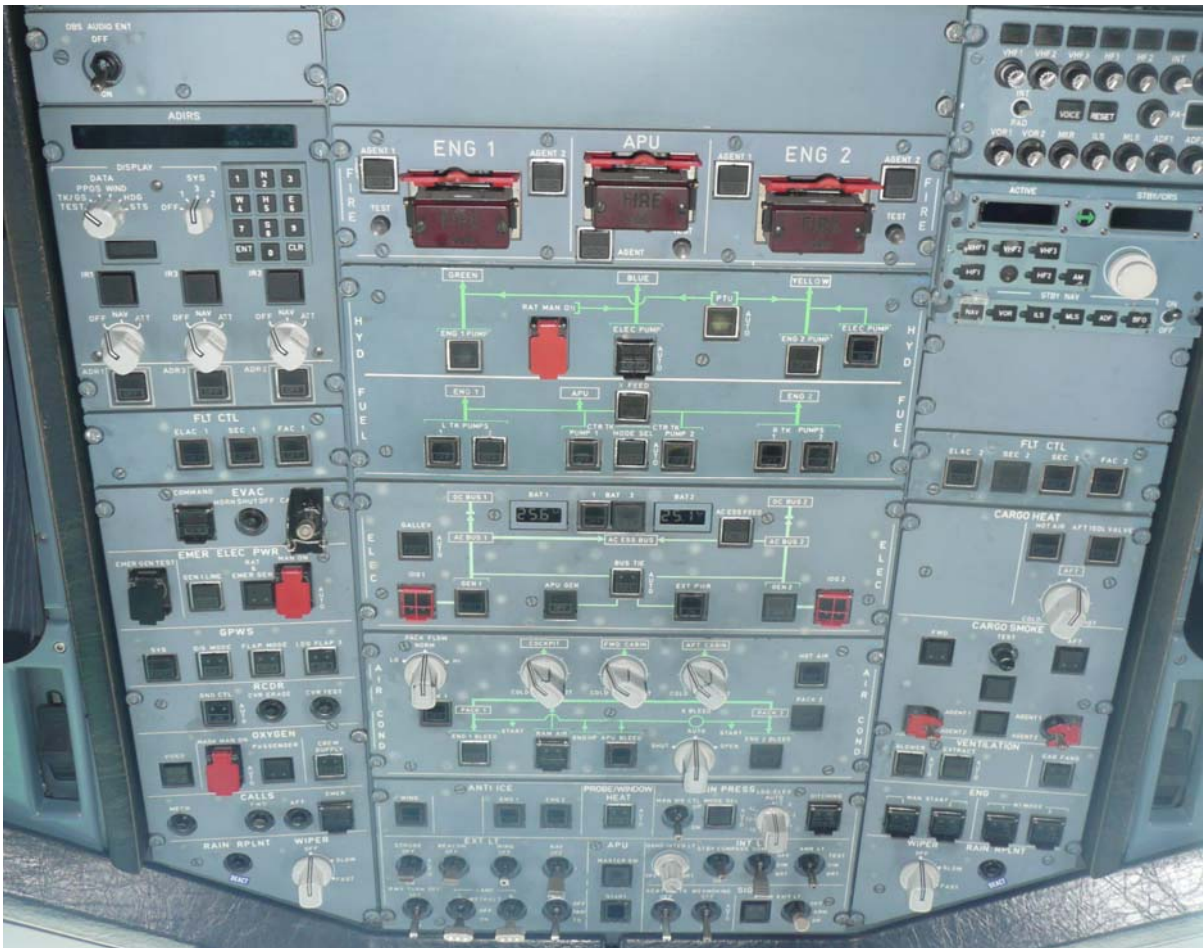
Figure 6A. Cockpit overhead panel.

On the electrical overhead panel, the following switch positions were observed after the airplane had been recovered to the examination area. In a conversation with a mechanic who had been involved with the move, he related that the switch positions that he needed

to change were those required by checklist to tow the airplane from the runway. He then restored the switches to the positions that he originally found them in. (See Figures 6A and 6B)

BATT 1 at 25.6, BATT 2 at 25.1 [volts]  
BATTERY 1 and 2 switches were found out.  
GALLEY switch was found in  
AC ESS FEED switch was found in  
GEN 1 switch was found in  
APU GEN switch was found in  
BUS TIE switch was found in  
EXT PWR switch was found out  
GEN 2 switch was found out

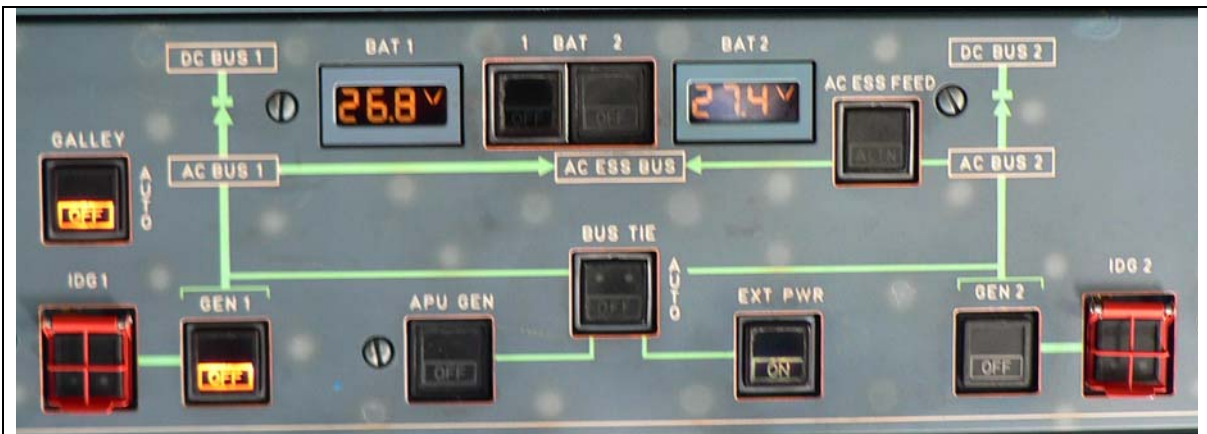
Figure 6B. Close up view of the electrical panel. The GEN 1 and GEN 2 push button switches control the transformer rectifiers (TR1 and TR2).

The GEN2 OFF light passed the bulb test, but did not appear to illuminate the OFF legend when the button was pressed. It was later noted that the switchlight was of the LCD type illumination and it was significantly less conspicuous than the bright amber bulb illumination in the other panel lighting.

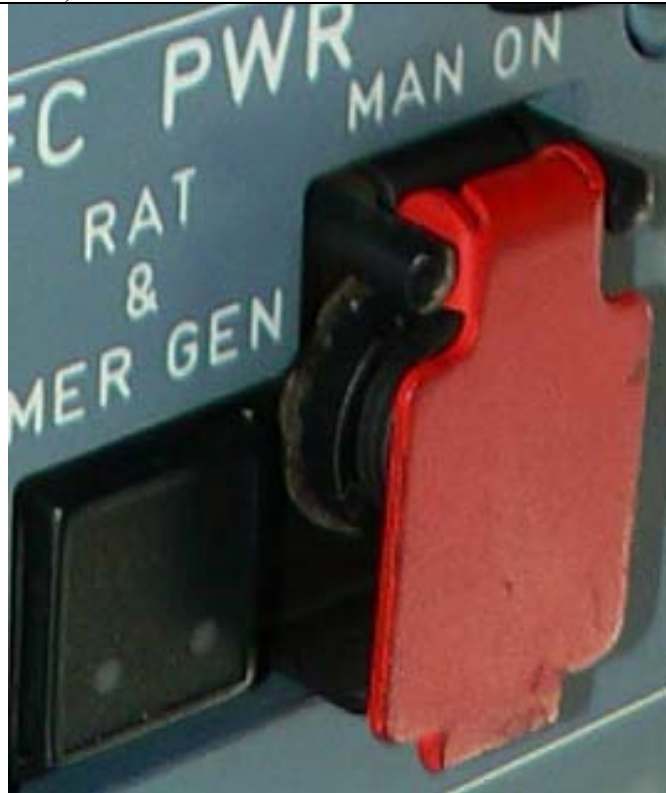
The ELEC EMER PWR panel was found with:  
RCDR GND CTL was found out  
GEN 1 LINE switch out. When powered, the legend showed OFF.  
After lifting the cover of the EMER ELEC PWR switch labeled MAN ON, the switch was found out (See Figure 7)

Figure 7. The edge of the MAN ON switch is visibly against the red cover, not in the depressed state. This is the EMER ELEC PWR control panel and the adjacent RAT & EMER GEN visible is not a switch, it is a fault light.

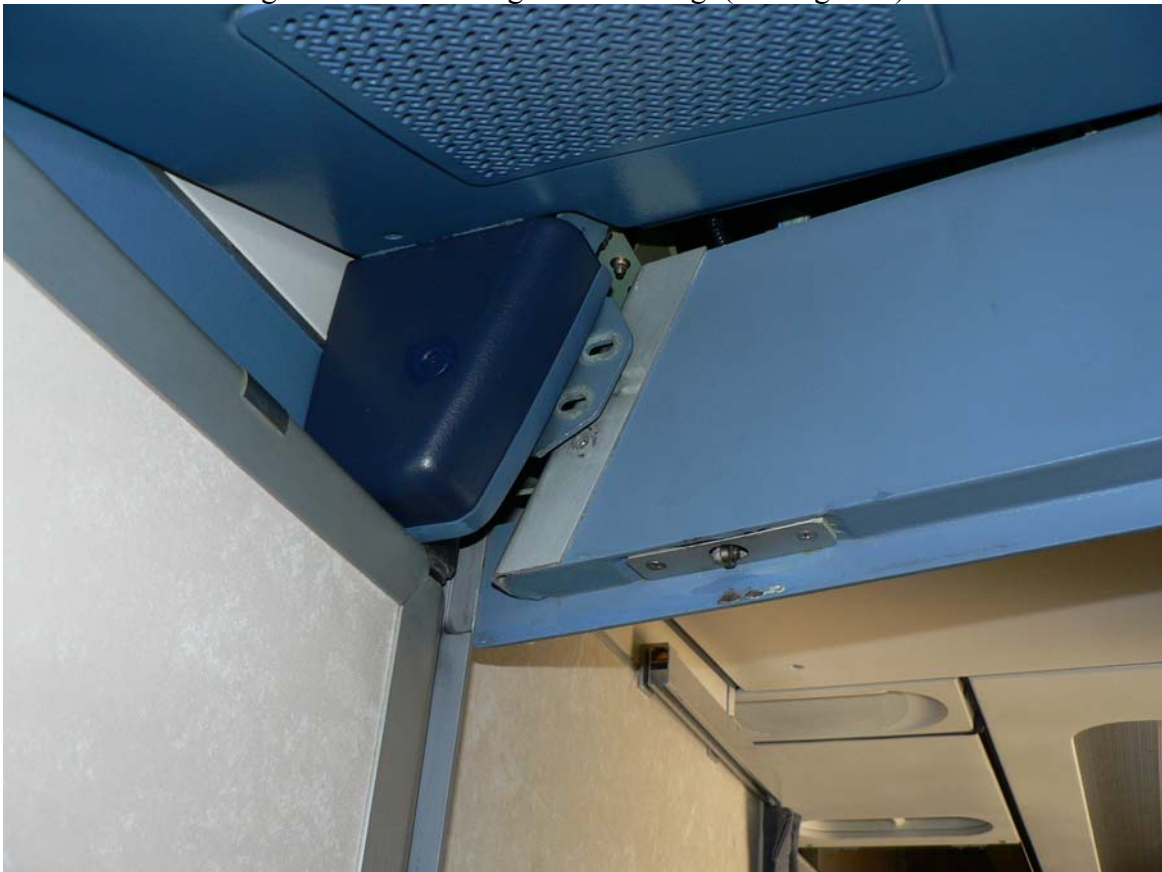
The panel over the cockpit door was missing two screws and the panel interfered with closing the cockpit door. The screws were not found on the cockpit floor and the metal around the remaining screws showed signs of fretting. (See Figure 7)

Figure 7. Panel over the cockpit door was missing screws, allowing the panel to descend

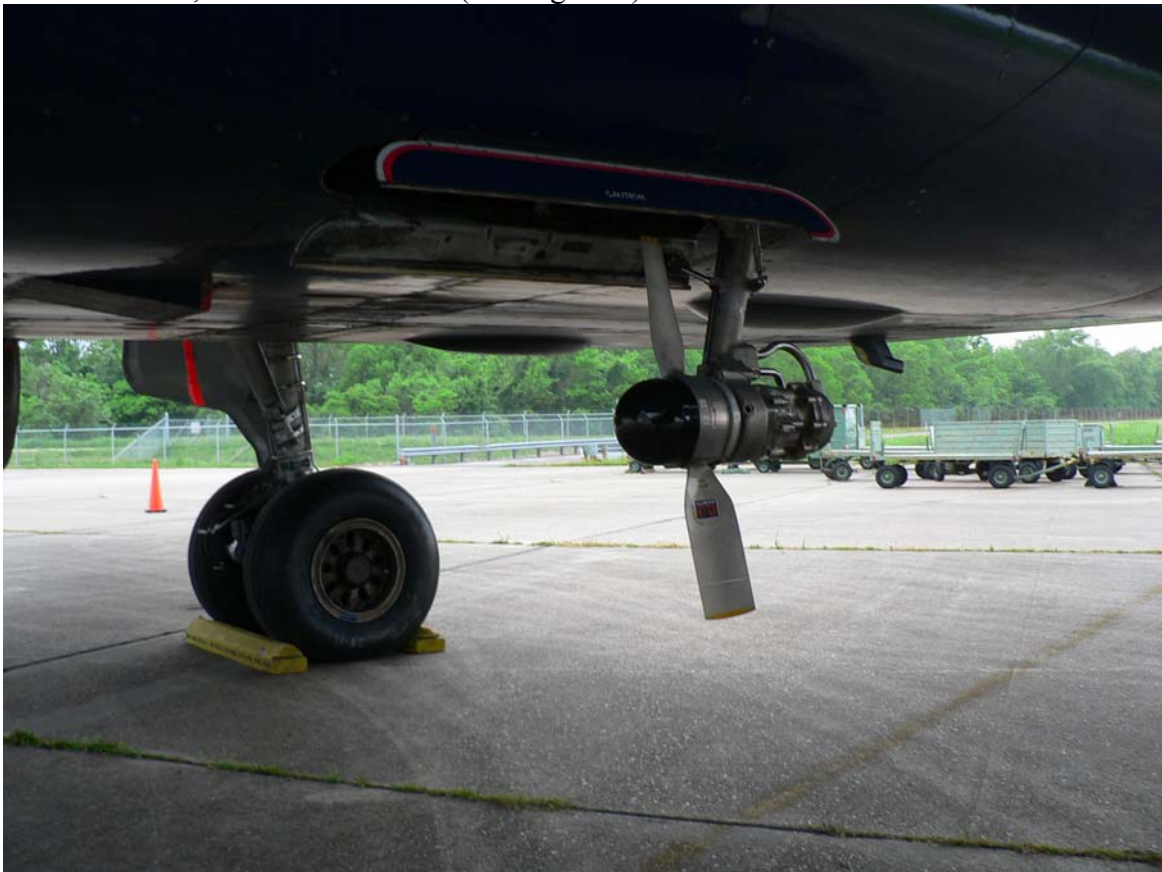
Airbus personnel noted that if electrical power is not sensed on AC busses 1 and 2 for about one second (sensed at the TR units and delayed to filter out transients) then the RAT will automatically deploy. Power to create a display on the ECAM may be interrupted for a period of seconds, as the system power source passes from the engine-driven generators, to the batteries, to the RAT CSMG. (See Figure 9)

Figure 9. Ram Air Turbine, as found extended beneath the airplane after flight.

The ram air turbine (RAT) was found extended and the AMM (24-24-00) shows that the blue hydraulic system drives a 5KVA constant speed magnetic generator (CSMG). The AMM provides the following descriptions about extension:

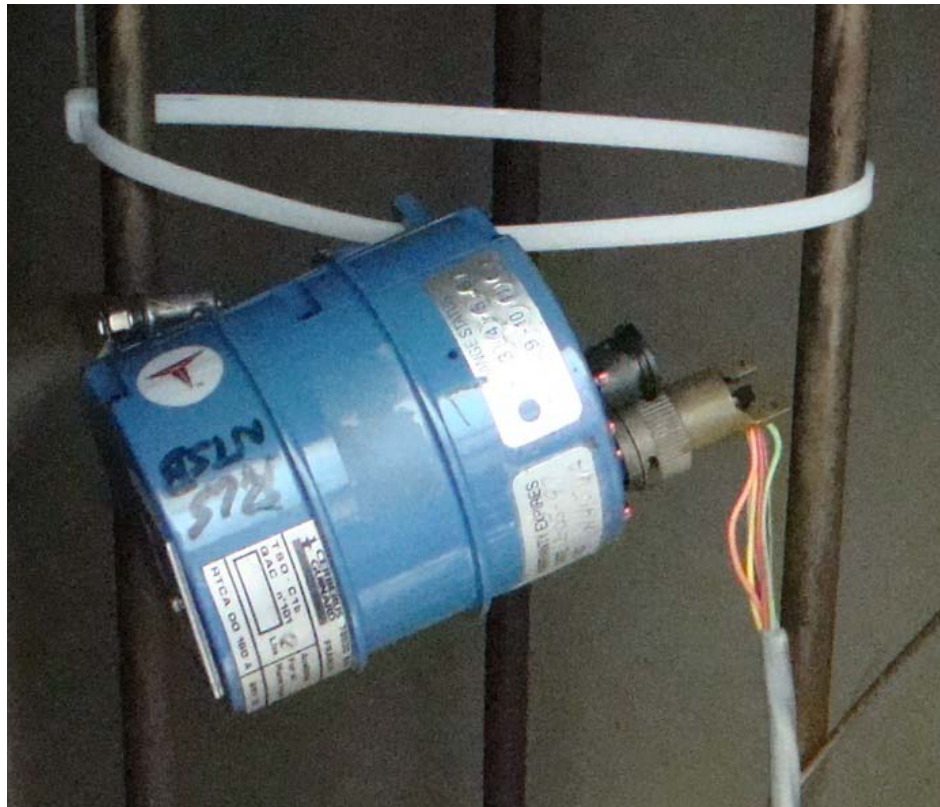
The avionics smoke detector was functioned within normal limits for smoke when tested at the FAA Fire Research Laboratory. In a non-standard test, the ionic type of detector also generated a warning signal when exposed to high humidity.<sup>1</sup>

The avionics smoke detector was installed in a duct at the outlet of the avionics compartment cooling system, near the overboard valve. The Component Maintenance Manual showed that the basic portion of this ionic type of smoke detector is used for cargo compartment protection. The part markings showed identification as United Airlines MR26150-28 (Chg Status 1), manufactured by Siemens/Cerberus as part number CG7GO, serial 1652. (See Figure 11)

Figure 11. Smoke detector undergoing testing at the FAA Fire Laboratory.

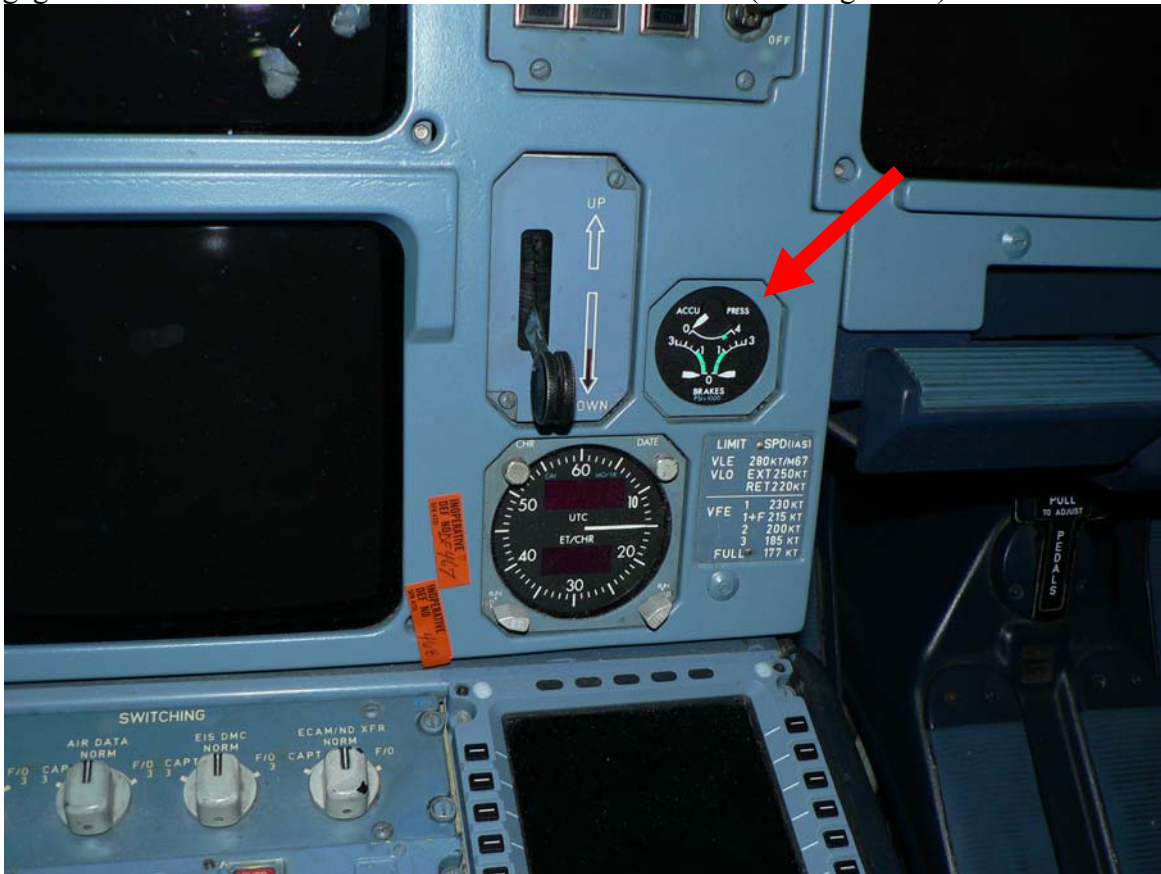
When the airplane electrical system is in the EMER ELEC configuration, the anti-skid system is not available. The pilots must regulate how hard the brake pedals are pressed to keep less than a specified level. This minimizes the potential for stopping tire rotation and a potential tire failure. To regulate how hard the pedals are pressed, a hydraulic pressure gage that is mounted near the left knee of the first officer. (See Figure 14)

Figure 14. The red arrow points to a gage with three needles that is used to determine brake pressure when landing without the antiskid system.
