NATIONAL TRANSPORTATION SAFETY BOARD
Office of Aviation Safety
Washington, D.C. 20594

Airworthiness Group Chairman's Factual Report

A. ACCIDENT DCA12MA020

Location: 14 Miles East of Las Vegas, Nevada
Date: December 7, 2011
Time: 1630 Local Time (PST)
Aircraft: Eurocopter AS350-B2, registration N37SH, Sundance Helicopters
 flight Landmark 57

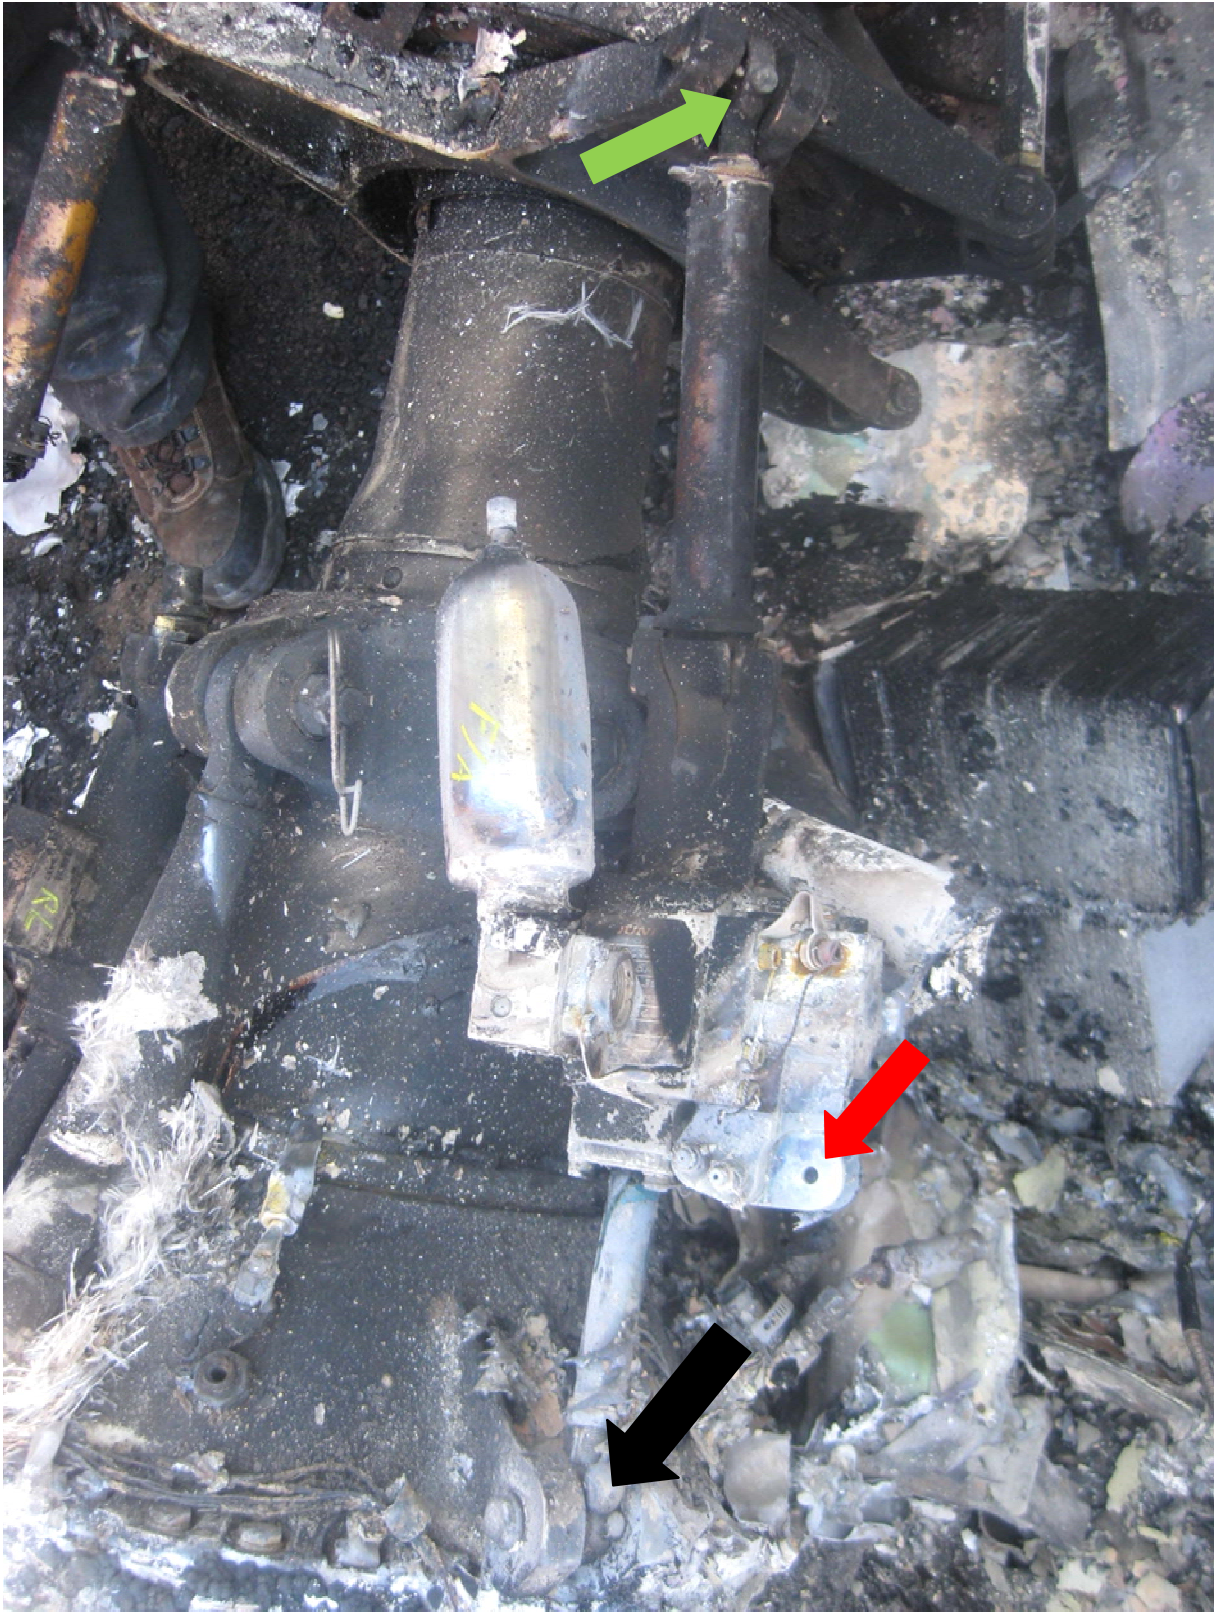
All three main rotor hydraulic servo commande actuators were attached to the main transmission (lower) and non-rotating swashplate (upper) attachment points. The piston rods of all three main rotor servos were deformed; the piston sleeves of both lateral servos (left and

right) were separated consistent with impact damage and displacement by the deformed piston rods. The servo input control clevis for both lateral servos (left and right) were observed attached to the servos and exhibited thermal damage; however, the input control rod upper rod end and hardware was not present on the fore/aft servo; the servo input attachment holes did not exhibit any visible elongation. All three main rotor servos and the majority of the remaining mechanical cyclic control system were removed and retained for further examination.

Figure 1 - Fore/Aft Servo Commande Unit, as found in wreckage, noted with connection to swash plate (green arrow), main transmission (black arrow), and input linkage connection (red arrow).

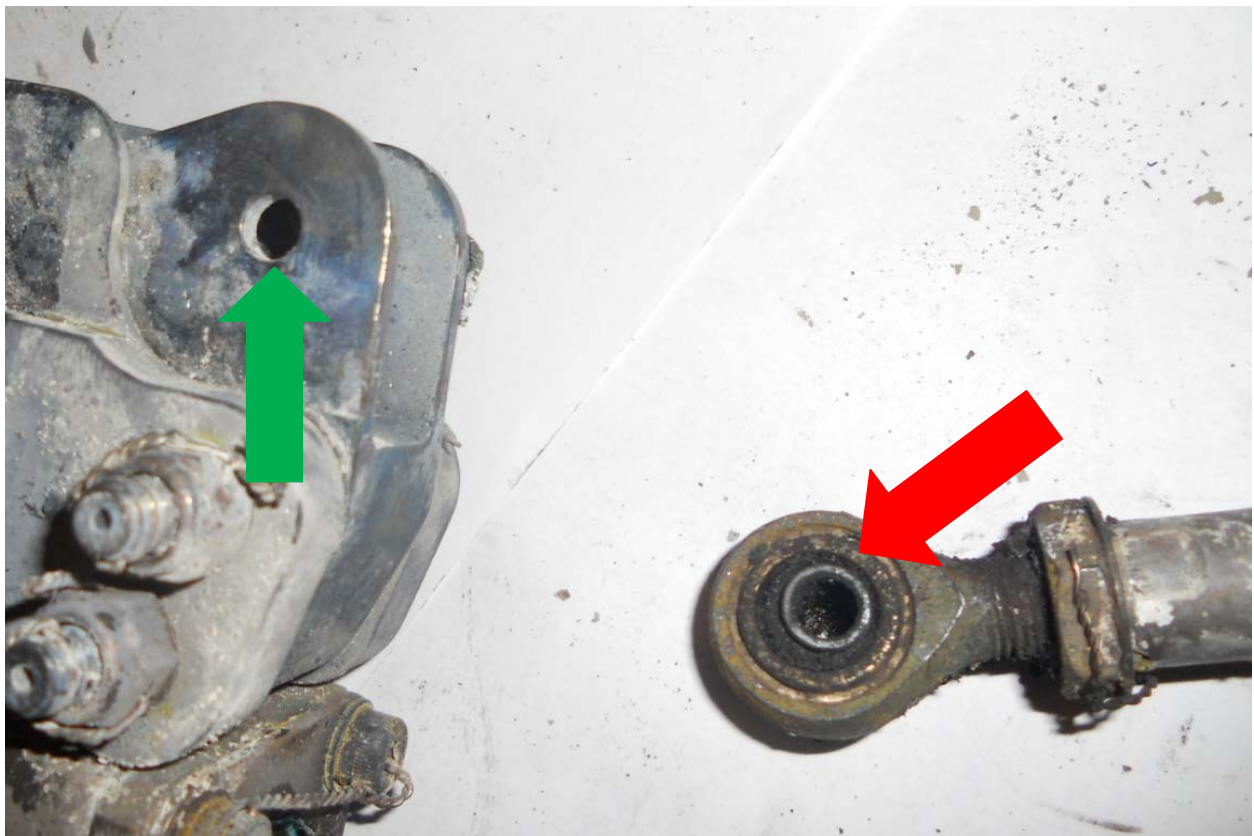
An approximate 14” section of a control rod with a similar appearance and dimensions as the fore/aft main rotor servo input upper rod end was observed without attachment hardware (bolt, nut, and cotter pin). No visible elongation of the bolt hole was observed. The approximate 3” lower section of the fore/aft main rotor servo input rod remained attached to the transmission deck bell crank from the mixing unit. The separation points on both sections were consistent with overload/impact damage.

Figure 2 - The Fore/Aft Servo Commande Unit (Left) and the Fore/Aft Servo Input Upper Rod End (Right), with areas of attachment on the Servo Commande Unit (green arrow) and rod end ball bearing (red arrow).

While looking at the fore/aft servo attachment area under microscopic power, the Senior Metallurgist indicated that he did not observe any marks indicative of hardware being installed at impact. In addition he did not observe any visible elongation or deformation of the attachment holes in either the fore/aft servo commande unit input linkage connection and the area around the rod end ball bearing of the fore/aft servo input upper rod end.

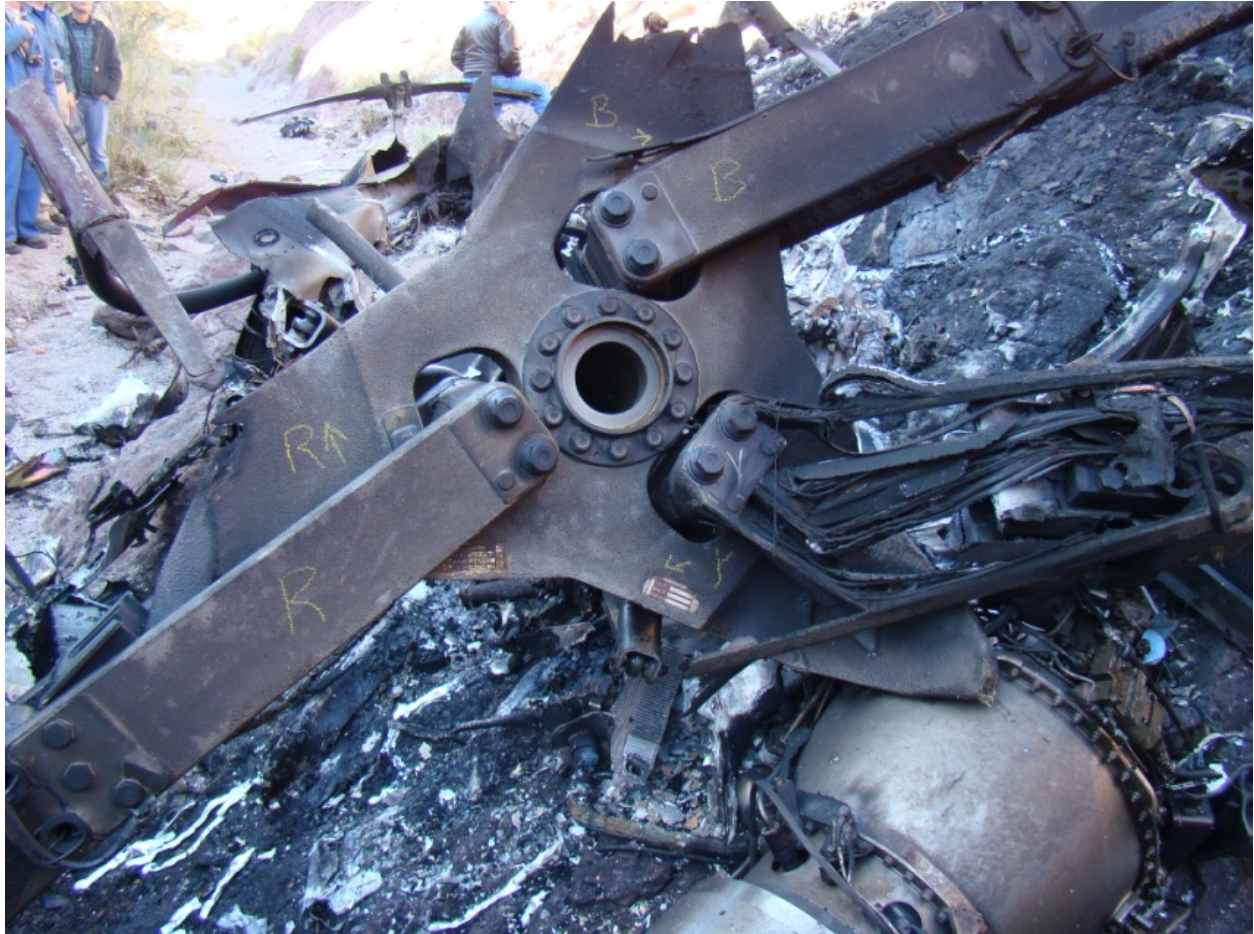
The main rotor Starflex arms and sleeves were broken and/or deformed consistent with a powered impact. The red star arm was fractured at a 45 degree angle with evidence of tension on the leading edge and compression on the trailing edge.

Figure 3 - Main Rotor "Starflex" Hub with letters to indicate each of the star arms (Yellow, Blue, or Red).

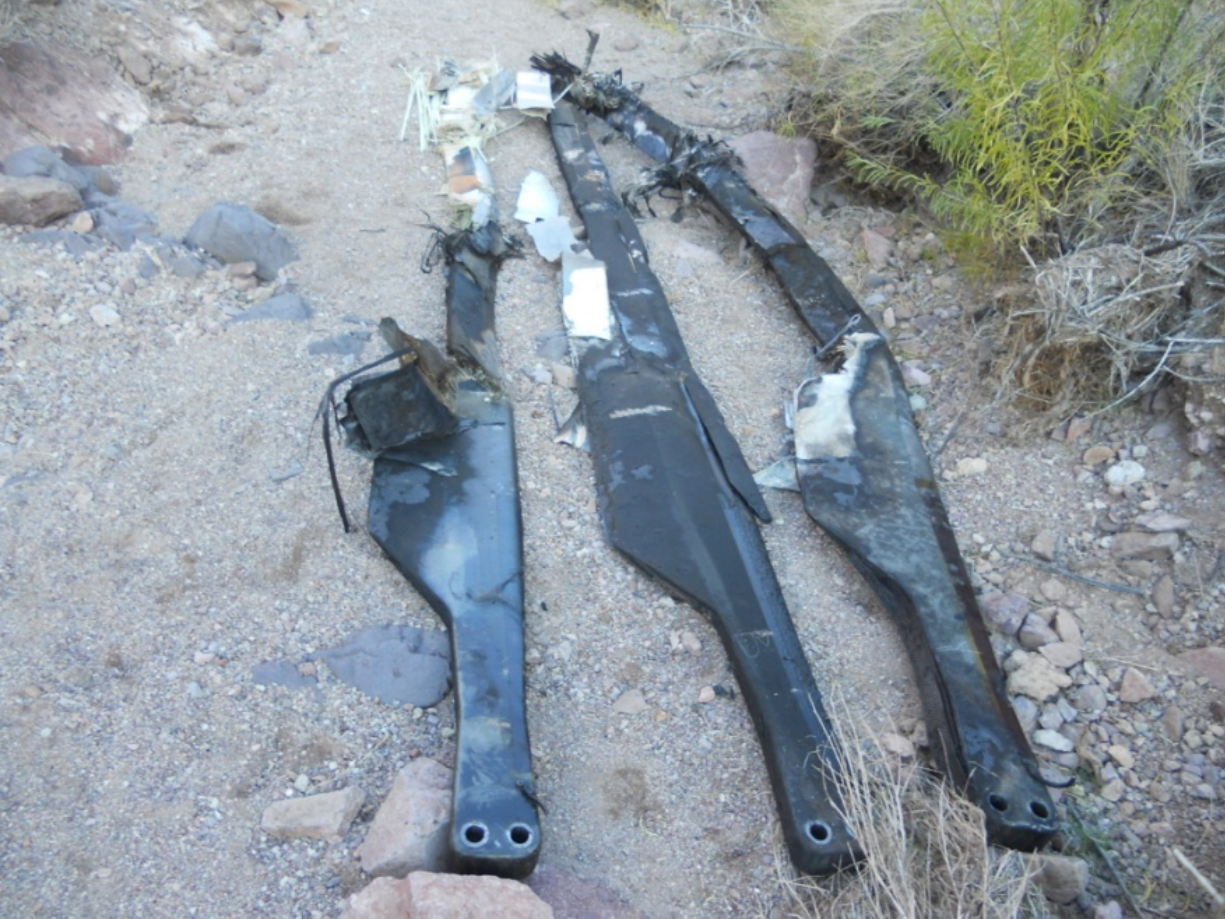
All three main rotor blade roots remained attached to their respective sleeves. All three main rotor blades exhibited impact damage consistent with a powered impact. Fragments of main rotor blade foam and skin were found surrounding the accident site. The red blade exhibited the most severe damage with broom-strawed segments of the spar found around the wreckage site. The majority of the spars from all three blades were found, and all tip weights were located within the immediate vicinity of the accident site.

Figure 4 - Main Rotor Blades after removal from the main rotor mast

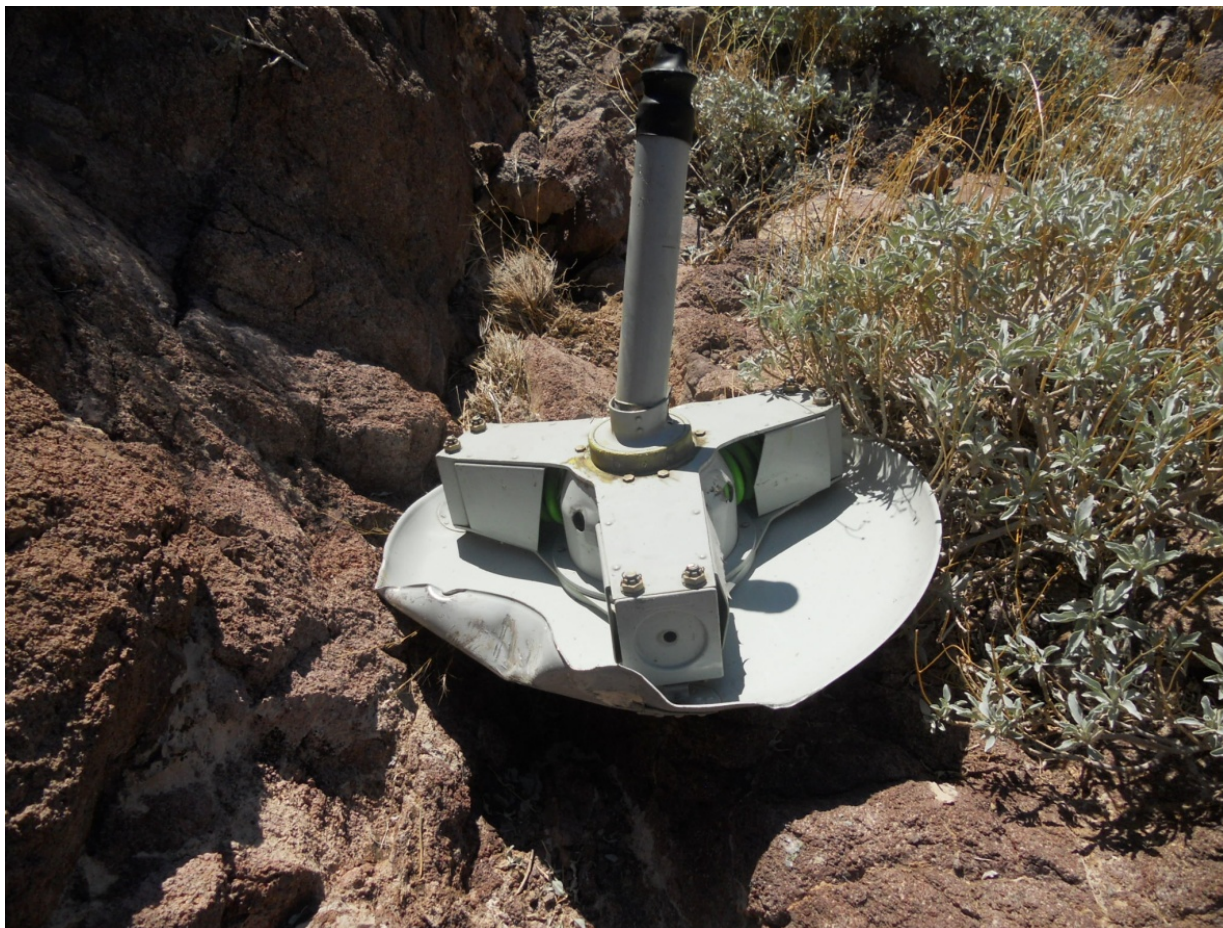
The main rotor hub and rotor head vibration absorber separated from the mast and was observed outside of the fire zone and did not exhibit thermal damage, but did exhibit impact damage.

Figure 5 - Main rotor head vibration absorber

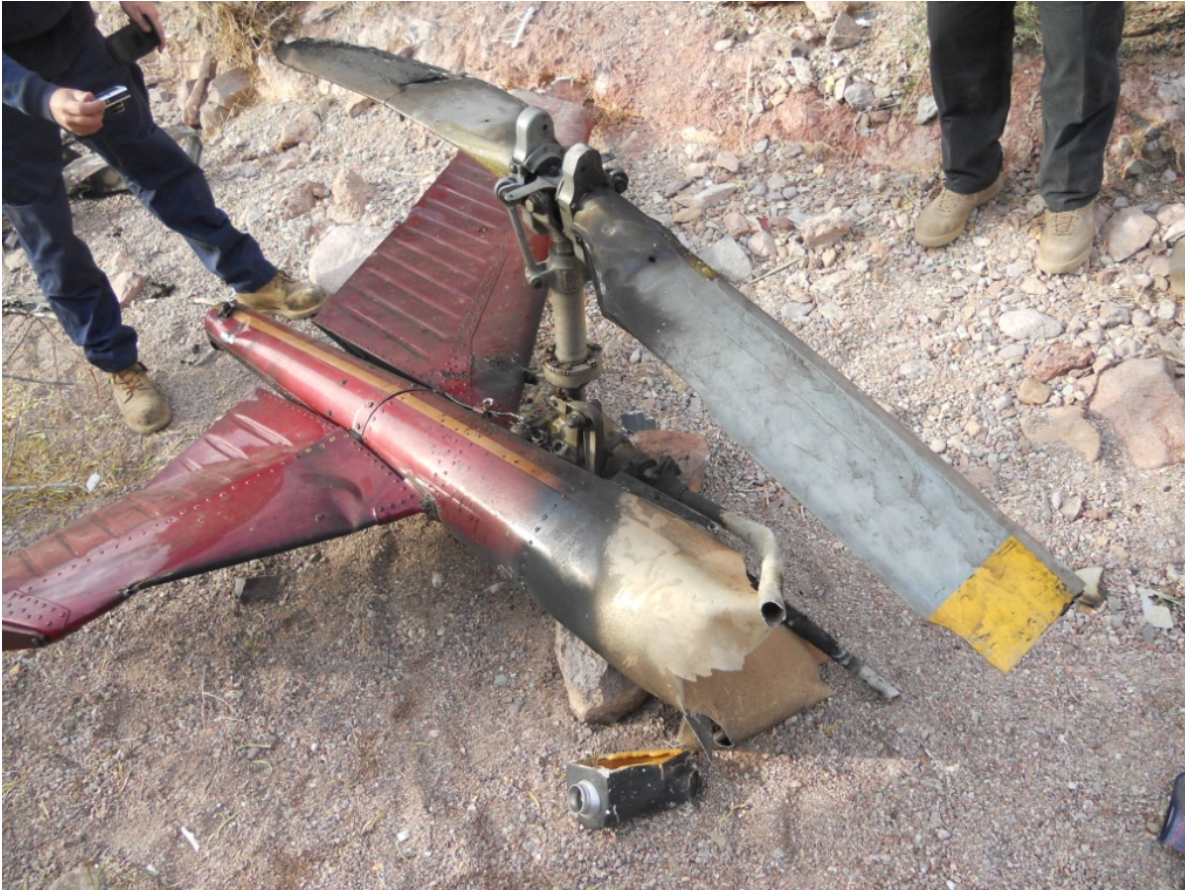
The tailboom forward of the horizontal stabilizer was consumed by the post impact fire. The separation of the horizontal stabilizer from the tailboom was consistent with fire and impact damage.

Figure 6 - Aft Tailboom

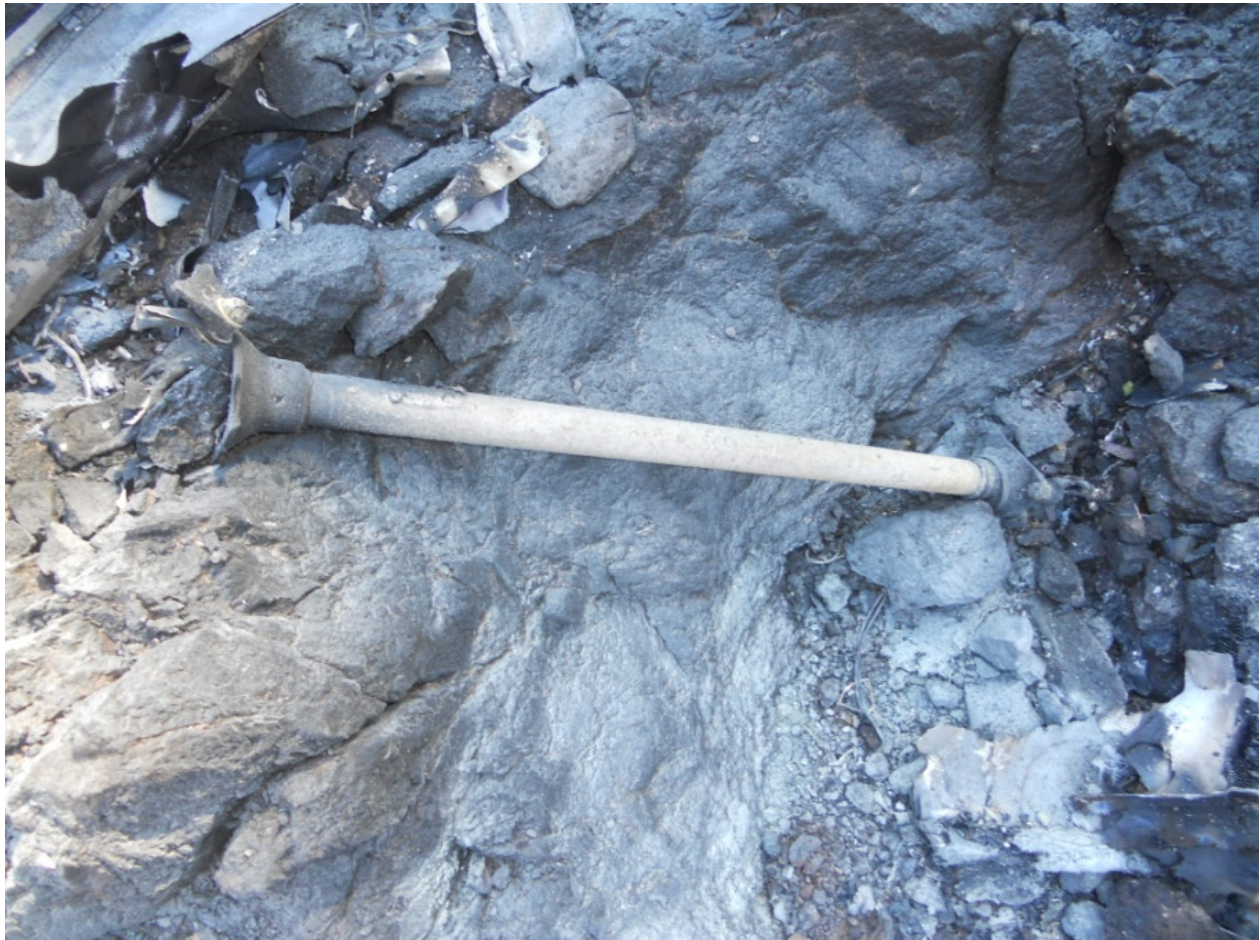
The tail rotor system was observed with extensive thermal damage. The tail rotor spar was broken and the blades exhibited thermal damage. One of the two blades exhibited some impact damage near the tip. The tail rotor drive system short shaft was observed with impact damage at both ends of the adapters, and flex couplings exhibited splaying consistent with separation during rotation. Four or the five hanger bearings were observed and exhibited extensive thermal damage.

Figure 7 - Tail Rotor Short Shaft
