NATIONAL TRANSPORTATION SAFETY BOARD

Airworthiness Group Chairman's Factual Report – Addendum 1

A. ACCIDENT DCA12MA020

Location: 14 Miles East of Las Vegas, Nevada
Date: December 7, 2011
Time: 1630 Local Time (PST)
Aircraft: Eurocopter AS350-B2, registration N37SH, Sundance
 Helicopters flight Landmark 57

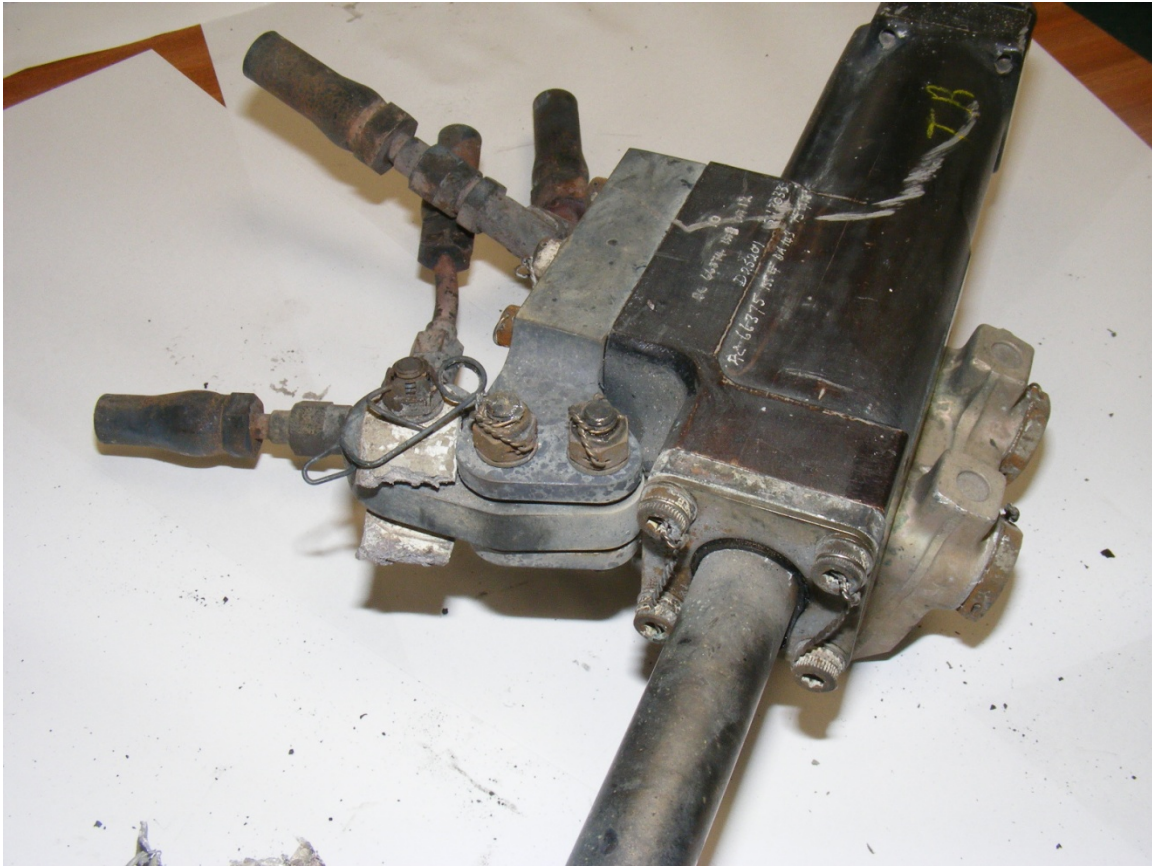
The servo input lever/linkage connection with input rod were still attached and examined. The installed pin noted on the attachment hardware (see Figure 1) was larger than the split pin used on the other servo commande units. Rather than a split (cotter) pin, the installed pin was a larger safety pin (p/n 23340AK1020LE). Eurocopter indicated that, since the accident helicopter was a former AS350-BA which had been upgraded in to an AS350-B2, which, for this variant, the larger safety pin was an accepted part. The version of AS350 could use either a split pin (cotter pin) or a safety pin. Other AS350 variants do not allow the use of the larger safety pin.

Figure 1 - Safety Pin on Tail Rotor Servo Input Linkage

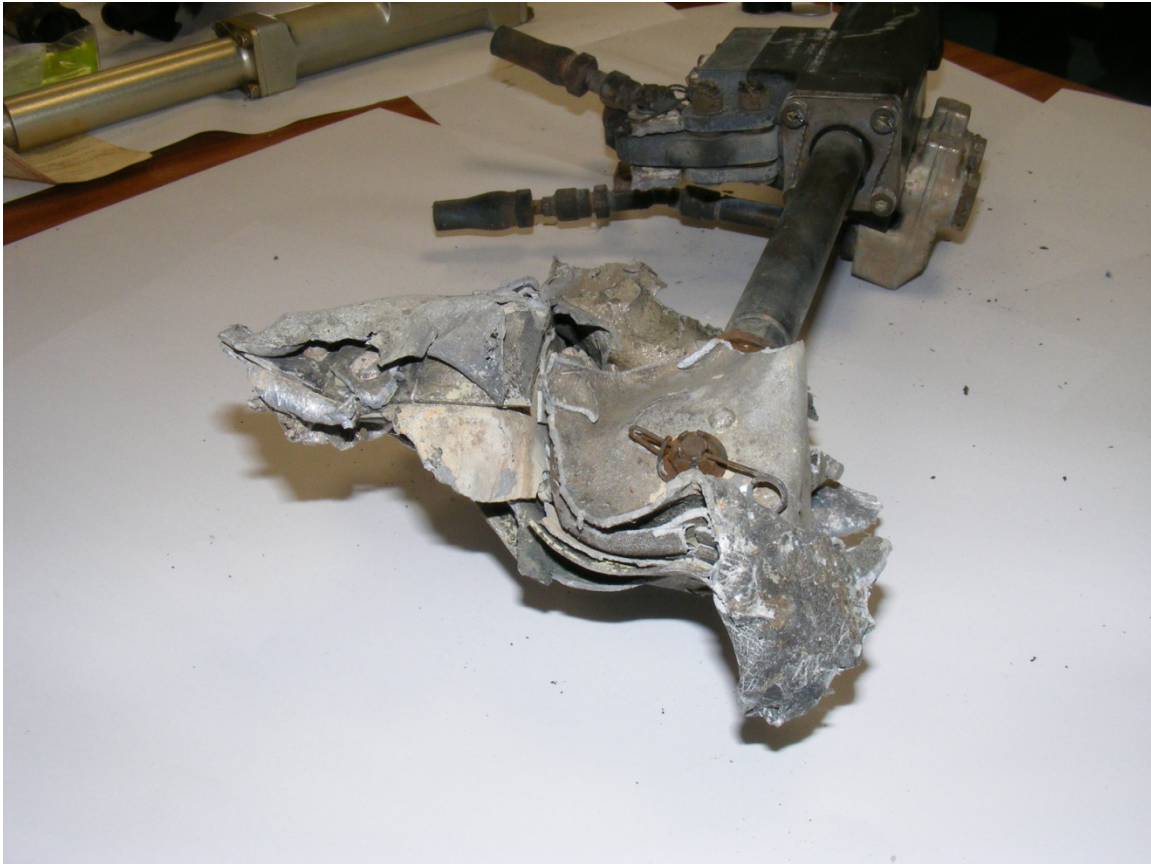
Figure 2 - Safety Pin on Tail Rotor Servo Connection
