**NATIONAL TRANSPORTATION SAFETY BOARD**

**Airworthiness Group Chairman's Factual Report – Addendum 1**

**A. ACCIDENT                    DCA12MA020**

Location:                    14 Miles East of Las Vegas, Nevada  
Date:                         December 7, 2011  
Time:                         1630 Local Time (PST)  
Aircraft:                    Eurocopter AS350-B2, registration N37SH, Sundance  
                                     Helicopters flight Landmark 57

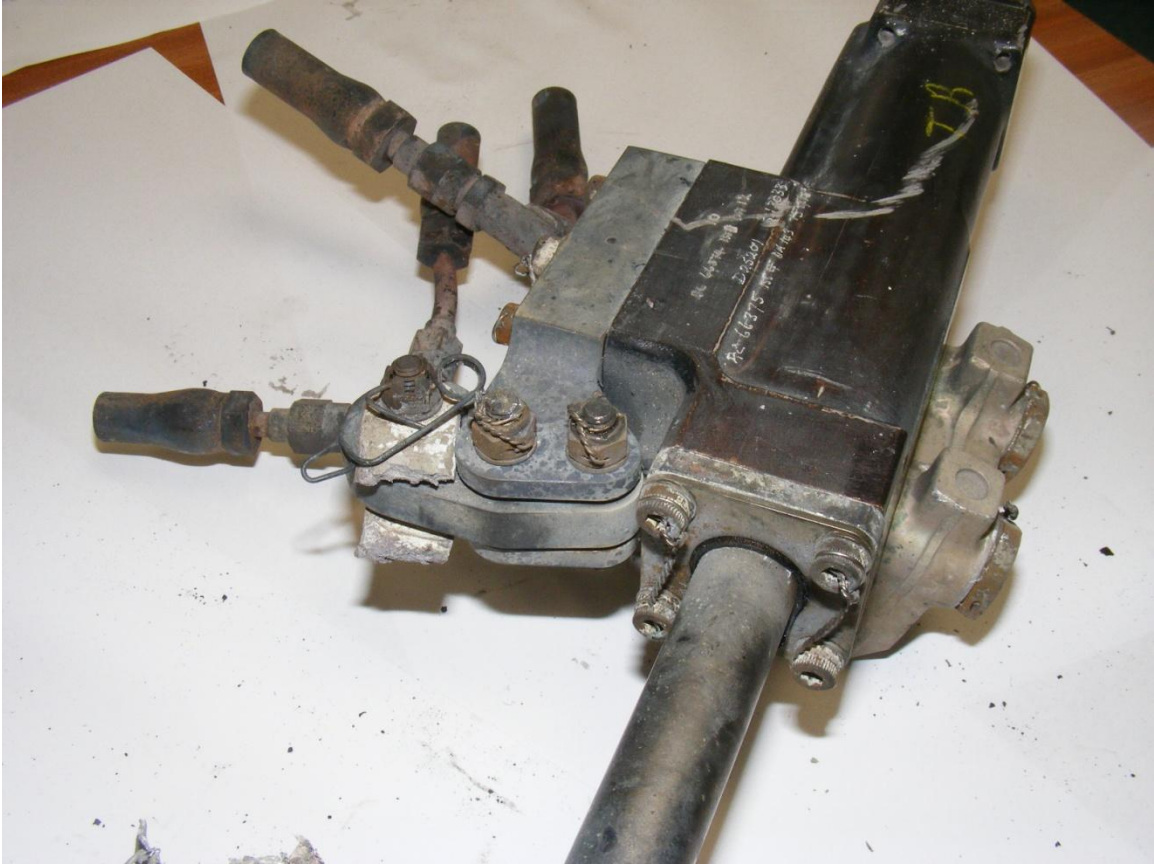
The servo input lever/linkage connection with input rod were still attached and examined. The installed pin noted on the attachment hardware (see Figure 1) was larger than the split pin used on the other servo commande units. Rather than a split (cotter) pin, the installed pin was a larger safety pin (p/n 23340AK1020LE). Eurocopter indicated that, since the accident helicopter was a former AS350-BA which had been upgraded in to an AS350-B2, which, for this variant, the larger safety pin was an accepted part. The version of AS350 could use either a split pin (cotter pin) or a safety pin. Other AS350 variants do not allow the use of the larger safety pin.

**Figure 1 - Safety Pin on Tail Rotor Servo Input Linkage**

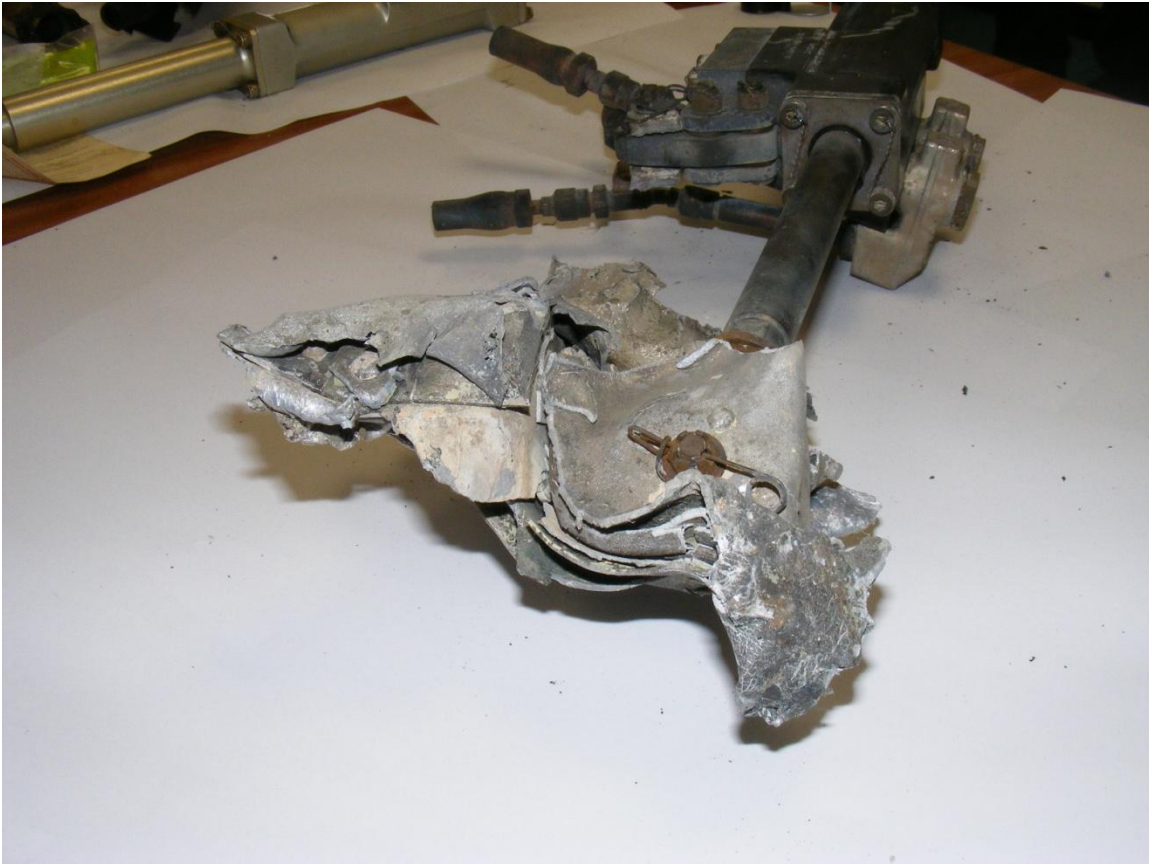
**Figure 2 - Safety Pin on Tail Rotor Servo Connection**
