# NATIONAL TRANSPORTATION SAFETY BOARD

# AIRWORTHINESS GROUP FACTUAL REPORT ADDENDUM 4 IN-SERVICE EVALUATION

# A. ACCIDENT DCA06FA058

Location:	Memphis, Tennessee
Date:	July 28, 2006
Time:	1125 Central Daylight Time (CDT)
Aircraft:	FedEx Express Flight 630, McDonnell-Douglas (Boeing) MD-10-10F,
	N391FE

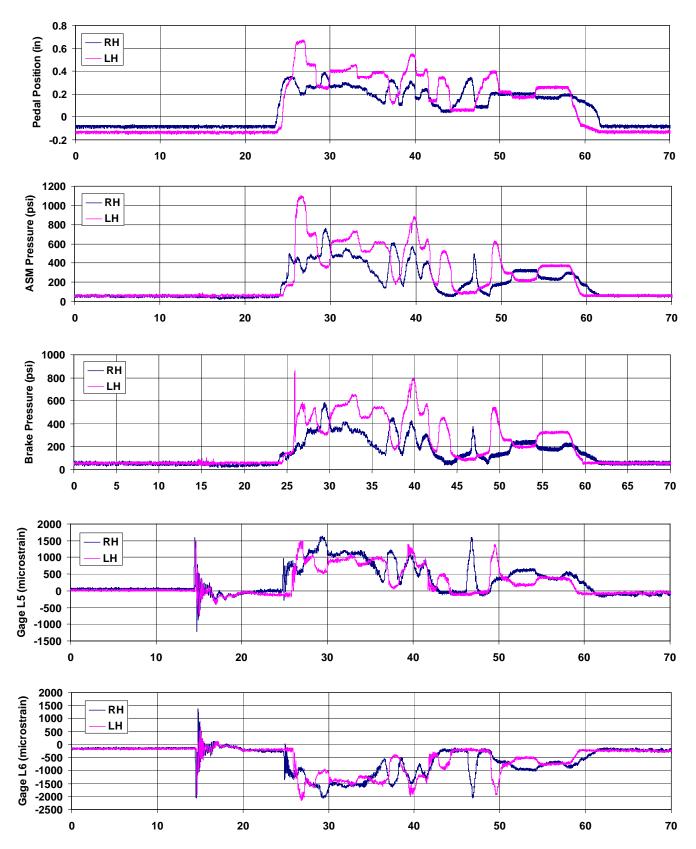
Figure 1 – Flight 910 (Flight ID 4.05)

Figure 1 shows Flight 910 on February 14 (Flight ID 4.05). This flight is an example of unsymmetric brake application by the flight crew and the resulting pressures and MLG response. Note the initial spike and immediate decrease in the LH brake pressure that indicates activation of the anti-skid feature of the system. The LH brake pressure is classified as medium due to peak pressures in the 600-1200 psi range and the RH brake pressure is classified as light due to peak pressures in the 0-600 psi range. The oscillation in the L5 and L6 strain for both MLG around 15 seconds shows the airplane touchdown and gear response. Note that the L6 data is essentially a mirror image of L5. The positive nature of L5 represents a tension stress on the forward side of the MLG and the negative nature of L6 represents a compressive stress on the aft side of the MLG as expected.

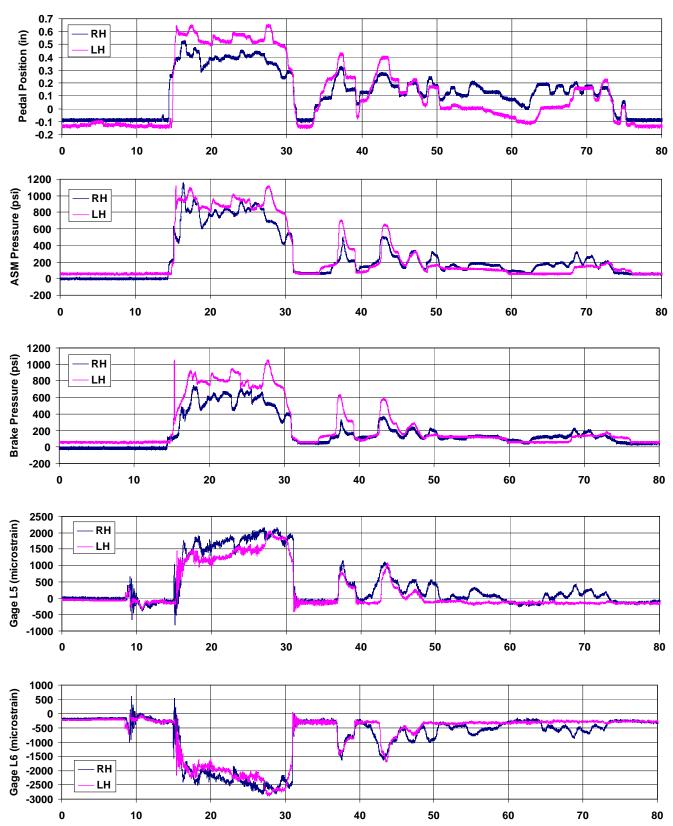
Figure 2 – Flight 1627 (Flight ID 5.10)

Figure 2 shows Flight 1627 on February 23 (flight ID 5.10). This flight is an example of symmetric brake application by the flight crew and the resulting pressures and MLG response. Note the initial spike and immediate decrease in the LH brake pressure that indicates activation of the anti-skid feature of the system. The same thing to a lesser degree can be seen in the RH brake pressure and there is a lag in the response of the RH brake pressure. The LH and RH brake pressures are classified as medium due to peak pressures in the 600-1200 psi range. The oscillation in the L5 and L6 strain for both MLG around 9 seconds shows the airplane touchdown and gear response. Note the oscillation in the L5 and L6 strain at the point of initial brake application on both the LH and RH MLG.

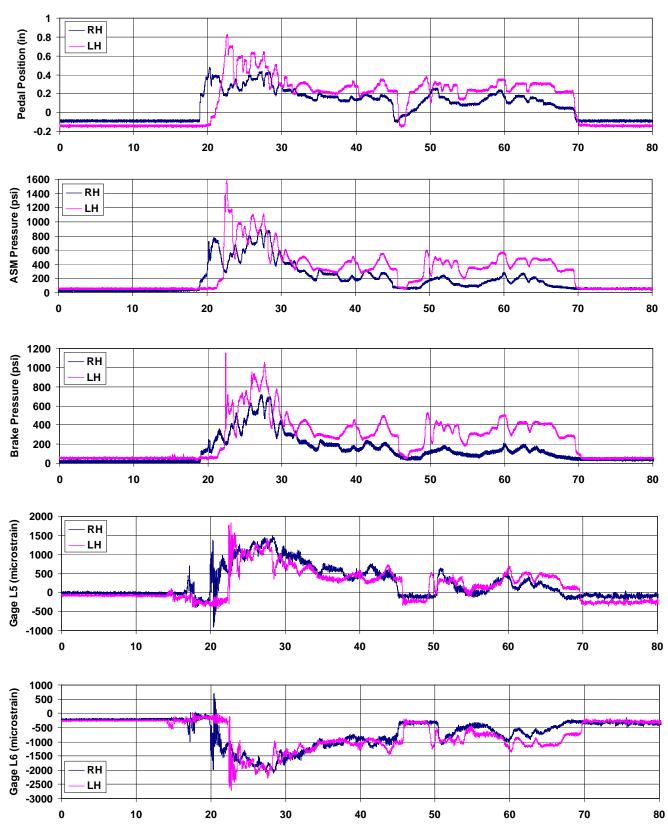
Figure 3 – Flight 1728 (Flight ID 6.05)

Figure 3 shows Flight 1728 on March 2 (flight ID 6.05). This flight is an example of erratic brake application by the flight crew and the resulting pressures and MLG response. Note the oscillating nature of the inputs to both brakes that are unsymmetrical. Again, there is an initial spike and immediate decrease in the LH brake pressure that indicates activation of the anti-skid feature of the system. The LH and RH brake pressures are classified as medium due to peak pressures in the 600-1200 psi range. The oscillation in the L5 and L6 strain for both MLG around 17 seconds shows the airplane light touchdown and minimal gear response. The oscillation in the L5 and L6 strains at the point of initial brake application is more pronounced for the RH MLG.
