**NATIONAL TRANSPORTATION SAFETY BOARD**  
Office of Aviation Safety  
Washington, D.C. 20594

**AIRWORTHINESS GROUP FACTUAL REPORT ADDENDUM 5**  
**MD-10 BRAKE SYSTEM**

**A. ACCIDENT      DCA06FA058**

Location:            Memphis, Tennessee  
Date:                July 28, 2006  
Time:                1125 Central Daylight Time (CDT)  
Aircraft:            FedEx Express Flight 630, McDonnell-Douglas (Boeing) MD-10-10F,  
                              N391FE

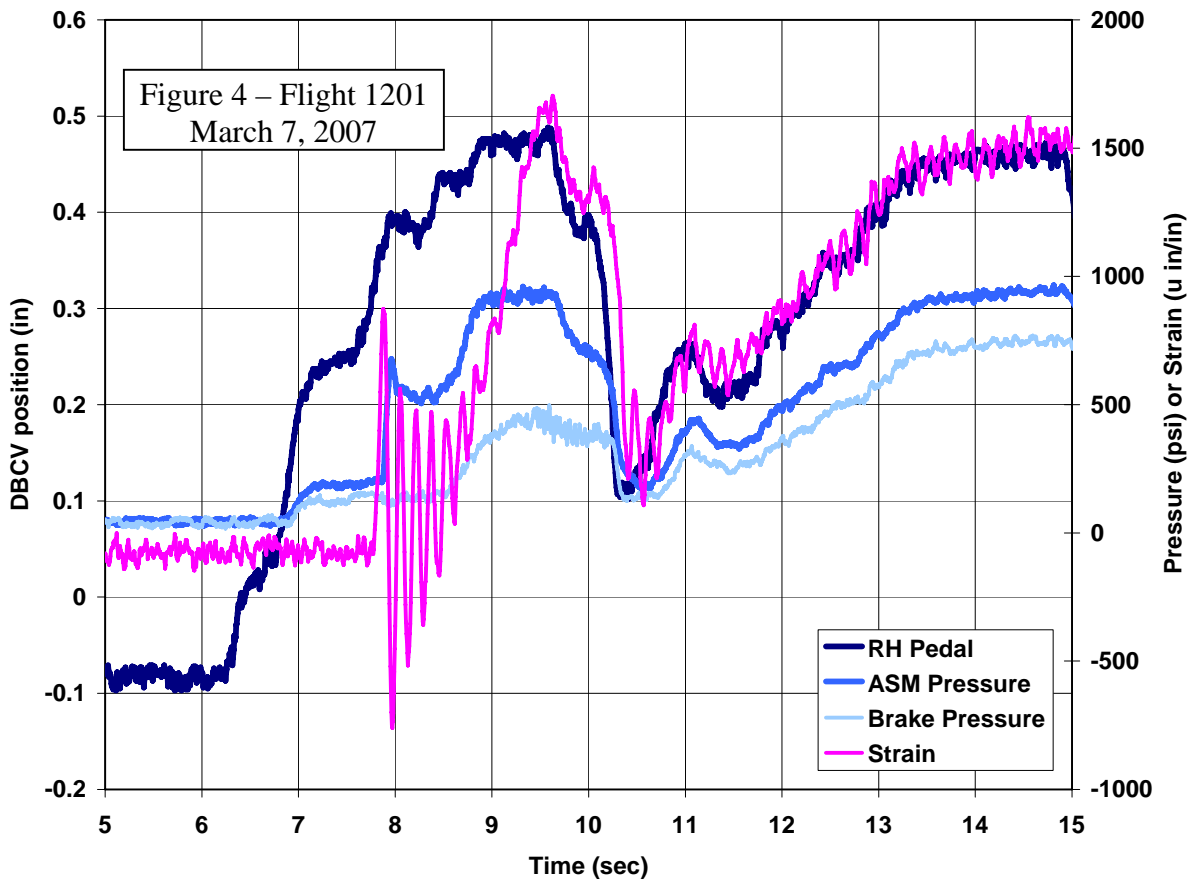
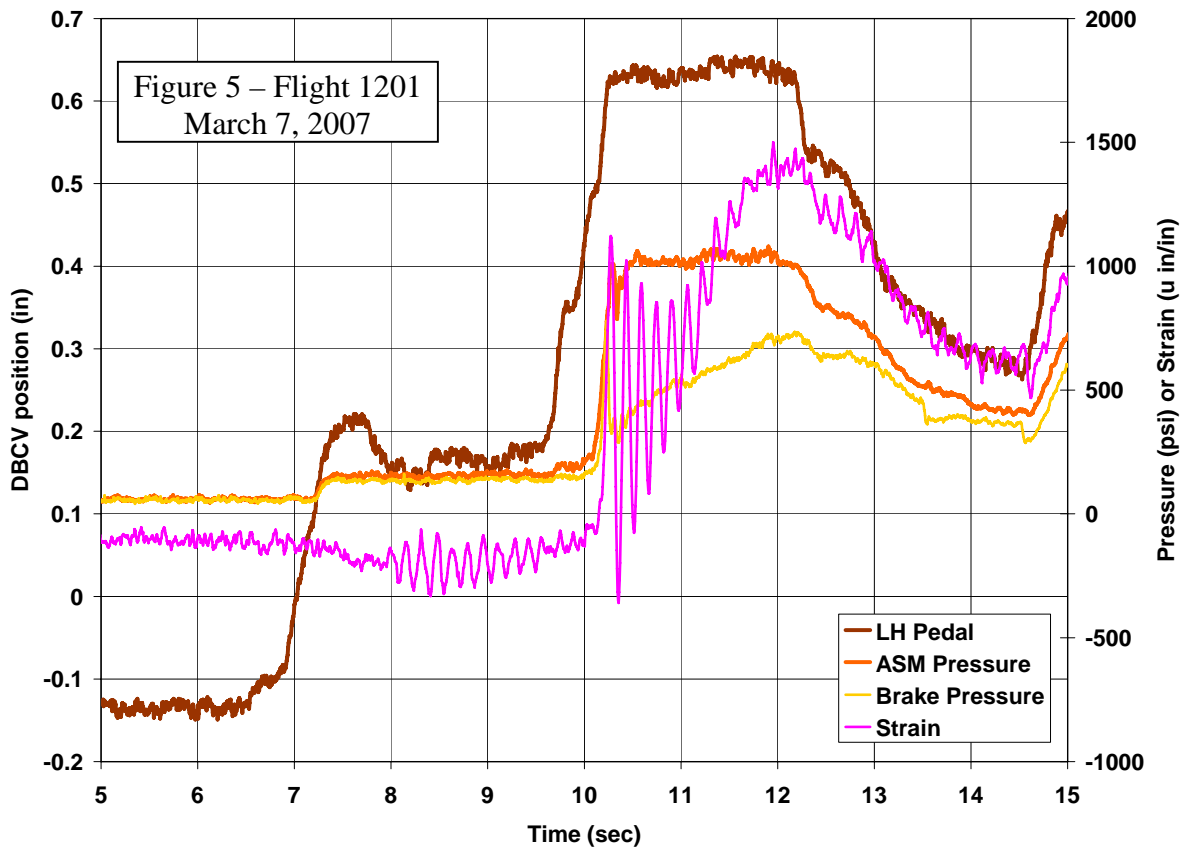
- 2) After initiation of braking torque, the antiskid control software can command a near simultaneous pressure reduction in multiple brakes on one or both MLG. The resulting brake torque can then be reduced to near zero for a short period, interrupting the airplane deceleration braking force from one or both MLG, causing directional pulling and/or allowing the MLG to oscillate fore & aft. The pressure reduction occurs due to the antiskid

initialization feature in the ASCU that is designed to quickly optimize brake pressures at the start of a rejected takeoff. Any abrupt deceleration of the MLG wheels causes this initialization to happen. Figures 4 and 5 show the same data parameters as above for the right and left MLG, respectively. Both plots were taken from flight 1201 on March 7, 2007. In Figure 4, the RH pedal position has a stepped characteristic as before and the ASM inlet and brake inlet pressures level off at about 150-200 psi while the brakes are filling. Once the brakes are filled the ASM inlet pressure spikes upward very abruptly. At the same time the strain on the forward side of the MLG begins a damped oscillation consistent with the MLG being pulled aft and then suddenly released causing it to oscillate at its natural frequency. In Figure 5, the LH MLG exhibits a similar response to that on the RH MLG. The one major exception is in the brake inlet pressure. The brake inlet pressure exhibits an abrupt spike at about the same time as the ASM inlet pressure but the brake inlet pressure drops quickly back to a low level. This is direct evidence of the ASCU commanding a significant reduction of the pressure input to one-half of the brake pistons on one wheel in response to the antiskid initialization on at least that LMLG wheel. The reason we don't see this type of spike in the brake inlet pressure on the RMLG is most likely because the brake where the pressure is measured was not completely filled at the time when the initialization was triggered by other brakes/wheels on the RMLG that had already completed their brake fill. Also, note that the application of brake pedals for both occurs between 6 and 7 seconds on the plot while the gear oscillations begin at about 8 and 10 seconds for the RH and LH MLG, respectively. The difference in the time of reduction in brake inlet pressures can result in pilot reports of aircraft pulling left or right during braking and aircraft shuddering during braking.

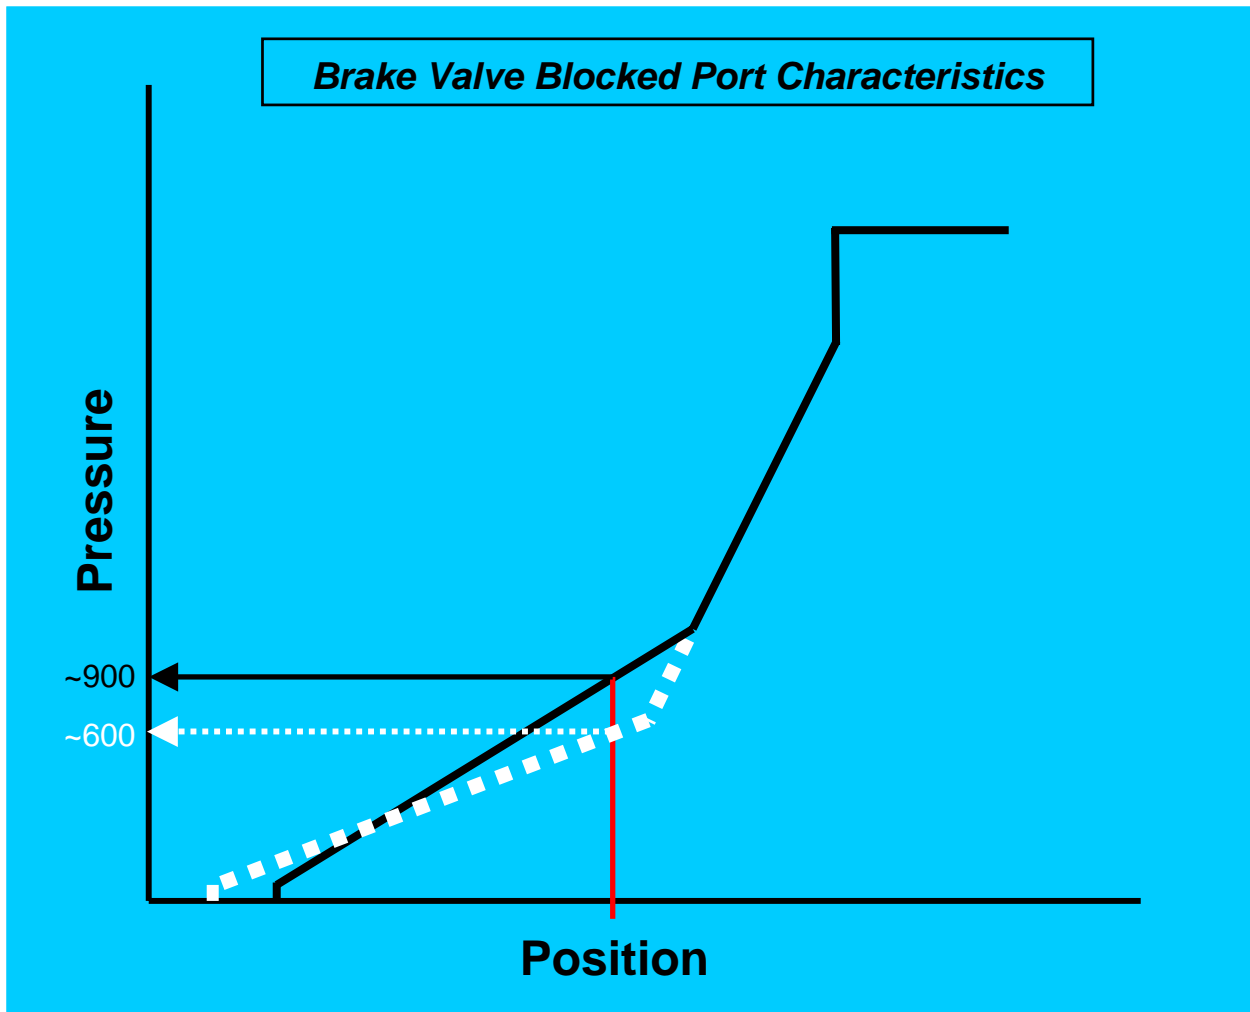
Figure 6 – DBCV Modifications (Post ISE)

The DBCV was modified to reduce both the initial dead band and the pressure gain versus the brake pedal position as illustrated in Figure 6. The black line is the original metered pressure schedule versus the input lever position for the DBCV and the dashed white line is the modified schedule. The modified schedule starts metered pressure output at a lower lever position (reduced dead band) and meters a lower pressure output for the first half of the lever travel. This modification reduces the delay between initial brake pedal advance and initial brake torque. In addition, other minor changes to the DBCV increased the fluid flow at small lever positions. The modifications make the MD-10 DBCV behave more like the MD-11 Integrated Brake Control Valve. Boeing Airplane Modification Letter (AML) MD-10-AML-32-103-A installs this improved DBCV on the FedEx airplanes.

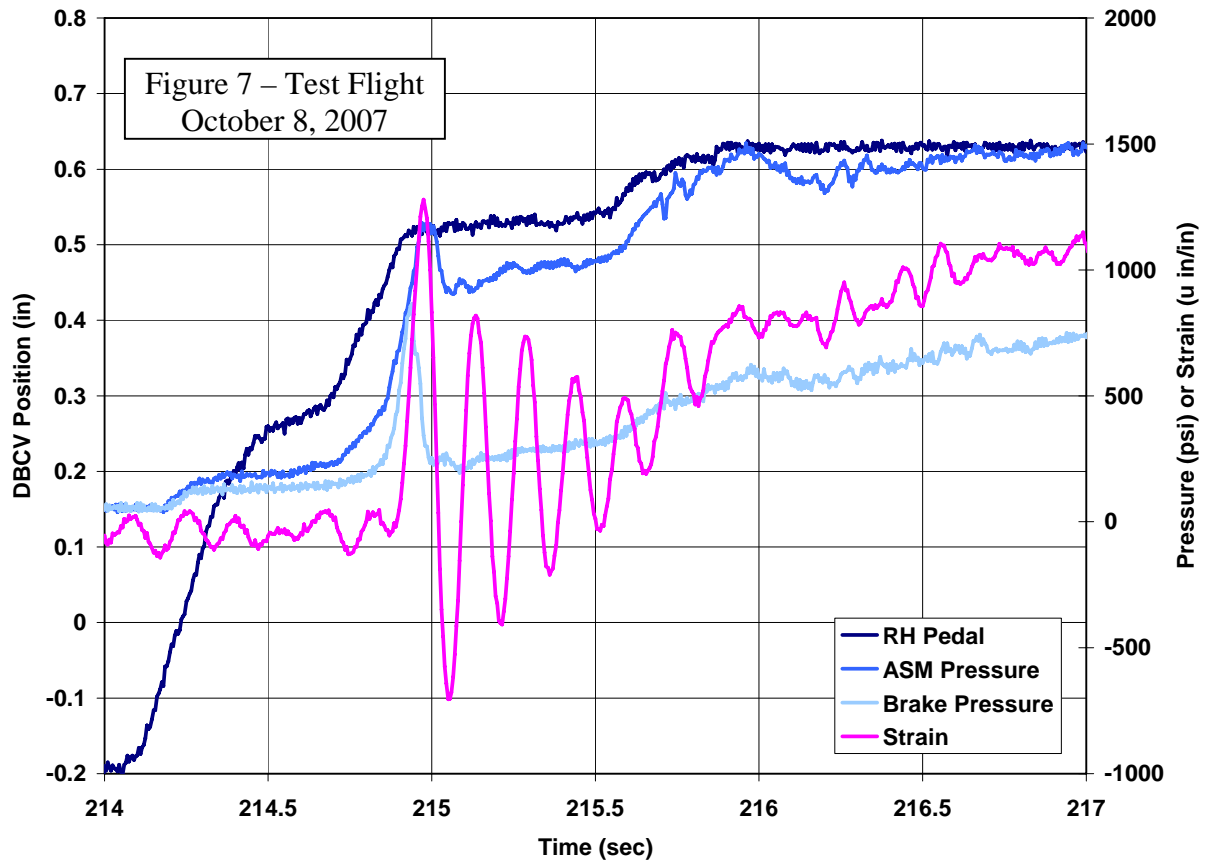
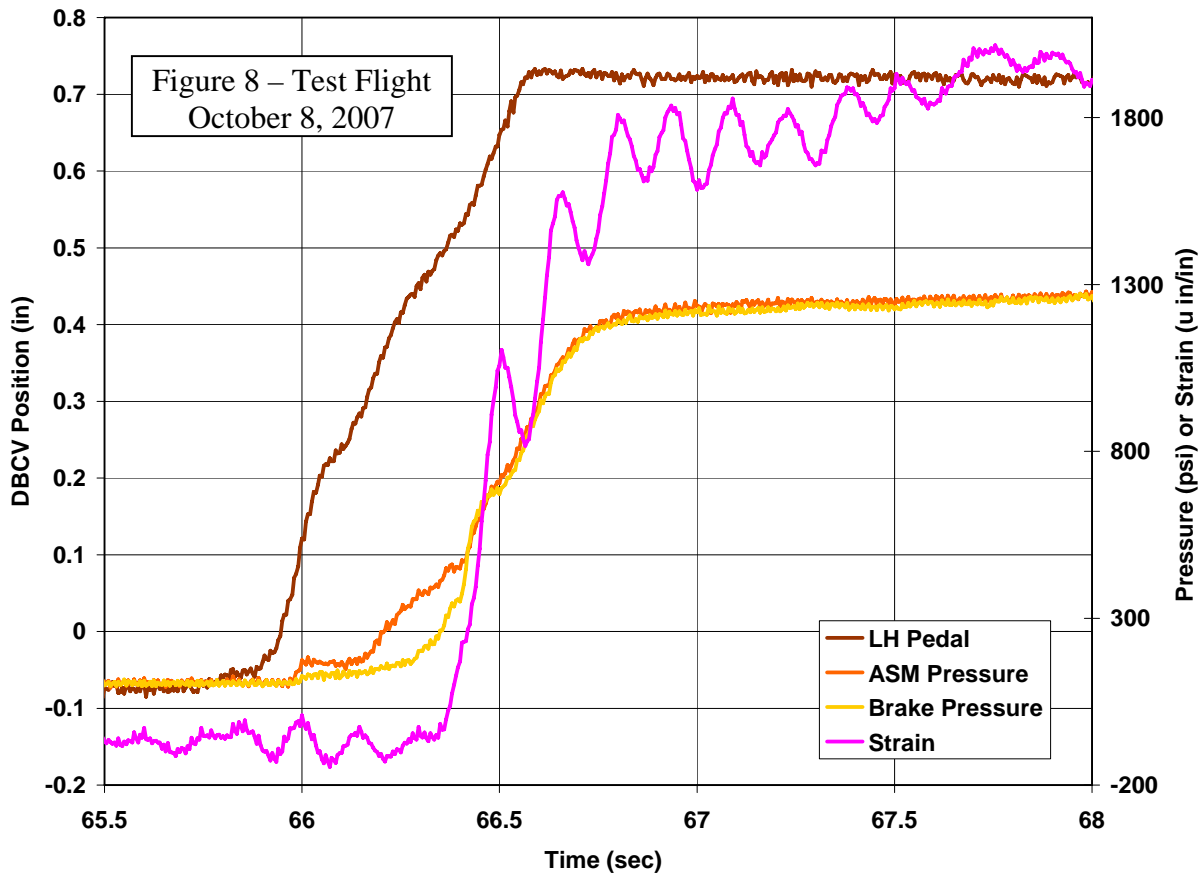
After the two above noted AML’s were incorporated on N357FE, a series of tests was performed to gather in-service brake system data. Figures 7 and 8 show results for the RH and LH MLG, respectively. For both plots the aircraft was taxiing at 25 knots and the brakes were applied. In Figure 7, brake system 1 was active and brake system 2 was shut off. The data shows that the time between pedal application and MLG response is less than 1 second, significantly less than before. The data also shows the antiskid system significantly reduces the brake inlet pressure causing a gear oscillation since the system 2 was off. In Figure 8, brake system 1 was shut off and brake system 2 was active. The data again shows less than 1 second from application of the pedal to MLG response. The MLG response is smooth and does not show any oscillations. The data shows significantly less delay to initiate brake torque, minimal advancing of brake pedals before brake torque initiation, lowers the initial brake pressure and torque, prevents any significant reduction in multiple brake pressures, and minimizes any fore/aft movement of the main gears during braking. These two brake system improvements, along with the modified brake system described earlier, are being installed on all MD-10-10F aircraft.
