**NATIONAL TRANSPORTATION SAFETY BOARD
OFFICE OF AVIATION SAFETY
WASHINGTON, D.C. 20594**

**MAINTENANCE DEMONSTRATION
AND
INTERVIEW OF COLGAN AIR MECHANICS**

NYC03MA183

Operator: Colgan Air Inc.
Aircraft: Raytheon Beechcraft 1900D
Location: Yarmouth, MA
Date: August 26, 2003
Time: 15:40 EDT

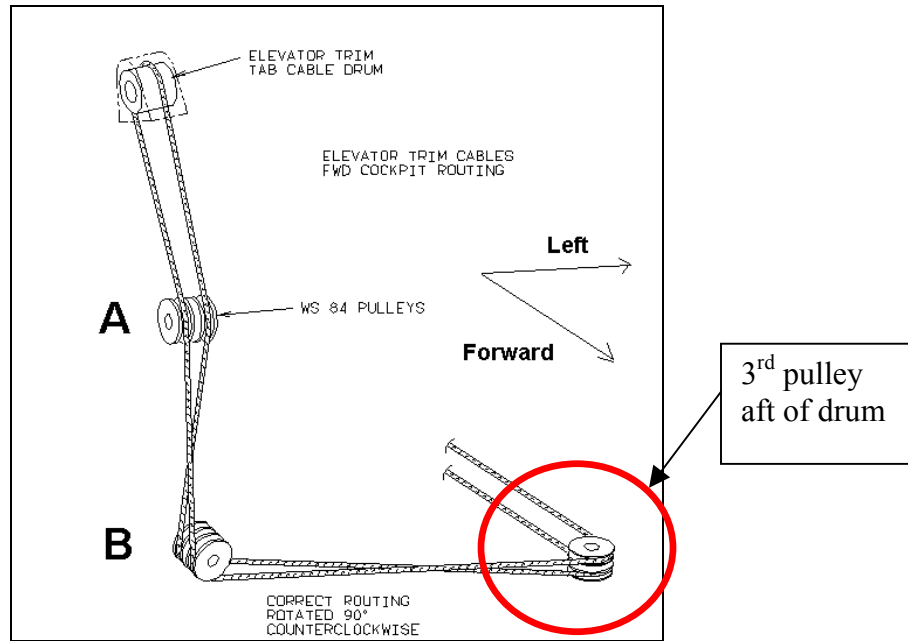
Figure 1 – Detail F from 27-30-04-201

- Before pulling the cables off, he marked the pulleys starting with the 3rd pulley aft of the drum (as circled in figure 1 below), with a “T” for top. This was before the retaining pins were pulled.

- Every pulley starting with 3rd one from the drum in the cockpit pedestal back through the spar was marked with a “T”.
- He went under the nose area to mark those pulley housings as well.

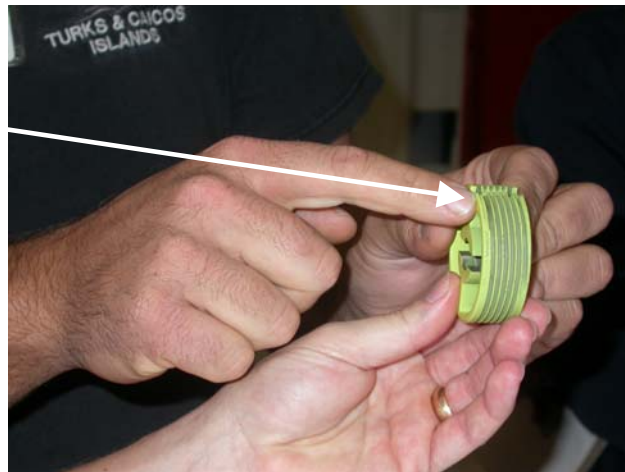
Figure 2 Elevator trim cables

- They then wrapped the drum using diagram 201 (“Elevator Tab Control Cable Winding”) from maintenance manual, section 27-30-04-210, as a guide. See picture below (Figure 2) showing where they positioned the left hand threaded cable.

Left hand threaded cable positioned here as shown by mechanic
