## **ATTACHMENT 2**

**AIRWORTHINESS GROUP CHAIRMAN'S FACTUAL REPORT**

**LAX-02-GA-201**

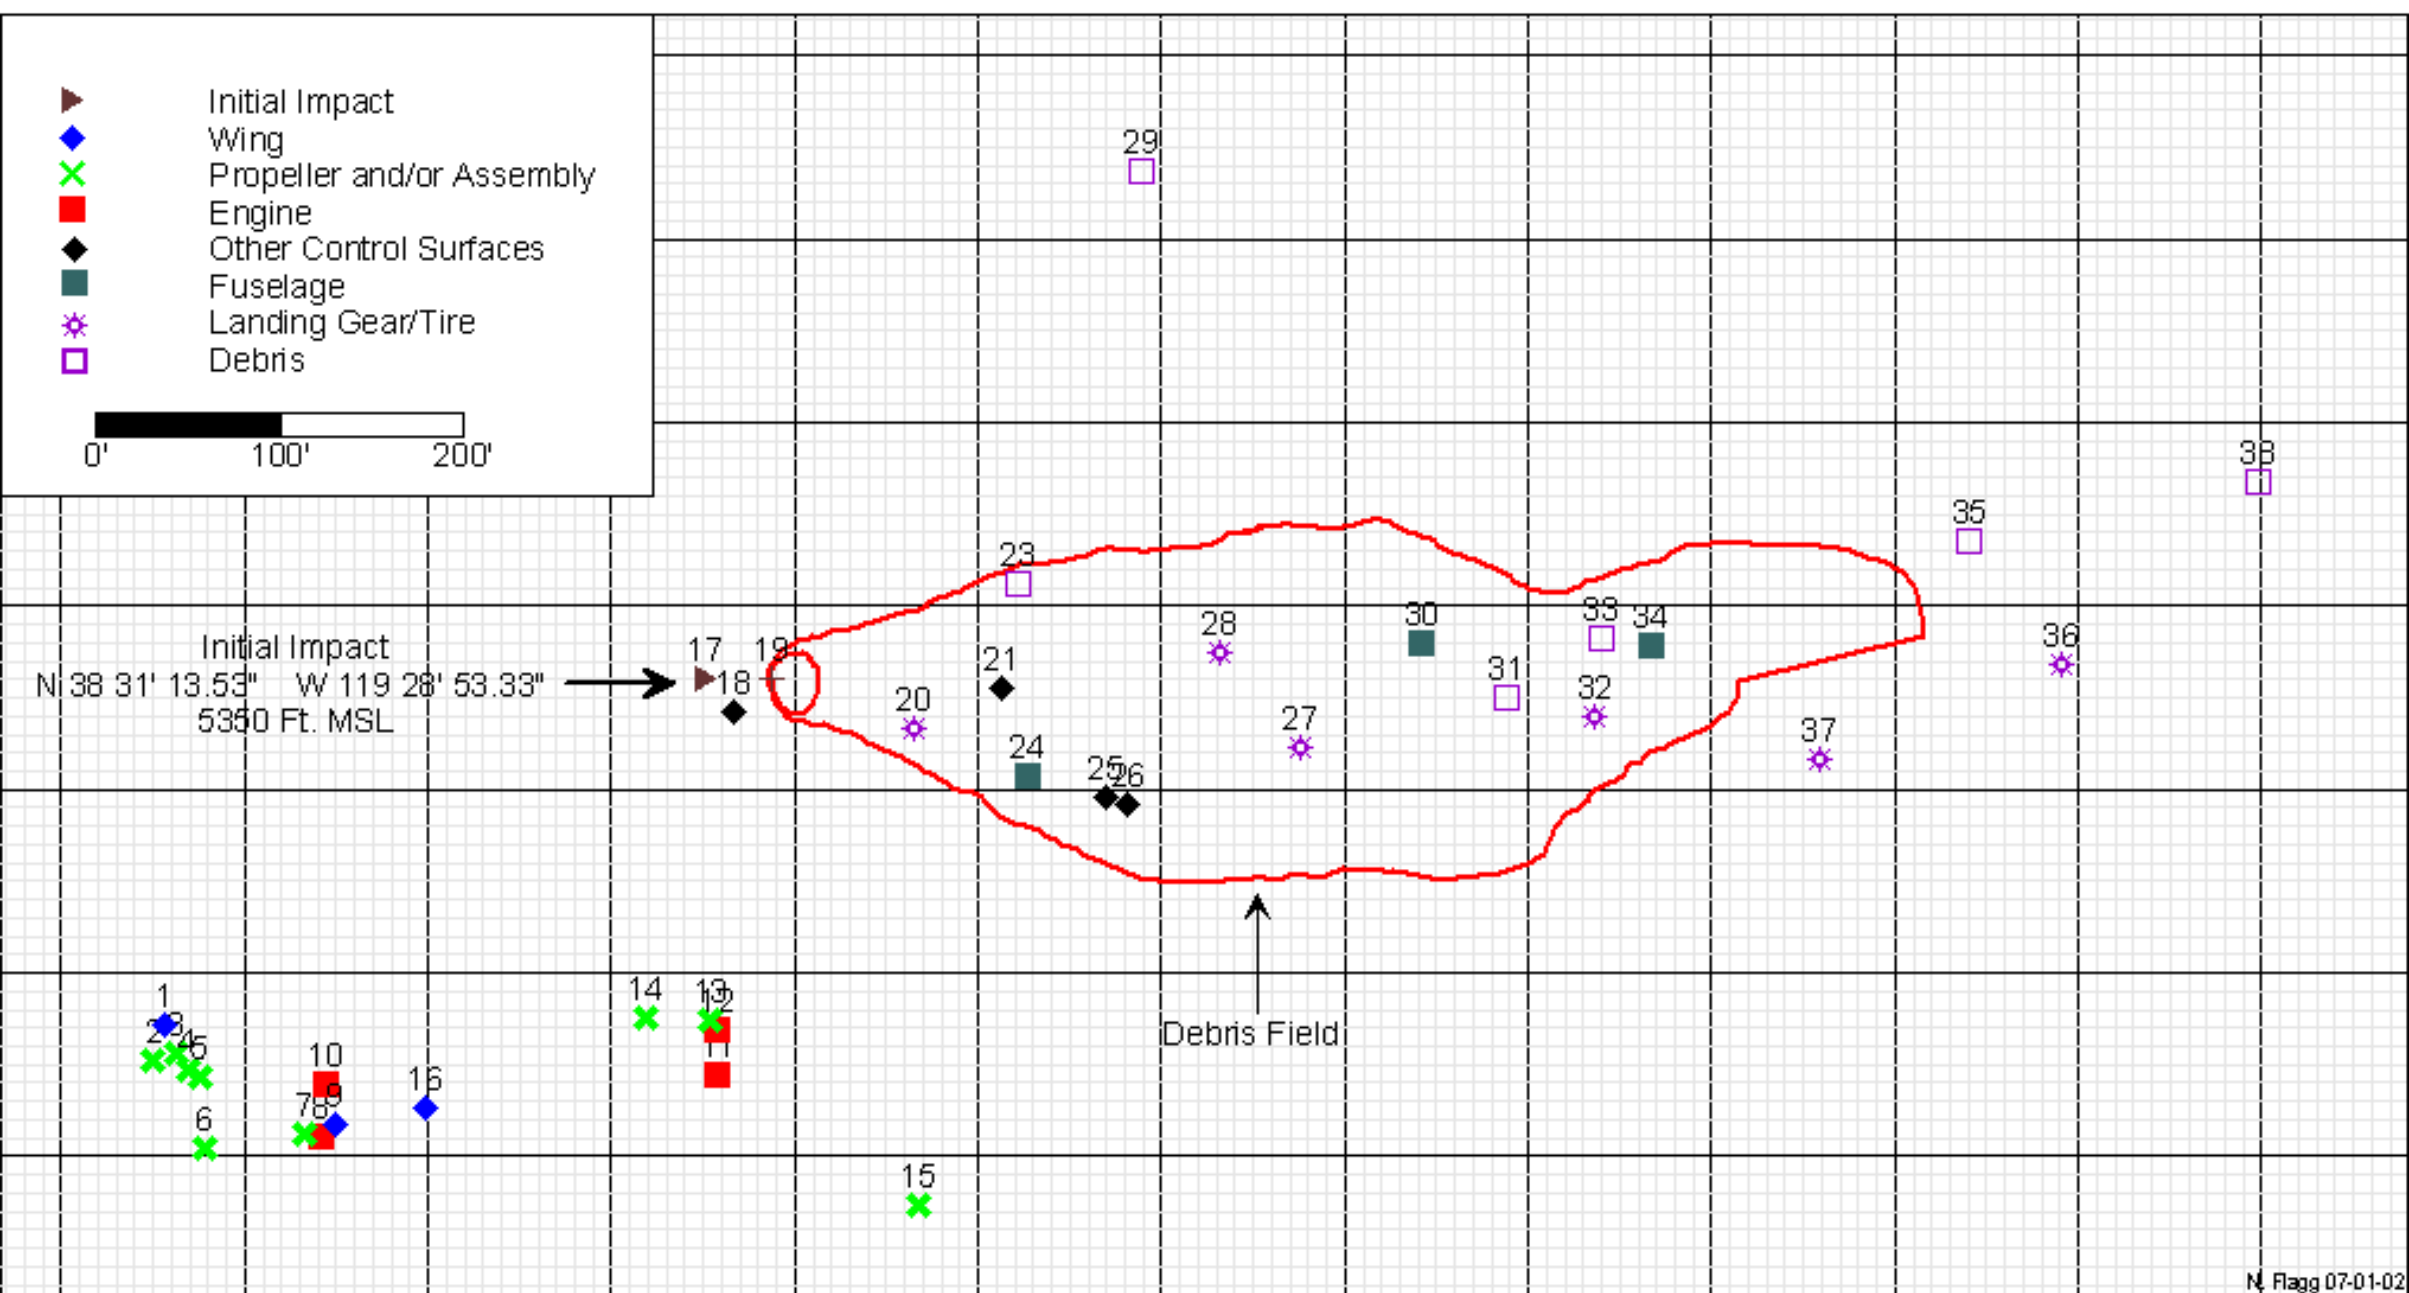
1	Wing - Left	13	Propeller Assembly	26	Tail
2	Propeller	14	Propeller	27	Main Gear w/Tire
3	Propeller	15	Propeller Assembly	28	Main Gear w/Tire
4	Propeller	16	Wing Section - Right	29	Farthest North Debris
5	Propeller	17	Initial Impact	30	Fuselage Skin - Aft Left Paratrooper Door
6	Propeller	18	Right Elevator (Outboard)	31	Cockpit area and Forward Cargo Compartment
7	Propeller Assembly	19	Start of Main Impact Site	32	Nose Gear Strut
8	Engine SN A101267	20	Landing Gear Strut	33	Retardant Tank Structure
9	Propeller Assembly/Left Outer Wing	21	Right Horizontal Stabilizer (Inboard)	34	Large Section Of Fuselage Skin
10	Engine	23	Upper Aft Cargo Ramp	35	Section of APU
11	Engine SN A100843	24	Wires/Fuselage Skin	36	Main Gear w/Tire
12	Engine SN AE101504/Bottom of Center Wing	25	Right Elevator with Trim Tab	37	Nose Gear and Axial
				38	Farthest East Debris - APU
