ATTACHMENT 28

AIRWORTHINESS GROUP CHAIRMAN'S FACTUAL REPORT

LAX-02-GA-201

4-140. INSPECTION CW 21, CENTER WING LOWER SKIN PANEL LAP JOINTS, CWS 220 TO 220 L/R. (See figures 4-20 and 4-21.)

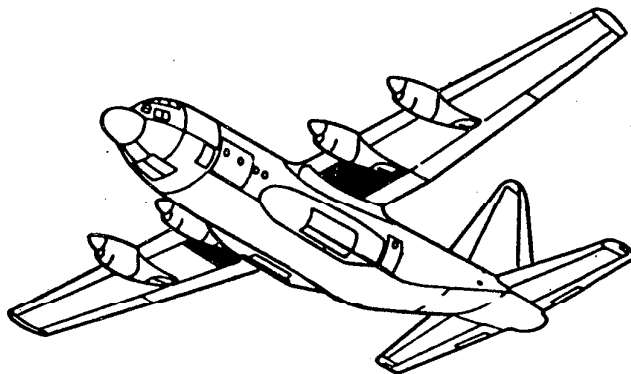
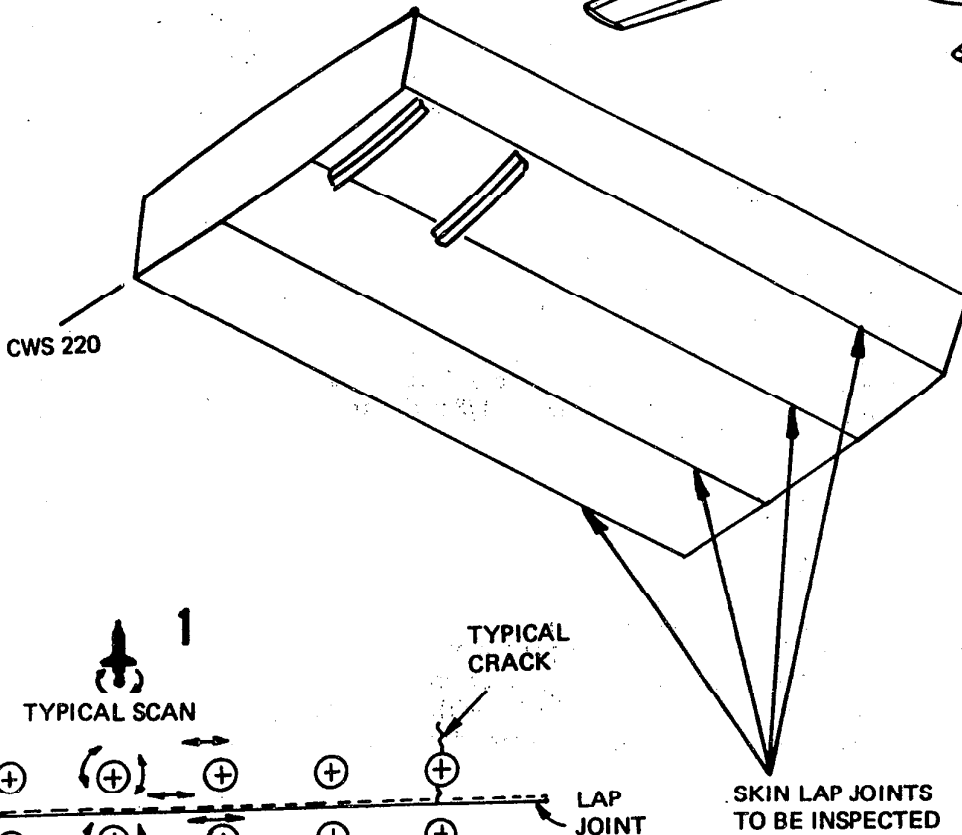
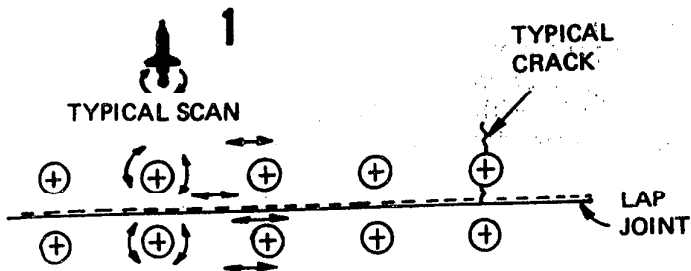
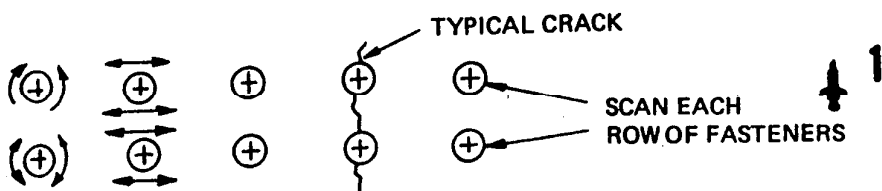
Figure 4-20. Inspection (No. 1) Of Center Wing Lower Skin Panel Lap Joints

(3) Scan around all fasteners in the skin lap areas including skin to spar cap. Fastener pattern and number of panels vary on different serial number aircraft. (See figure 4-20, item 1.)

1. SOME AIRCRAFT HAVE FOUR LOWER PANELS.
2. FASTENER PATTERNS VARY.
3. APPLICABLE TO C-130A/D ONLY.

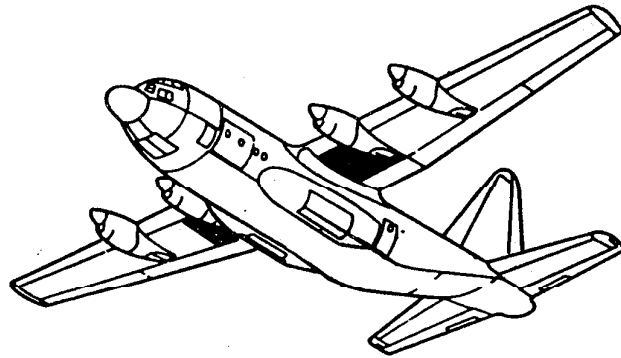
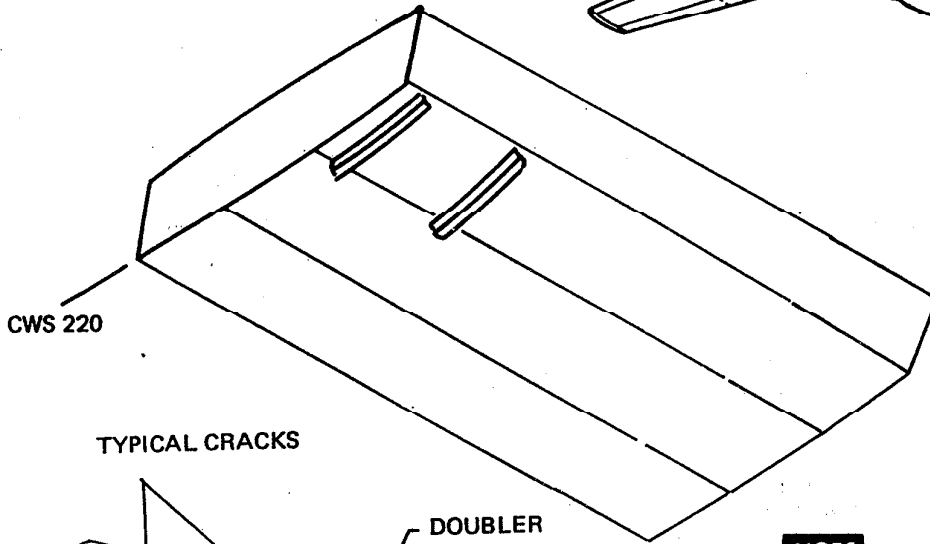
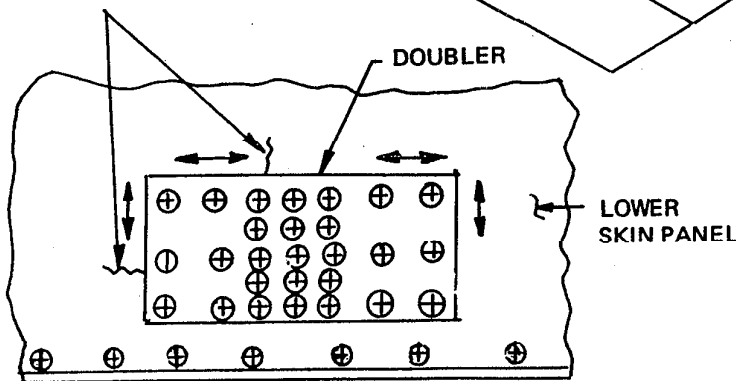
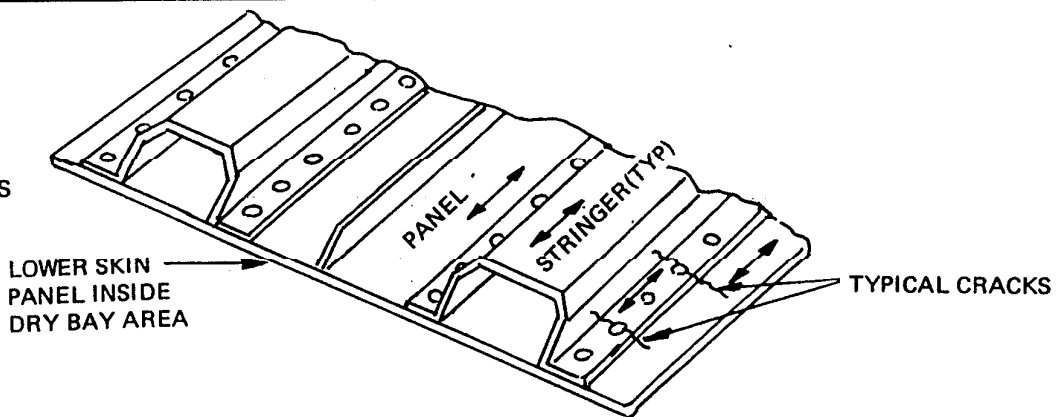
Figure 4-21. Inspection (No. 2) of Center Wing Lower Skin Panel Lap Joints

(1) If doubler exists scan around the edges of doubler for cracks emanating in covered wing panel. (See figure 4-21, item 2.)

INSPECT EDGES OF DOUBLER(S) ON WING PANEL(S) (BETWEEN CWS 220 TO 220 L/R).

1. IF CRACK IS FOUND COMING OUT OF DOUBLER, GAIN ACCESS TO THE DRY BAY AREA AND INSPECT STRINGER(S) AND WING PANEL(S) IN SUSPECTED AREA(S).
2. DOUBLER MAY BE INSTALLED OVER PANEL LAP JOINT. IF SO SCAN AROUND EDGES OF DOUBLER.

(2) If crack emanating beneath the doubler is found, gain access to the dry bay area and eddy current inspect (with shielded or regular 1/8 inch probe) the panel and stringers in suspected areas for cracks.
