ATTACHMENT 3

AIRWORTHINESS GROUP CHAIRMAN'S FACTUAL REPORT

LAX-02-GA-201

NON-DESTRUCTIVE INSPECTION OF WING SECTION AREAS OF EXTERNAL DOUBLER PANELS LOCATED TO EITHER SIDE OF CENTER WING STATION 61 LEFT

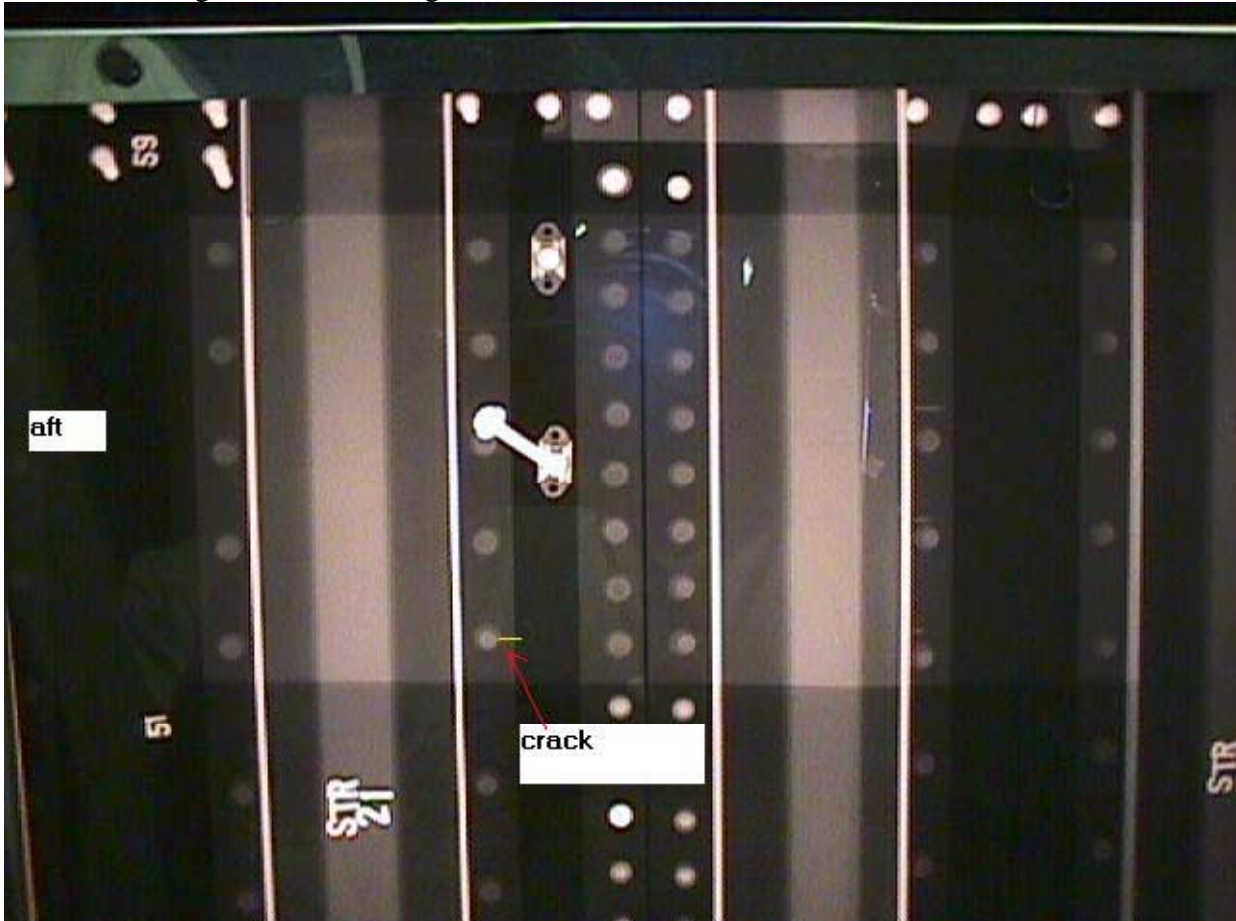
Photo-2 looking down from stringer side of skin

Crack X1 at inboard aft external doubler panel, extends aft from the 2nd fastener hole from the aft end of the external doubler panel and in the first row of fasteners along the inboard edge of the external doubler panel. Crack length is measured at .300". (Under forward flange of stringer 21 at wing station 51L) (See Photo-2)

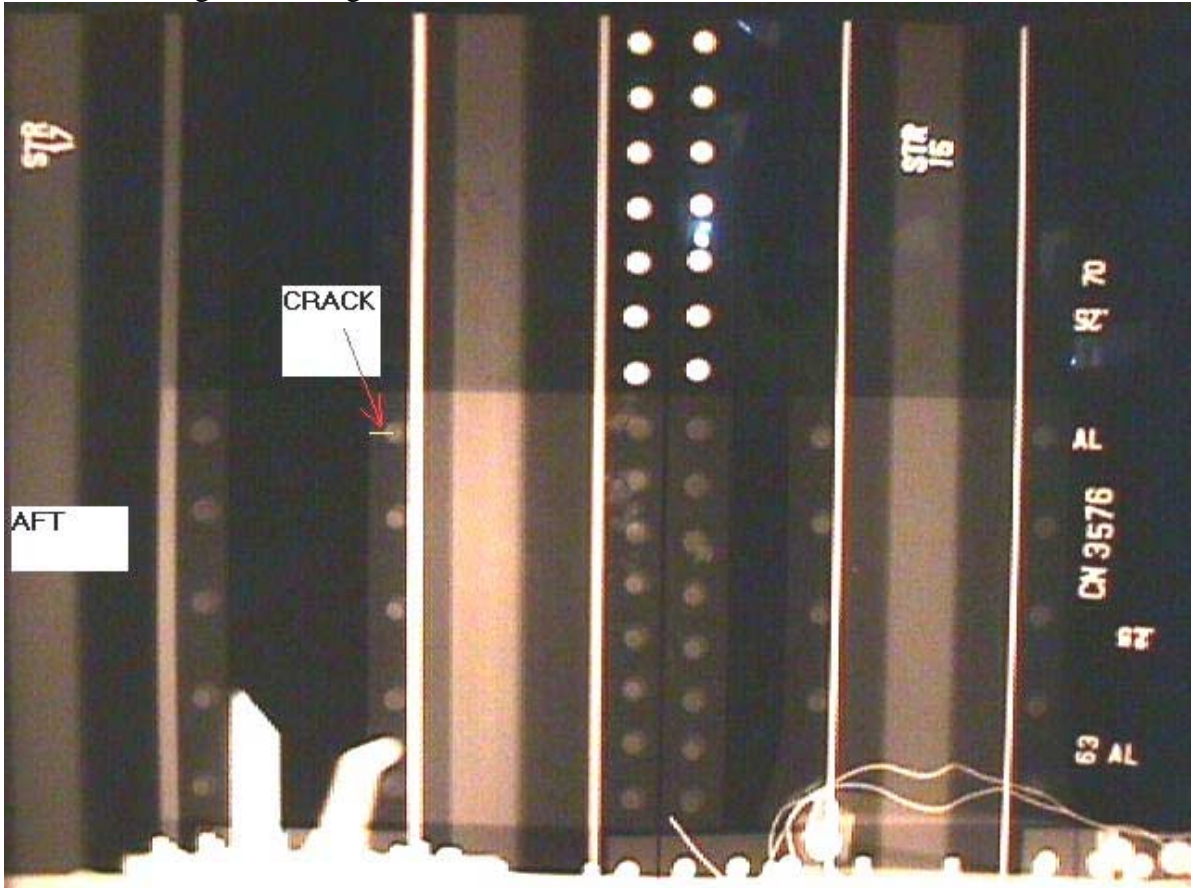
Photo-3 looking from stringer side of skin

Crack X2 at outboard forward external doubler panel, extends forward from the 2nd fastener hole from aft, in the first row of fasteners along the outboard edge of the external doubler panel. Crack length is measured at .450" (under aft flange of stringer 16 at wing station 70L) (See photo-3)

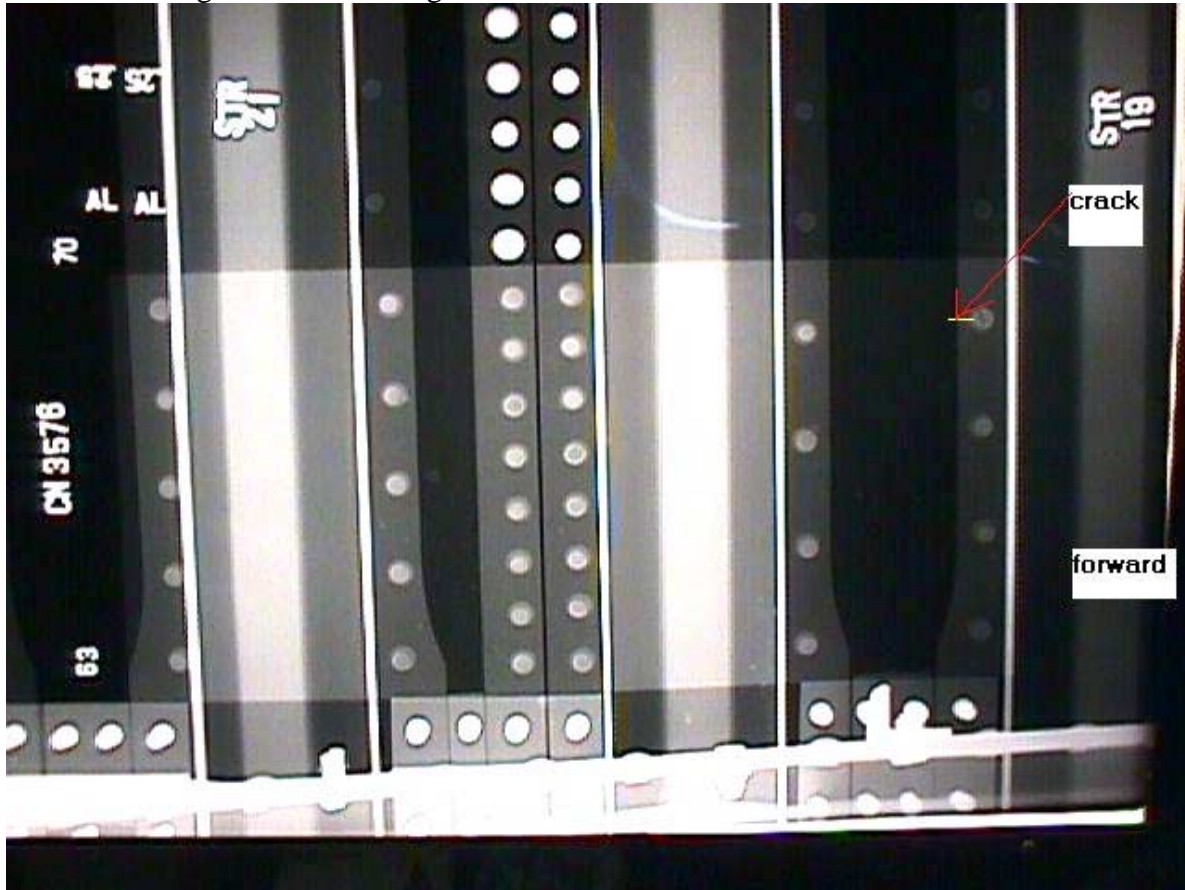
Photo-4 looking down from stringer side of skin

Crack X3 at the outboard aft external doubler panel, extends forward from the aft outboard corner fastener hole of external doubler panel 3 (Under aft flange of stringer 19 at wing station 70). Crack length is measured at .350" (see Photo-4)

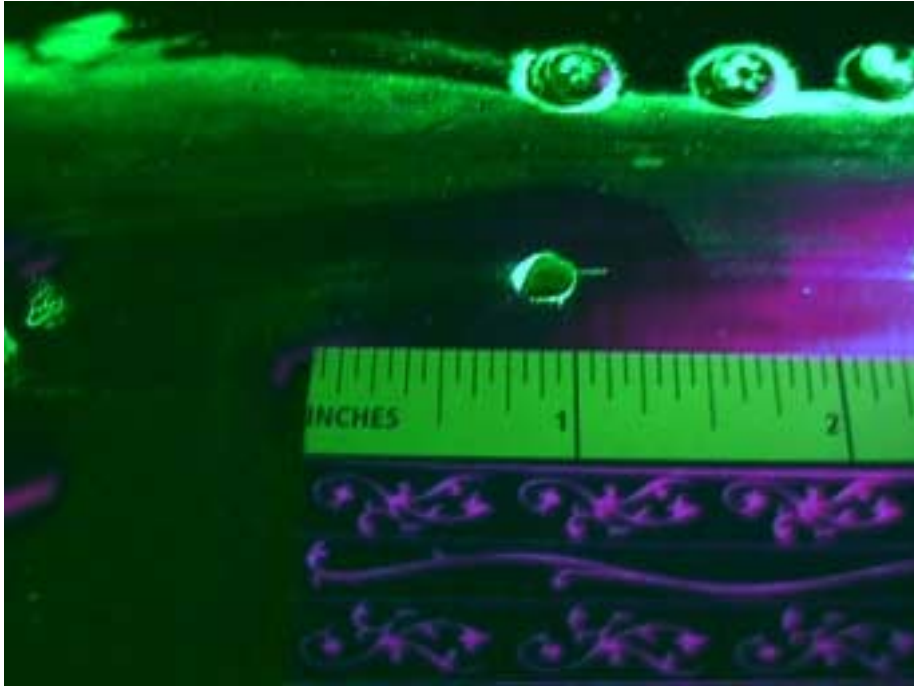
Photo 5

Crack P1 under outboard aft external doubler panel. Crack is .120" in length.

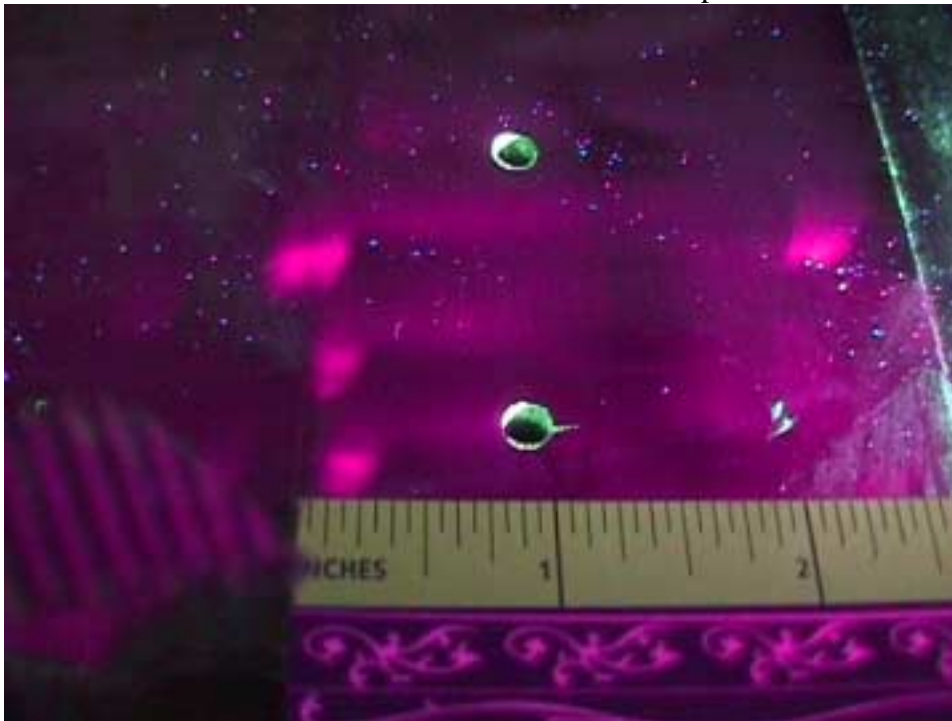
Photo 6 Crack-P2 under outboard aft external doubler panel. Crack is 100" in length.

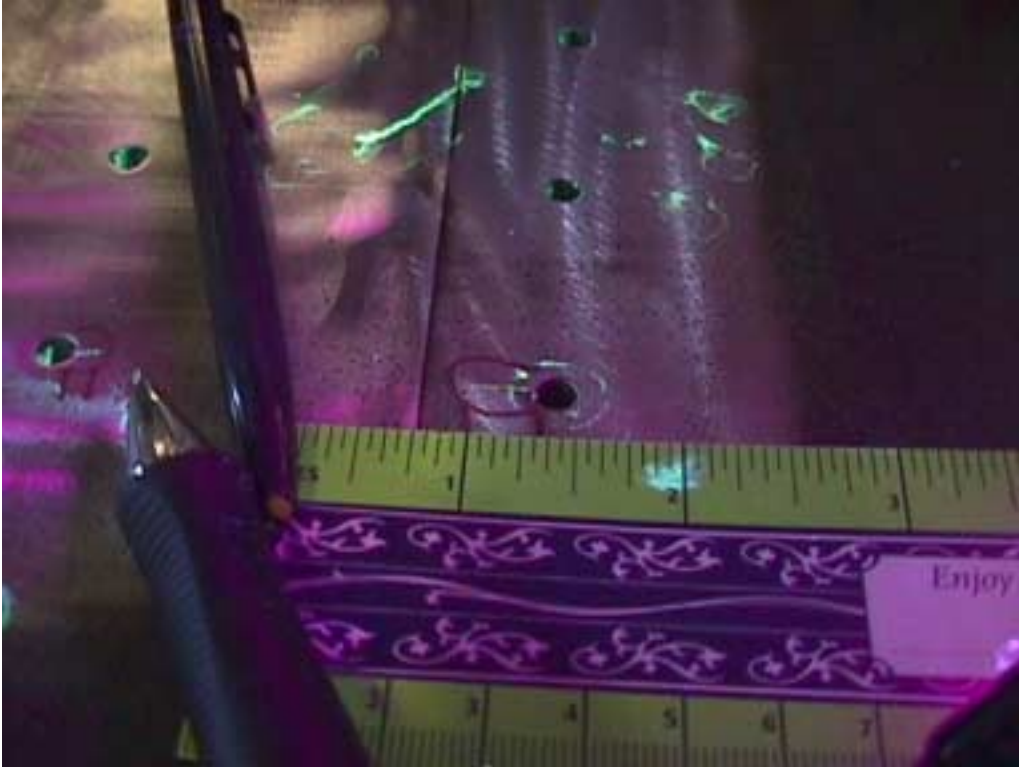
Photo 7 Crack P3 under outboard aft external doubler panel. Crack is 300'' in length. and corresponds with crack X3

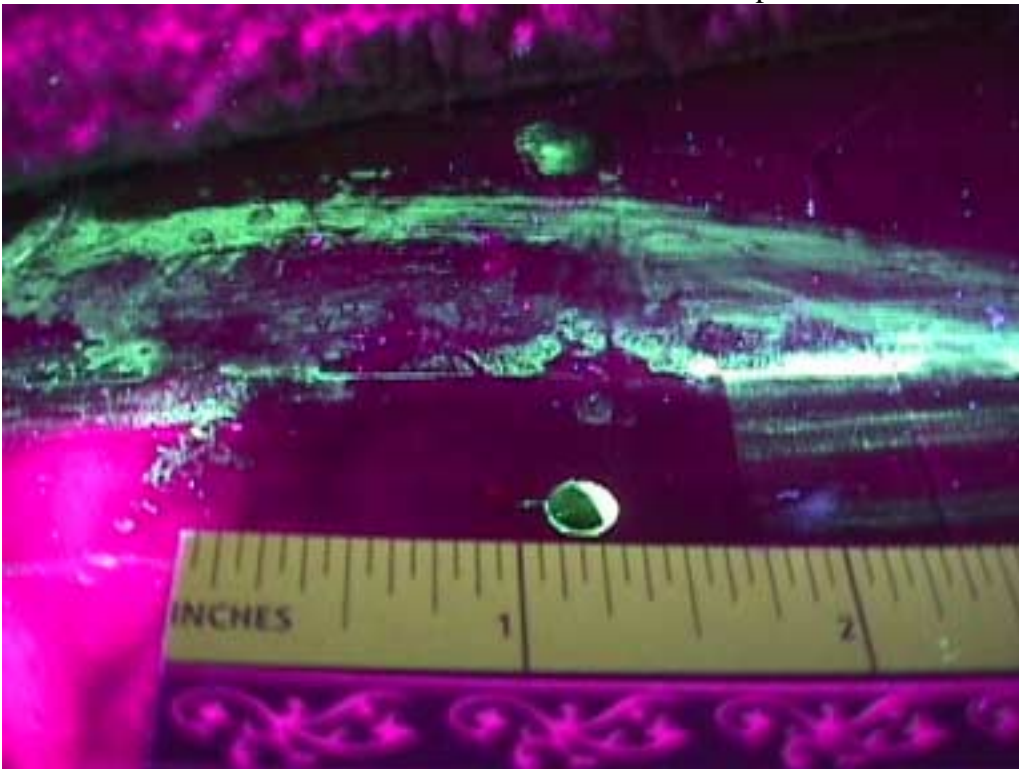
Photo 8 Crack P4 under inboard forward external doubler panel. Crack is .035'' in length

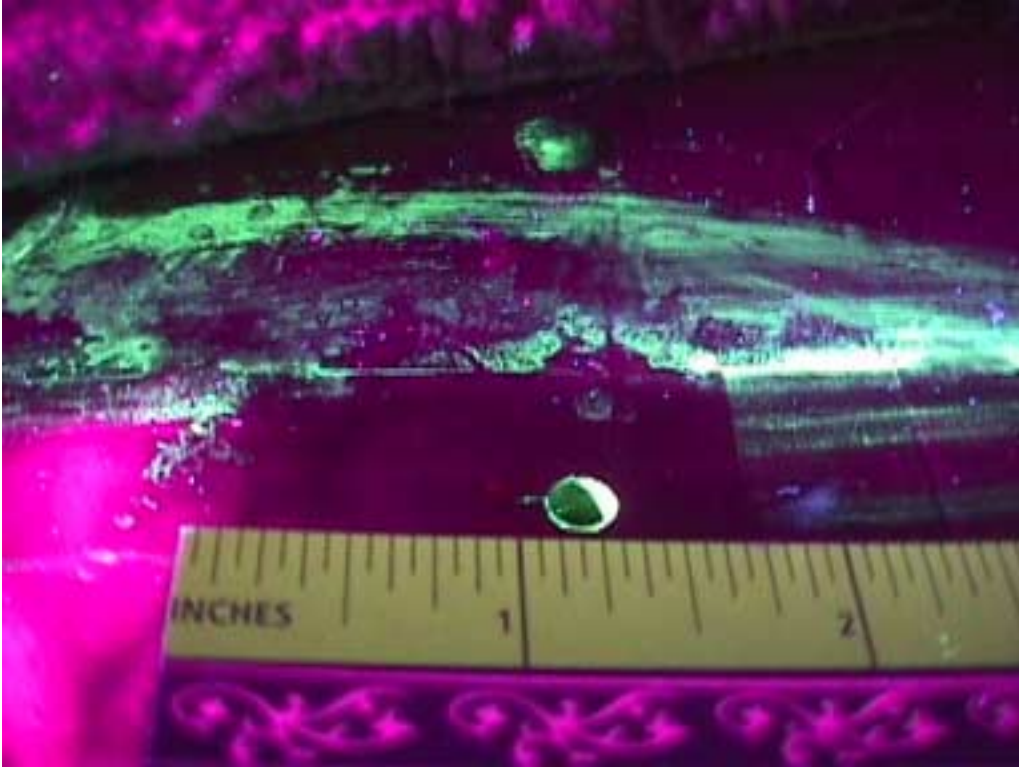
Photo 9 Crack-P5 under inboard forward external doubler panel. Crack is .050" in length

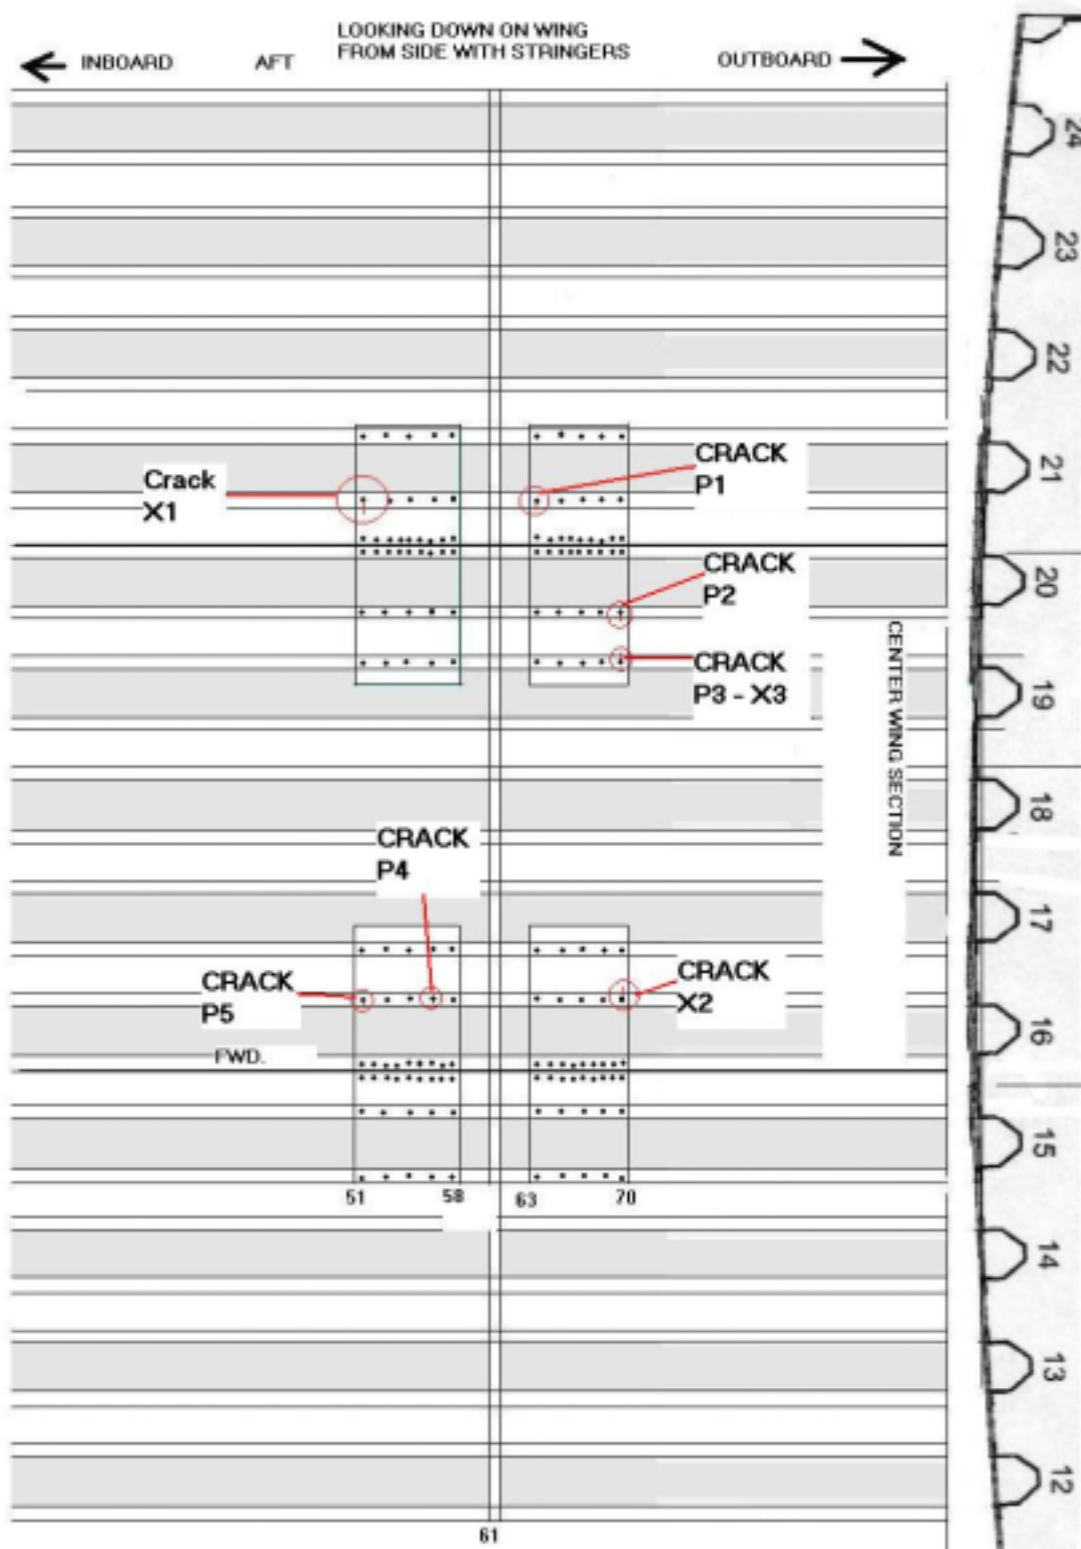
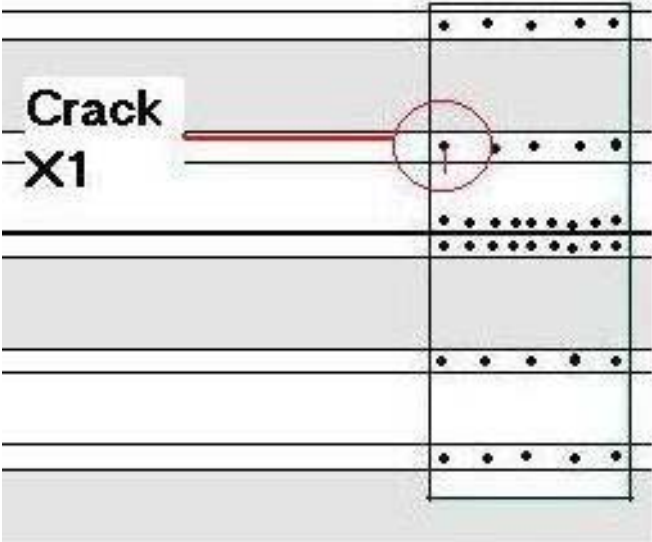
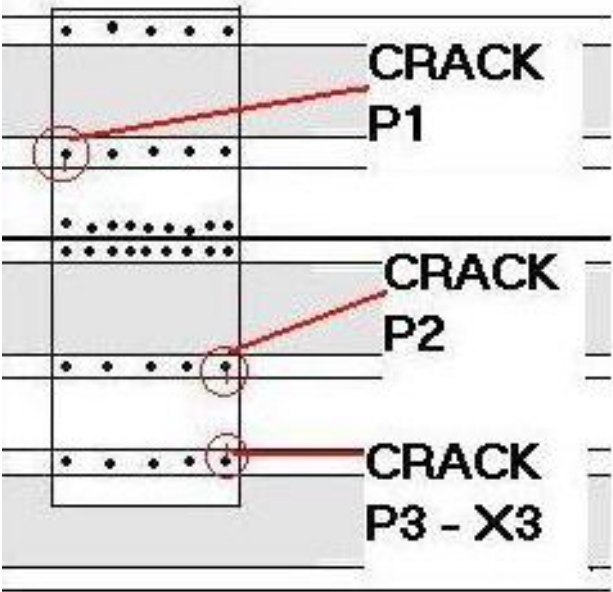
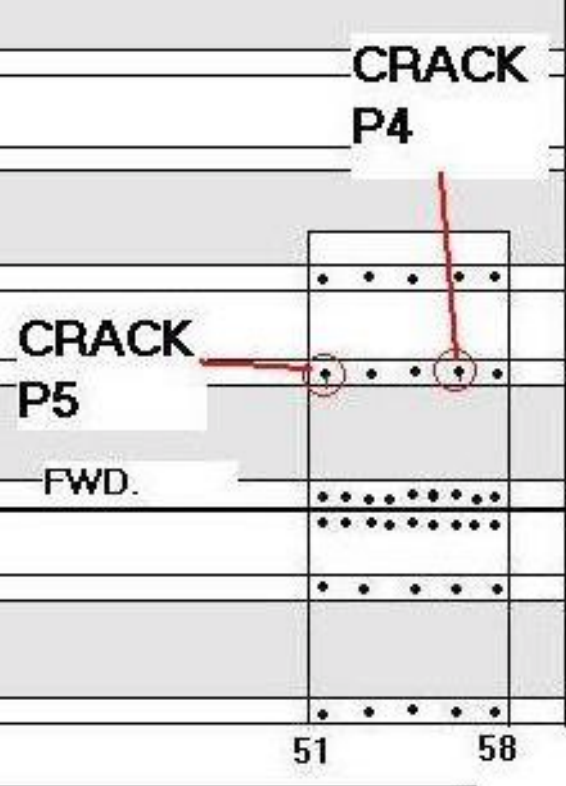
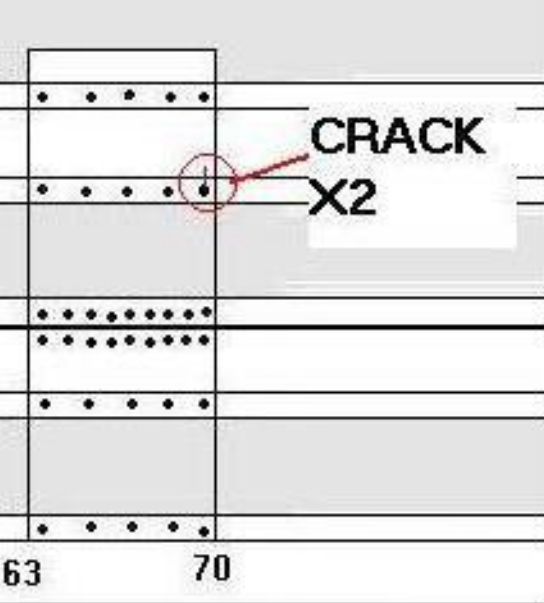
Figure 2 thru figure 6 show all cracks under the external doubler panels and their locations, Figures 3 thru 6 are enlargements of figure 2
Figure 2

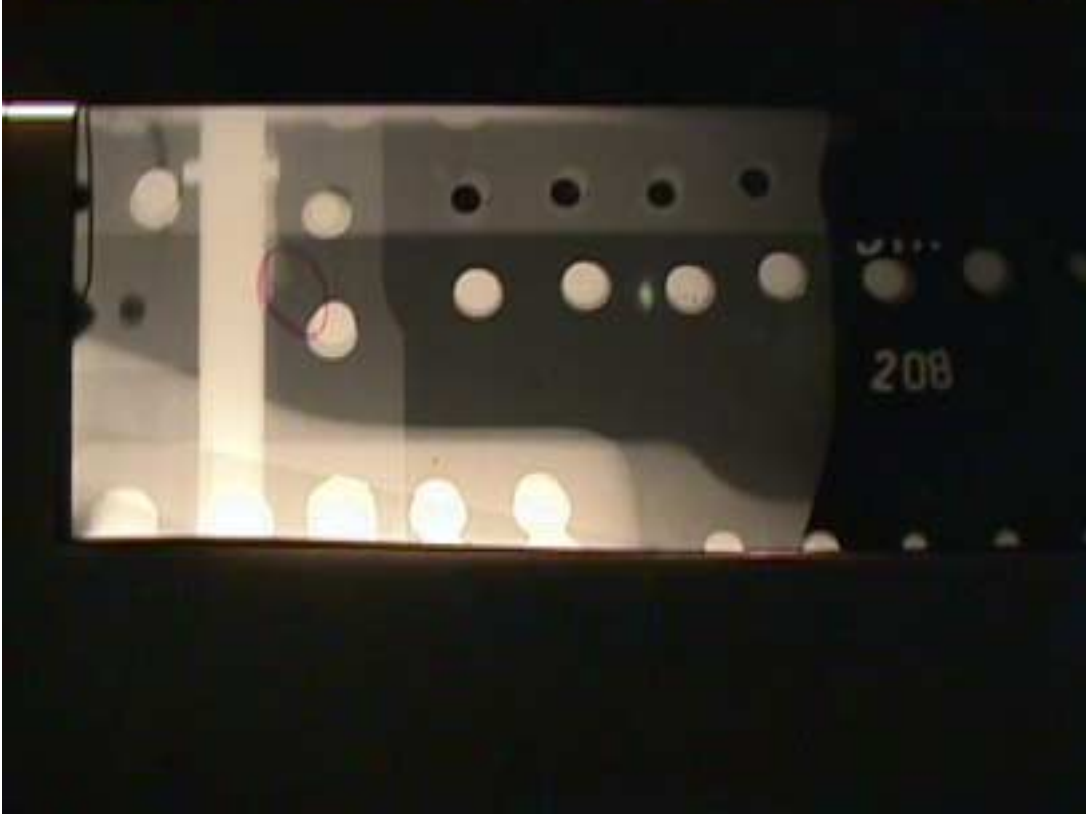
Photo 10 Crack X4

Crack X4 is located in the attach drag angle. The crack extends at a 45° angle and then turns cord length from the center of three fasteners located between stringer 12 and the forward beam. Crack length is .450". (See Photo 10 and figure 8 and 9)

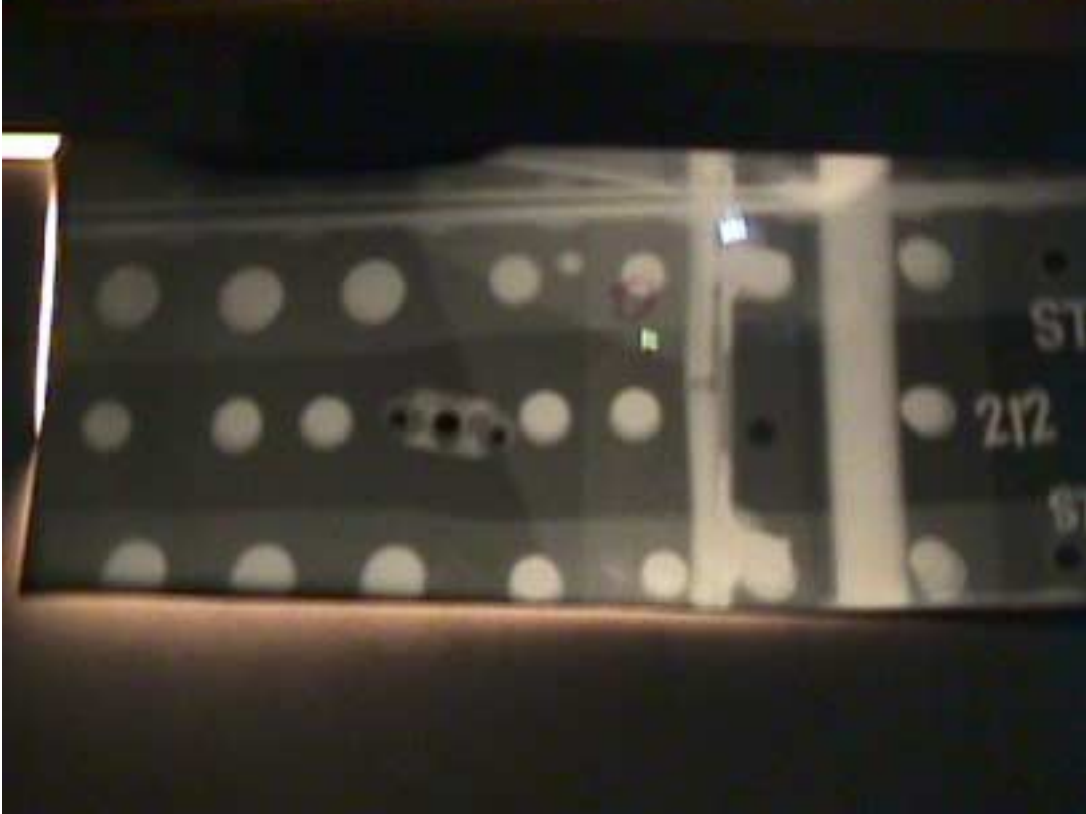
Photo 11 Crack X5

Crack X5 extends from forward from the second fastener hole outboard of the attach angle under stringer 15 flange. Crack length is .120" (see Photo 11 and Figure 8 and 10)

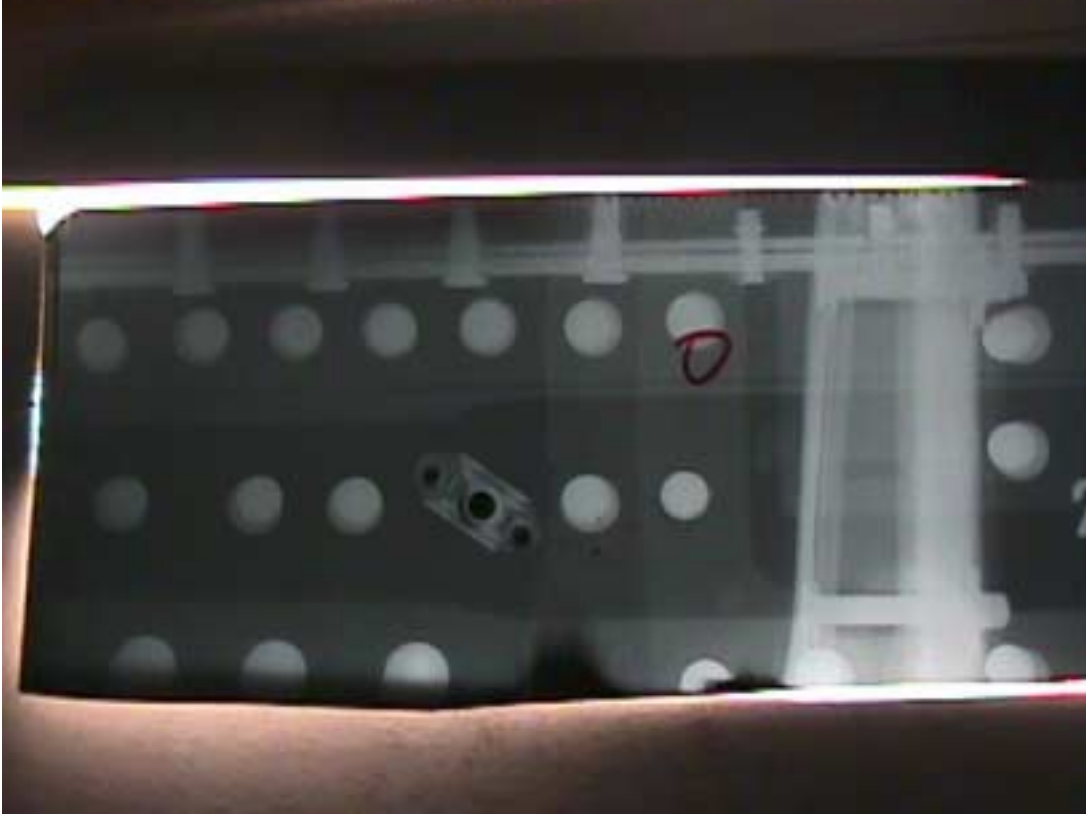
PHOTO 3 CRACK X6

Crack X6 extends from forward from the first fastener hole outboard of the attach angle under stringer 16 flange. Crack length is .220". (See Photo 12 and Figure 8 and 11)

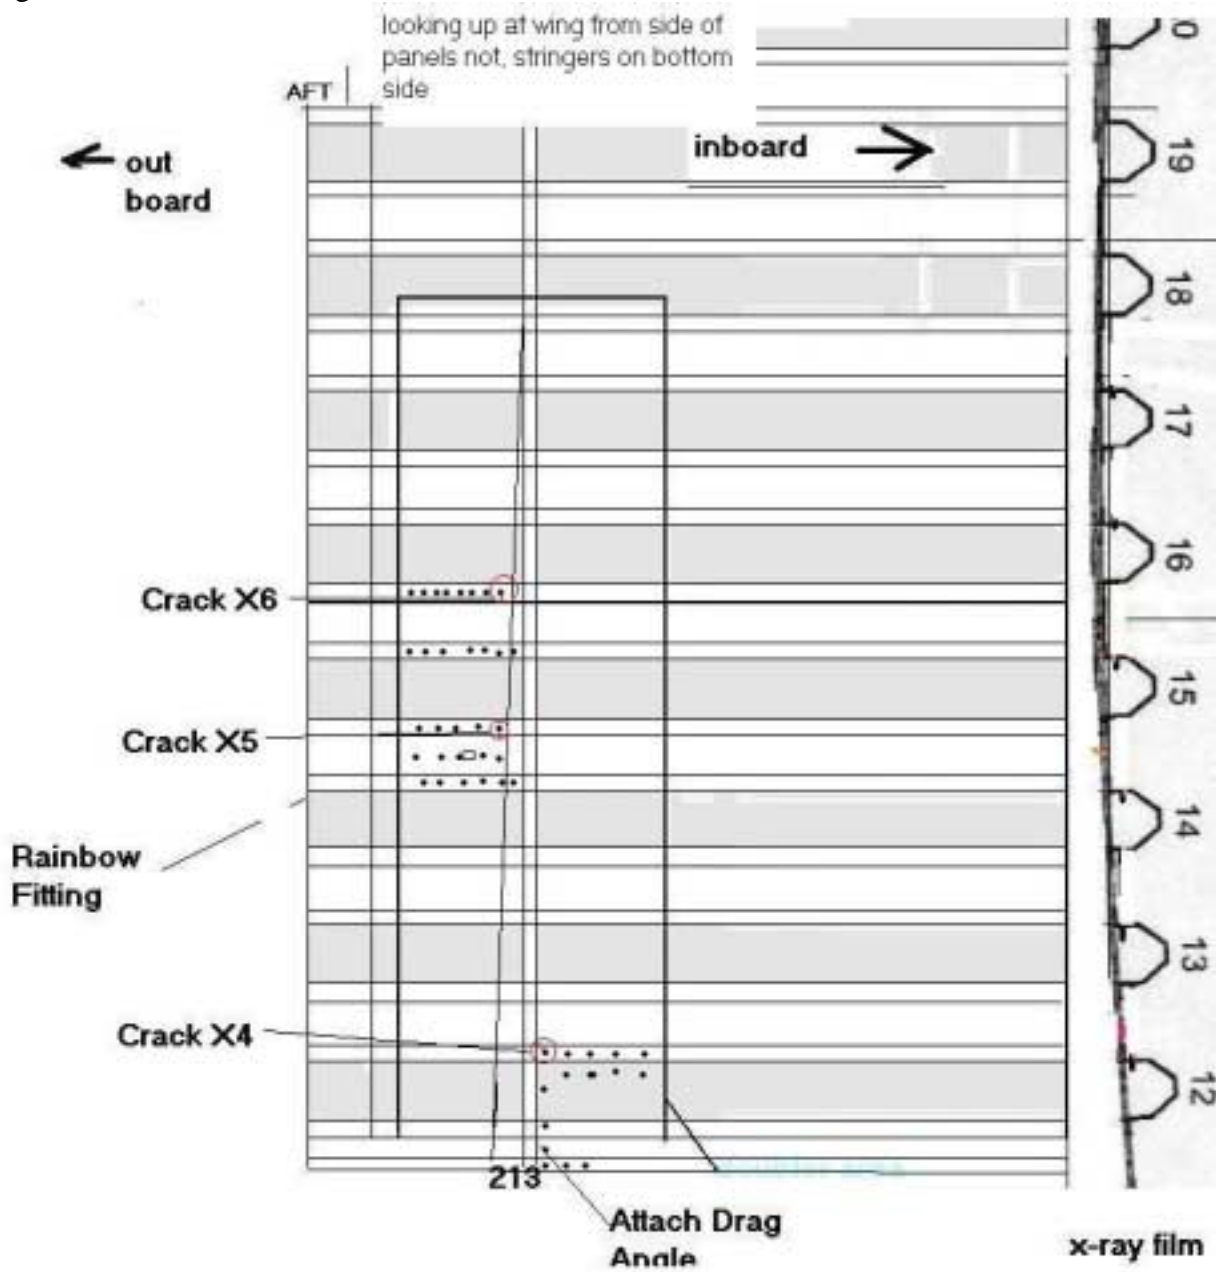
The x-ray inspection to the sides of wing station 213L along the length of the external doubler revealed 3 cracks. Photos 11-13 show the crack location on x-ray film. All extend from fastener holes. Figure 8 depicts crack locations in relation ship to the wing. It could not be determined from this inspection if cracks X5 and X6 are located in the wing panel or the doubler.

Additional work proposed for the area of the doubler around wing station 213L The drag angle should be removed and further inspection be performed to determine if the cracks are in the wing panel or the doubler.

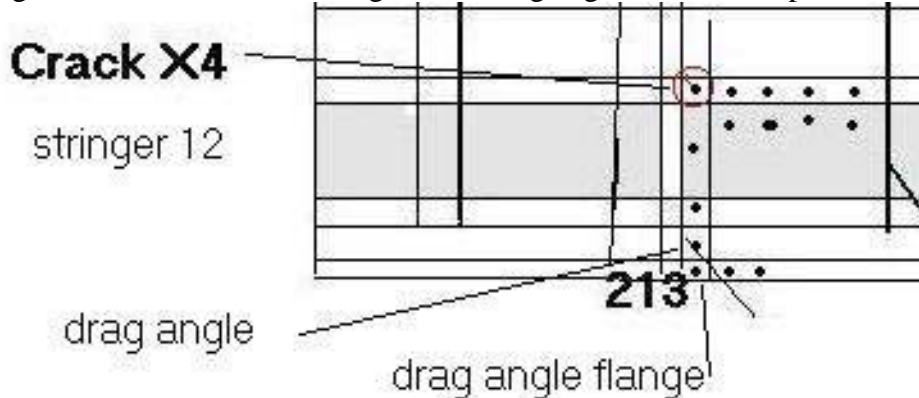
Figure 11 Crack is in the flange of the drag angle not the skin panel
