**AIRWORTHINESS GROUP CHAIRMAN'S FACTUAL REPORT**

**LAX-02-GA-201**

METALLURGICAL ANALYSIS  
FAILURE ANALYSIS &  
EXPERIMENTAL TESTING

Aircraft: Lockheed C130A, S/N 56-538  
Registration: N130HP  
Location: Walker, CA  
Date: June 17, 2002  
NTSB File No.: LAX 02GA201

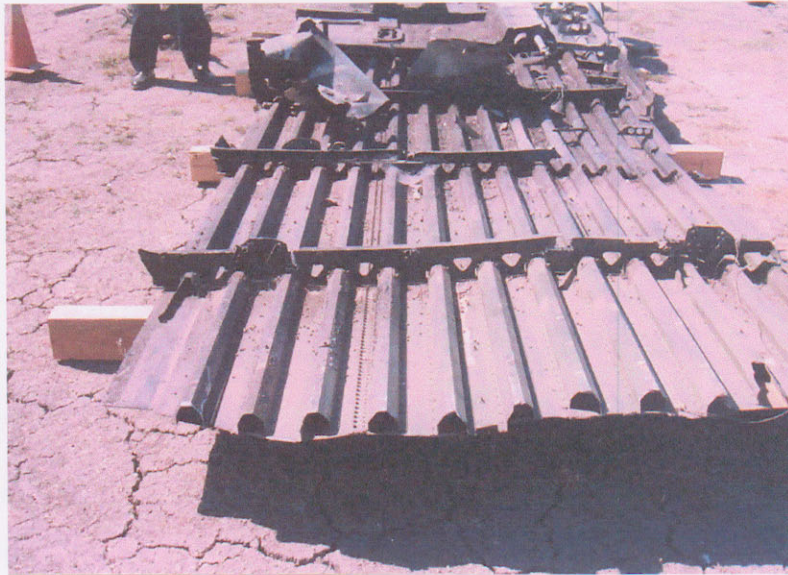
**Figure 1**

**Lower Panel of Center Wing Section**

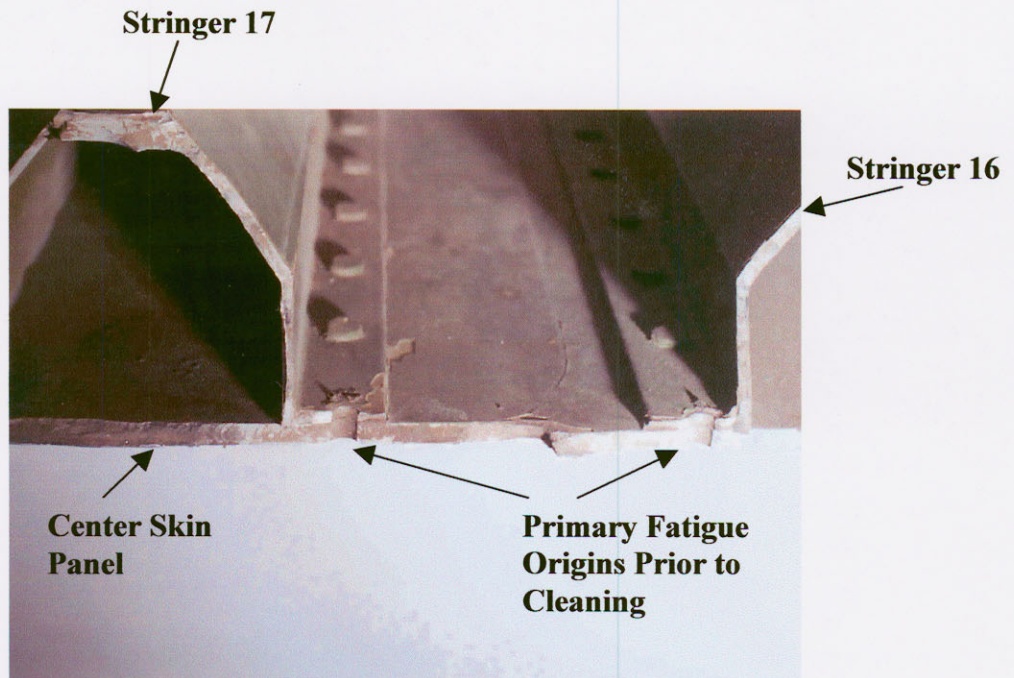
**Figure 5**

(striations) characteristic of fatigue crack growth. Fatigue is a progressive mechanism of crack growth that occurs due to cyclic stress of sufficient magnitude. Figure 5 shows the suspected area of fatigue crack propagation prior to cleaning. The fracture surface was cleaned in a soap solution with mild scrubbing using a nylon bristle brush, followed by an acetone rinse. The fracture surfaces were examined further under the binocular microscope. Figure 6 shows an illustration of the wing panels in the area of fatigue crack initiation and panel fracture. Clearly defined fatigue striations were observed to have initiated from two rivet holes where stringers 16 and 17 are attached to the lower wing skin center panel. Figure 7 shows a closer view of the region exhibiting fatigue crack initiation and propagation after cleaning.

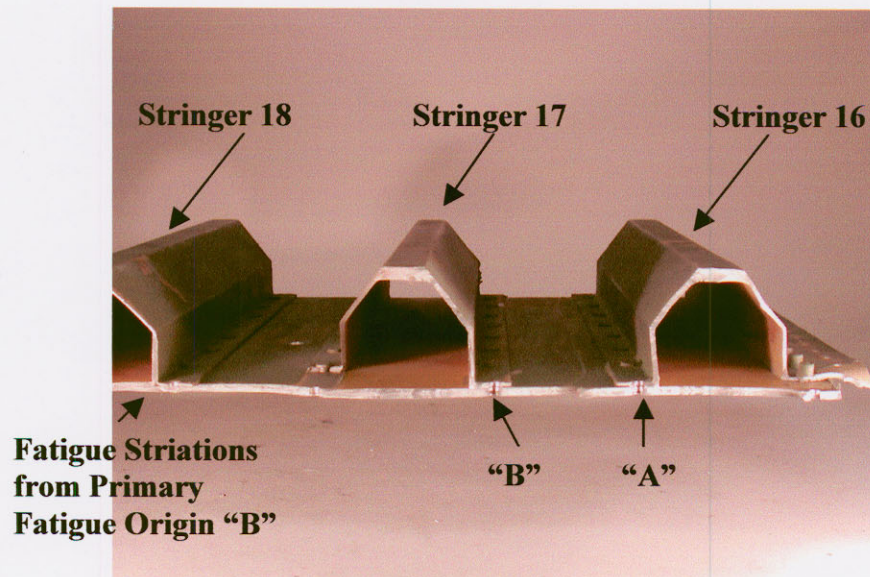
**Figure 7**

**Center Skin Panel Showing Primary Fatigue Origins "A" and "B" (see Figure 8)**

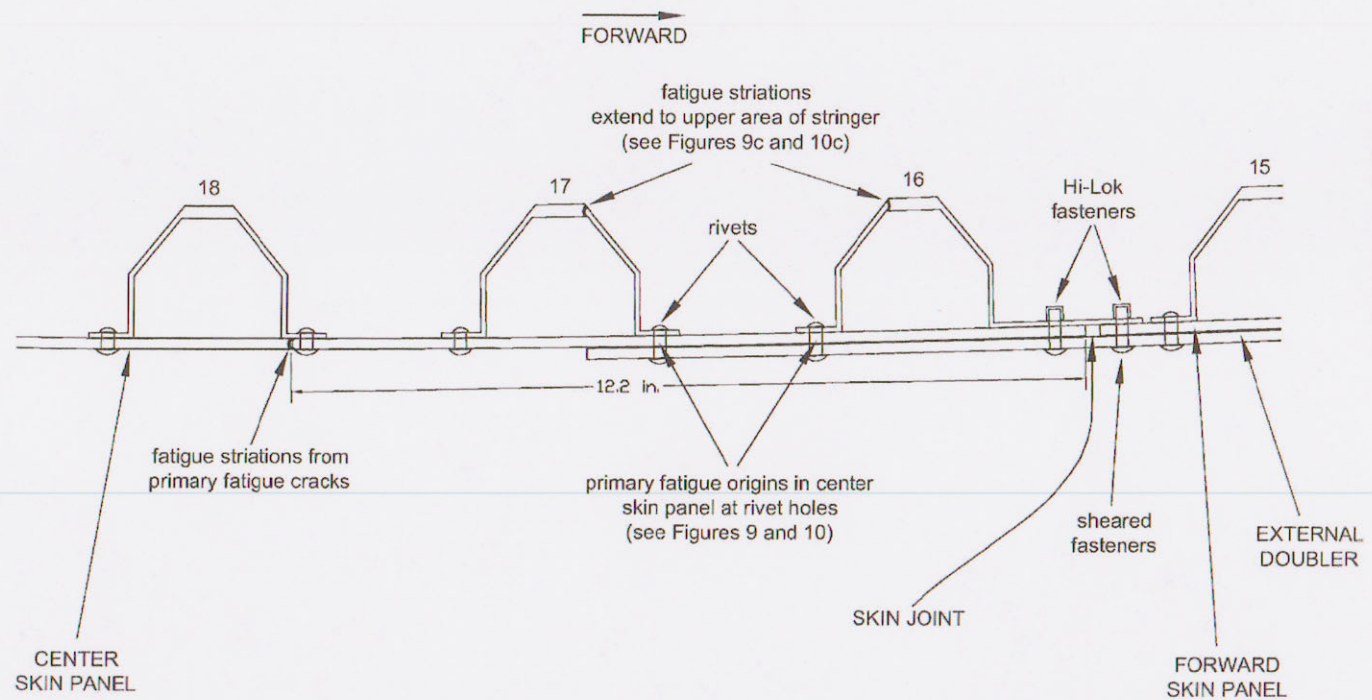
Figure 8

The primary areas of fatigue crack initiation are at two adjacent holes in the skin where rivets attach stringers 16 and 17 and an external doubler to the lower skin panel at approximately center wing station 53R. An illustration of the area of primary fatigue initiation and growth is shown in Figure 8. Fatigue cracks initiated in the skin from both sides of the aft rivet hole for stringer 16 (Origin "A" shown in Figures 9a through 9c) and the forward rivet hole for stringer 17 (Origin "B" shown in Figures 10a through 10c) and grew outward from each rivet hole. The fatigue cracks at origin "A" initiated from the rivet hole surface adjacent to an indent on the forward side and appeared to have multiple origins from the hole surface on the aft side. The fatigue cracks at origin "B" initiated from the lower corner of the rivet hole on the forward side and appeared to have multiple origins from the hole surface on the aft side. The rivet hole surfaces contained shallow circumferential marks from drilling and residual sealant from installation of the external doubler. Fatigue cracks also initiated in the stringer flanges above the areas of primary initiation in the skin and propagated to the upper section of stringers 16 and 17 (see Figures 9c and 10c). The skin fatigue cracks that grew in the aft direction from stringer 16 and forward from stringer 17 eventually joined together resulting in one longer crack as indicated by the presence of black (aluminum) oxide caused by rubbing of the mating fracture surfaces in the area where the cracks joined. The length of fatigue crack growth based on the presence of striations on the fracture surface from each hole is listed in Table I. The aft crack from the skin hole at stringer 17 had multiple bands of fatigue crack growth separated by stable tearing of the skin. This crack grew into the rivet hole under the aft flange of stringer 17 and reinitiated on the opposite side of the hole. The aft most band of fatigue crack growth was under the forward flange of stringer 18 (see Figures 7 and 8). The other cracks from the primary fatigue origins also exhibited areas of stable tearing of the skin followed by crack arrest and continued fatigue crack growth. The total crack length based on the presence of fatigue striations for the forward end of the crack from stringer 16 and the aft end of the crack from stringer 17 was approximately 10.9 in. Assuming the crack grew to the forward edge of the center panel then the total crack length was 12.2 in. (see Figure 8). The lower skin thickness measured adjacent to the fatigue origins was 0.163 in. (with primer present).

C130A RIGHT WING AT STA 53R  
STRINGERS 18 - 15  
SHOWING PRIMARY FATIGUE CRACK ORIGINS

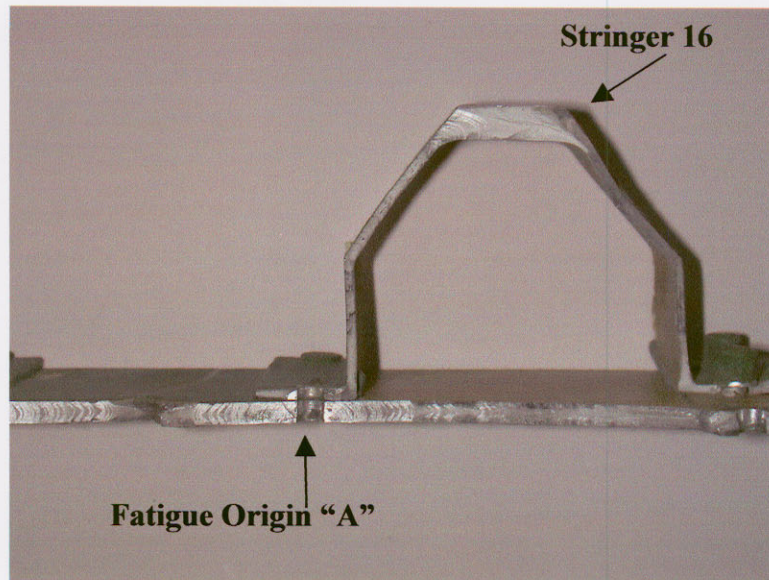
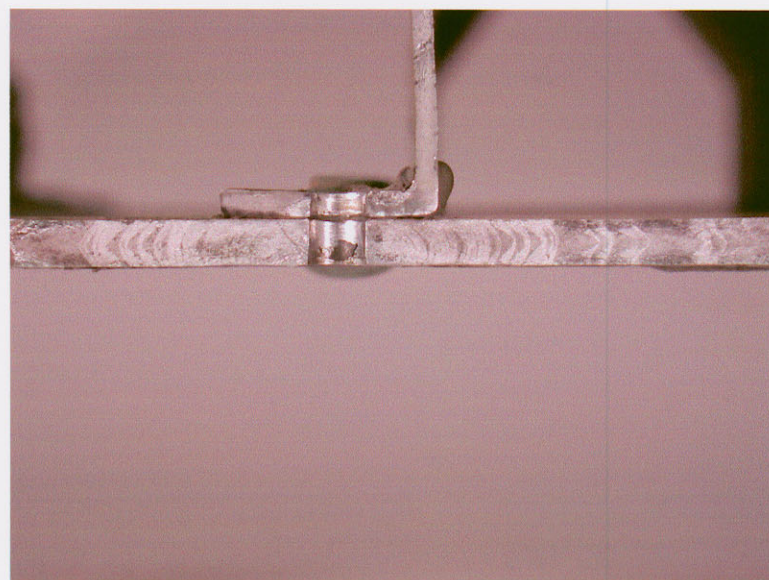
| Primary Origin "A" | Fatigue cracks initiated in the skin from both sides of the aft rivet hole where stringer 16 is attached to center panel, lower skin at STA 53R. Fatigue striations extended 2.2 in. forward of the hole and 0.75 in. rearward. Fatigue cracks also initiated in the stringer flange rivet hole and grew to the upper (thicker) section. See Figures 8 and 9c. |

**Primary Fatigue Origin "A"**

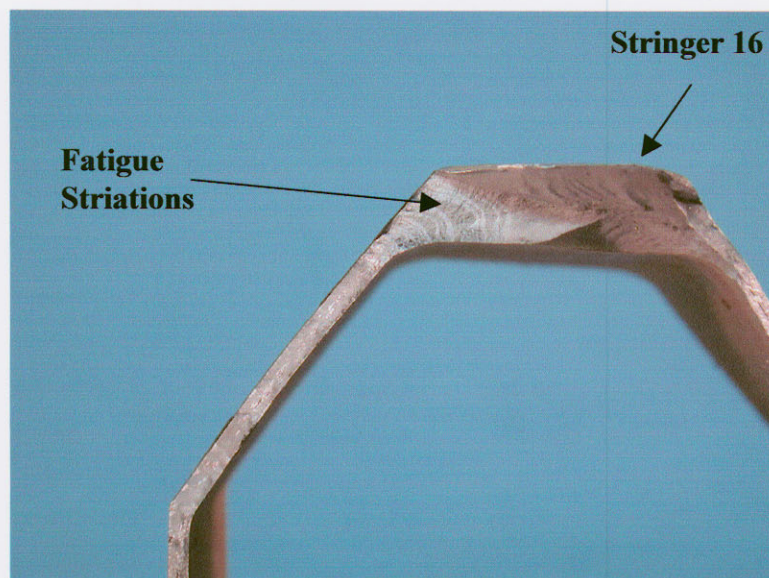
**Figure 9c**

**Fatigue Crack Growth in Stringer 16**

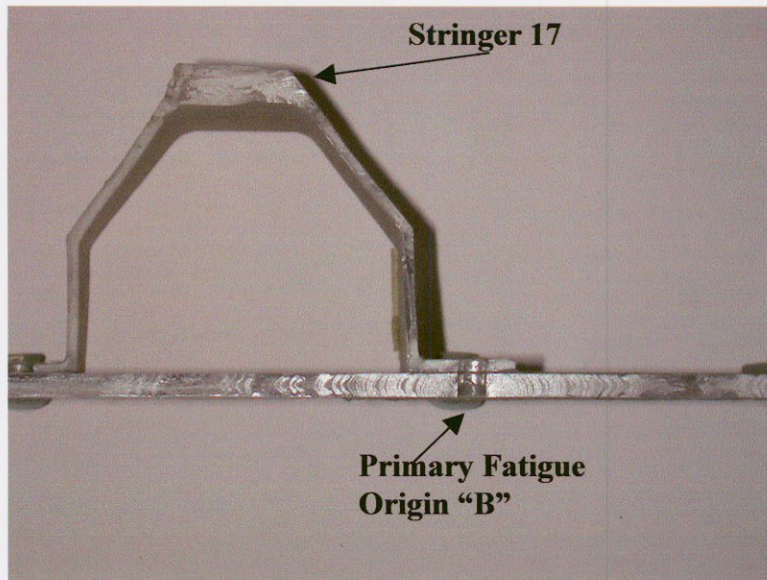
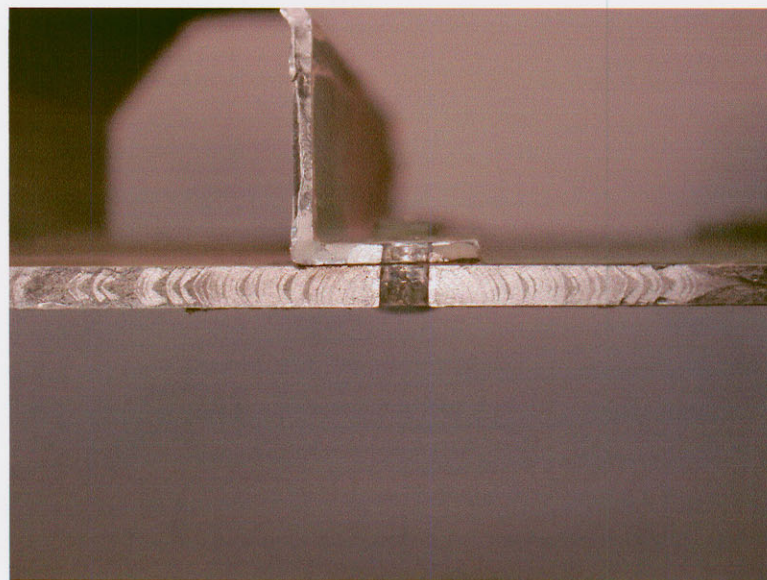
| Primary Origin "B" | Fatigue cracks initiated in the skin from both sides of the forward rivet hole where stringer 17 is attached to center panel, lower skin at STA 53R. Fatigue striations extended 1.08 in. forward of the hole and 6.0 in. rearward. Fatigue cracks also initiated in the stringer flange rivet hole and grew to the upper (thicker) section. See Figures 8 and 10c. |

**Primary Fatigue Origin "B"**

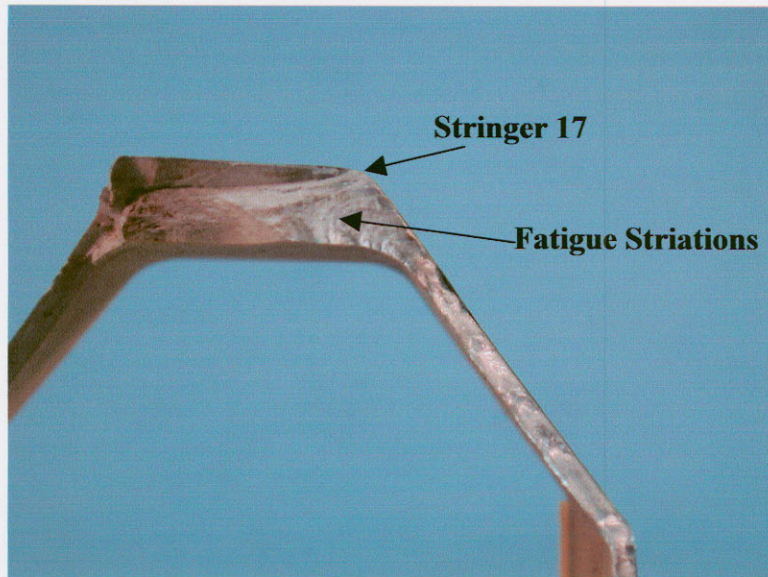
**Figure 10c**

**Fatigue Crack Growth in Stringer 17**

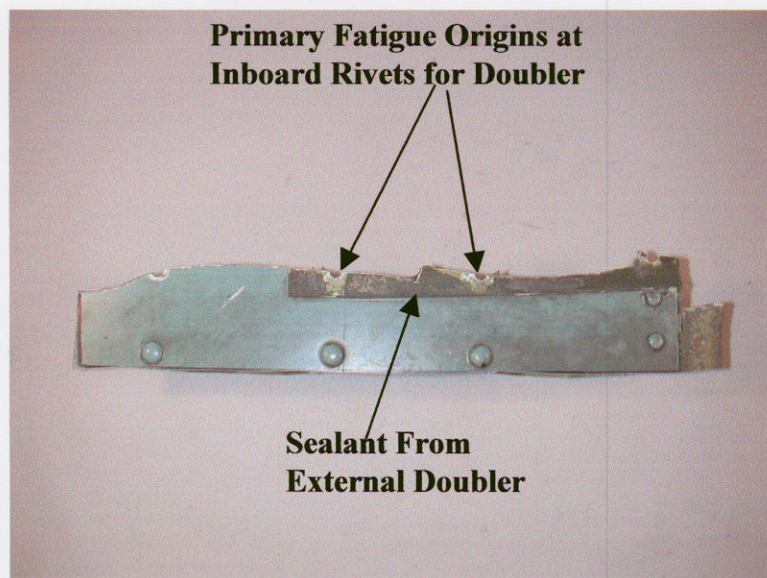
**Figure 11**

The lower surface of the center panel skin had a rectangular shaped outline of sealant material extending aft 6.95 in. from the forward edge (Figure 11) and extending onto the forward skin panel. The sealant is from the installation of an external doubler riveted to the lower surface of the skin across the joint between the forward and center skin panels.

**Lower Surface of Center Wing Panel**

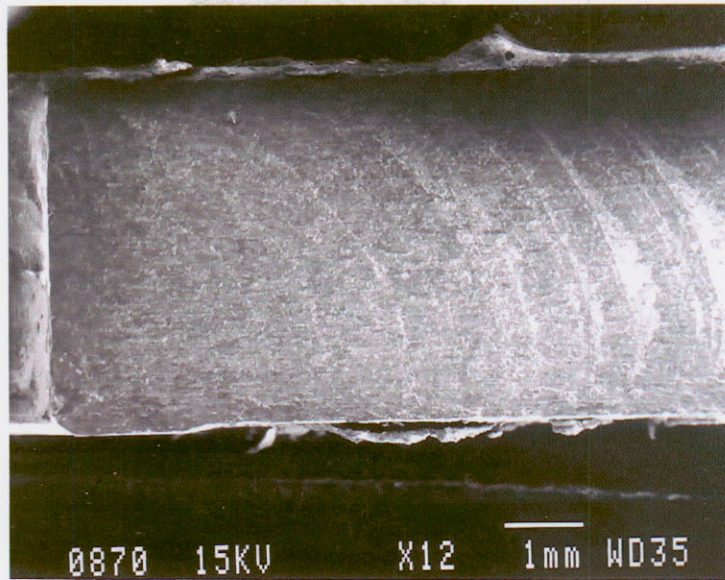
An examination of the area of crack initiation from primary fatigue origin “B” was conducted in the scanning electron microscope (SEM). Figure 12a shows an overall view of the skin fracture surface at primary fatigue origin “B” from the rivet hole at stringer 17. Clearly visible fatigue striations are present on the fracture surface. The fatigue crack initiated from the lower corner of the rivet hole. The origin area had been partially rubbed on both sides of the rivet hole eliminating identifiable fracture features (Figure 12b and 12c). Clearly defined fatigue striations are present along the fracture surface away from the hole edges (Figures 13a and 13b). A secondary fatigue origin in the stringer 17 flange above primary skin fatigue origin “B” was examined and found to have multiple small fatigue cracks initiating from the rivet hole and adjacent areas on the lower surface of the stringer (Figures 14a through 14c). The fatigue crack initiating in the skin from the forward side of the hole under the forward flange at stringer 16 (crack F2 in Figure 6) is shown in Figures 15a and 15b. The fatigue crack initiated from both sides of the Hi-Lok fastener hole. No indication of inter-granular fracture associated with stress corrosion cracking was found at the fatigue origin sites.

**Primary Fatigue Origin "B", Forward Side of Rivet Hole**  
**Figure 12a**

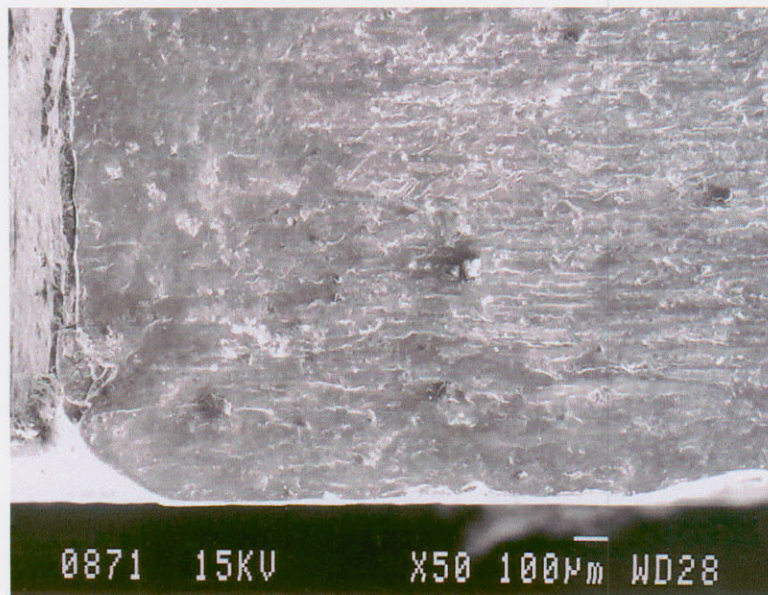
**Lower Corner of Rivet Hole Shown in Figure 12a**  
**Figure 12b**

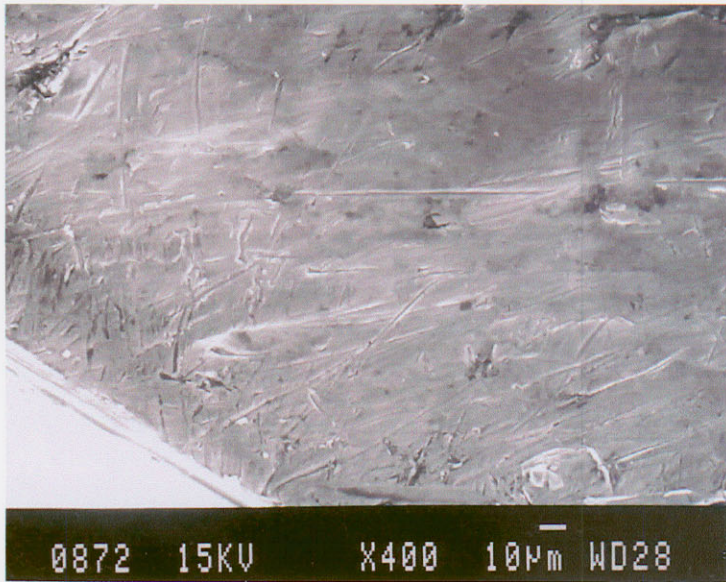
**Figure 12c**

**Closer View of Area in Lower Left of Figure 12b**

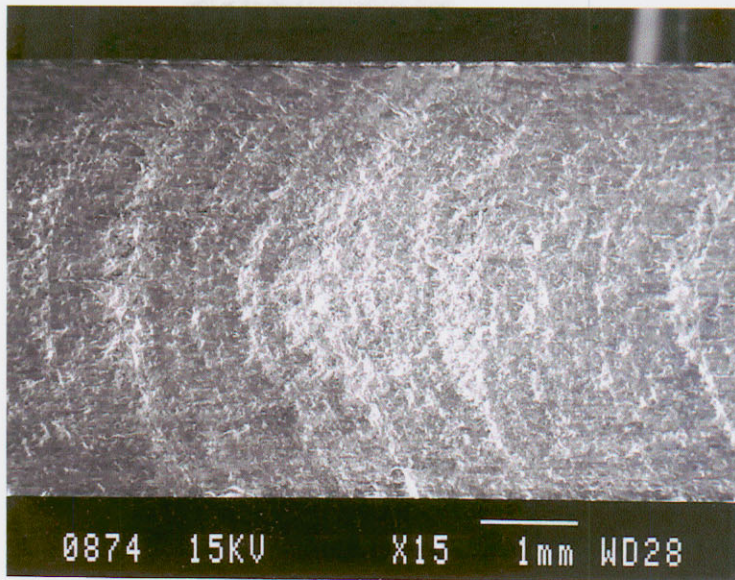
**Figure 13a**

**Fatigue Crack Growth in Center Skin Panel, Aft of Origin "B"**

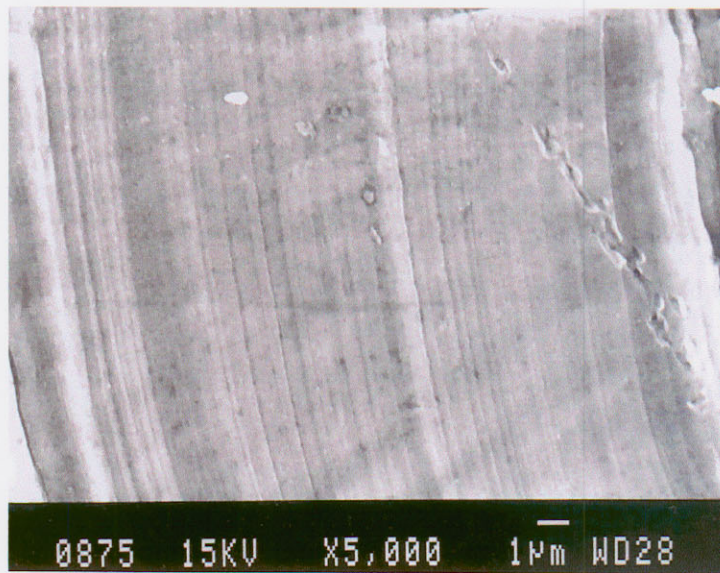
**Figure 13b**

**Fatigue Striations in Center of Figure 13a**

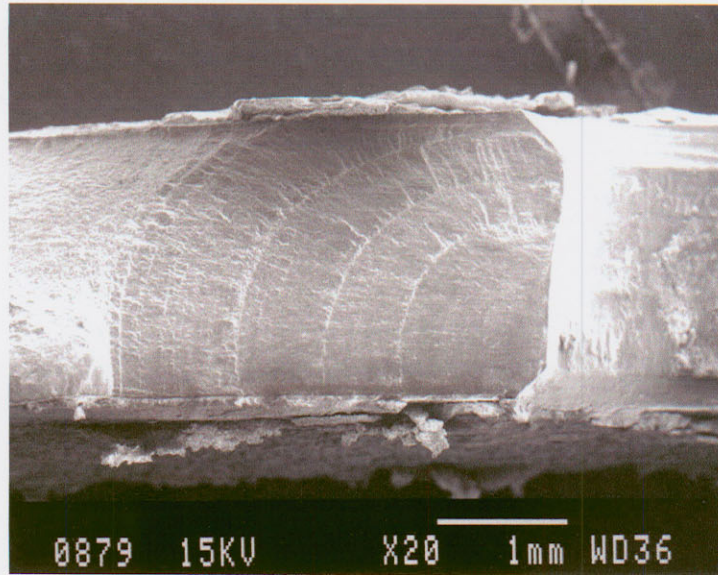
**Figure 14a**

**Fatigue Crack in Stringer 17 Above Primary Fatigue Origin "B"**

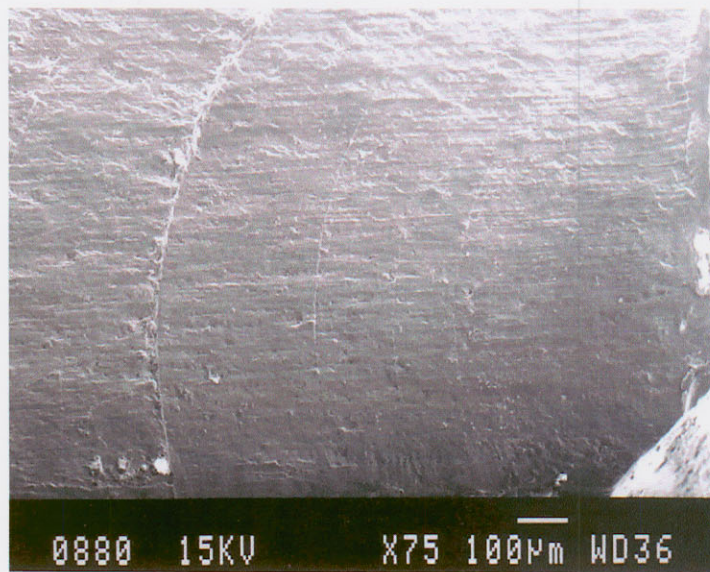
**Figure 14b**

**Closer View of Fracture Surface Adjacent to Rivet Hole**

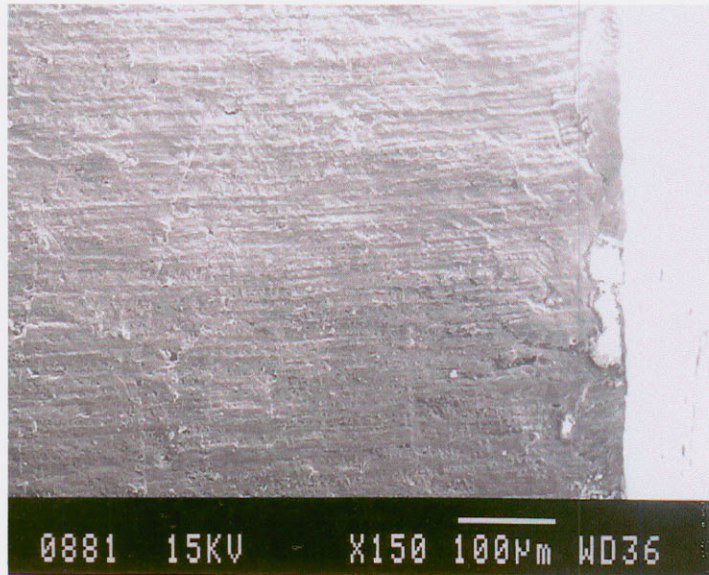
**Figure 14c**

**Closer View of Fracture Surface at Rivet Hole**

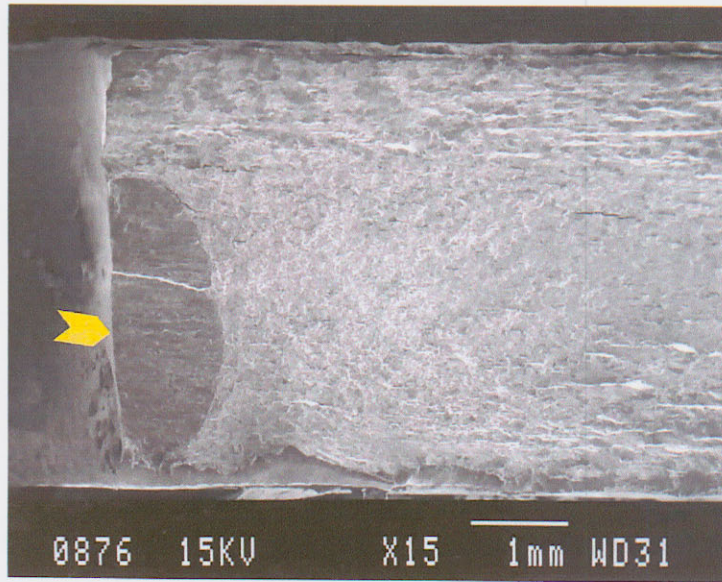
**Figure 15a**

| F2* | Fatigue cracks initiated in skin at both sides of fastener hole, forward flange stringer 16, and grew 0.05 in. forward and 0.13 in. rearward. |

**Fatigue Crack at F2 (See Figure 6), in Center Skin Panel**

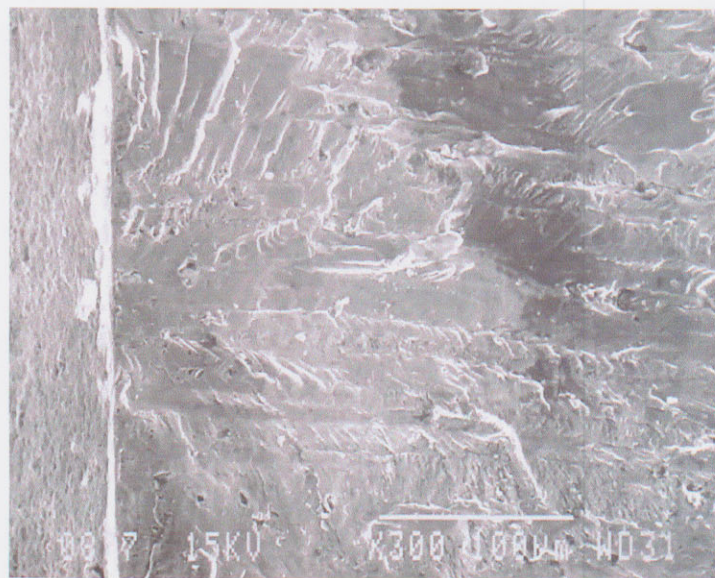
**Figure 15b**

**Closer View of Area Marked with Arrow in Figure 15a**
