NATIONAL TRANSPORTATION SAFETY BOARD
Office of Aviation Safety
Washington, D.C. 20594

AIRWORTHINESS GROUP CHAIRMAN'S FACTUAL REPORT

NTSB No: LAX-02-GA-201

Location: Walker, California
Date: June 17, 2002
Time: 1445 Pacific Daylight Time
Aircraft: United States Department of Agriculture Forest Service Lockheed C-130A
"Hercules", N130HP

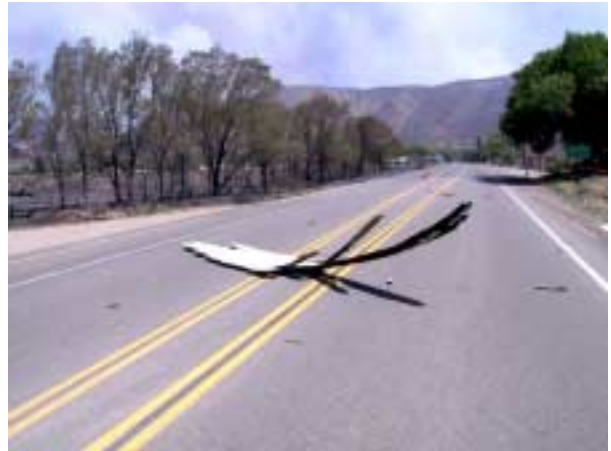
PHOTO 2: CENTER WING UPPER SKIN

Several pieces of the airplane came to rest outside either of the two debris fields. Pieces were found in the brush on both side of Highway 395, including on the highway itself, along the general flight path of the airplane. The two largest pieces that were recovered outside either of the two main DFs were pieces of the center wing box beam upper skin.¹ The largest piece came to rest on Highway 395 (Photo 2) and measured approximately 277-inch laterally x 44-inch longitudinally with a maximum of six stringers still attached. Examination of this piece revealed that it was comprised of 2½ panels and that the outboard section of the piece was significantly curled upwards. The other significant piece was found in the brush east of Highway 395. This piece of upper center wing skin measured approximately 93-inch laterally x 13-inches longitudinally and was comprised of a piece from two different skin panels with no stringers still attached.

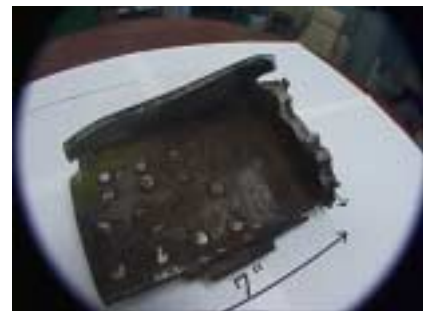
PHOTO 3: RECOVERED PART

One piece of airplane structure was recovered high up on the eastern side of the drainage valley along the general flight path where the airplane had made its fire retardant drop. The piece measured 5 x 7 x 2-inches and was comprised of several layers joined together by Hi-Lok fasteners (Photo 3). The piece was sent to Lockheed for metallurgical examination as well as part identification (See section 4.2 Airplane Structure Found in Drainage Valley of this report for details of the metallurgical examination). No part numbers were on any of the pieces to help identify the piece of recovered airplane structure. Lockheed compared the geometry and material comprised of the entire piece as well as the individual layers with known C-130 structural members. Lockheed concluded that this part was not a production designed C-130 part, nor was it part of any known Lockheed designed retrofit. After Lockheed completed its metallurgical analysis of the airplane structure, it was sent to H&P where it was identified as coming from the under the left wheel well (Photo 4) of a similarly modified H&P tanker C-130 aircraft.

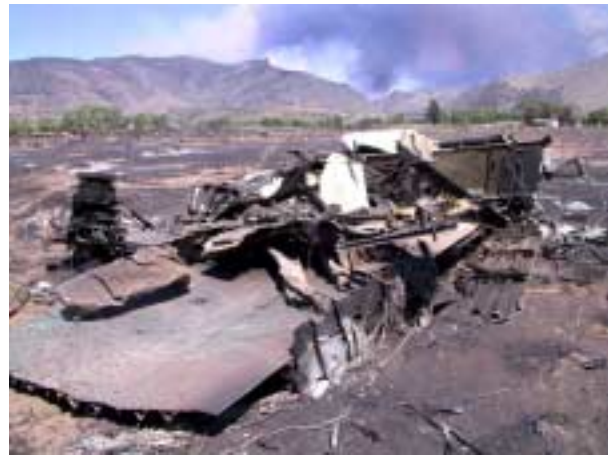
PHOTO 5: CENTER WING LOWER SKIN

At GPS point 12, the entire center wing lower surface was recovered, with the exception of approximately the right outboard 167-inches and two pieces of the center wing upper surface (Photo 5).² The center wing lower surface was found down side up, lower skin facing upwards. Still attached to the center wing lower skin was the No. 2 engine (left inboard) pylon and approximately 39-inch lateral section of the outer left wing. Fire damage and blistering of the paint was observed throughout the inside of the lower surface with the most intense fire damage observed in the vicinity of the fuel cross-feed manifold. Two center wing upper skin pieces were also recovered. One piece measured approximately 150-inches laterally x 79-inches with 11 stringers still attached with an approximately 30-inch longitudinal section of the outer wing was still attached. The other piece measured approximately 130-inches laterally x 38-inches chordwise with five stringers still attached.

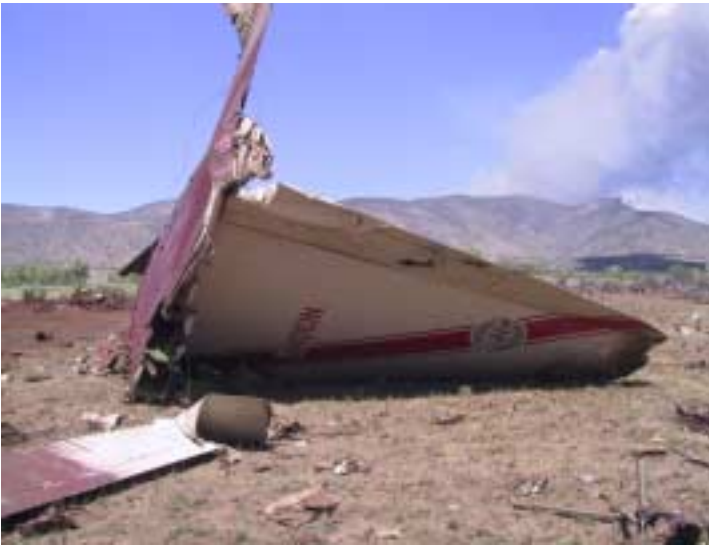
PHOTO 6: EMPENNAGE/TAIL SECTION

The empennage/tail section was found separated from the rest of the airplane and was lying on its' right side (Photo 6). The empennage/tail section had separated in-line with the upper escape hatch attachment. Both the cargo door and the ramp were found detached from the airplane structure. The right horizontal stabilizer was fractured at the root of the vertical stabilizer while the left horizontal stabilizer remained intact, with the counterweight still attached, but the outer tip exhibited impact damage (Photo 7). The entire left horizontal stabilizer tip was bent downwards and the leading edge of the outer tip was bent aft and the skin was compressed. The vertical tail was intact but exhibited some impact damage. A hole was observed on the right side near the middle of the rudder; however, the hole did not pass through to the left side. The lower rudder surface near the horizontal stabilizers was pushed forward and deformed. Still attached to the empennage were the two elevator and rudder boost packs.

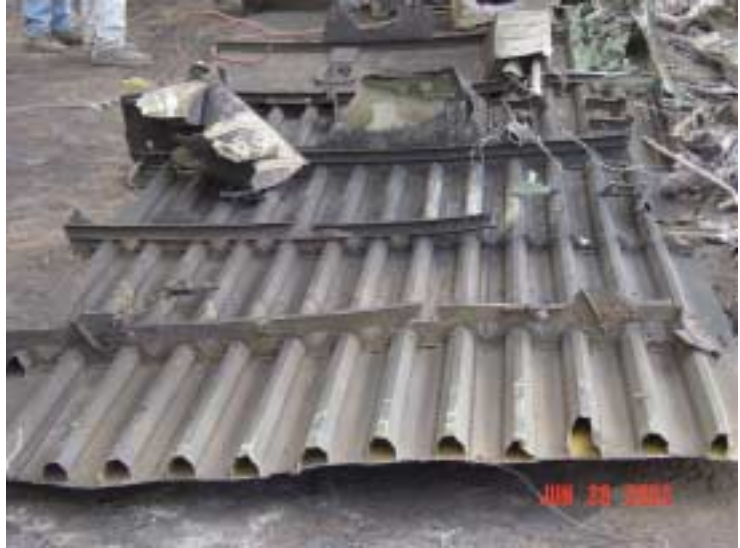
PHOTO 8: CENTER WING LOWER SURFACE

The entire lower surface of the center wing was recovered except for approximately the right outermost 167-inches (approximately CWS 53R to CWS 220R) (Photo 8). All thirteen stringers were attached to the center wing lower surface. No pieces of the aft beam or aft spar cap remained attached to the center wing lower surface except for a small piece of the left aft corner fitting. Approximately 134-inches of the forward beam (CWS 220L to CWS 86L) and approximately 62-inches of the forward lower spar cap remained attached to the center wing lower surface. The part of the forward beam that remained attached exhibited heat damage and melting. The forward lower spar cap pieces that remained attached to the center

wing lower surface were within the area of the attached forward beam. Rainbow fittings and the corresponding corner fittings for the center wing left lower surface and the left outer wing lower surface were all intact. All the bolts that join outer wing to the center wing through the rainbow and corner fittings were also intact. The entire bottom of the center wing lower surface exhibited fire damage.

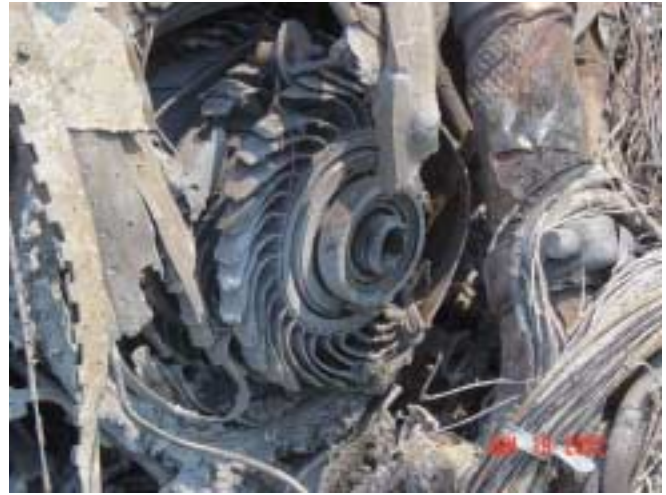
Photo 9: Bent 1st- & 2nd-Stage Compressor Blades

The 1st- and 2nd-stage compressor blades were easily examined in-situ. Both stages were heavily bent in the direction opposite rotation to the point that the blades were laying one on top of the other and were covered with a white soft powder (Photo 9). Examination of the 4th-stage turbine blades revealed that they were bent slightly over in the direction opposite rotation considerably less than what was observed in the compressor stages. The bottom of the engine was not visible; however, examination of the engine from the 7:00 to 4:00 o'clock positions showed no breaches of any of the external engine cases.

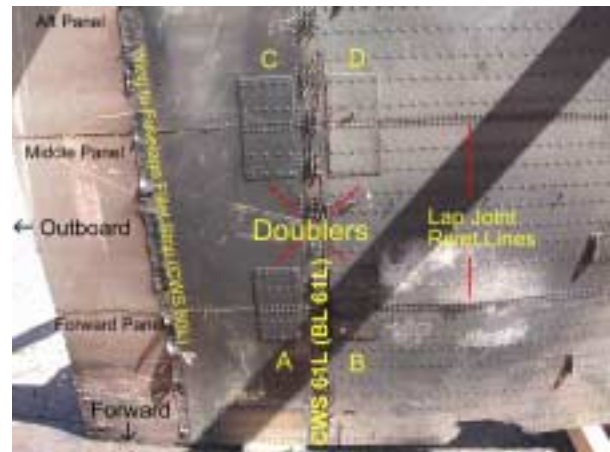
PHOTO 10: CW LOWER SURFACE - LEFT

After the completion of the on-site portion of the investigation at Walker and Bridgeport, the entire wreckage was transported to the “Plain Part” storage facility in Pleasant Grove, California. The Airworthiness Group meet at “Plain Part” from September 17 – 19, 2002 to perform additional examination of the wreckage and inspections on the center wing lower surface. Before the arrival of the Airworthiness Group, the center wing lower surface had been previously cut chordwise at approximately CWS 41R just inboard of the fracture line at CWS 53R and was sent to Fowler Inc., Gardena, California for metallurgical examination. See Section 4.0 entitled *Metallurgical Examination* for details on the Fowler report findings.

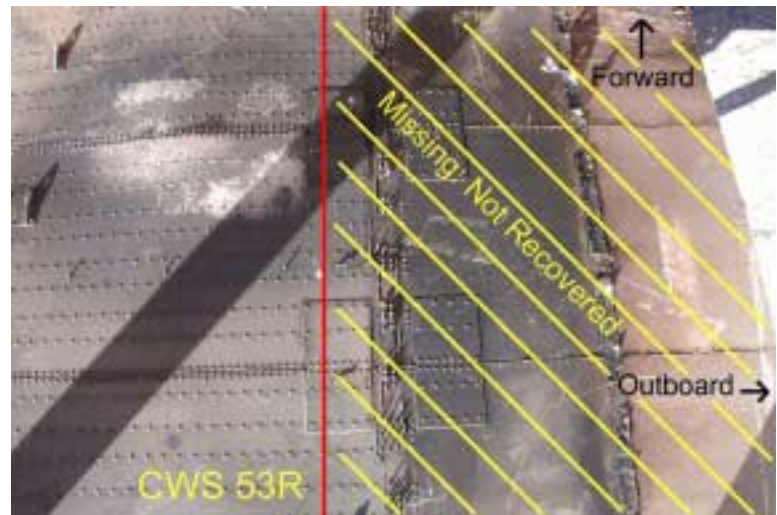
PHOTO 11: CW LOWER SURFACE

Metallurgical examination of the fracture surface at CWS 53R by Fowler Inc. revealed fatigue in the forward and middle lower skin panels and in stringers 16 and 17 (Attachment 4). Binocular examination revealed that the primarily areas of fatigue initiation were at two adjacent rivet holes, where stringers 16 and 17 attach to the lower skin panel (See Attachment 4, Figure 6), along the second to last longitudinal row of rivets holes of the forward inboard doubler (See Photo 11)⁶.

⁶ Photo 11 is of the center wing left side depicting the fracture location on the center wing right side.

Lower skin panel fatigue cracks were found to have initiated at the aft rivet hole of stringer 16 and the forward rivet hole of stringer 17 (See Attachment 4, Figures 9 & 10). At both the stringer 16 and 17 locations, the lower skin panel exhibited a fatigue crack propagating from the forward and aft sides of the rivet holes. The skin panel cracks that propagate from the stringer 16 rivet hole grew approximately 2.2-inches forward and approximately 0.75-inches aft, joining the forward crack from the stringer 17 rivet hole. The forward propagating crack from stringer 16 spanned across the middle skin panel to the forward skin panel. The skin cracks that propagated from stringer 17 holes grew approximately 1.08-inches forward, joining with the aft crack from stringer 16, and approximately 6-inches aft. The total length of the cracks from stringers 16 and 17, after they linked-up, measure 12.2-inches. Several other smaller crack initiation sites were noted along the fracture line as well as at other doubler rivet hole locations (See Attachment 4, Table 1 for additional details).

Fatigue cracks were also noted in stringers 16 and 17 themselves. The cracks initiated in the stringer flanges, above the area the primary skin panel cracks originated, and propagated into the upper surface of the respective stringers (See Attachment 4, Figures 9 & 10).
