**NATIONAL TRANSPORTATION SAFETY BOARD
OFFICE OF AVIATION SAFETY
WASHINGTON, D.C. 20594**

**AIRWORTHINESS GROUP CHAIRMAN'S FACTUAL REPORT OF
INVESTIGATION**

NYC03MA183

Operator: Colgan Air
Aircraft: Raytheon Model 1900D
Location: Yarmouth, MA
Date: August 26, 2003
Time: 15:40 EDT

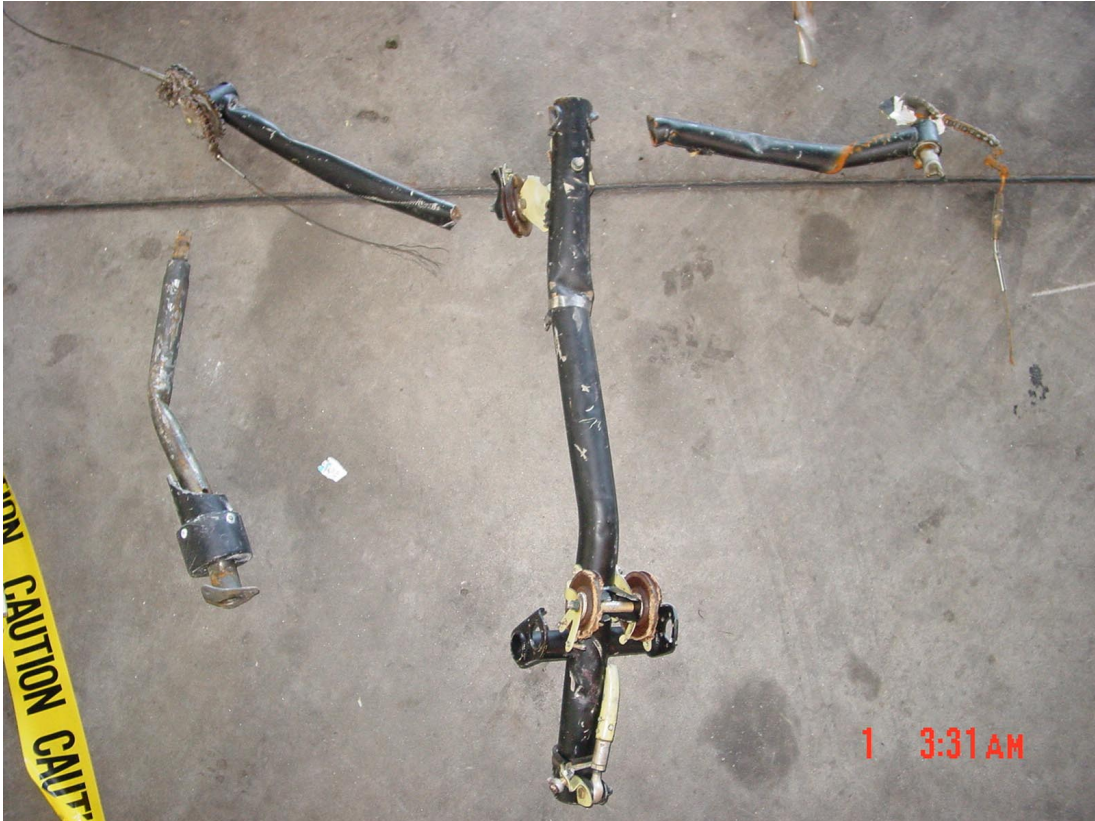
Figure 4. Elevator Control Column.

The control column was recovered from the wreckage (Figure 4). The pushrod that connects the column to the forward bell crank was fractured, but a short segment remained attached to the column (Figure 5). The Flight Data Recorder (FDR) elevator position sensor rod was fractured. The rod end remained attached to the column. The position sensor and the other segment of the rod was found intact, attached to structure in the pedestal (Figure 6).

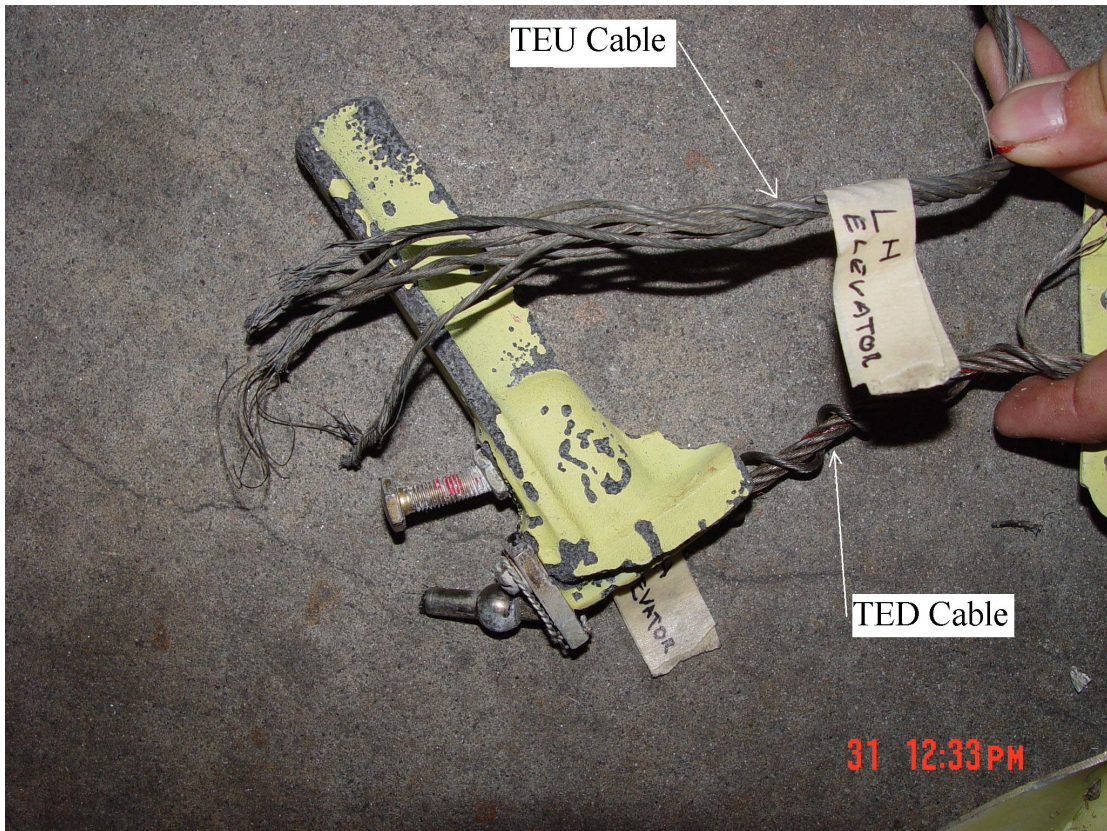
Figure 7. Elevator Control Forward Bell Crank with Cables

A portion of the forward bell crank was recovered (Figure 7). The elevator trailing edge Down (TED) control cable (forward cable in tail) was found attached to the forward bell crank. The elevator trailing edge up (TEU) cable was detached from the forward bell crank.

The TED cable was found intact from the forward bell crank to the aft bell crank. The TEU control cable (aft cable in tail) was intact from near the forward bell crank to the aft bell crank.

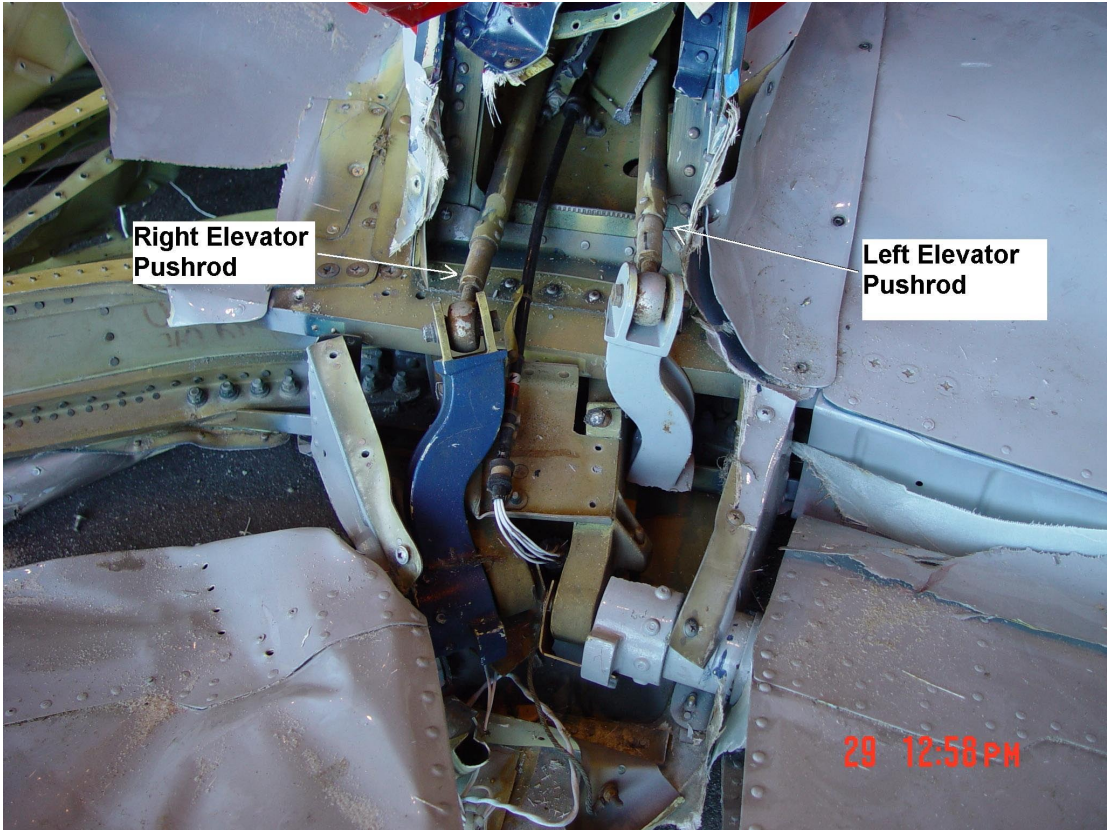
Figure 8. Pushrods Attached to the Elevator Control Horns.

The pushrods from the aft bell crank to the elevator horns were intact (Figure 8) and connected to their respective control horns.

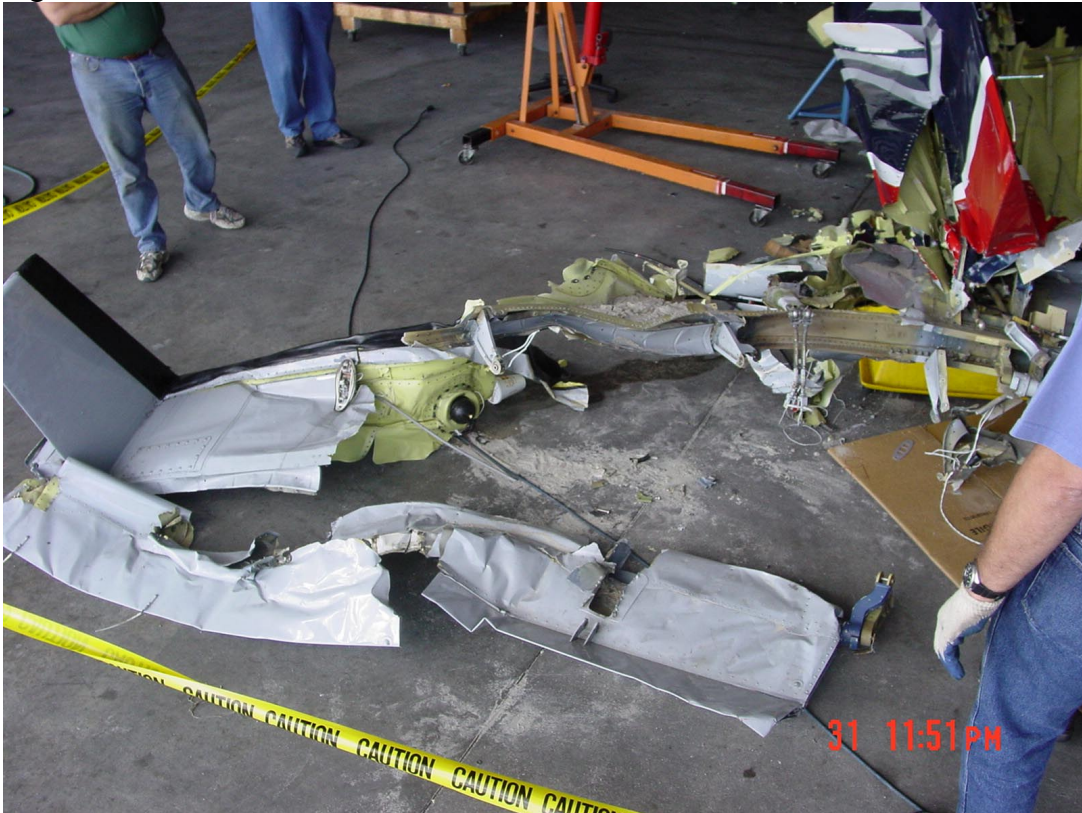
Figure 9. Right Elevator parts after removal from the Horizontal Stabilizer.

There was approximately eight (8) feet of the right elevator found in two (2) parts (Figure 9). Nominal length of the elevator, along the trailing edge, is 8 feet 9 inches. The inboard portion of the right elevator was attached to the elevator horn and two (2) hinge points. The right elevator control horn was riveted to the inboard end of the elevator torque tube. The rivets connecting the right side control horn were found to be tight and the horn was fixed to the right elevator torque tube.

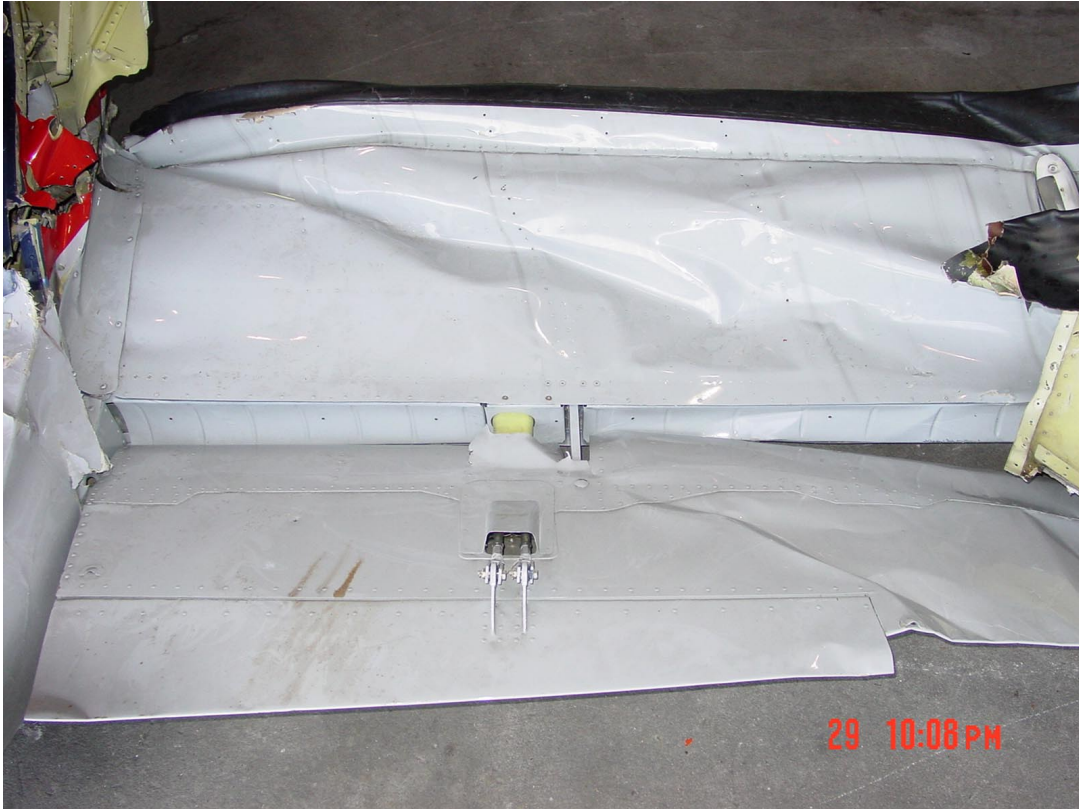
Figure 10. Left Elevator and Horizontal Stabilizer.

There was approximately five (5) feet of the left elevator found (Figure 10). The left elevator was attached to its most inboard hinge. The left side control horn fractured in two pieces. One piece (arm) was attached to the pushrod and the other portion remained riveted to the left elevator torque tube.

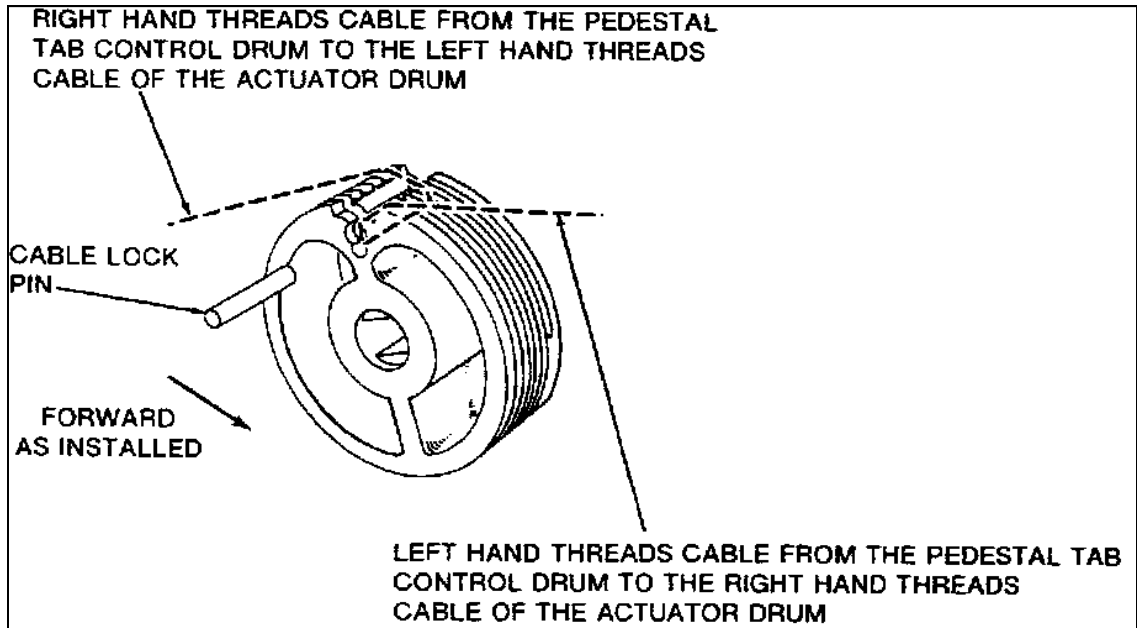
Figure 15. Maintenance Illustration for Wrapping the Cable Drum.

It was observed that the Figure 15, maintenance illustration did not accurately depict the cable drum part. The illustration appeared to indicate that with the slotted side of the cable drum facing the installer, the cable with the LH threaded turnbuckle should start to the right in the illustration. If installed in this manner, the cable with the LH turnbuckle would come off the aft portion of the cable drum. The cable coming off the aft portion of the cable drum provides a nose down command to the actuator. However, Figure 17 showed that the LH threaded turnbuckle is on the “Nose up” side of the cable. Installing the cable on the drum in this manner would reverse the control to the trim actuator. Note that to reverse the control, the cables would have to

be crossed between the cable drum and the turnbuckles in order to connect to the turnbuckles.

Both mechanics answered that they interpreted the maintenance illustration (Figure 15) as showing the open or slotted side of the cable drum facing them. Positioning the cable as instructed by the manual would reverse the control from the manual trim wheel. This in conjunction with a crossing of the cables, so that the turnbuckles could be connected, would produce a situation where wheel motion in the trim up direction would cause trim down commands to the trim tab and vice versa.

Following this observation, Raytheon and the FAA released documentation to address the misleading maintenance procedure. Raytheon released the following Temporary Revisions to the 1900D Maintenance Manual to address the issues:

1. TR 27-9, issued September 12, 2003 to add a Manual Elevator Trim Operational Check.
2. TR 27-10, issued October 22, 2003, which revised the "Elevator Trim Tab Cable Installation" AMM 27-30-04.
3. TR 27-11, issued December 5, 2003, which revised the Elevator Trim Tan Rigging and Elevator trim Tan Actuator Installation procedures.
4. TR 27-12, issued December 18, 2003, which revised the Elevator Trim Tab Cable Installation procedure.
5. TR 27-15, issued March 3, 2004, which revised the Elevator Trim Tab Indicator Adjustment procedure.
6. TR 27-16, issued March 31, 2004, which revised the Elevator Trim Tab Rigging procedure and revised the Elevator Trim Tab Actuator Removal, Cable Replacement and Installation procedure.

The FAA released an immediately adopted Airworthiness Directive (AD2003-20-10), effective October 15, 2003, which instructs operators to incorporate TR 27-9 and provided a change to the maintenance illustration.

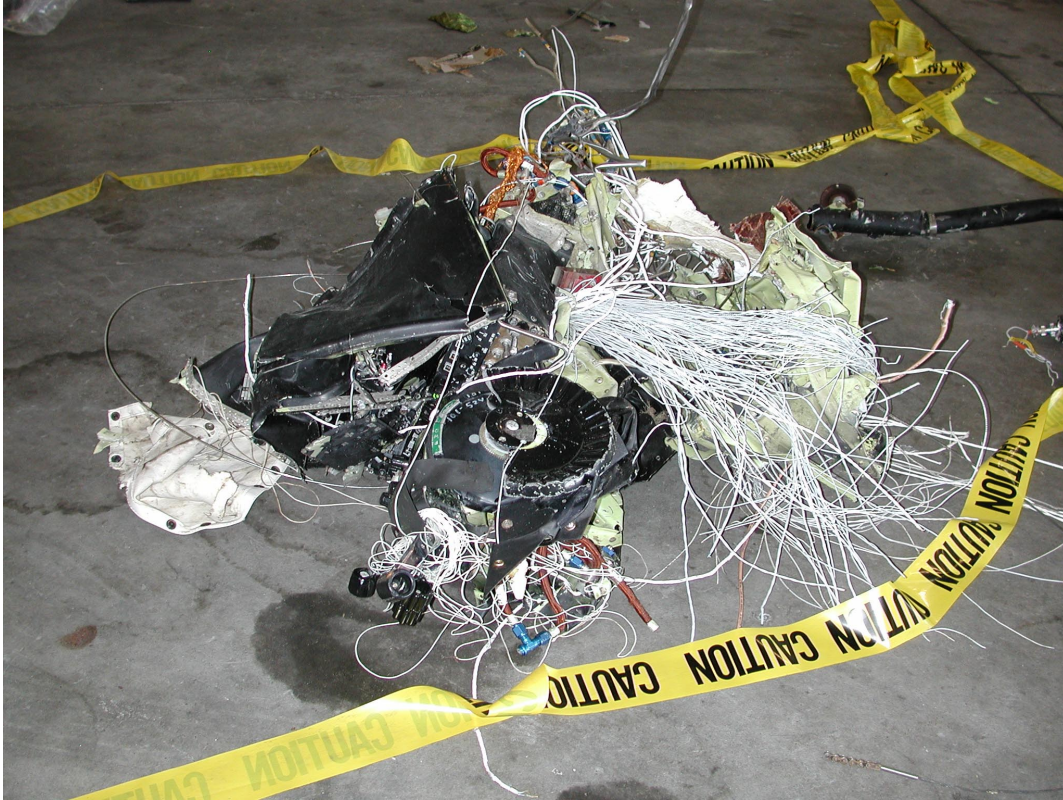
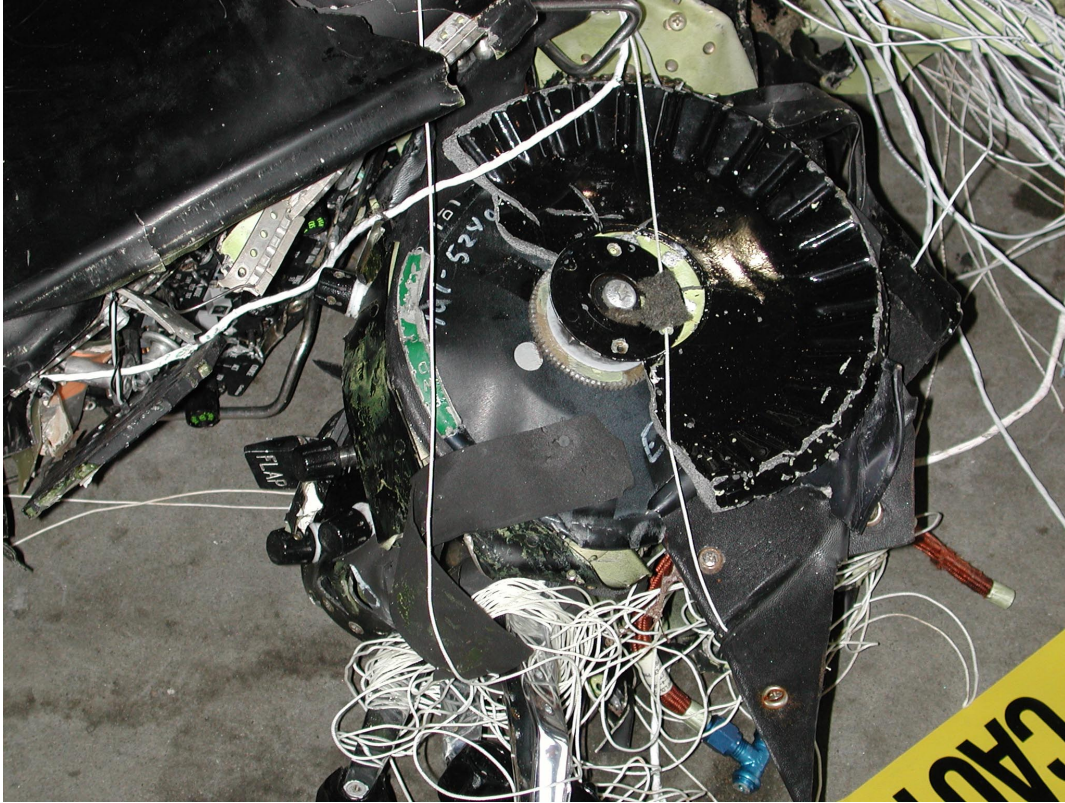
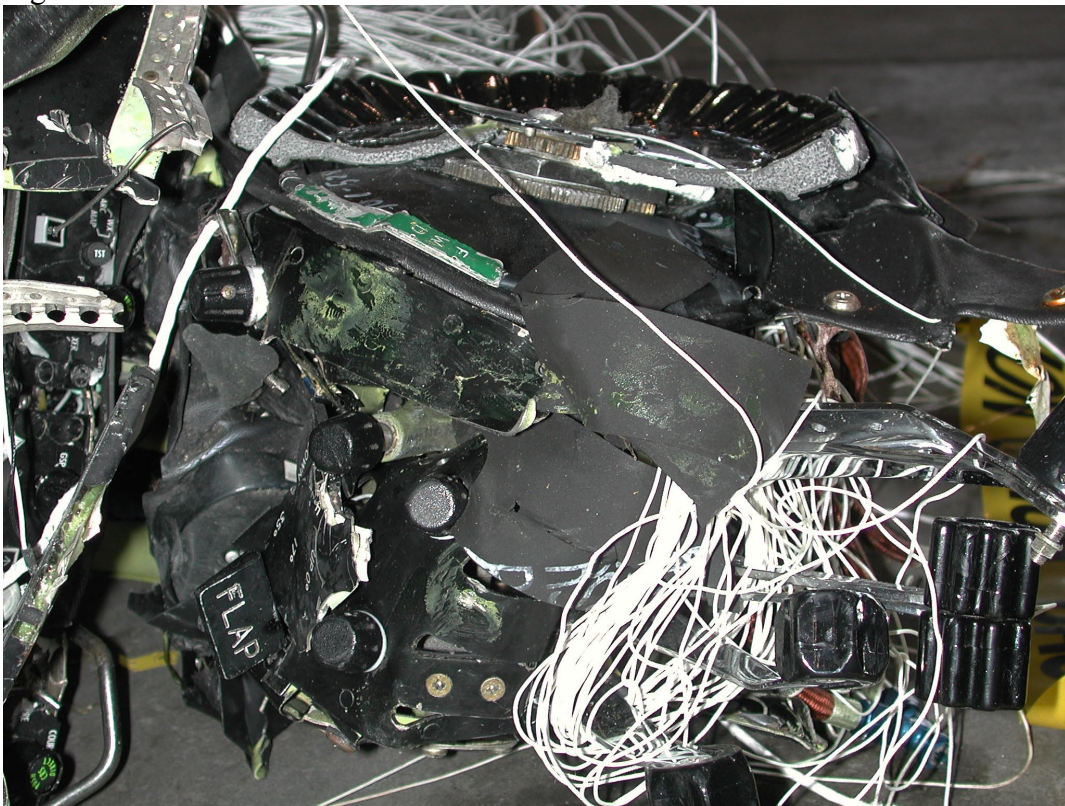
All of the manual elevator trim components in the pedestal were recovered from the wreckage, though they were badly damaged (Figures 23 –25).

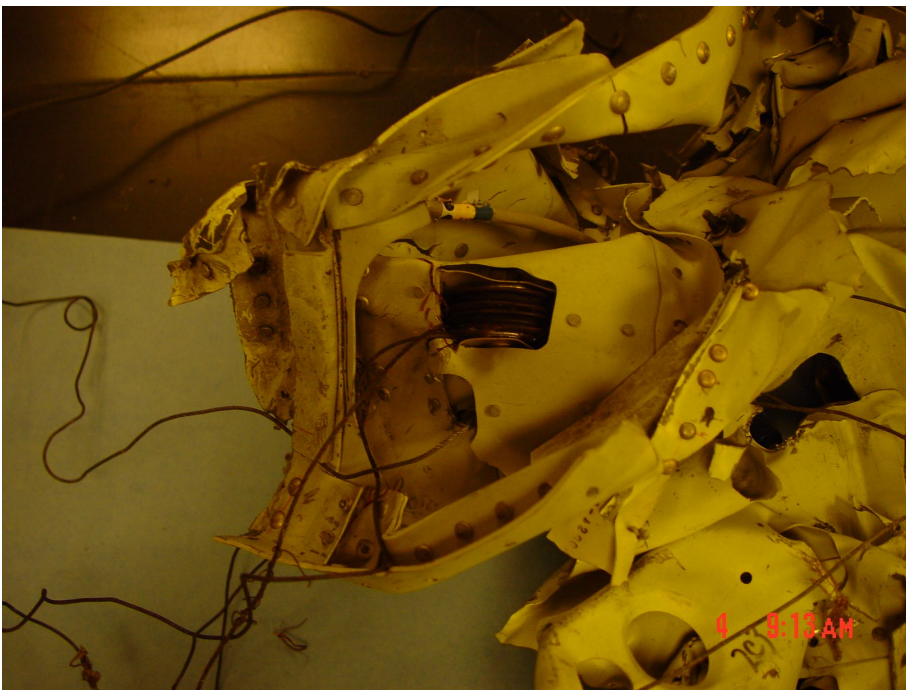
Figure 26. Elevator Trim Cables Passing Through Pulleys

Segments of the elevator trim cables were observed to exit the pedestal and pass through a set of pulleys shown in Figure 26. It was determined that these pulleys were the second set of pulleys from the cable drum shown in Figure 27, location B. The forward cable exiting the cable drum was routed over the aft pulley at location B. The pulleys at location A were not identified in the wreckage.

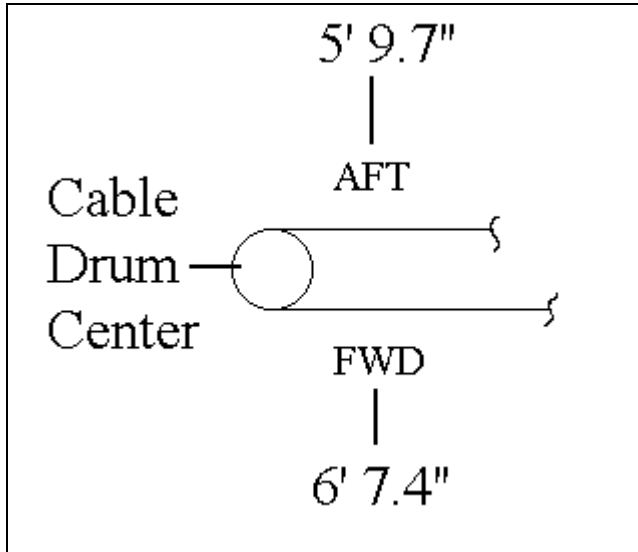
Figure 32. Cable Lengths to “Center” of the Cable

The cable was removed from the cable drum. A permanent notch was evident where the cable lock pin (Fig. 15) was installed at the “Center” of the cable. The cable segment lengths were measured relative to the “Center”(Figure 32).

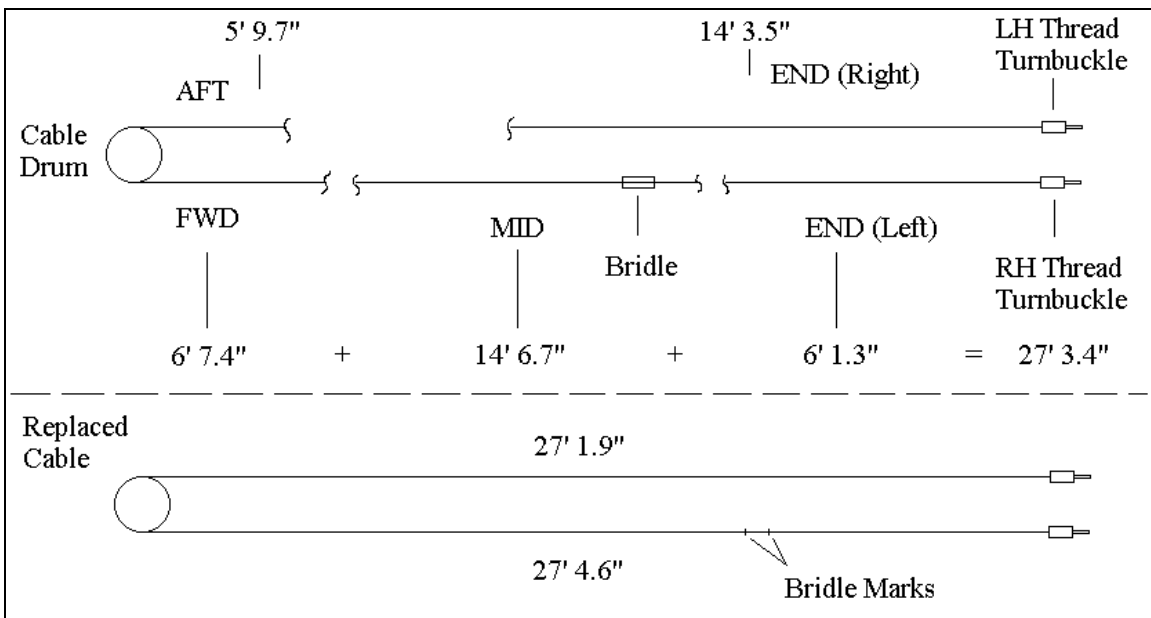
Figure 33. Dimensions of Cable Lengths

Three additional segments of the forward cable were recovered from the wreckage. In addition, the cable which was removed from the accident airplane during maintenance prior to the accident flight, was obtained from the airline. The dimensions of all of the cables were measured at the NTSB lab, and the results are provided in Figure 33.

The total length of the cable segments labeled FWD, MID, and END(Left) equal 27' 3.4". This dimension is within 1.2 inches of the replaced cable length 27' 4.6".

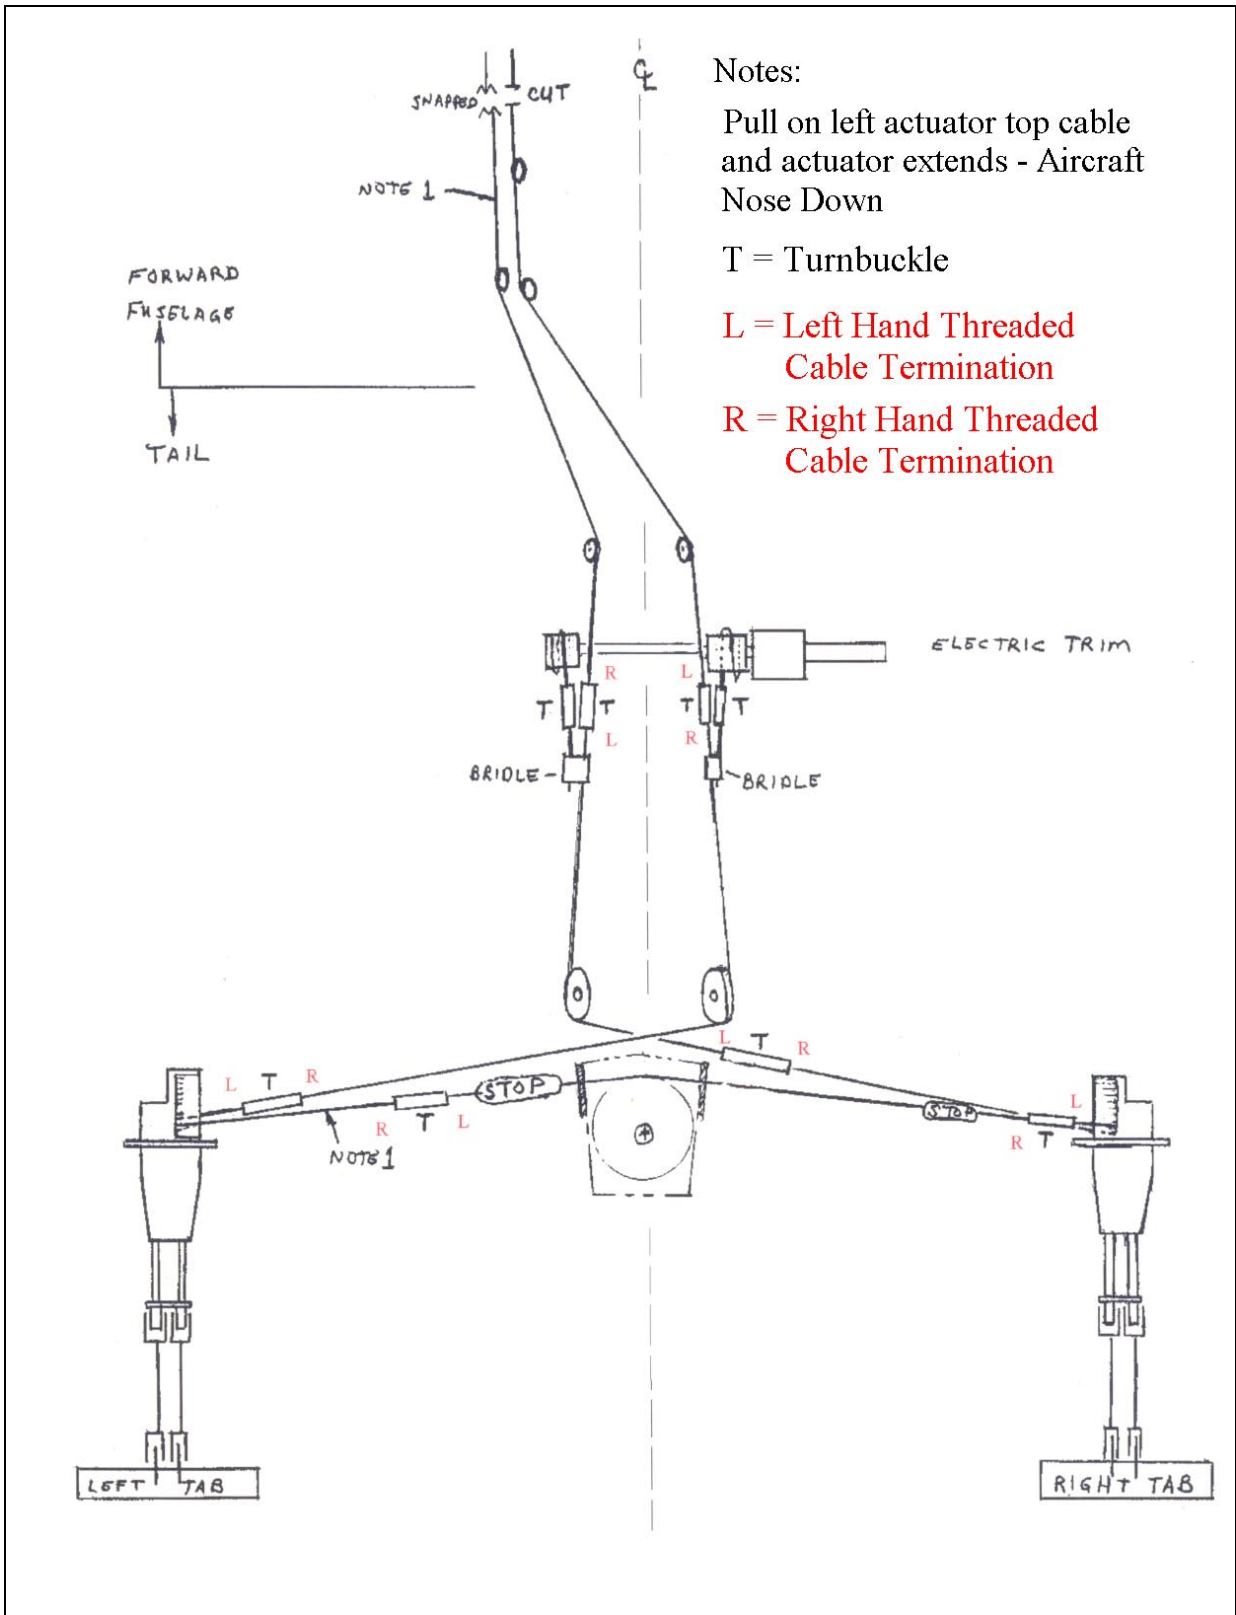
Figure 34. Sketch of Recovered Aft Elevator Trim Components

The remainder of the trim system was recovered relatively intact. A sketch of the recovered components is provided in Figure 34. The group agreed that the rigging of the cables shown in the sketch are all correct. It was observed that the stop on the elevator trim cable on the left side was close to its stop block at the inboard pulley bracket. The cable stop on the right side was located near the right actuator. This position is consistent with a near full airplane nose down trim position.

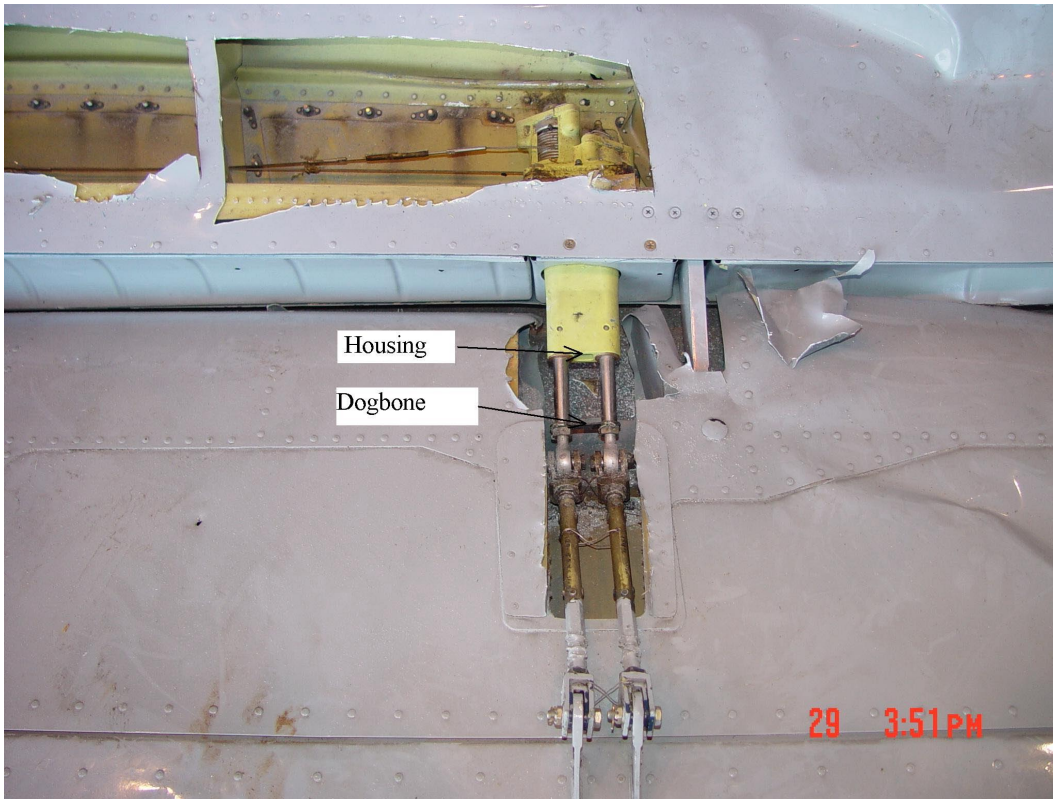
Figure 35. Left Elevator Trim Actuator.

The left trim actuator, Figure 35, was identified as part number 129-526033-7, serial number PAA 010903. The distance between the actuator housing and the "Dogbone" was 2.28 inches.

Raytheon Aircraft Company advised that the above measured extensions were consistent with the actuators being at or near the full nose down trim position.

The group checked the left side trim actuator by pulling on the top cable. The actuator extended, which would produce an airplane nose down effect. The right actuator was fractured and full of sand and could not be checked.

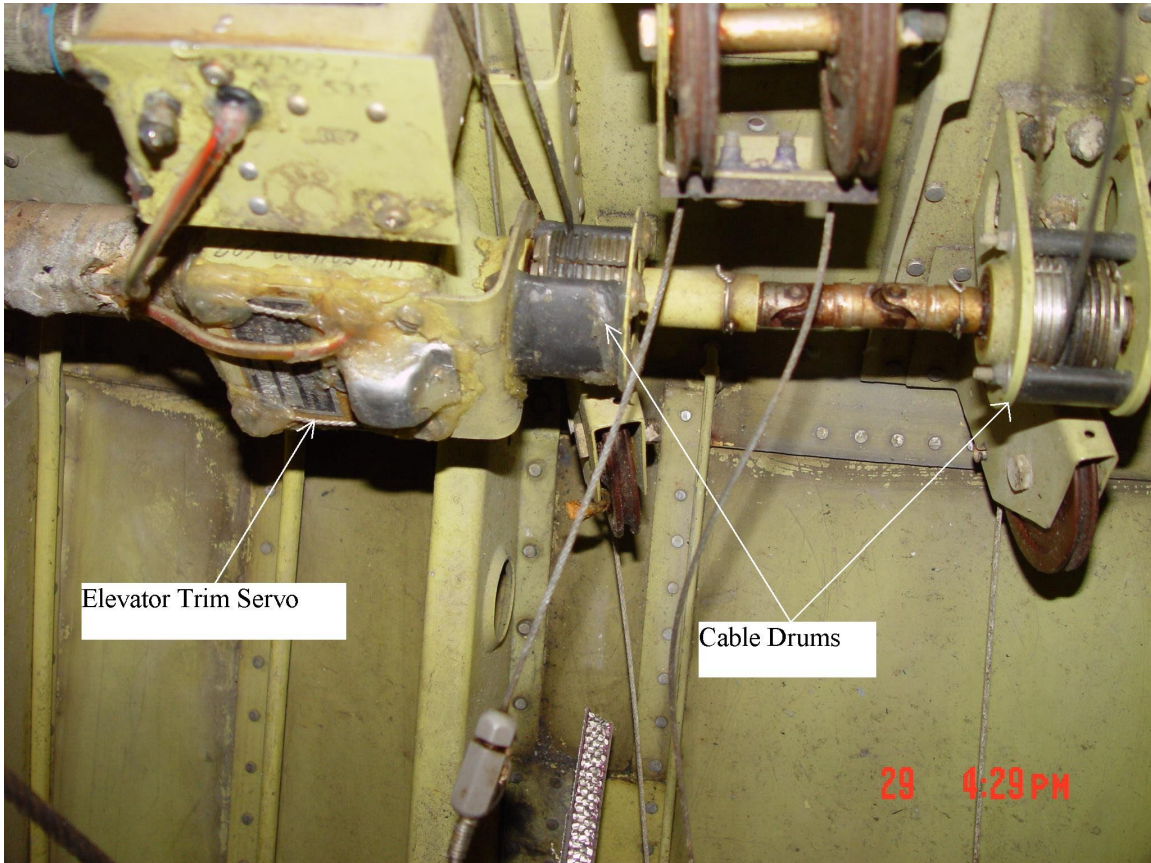
Figure 37. Electric Elevator Trim Servo Motor and Cable Drums

The electric elevator trim servo installation was found still attached to its usual location at the base of the tail, Figure 37. The identification placard showed part number 109-524329-9 and serial number 525-F-92. The servo and drums were removed for examination.

Water was observed seeping out of the clutch housing. A hole was made in the cap over the clutch assembly and the water was drained. The end cap of the motor was removed, rust and a small amount of liquid was observed. The sealant was removed from a portion of the control box and no water was observed.

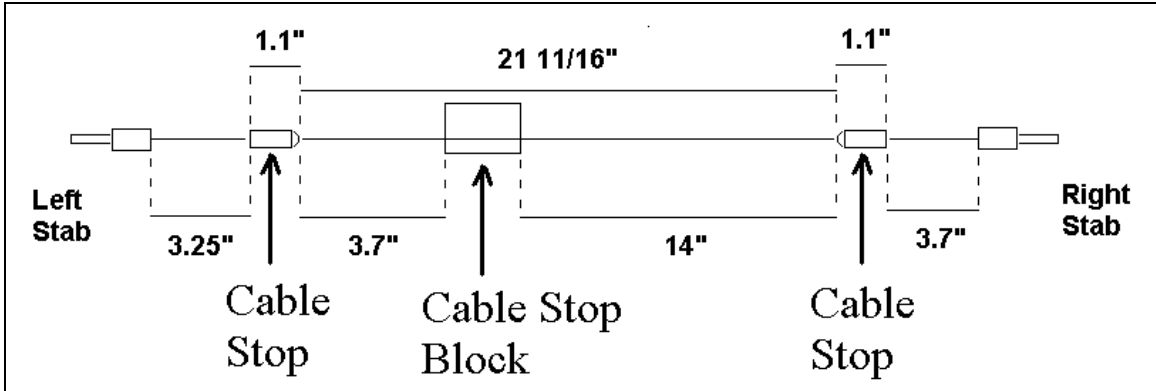
Figure 38. Position of elevator trim stops.

The cables and stops in the tail were examined, measured, and a sketch was made (Figure 38). The measurements in Figure 38 were taken with the tab in the zero degree position. The position of the trim wheel and trim tab were measured (Table 2)
