NATIONAL TRANSPORTATION SAFETY BOARD
Office of Aviation Safety
Washington, D.C. 20594

AIRWORTHINESS GROUP FACTUAL REPORT
December 26, 2006

A. ACCIDENT DCA06FA058

Location: Memphis, Tennessee
Date: July 28, 2006
Time: 1125 Central Daylight Time (CDT)
Aircraft: FedEx Express Flight 630, McDonnell-Douglas (Boeing) MD-10-10F,
 N391FE

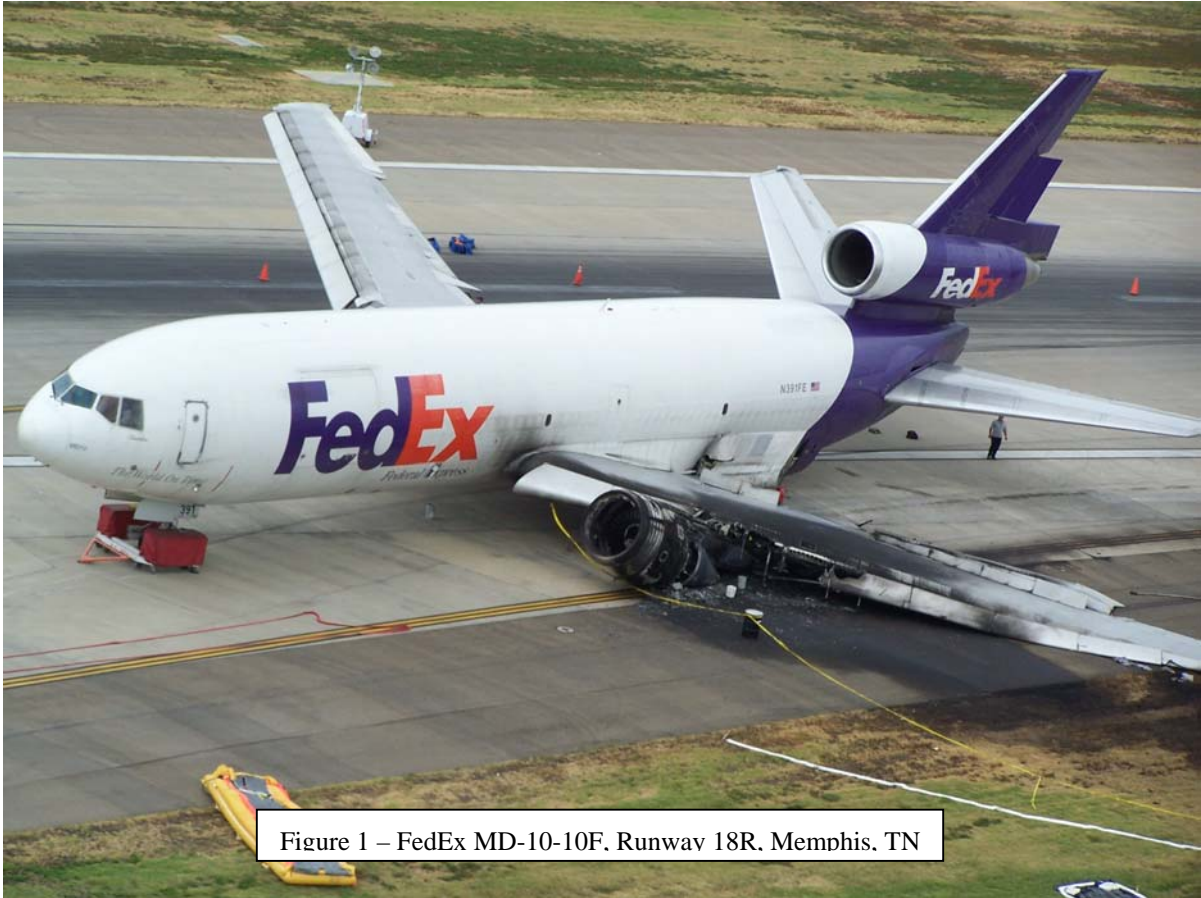
The airplane came to rest on the left side of Runway 18R at the M4 taxiway exit about 6,050 feet from the approach end of the runway (Figure 1). The left main landing gear (LMLG) collapsed during the accident sequence and was folded aft with the strut in a horizontal position and the truck beam in a vertical position (Figure 2). The truck beam positioning actuator was fractured from the truck beam while the axles were in the normal position. The aft tires of the LMLG impacted the left inboard flap damaging it and deforming it upwards. The left side of the airplane was resting on the left nacelle, the left wing outboard flap hinge fittings, and the left wingtip while the right side was resting on the right main landing gear (RMLG) inboard tires. The left engine aft mount was fractured and the left engine was canted upwards about the forward mounts. A post crash fire ensued on the left side of the airplane consuming the number 3 slat, the inboard end of the number 4 slat, the left and upper portions of the left nacelle, and the left side of the engine case. The remainder of the left wing and nacelle sustained moderate to heavy fire damage. There was some minor sooting to the left fuselage in the vicinity of the wing attach area. The nose landing gear (NLG) was intact and turned to the right about 20° and was resting on only the left tire. The left NLG tire had no tread evident, some of the reinforcing plies showing, and cross-wise scuffing while the right NLG tire appeared essentially normal. The RMLG was intact with the two inboard tires contacting the ground. The RMLG forward, inboard tire tread was considerably worn while the other three appeared essentially normal. The rest of the airplane was undamaged. The flaps and slats were in the deployed position and the left engine thrust reverser was in the deployed position. The right engine thrust reverser was in the stowed position.

Figure 1 – FedEx MD-10-10F, Runway 18R, Memphis, TN

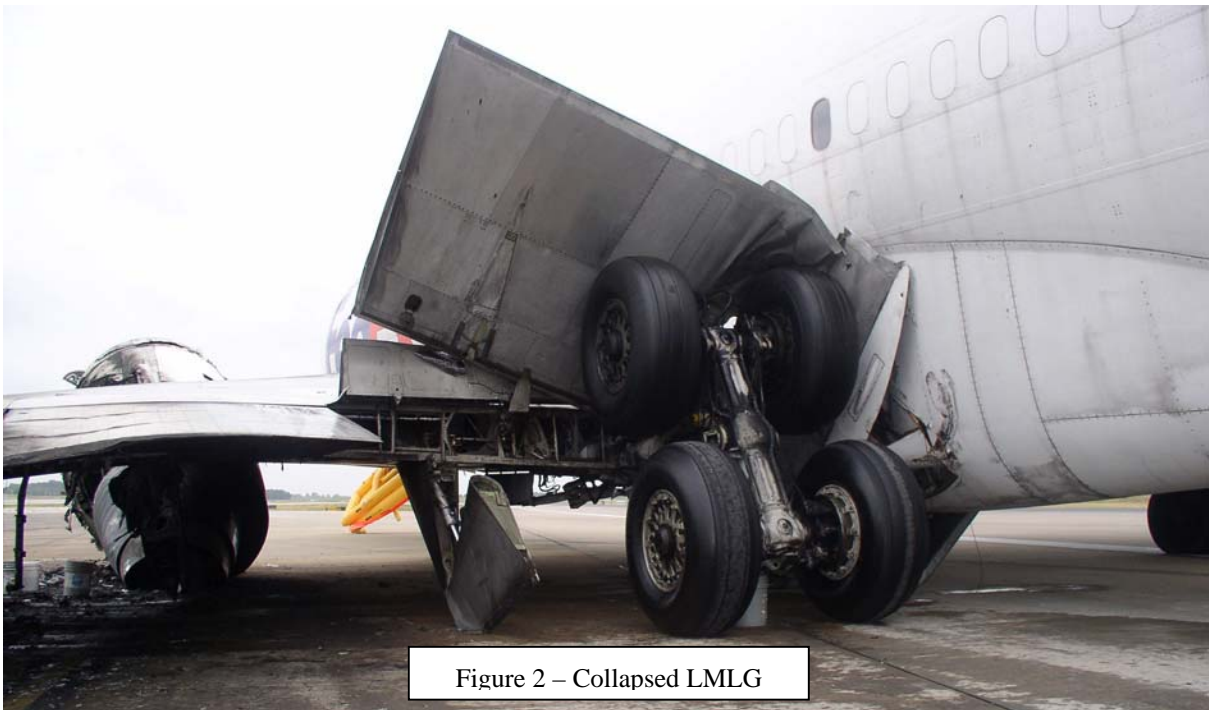
Figure 2 – Collapsed LMLG

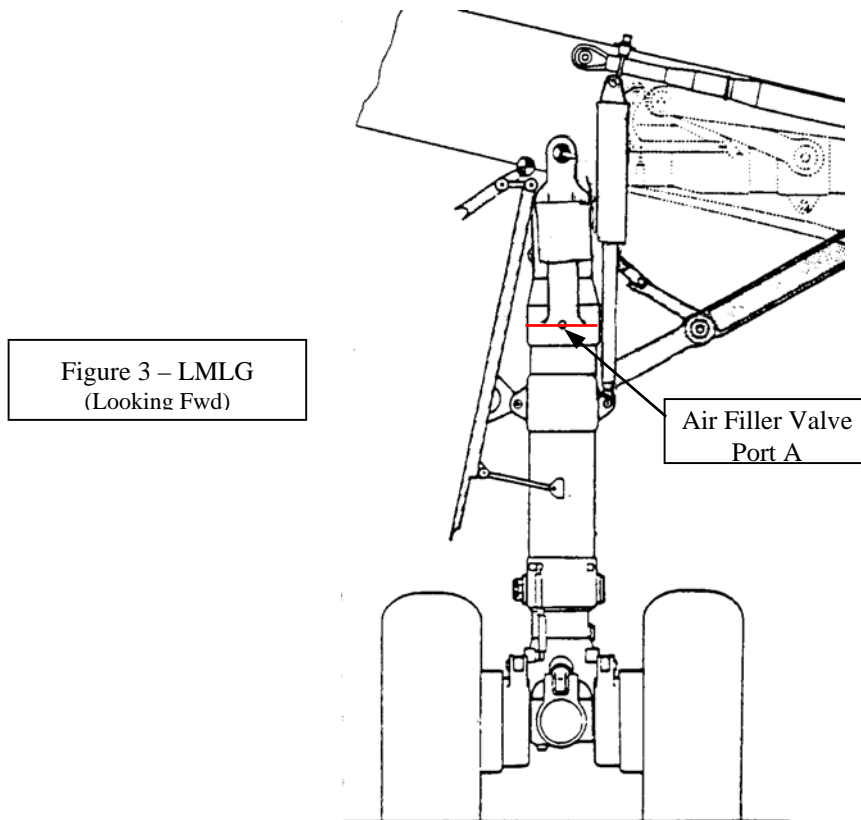
The LMLG outer cylinder was fractured midway through the air filler valve boss at port A on the aft side of the outer cylinder (Figure 3). The fracture continued around the circumference of the outer cylinder at the same level for about 240°. The fracture then turned upwards and continued the rest of the circumference about 5 inches above the level of the filler valve on the forward side of the outer cylinder. A piece of the outer cylinder about 5 inches high by 8 inches wide was recovered on the runway. The LMLG lower side brace remained attached to the lower outer cylinder and the upper side brace was twisted about 90° along its length. The LMLG retract actuator was in the extended position and the rod end was fractured. The LMLG lock links were fractured.
