# **NATIONAL TRANSPORTATION SAFETY BOARD**

## **AIRWORTHINESS GROUP CHAIRMAN'S FACTUAL REPORT**

- A. ACCIDENT:** DCA08MA076
- LOCATIONS:** San Francisco International Airport, California
- DATE/TIME:** June 28, 2008, approximately 10:15 pm local time
- AIRCRAFT:** Boeing 767-281SF, N799AX

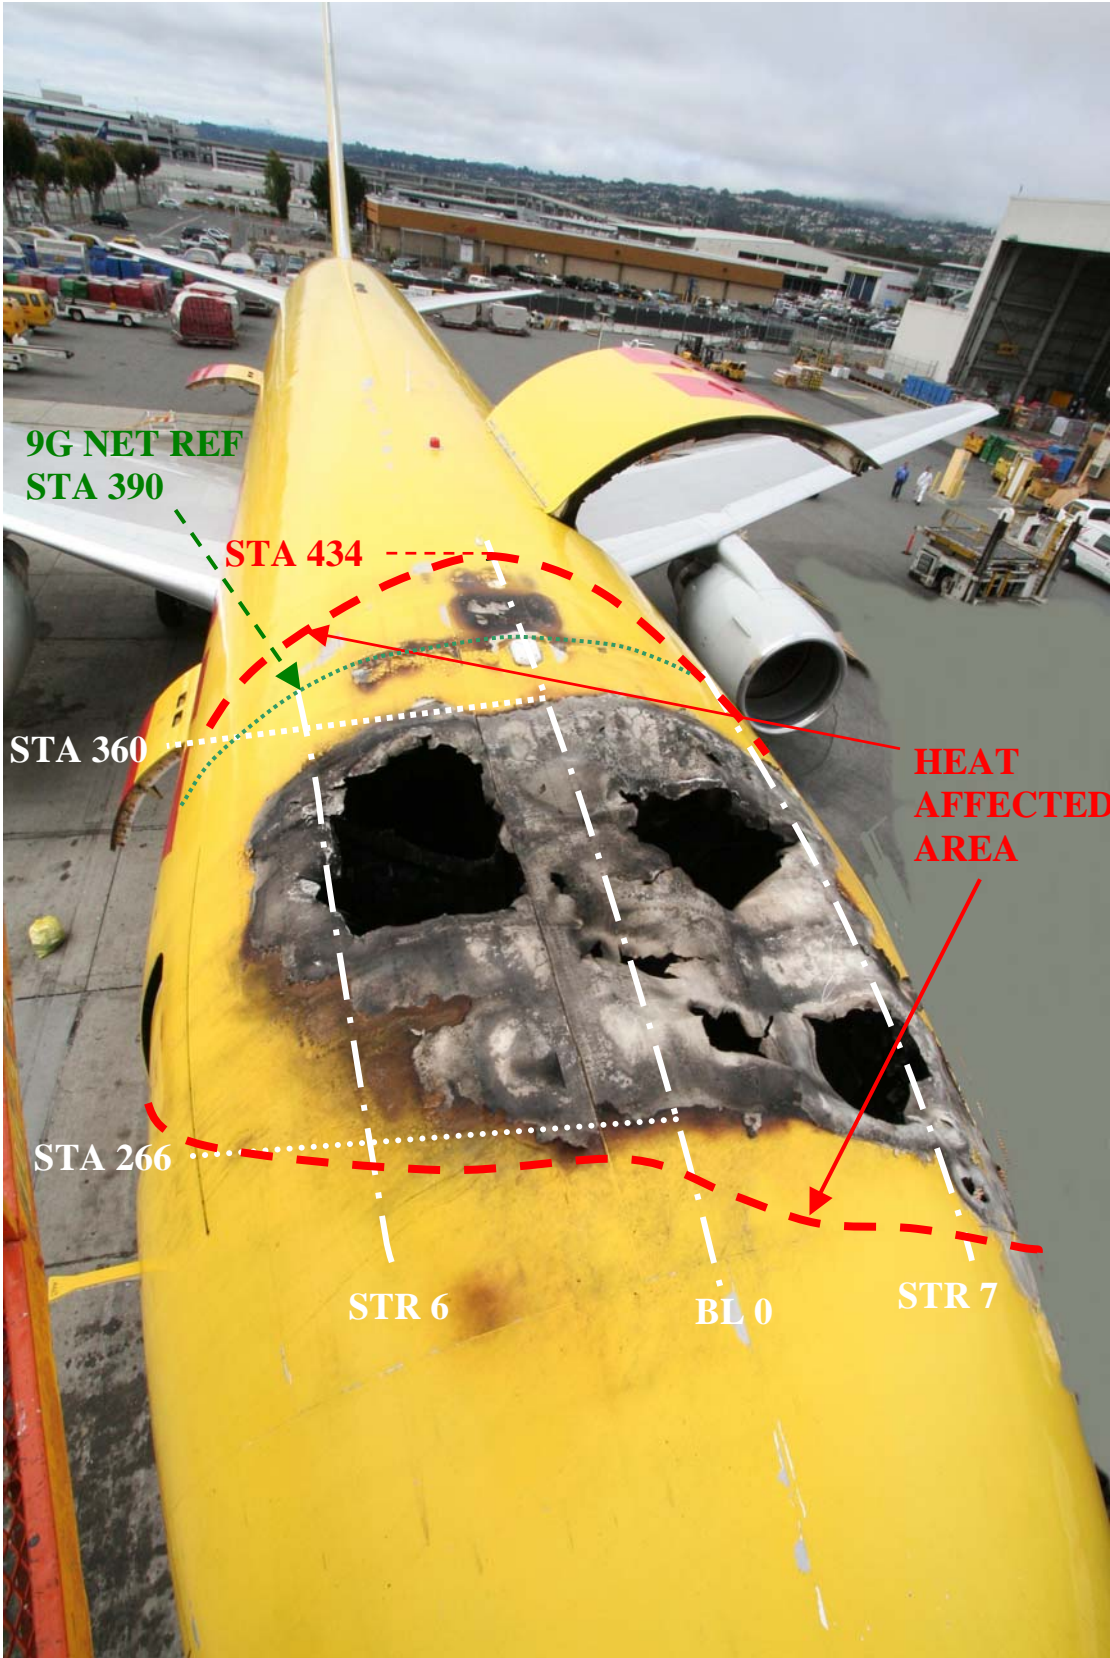
- 1) Most of the skin, stringers, and frames between stations 266 to station 360 and from stringer 7-Left to stringer 6-Right had been consumed, melted, or had been heavily damaged.
- 2) Frames & stringers from station 266 to station 390 below stringer 6 on the left and right hand side up to the floor level had been heat-damaged and distorted.
- 3) Frames and stringers from station 360 aft to station 434 in the crown area had been distorted.
- 4) Holes were in the left side of the fuselage where frames and stringers had been outboard of the lavatory. This damage extended from station almost FS 270 forward to the cockpit partition, and above roughly 30 inches above the floor level.
- 5) The non-metallic materials in most of the 9-G cargo restraint (net) had burned away.
- 6) The structural center portion of the aft cockpit wall was missing from about 5 feet above floor level.

Figure 1. The general areas of heat damage to the top of the fuselage.

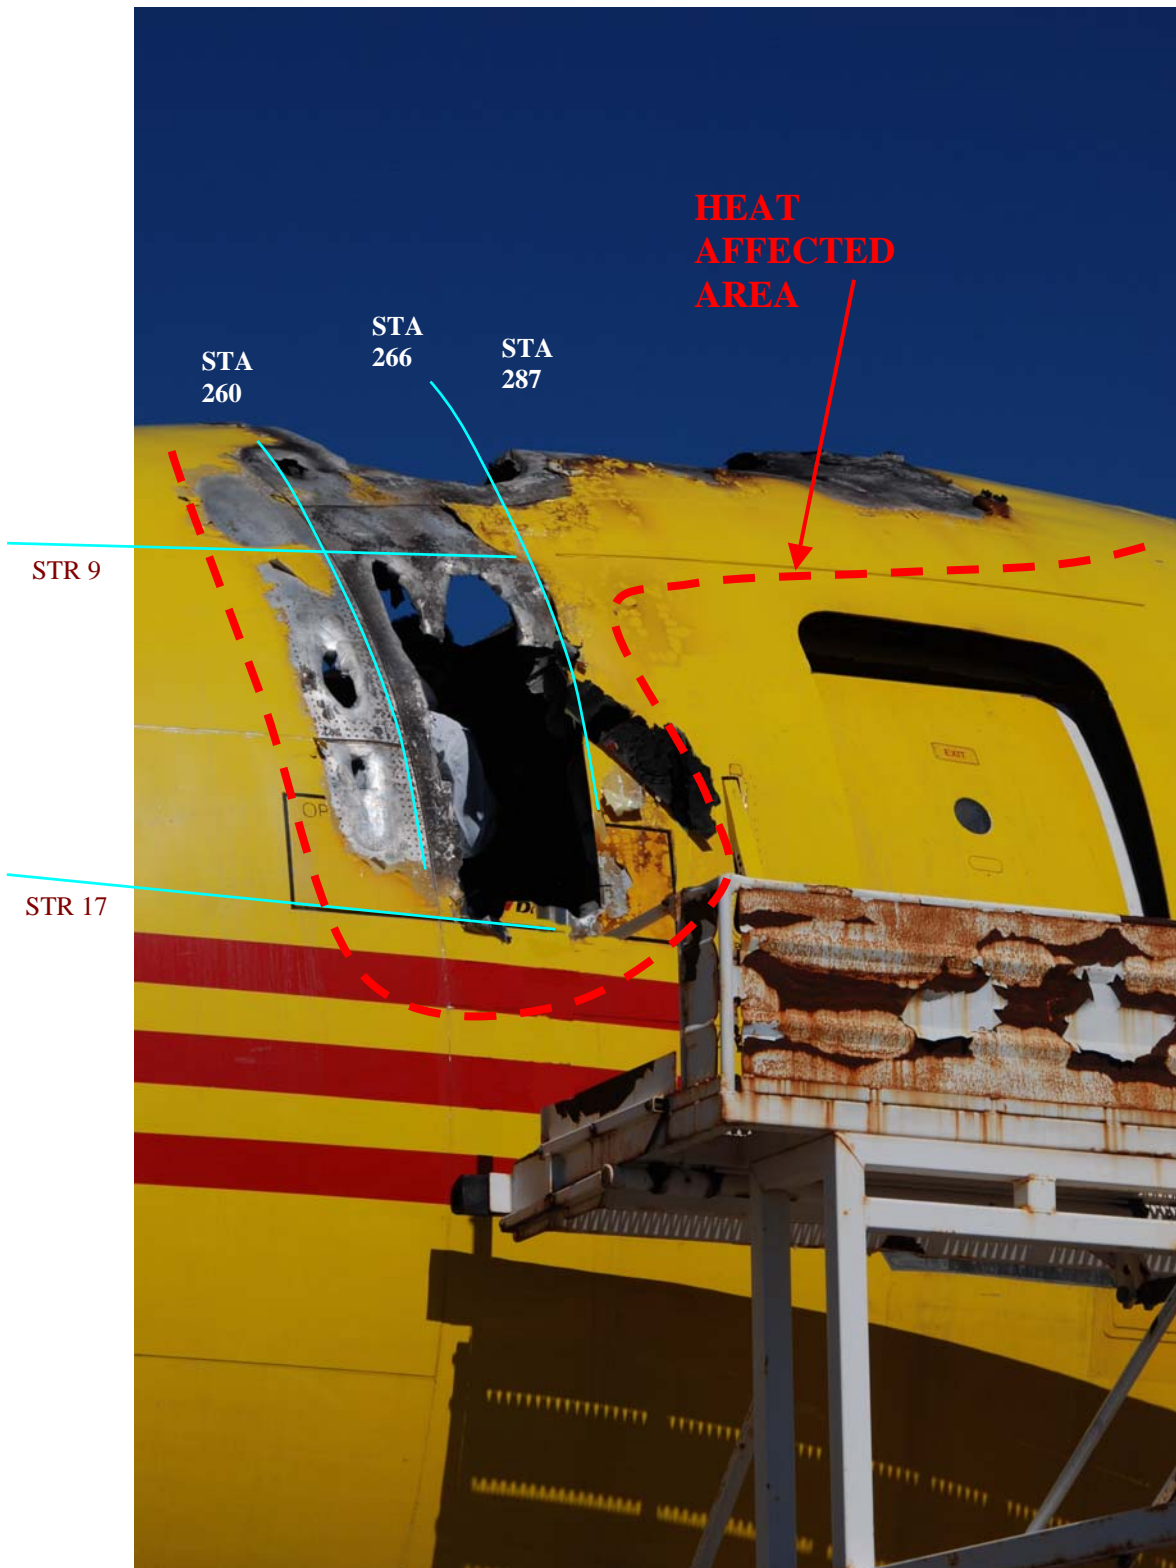
Figure 2. Externally visible heat damage to the left side of the fuselage, ahead of the L1 door. The underlying structure had extensively more damage than can be seen.

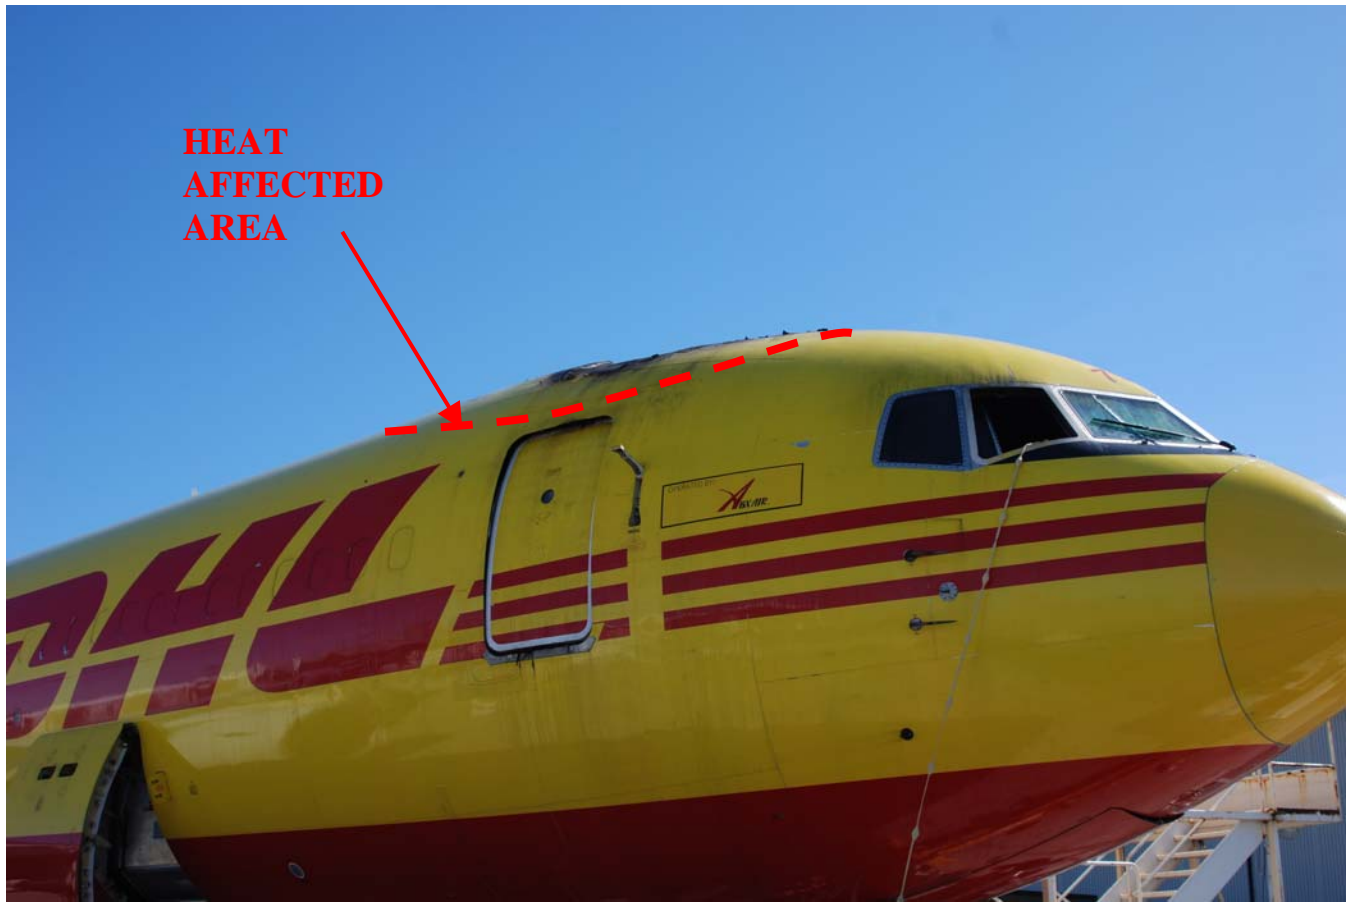
Figure 3. Heat damage to the right side of the fuselage, above the R1 door.

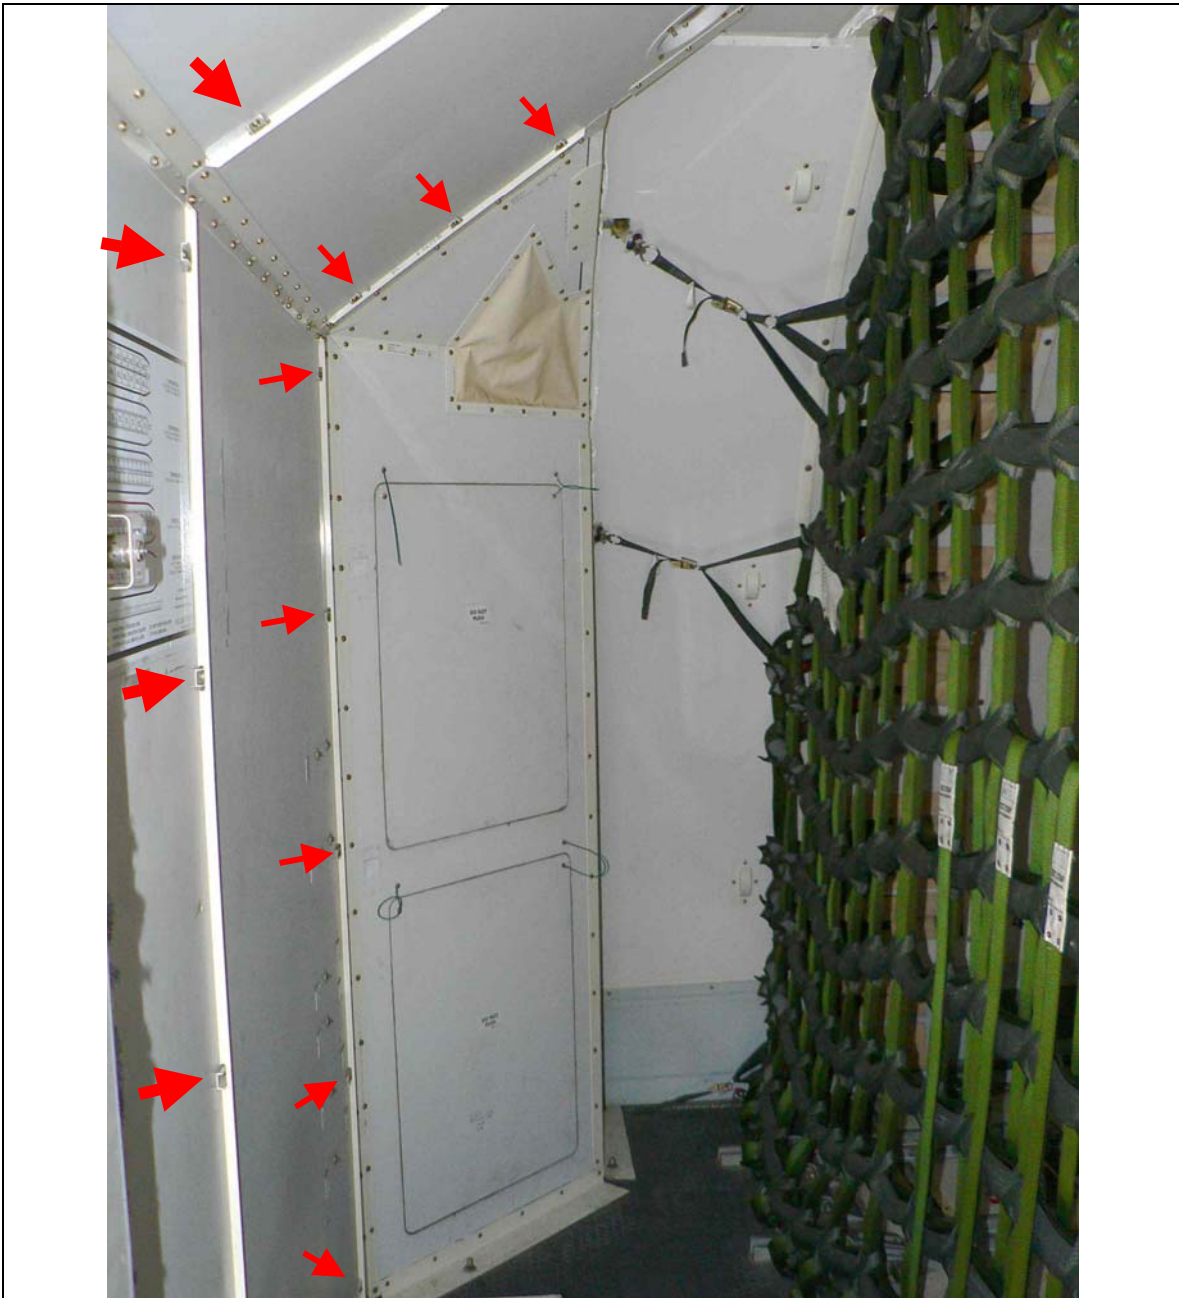
The smoke wall that had separated the occupied spaces from the cargo compartment split vertically at or near butt-line zero, where a modified aluminum T-section connected the left and right panels. The panels had been held together by metal clips installed in slots that had been milled through the T-strip. (See Figure 4)

Figure 4. Photo of the aft side of the smoke wall in an exemplar aircraft. The supernumerary compartment and cockpit would be to the left of this wall. The net is the 9-G cargo barrier and the tail is to the right of this photo. The arrows show clips installed through T-strip in a similar airplane, holding the left and right smoke wall panels together. The center-wall clips and T-section had been consumed in the accident aircraft.

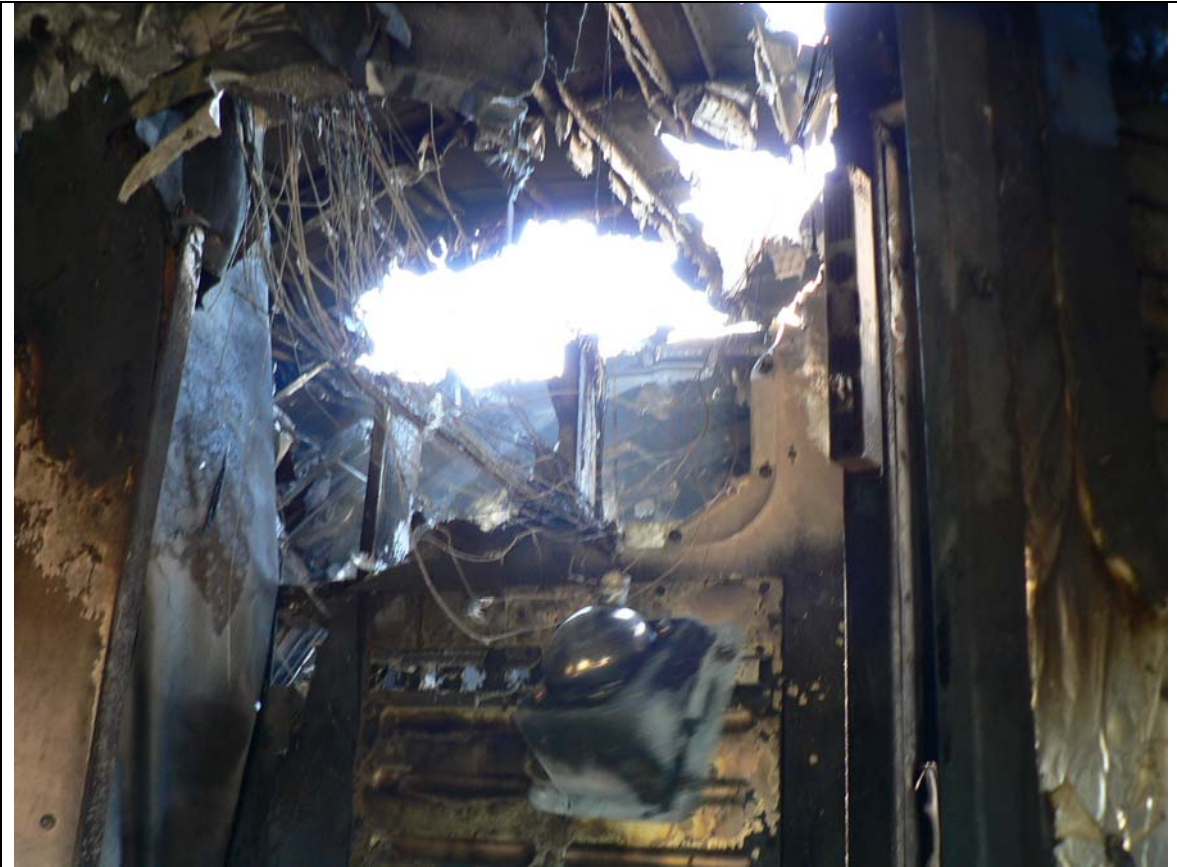
compartments. The top of the cockpit to supernumerary wall had been breached by the fire. (See Figure 5)

Figure 5. As viewed aft and up from the Captain's seat in N799AX, this view shows where fire breached the wall that had separated the cockpit from the supernumerary compartment. The sky is visible through the holes that had penetrated the top of the supernumerary compartment. The supplemental oxygen tubing and wiring that were not found for inspection had been in this missing area.

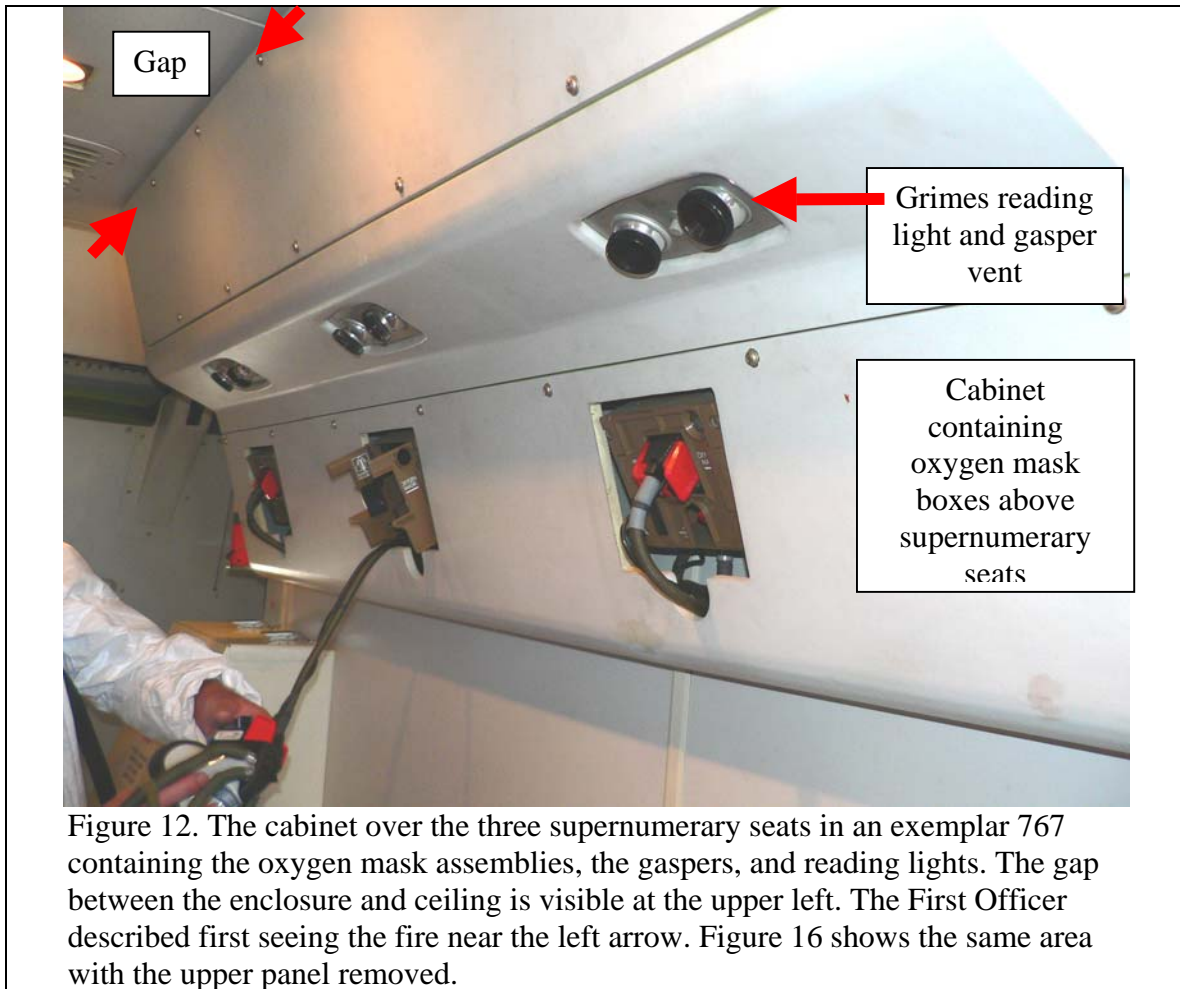
Above the supernumerary seats was an enclosure for the horizontal portion of the metal supply tube, the mask box assemblies, the gasper tubes, reading lights, and reading light switches. The air to each gasper was routed through orange hoses from above the ceiling. The enclosure was made of fiberglass facial panels and composite or aluminum honeycomb cores. In other aircraft a gap existed between the enclosure and the ceiling. The width of the gap seen in two other airplanes varied between about 1/8-inch and 5/8-inch. (See Figures 12 and 13)

Figure 12. The cabinet over the three supernumerary seats in an exemplar 767 containing the oxygen mask assemblies, the gaspers, and reading lights. The gap between the enclosure and ceiling is visible at the upper left. The First Officer described first seeing the fire near the left arrow. Figure 16 shows the same area with the upper panel removed.

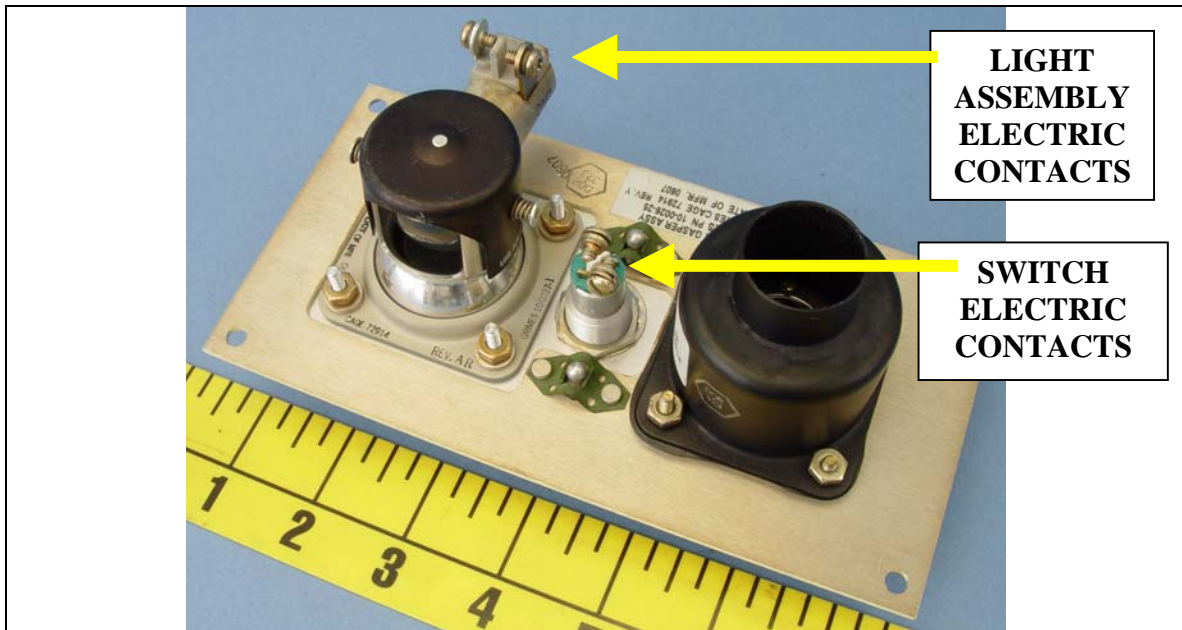
ABX inspected the fleet of 767 freighter airplanes after the fire and found that many were missing rubber boots that isolated electrical parts of light assemblies. When the lights were rotated, the light switch in the center of the assembly was able to contact the grounded light housing. (See Figures 13 and 14) The ABX personnel were able to produce visible sparks by contacting the electrical components.

Figure 13. Light assembly from an exemplar aircraft (left) in an unrotated orientation. A pushbutton switch is in the middle and the electrical connection screws are visible. An orange fresh air (gasper) hose would be connected to the black housing on the right.

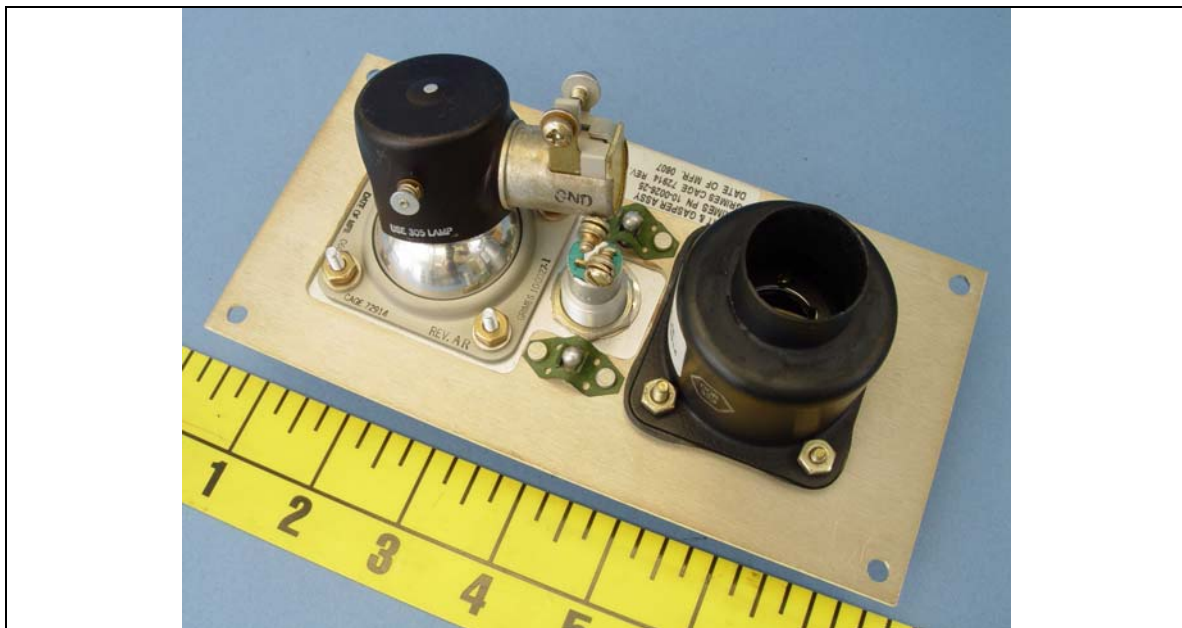
Figure 14. The same light assembly after rotating until the lighting shell contacted a potentially powered screw at the light switch.

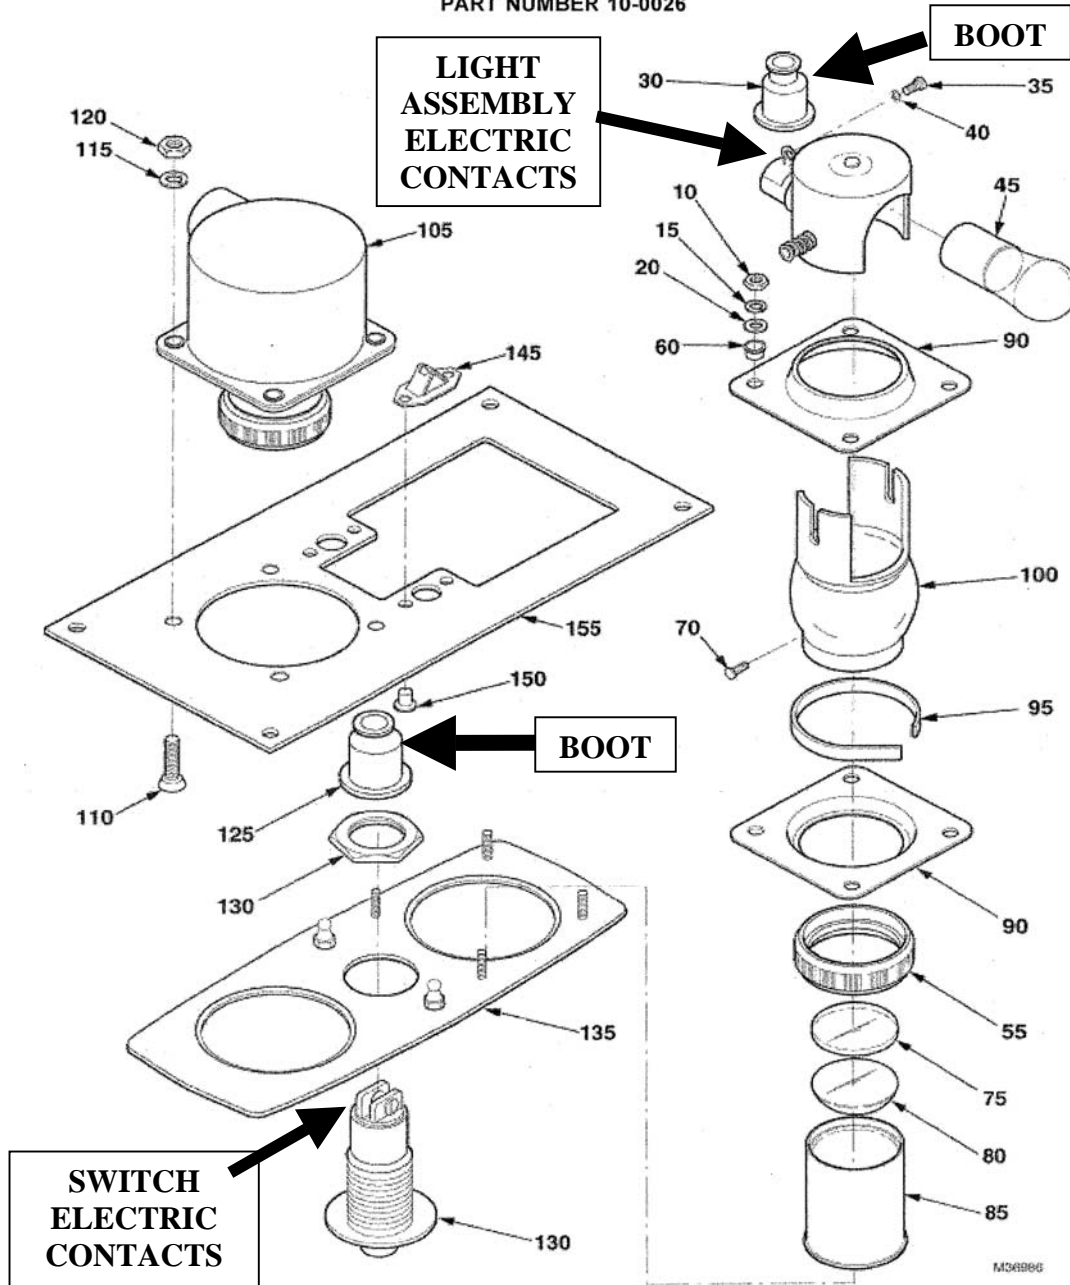
Reading Light and Gasper Assembly  
 IPL Figure 1

Figure 15. Grimes Component Maintenance Manual illustration showing the missing rubber boots, with added text in boxes. Items numbered 30 and 125 (see “BOOT”) are listed in the CMM as a p/n 60-2517-1 silicone boot and cover the electrical connections. As an alternative, item #30 could have been a p/n 60-2636-1 cable nipple.

The boots were found inconsistently installed between the ABX airplanes examined, although the boots had been required in each location. Some airplanes had the boots installed in both locations, some in one location and others with no boots installed. At least one was found with black tape protecting the switch contacts. (See Figure 16) The operator decided to deactivate the lights on the ABX and the ATI 767 freighter airplanes until the assemblies were modified to prevent the light assembly in the unit from being able to rotate into contact with the switch terminals, with or without the boots. The ABX modification to the PSU installed insulated stand-offs to prevent the light socket terminals from rotating far enough to contact the terminals of the light switch (Ref. ABX Drawing M08858). When the work was accomplished to modify the lights for incorporation of the change, the wire insulating boots were also inspected and corrected where necessary.<sup>5</sup>

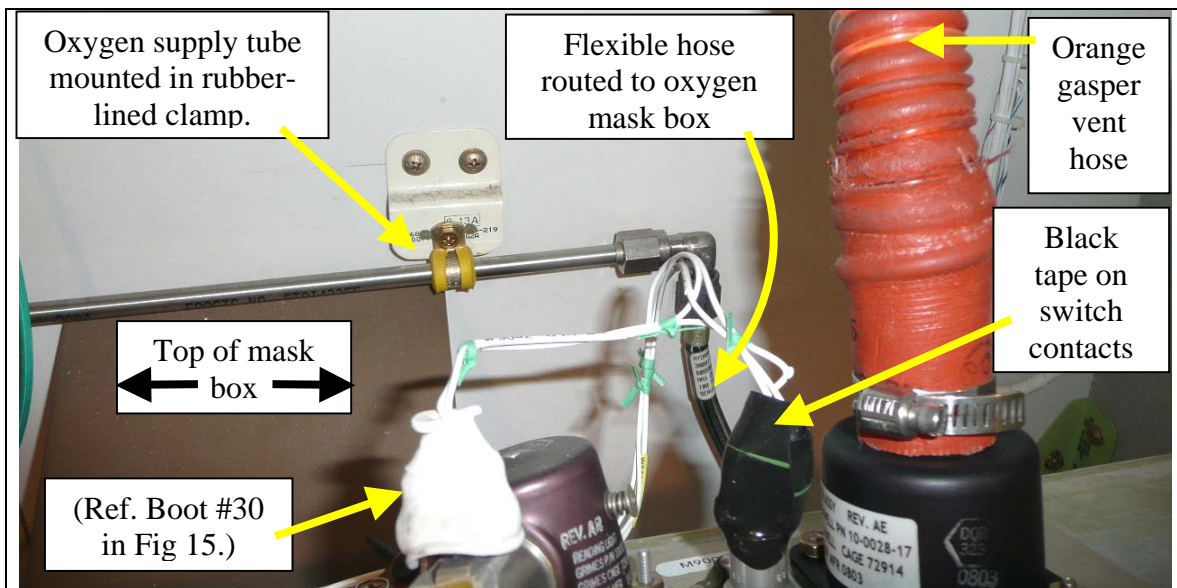
Figure 16. Exemplar airplane. Proximity of the oxygen supply tube located above the supernumerary seat to the gasper hose (orange). This was above the left-most seat and a typical installation for component proximity above each of the three seats. Figure 17 shows a the same installation from below.

The white boot is Item #30 in Figure 15 and was missing in some airplanes. The switch contacts in this airplane were covered with black tape, rather than having a similar white boot (Ref. Figure 15 Item #125). Figure 12 shows the same area with the upper panel installed. The supplemental oxygen mask box was mounted beneath the Grimes passenger service unit.

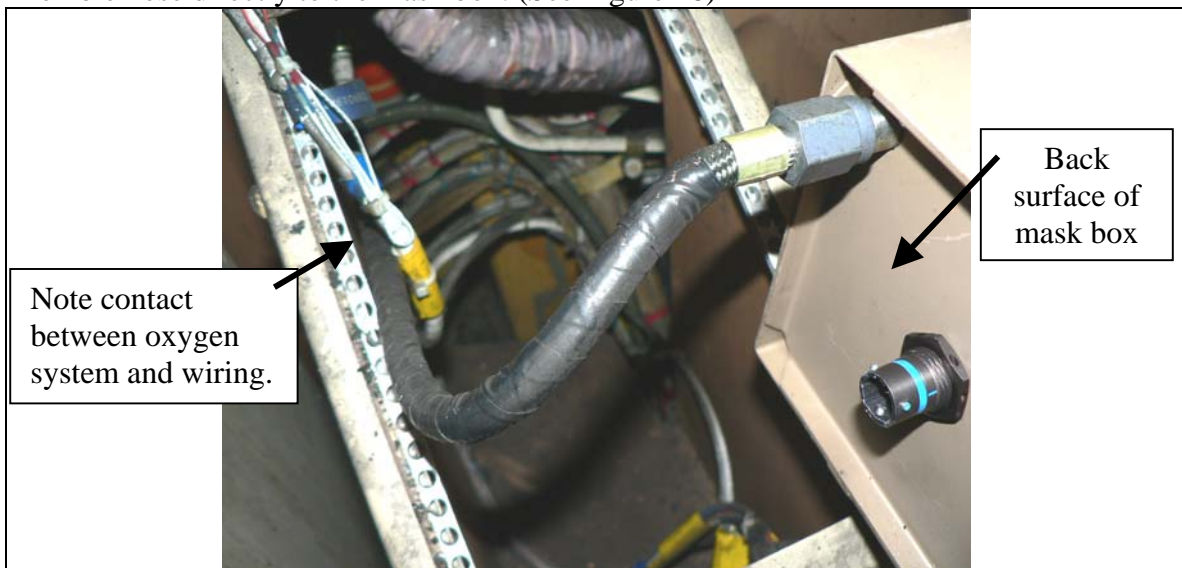
The short section of stainless steel tubing was a difference between the Boeing installations that investigators saw in the cockpit and the IAI-Bedek design in the supernumerary compartment. The Boeing installations found in the cockpit connected the flexible hose directly to the mask box. (See Figure 18)

Figure 18. The PVC hose connecting the N799AX left observer's cockpit supplemental oxygen mask box and the stainless steel supply tube. The stainless steel supply tube at the hidden end of this PVC hose is not visible. This tube had been

wrapped in PVC black tape and a wear pattern was seen on structure that this hose had rested against. (The protective over-wrap of tape was described in Boeing SB 767-35A0034). The open electrical connector in the lower right corner of the photo was a provision for the oxygen mask microphone assembly. Note co-routed electrical wiring.

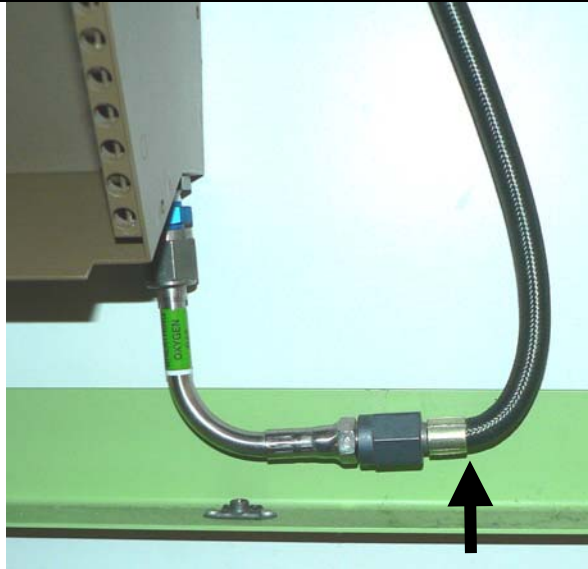
The hose assemblies routed to each mask box in two other airplanes were examined and the hose was found routed tightly in one installation, to displace the stainless elbow upward, pulling on the bottom of the flexible hose. (See Figure 20)

Figure 20. The arrow shows where an improper routing placed tension on the PVC flexible hose, where it entered the fitting at the bottom of the oxygen mask box assembly. Photo taken in N798AX before deactivation and removal.

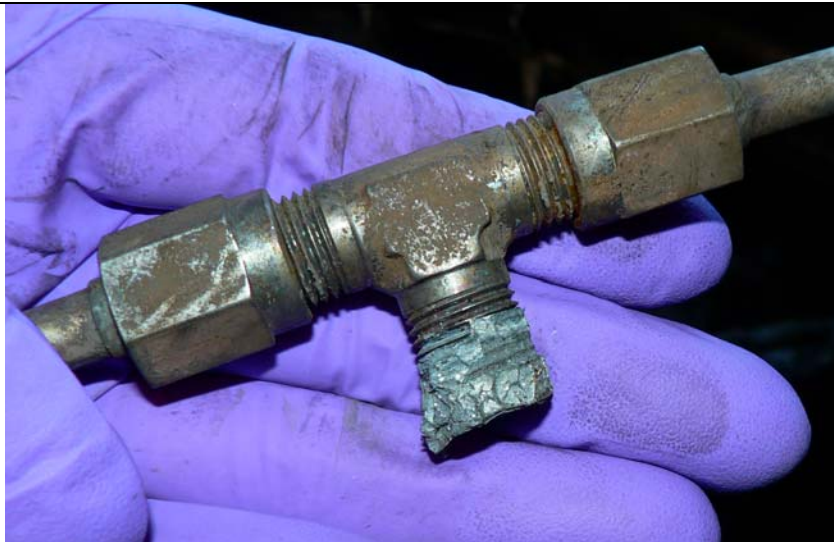
The oxygen supply metal tube fitting which had been located above the center supernumerary seat was different than the fittings for the hoses that had been connected to the other two oxygen mask assemblies. The difference was that the fitting for the hose connecting to the center seat flexible hose assembly had resolidified aluminum in the fitting threads. (See Figure 21)

Figure 21. N799AX: Resolidified aluminum filled the threads of the center supernumerary seat threads. The flexible hose to the mask box would have hung from this fitting.

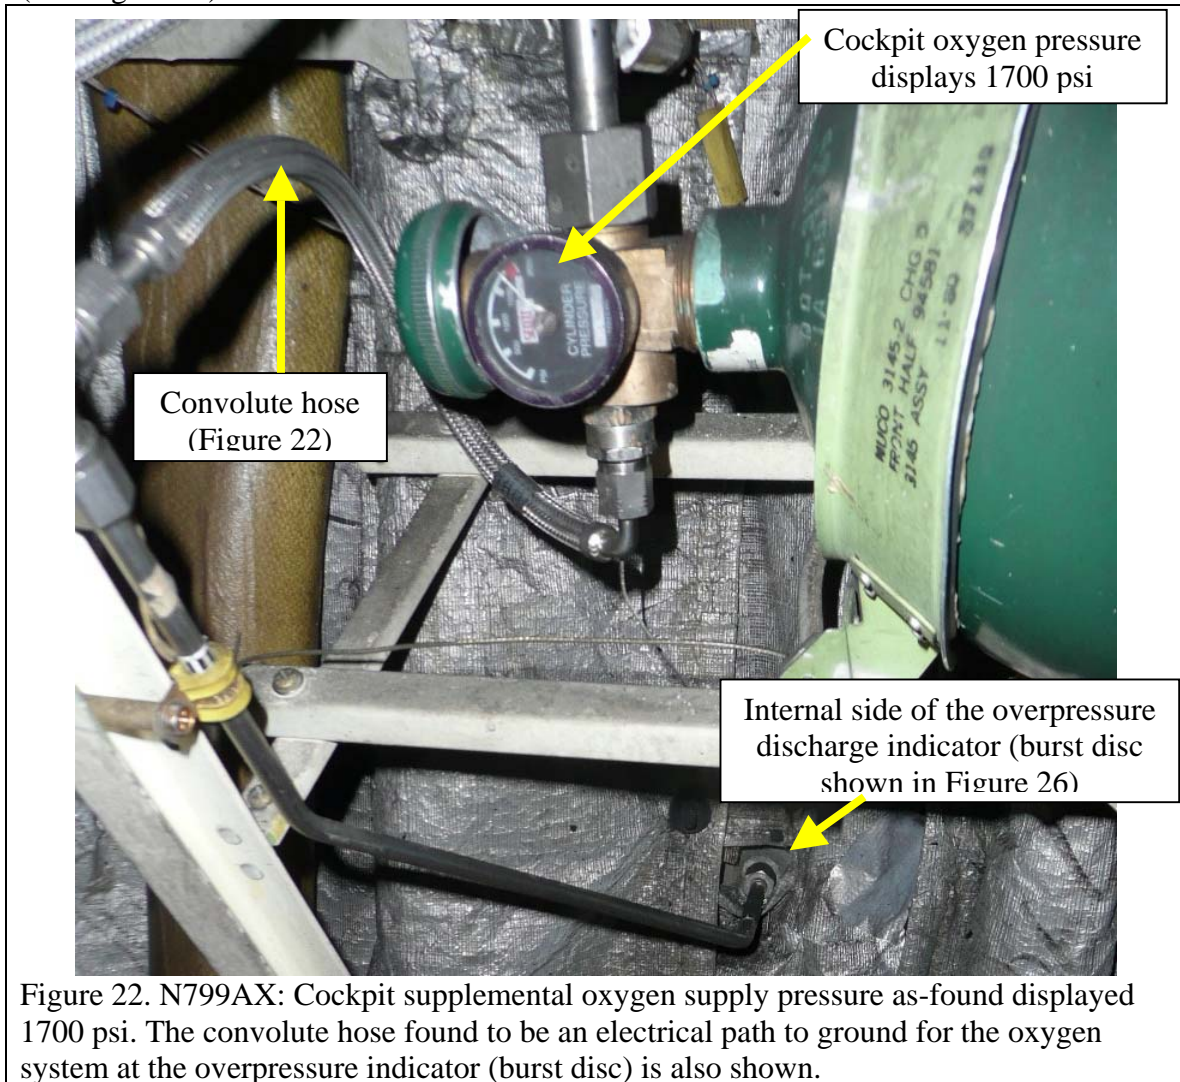
Maintenance personnel on-scene provided the pressures of the oxygen bottles from pre-flight as 1580 psi for the supernumerary cylinder and 1700 psi for the crew cylinder, and related that they had turned the valves to off after the fire.<sup>9</sup> When the group inspected the cylinders, the supernumerary cylinder was empty and the crew cylinder was 1700 psi. (See Figure 22)

Figure 22. N799AX: Cockpit supplemental oxygen supply pressure as-found displayed 1700 psi. The convolute hose found to be an electrical path to ground for the oxygen system at the overpressure indicator (burst disc) is also shown.

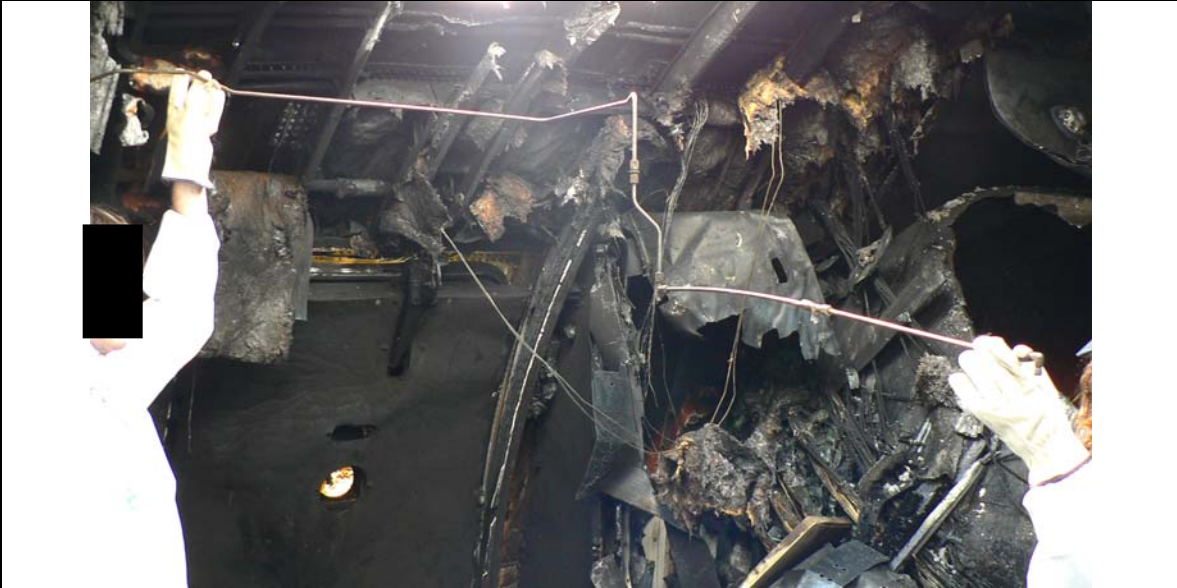
The metal oxygen supply tube in the supernumerary area was found intact, with each of the fittings that had been above the supernumerary seats. The fittings were tight and no penetrations of the tube were found. The recovered rigid stainless steel tubing was removed for detailed inspection with a 3X magnifying glass and no punctures or damage was found. (See Figure 23)

Figure 23. N799AX: The metal oxygen tube remained intact in the supernumerary compartment. The R1 door is in the background.

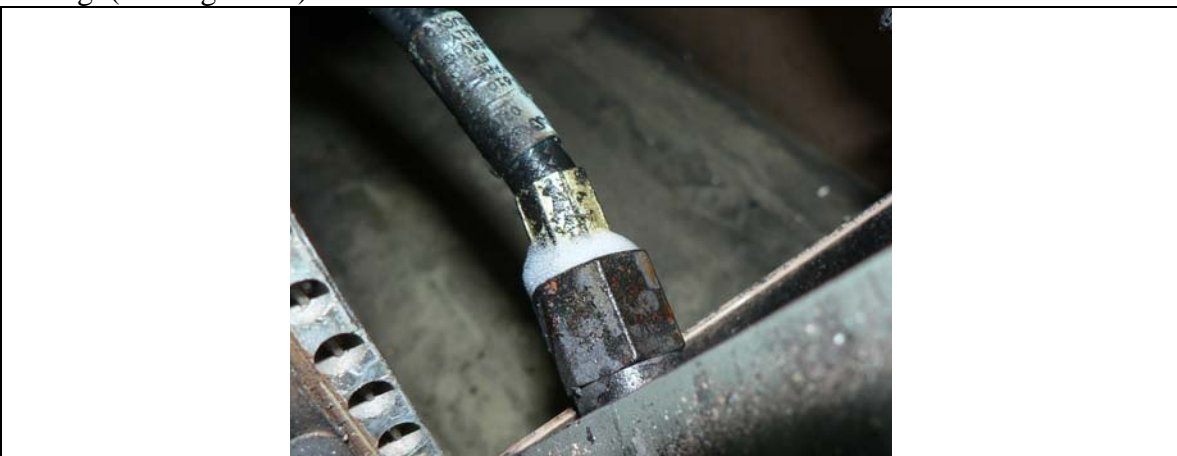
The supplemental oxygen system was pressure tested for leaks with shop air at about 110 psig. This test required plugging the tube to the previously removed supernumerary system and plugging the missing area of tubing, aft of the circuit breaker panels in the cockpit. When soapy water was sprayed onto each of the fittings, the pressure test revealed one minor leak. The leak was in a heat-damaged area, where the PVC hose connected to the back of the right observer mask box. Specifically, the foaming was between the B-nut and swaged fitting, not between the PVC hose and the swaged fitting. No sound could be heard and the leak created only an extremely slow foaming at the fitting. (See Figure 24)

Figure 24. N799AX: Slight foaming at the right observer station hose. This slow foaming action required about a minute to produce.

The same hose fitting (after removal from the airplane) did not leak during testing at Hydraflow. The Hydraflow engineering staff noted on several occasions that they had experienced such leakage due to the deformation of the mating surface, which in this case was still on the airplane. The mating surface was designed to be a bulb seal and they had seen fittings in which maintenance or installation personnel had over-torqued and deformed the shape of the bulb seal.

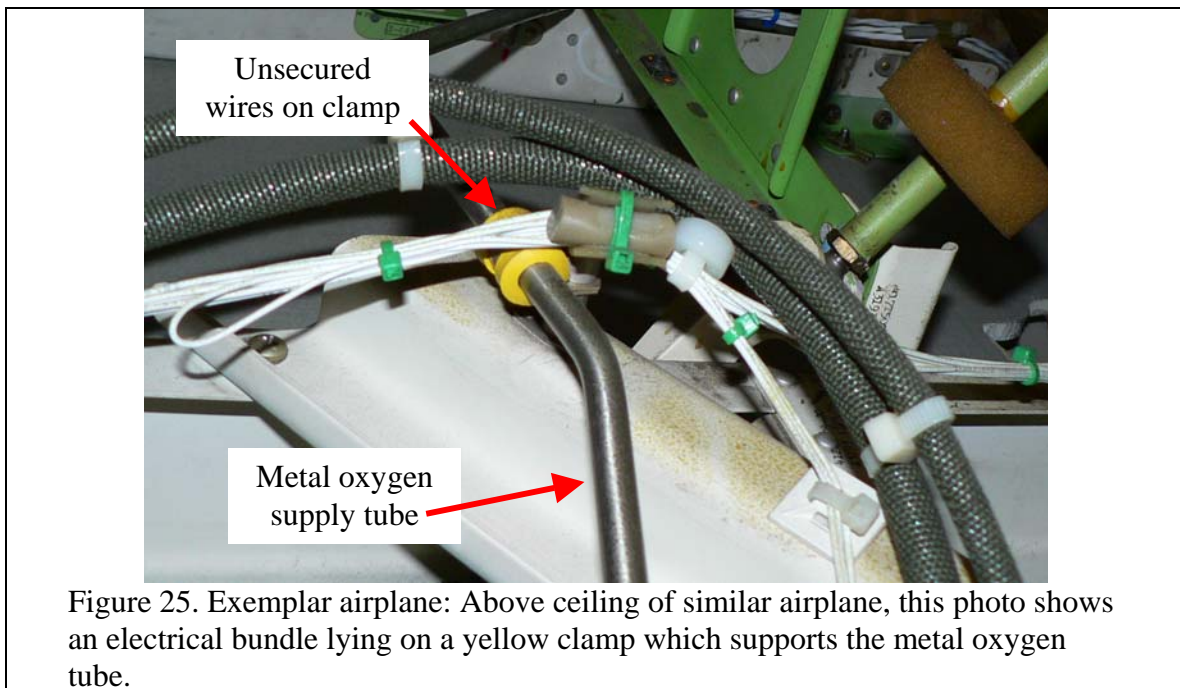
Inspections of operational ABX 767 freighters were initially conducted to aid in orientation of components that had been in the fire-damaged N799AX. Electrical wires were found that crossed the routing of the metal oxygen tube, above the ceiling panels. In two airplanes, the wiring was routing beneath the oxygen tube or was securely clamped with significant spacing from the oxygen. In one airplane, wire bundles were found in two locations not clamped or clamped in such a way that the wires could contact the oxygen tube. (See Figure 25)

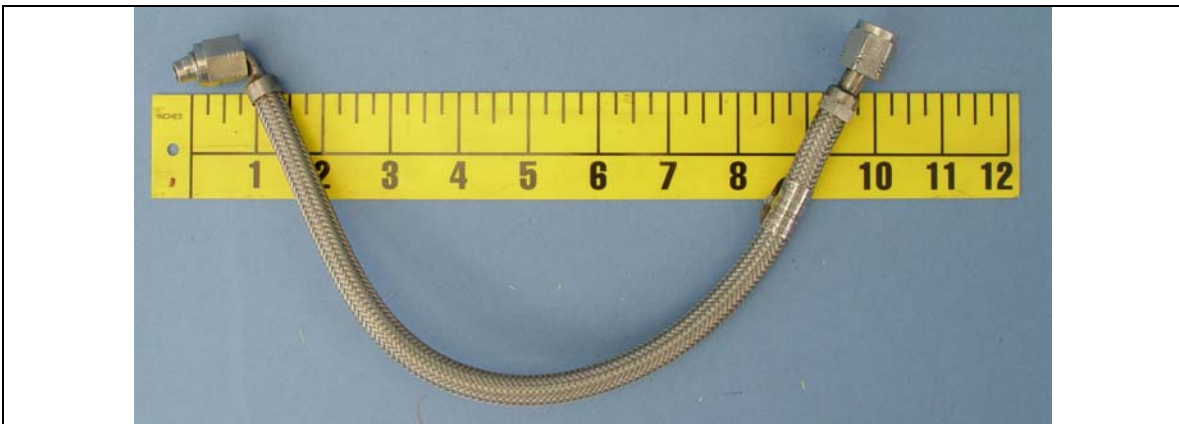
Figure 27. Detail of the Titeflex convolute hose from N799AX. (See Figure 22) The hose had an outer braid of stainless steel wire and welded end fittings.

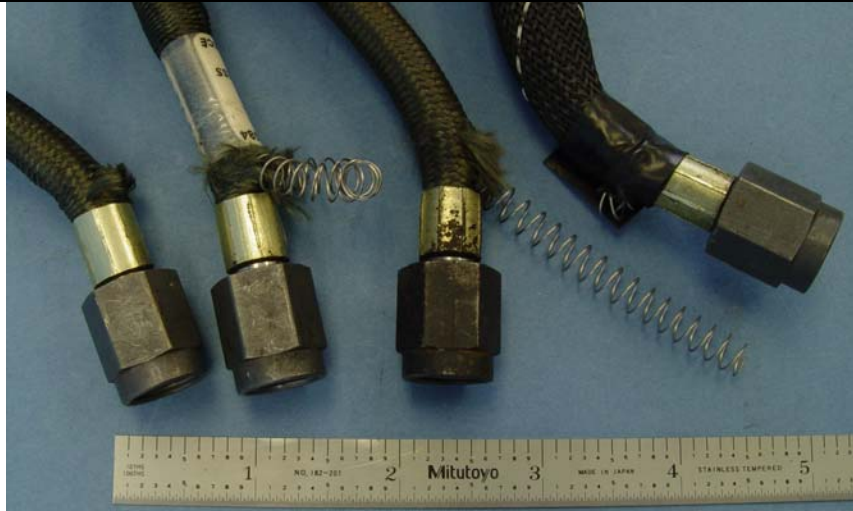
Figure 28. The photo shows the results of pressure testing four hoses to ultimate failure. From left to right, the photo shows the hoses of the N799AX Captain station, left observer station, right observer station, and First Officer station.

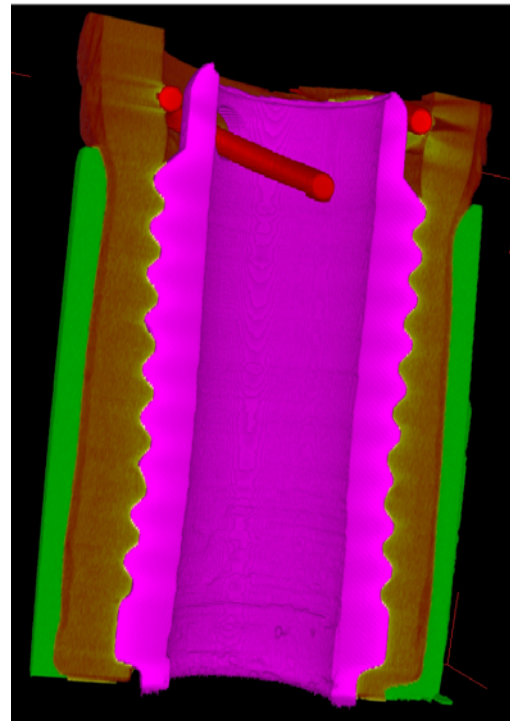
Figure 30. Exemplar airplane: Computerized tomography image of the older style sleeve that was found with no internal serrations.

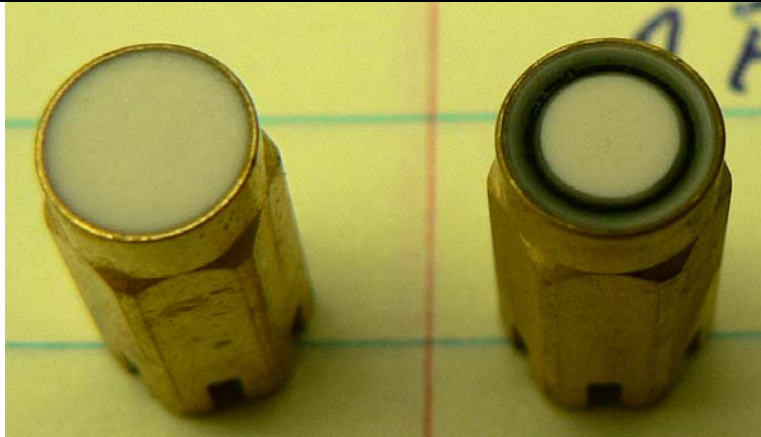
Figure 32. N799AX: New overpressure valve poppet on left. On the right is an overpressure valve poppet which was subjected to 140 psig for about 30 seconds and a darkened annular ring is visible.
