# **NATIONAL TRANSPORTATION SAFETY BOARD**

## **AIRWORTHINESS GROUP CHAIRMAN'S FACTUAL REPORT**

- A. ACCIDENT:** DCA08MA076
- LOCATIONS:** San Francisco International Airport, California
- DATE/TIME:** June 28, 2008, approximately 10:15 pm local time
- AIRCRAFT:** Boeing 767-281SF, N799AX

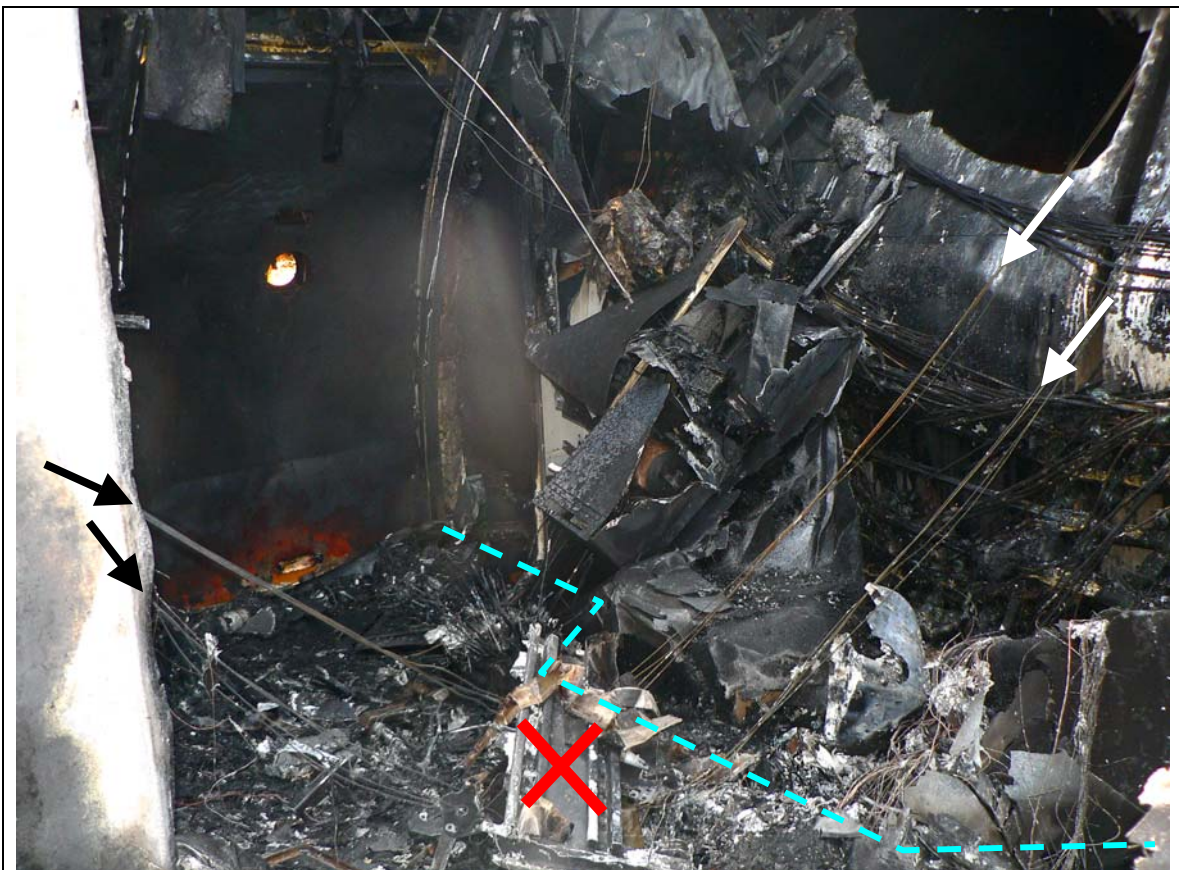
Figure 36. N799AX: The mounting for the control pulleys found on the floor of the supernumerary compartment were from the rudder, stabilizer trim, and First Officer side of the elevator system. The mounting is indicated by the red “x” at the bottom of the photograph. The arrows at the left and upper right point to the control cables. The view in this photo is from the forward left toward the aft right from the lavatory. The approximate base of the smoke wall is traced with the dashed blue line.

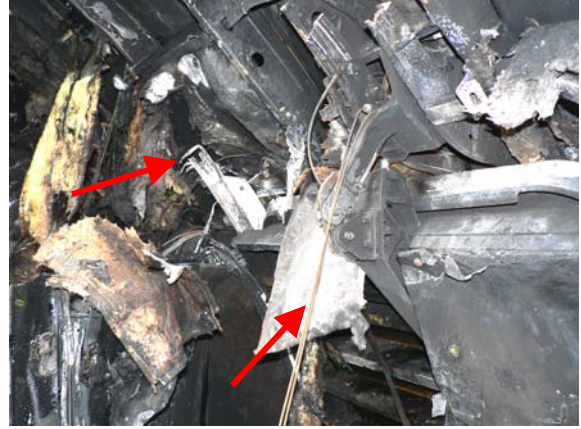
Figure 38 N799AX: The top of the L1 door, with the upper arrow pointing to the remaining end of the door track and the lower arrow pointing to the slack counterbalance cable.
