**NATIONAL TRANSPORTATION SAFETY BOARD**

**Airworthiness Group Chairman's Factual Report**

DCA-08-IA-033

Operator: United Airlines Inc.  
Location: Newark Liberty International Airport, Newark (EWR), New Jersey  
Date: January 25, 2008  
Time: 9:45 AM Eastern Standard Time  
Airplane: Airbus A320, N462UA

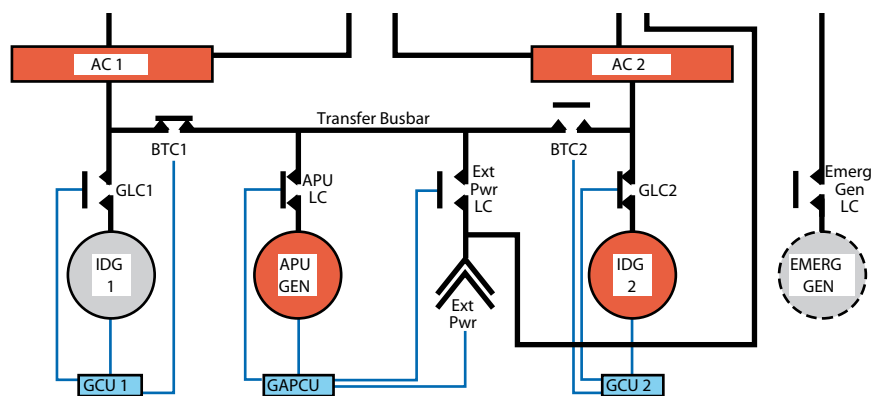
**Figure 6**

EPGS in G-EZAC dispatch configuration for incident flight

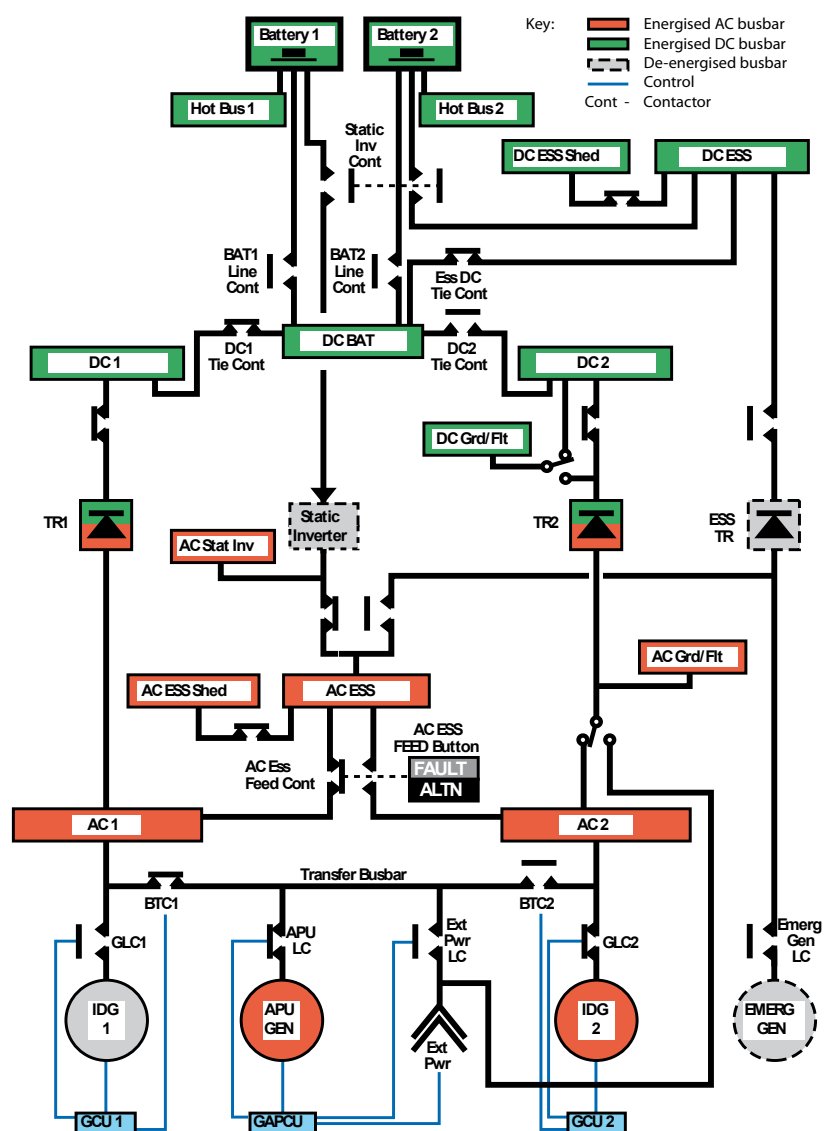
Figure 7

EPGS Distribution System - G-EZAC Dispatch Configuration shown

Thus, loss of AC BUS 1 results in loss of the AC ESS busbar, and also the loss of the AC ESS SHED busbar. As loss of AC BUS 1 de-powers TR 1, it also causes loss of the DC BUS 1 as well as loss of the DC ESS and DC ESS SHED busbars (Figure 8). After five seconds DC BUS 1 is automatically transferred to feed from DC BUS 2 via the DC BAT busbar, but it does not supply the DC ESS busbar.

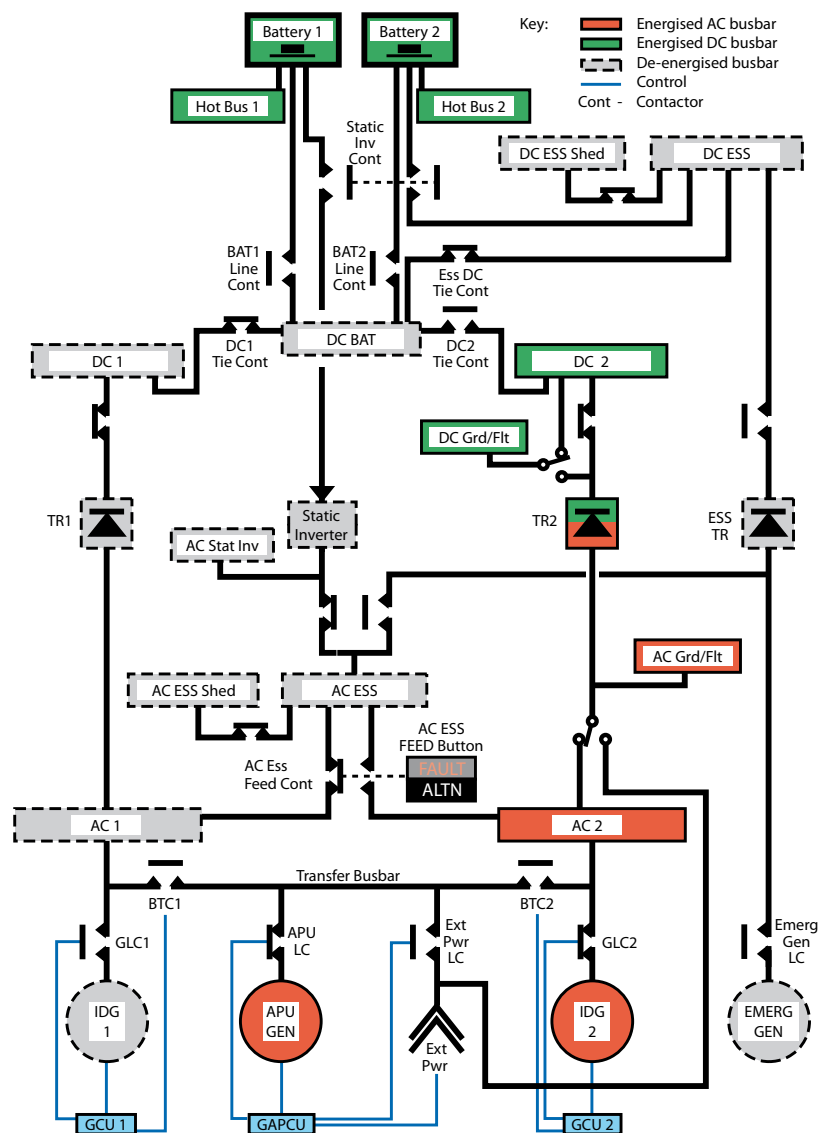
**Figure 8**

EPGS Distribution System – Immediately After Failure

action item following an electrical failure. Loss of the AC ESS busbar should cause the Master Caution to trigger, an 'AC ESS FAULT' warning message to appear on the ECAM DU and an amber 'FAULT' caption to illuminate in the 'AC ESS FEED' push-button selector switch on the EPGS control panel. Data from Airbus suggests that, following AC BUS 1 failure, a flight crew will typically take, on average, about one minute to restore power to the AC ESS busbar by selecting the AC ESS FEED switch. The crew of G-EZAC reported that they performed this action a number of times, but it did not result in power being restored to the AC ESS busbar.
