NATIONAL TRANSPORTATION SAFETY BOARD

AIRWORTHINESS GROUP CHAIRMAN'S FACTUAL REPORT

WPR10FA371

Operator: AirMethods Corporation
Location: Tucson, Arizona
Date: July 28, 2010
Time: 1342 Mountain Standard Time (MST)
Aircraft: N509AM, American Eurocopter AS350B3

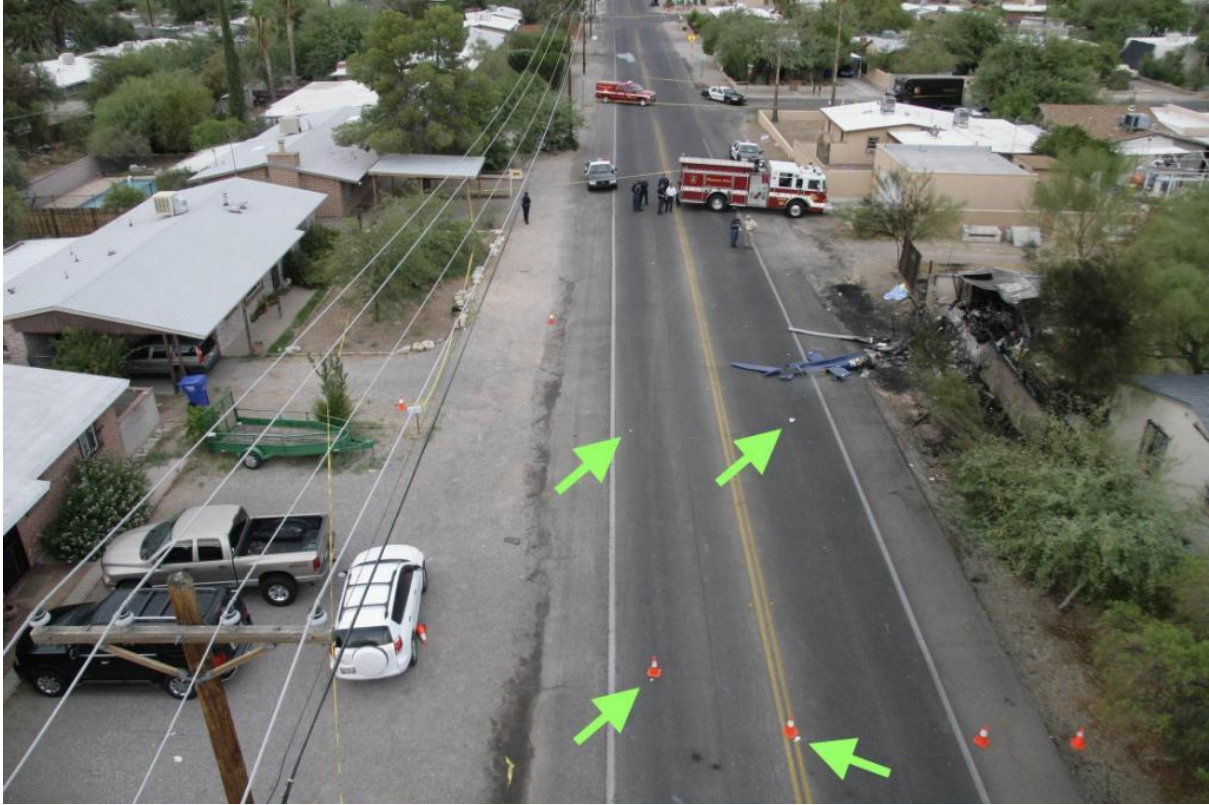
The helicopter came to rest upright, on a heading of 055 degrees magnetic, along the east verge of a north-south residential street. (Figure 2) The center fuselage structure was straddled across a five-foot-tall cement-block wall, with the nose resting on a garden shed. Both the shed and the wall were fragmented by the impact, with fire consuming the shed, its contents, and vegetation within a 15-foot radius of the fuselage. (Figure 3) The top of a tree located 5-feet east of the helicopter nose had been severed at the 12-foot-level. A 40-foot-tall set of power lines paralleled the street on the opposite verge, about 50-feet west of the main wreckage. No impact marks or damage were observed to the power lines, or any other adjacent tree or structure. Fragments of the fuel tank were found about 30 feet to the southwest, and the odor of jet fuel was present throughout the site.

Figure 2: Photo of accident location viewed from above and to the north. Power lines are to the left, with fuel tank fragments indicated by green arrows. The tail boom is visible lying on the right side of the road.

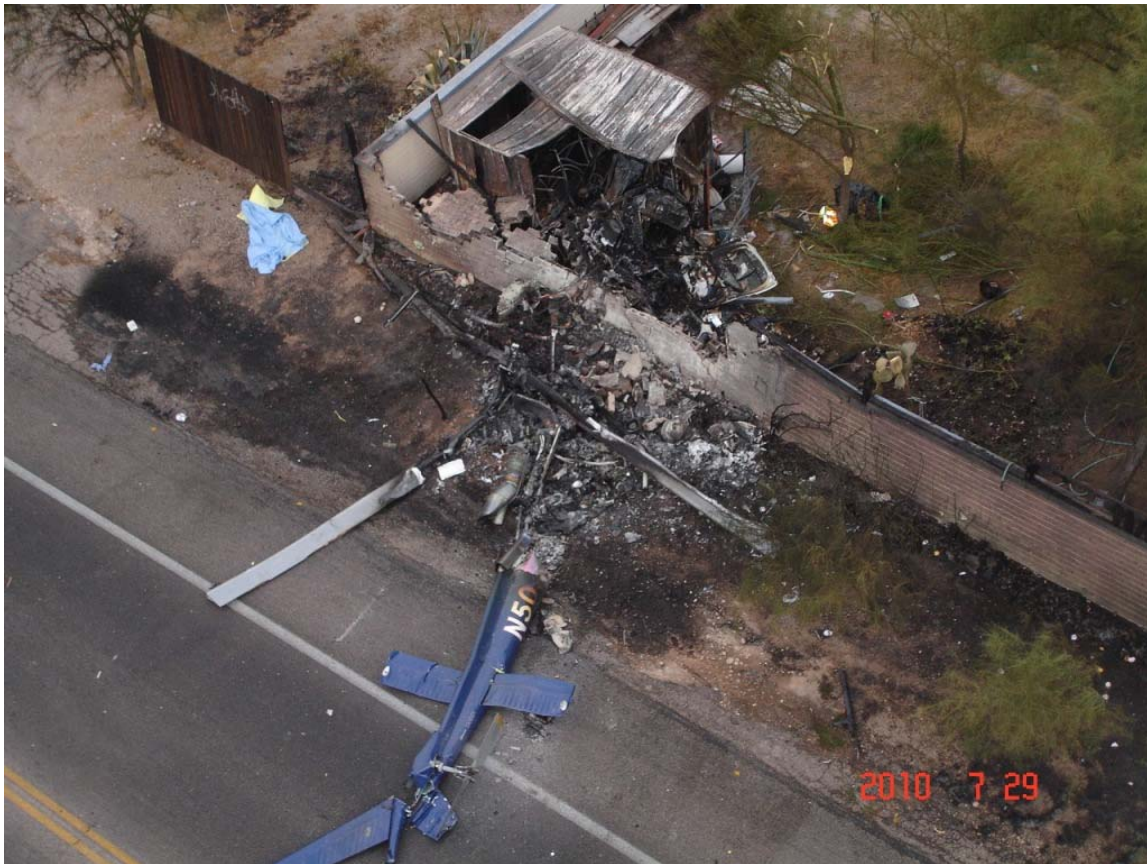
Figure 3: Photo of accident location viewed from above. The center fuselage structure is situated on the brick wall, which runs diagonally across this image. All three main rotor blades and the engine are visible in the center of image.

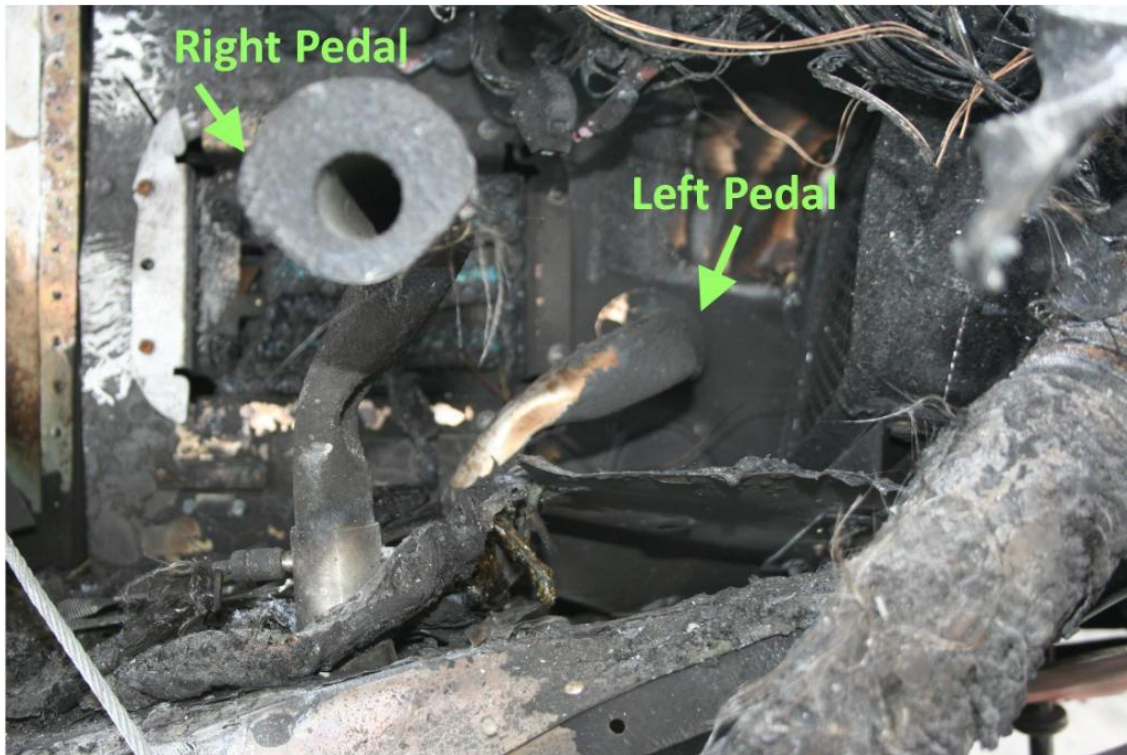
The left foot pedal of the tail rotor control was found in the forward position, and it was deformed forward and down. (Figure 4) The collective control was in the full down position, with the rotary throttle set to 'VOL' (flight position). The cyclic control exhibited buckling deformation to its shaft at the cabin floor, with the control pointing forward and to the right. The flight control linkages located beneath the cabin floor were deformed and impinged against the cross members. The remaining linkages aft of the cabin were consumed by fire through to the flight control servo actuators. The rotor brake and fuel shutoff valve control assemblies sustained thermal damaged, with both controls pointing to the forward position.

Figure 4: Photo of tail rotor foot pedal controls viewed from the right side of the cabin, the front of the helicopter is to the right.

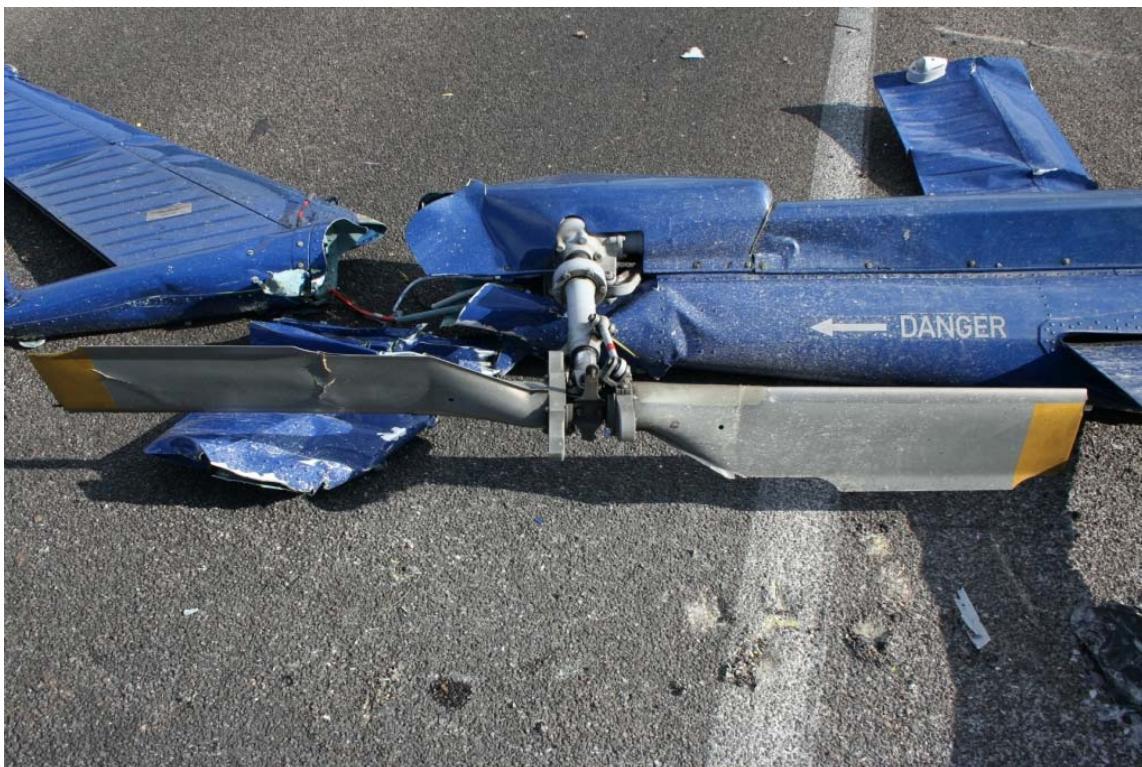
The tail rotor gearbox remained intact and affixed to the tailboom structure. Oil was observed through the gearbox sight window, and rotation of the tail rotor yoke resulted in a corresponding rotation of the tail rotor drive shaft at the tailboom heat shield. Both blades remained firmly affixed at the rotor hub, were largely intact, and their associated pitch change links were noted connected to both the rotating plate, and blade control horns. The yellow blade sustained a leading edge tar-covered nick at the tip. A corresponding cut in the tarmac road surface was noted adjacent to the blade. The balance weight mount was bent inboard; road tar transfer and scrapes in the paint were noted on the surface of the mount and the yellow blade control horn. Corresponding indentations were noted in the adjacent road surface, about 2-feet to the south.

(Figure 5) The tail rotor push-pull tube was continuous from the rotor hub bellcrank through to the tailboom heat shield. Forward of the heat shield, the remaining control tube and drive shaft were fire consumed through to the area of the steel forward drive shaft. The cylinder casing and control lines of the yaw pedal servo actuator were fire consumed; the associated servo rod end and input control bolts remained in place.

Figure 5: Photo of tail rotor blades and gearbox affixed to aft tailboom. The lower right hand corner of image displays ground scars corresponding to balance weight contact.

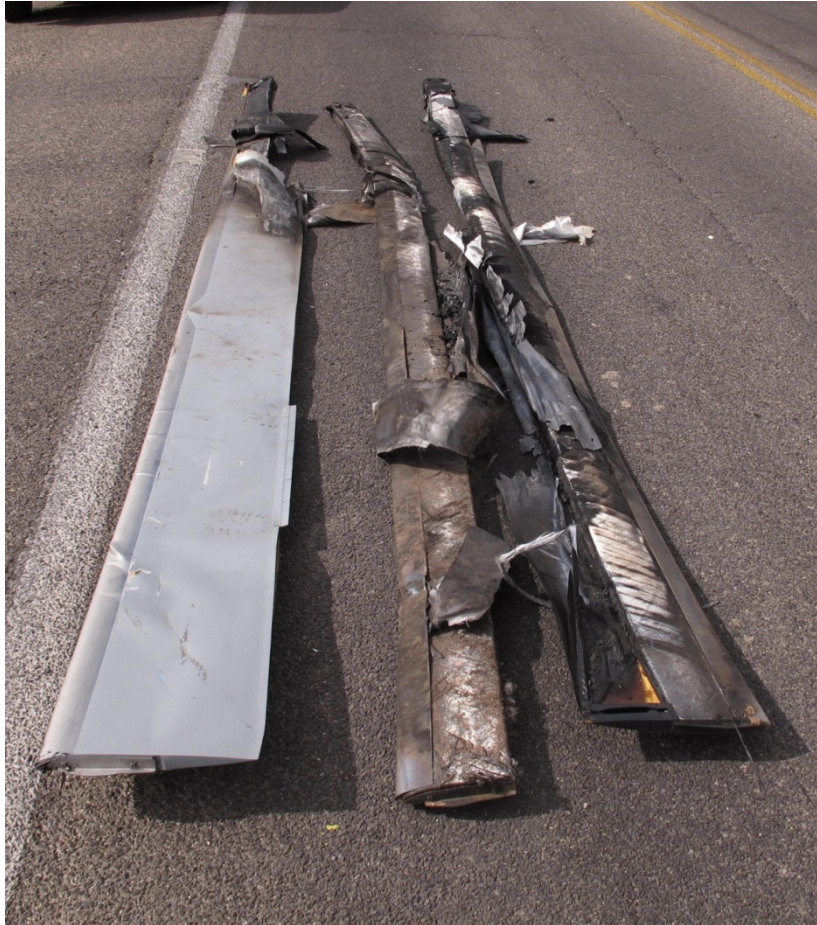
One of the main rotor blades (S/N 31257) exhibited nicks and scrapes to the lower leading edge surface consistent with road surface contact, and sustained fire damage from the root to 5-foot outboard from the root. The entire trailing edge of the second blade (S/N 31175) was consumed by fire; the leading edge displayed no indications of abrasions. The outer surfaces of the third blade were consumed by fire, and as such the serial number could not be identified. (Figure 6)

Figure 6: Photo of main rotor blades after removal from immediate accident site.

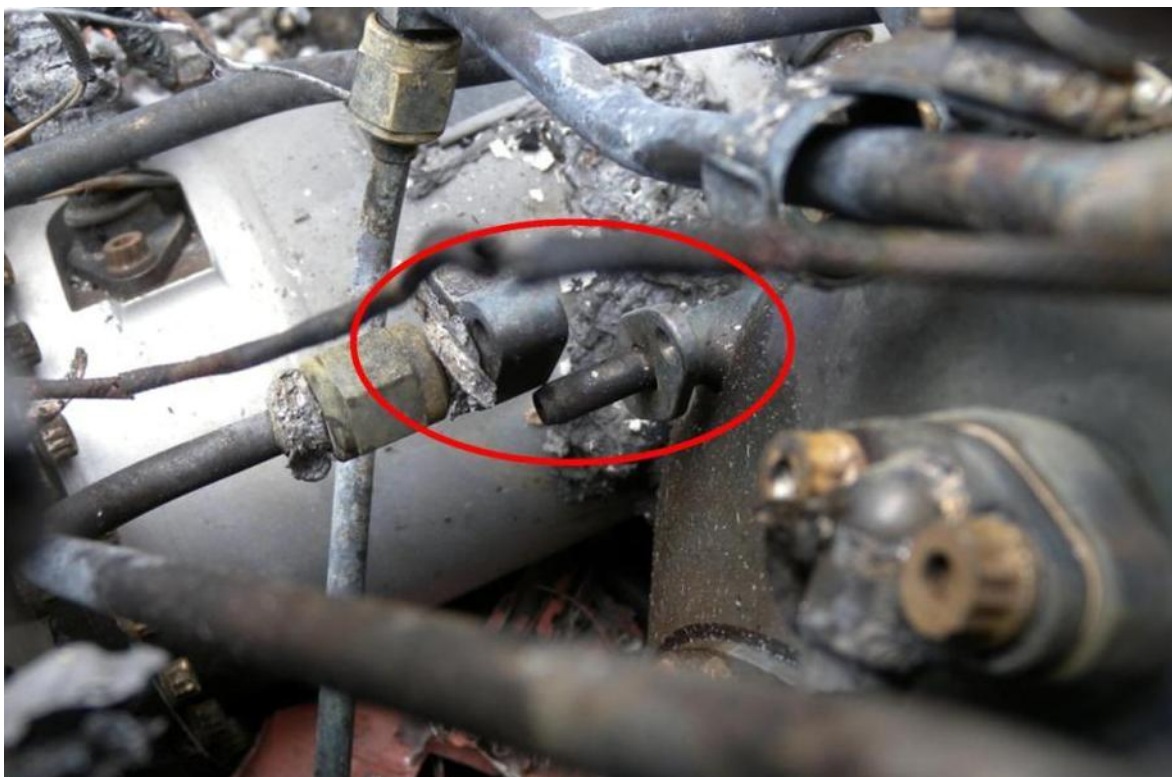
External examination of the engine at the accident site revealed that the fuel inlet union, located on the lower right-hand-side of the engine, had become detached from the boss on the compressor case. (Figure 7) The fuel supply line remained attached to the union and to the hydro-mechanical unit (HMU). The intermediate gasket was located in the fuselage debris,

directly below the union. The remaining wreckage and ground area were extensively examined utilizing a series of magnets and sifting grates, but did not reveal the presence of the two five-point bolts and self locking nuts for mounting the union to the compressor case flange.

Figure 7: Photo of fuel union and compressor case as found at accident site. The nipple is in the center of the image, protruding from the compressor case on the right. The fuel union is separate from the flange and to the left of center.

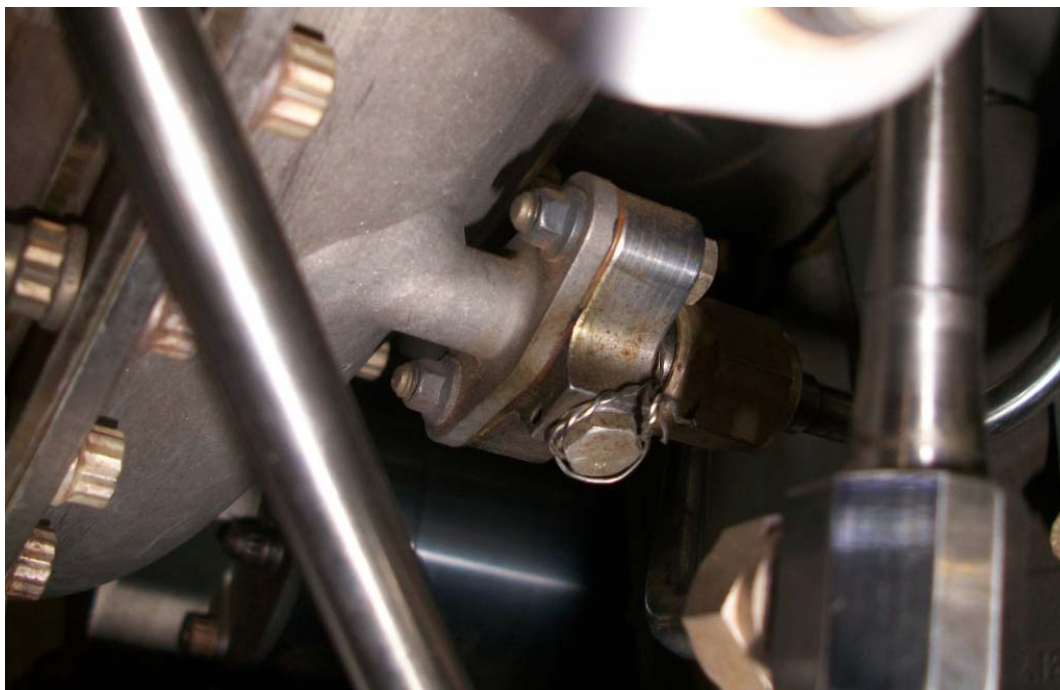
Figure 10: Photo of exemplar installation of fuel union at the compressor case. Note about 1 1/2 threads visible on exposed bolt heads.

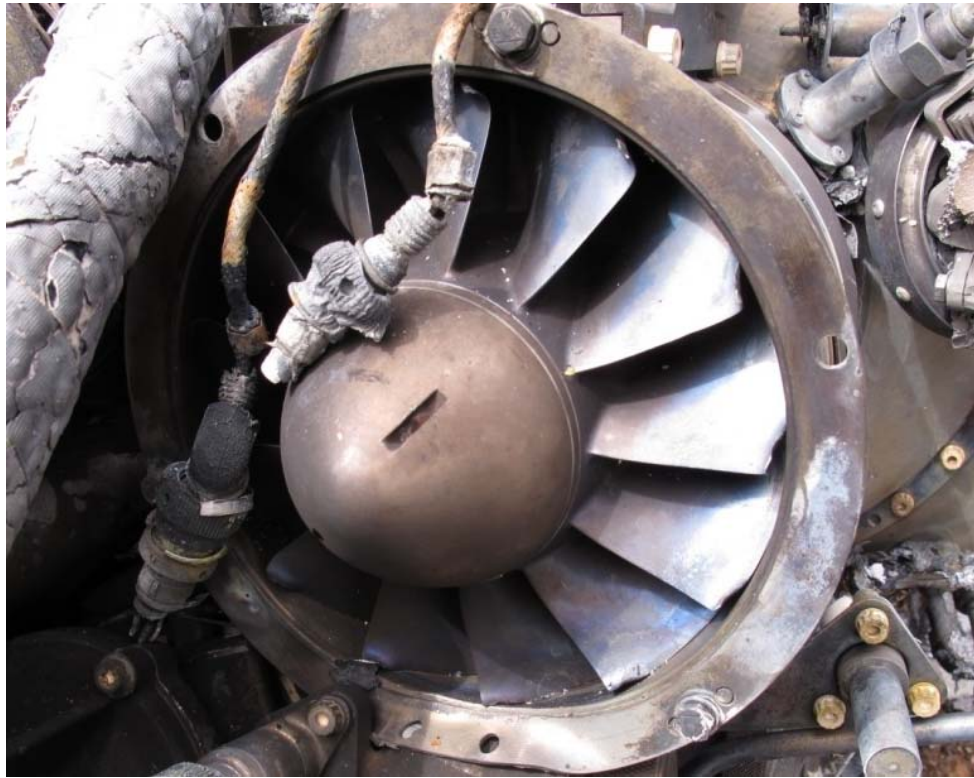
The reduction gearbox (module 5) was removed from the engine to facilitate examination. Gearbox drive continuity was confirmed from the input to the output shaft, through hand rotation. The axial compressor casing sustained crush damage to the lower lip of the inlet flange. (Figure 11) Corresponding damage was observed on the tips of the axial compressor wheel around its full circumference. The power turbine wheels were intact; and could be rotated smoothly by hand.

Figure 11: Photo of axial compressor and casing

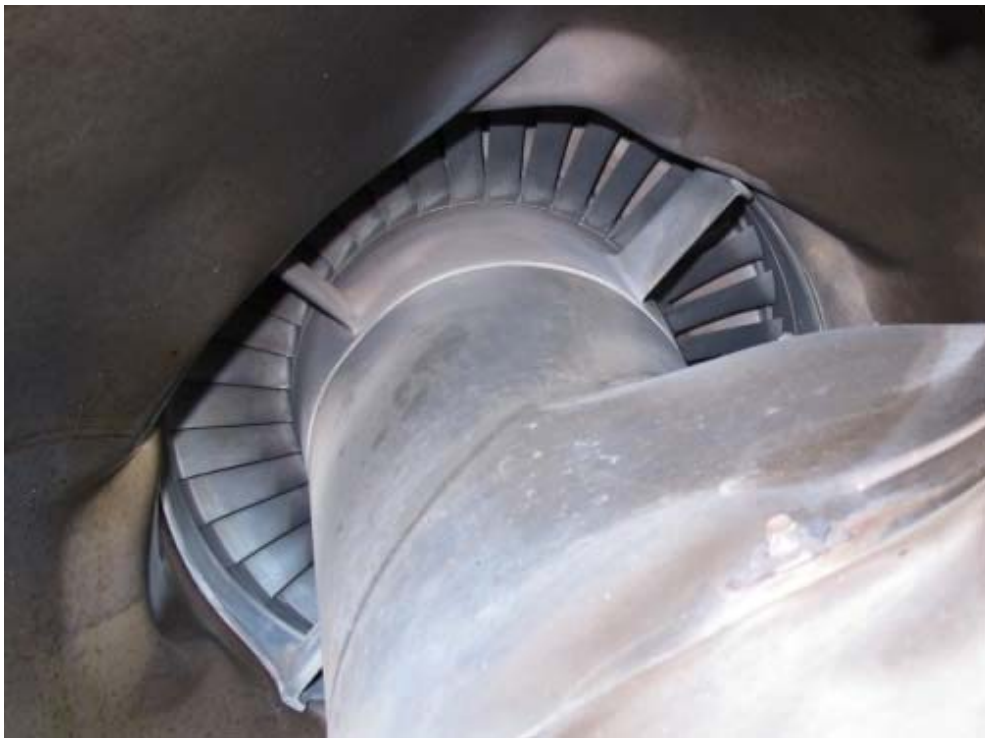
The power turbine blades were intact, exhibited no obvious indications of damage when observed through the exhaust stack, and could be rotated. (Figure 12) The gearbox input power shaft was rotated, with a corresponding smooth rotation of output shaft. Rotation of the entire gas generator assembly revealed continuity through to the pad outlets on the accessory gearbox.

Figure 12: Photo the of power turbine blades viewed through the exhaust pipe

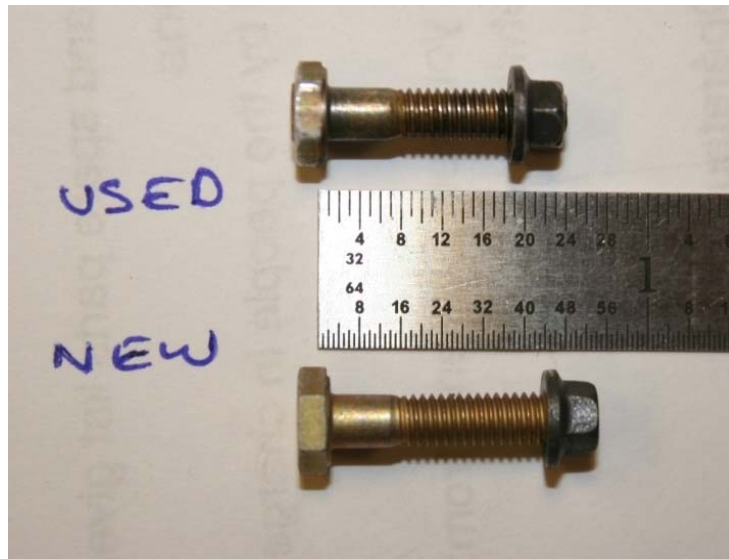
The group examined comparative dimensions for new and used union nuts and bolts¹. The results revealed that when tightened by hand, a new bolt would engage about two threads into the nut before friction was felt, resulting in an exposed bolt shank length of about 17 millimeters. By comparison, a used nut and bolt were similarly tightened, resulting in an exposed bolt shank length of about 13.5 millimeters. (Figure 13) The threaded end of the used bolt was also observed to extend beyond the end of the nut by about half a thread. Comparative dimensions taken from an exemplar engine installation revealed that with the nuts and bolts installed and tightened to the specified torque on the union flange, approximately 1.5 threads were exposed beyond the nut, resulting in a bolt shank length of about 13 millimeters. (Figure 13)

Figure 13: Photo of new and used union attachment nuts and bolts, with the nuts tightened by hand.
