NATIONAL TRANSPORTATION SAFETY BOARD
Office of Aviation Safety
Washington, DC 20594

AIRWORTHINESS GROUP CHAIRMAN'S FACTUAL REPORT

A. **ACCIDENT**

Operator : SK Logistics d.b.a SK Jets
Aircraft : Bell Helicopter 206BIII [N5061M]
Location : Green Cove Springs, FL
Date : December 26, 2011
Time : 0554 EST
NTSB # : ERA12MA122

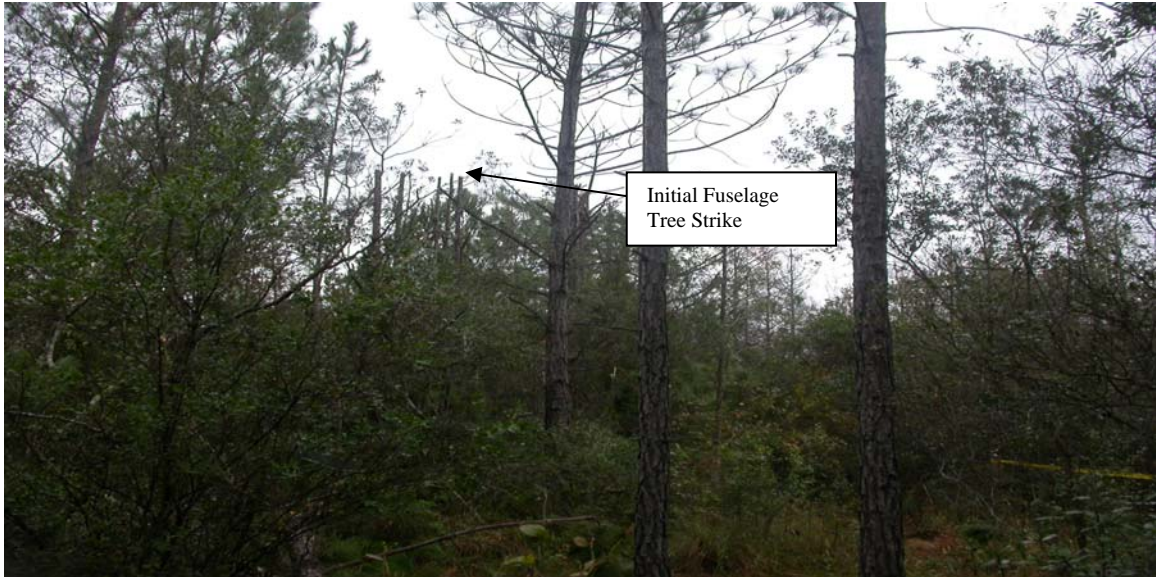
The wreckage was located in a sparsely populated pine tree forest area located in the vicinity of Green Cove Springs, Florida. The helicopter collided with a 50-foot tall tree at an estimated height of 30 feet above the ground, in a level attitude on a heading of 172 degrees magnetic, and the majority of the helicopter was consumed by a postcrash fire. The crash debris line (CDL) covered an area 320 feet long by 70 feet wide. From the initial tree strike to the final tree strike was about 175 feet. The cockpit and other items extended about 130 feet beyond the main crash site location. Pieces of the chin bubble and airframe skin was present along the CDL from the initial tree strike to the main wreckage. Numerous trees along the CDL were hit by the helicopter as it descended.

Photo1: Initial Tree Strike

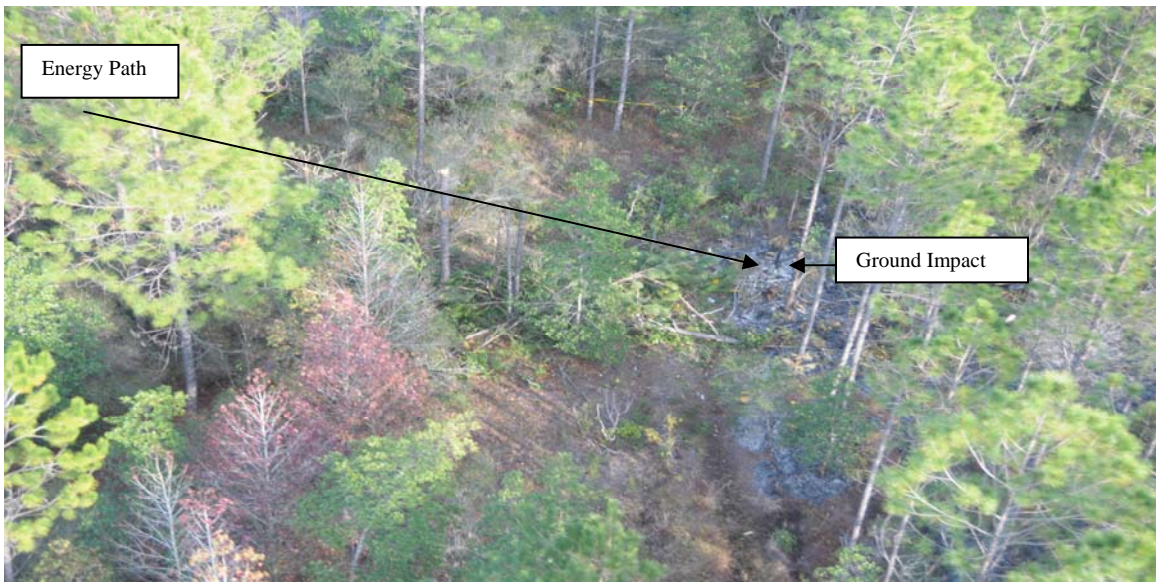
Photo 2: Descending Tree Strikes

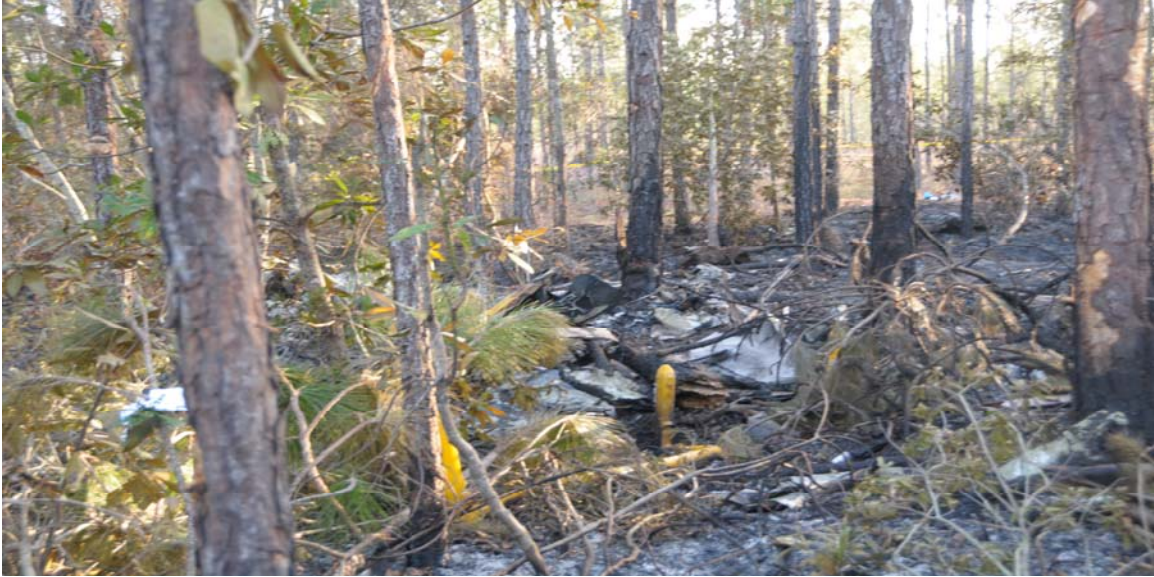
A large piece of the tail boom was located about 110 feet down the CDL along with the aft cross tube. The toe of the right main skid was located about 10 feet forward of the aft cross tube. Both rear cabin doors were located a few feet beyond the tail boom and right skid followed by the cockpit doors. All of the items were located within 10 feet of the CDL. The main rotor hub with about half of the main red rotor blade still attached was located 8 to 10 feet forward of the cockpit doors. One of the tail rotor blades was located 25 feet right of the CDL and 128 feet down the CDL. The tail rotor gear box and the vertical fin were to the left of the CDL and located 10 to 12 feet from the red main rotor blade. A few feet further, were the remnants of the fuel tank, one boost pump, and a fire extinguisher normally located in the cockpit area. Twelve feet further was the remainder of the helicopter laying on its left side with the nose section against a tree on a heading of 350 degrees magnetic. The flight controls were separated from the helicopter and were located beyond the main wreckage. The pilot

Photo 3: View of the Wreckage Debris

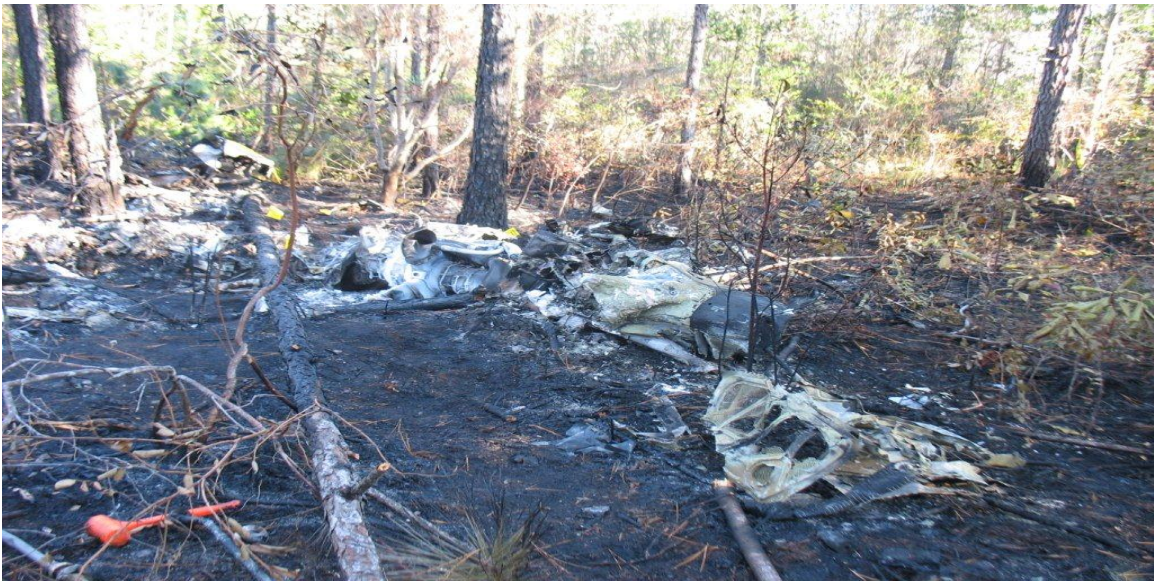
Photo 4: View of Wreckage Site

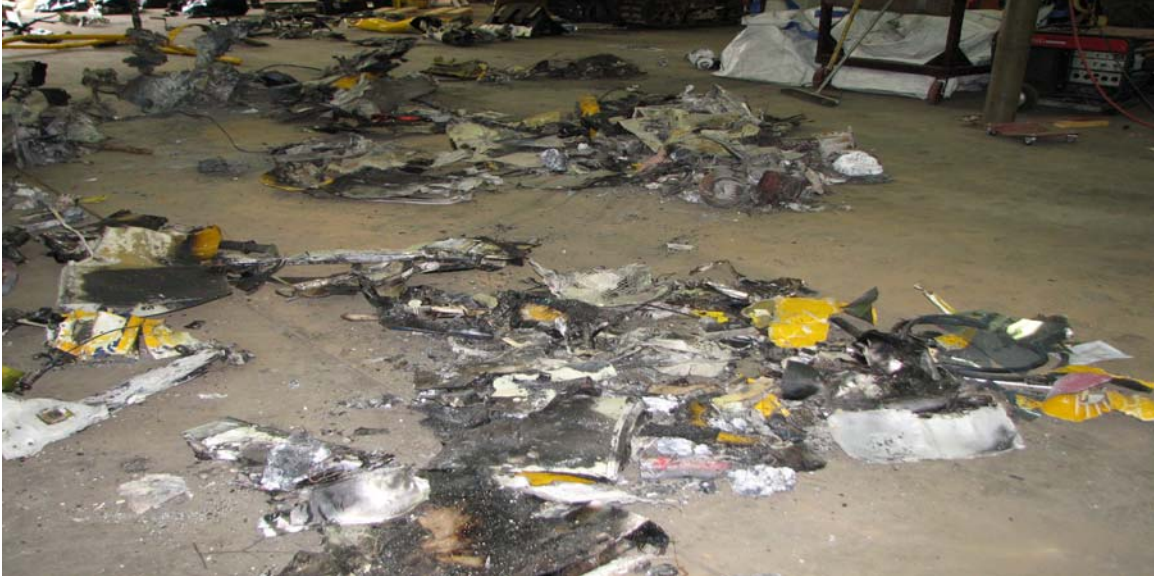
The majority of the airframe and the transmission was consumed by the postcrash fire. The center console and all instrument gauges were fire damaged. Fragments of windscreen, left and right chin bubble, and over head green house were located along the CDL. The forward and aft cabin seats and restraint systems were consumed by fire. Aft cabin doors were consumed by fire. Continuity of the flight controls could not be

confirmed due to the post crash fire. The cyclic and collective controls were separated along with the anti torque pedals. The pilot's anti torque pedals were located past the first piece of the tail boom. The copilot's ant torque pedals were located to the right and forward of the main wreckage. .

Photo 7: Remnants of the Fuselage and Cabin Areas

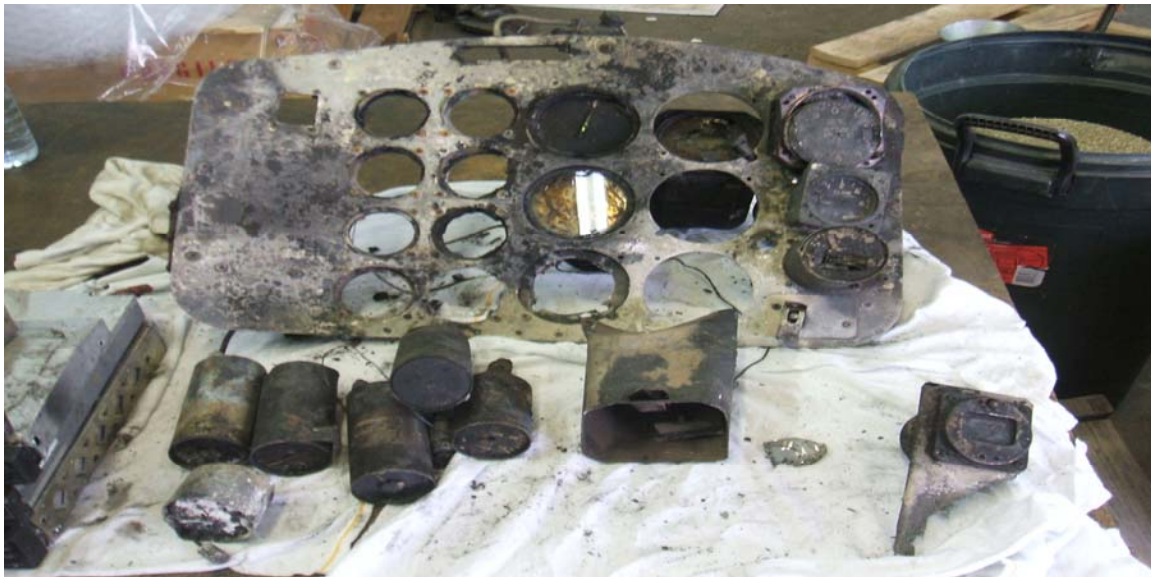
Tablet 1: Instruments		
Directional Gyro	Destroyed	-
Altimeter	Impact & Thermal Damaged	Baro Window at 30.22
Vertical Speed Indicator	Impact & Thermal Damaged	unreliable
Turn & Bank Indicator	Impact & Thermal Damaged	Left Turn
Attitude Indicator	Impact & Thermal Damaged	10 degrees nose above the horizon
Standby Compass	Impact & Thermal Damaged	unreadable
Main Rotor / Engine Speed RPM	Impact & Thermal Damaged	unreadable
Fuel Quantity Indicator	Impact & Thermal Damaged	unreliable
Engine Oil Pressure	Impact & Thermal Damaged	unreliable
Airspeed	Impact & Thermal	unreliable

Damaged	
Engine Temperature	Impact & Thermal Damaged	unreadable
% RPM Gas Producer	Impact & Thermal Damaged	14 percent
Turbine Out Temperature	Impact & Thermal Damaged	unreadable

Tablet 2: Navigation / Communication		
Intercom Control Unit	Impact & Thermal Damaged	Selector to Pilot ISO Position
Bendix/King, KMAA24H	Impact Damaged	Com 1 knob, HF Comm 1 & 2, Nav, & DME selected
King, KY 196 TSO, Radio Digital	Impact Damaged	Digital
Garmin GTX 328, Digital Transponder	Impact & Thermal Damaged	Digital
Garmin 430 GPS	Impact & Thermal Damaged	Digital

Photo 8: Instrument Panel

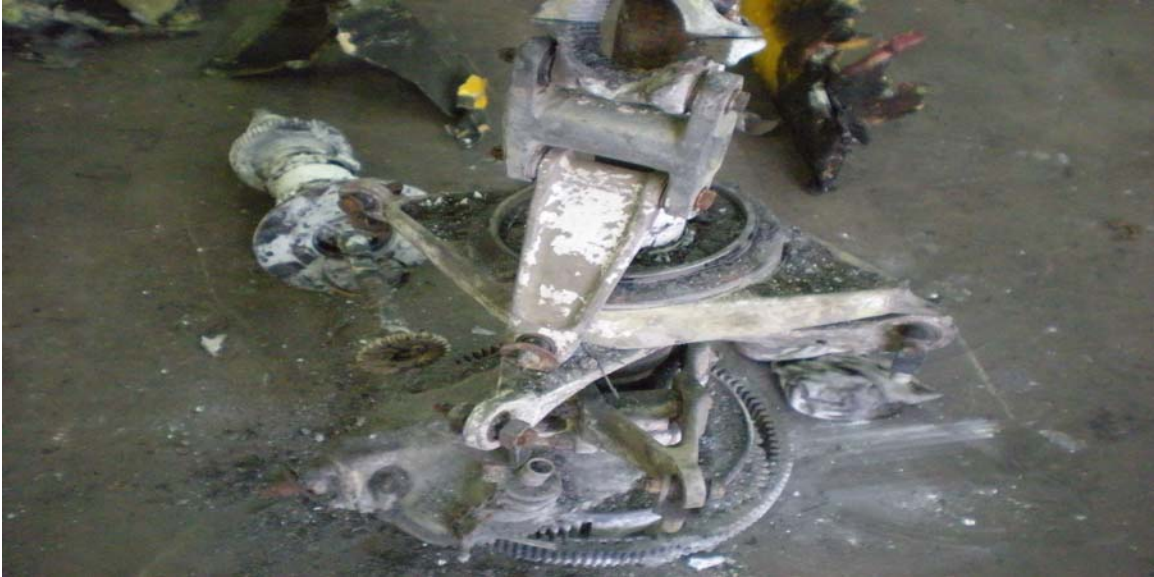
The majority of the transmission was consumed in the post crash fire, exposing the planetary gears, ring gears, and the sun gear.

Photo 9: Transmission Assembly

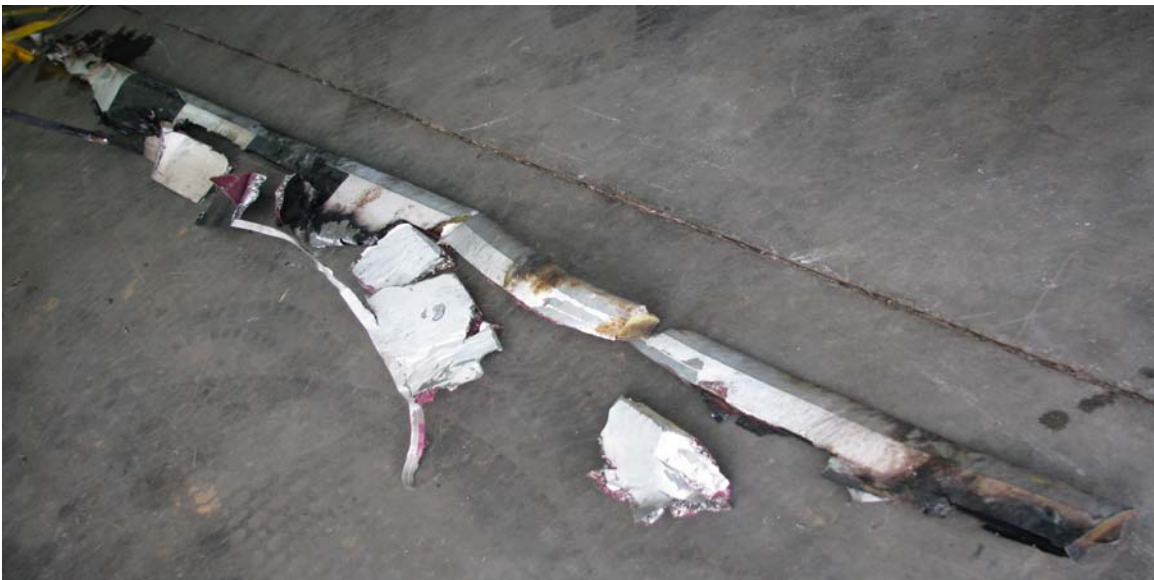
The main rotor blades were damaged and the main rotor hub remained attached to the red blade yoke. The red blade spar was separated into three sections and the leading edge exhibited bending. Yellow paint transfer marks were present near the tip of the rotor blade. The tip cap was intact.

Photo 10: Red Blade

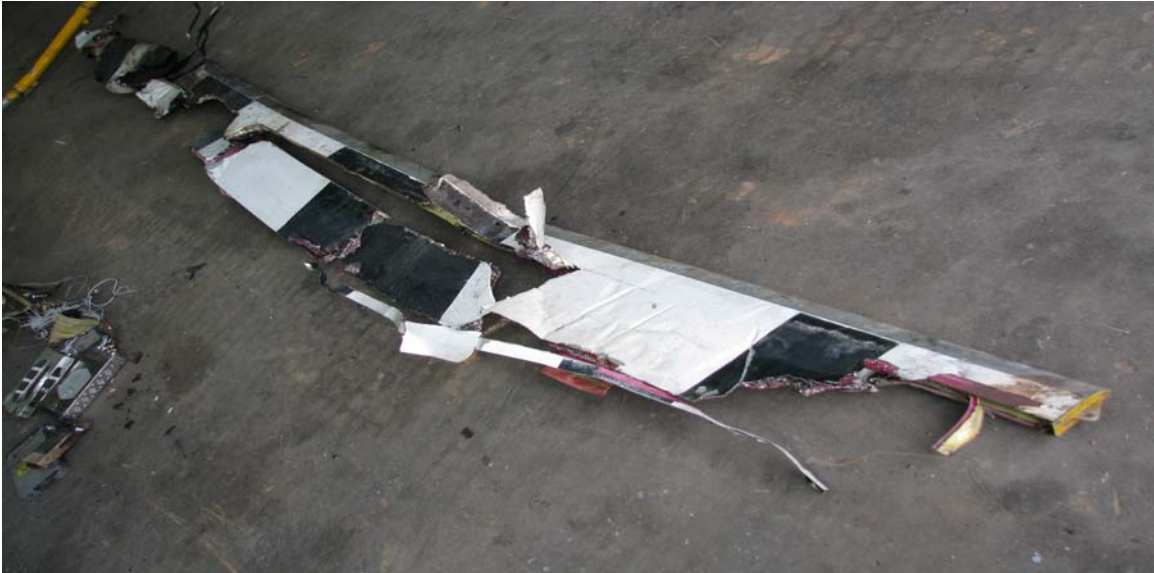
The white main rotor blade was damaged and exhibited yellow paint transfer about 4 feet from the rotor blade tip. The outboard 10 to 15 inches of the afterbody from the red and white main rotor blades separated from their blade spars, leaving a 45-degree tear where the sections attached.

Photo 11: White Blade

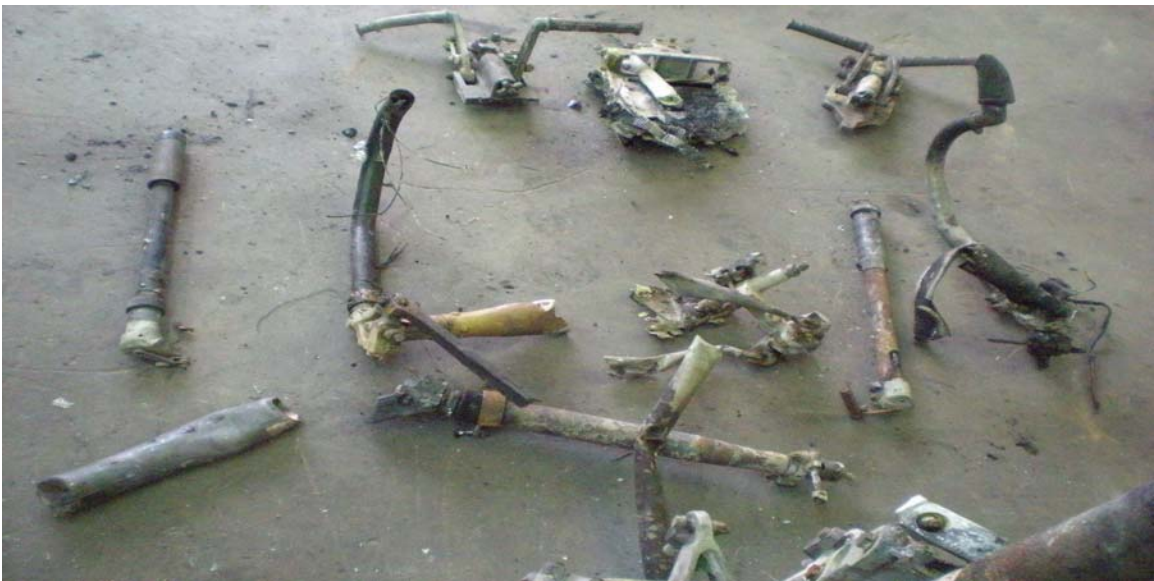
The collective pitch jack shaft was wrapped around a tree with the engine, transmission, and oil cooler, which extended beyond the tree on a heading of 170 degrees magnetic. The cyclic and collective controls were separated from the system along with the anti torque pedals, which were located forward past the first piece of the tail boom and the co-pilots tail rotor controls. The broom closet had been consumed by fire. All control tubes exhibited evidence consistent with overload failure and some tubes were also crushed. The pitch change links were broken off at the clevis and the swash plates were fused together.

Photo 12: Flight Controls

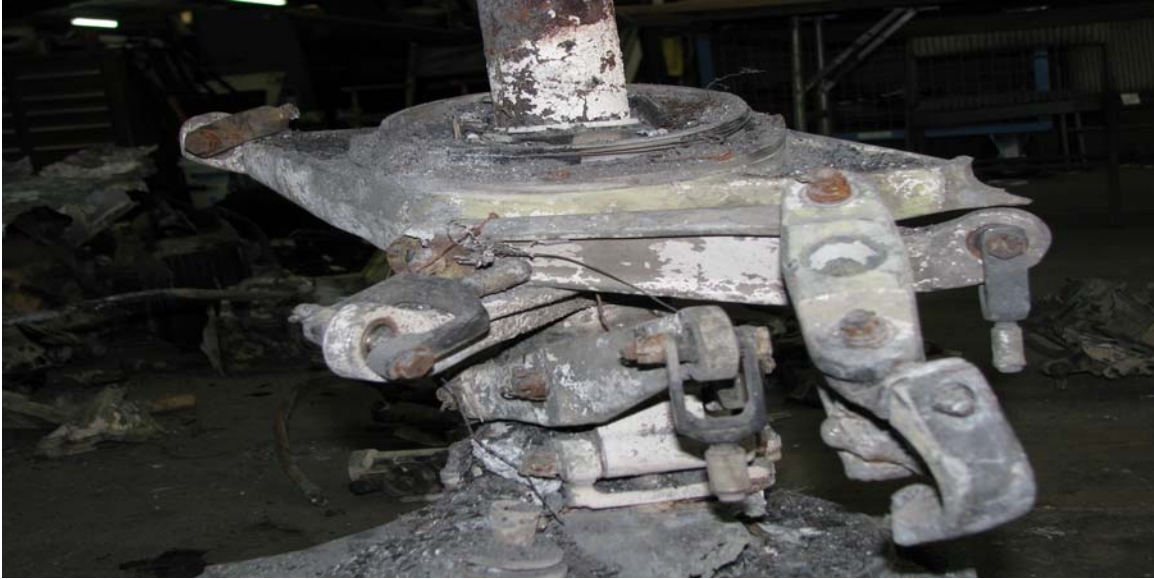
Photo 13: Swashplate Assembly

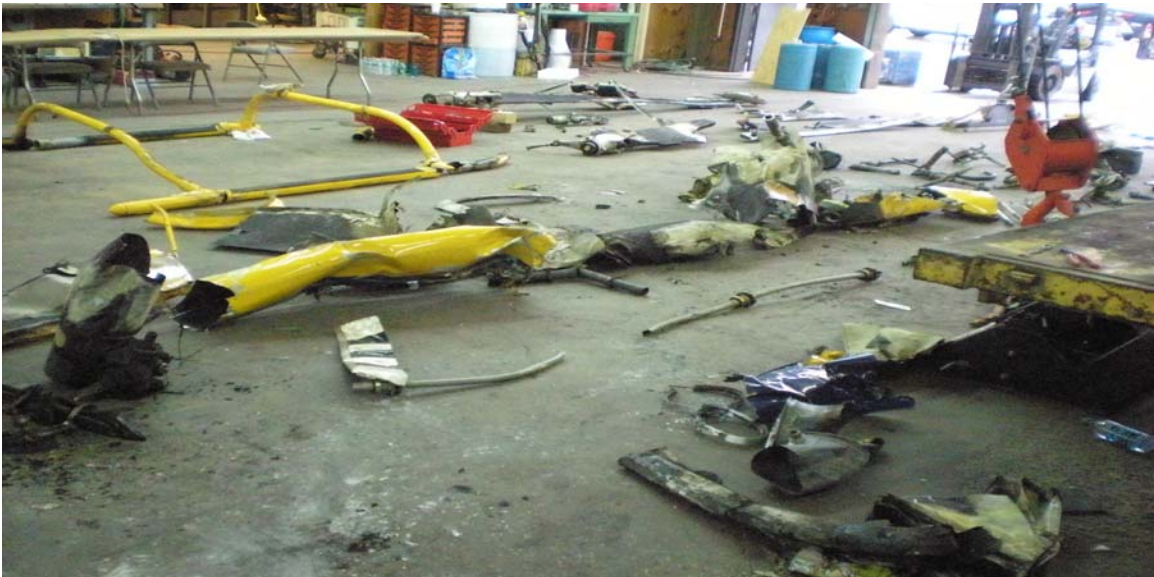
The majority of the tail boom was consumed by post crash fire and located next to the engine assembly. A torn section of the tailboom was located on the ground under trees along the CDL.

Photo 14: Tailboom

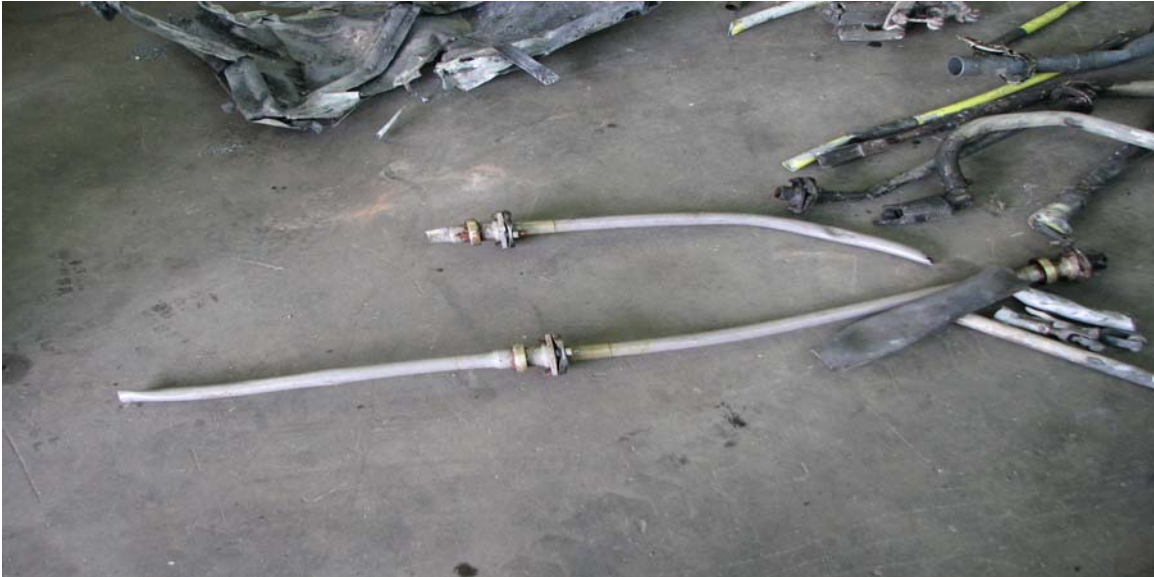
All tail rotor drive shaft segments with Thomas couplings extending reward from the short shaft to the 90-degree gear box separation. Some segments were not located and were probably consumed by the post crash fire. The remaining drive shaft segments

exhibited evidence of overload signatures. Both tail rotor blades separated from the 90-degree gear box and exhibited characteristics consistent with low speed at impact.

Photo 15: Tail Drive Shaft

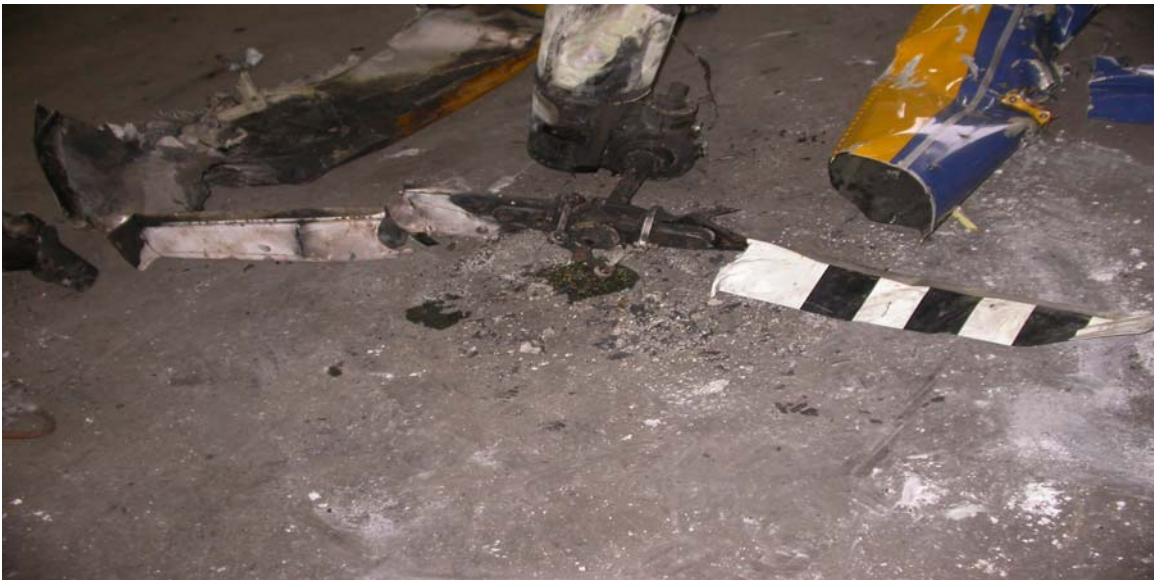
Photo 16: Tail Rotor Assembly

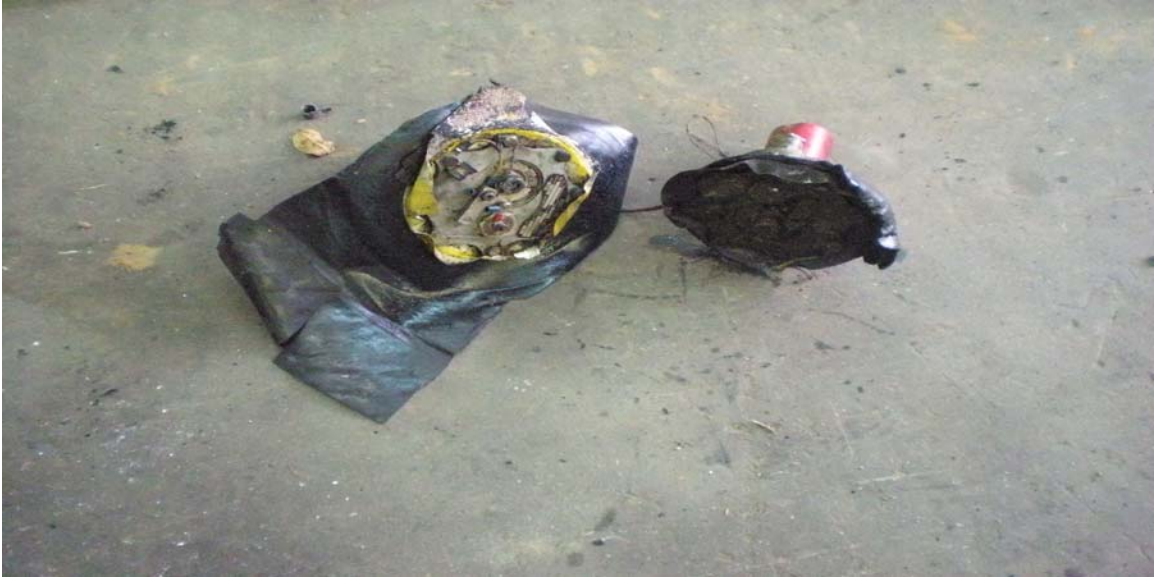
Both fuel boost pumps were recovered along with remnants of the fuel bladder and the goose neck from the extended fuel tank. The fuel filler cap was located and was secured in the locked position. Remnants of the three hydraulic servo actuators were located. The actuators positions were unreadable due to thermal damage. The respective connecting bolts, with cotter keys, were in their respective location. The hydraulic fluid filter was observed with heat exposure.

Photo 17: Fuel Boost Pumps and Remnants of Fuel Bladder

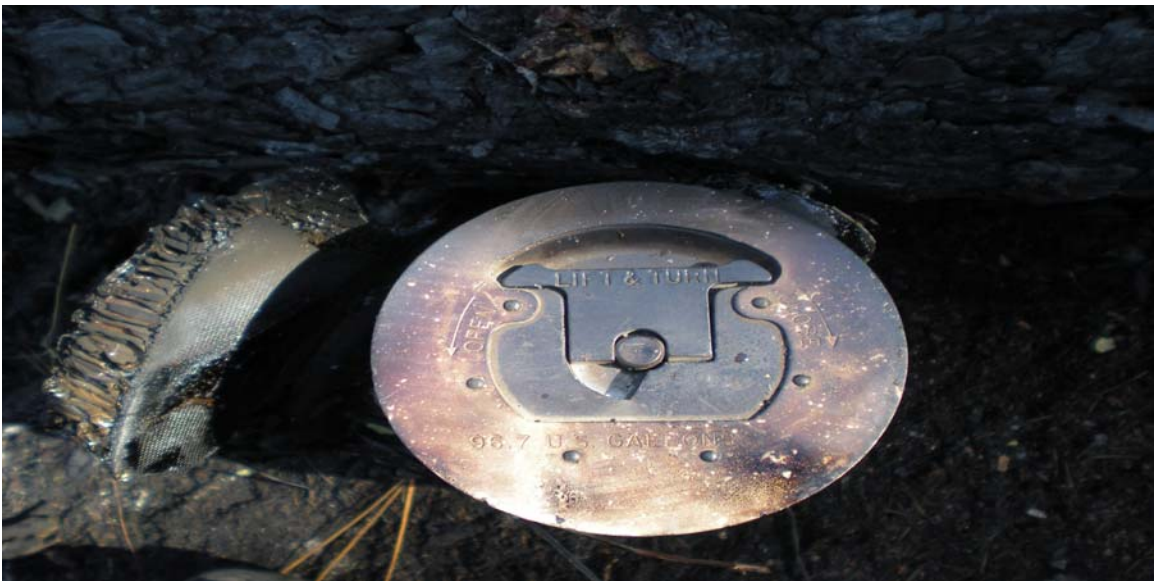
Photo 18: Fuel Filler Cap

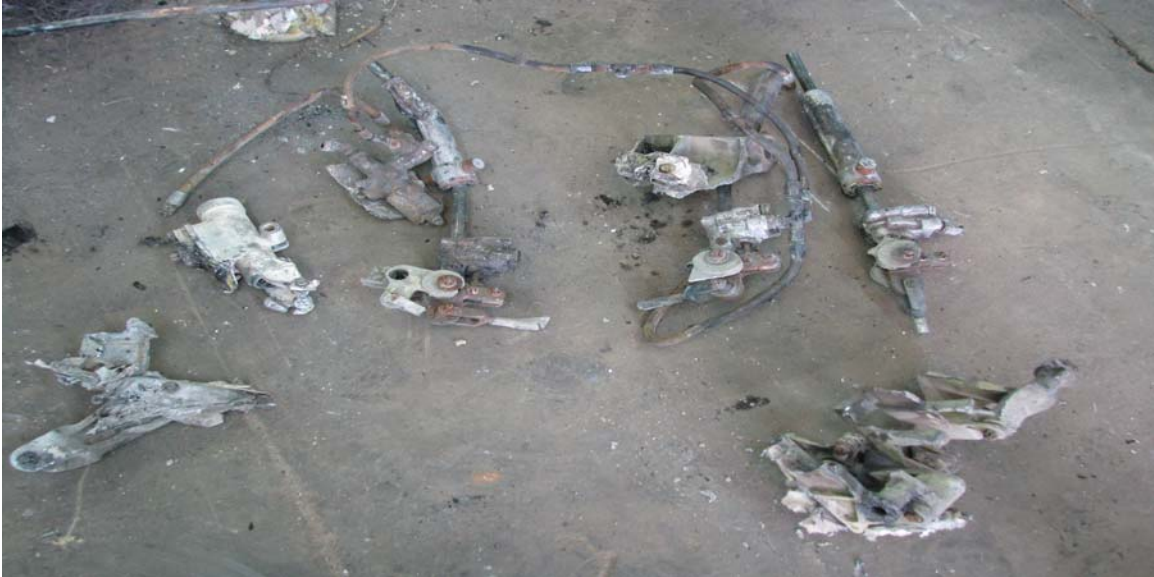
Photo 19: Hydraulic Servo Actuators

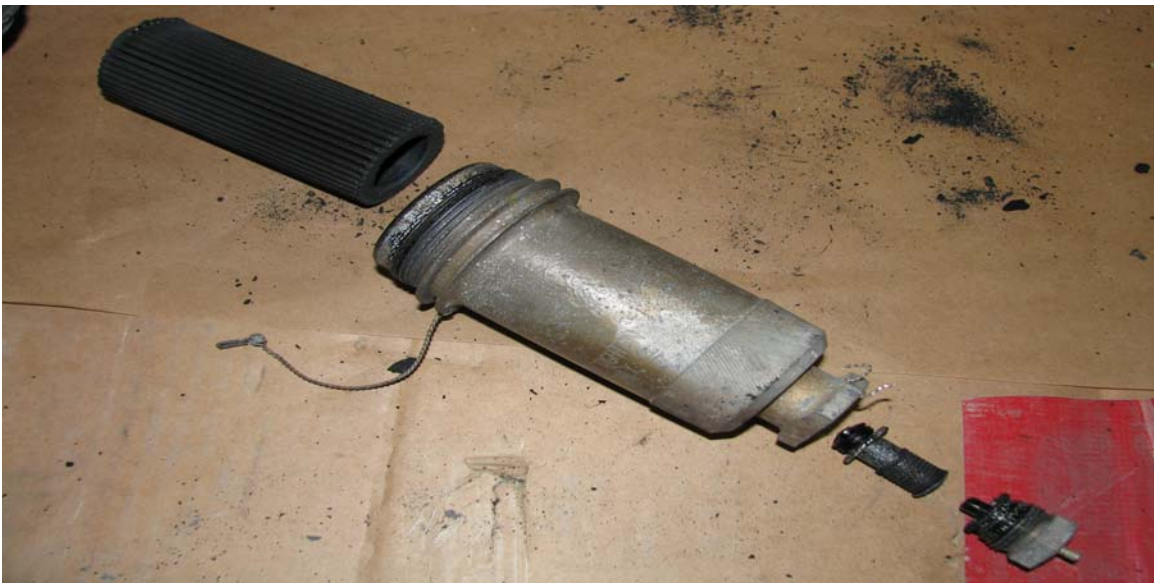
Photo 20: Hydraulic Fluid Filter

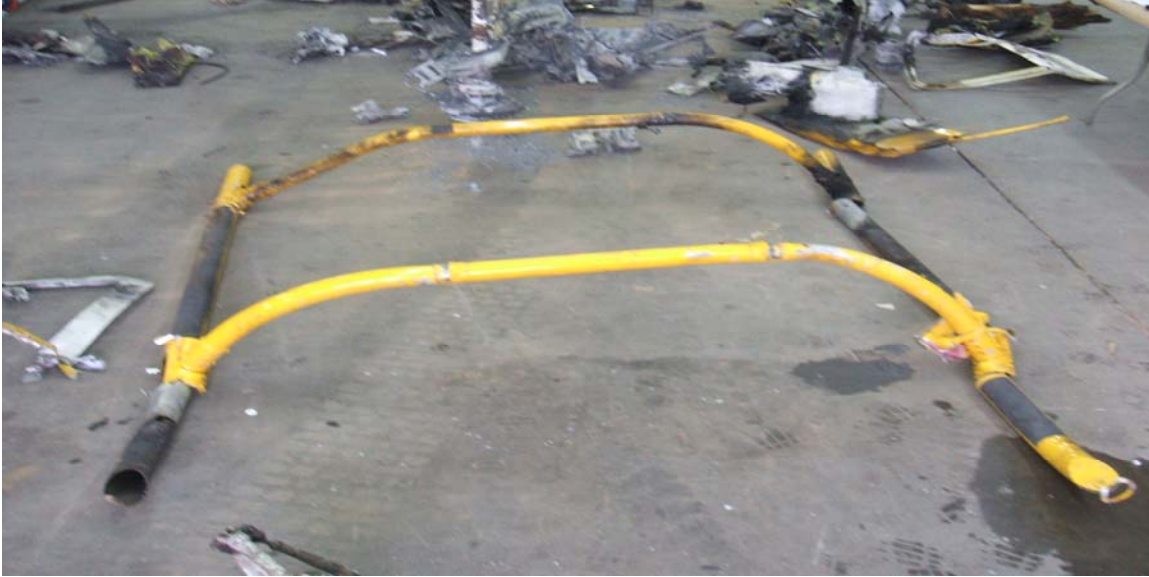
The right landing gear skid tube was spread out with both forward saddles toed-in and having a downward vector. Both toes separated at the rivet line forward of the forward cross tube. The forward cross tube was cantered aft. Both skid tubes separated from the landing gear assembly at the aft rivet line of the forward saddle and from the forward rivet line of the aft saddle. The heels remained attached to the aft saddles and aft cross tube. The aft cross tube was bent aft.

Photo 21: Main Landing Skid System.

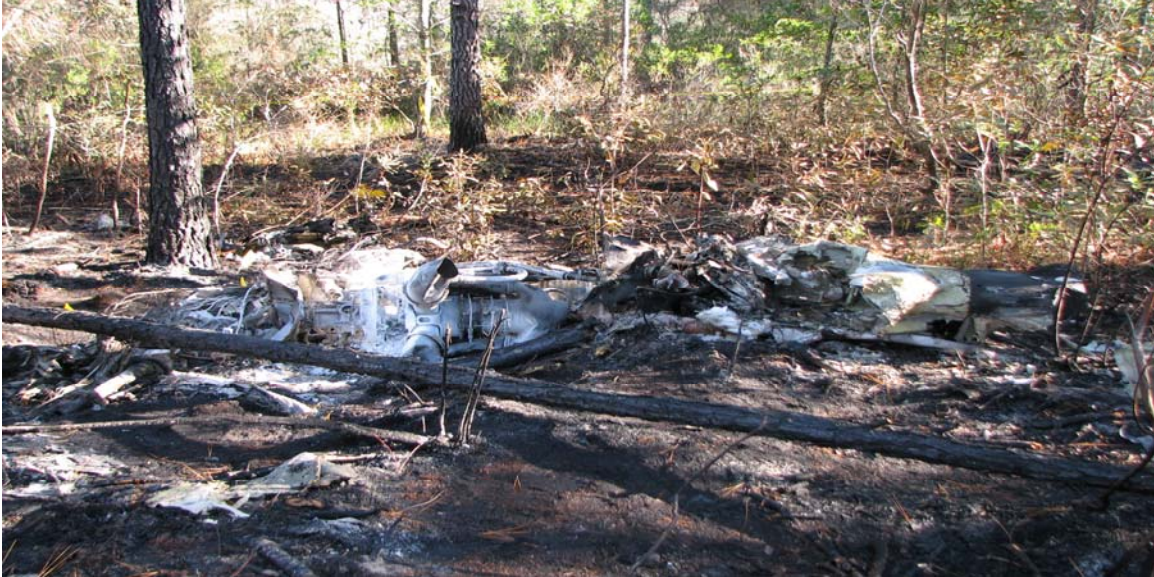
The engine was located approximately 170 feet downstream in the debris field, was oriented in a northerly facing direction and was positioned on its left side. The engine was fire damaged. The accessory gear box had been consumed by fire. All engine fuel, oil and pneumatic lines had sustained damaged. The compressor remained in position supported by the left and right side compressor air discharge tubes and the spur adapter gear shaft. The bleed valve had been consumed by fire. The compressor inlet guide vanes were crushed. The first stage compressor blades and second stage stator vanes revealed no visible damage. The compressor scroll remained in position and had burned through near the left shoulder area. Both left and right side compressor air discharge tubes were in position and properly seated. The right side air tube appeared normal while the left side exhibited crushed and burn damage along its length. The exhaust collector remained in position with no visible external impact damage. Both exhaust stacks remained attached to the exhaust collector with the left side displaying crush damage and the right side displaying both crush and tearing damage. The turbine module remained in position. The thermocouple harness remained in position as did the No. 6/7 bearing external oil sump can. The outer combustion case was in position and displayed denting to the dome and top areas. A puncture hole was present just forward of the left shoulder area. The fuel nozzle and igniter were both in position. The fuel control unit was present and supported only by remaining tubing with the mounting flange. The forward portion of the housing had burned away. The power turbine governor, fuel pump and oil pump were consumed by fire.

Photo 22: Engine at Accident Site
