**NATIONAL TRANSPORTATION SAFETY BOARD**

**AIRWORTHINESS GROUP CHAIRMANS' FACTUAL REPORT**

**A. ACCIDENT: DCA17FA109**

Operator: Air Cargo Carriers flight 1260  
Location: Charleston, West Virginia  
Date: May 5, 2017  
Time: 0651 EDT  
Aircraft: Short Brothers Ltd. SD3-30 Variant 200  
Registration: N334AC  
Serial Number: SH-3029

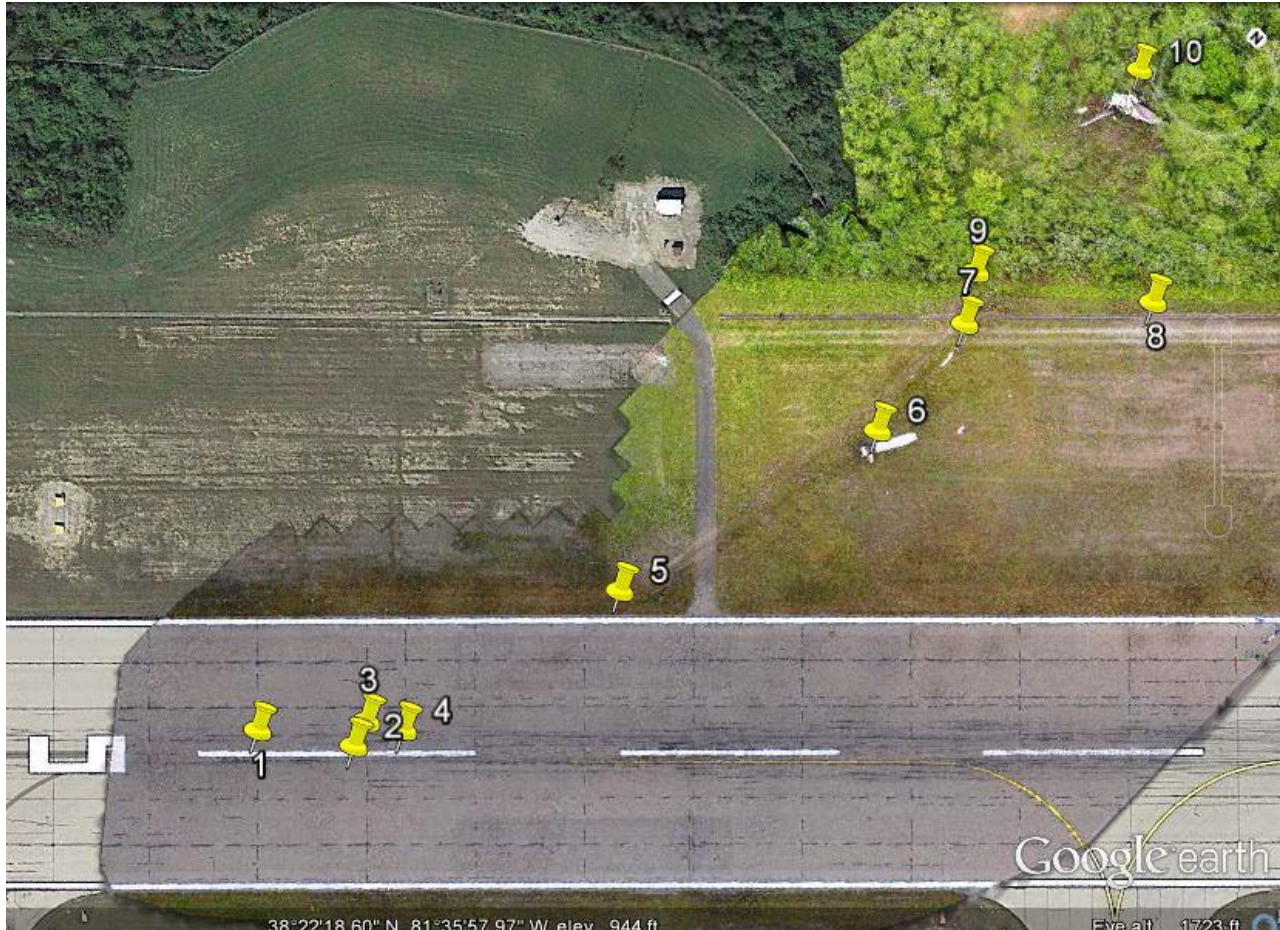
Figure 4: Accident Site Overview and Points of Interest

The airplane impacted the runway at the centerline, exited the left side of the runway, traveled through the runway safety area, and went down a steep tree-covered slope before coming to rest (Figure 4). The first ground scar originated about 29 ft-6 in from the start of the centerline stripe and directly on the centerline seam. It was about 3.5 in wide and 16ft-4 in long, and oriented on a heading of about 16° when overlaid on Google Earth. Proceeding along the centerline, the next witness mark was a black scuff mark that originated about 82 ft-9 in from the start of the centerline stripe, and about 8 ft-6 in to the right of the centerline seam. This black mark was oriented on a heading of about 15°, and transitioned into a deep gouge as it crossed the runway centerline. The next witness mark was the first of 14 parallel marks consistent with propeller strikes. It was located about 89 ft-2 in from the start of the centerline stripe and about 4 ft-9 in to the left of the centerline seam. The first two strikes were about 16 in apart and the path of consecutive strikes was on a heading of about 27°. The last prop strike was a small chunk of missing pavement located about 108 ft-7 in from the start of the centerline stripe and about 11 ft-2 in to the left of the centerline seam.

Continuing along the centerline, there was an area of runway scarring, about 18 feet wide, that crossed the centerline seam. The first witness mark from this area was a scuff located about 93 feet from the start of the centerline stripe. There was a deep gouge, about 9 in wide, located about 95 feet-11 in from the start of the centerline stripe. A smaller gouge was located about 3 feet further down the centerline (as measured from the two closest edges of the gouges). The last witness mark from this area was heavy scuffing, about 11 in wide, with the far edge located about 111 ft from the start of the centerline stripe. This witness mark trail widened as it continued on a heading of about 14° to the edge of the runway, through the runway safety area, and to the edge of a steep drop off. The edge of the drop off was located about 178 ft from the left edge of runway 5.

1. Start of First Ground Scar on Centerline
2. First Black Scuff Mark to Right of Centerline
3. First Prop Strike
4. Far Edge of Last Heavy Scuff Mark on Centerline
5. Runway Departure Point
6. Left Wing and Engine
7. Left Landing Gear and Strut
8. Left Landing Gear Shock Absorber
9. Runway Safety Area Departure Point and Start of Drop Off
10. Main Wreckage Location

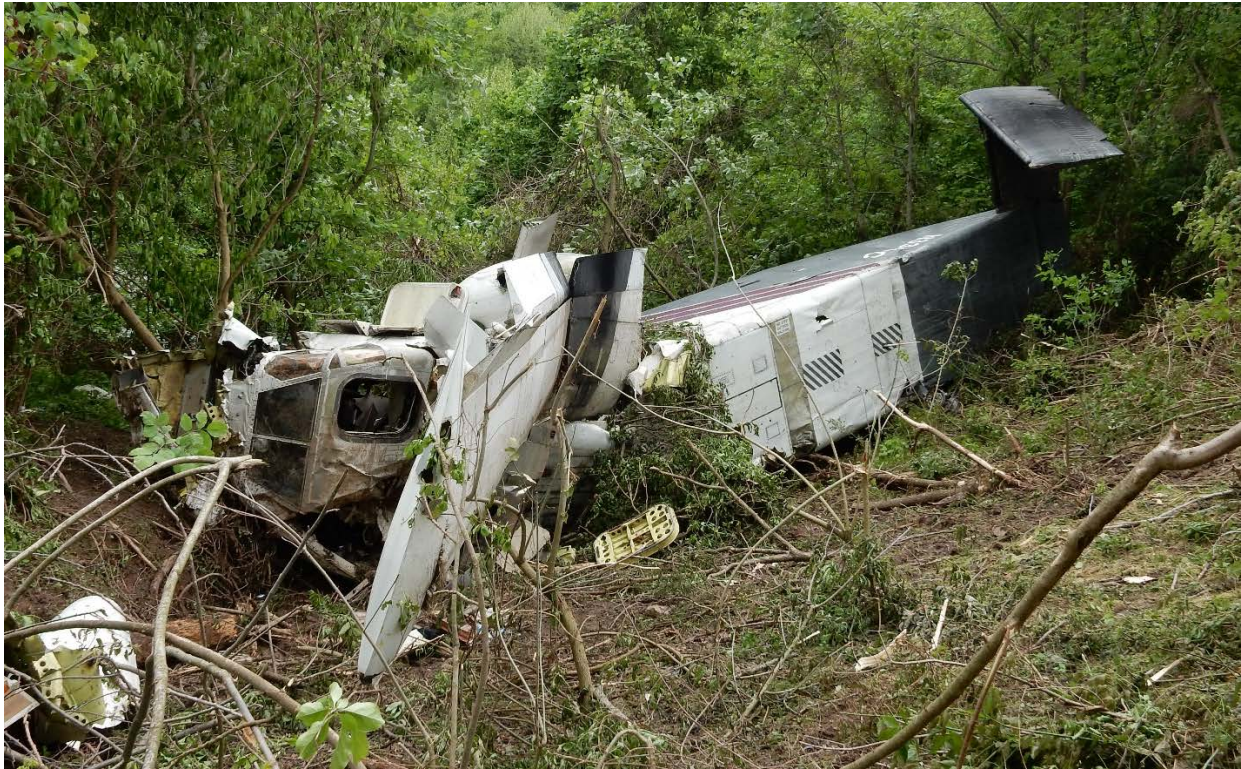
Figure 5: Main Wreckage

The fuselage was resting on its left side with significant crushing damage and deformation noted forward of the location of the main landing gear (Figure 5). There was no evidence of fire on any of the wreckage or surrounding vegetation. The cockpit area was crushed and damaged on the left side. The nose structure and radome were separated from the fuselage near fuselage station (FS) 0 and recovered about 20 feet forward of the fuselage. The radome was essentially undamaged. There was a fracture in the fuselage along the lower right corner between about FS 89 and FS 250, and the fuselage was distorted and buckled throughout this area. The nose and right main landing gear remained attached and were in an extended position. The right stub wing, right main landing gear, and a portion of the right strut remained attached to the fuselage with little apparent damage. In the center wing area, both tie rods that couple the left flaps cable quadrant to the right flaps cable quadrant were intact and secure. Following aircraft recovery, it was noted that the flaps springpot was severed at the left side eye-end and that a control cable connected to the forward quadrant of the flaps input duplicated quadrant was broken. It was also observed that the left inner flap actuator chrome extension measured 3-1/8 in from the housing to the center of the attachment bolt and the right inner flap actuator chrome extension measured 3-3/8 in from the housing to the center of the attachment bolt. A discolored outline of the right inner flap surface was found on the right side of the fuselage corresponding with a flaps position of about 35°.

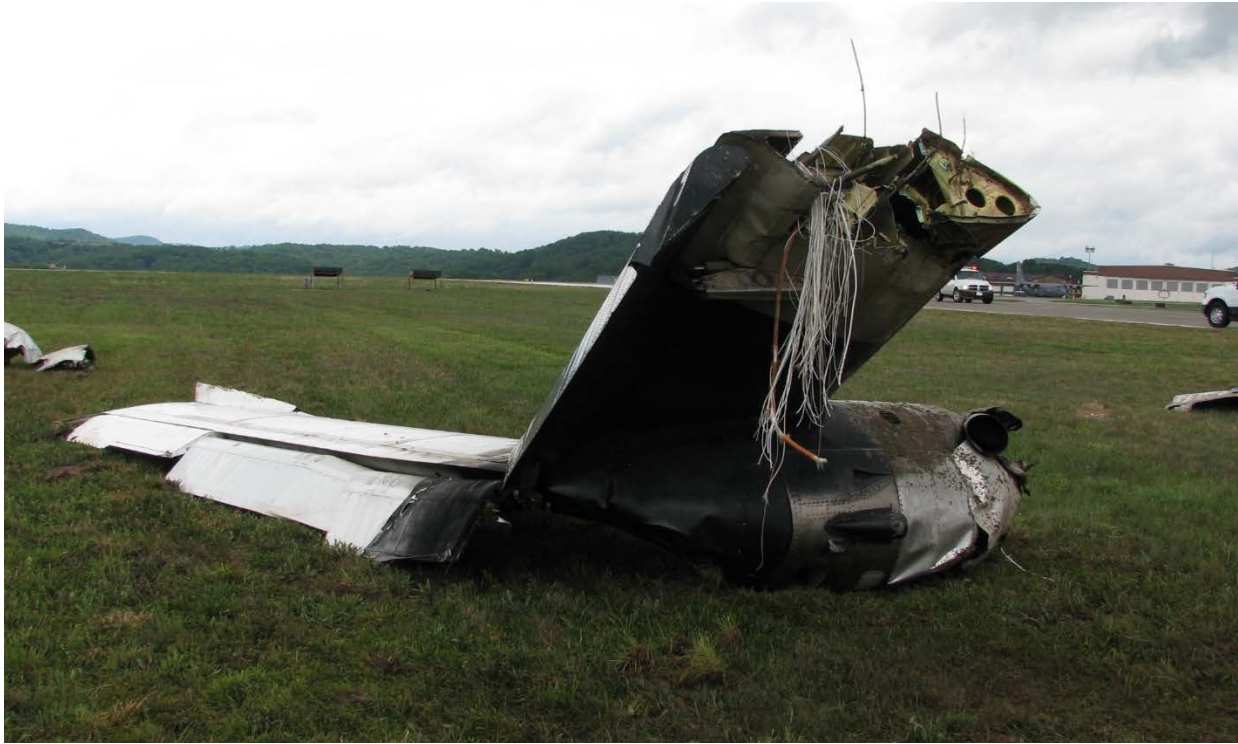
Figure 6: Left Wing and Engine

The left wing was separated from the aircraft and found along the debris path in the runway safety area on the left side of runway 5 (Figure 6). The left wing was mostly intact with all three flaps, the aileron, a portion of the wing strut, and the engine still attached. The left propeller and reduction gearbox were fractured from the left engine. The wing separated at the side-of-body near wing station (WS) 45. The outboard left wing forward and aft spar attach pins were intact. The inboard left wing forward and rear spar attach point structure was torn from the wing and remained with the fuselage. The upper 4 feet of the left wing strut remained attached to the wing. The wing was free to move about the hinge point at WS 140.75. The inboard left wing was resting on the engine nacelle and the outboard left wing was resting on the lower surface such that the inboard wing was rotated up about the hinge point. The fairings around the hinge point were damaged consistent with the wing position. The forward end of the left wingtip fairing and strobe light were separated and the outboard portion of the wing leading edge was crushed rearward from about WS 343 to the tip. There was mud, dirt, and grass on and embedded in the leading edge and wing tip. The inboard aileron counterweight remained attached to the left aileron but the outboard aileron counterweight was separated from the aileron hinge.

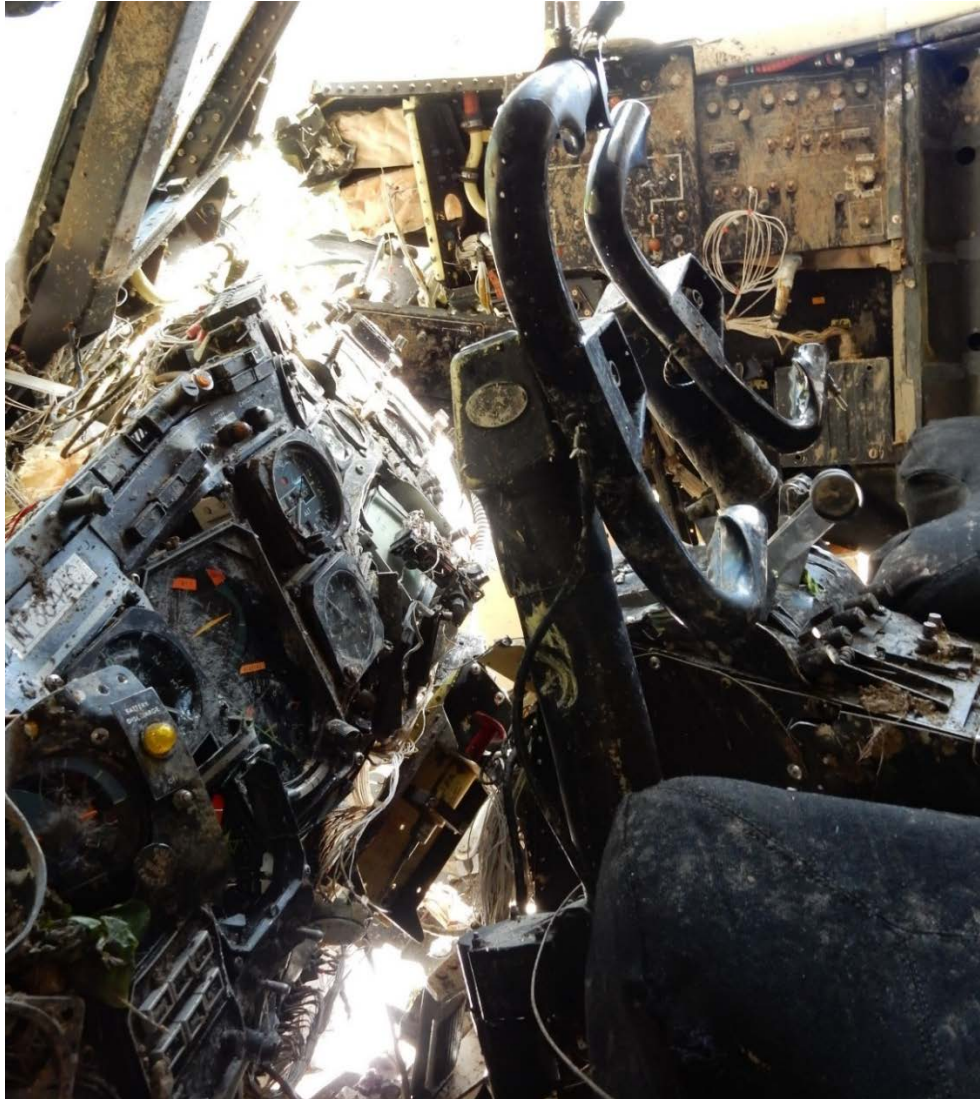
Figure 7: Flight Deck

The flight deck was damaged and distorted (Figure 7). The following observations were documented prior to aircraft recovery unless otherwise stated. It should be noted that emergency responders and investigators accessed the flight deck prior to the Airworthiness Group's documentation, and that it is possible that switches or levers were unintentionally moved at that time.
