**NATIONAL TRANSPORTATION SAFETY BOARD**  
**Office of Aviation Safety**  
**Washington, D.C. 20594**

**AIRWORTHINESS GROUP CHAIRMAN'S FACTUAL REPORT**

**NTSB No: ERA18MA099**

Operator: Liberty Helicopters, Inc.  
Aircraft: Airbus Helicopters AS350 B2, Registration N350LH  
Location: New York, New York  
Date: March 11, 2018  
Time: 1908 eastern daylight time

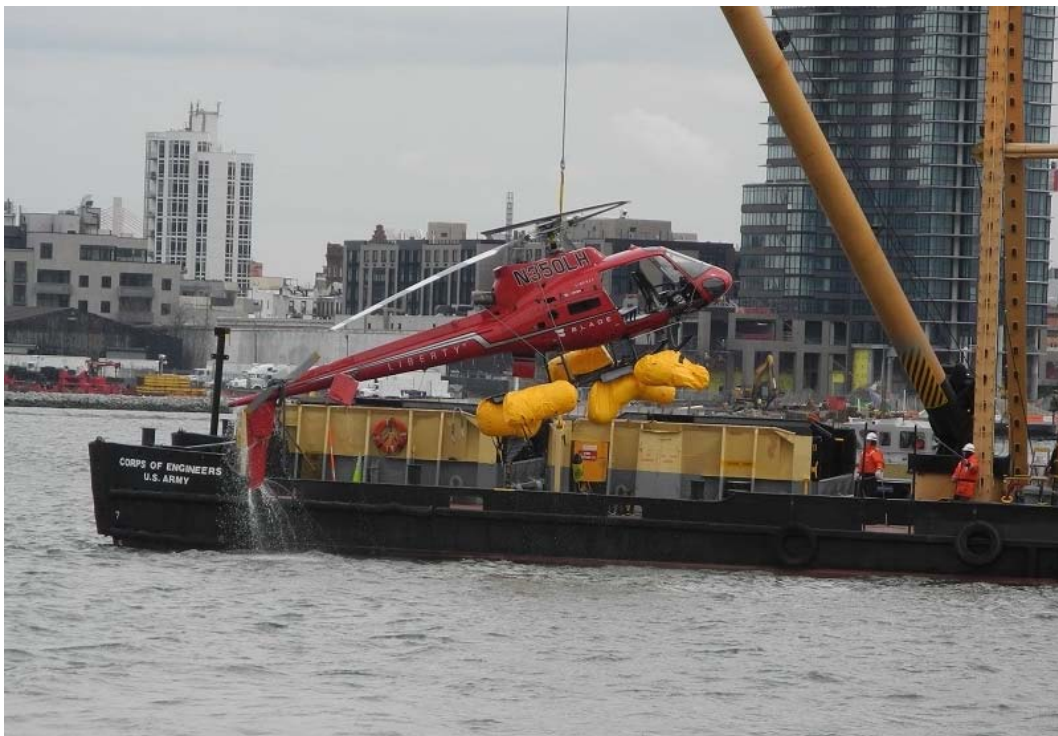
On March 12, 2018, members of the Airworthiness Group convened at the East 23<sup>rd</sup> Street Pier in Manhattan, NY. The wreckage was submerged and inverted in the East River, with only the emergency floatation system visible above the water. The wreckage was tethered to the pier by first responders. A fairing, later determined to originate from the underside of the helicopter, was recovered by first responders, and was on the pier before the Airworthiness Group arrived on scene. The wreckage was recovered (**Figure 1**) and relocated to the New York Police Department (NYPD) Aviation Unit hangar at Floyd Bennett Field in Brooklyn, NY. On March 13-15, 2018, members of the Airworthiness Group convened at the NYPD Aviation Unit hangar to document the recovered wreckage. Unless otherwise noted, all observations were recorded after the helicopter was recovered and relocated to the NYPD Aviation Unit hangar.

**Figure 1. The accident helicopter recovered from the East River.**

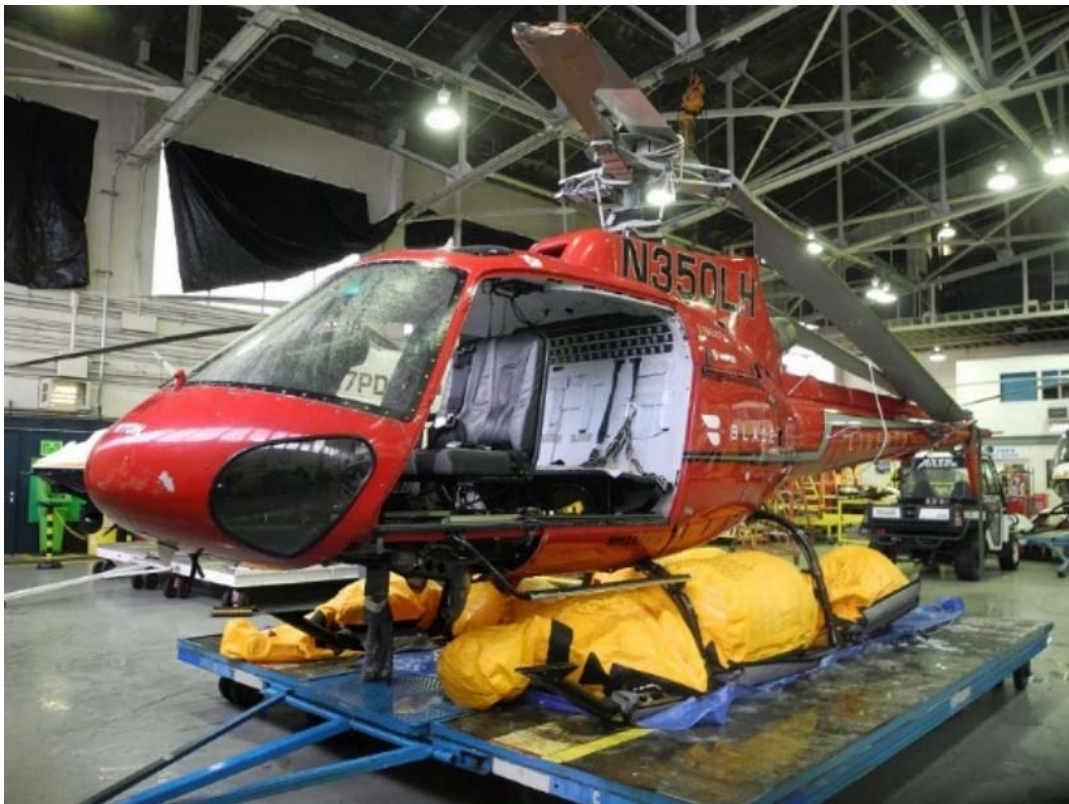
The helicopter airframe remained generally intact. The main fuselage did not exhibit evidence of major breakup or fractures. The center fairing, adjacent to the landing lights, was deformed upward. The left front door and the two right doors were removed prior to the accident flight; according to the operator, the removed doors were still at the operator's facility in Kearny, NJ. The left sliding door, normally locked in the open position during doors-off flights, was missing and not recovered (**Figure 2**). A remnant piece of plastic block, part of the left sliding door installation, was found within the lower track for the left sliding door. The fuel tank remained installed in the main fuselage and did not exhibit evidence of fractures or leaks. After recovery, a hole was drilled into the left side of the fuel tank to empty its liquid contents; a plug was installed over the drilled hole.

**Figure 2. Front quarter view of the accident helicopter.**

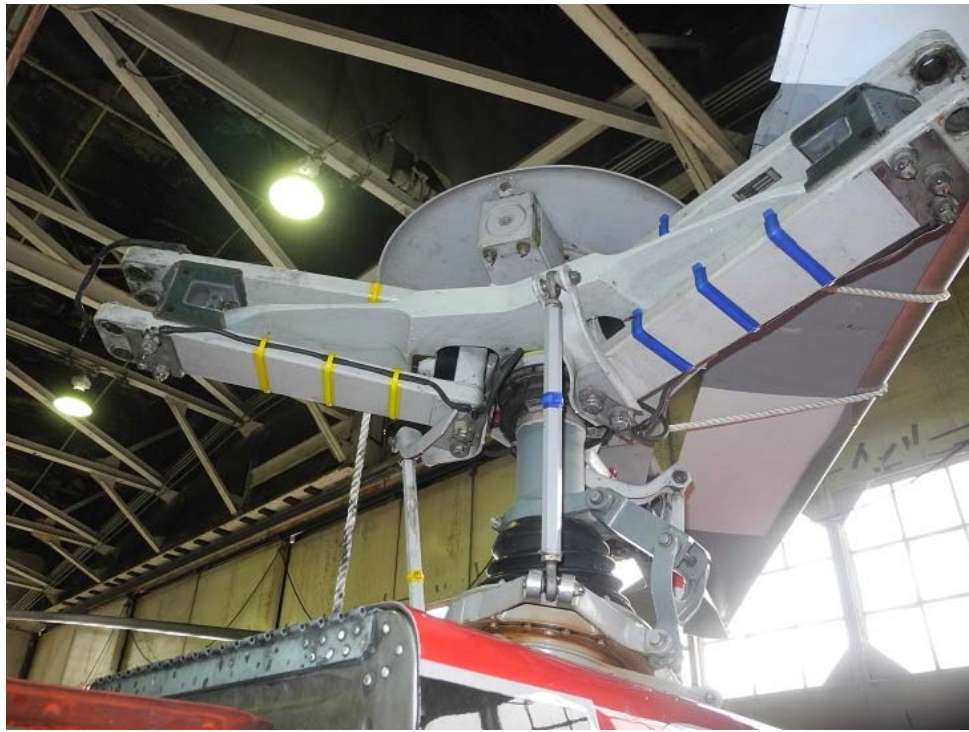
The Starflex did not exhibit evidence of fractures (**Figure 3**). All three main rotor blades remained attached to their respective sleeve assemblies, which in turn remained attached to the Starflex via their respective elastomeric spherical thrust bearings and

**Figure 3. Main rotor Starflex and the 'yellow' and 'blue' sleeve assemblies.**

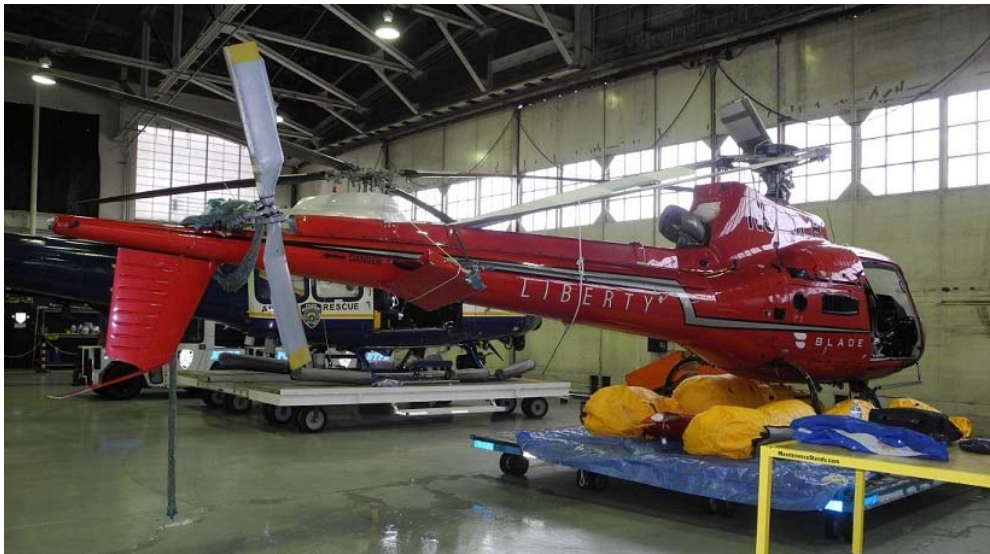
The tail boom remained attached to the main fuselage. Wrinkled metal skin on the tail boom was observed immediately forward of the horizontal stabilizer, but the remainder of the tail boom structure was generally intact. The right horizontal stabilizer was folded downward and exhibited a partial fracture about 18 inches outboard of, but remained attached to, the tail boom. The left horizontal stabilizer was fractured and the

majority of it was missing. The remnant portion of the left horizontal stabilizer that remained attached to the tail boom exhibited impact deformation with an aft and inboard directionality. The upper vertical fin was partially fractured from the tail boom and leaning over to the left side of the tail boom during recovery at the East 23<sup>rd</sup> Street Pier. The upper vertical fin was separated after recovery. The upper vertical fin was generally intact. The lower vertical fin remained attached to the tail boom and was generally intact.

An impact mark was observed on the tail rotor drive shaft (TRDS) cowling at the frame station coincident with the trailing edge of the horizontal stabilizer. The remaining TRDS cowlings remained installed and intact along the tail boom. The engine cowling remained installed and intact.

**Figure 4. Rear quarter view of the accident helicopter.**

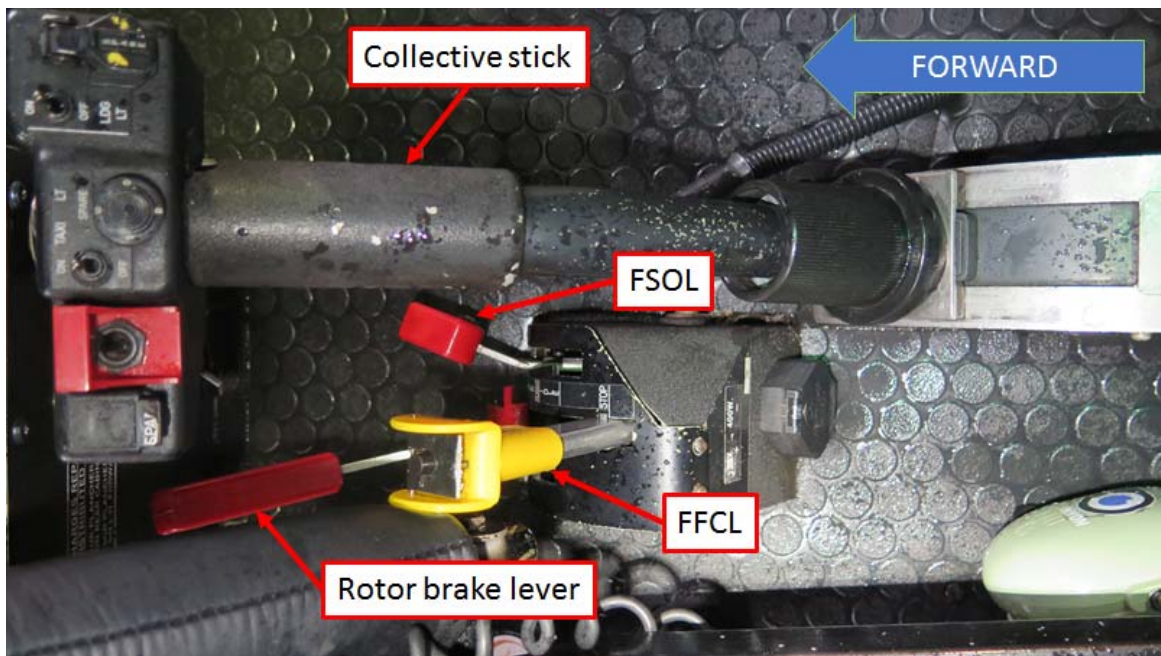
The engine controls and rotor brake lever were found in their normally installed, floor-mounted location adjacent to the collective control (**Figures 5 and 6**). The FFCL was found in the shutoff position.<sup>8</sup> The FSOL was found in the forward and down position, consistent with the fuel shutoff valve being in the open position.<sup>9</sup> A snap wire<sup>10</sup> is normally installed around the FSOL and routed through a hole in the fuel control plate. The snap wire was found around the FSOL but was broken at its bottom end where it normally routes through the plate hole. The snap wire was retained for further examination.<sup>11</sup> Movement of the FSOL from the forward-down position to the aft-up

position resulted in a corresponding movement of the fuel shutoff valve at the engine firewall, consistent with closing of the fuel shutoff valve. The FSOL could not be moved fully into the detent for fuel shutoff. The rotor brake lever<sup>12</sup> was found in the forward and down position, consistent with being stowed.<sup>13</sup>

**Figure 5. The engine controls and rotor brake lever.**

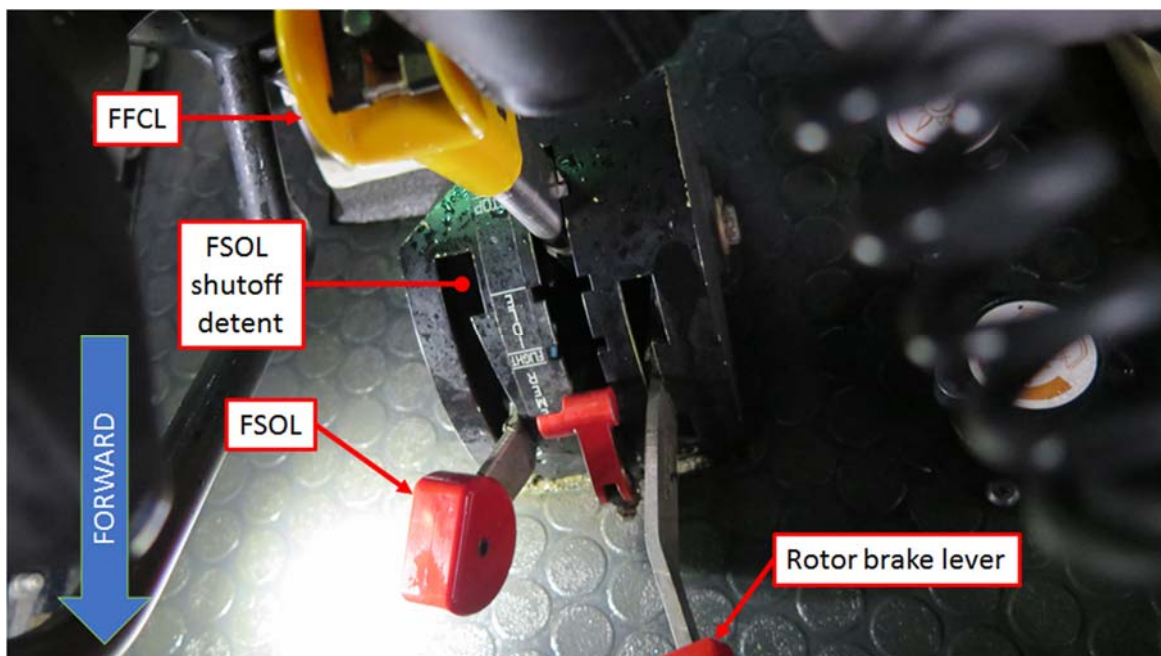
**Figure 6. A view of the engine controls and rotor brake lever showing their travel paths and detents.**
