# **NATIONAL TRANSPORTATION SAFETY BOARD**

## **AIRWORTHINESS GROUP CHAIRMAN'S FACTUAL ADDENDUM** **ENGINES AND THRUST REVERSERS**

**A. ACCIDENT:** DCA08MA098  
**LOCATIONS:** Columbia, South Carolina  
**DATE/TIME:** September 19, 2008  
**AIRCRAFT:** Learjet Model 60, N999LJ, S/N 60-314

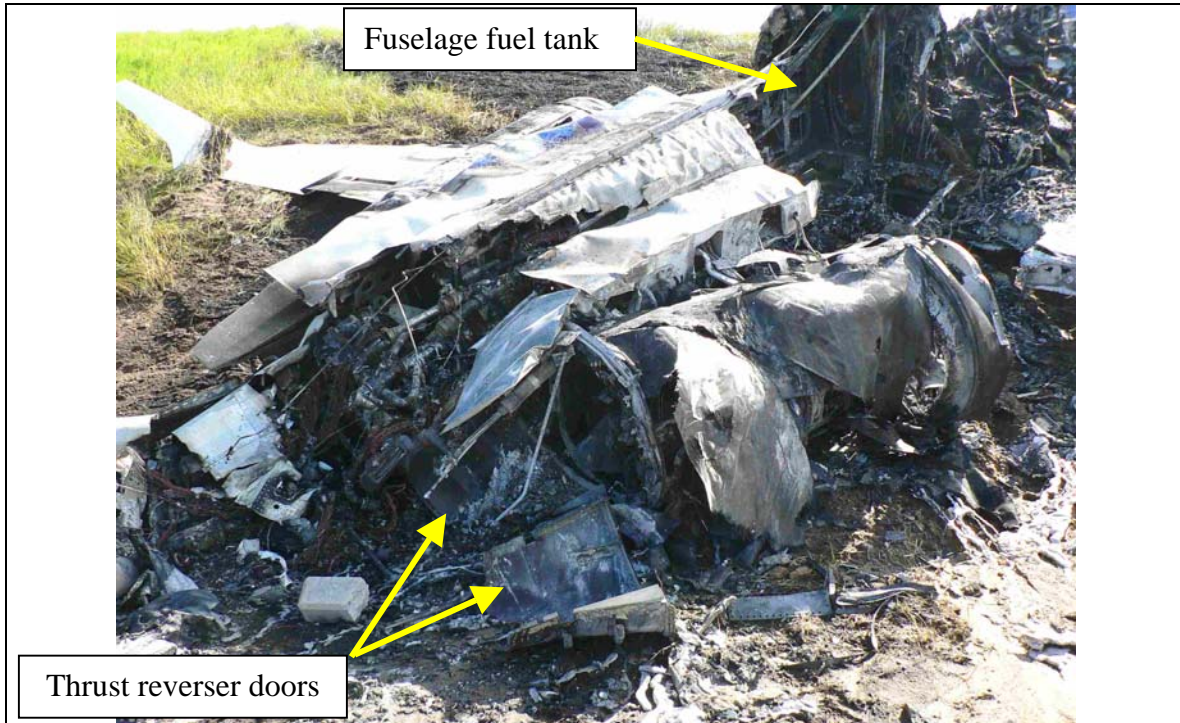
The right engine had received extensively more fire damage than the left engine. The engine had been in the path of fuel leaking from the fuselage fuel tank. (See Figure 3)

Figure 3. The right engine had substantially more fire damage than the left engine and the thrust reverser doors were found forward, in the stowed position. Note: The light-gray block above the “Thrust reverser doors” caption is the top of the concrete marker post from the west side of Highway 302.

The lower T/R door was found in the stowed/forward orientation and the leading edges had no damage to indicate that the door had been open when the airplane passed through the ILS antenna array, or when it struck the hillside. The upper door was also found in the stowed/forward position, lying loosely next to the bottom door and the leading edges were also undamaged.

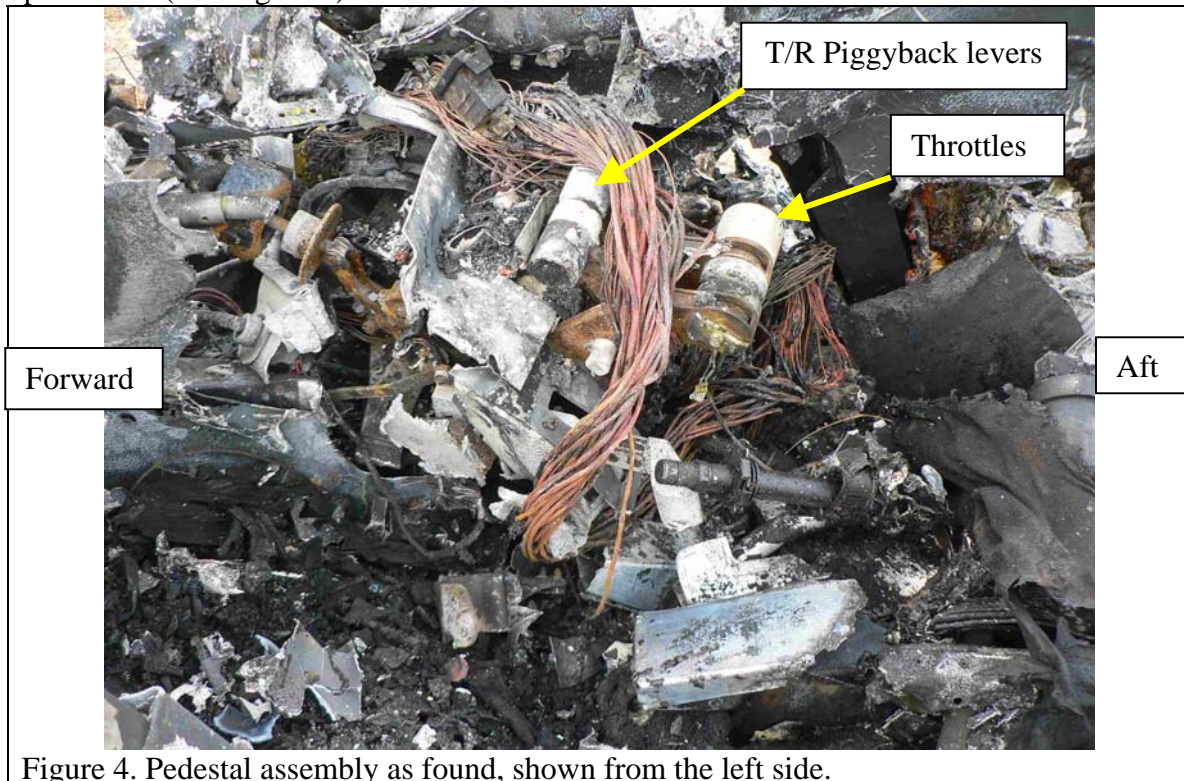
The two thrust levers were found at the forward end of the travel limits and the sheet-metal from forward of each was cut forward. The pedestal assembly in general had been displaced up and to the right and the linkages to the thrust levers had been disrupted. The thrust reverser control (a.k.a. piggy-back) levers were found in the down/stowed positions. (See Figure 4)

Figure 4. Pedestal assembly as found, shown from the left side.

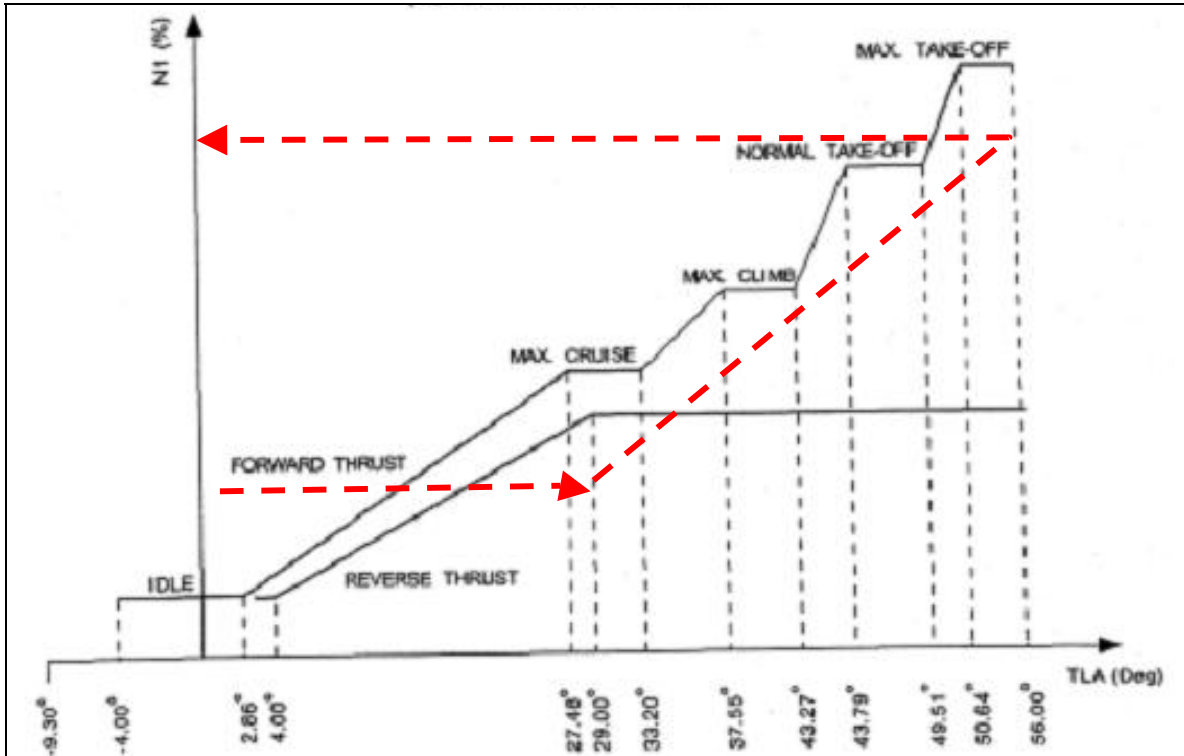
With the thrust reversers transitioning to the stow position, the engineering review found that the EECs would transition from the reverse thrust N1/TLA schedule to the forward thrust N1/TLA schedule, within about a 2 second transition through idle power. At this point, the T/R piggyback levers would be in the positions normally used for full reverse thrust.<sup>11</sup> The engines would be applying forward thrust according to the RVDT angle and the conditions of the day per the thrust schedule. (See Figure 20)

Figure 20. Modified from Figure 6 during the group meeting at the Learjet factory in Wichita from October 6-10, 2008. The red arrow drawn from maximum reverse TLA (horizontal axis) shows how a shift in between the reverse and forward thrust schedules could affect N1 (vertical axis), due to removal of the 29 degree TLA restriction. The chart is graphic in nature and the vertical proportions are not to scale. On the ground at airspeeds less than  $V_1$ , only minor differences in  $N_1$  would exist through the detents.<sup>12</sup>

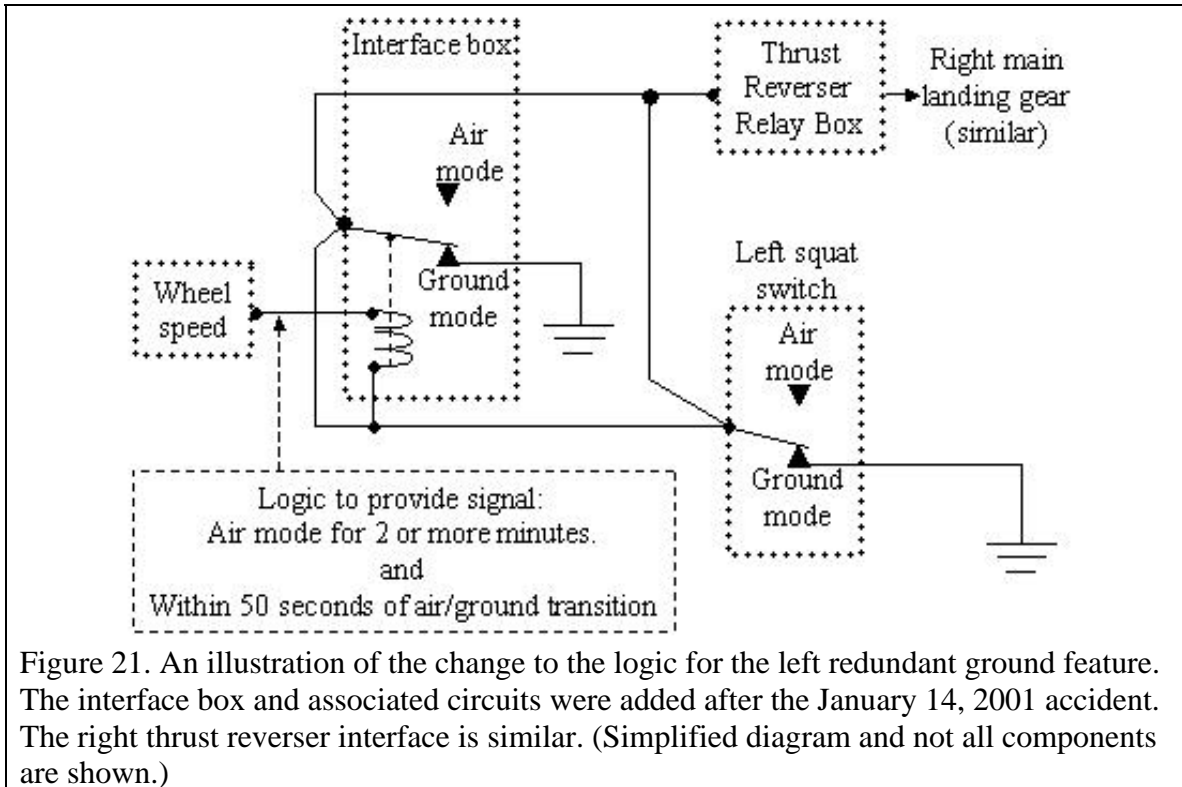
Figure 21. An illustration of the change to the logic for the left redundant ground feature. The interface box and associated circuits were added after the January 14, 2001 accident. The right thrust reverser interface is similar. (Simplified diagram and not all components are shown.)

This change protected against inadvertent stowage of the thrust reversers after landing and selecting reverse thrust. Damage to a squat switch or other required circuit prior to the selection of reverse thrust would still prevent the thrust reversers from going to the doors deployed and idle thrust positions. The design change would not be applicable to inadvertent reverser stowage in a takeoff situation, because the airplane had not been in the air for two minutes.

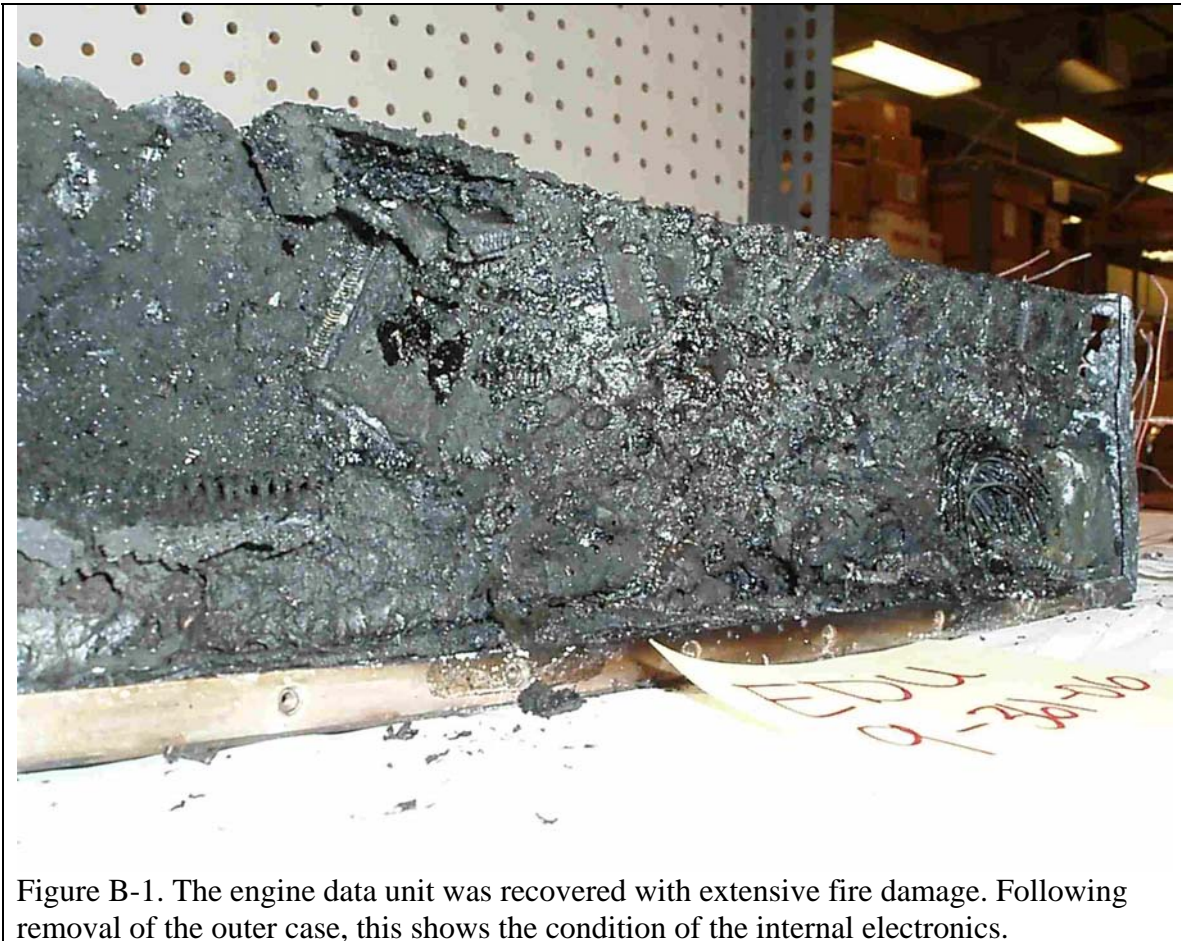
Figure B-1. The engine data unit was recovered with extensive fire damage. Following removal of the outer case, this shows the condition of the internal electronics.

The EDU was partially consumed by fire at one end. The opposite end had the remnant of a RS-232 connector and had gotten hot enough that the pins of the connector were missing. The EDU box rattled when it was shaken. The part number of the EDU was 9-361-06 and the manufacturer was the ELDEC Division of Crane. The Control Display Unit has no non-volatile memory and a 31B5424-02, also identified by the ELDEC part number of 9-362-03.
