NATIONAL TRANSPORTATION SAFETY BOARD

**AIRWORTHINESS GROUP CHAIRMAN'S FACTUAL ADDENDUM FOR
TIRE, WHEEL, AND BRAKE DOCUMENTATION
WITH AIRCRAFT TIRE STUDY**

A. **ACCIDENT:** DCA08MA098

AIRCRAFT: Learjet Model 60, N999LJ, S/N 60-314

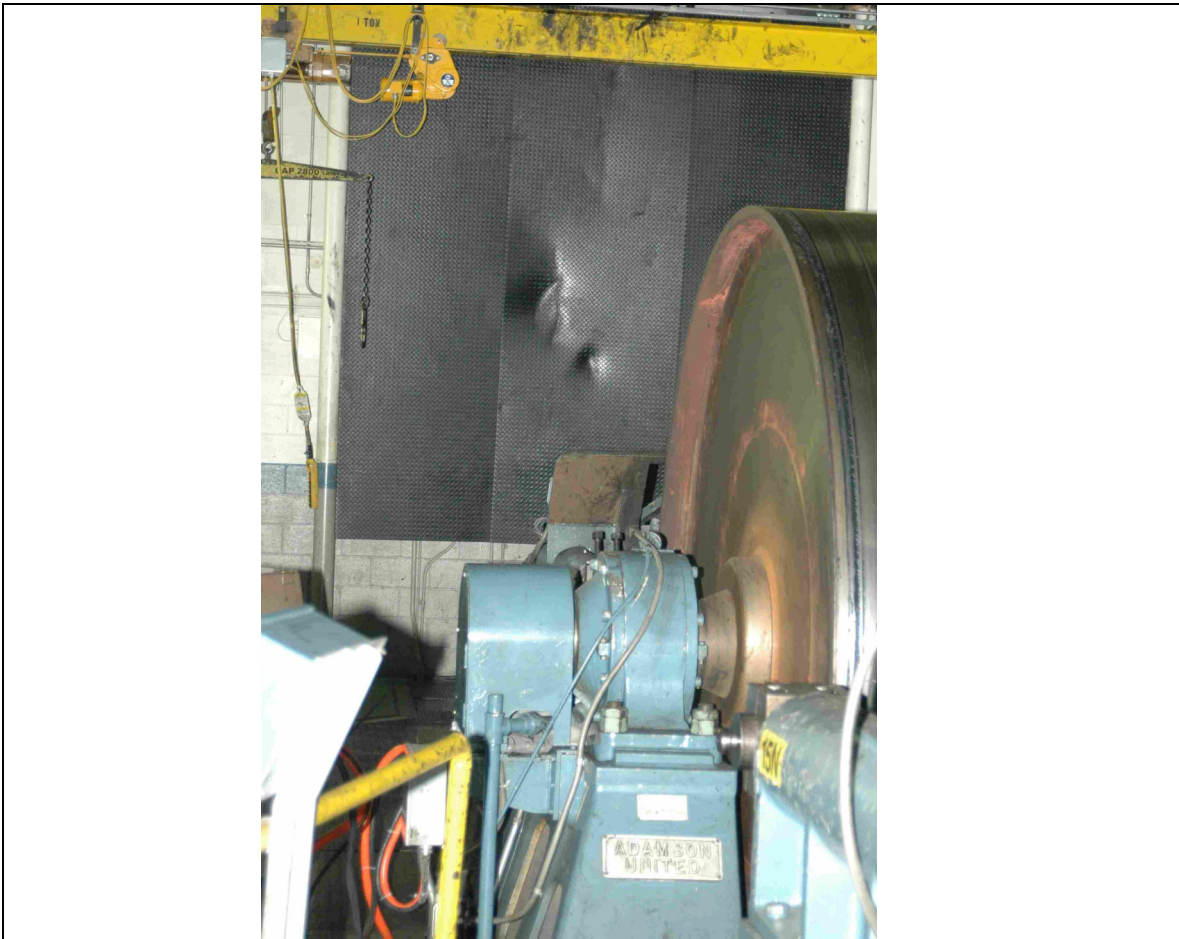
Figure 4. Dents in the diamond-plate steel on the walls of the Goodyear dynamometer test room. For scale reference, the large steel wheel is 120 inches in diameter and the smaller dent is fully the size of a man's fist.

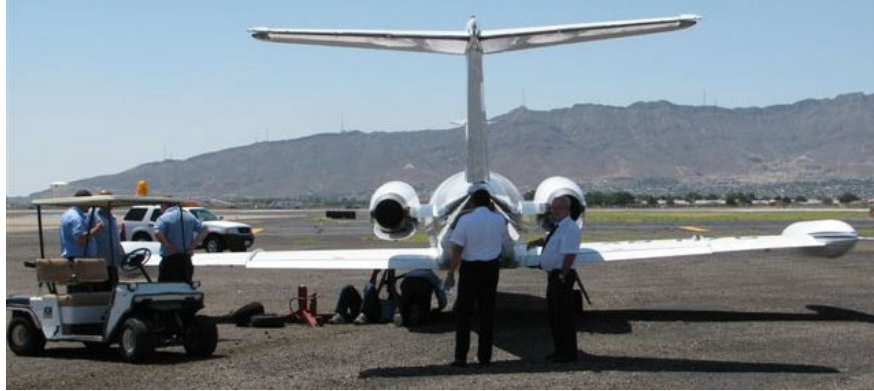
Figure 14A. XB-MYG displays 1.8 to 1.9 degree airplane roll angle that existed with flat right tires and resting on left wheel rims.

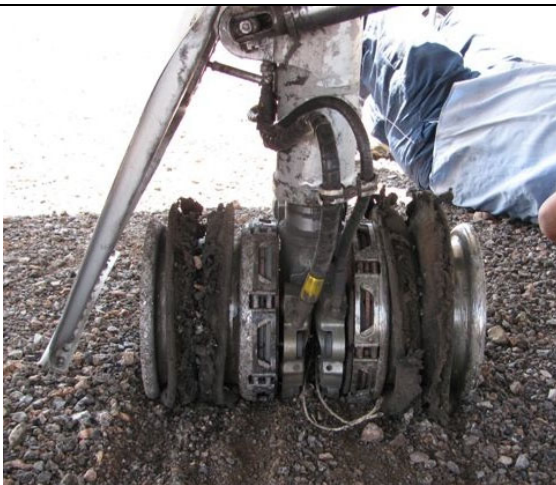
Figure 14B. View from the rear of the airplane, XB-MYG, showing the left wheels and tire remnants.

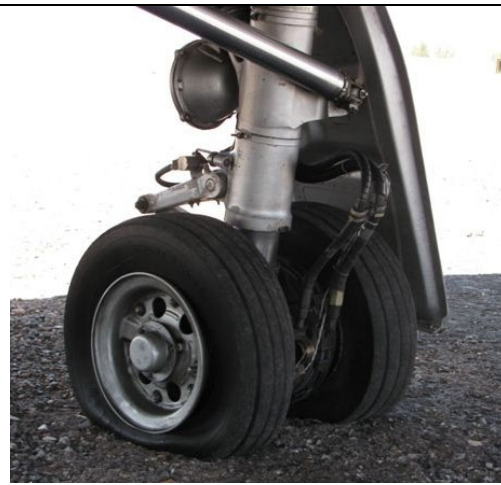
Figure 14B. View from the rear of the airplane, XB-MYG, showing the right wheels and deflated tires.

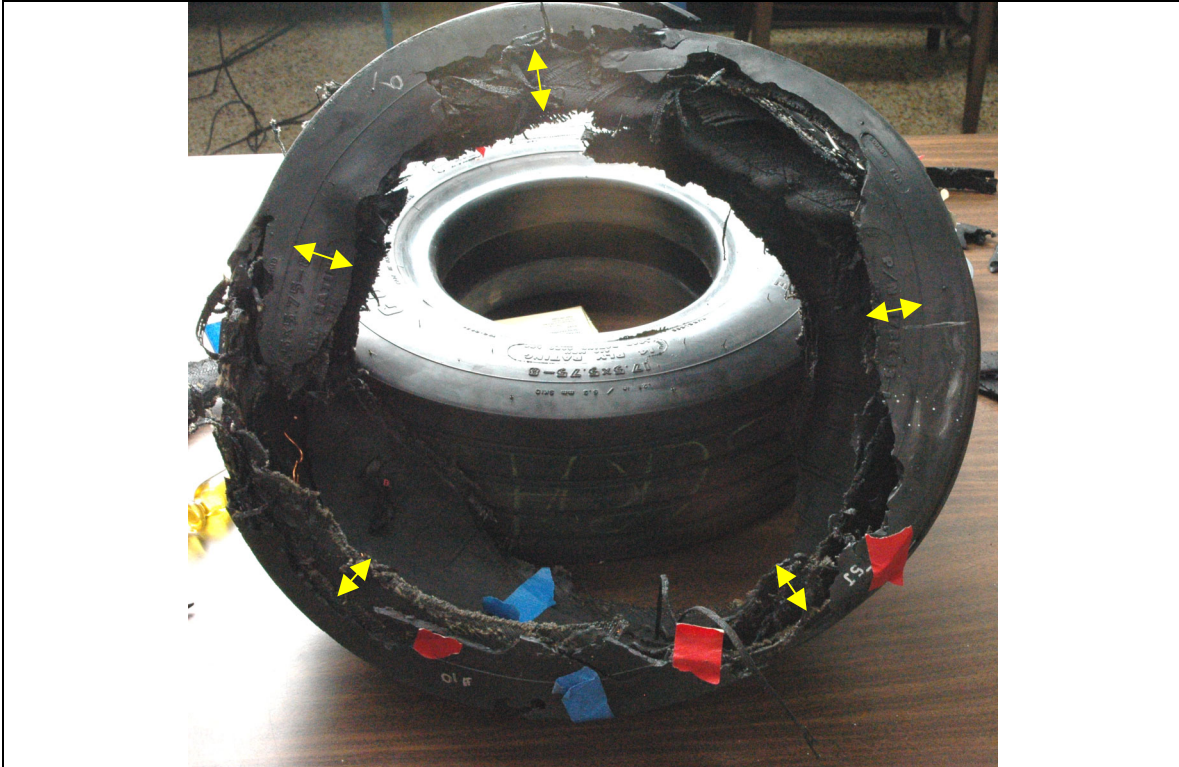
Figure 21. Overall photograph of the reconstruction of the right outboard tire, on the outboard sidewall.²¹ Visible is the generally ragged or torn appearance of the edge that is at a relatively constant radius from the hub. The added arrows show the relatively constant distance from a decorative rib.

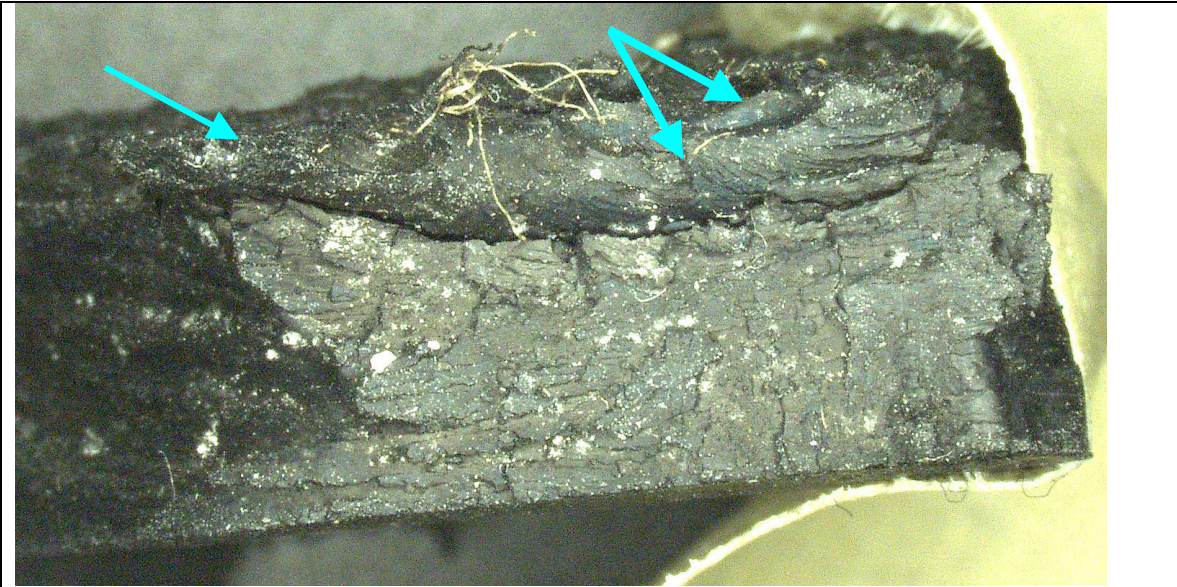
Figure 27. Fragment #2 edge that had been 1.2 inches from the decorative rib, with arrows pointing to blue tinting from heat damage.

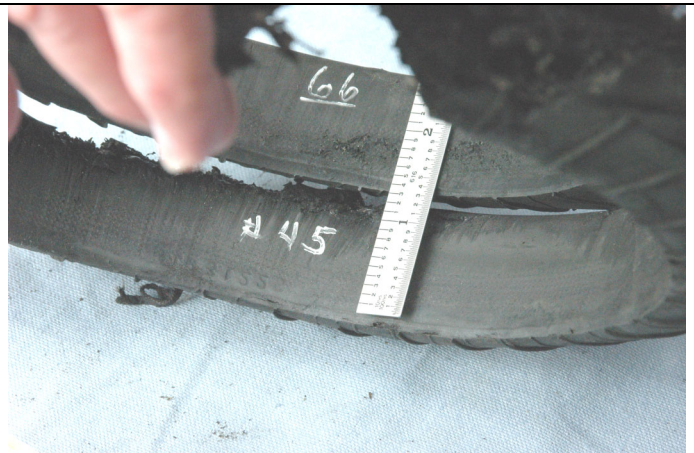
Figure 29. These fragments from N999LJ show the tire beads (Fragments #45 and 66), and the lack of heat-type damage that is visible in the photo to the left. Specifically, note the lack of damage under the lettering "45" and "66." The ragged edges visible in this photo are where the bead material had rolled on the grooved pavement.

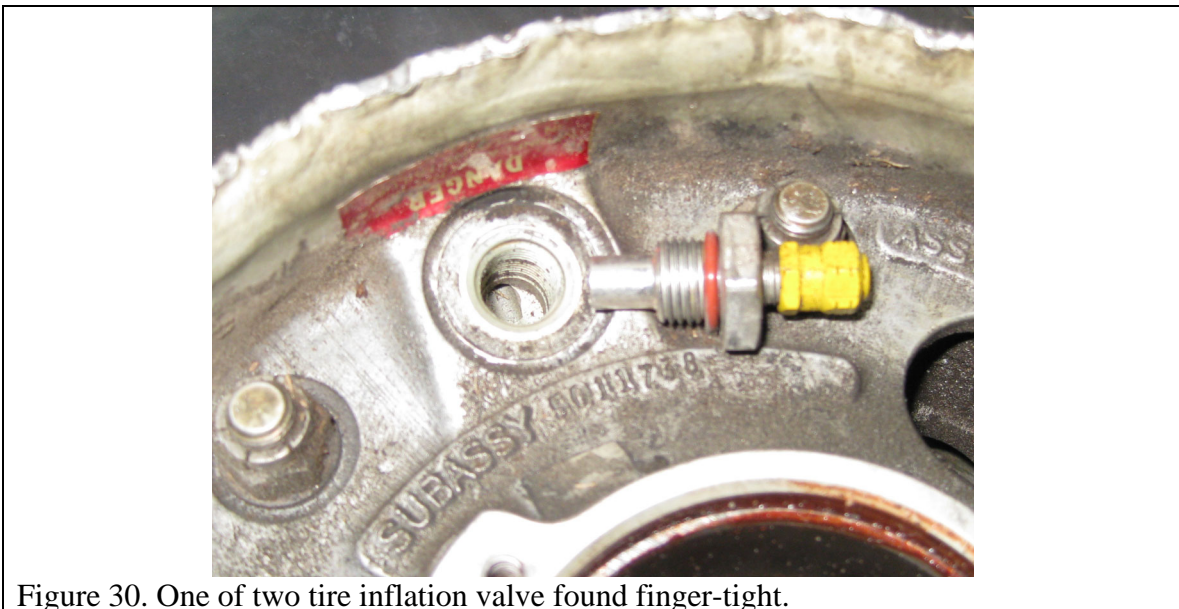
Figure 30. One of two tire inflation valve found finger-tight.

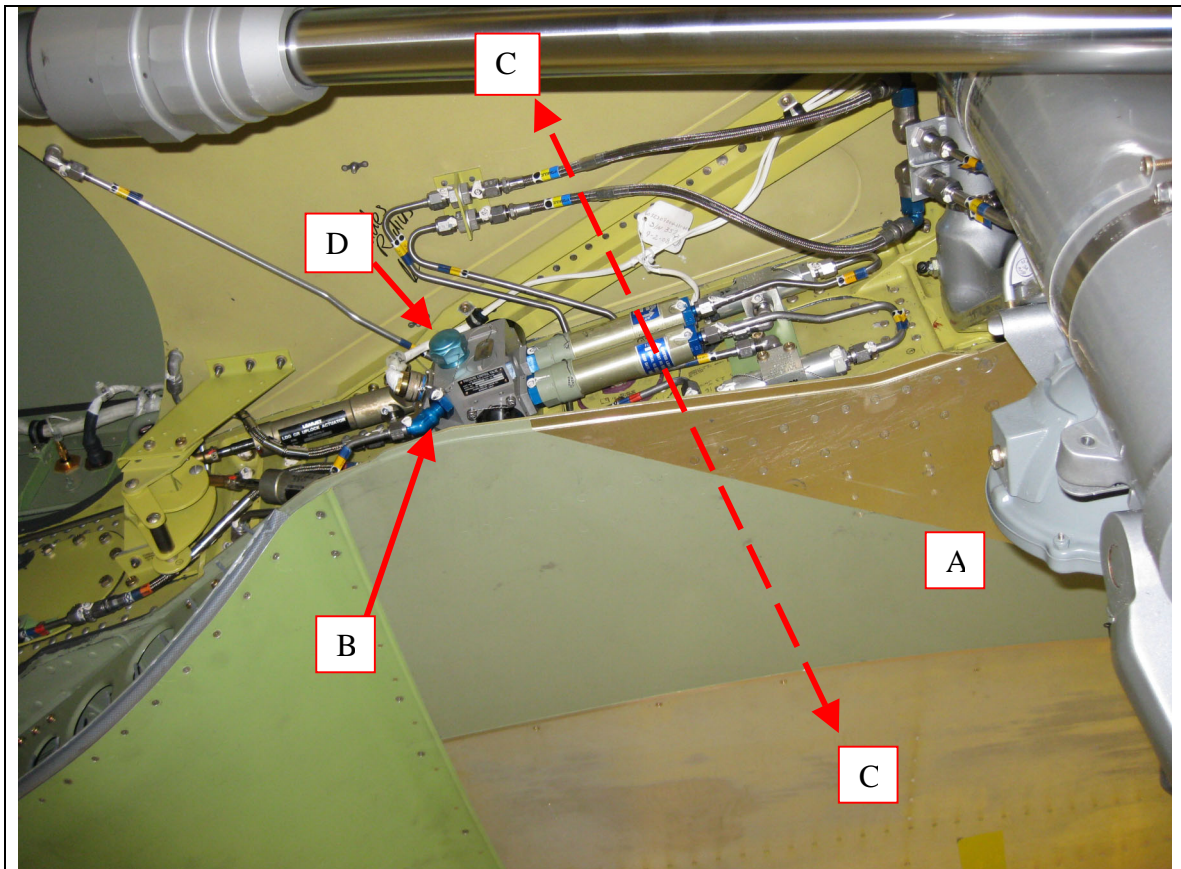
Figure 35. This view from a similar airplane is upward from the side of the inboard right main landing gear tire. The large assembly is the antiskid valve and hydraulic fuse assembly. For orientation, the back of the landing light is visible as (A). The (B) arrow points to the hydraulic supply tube, which is about 6 inches inboard of an imaginary line

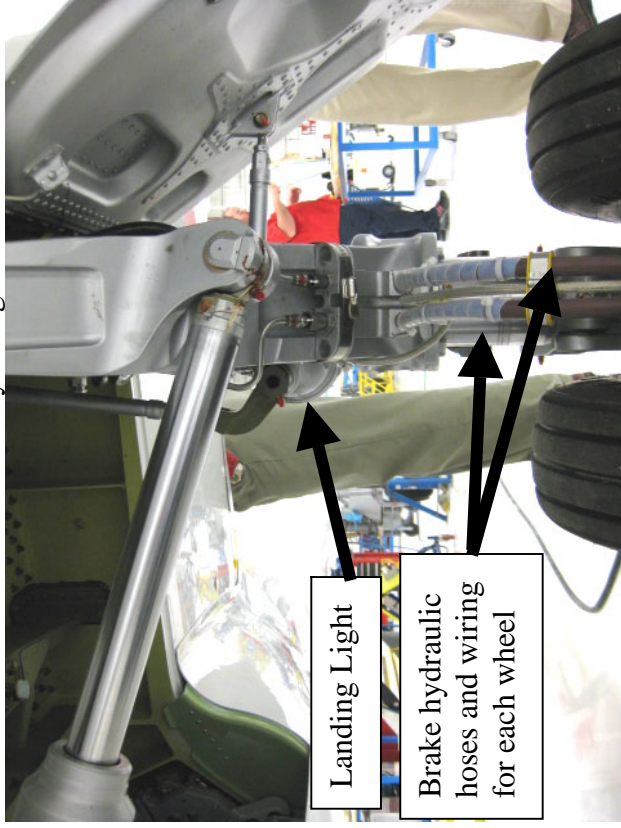
Figure 36B. Learjet Model 60 aft features of the right main landing gear, as viewed from behind. The hydraulic hoses and anti-skid wiring are in the plane of rotation for the outboard tire.

Note hydraulic components between red arrows.

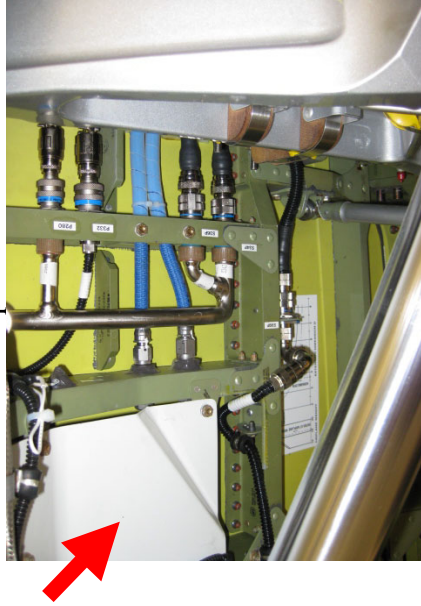
Figure 38B. Learjet Model 60. Hydraulic components mounted on wing spar that is above, and inboard of, the rotational plane of the right inboard tire. The upper-left arrow points to an unfused hydraulic return tube. The lower-right arrow points to an unfused hydraulic supply tube.

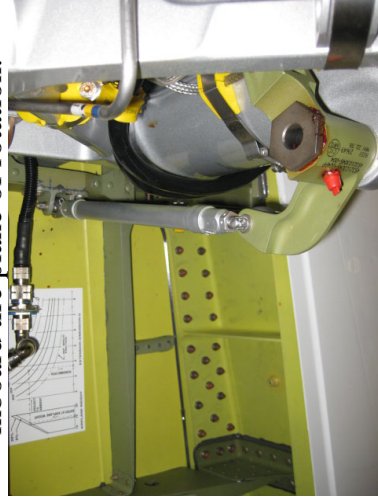
Figure 38D. Learjet Model 60 at top of right main landing gear strut, slightly oriented outboard of the photo above (Figure 38B) and above inboard tire plane of rotation.

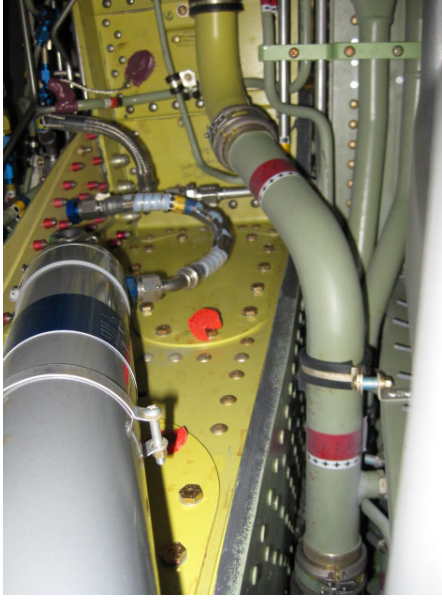
Figure40D. Learjet Model 60: View shows exposed hydraulic components on the front and inboard walls of right wheel bay inboard. (Composite of two photos)
