**NATIONAL TRANSPORTATION SAFETY BOARD**

**Airworthiness Group Chairman's Factual Report – Addendum 1**

**A. ACCIDENT                      DCA16MA204**

Location:                      Lockhart, Texas  
Date:                              July 30, 2016  
Time:                              0742 central daylight time (CDT)  
Aircraft:                      Heart of Texas Balloons Balony Kubicek BB85Z, registration  
   N2469L

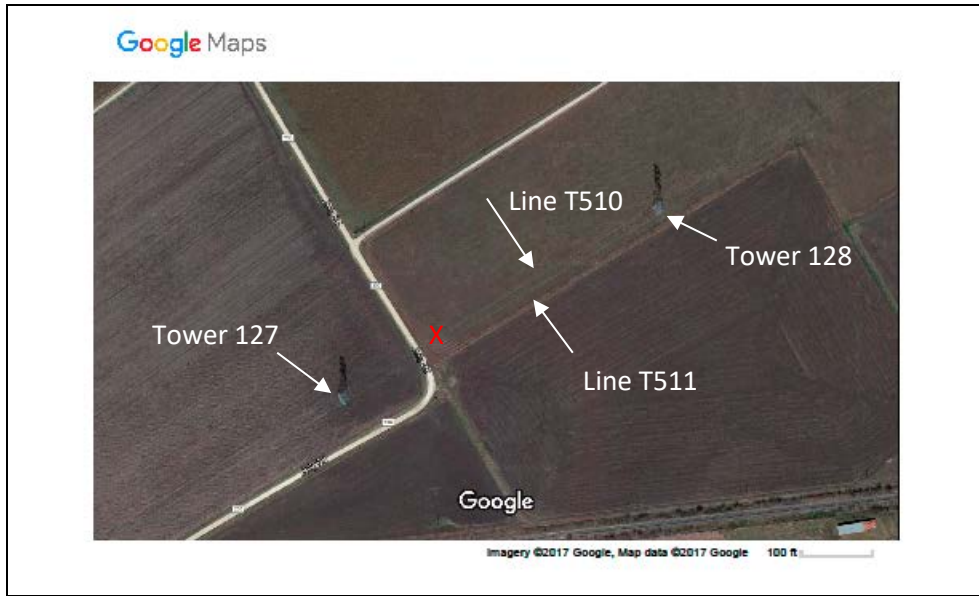
The balloon impacted transmission lines between LCRA Tower 127 and 128 (see Figure 1). The transmission lines strung between the towers run approximately southwest/northeast. Transmission Line 510 is the northern set of lines between the towers, while Transmission Line 511 is the southern set of lines.

Figure 1 - Power Transmission Lines in Vicinity of Accident Site. Approximate Location of Basket marked with red X.

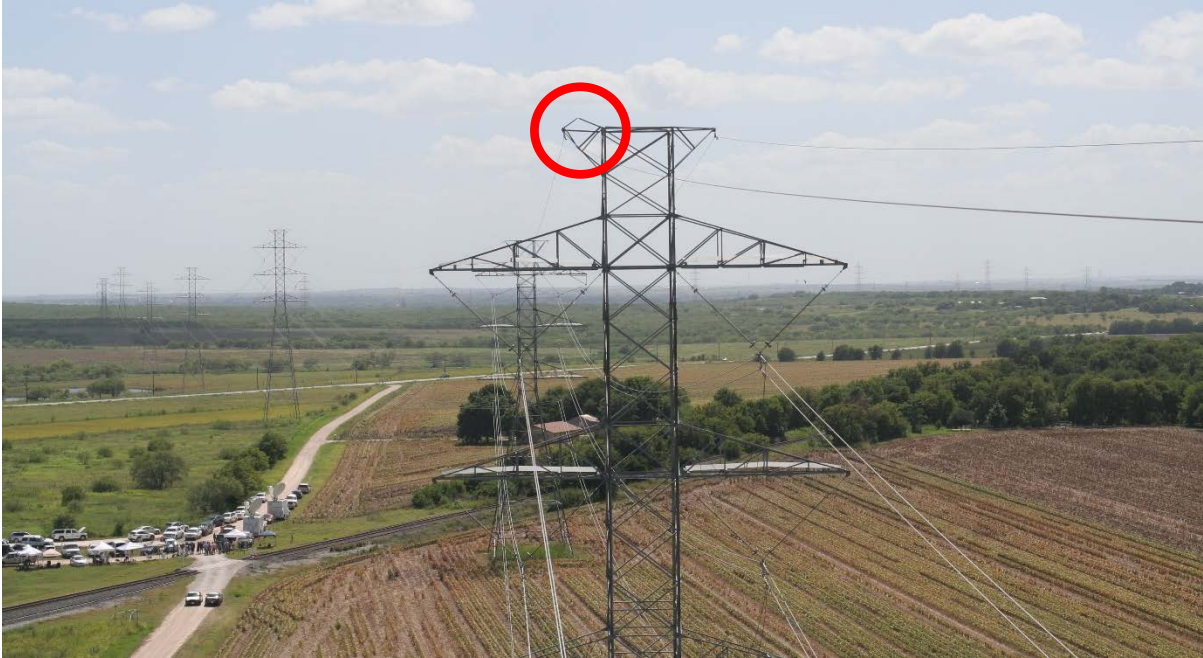
- a. Abrasions/light pitting on the transmission lines.
- b. Bend on the elbow for the ground/static line on Line 511 at Tower 127. See

Figure 5.  
c. Reconstituted metal on lines.

Figure 5 - Bent elbow on Tower Structure 127 (circled). Transmission T511 lines are on left side of tower, Transmission T510 lines are on right side of tower.
