NATIONAL TRANSPORTATION SAFETY BOARD

Group Chairman's Factual Report

ANC15MA041

**Appendix A – Figures
(4 pages)**

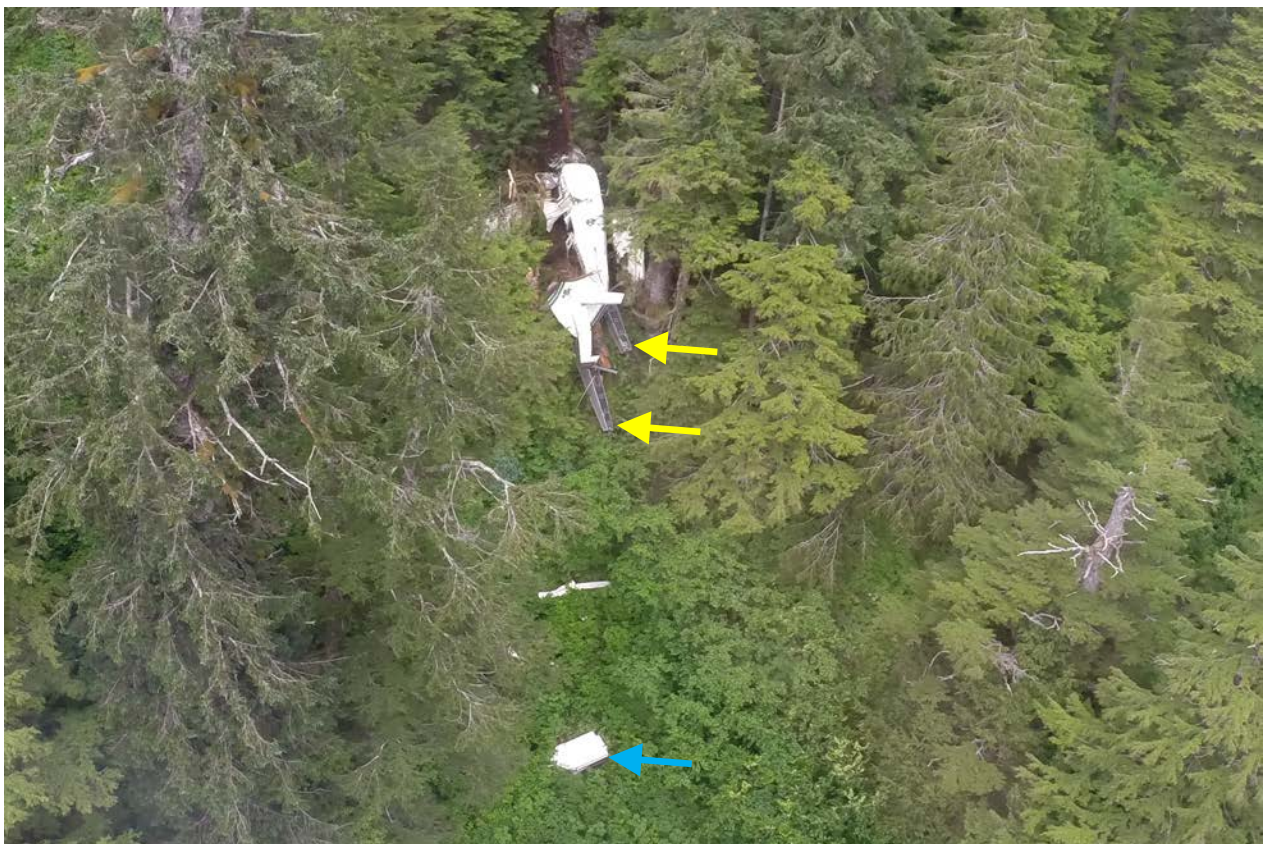
Figure 2 – Main wreckage site, aerial view

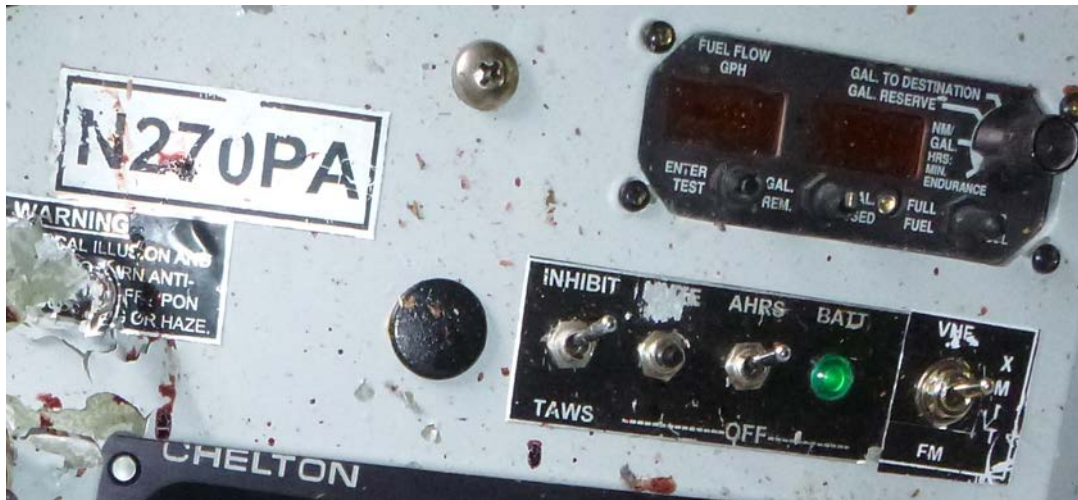
Figure 3 – Switch panel with TAWS switch from N270PA wreckage

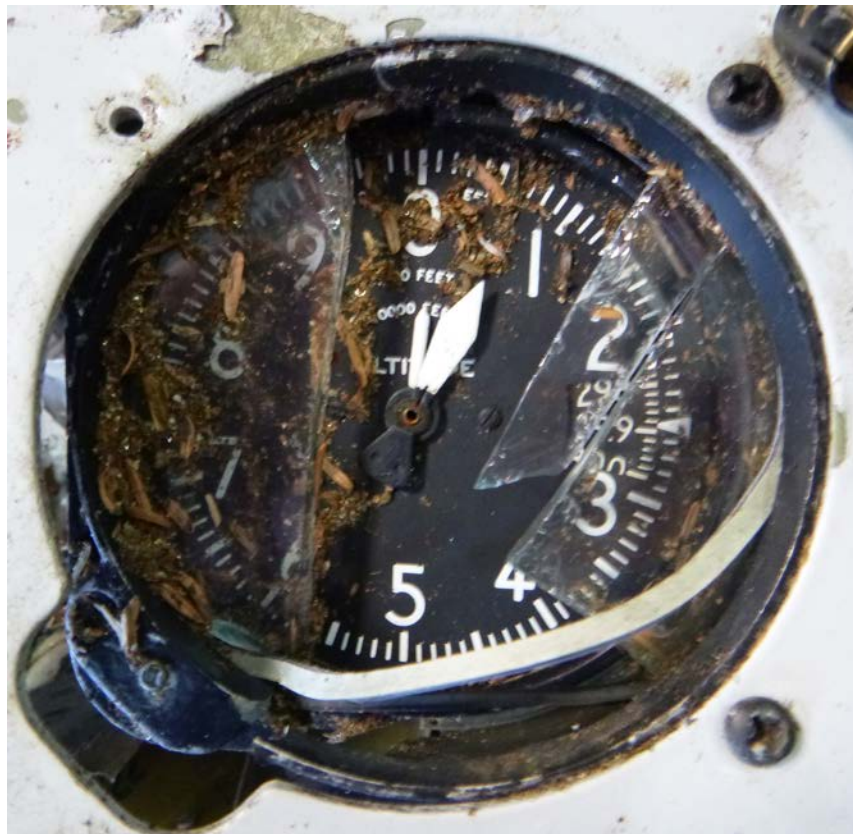
Figure 4 – Altimeter from N270PA wreckage

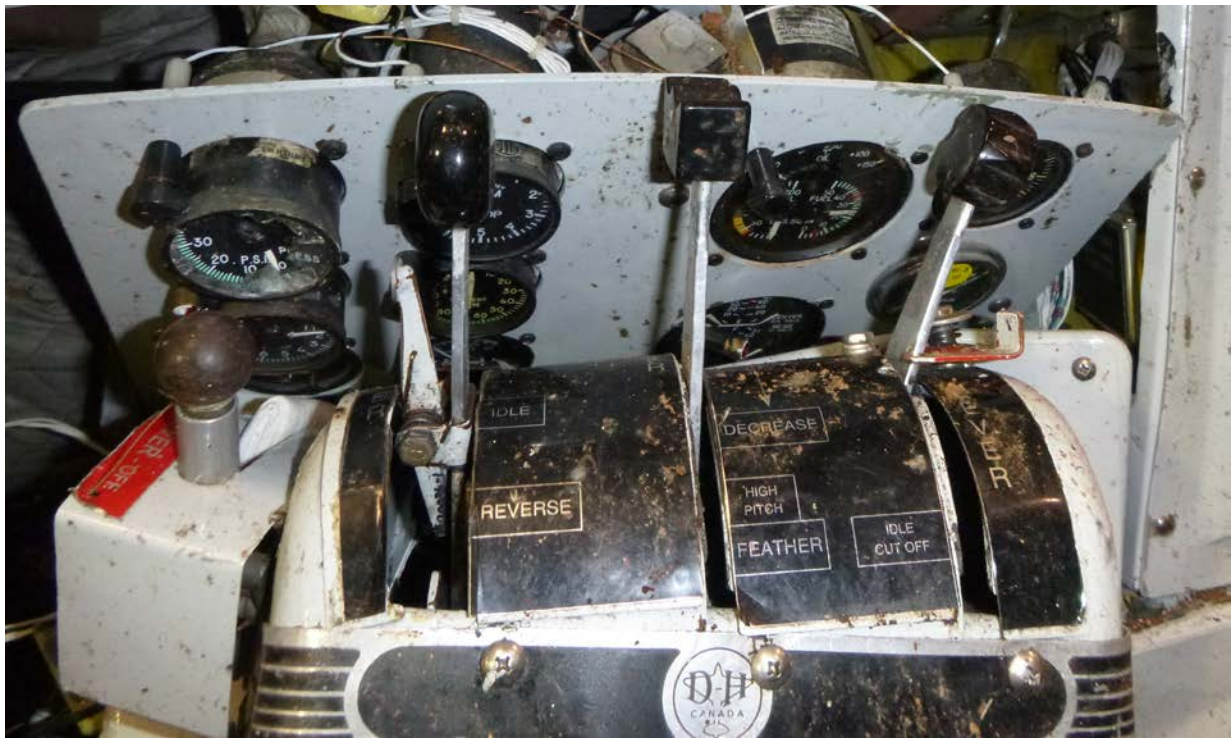
Figure 5 – Center quadrant from N270PA wreckage

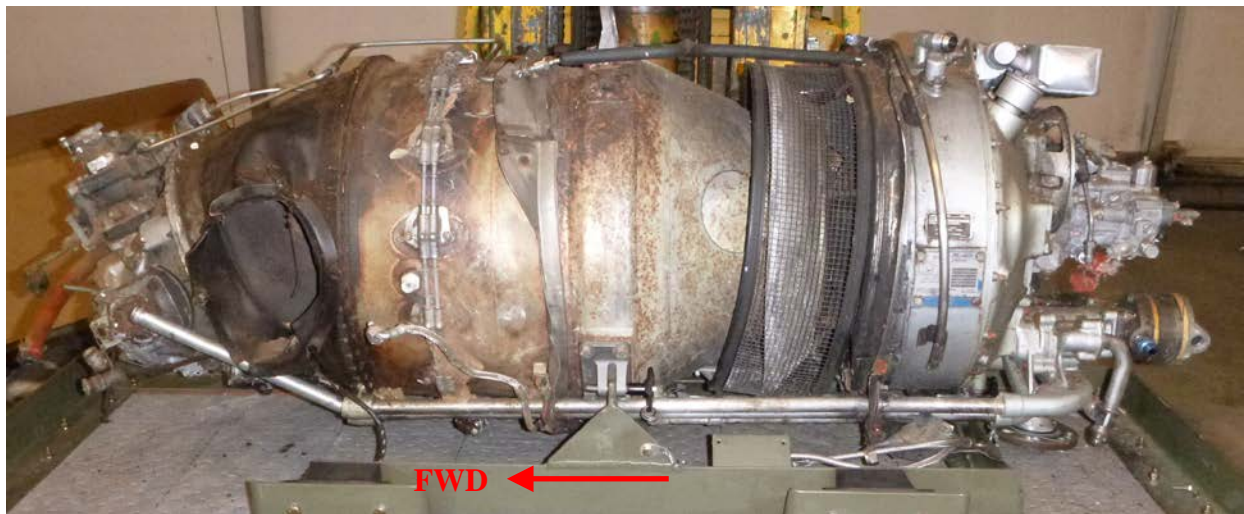
Figure 6 – PT6A-135A engine from N270PA

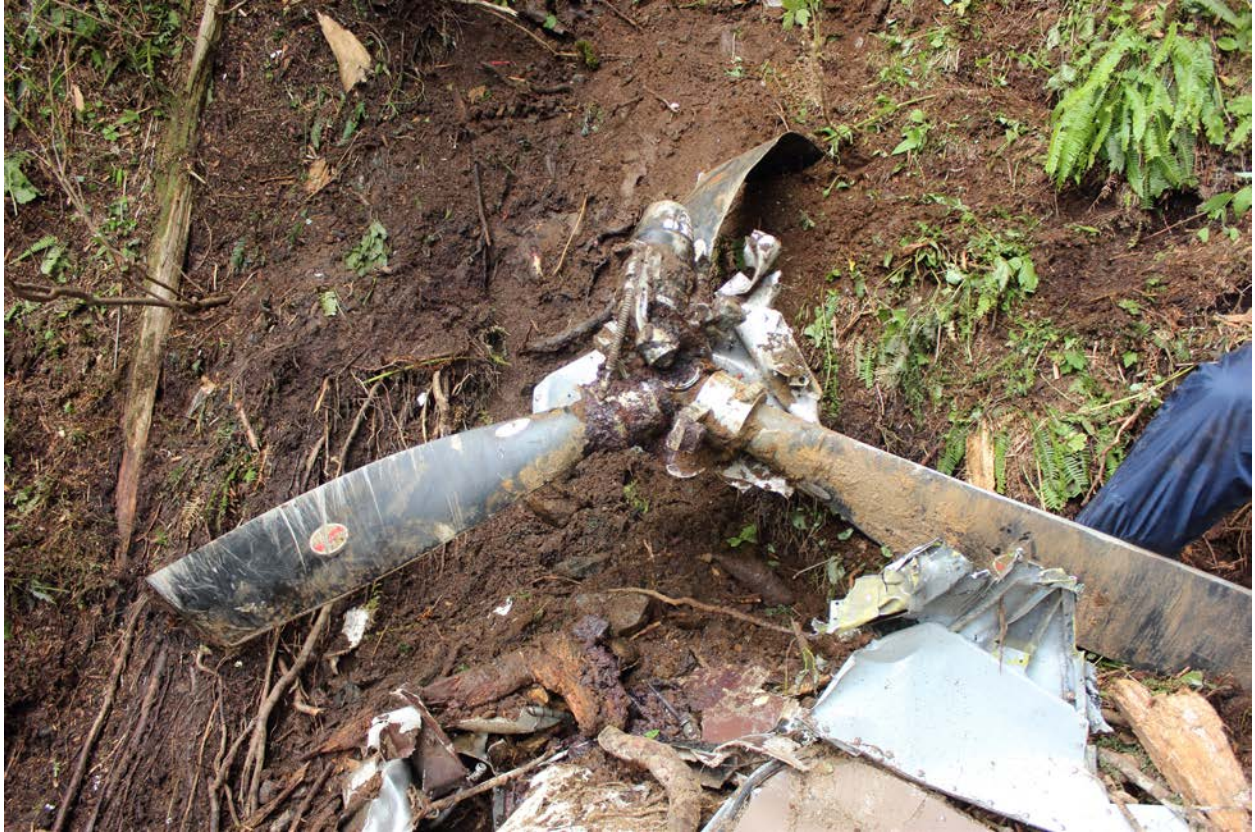
Figure 7 – HC-B3TN-3DY Propeller from N270PA
