NATIONAL TRANSPORTATION SAFETY BOARD

Group Chairman's Factual Report

ANC15MA041

**Promech Air Inc.
de Havilland DHC-3 Reg. N270PA
Ketchikan, Alaska
25 June 2015
PT6A-135A Engine
S/N 35056**

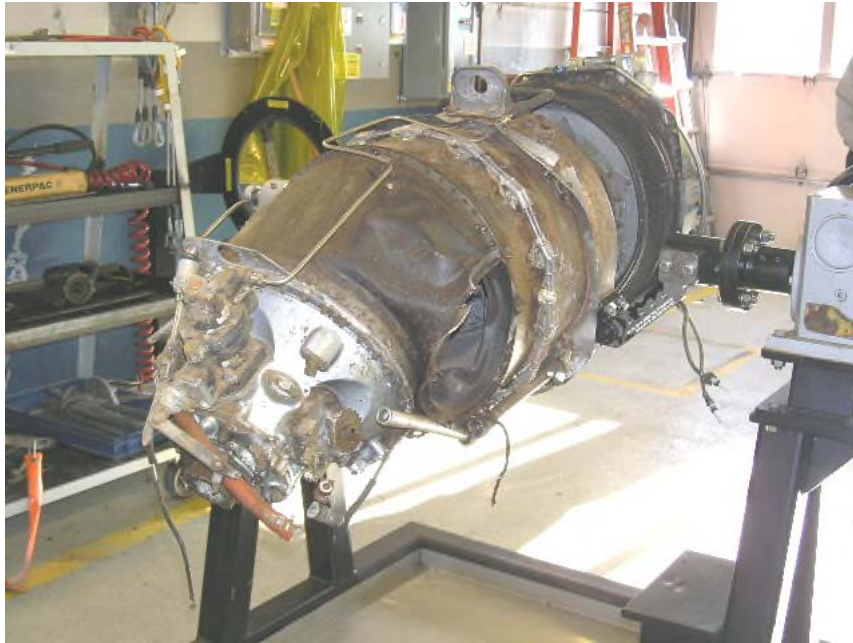
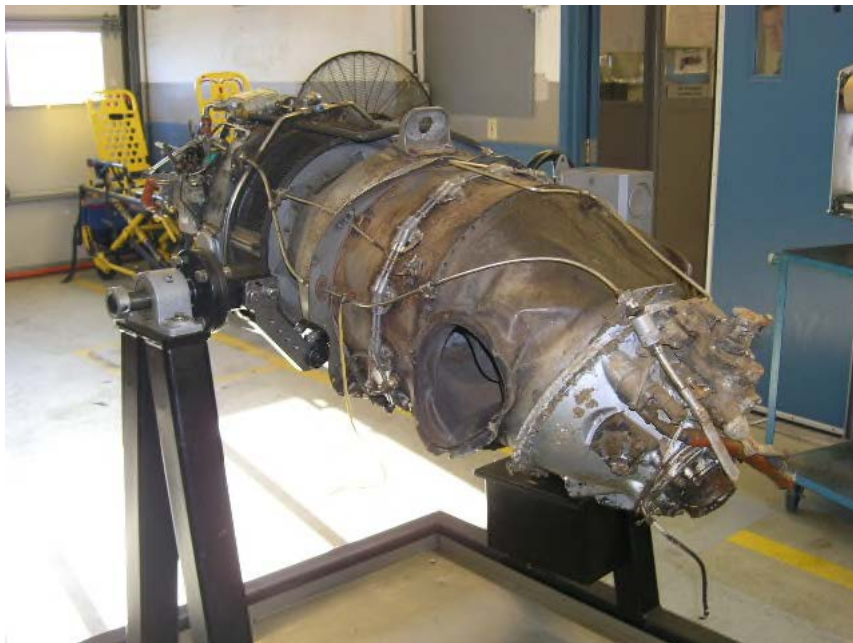
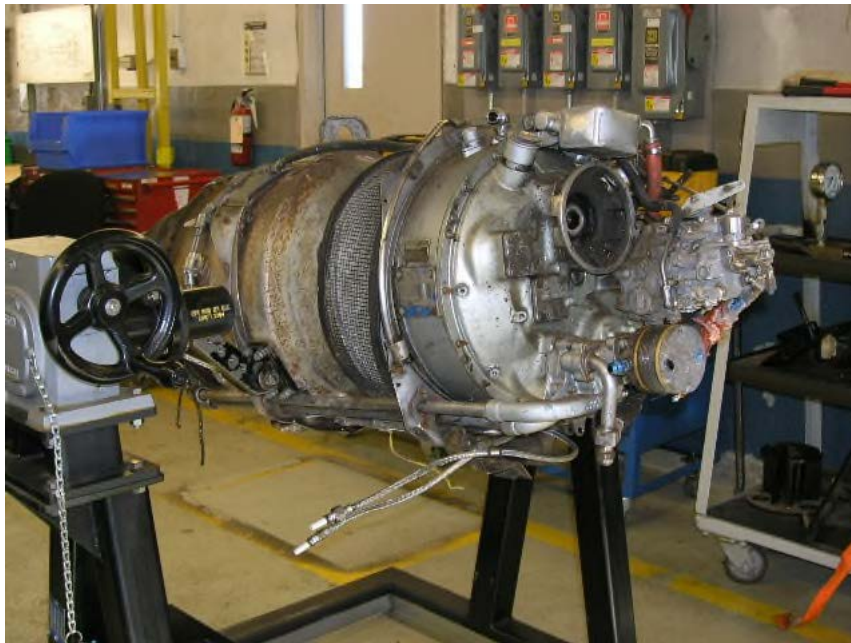
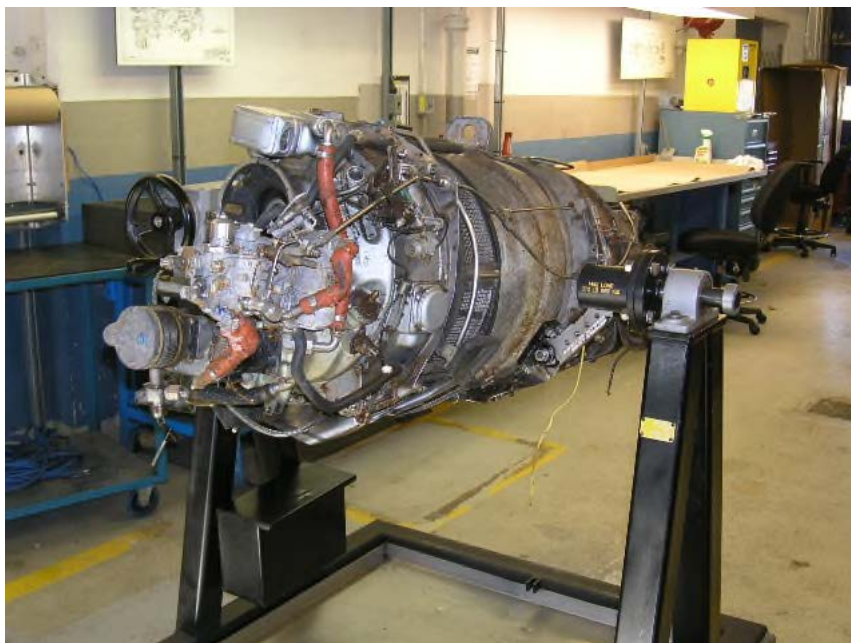
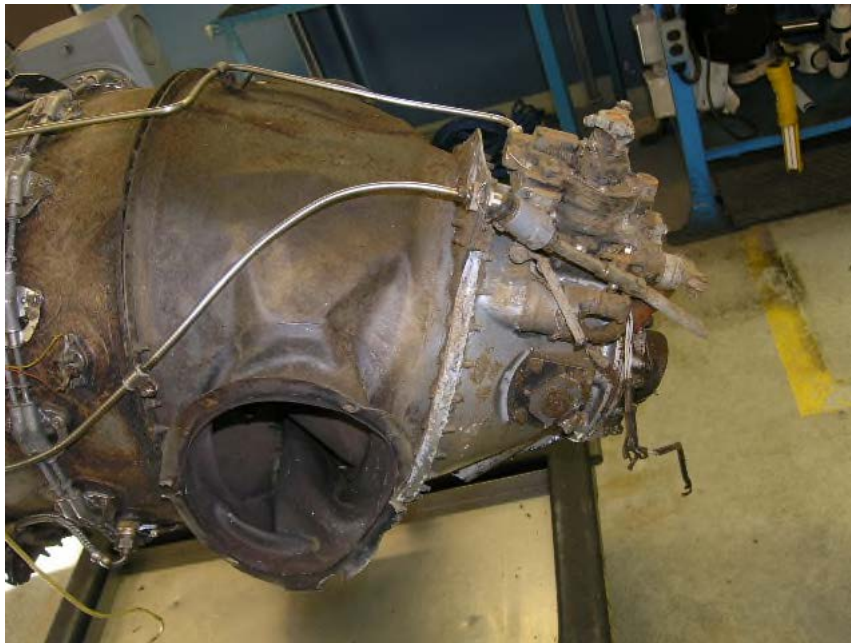
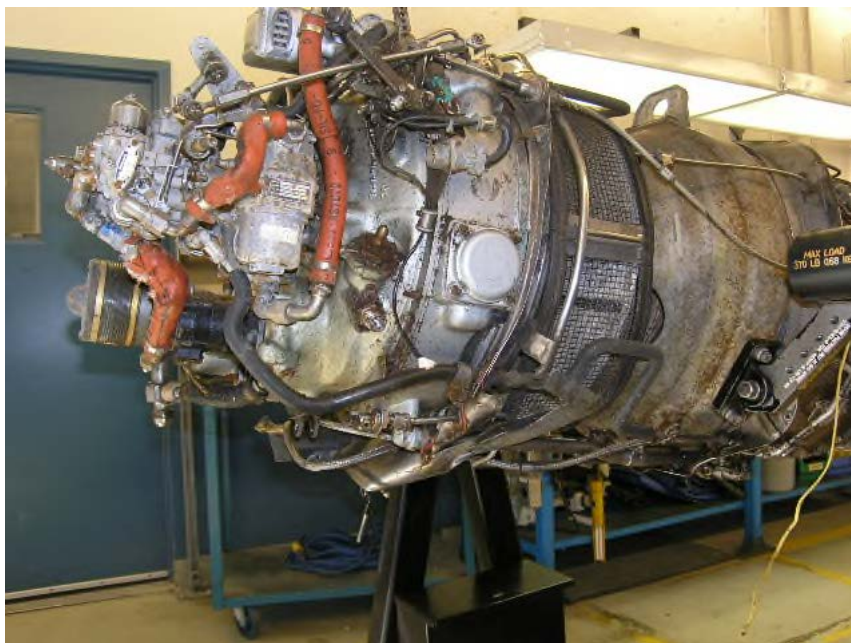
Reduction Gearbox: The propeller shaft was impact fractured immediately aft of the propeller mounting flange. The housing was impact fractured around the lower circumference. The Np tachometer generator and the propeller over speed governor housings were impact fractured. The propeller governor was in place and intact.

Exhaust Duct: The duct was deformed approximately 30 degrees downward in relation to the engine centreline. Power turbine blade debris was recovered from the duct interior.

Gas Generator Case: The housing was intact. The fuel manifold was in place and intact.

Accessory Gearbox: The housing was intact. The accessory gearbox mounted controls and accessories were in place with impact damage.

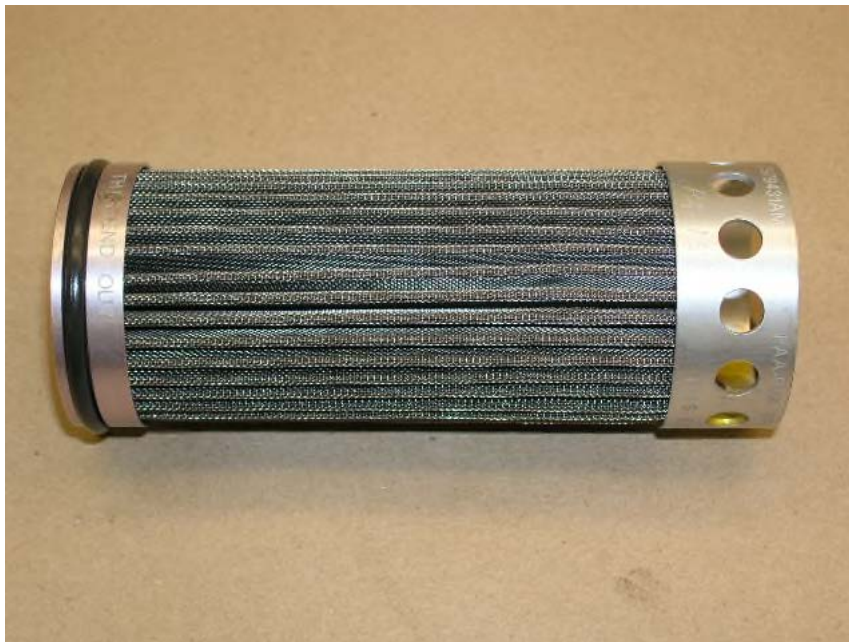
Oil Filter: Clean. Please refer to photo No. 7.

Photo No. 7
Oil filter.

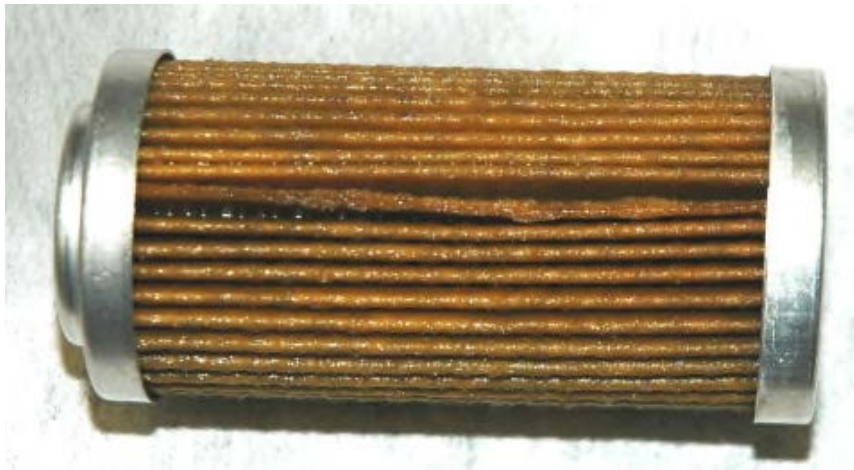
Fuel Filter: The inlet screen and outlet filter were clean. Please refer to photos No. 8 and 9.

Photo No. 8
Fuel filter.

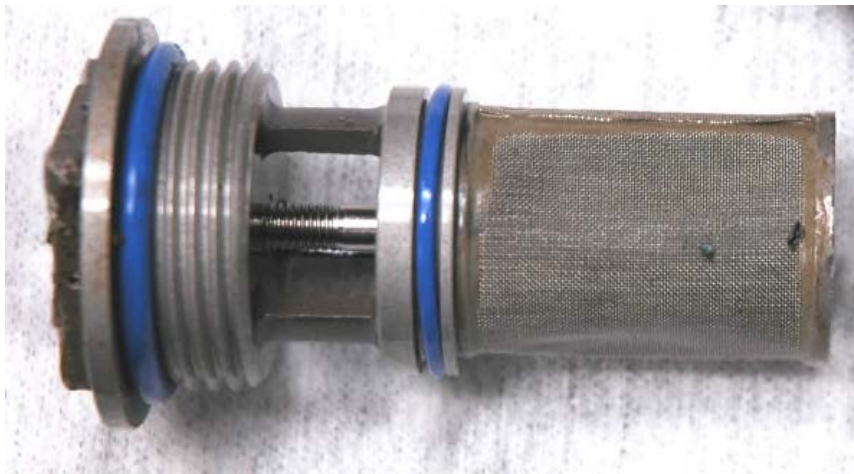
Photo No. 9
Fuel pump inlet screen.

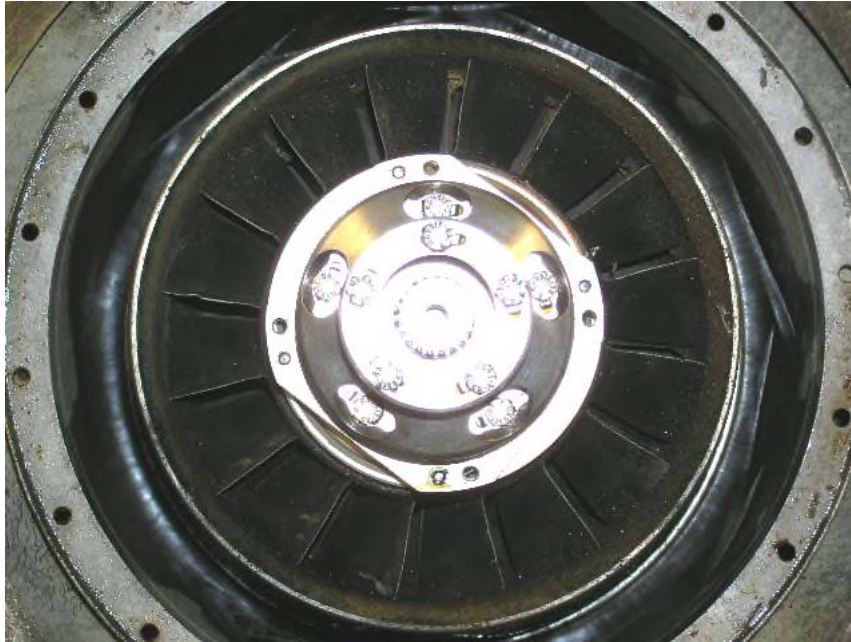
Photo No. 10

Loose soil was ingested through the compressor to the centrifugal impeller. Please refer to photos No. 10, 11, and 16.

Compressor 1st, 2nd, and 3rd Stage Discs and Blades: The blade airfoils were intact. The tips displayed light circumferential rubbing due to contact with their adjacent shrouds. Please refer to photos No. 10 through 12.

Compressor 1st stage and No. 1 bearing housing, in-situ.

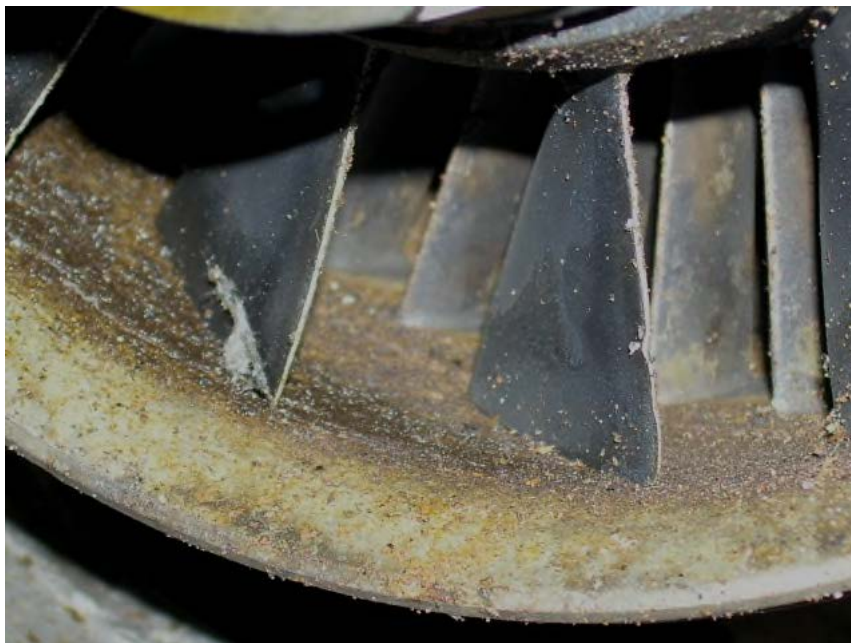
Photo No. 11

Compressor 1st stage blades and shroud, in-situ, detail.

Compressor 1st, 2nd, and 3rd Stage Stators and Shrouds: The stator airfoils were intact, with light circumferential rubbing to the tips due to contact with their adjacent spacers. The shrouds displayed light circumferential rubbing due to the contact with their adjacent blades. Please refer to photos No. 11 and 13.

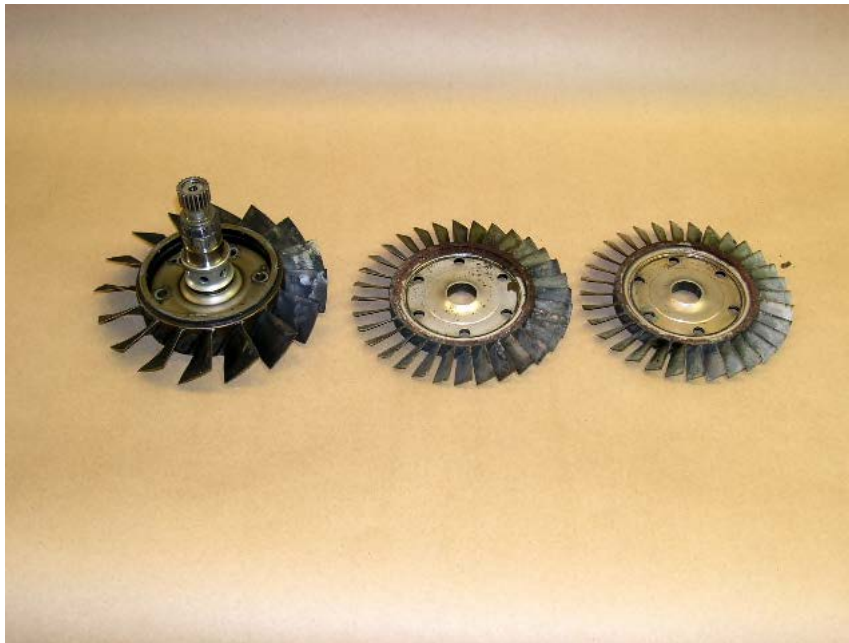
Photo No. 12

Compressor 1st, 2nd, and 3rd stage blades and discs.

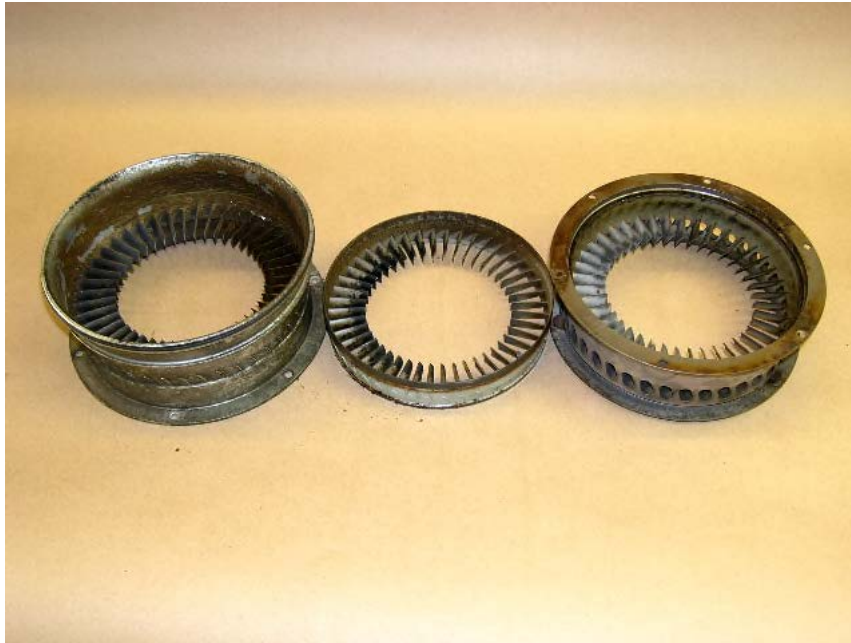
Photo No. 13

Compressor 1st, 2nd, and 3rd stage stators and shrouds.

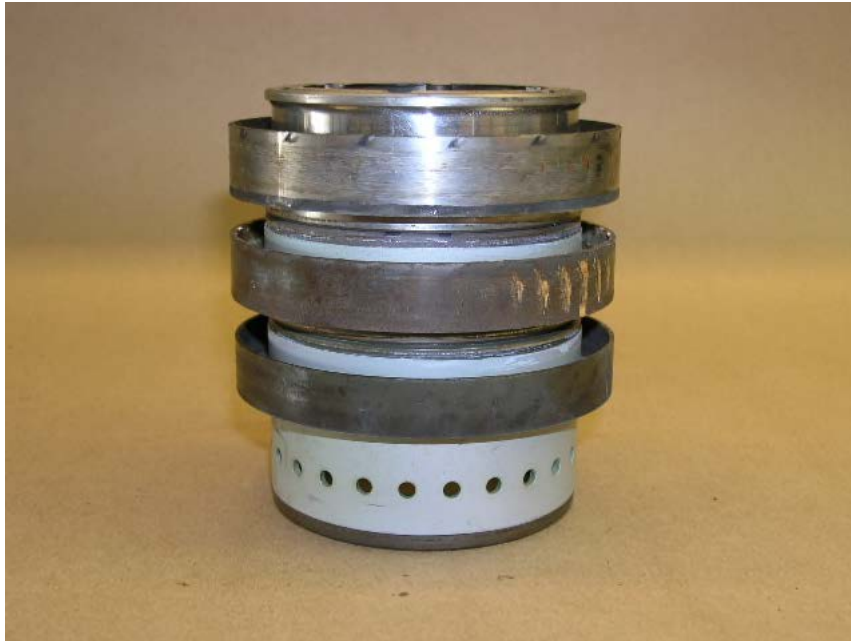
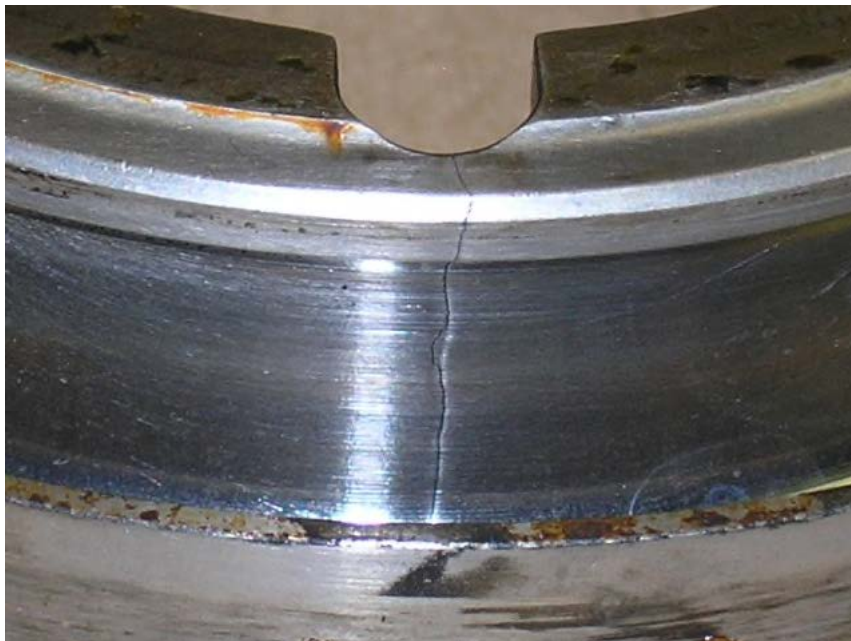
Compressor 1st, 2nd, and 3rd Stage Spacers: The spacers displayed circumferential rubbing due to contact with their adjacent stator vane tips. The 1st stage spacer displayed axial cracks at the compressor through bolt locations. There were no indications of operational distress. Please refer to Photos No. 14 and 15.

Photo No. 14
Compressor 1st, 2nd and 3rd stage spacers.

Photo No. 15
1st stage spacer, detail.

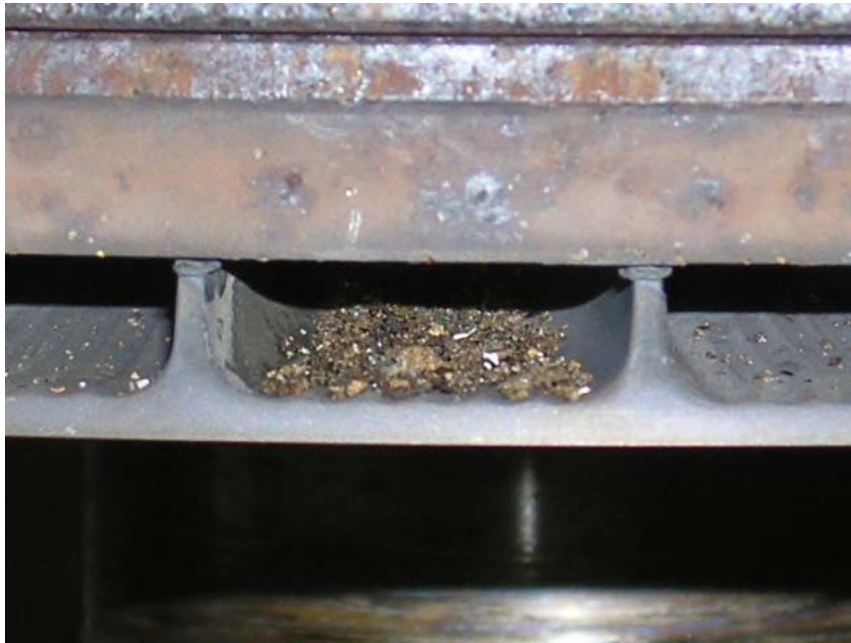
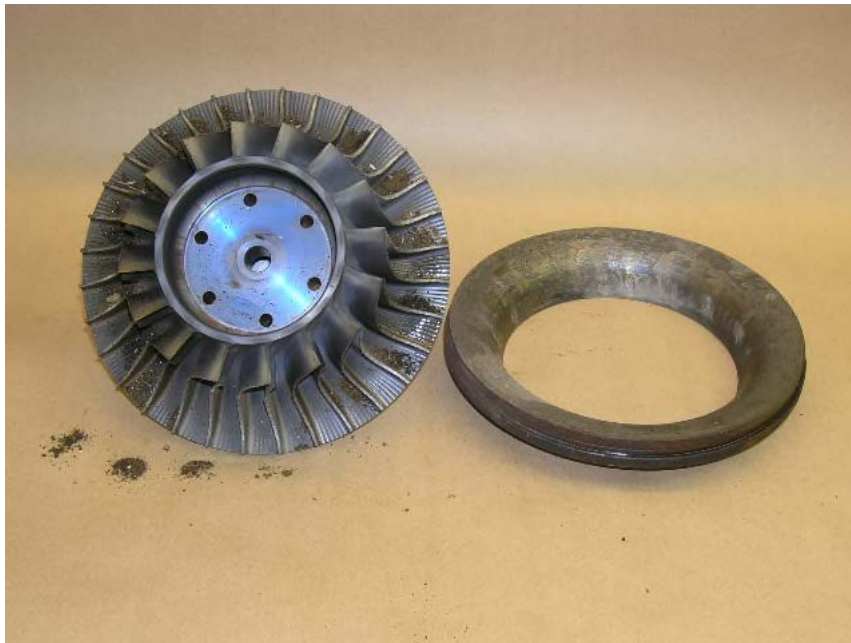
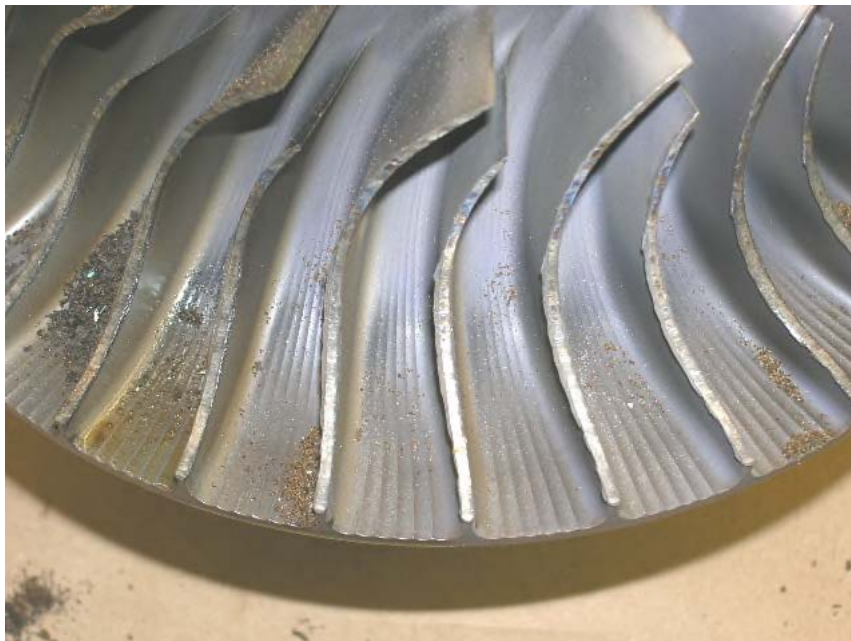
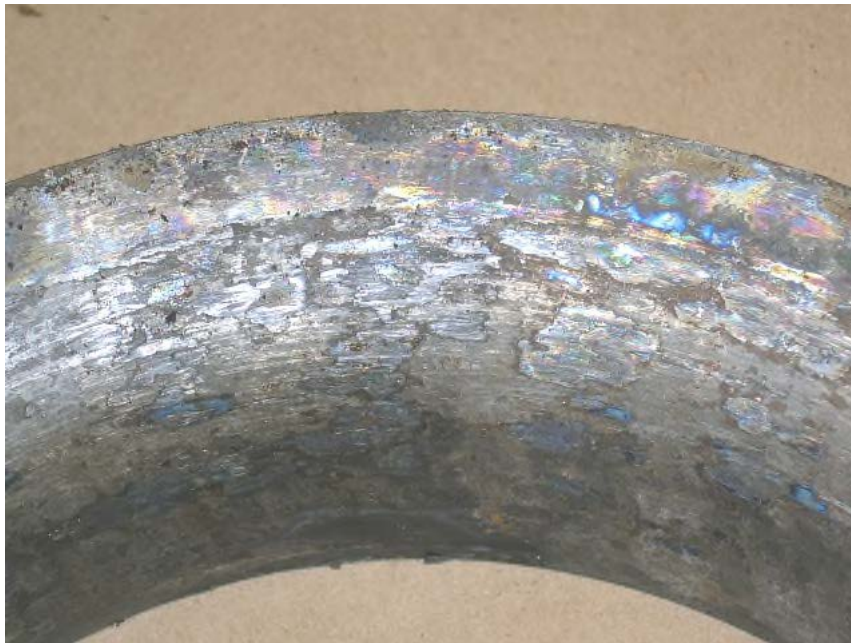
Centrifugal Impeller and Shroud: Loose ingested soil was observed distributed through the impeller prior to disassembly. The impeller vanes and shroud displayed severe circumferential contact rubbing, with heavy frictional heat discoloration and material smearing. Please refer to photos No. 16 through 19.

Photo No. 16
Centrifugal impeller and shroud outlet, detail.

Photo No. 17
Centrifugal impeller and shroud.

Photo No. 18
Centrifugal impeller, detail.

Photo No. 19
Centrifugal impeller shroud.

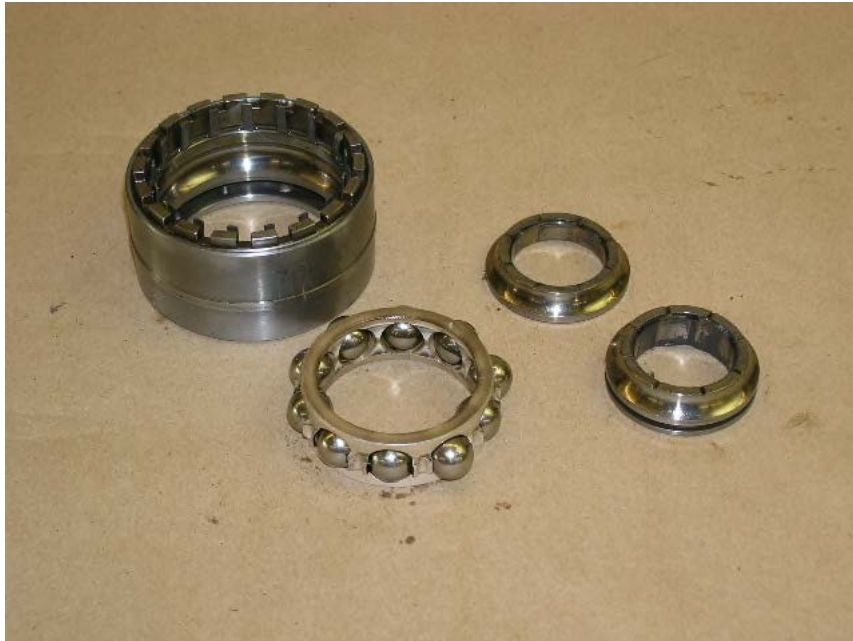
No. 1 Bearing and Air seals: The bearing displayed no indications of distress. Please refer to photo No. 20.

Photo No. 20
No. 1 bearing.

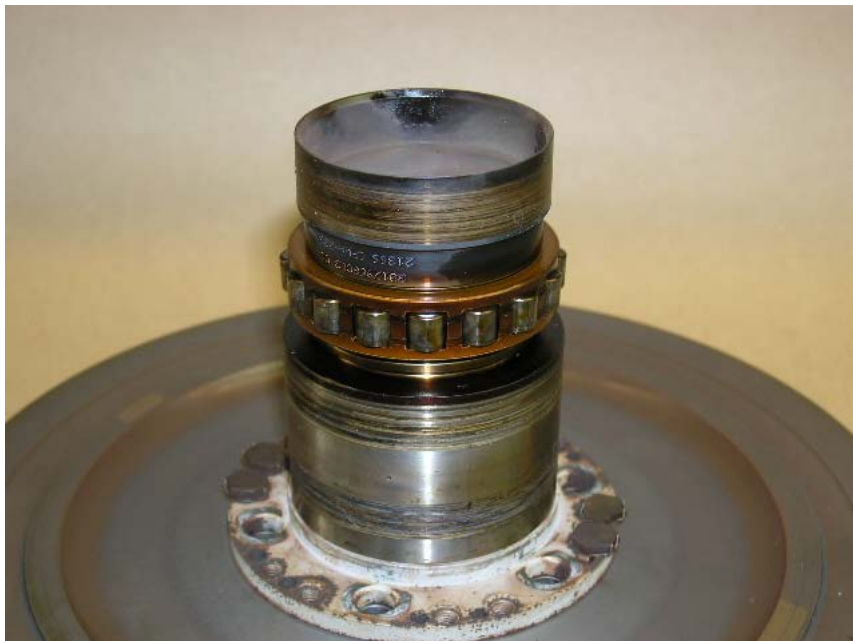
No. 2 Bearing and Air seals: The bearing displayed no indications of distress. The air seal rotors displayed circumferential rubbing and scoring due to contact with the stator knife edges. Please refer to photo No. 21.

Photo No. 21
No. 2 bearing and air seal rotors, in-situ.

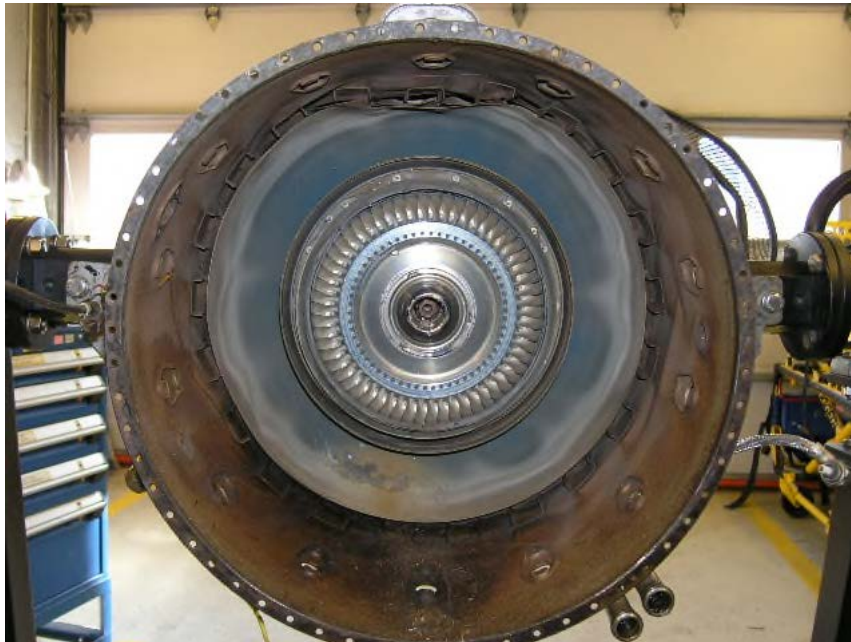
Photo No. 22

Large Exit Duct: Displayed no operational distress. The flame pattern indications were normal. Please refer to photos No. 22 and 23.

Gas generator case interior, large exit duct and compressor turbine, in-situ.

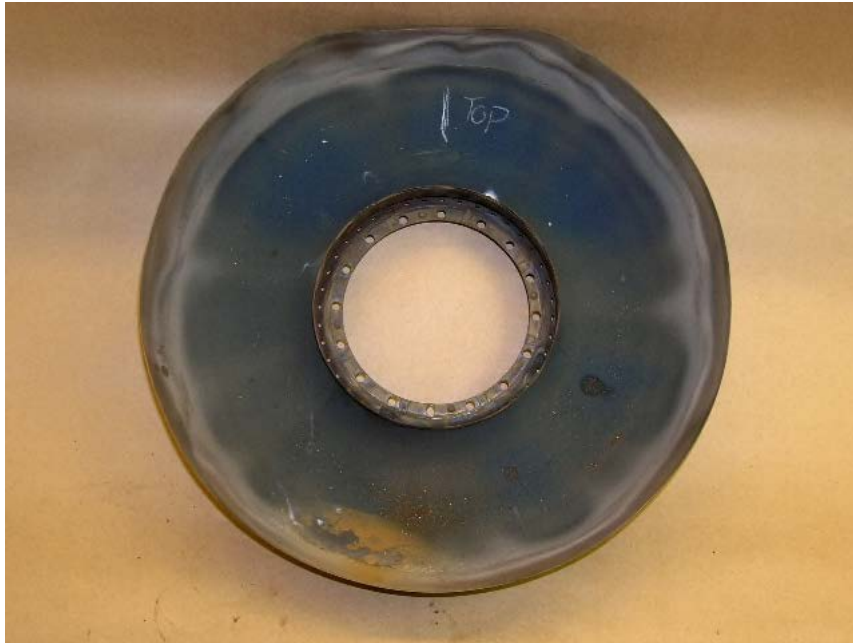
Photo No. 23
Large exit duct.

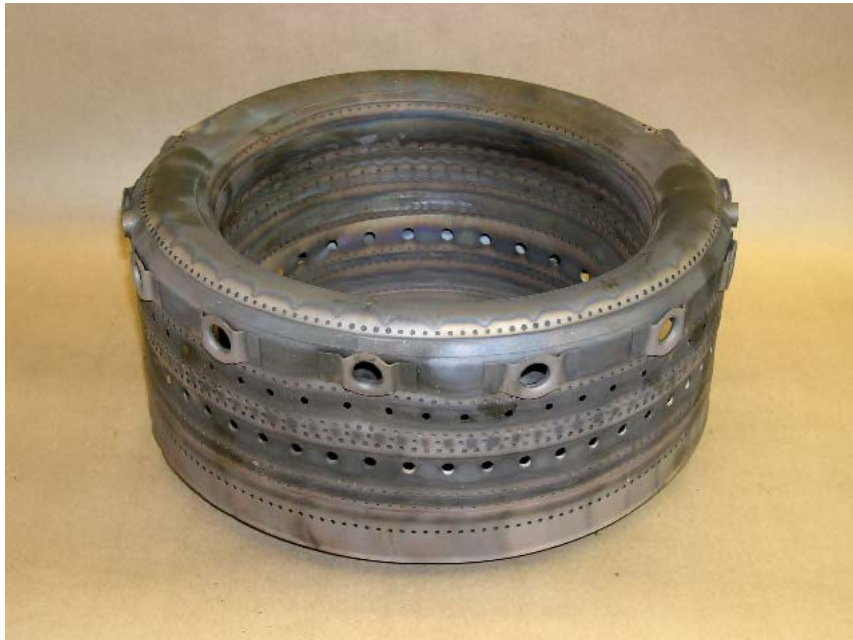
Combustion Chamber Liner: Displayed no operational distress. Please refer to photos No. 24 and 38.

Photo No. 24
Combustion chamber liner.

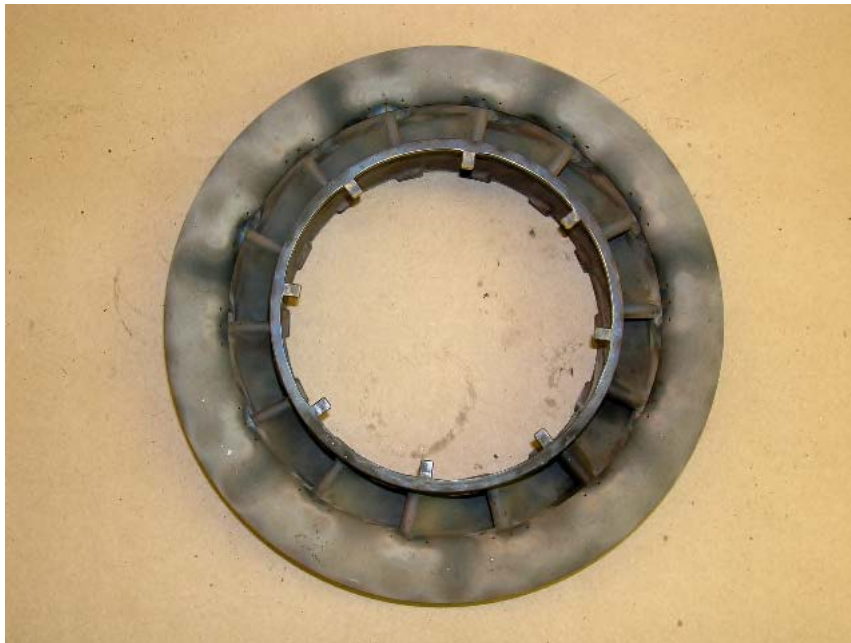
Photo No. 25

Small Exit Duct: Displayed minor heat erosion, with no operational distress. Please refer to photo No. 25.

Compressor Turbine Guide Vane Ring: The vane airfoils displayed no operational distress. The inner drum downstream side displayed circumferential machining, with frictional heat discoloration, due to contact with the compressor turbine. Please refer to photos No. 25 through 27.

Small exit duct and compressor turbine guide vane ring, upstream side.

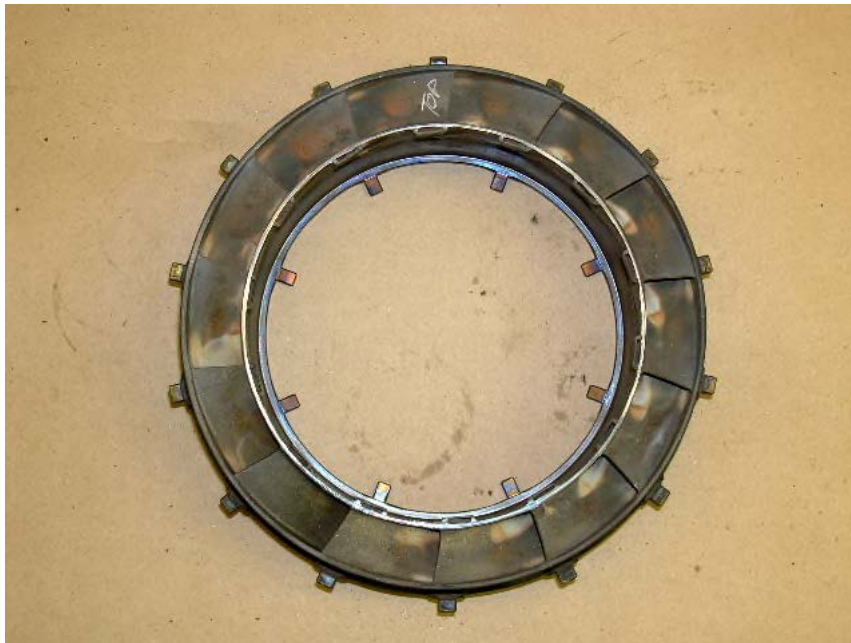
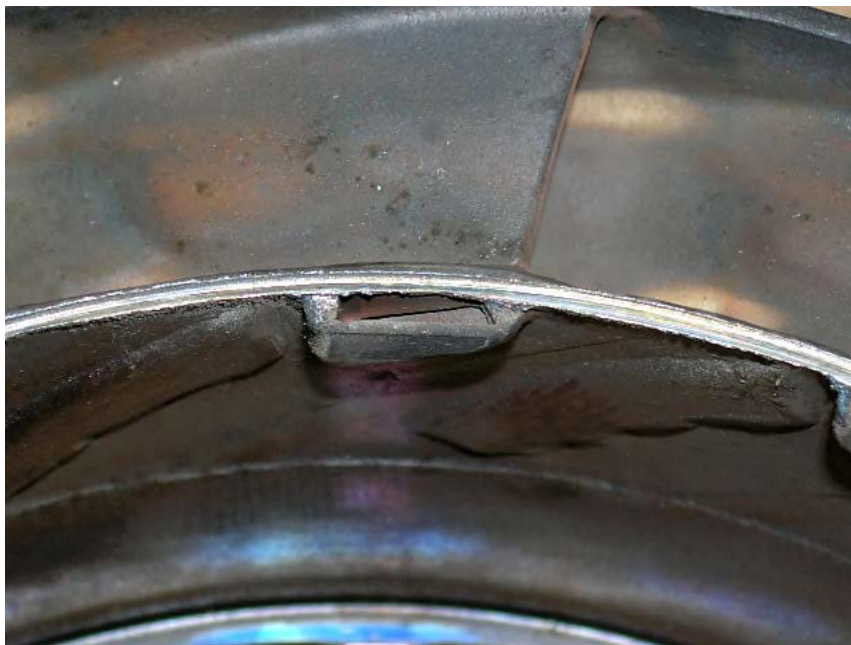
Photo No. 26
Compressor turbine guide vane downstream side.

Photo No. 27
Compressor turbine guide vane ring downstream side, detail.

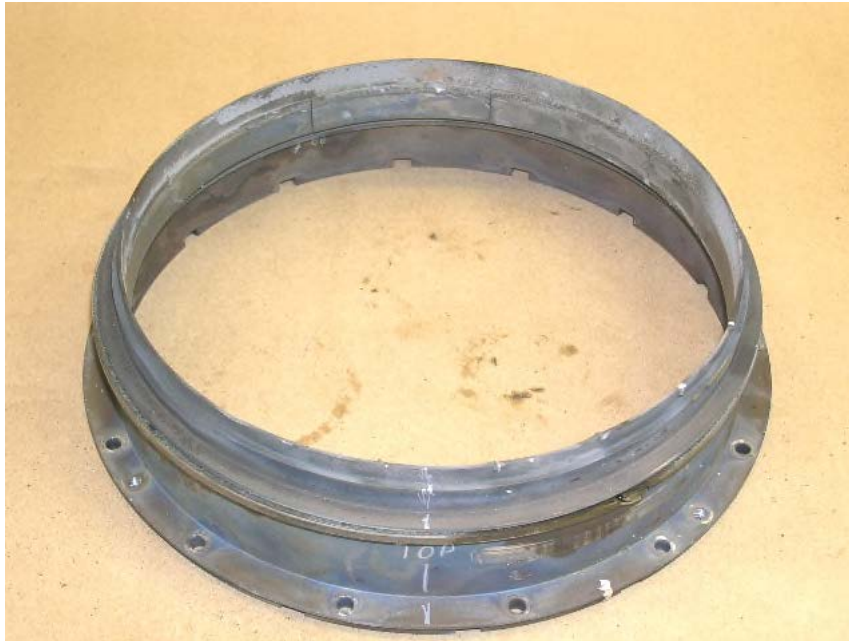
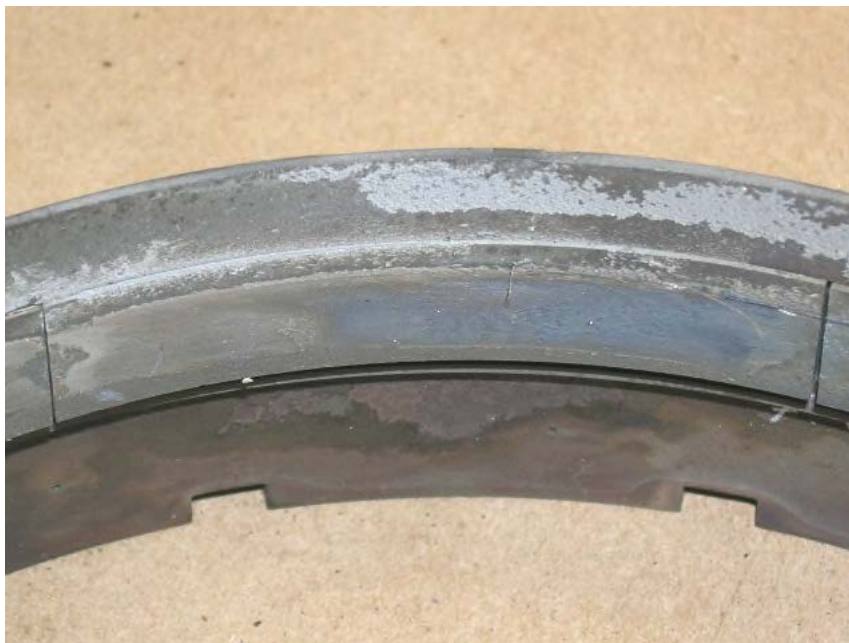
Compressor Turbine Shroud: Displayed heavy circumferential rubbing, with frictional heat discoloration and material smearing, due to contact with the compressor turbine blades. Please refer to photos No. 28 and 29.

Photo No. 28
Compressor turbine shroud.

Photo No. 29
Compressor turbine shroud lower circumference, detail.

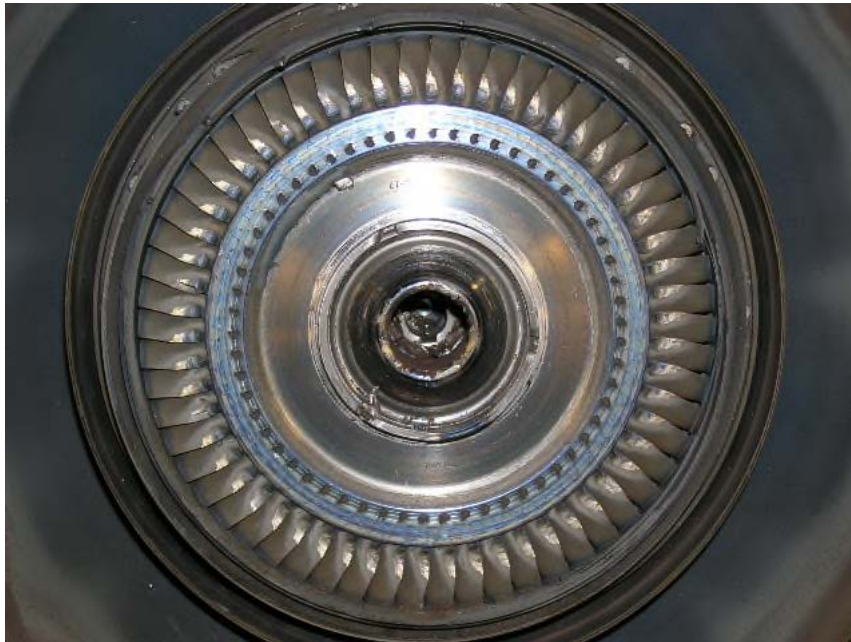
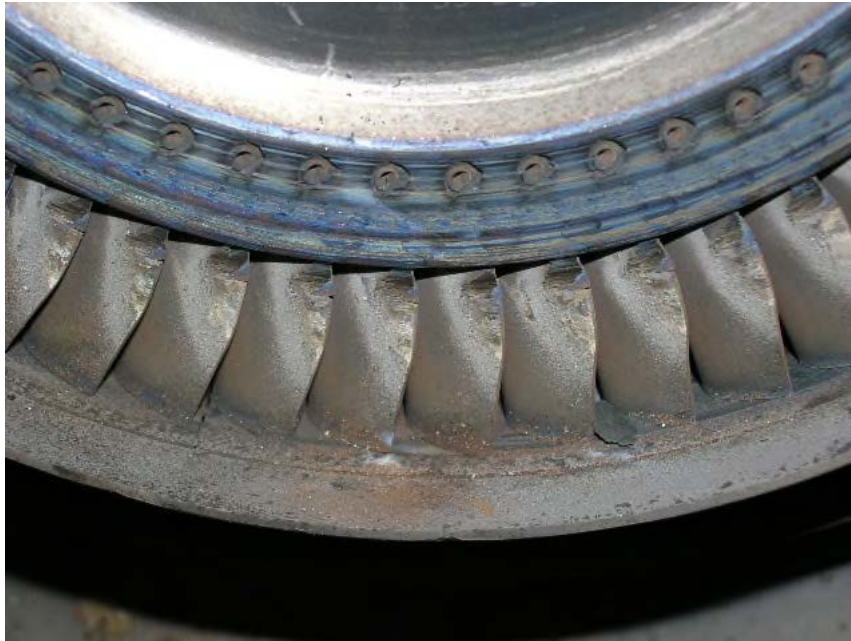
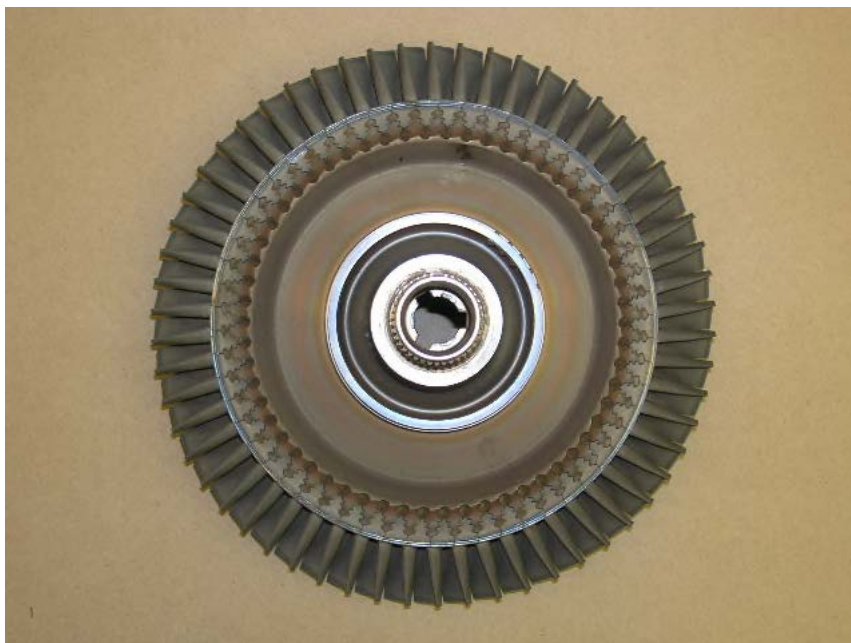
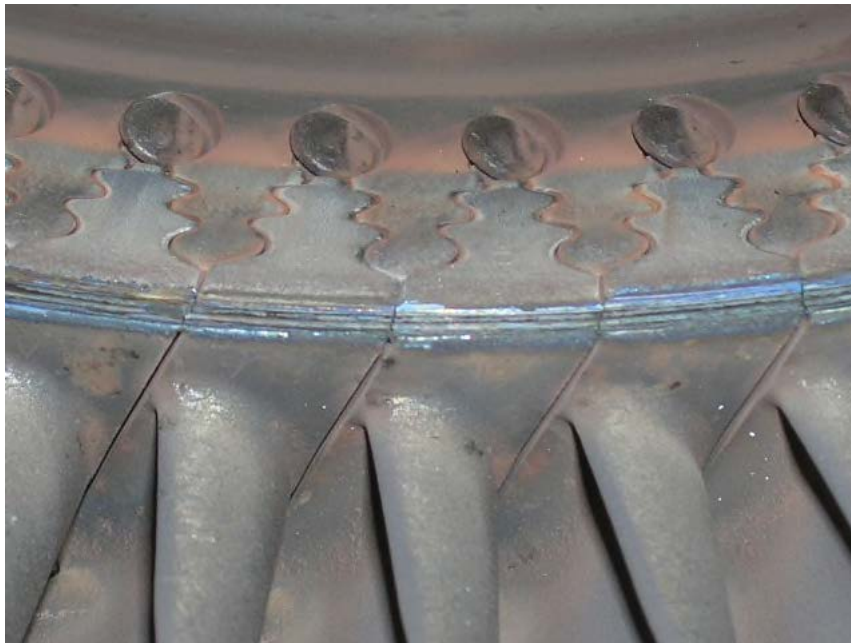
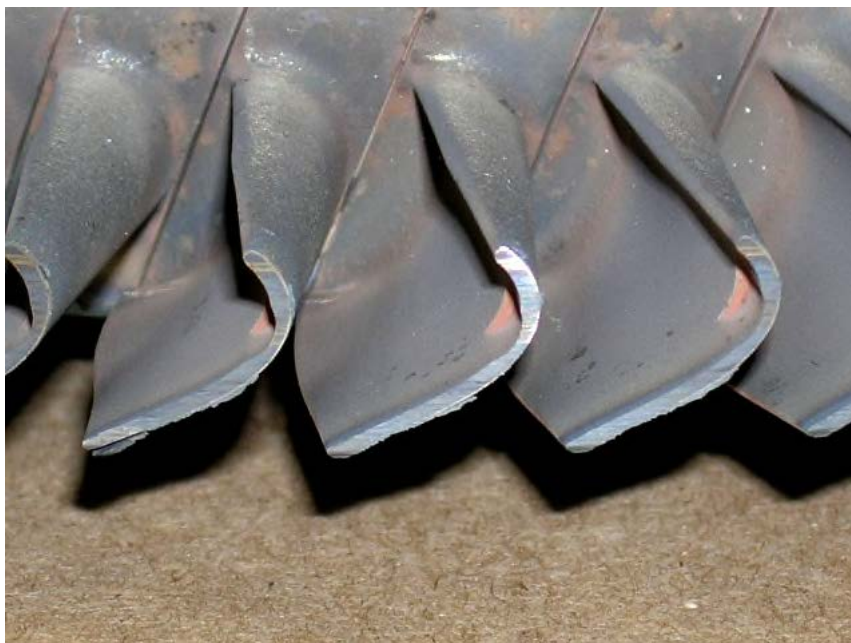
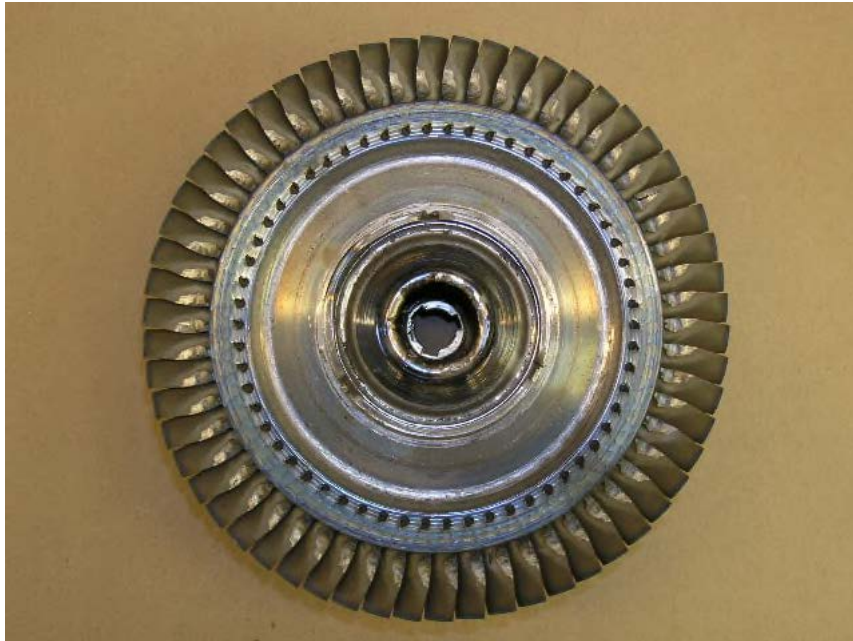
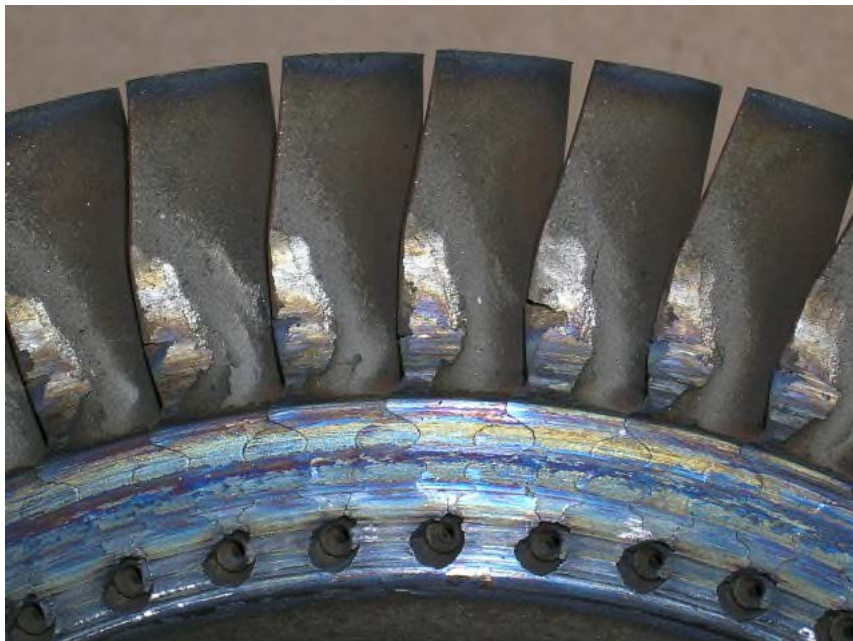
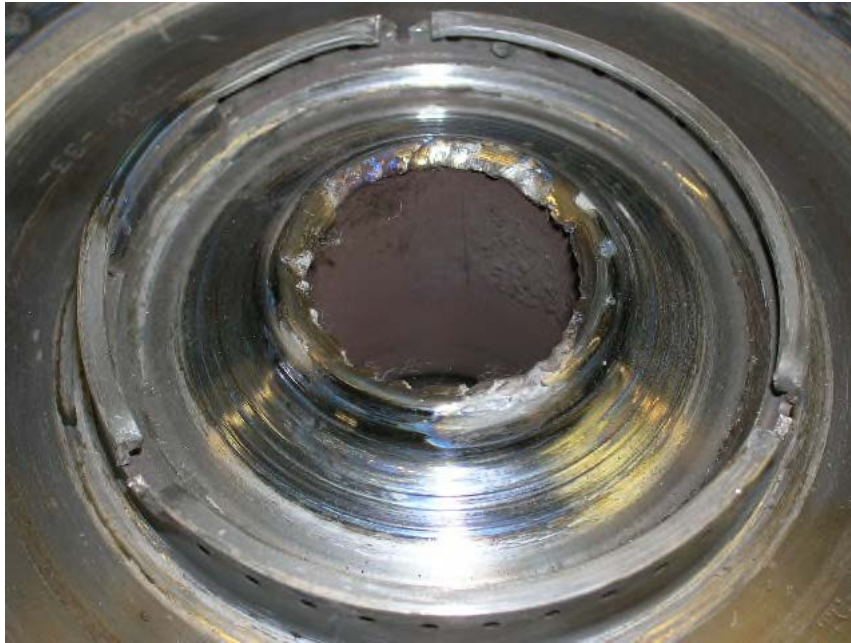
Compressor Turbine: The blade airfoils displayed no indications of operational distress. The blade tips displayed heavy circumferential rubbing, with frictional heat discoloration and material smearing, due to contact with the adjacent shroud. The upstream side disc outer rim and blade platforms displayed circumferential machining, with frictional heat discoloration, due to contact with the compressor turbine guide vane ring. The blade airfoil trailing edges displayed circumferential machining and deformation, and the disc downstream side displayed severe circumferential rubbing, with heavy frictional heat discoloration and material smearing, due to contact with the power turbine guide vane ring and interstage baffle. The downstream side disc hub displayed heavy circumferential machining due to contact with the power turbine disc, though the interstage baffle. Please refer to photos No. 30 through 37.

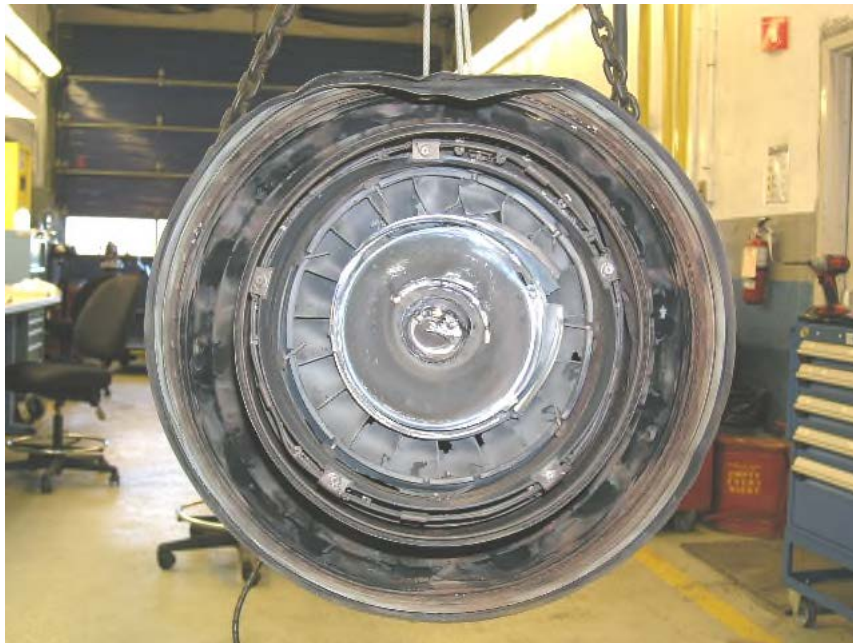
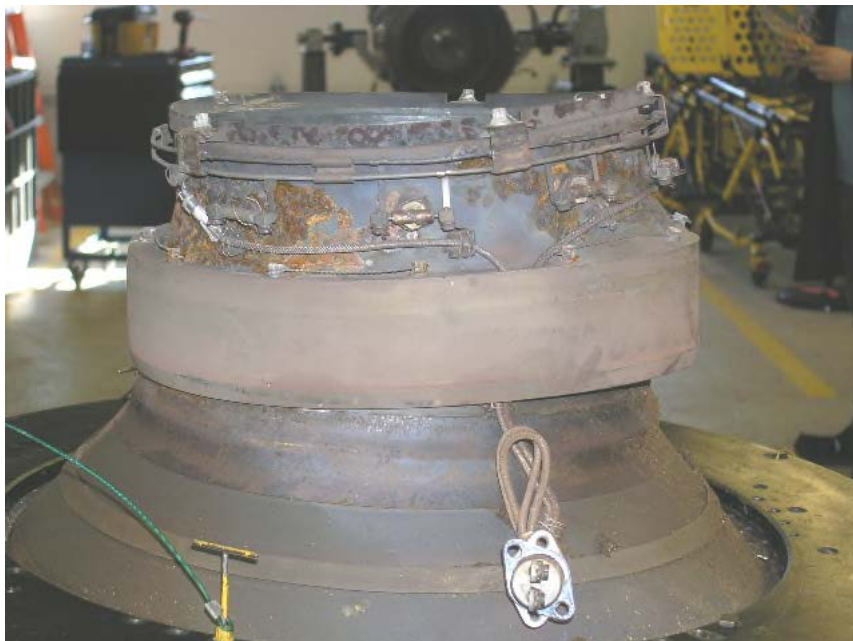
ITT Probes, Busbar, and Harness: The probes displayed impact deformation due to contact with the power turbine guide vane ring. The probes displayed no burning or other indications of operational distress. Please refer to photos No. 38 through 41.

Power Turbine Housing: Displayed impact deformation around the upper circumference due to deformation of the exhaust duct and power turbine shaft. Please refer to photos No. 38 and 39.

Power Turbine Guide Vane Ring and Interstage Baffle: The vane ring and airfoils were impact fractured around the right hand circumference and the interstage baffle was displaced due to contact with the power turbine. The upstream side inner drum and baffle face displayed severe circumferential rubbing and machining, with heavy frictional heat discoloration, due to contact with the compressor turbine. The downstream side vane ring, airfoils, and baffle face displayed heavy circumferential rubbing and machining, with heavy frictional heat discoloration due to contact with the power turbine. The baffle was machined completely through the material in localised areas. Please refer to photos No. 38 through 47

Power turbine housing, power turbine guide vane ring, and combustion chamber, in-situ.

Power turbine housing right hand side.
