NATIONAL TRANSPORTATION SAFETY BOARD

Group Chairman's Factual Report

ANC15MA041

**Promech Air Inc.
de Havilland DHC-3 Reg. N270PA
Ketchikan, Alaska
25 June 2015
PT6A-135A Engine
S/N 35056**

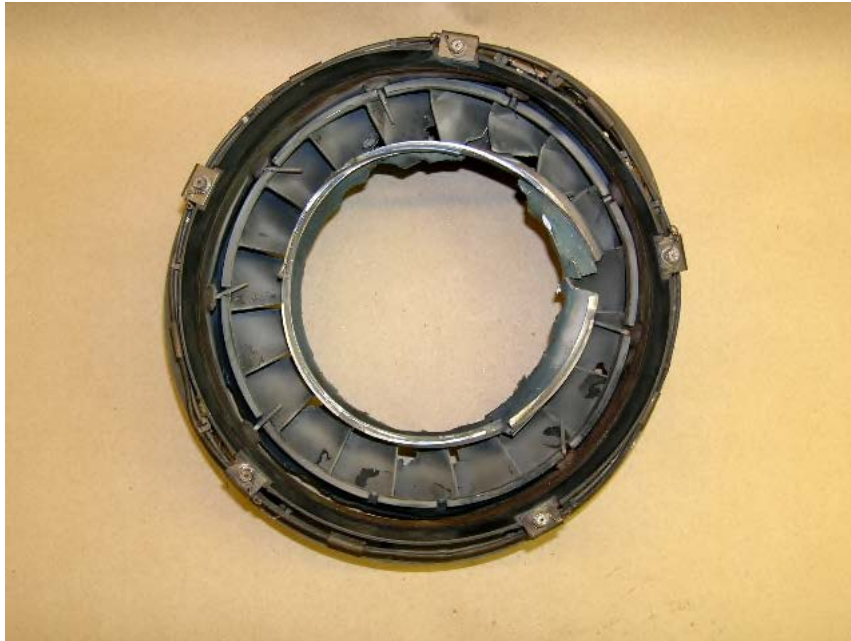
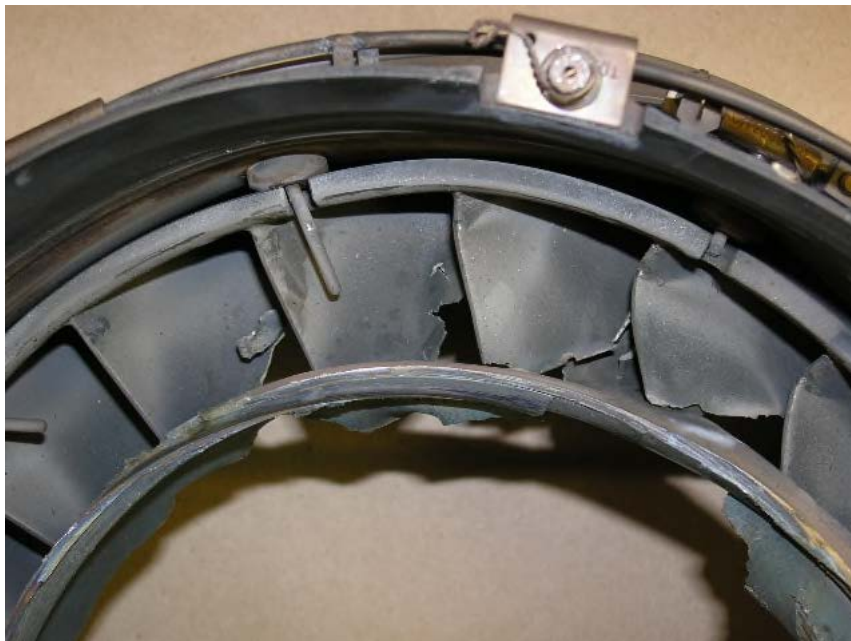
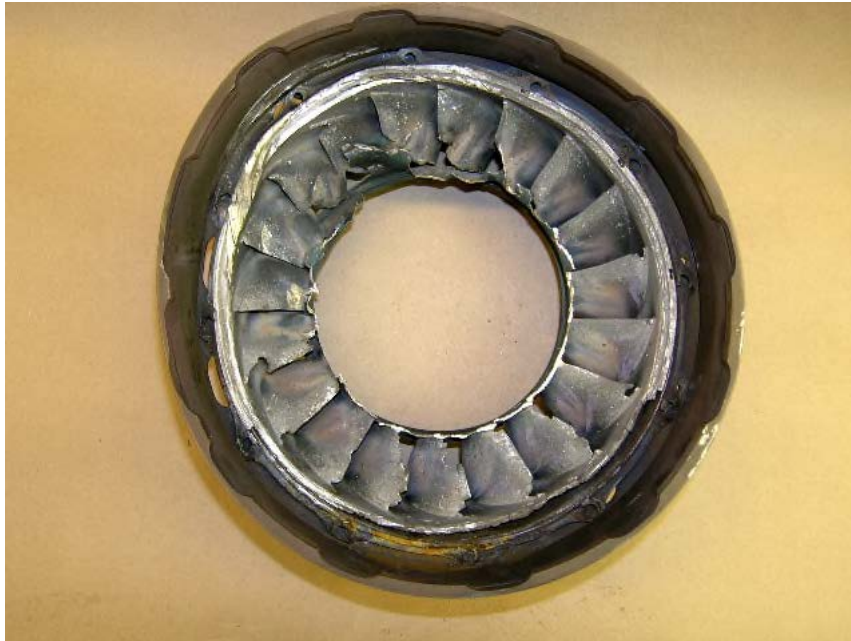
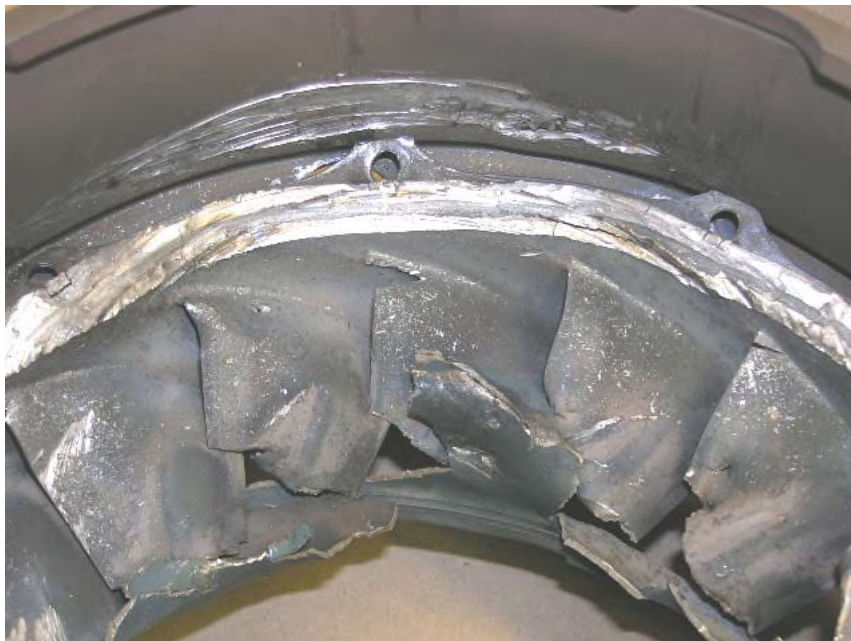
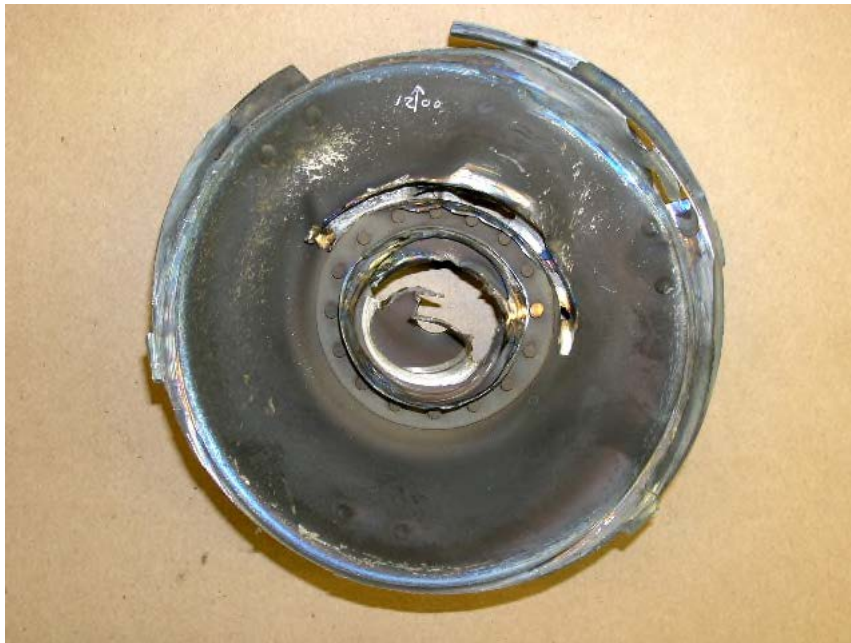
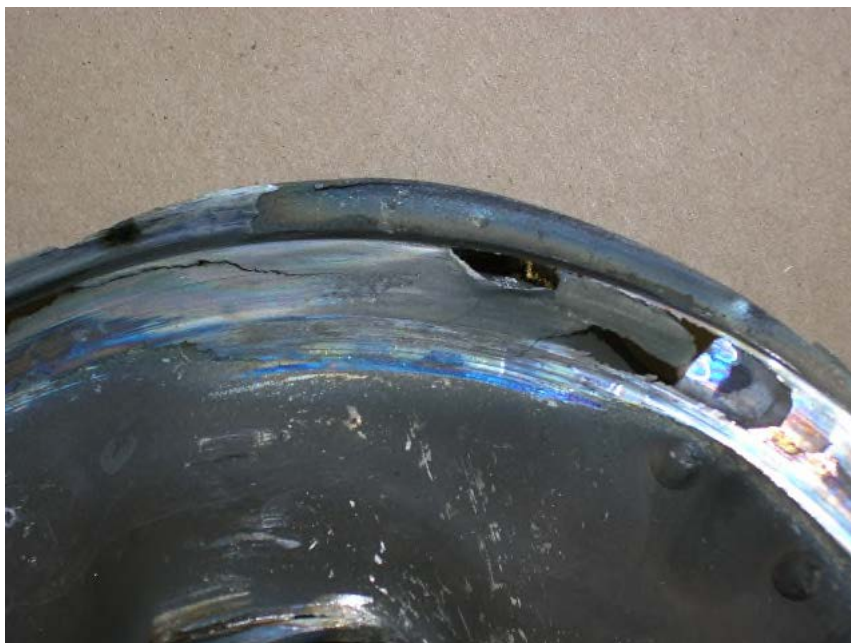
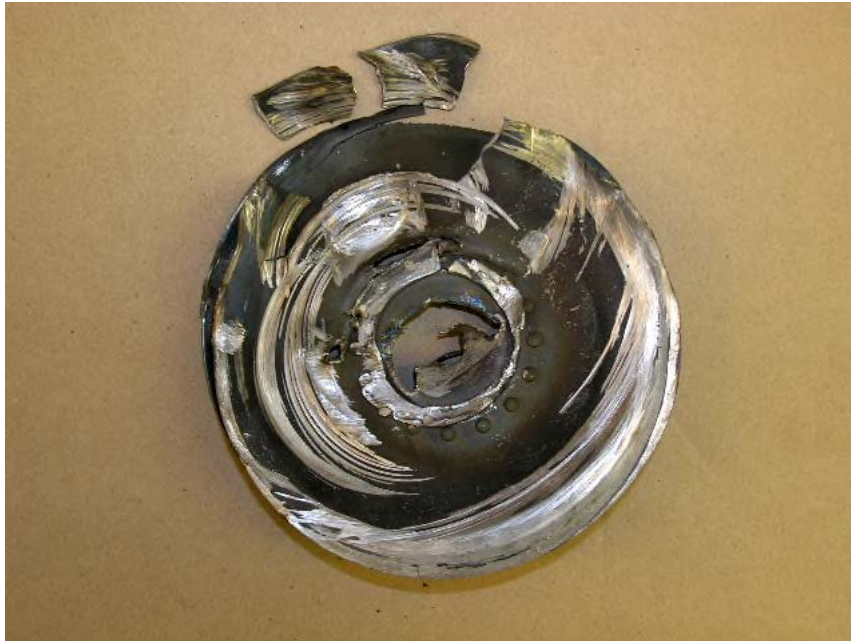
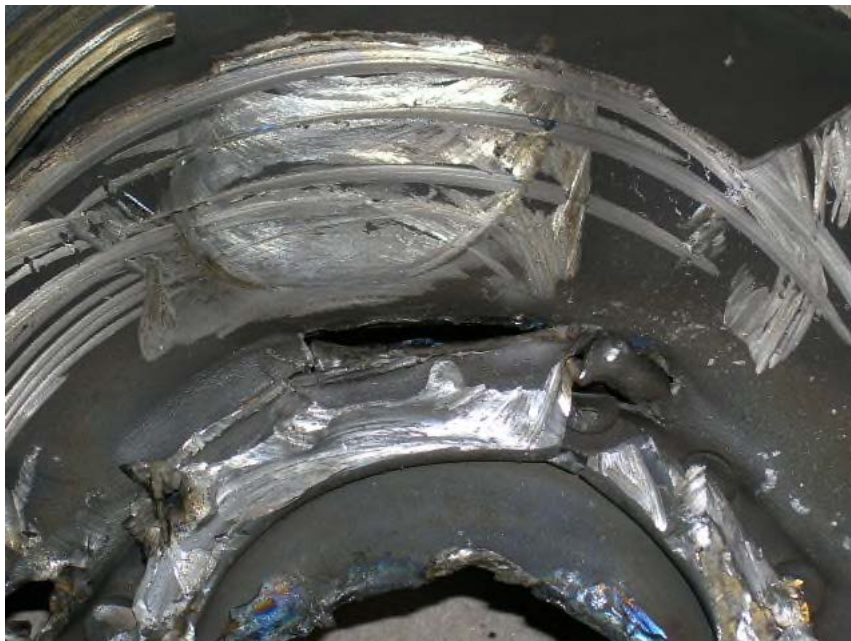
Power Turbine Guide Vane Ring and Interstage Baffle: The vane ring and airfoils were impact fractured around the right hand circumference and the interstage baffle was displaced due to contact with the power turbine. The upstream side inner drum and baffle face displayed severe circumferential rubbing and machining, with heavy frictional heat discoloration, due to contact with the compressor turbine. The downstream side vane ring, airfoils, and baffle face displayed heavy circumferential rubbing and machining, with heavy frictional heat discoloration due to contact with the power turbine. The baffle was machined completely through the material in localised areas. Please refer to photos No. 38 through 47

Power turbine housing and power turbine guide vane ring, upstream side.

Power turbine guide vane ring upstream side, detail.

Power turbine housing and power turbine guide vane ring, downstream side.

Power turbine housing and power turbine guide vane ring downstream side, detail.
Centred at the approximate 1:00 position.

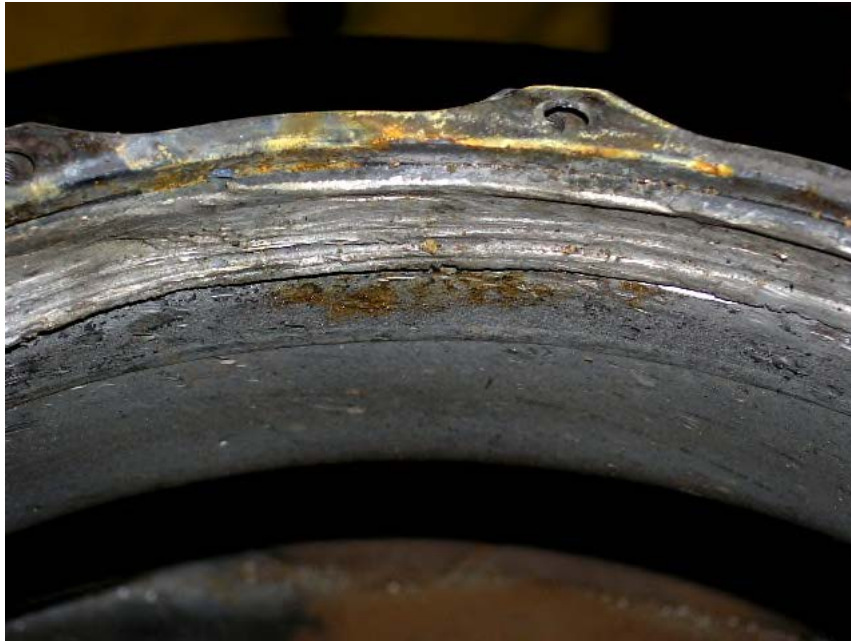
Photo No. 48

Power Turbine Shroud: Displayed heavy circumferential rubbing and machining, with frictional heat discoloration and material smearing, due to contact with the power turbine disc. Please refer to photos No. 48 and 49.

Power turbine shroud lower circumference, detail.

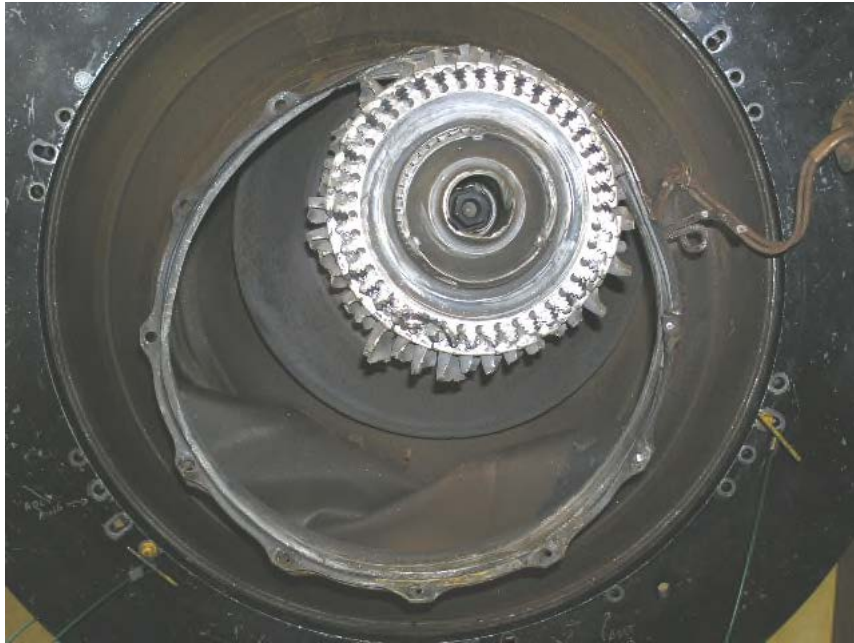
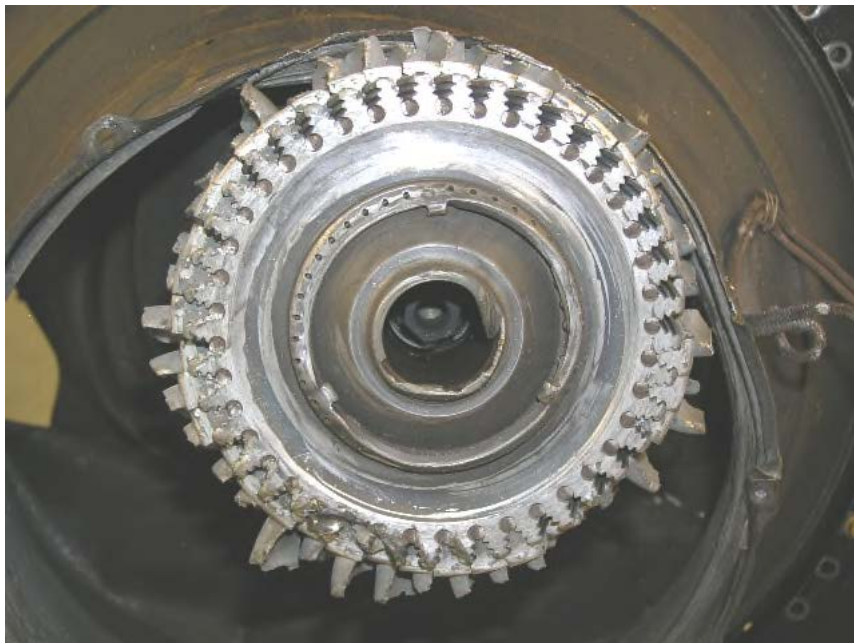
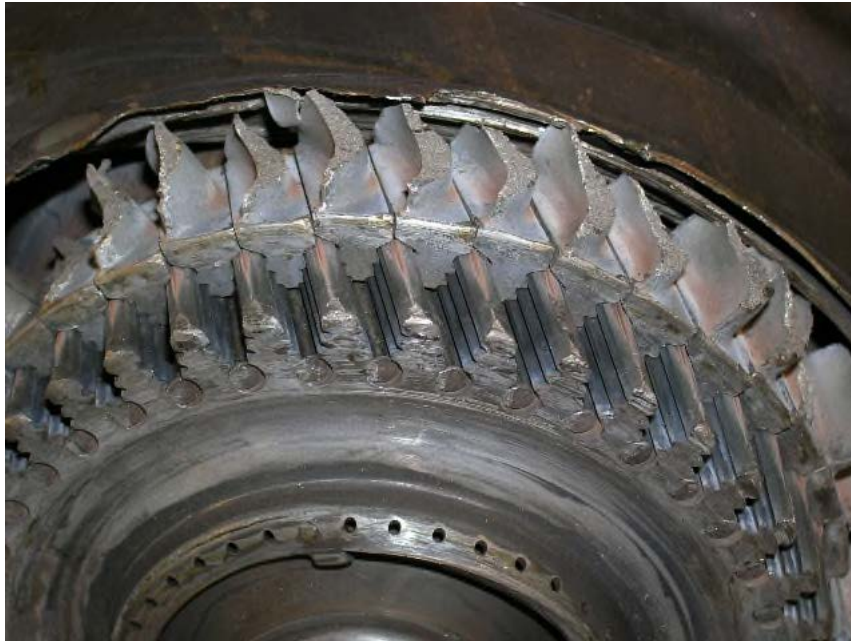
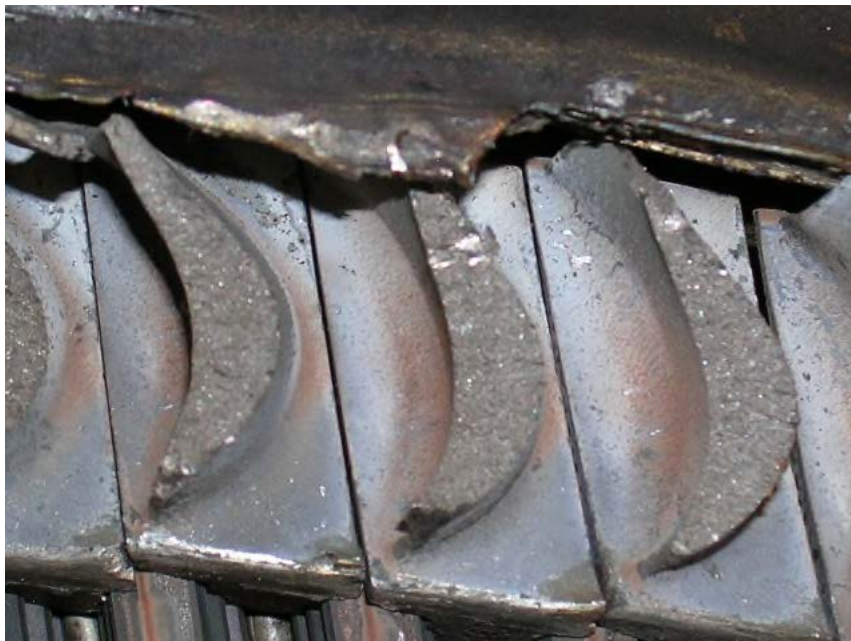
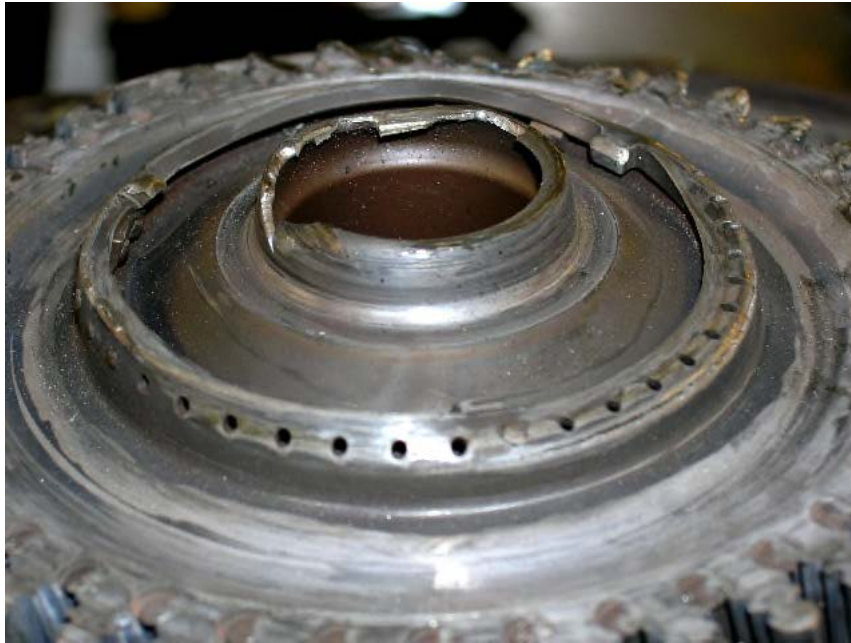
Power Turbine: The power turbine was displaced sharply to the approximate 1:00 position due to deformation of the exhaust duct and power turbine housing. The blades airfoils were impact fractured and displaced forward in their serrated fixings due to contact with the shroud, housing, and power turbine guide vane ring. Under unaided visual and macroscopic inspection the airfoil fracture surfaces displayed coarse granular features with no indications of fatigue or other progressive fracture mechanism. The disc face and blade platforms displayed heavy circumferential rubbing, machining, and deformation due to contact with the power turbine guide vane ring and compressor turbine disc. Please refer to photos No. 49 through 53.

Photo No. 49
Power turbine downstream side, in-situ.

Photo No. 50
Power turbine downstream side, in-situ.

Photo No. 51
Power turbine downstream side, in-situ, detail.

Photo No. 52
Power turbine blade roots, detail

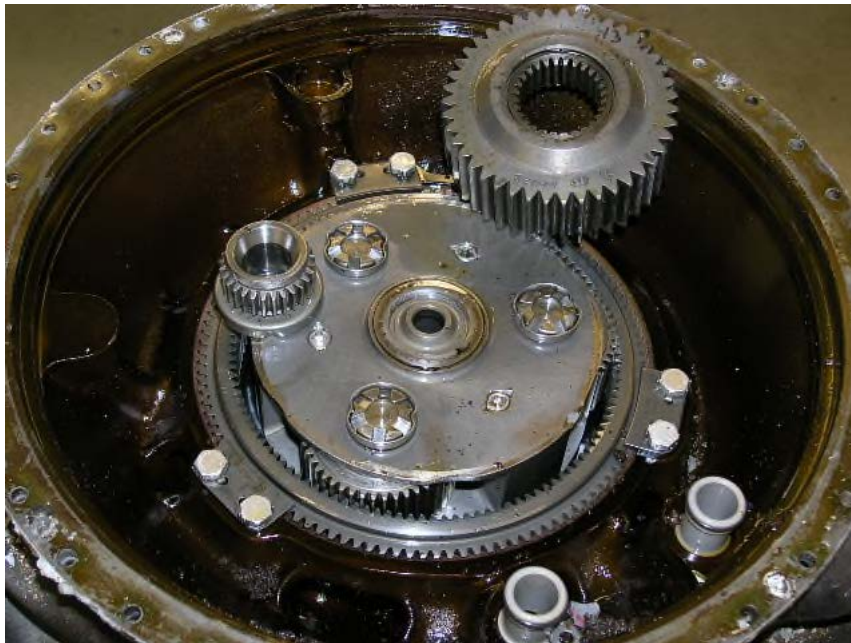
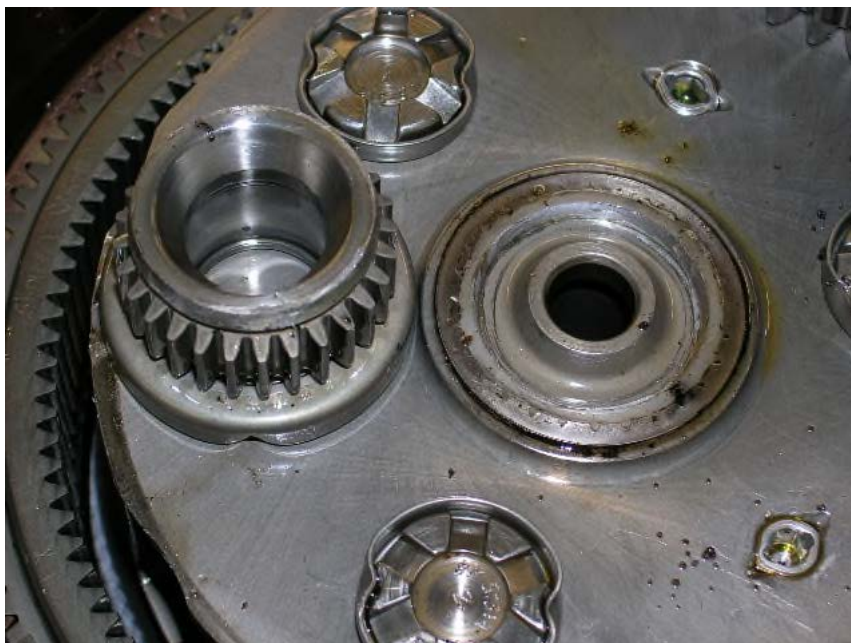
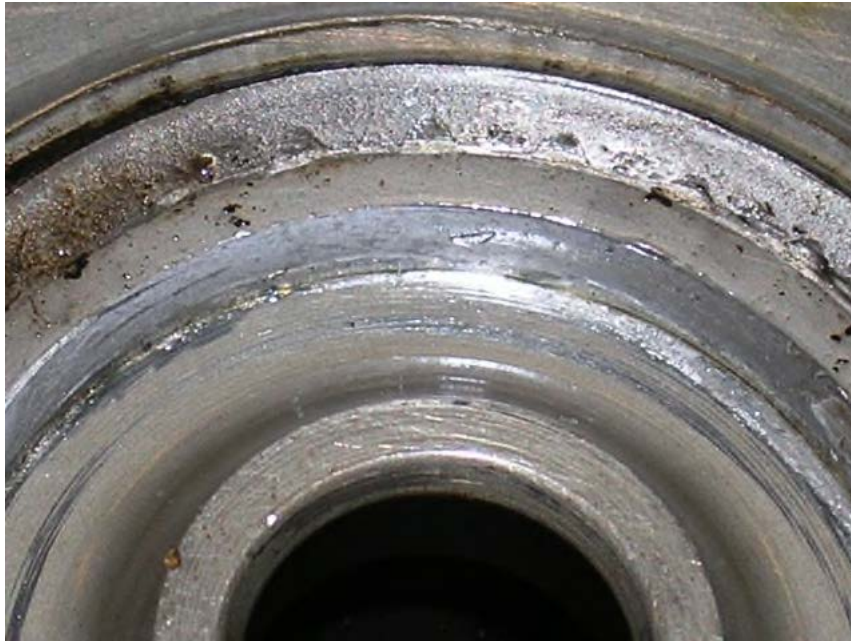
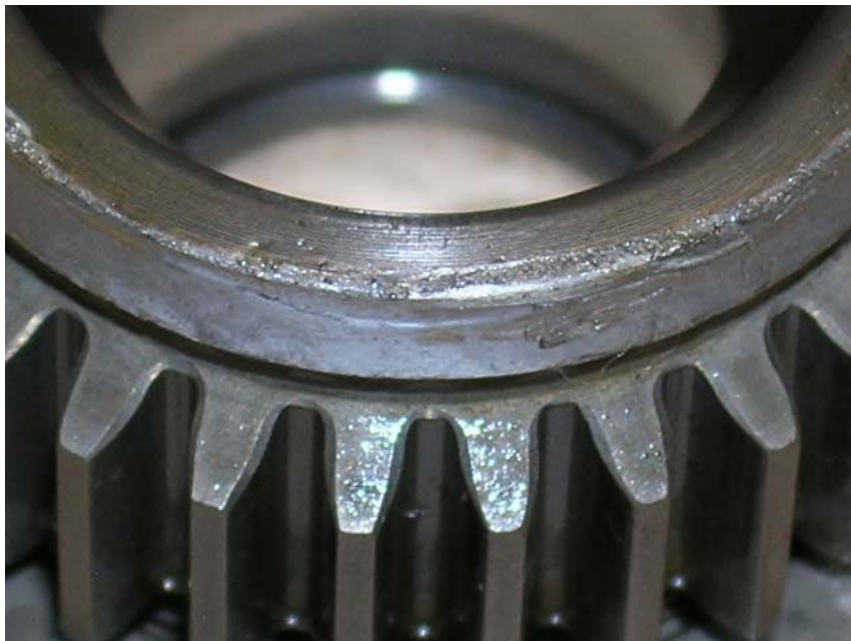
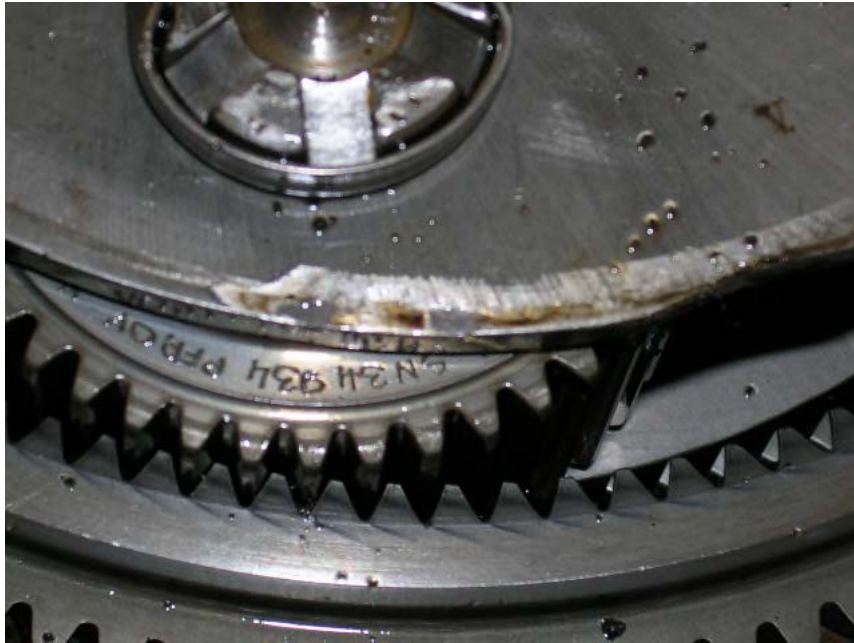
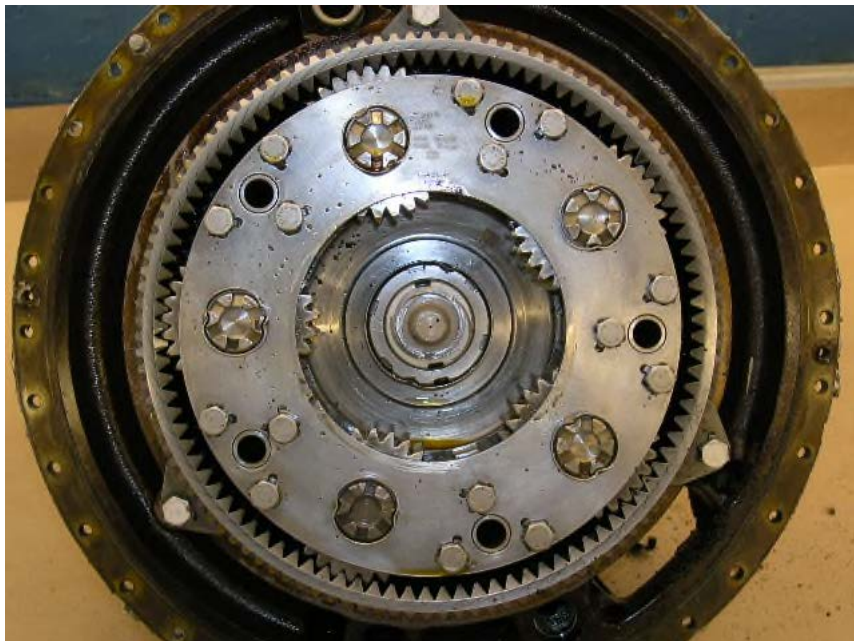
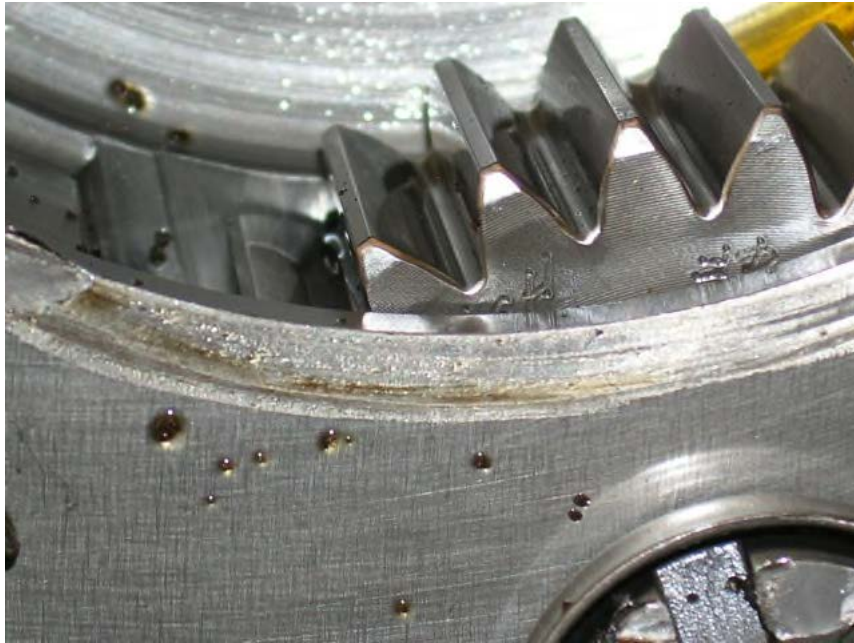
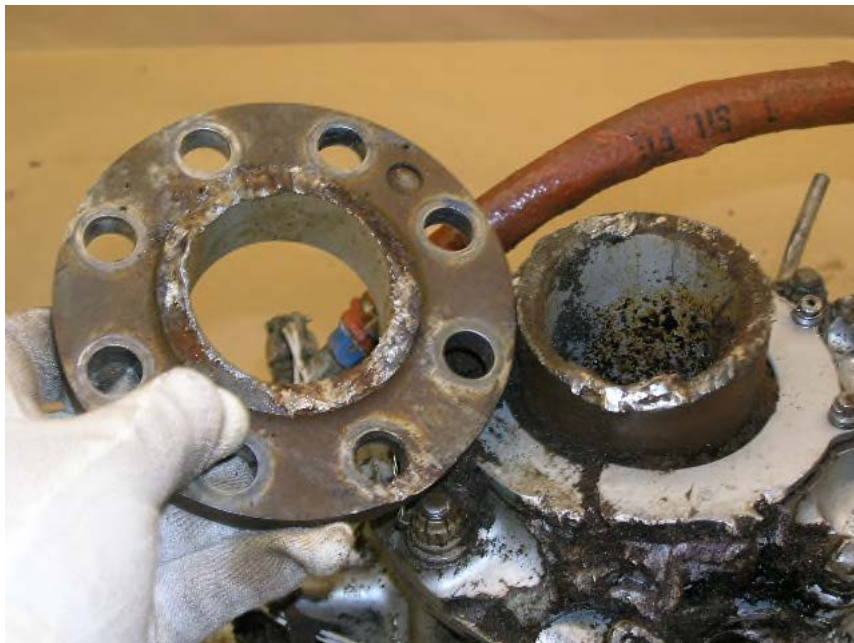
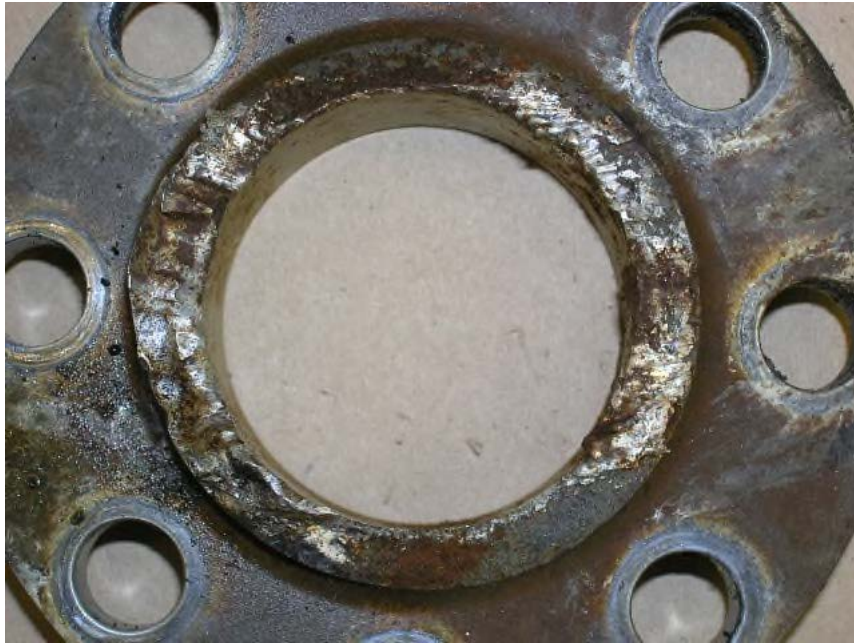
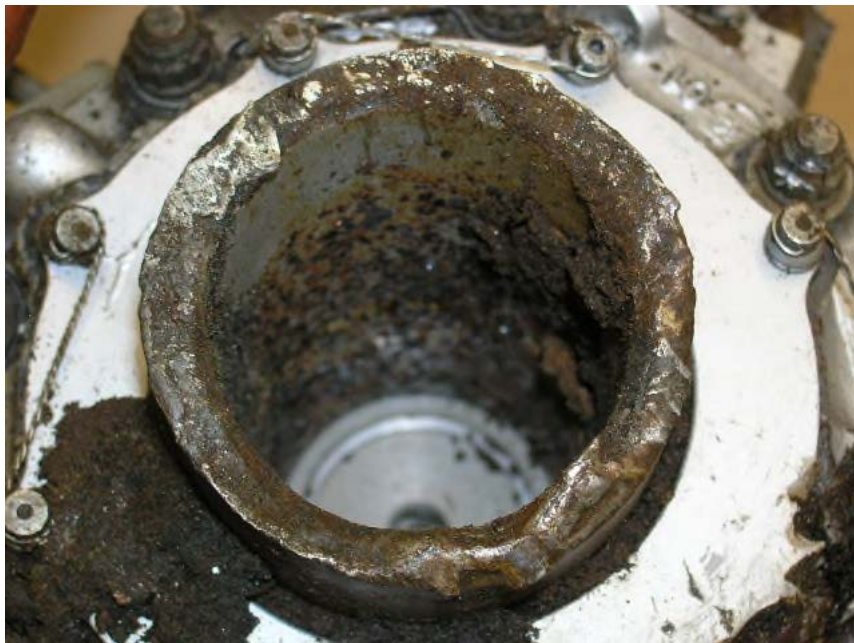
The propeller shaft was impact fractured immediately aft of the propeller mounting flange. Unaided visual and macroscopic inspection of the fracture surfaces showed coarse granular features with collateral circumferential rubbing. The fracture surfaces displayed no indications of fatigue or other progressive fracture mechanism. The 1st stage planet gear carrier spline coupling to the 2nd stage sun gear was impact fractured at the carrier web. Unaided visual and macroscopic inspection of the fracture surfaces showed coarse granular features with collateral circumferential rubbing. The fracture surfaces displayed no indications of fatigue or other progressive fracture mechanism. The 1st and 2nd stage carrier webs displayed circumferential rubbing, with frictional heat discoloration, due to their making axial contact. The reduction gearbox 1st and 2nd stage gearing displayed no indications of operational distress. Please refer to photos No. 54 through 62.

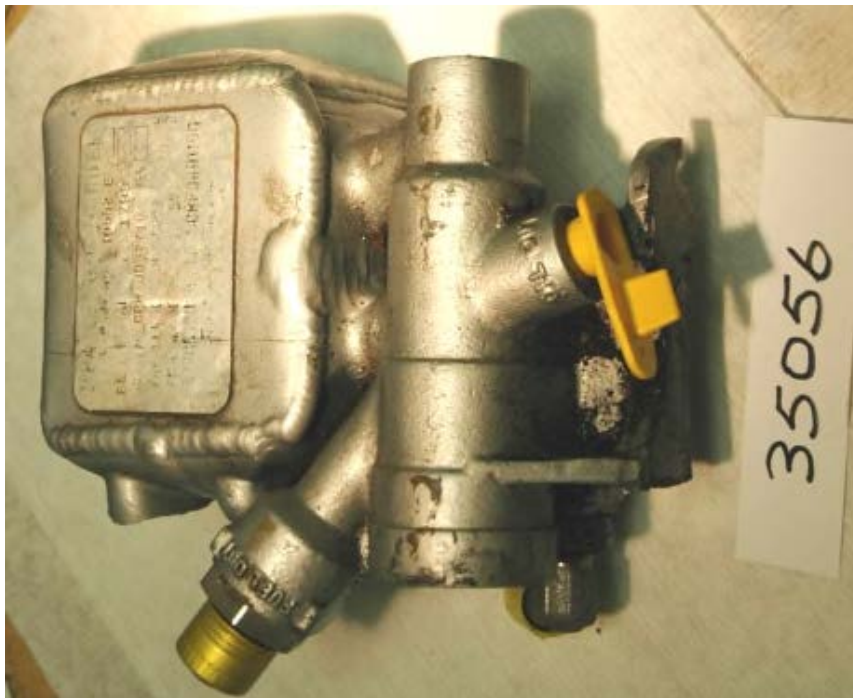
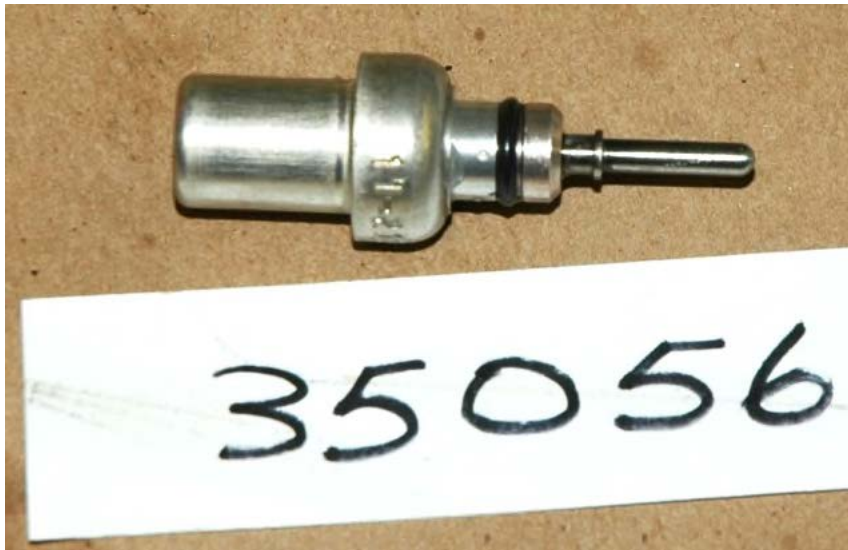
Fuel Heater: The unit displayed impact damage including impact fracture of the mounting foot and the fuel inlet fitting. Functional testing of the thermal element showed limited travel toward the full cold position due to impact damage. Please refer to photos No. 64 and 65.

Photo No. 64
Oil to fuel heater.

Photo No. 65
Fuel heater thermal element.

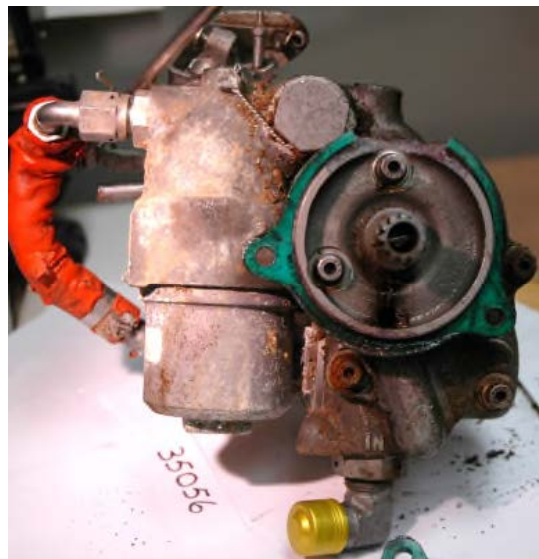
Fuel Pump: Impact damage included partial fracture of the mounting pad. Functional testing was satisfactory with minor deviations not affecting normal operation. Please refer to photos No. 66 and 67.

Photo No. 66
High pressure fuel pump.

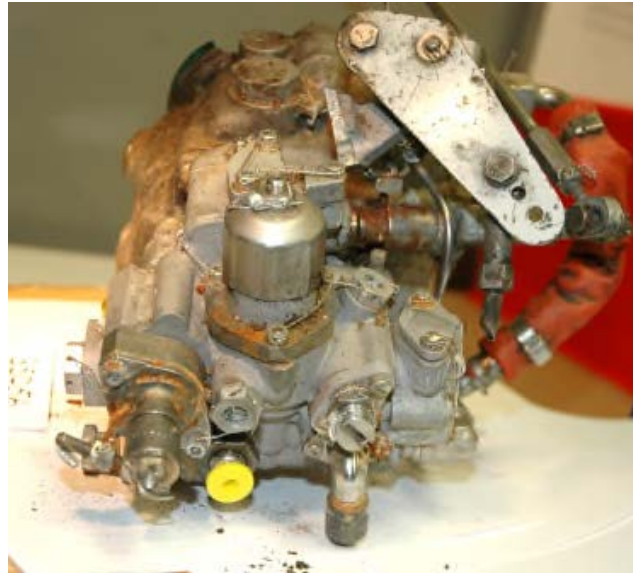
Photo No. 67

Fuel Control Unit: Impact damage included deformation of the input lever to the maximum flow position and deformation of the condition lever assembly. Functional testing was limited to operation at the fixed input lever position and showed no conditions limiting full power operation. Disassembly and inspection revealed no pre-impact conditions that would preclude normal operation. Please refer to photos No. 67 and 68.

Fuel control unit and high pressure fuel pump.

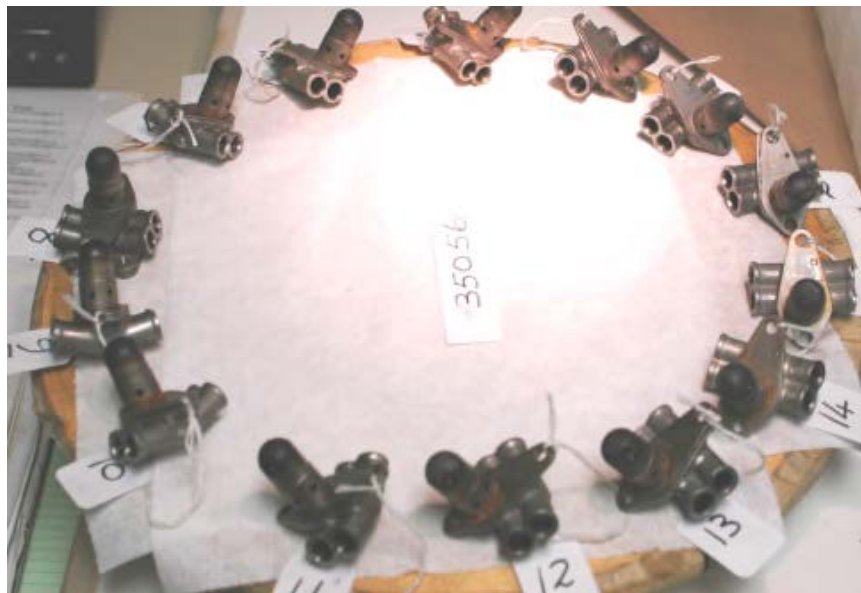
Photo No. 70

Fuel Nozzles: Functional testing of the fuel nozzles showed streaking of the nozzle flows in excess of the return to service specifications. The condition of the large exit and compressor turbine guide vane did not reflect any streaking or other flow anomaly of the fuel nozzles in operation prior to impact. Please refer to photos No. 70, and 23, and 25.

Fuel nozzle assemblies.

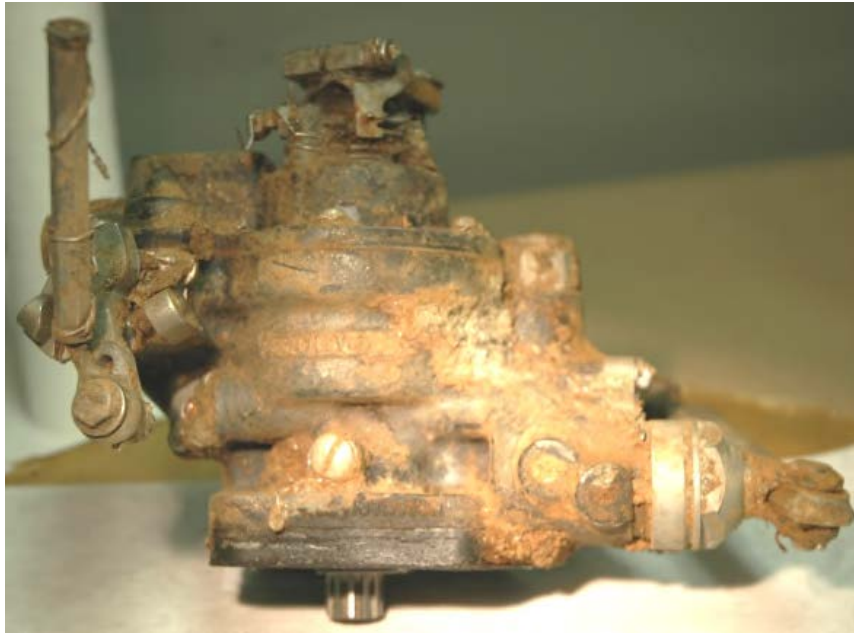
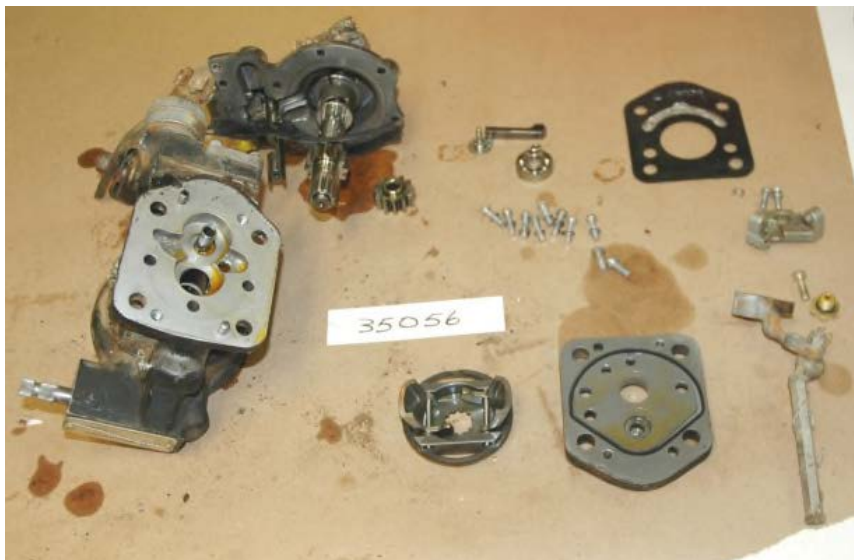
Propeller Governor: Impact damage included limitation of travel of the speed setting lever and the reset arm. The input shaft could not be rotated by hand. This impact damage precluded functional testing. Disassembly and inspection showed no conditions affecting normal operation prior to impact. Please refer to photos Nos. 72 and 73.

Photo No. 72
Propeller governor.

Photo No. 73
Propeller governor, as disassembled.
