NATIONAL TRANSPORTATION SAFETY BOARD

Group Chairman's Factual Report

ANC15MA041

**Attachment 4 – Hartzell Propeller Report No. 150625
(15 pages)**

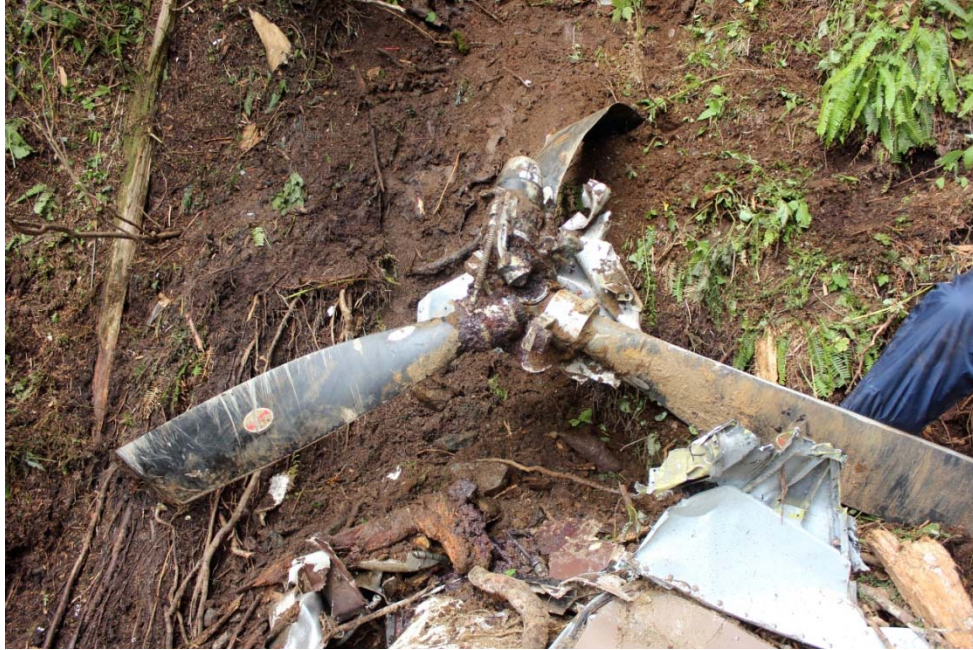
Photo #1

The propeller fractured off the engine at the propeller shaft flange during impact and was found near the airframe wreckage as shown in Photo #1. The propeller was relocated from the crash scene to Temsco Helicopter for examination (see Photo #2). All three blades remained attached to the propeller hub. Approximately 5” of tip fractured from two blades during impact and the tip fragments were recovered at the crash scene. Approximately 95% of the spinner dome had fractured/torn from the spinner bulkhead. Approximately one-third of the spinner bulkhead was torn from the propeller assembly. All blade clamps and counterweights were intact. Impact forces fractured/pried the piston-cylinder assembly off the hub mounting but it remained attached to the propeller assembly by two link arms and two beta rods (see Photo #3). The propeller assembly had tree debris (bark and sawdust type material) and dirt packed into the hub and around the blades. The beta ring was pulled forward and crushed, crimping a piece of fiberglass in the ring channel; the beta ring remained attached to two of three beta rods. The feathering springs remained intact and retained by the spring keepers. The aft two inches of the pitch change rod was bent approximately 30 degrees off the rotation axis. All three blades exhibited chordwise scoring and leading edge (LE) impact gouges indicating rotation. One blade exhibited spanwise scoring suggesting sliding/scraping after rotation stopped. All three blades exhibited bending aft. All three start lock assemblies were NOT engaged suggesting the clamp/counterweight angle at impact and/or rotation stoppage was at minimum higher than the start lock setting. The as-received counterweight angles were measured to be 51.5°, 27.8° and 40.3° (measured from the horizontal, plane of rotation).

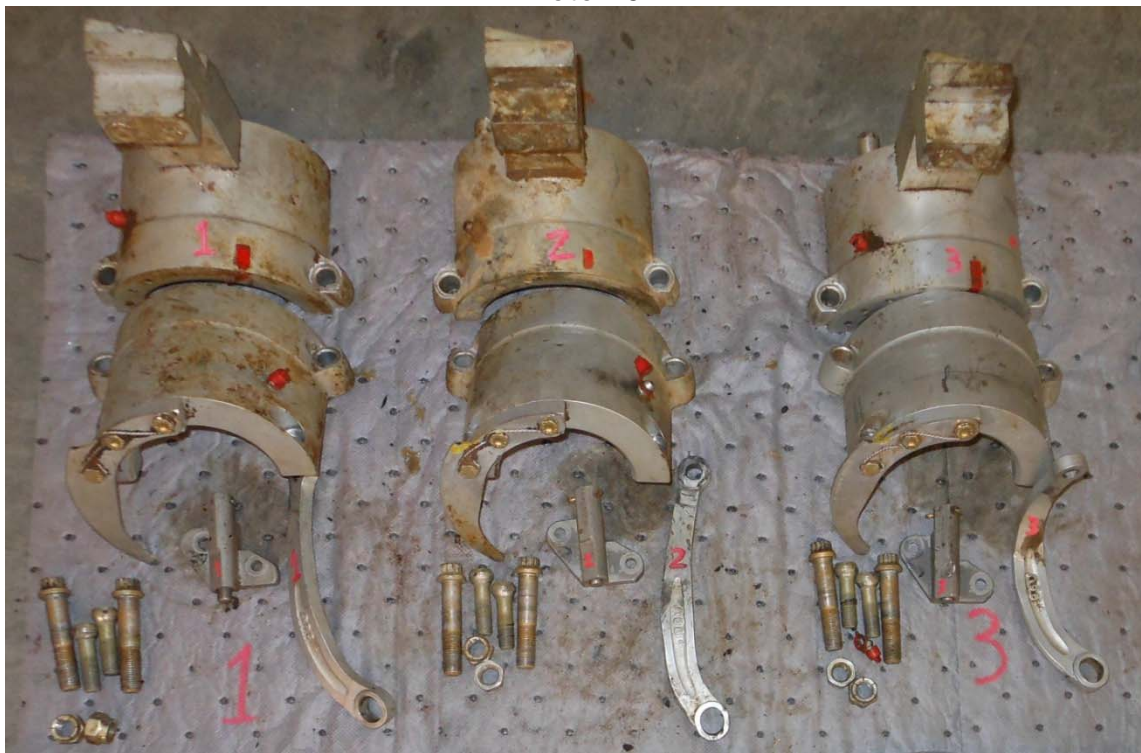
Link Arms: See Photo #5

#1: The #1 link arm was still attached at the clamp link pin (plastic bushing smashed) and at the piston attach points. There was visible elongation of the link pin hole and the link arm showed visual evidence of compression bending and lateral bending in the direction of blade #3.

#2: The #2 link arm detached from the clamp link pin but remained attached to the piston. There was visible elongation of the link pin hole similar to link arm #1 and the arm showed visual elongation.

#3: The #3 link arm was still attached at the clamp link pin and at the piston (plastic bushing smashed and cotter pin damaged). The link arm was bent laterally in the direction the piston toward blade #3. There was visible elongation of the link pin hole but less than that seen on #1 and #2 link arms. This arm showed the highest amount of compression bending.

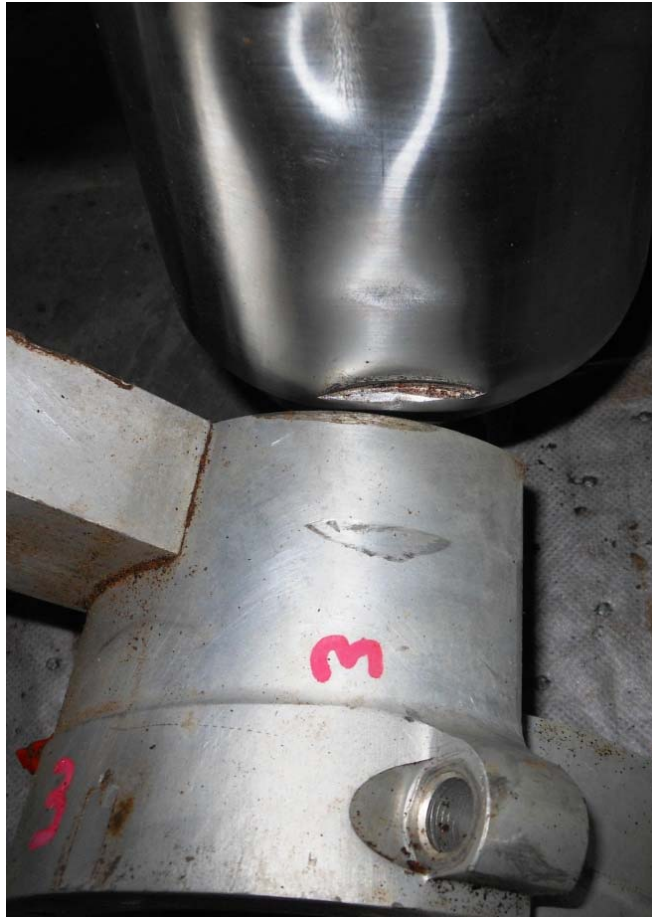
Photo #6

Cylinder: The cylinder was forced off the hub mounting threads during impact. The threads on the cylinder were damaged with some thread whiskers visible on the hub. There were three distinct impact dents in the cylinder corresponding to impact with the #3 clamp, clamp bolt and piston. There was an indentation/cut corresponding to the edge of the clamp, a crease corresponding to the bottom edge of the piston, and a dent corresponding to impact with the outboard clamp bolt (see Photo # 6)

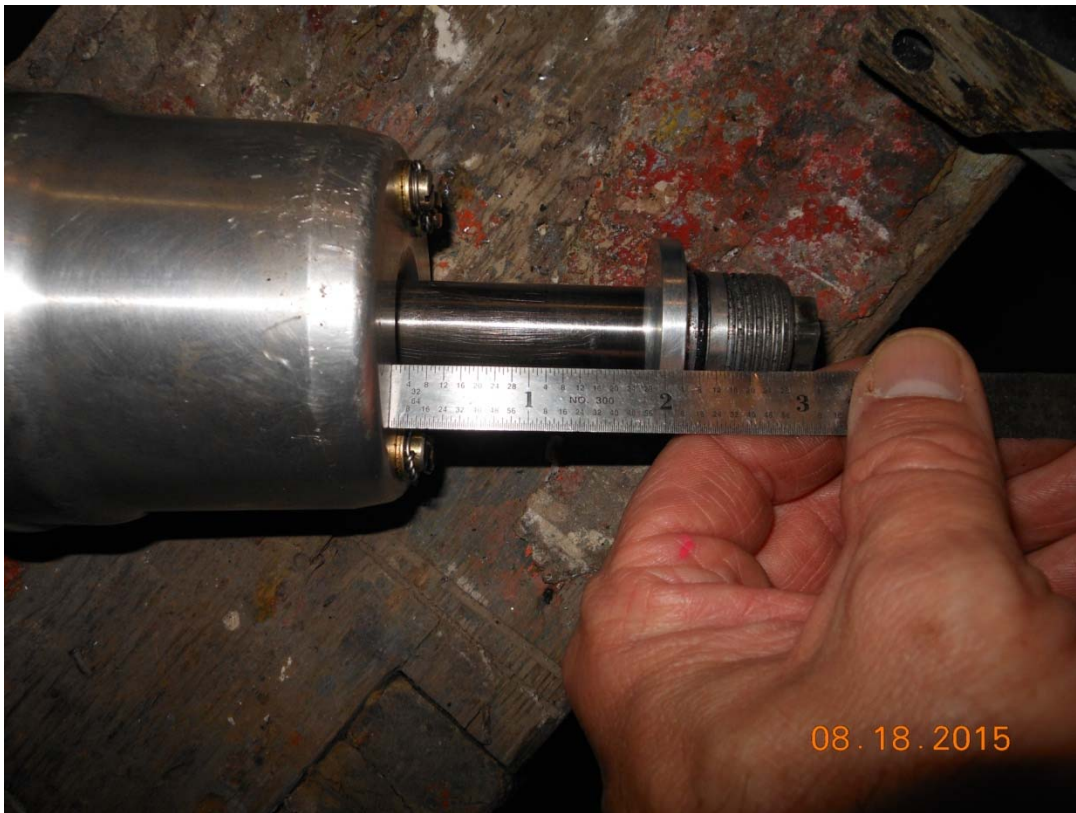
Photo #7

Pitch Change Rod: (P/N D-5862, S/N (A)6236) The pitch change rod was cut near the bend/fracture to facilitate spring removal. The rod could not be removed from the forward spring cup due to bending and inability to remove the reverse stop sleeve. The rod could be extended from the top of the spring cup approximately 1.9" before stopping (see Photo #7).

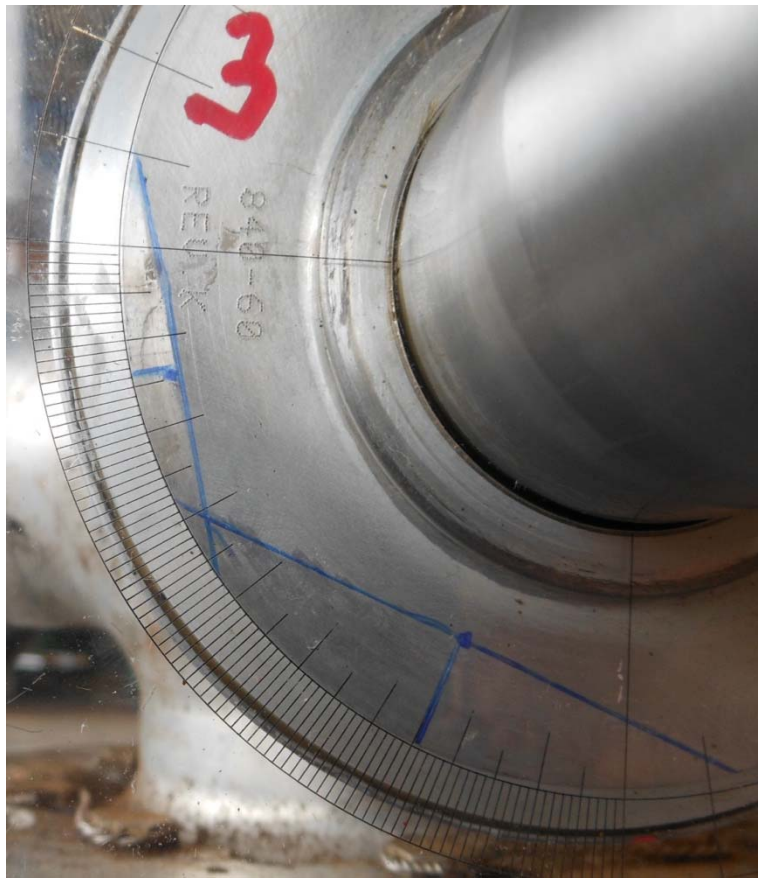
Photo #8

Impression marks from blade butts: There were discernible blade butt impression marks on blade arm flanges #1 and #3. The #1 flange had a contact mark approximately 78.5° from the plane of rotation and #3 had two marks; one at approximately 14-15° and one at approximately 65° from the plane of rotation (see Photo #8).

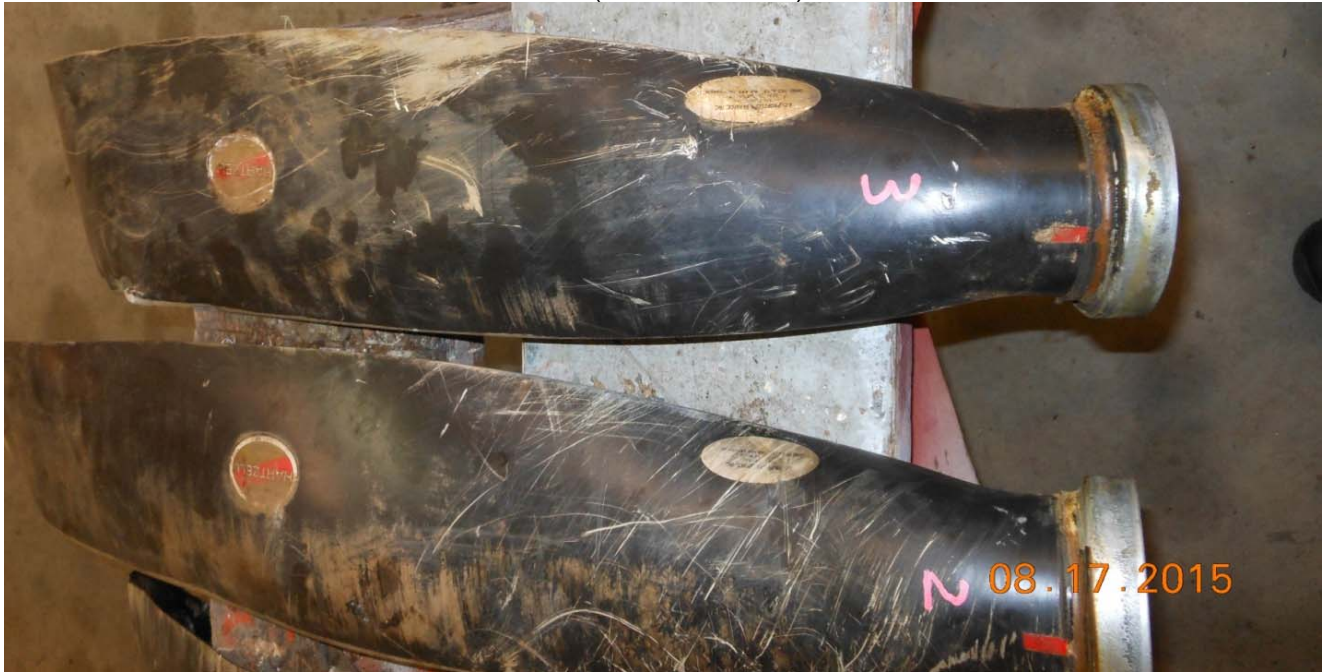
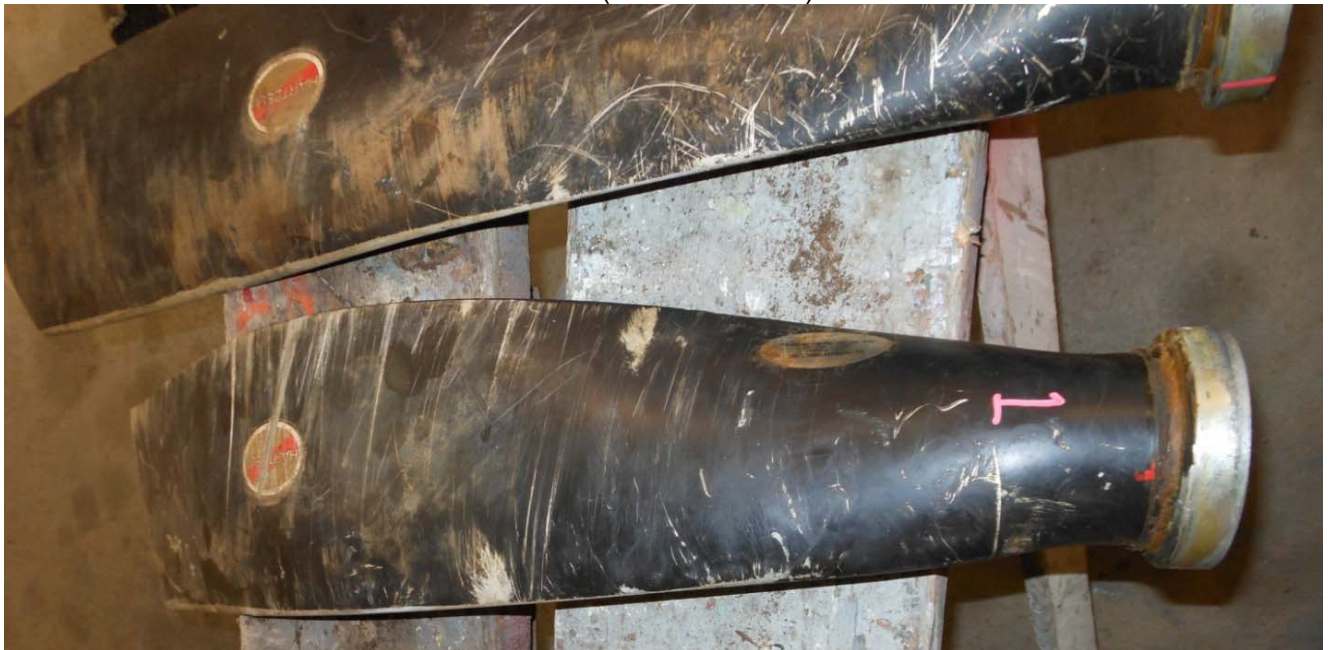
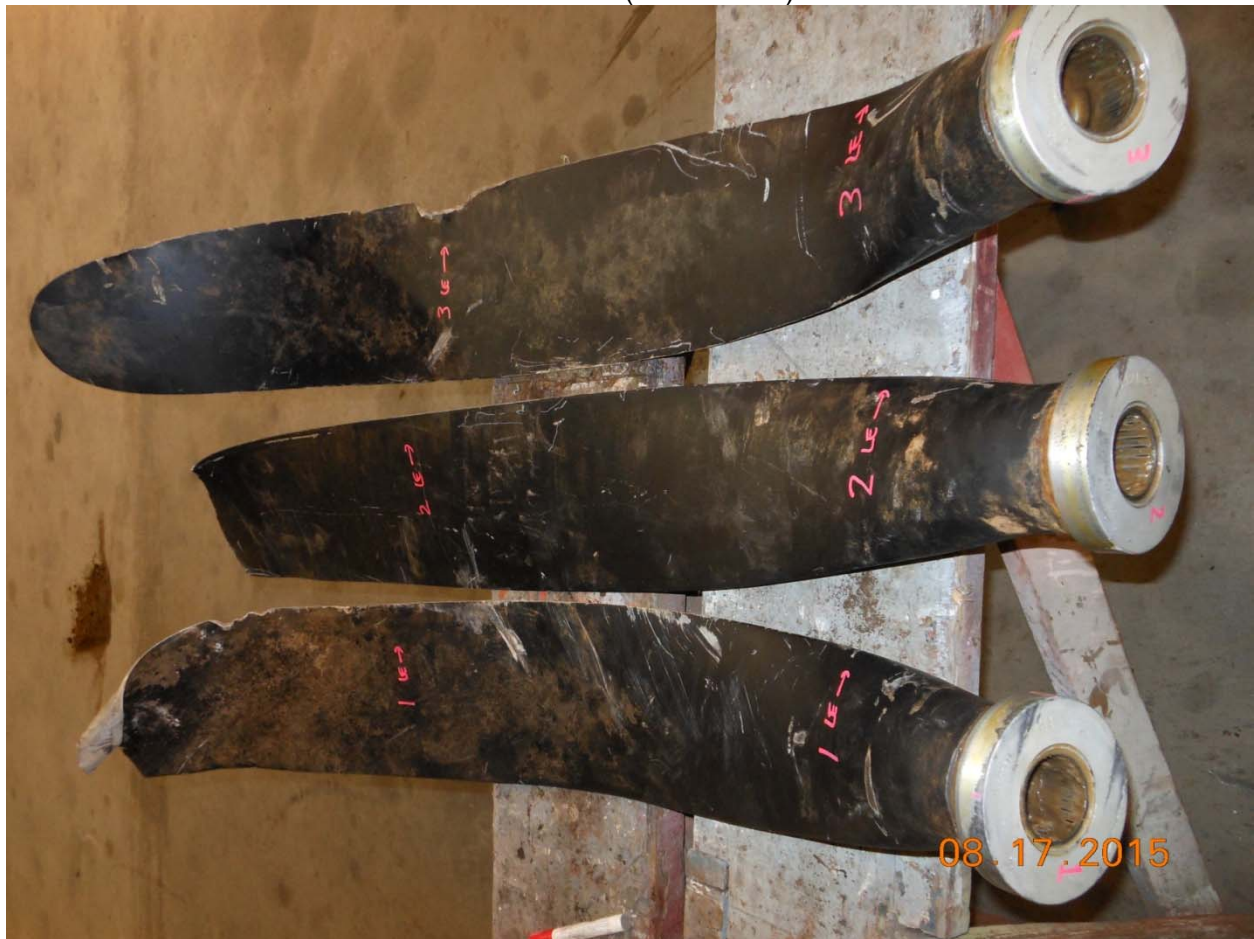
Blades: (See Photos #9 through #11)

- Paint, camber side - Chordwise scoring.
- Paint, flat side - Chordwise scoring 12-24" from butt.
- Bend - Bending aft starting at approximately 12" from butt.
- Twist - LE down near tip.
- Lead edge damage - ½" gouge 35-37 from butt. Outboard 5" of tip fractured, LE curled down.
- Trail edge damage - None.
- Butt impression - Face side.

- Paint, camber side - Chordwise scoring. Brown chordwise abrasion.
- Paint, flat side - Chordwise scuffing. Brown chordwise abrasion.
- Bend - Bend aft starting 12" from tip.
- Twist - LE down but less deflection compared to #1 and #3.
- Lead edge damage - No damage except for outboard 5" tip torn/fractured, LE curled down.
- Trail edge damage - None
- Butt impression - None

- Paint, camber side - Chordwise scoring and spanwise scoring. Brown chordwise abrasion.
- Paint, flat side - Chordwise scuffing/abrasion 12" from butt.
- Bend - Bend aft 12" and 36" from butt.
- Twist - LE down near tip.
- Lead edge damage - 1" deep gouge 28" from butt, both LE up and down deformation.
- Trail edge damage - Spanwise scoring.
- Butt impression - Circular impression mark due to blade arm flange centered approximately along trailing edge and another impression mark on the face side.
