AIRWORTHINESS GROUP CHAIRMAN'S FACTUAL REPORT

DCA16FA217

**CFM CFM56-7B ESN 874112 event – Fragment Trajectory Analysis, dated
October 28, 2018**

CFM56-7B Southwest ESN874112 event Fragment trajectory analysis

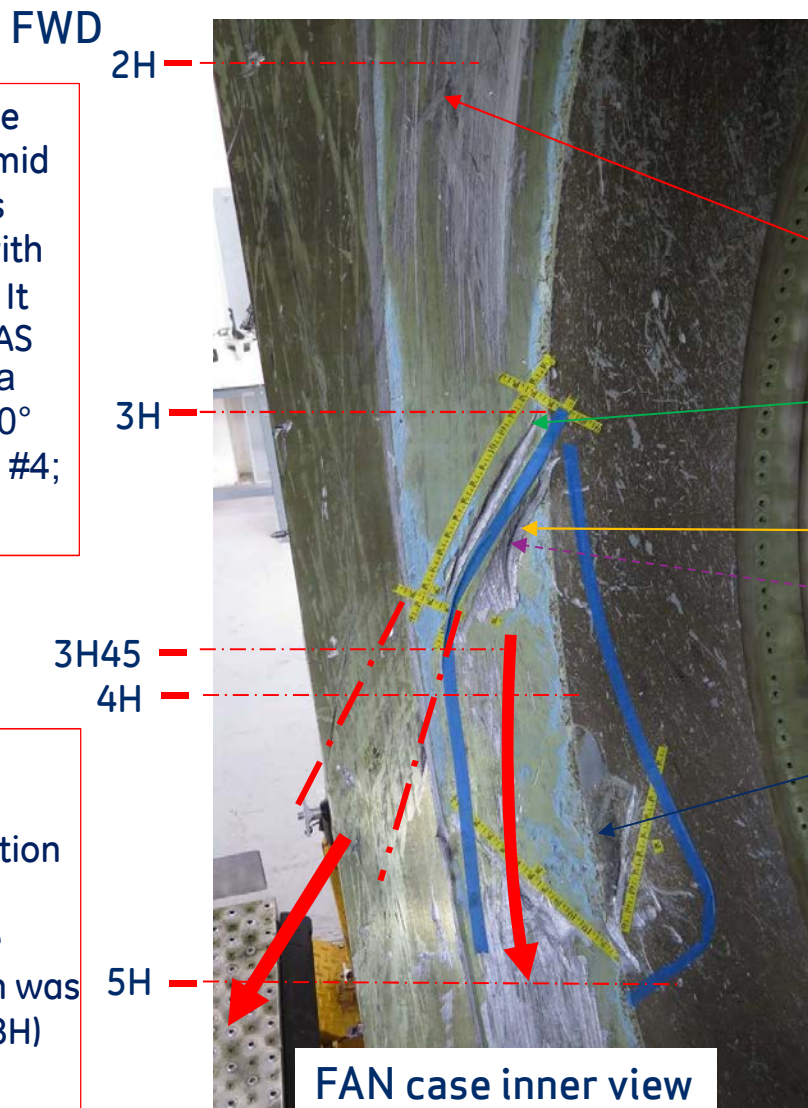
Marks on fan case suggesting some mid span fragments ejection at 4H30 with an angle of $\approx 37^\circ$. It could fit with UTAS Assumption of a fragment with 30° angle (see pages #4; #20 & #21)

Mid span fragments ejection direction (except one of them which was ejected at 8H)

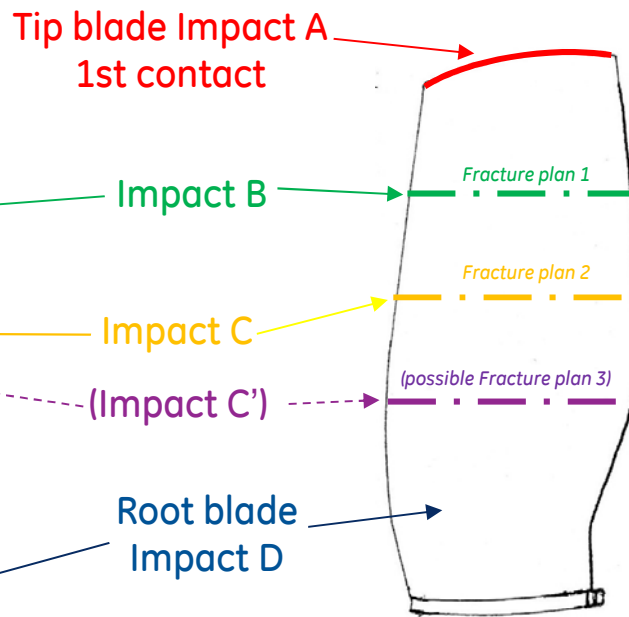
After first contact, successive blade bends led to Fracture Plans n° 1 - 2 - (3). Each fracture plan impacted FAN case. At last, root blade suction side impacted FAN case

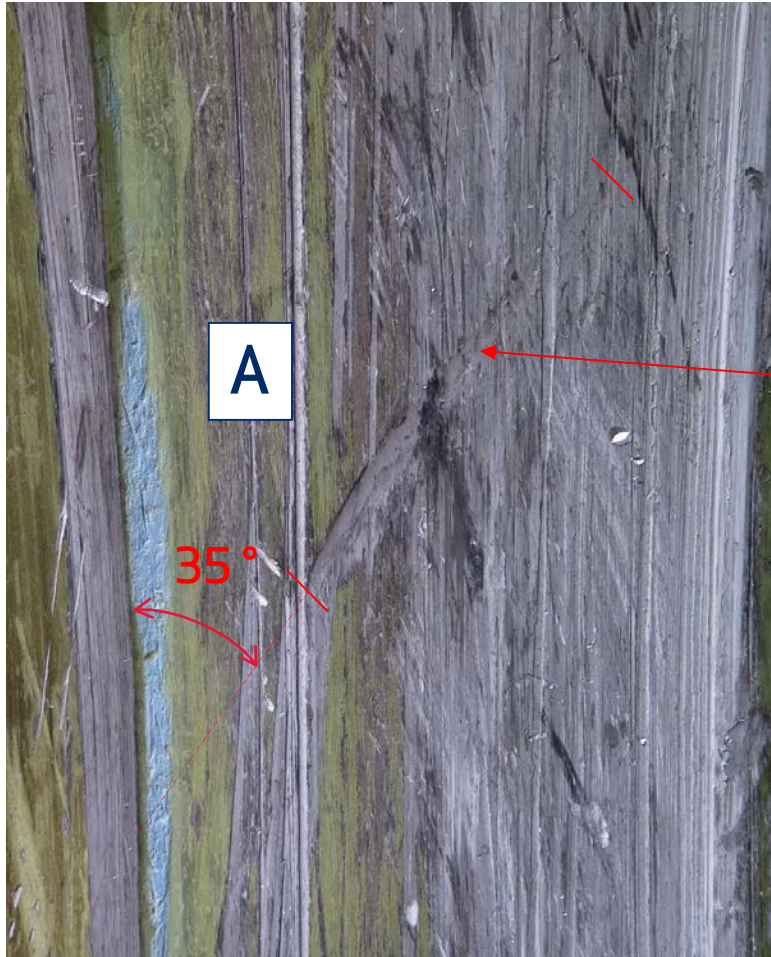
Tip blade Impact A
1st contact detail

Low energy
No
external deformation
or tear

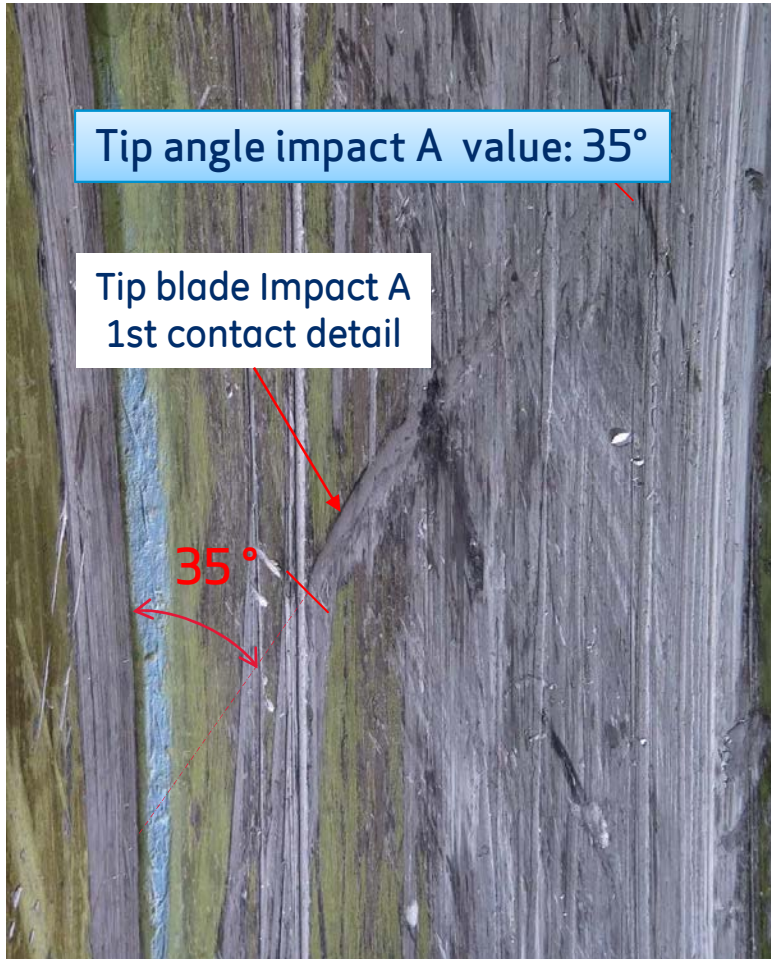
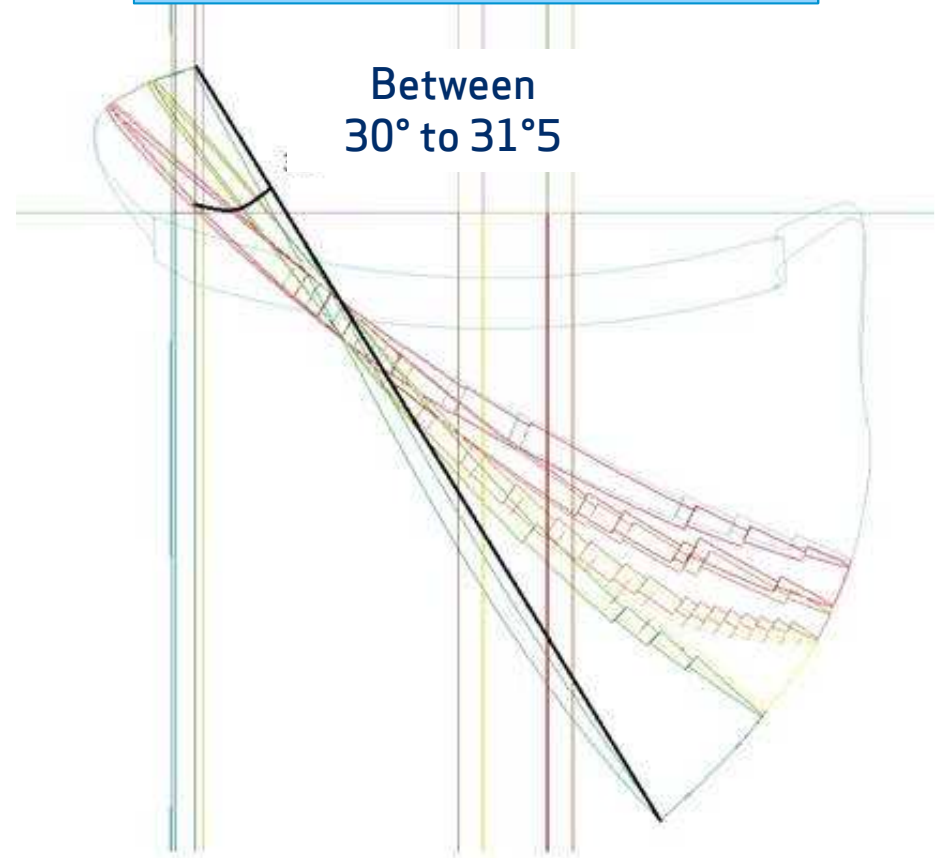
Theoretic tip angle at climb value:
between 30° to 31°5

First impact tip angle value close to theoretic tip running angle value

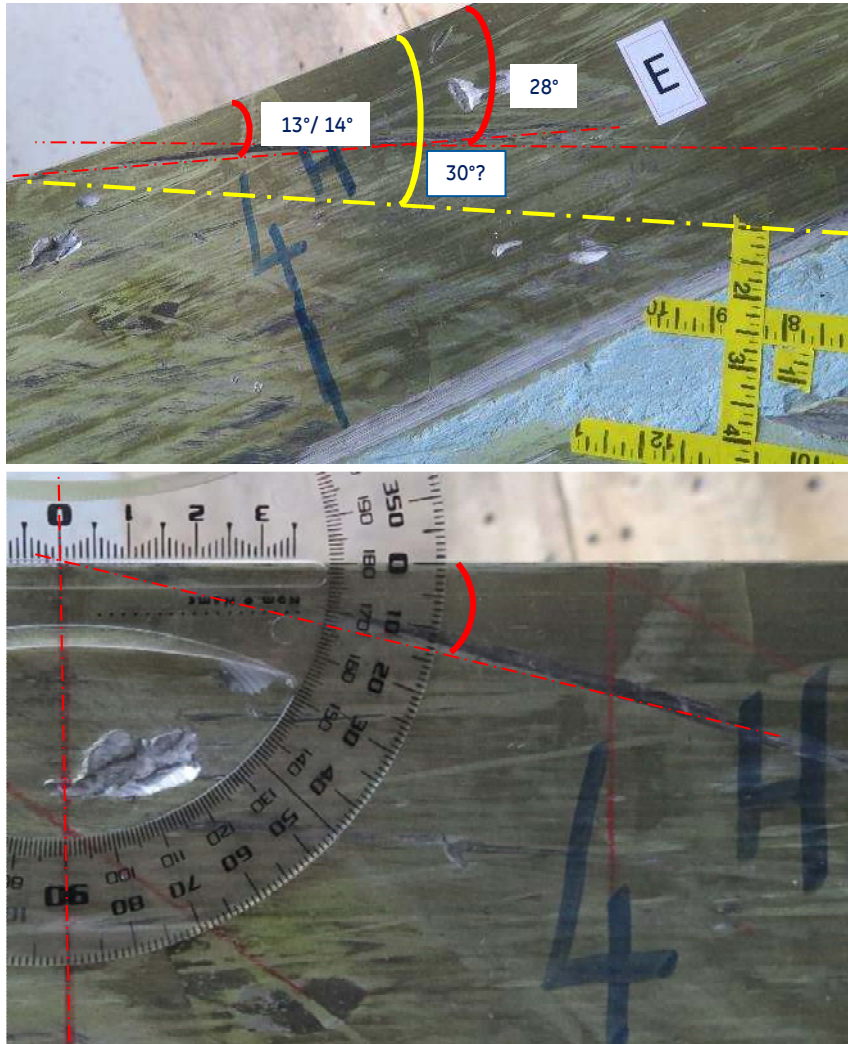
FAN BLADE # 23 TIP PANEL TRAJECTORY

- Fan case experienced impact deformation during event around tip panel exit area (close to B & C impact location)
 - This deformation causes deviation in the trajectory of the tip panel (from $\approx 28^\circ$ to $\approx 14^\circ$)
- ➔ Tip panel fan case exiting angle = 14°
- ➔ A 30° fan case exiting angle seems not consistent with the marks in the fan case (see upper picture)

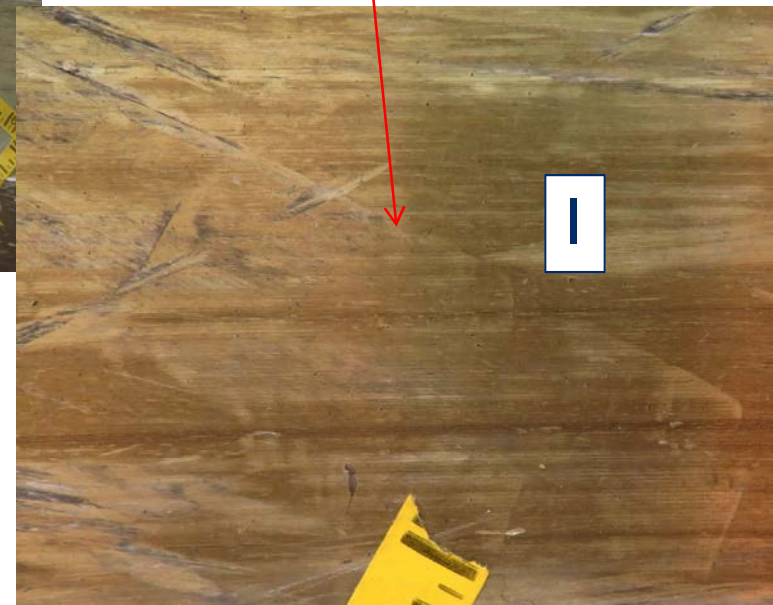
Upper panel print

Upper panel was exited between 4H & 5H

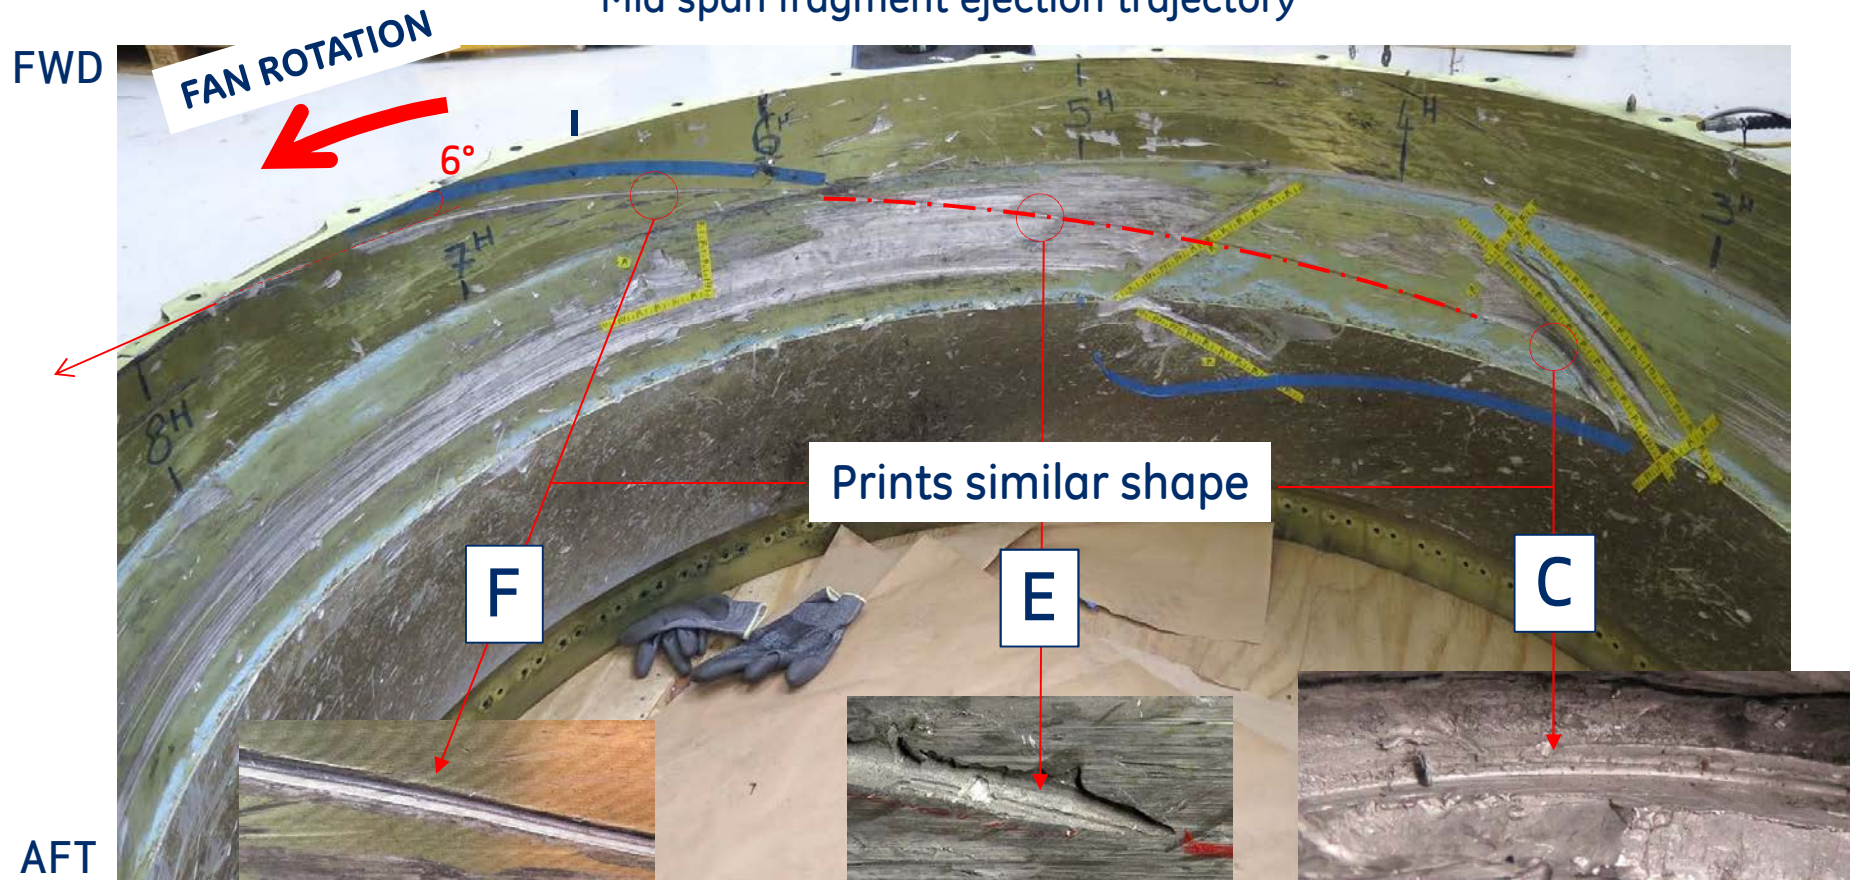
Mid span fragment ejection trajectory

Mid span fragment exited at 8H

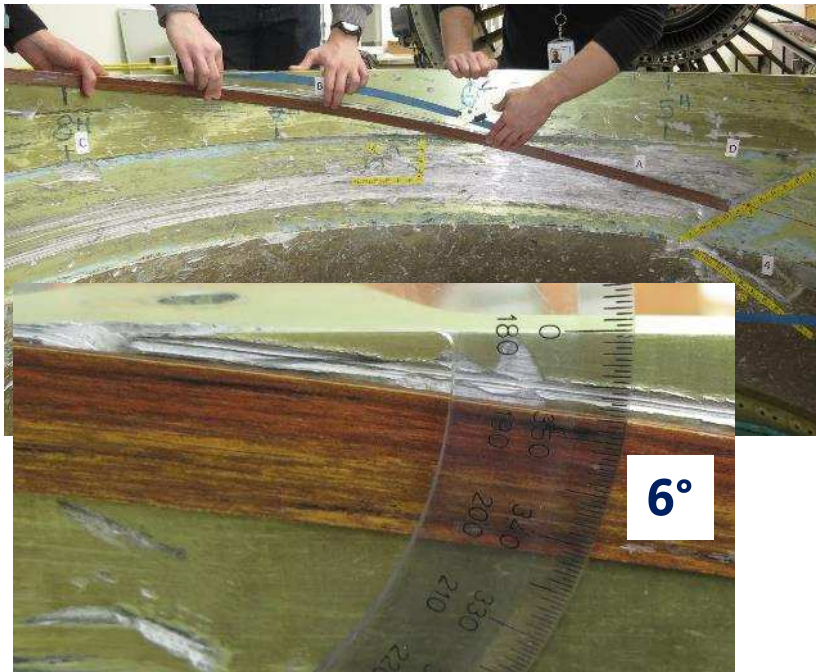
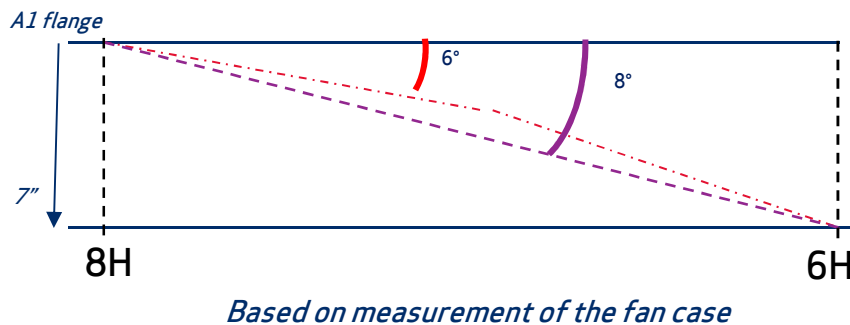
FAN BLADE # 23 MID SPAN #1 FRAGMENT TRAJECTORY

- Local deformation of the fan case along the mid panel trajectory
- Deformation causes deviation of the trajectory
- Direct measurement of the exiting angle at the A1 flange location: 6°
- Exiting angle with linear trajectory based on the marks between abrasible and A1 flange: 8°

➔ $6^\circ < \text{Mid span fan case exiting angle} < 8^\circ$

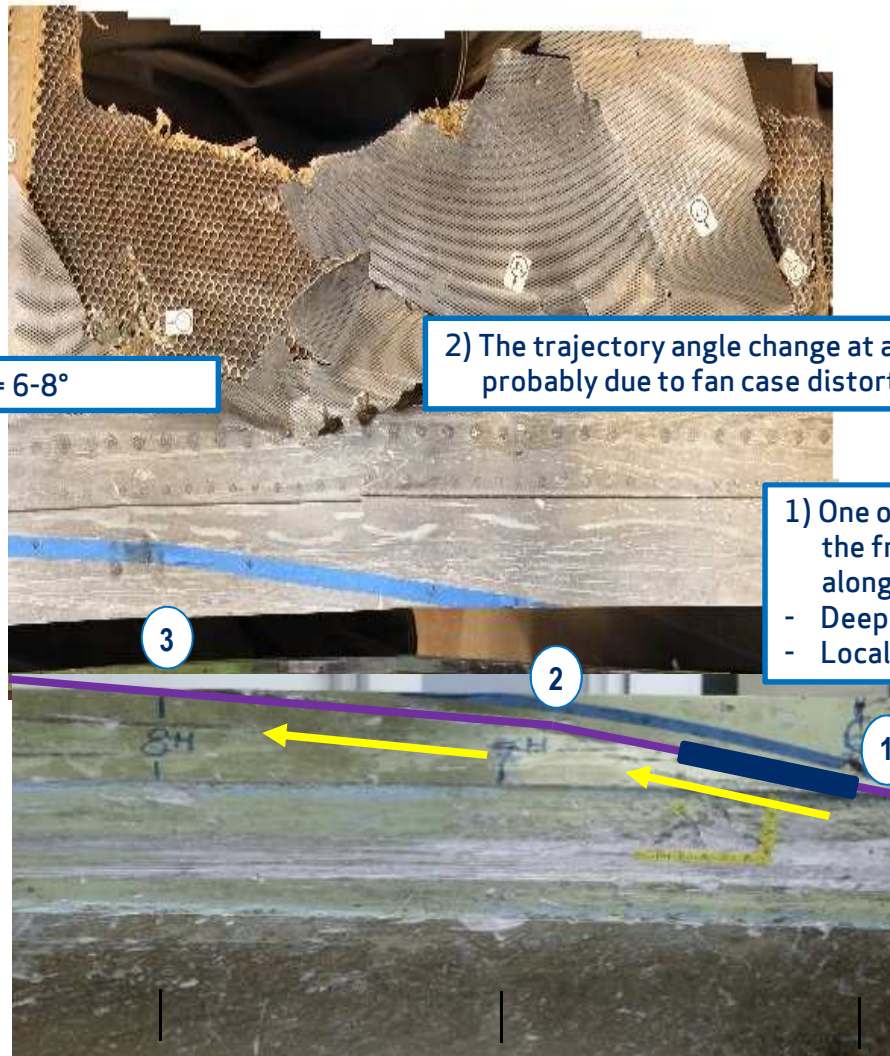
FAN BLADE # 23 MID SPAN #1 FRAGMENT TRAJECTORY

3) Fan case exiting angle = 6-8°

2) The trajectory angle change at around 7H, probably due to fan case distortion

1) One of the mid span **probably** slides on the fracture surface, which causes along the trajectory:
- Deep groove
- Local distortion of the fan case

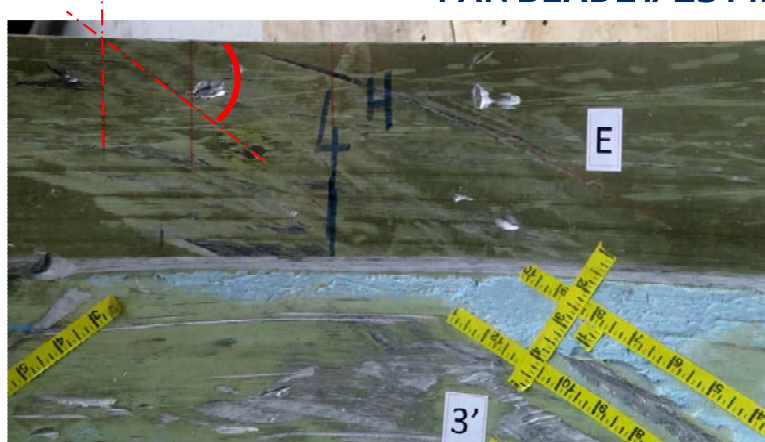
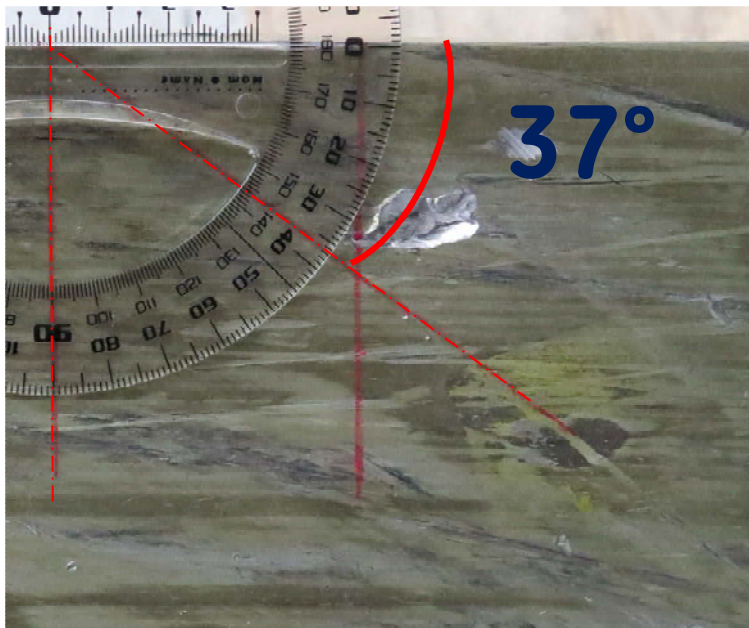
FAN BLADE # 23 MID SPAN #2 FRAGMENT TRAJECTORY

- Many marks in the area around 4H30 suggesting some mid span fragments ejection in the area . The trajectory of these fragments is very close to the tip panel trajectory (see page 21)
- the exiting angle of the deepest mark = 37°

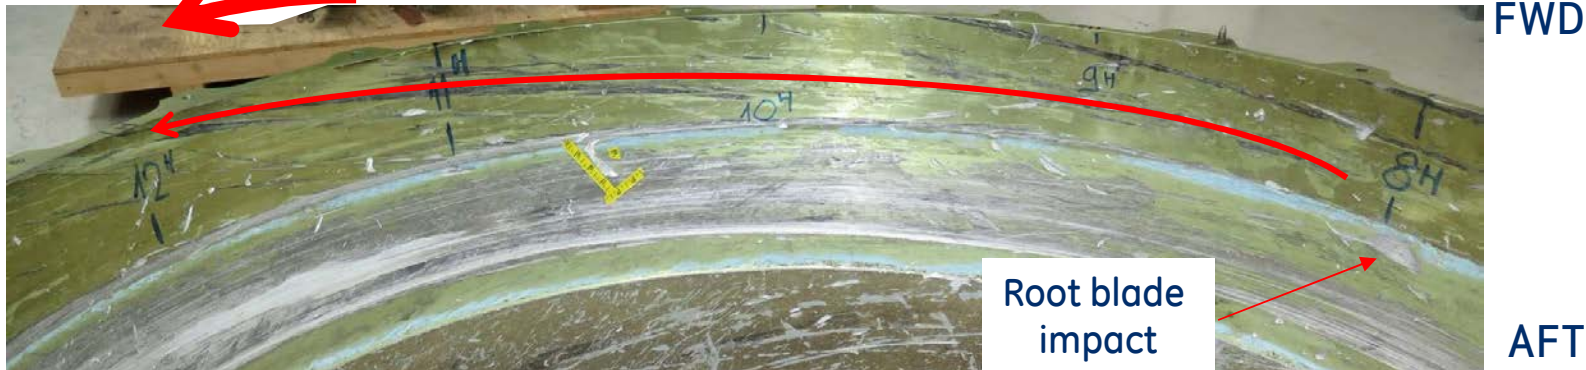
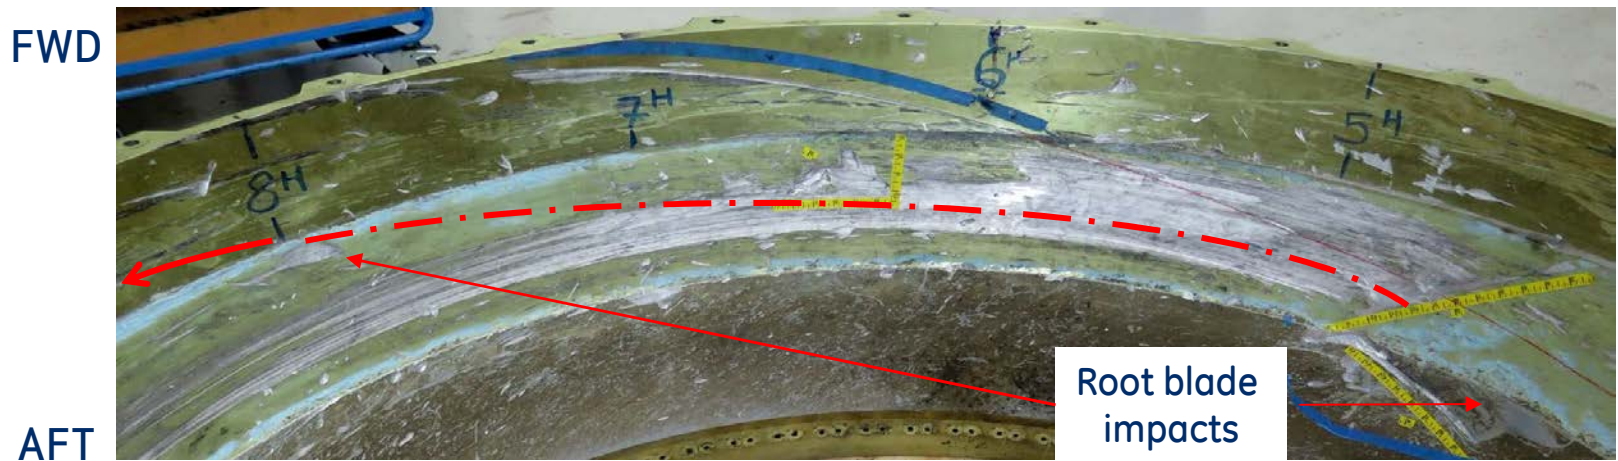
Root blade ejection trajectory

Root blade exited at 12H

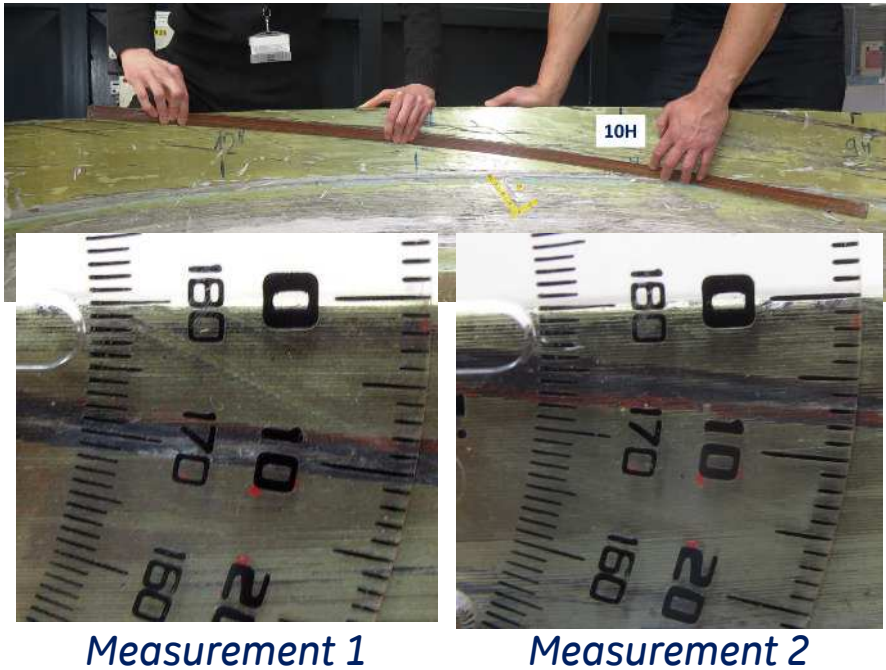
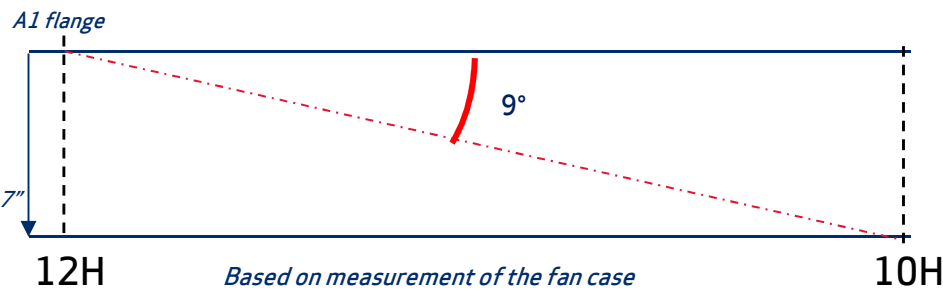
FAN BLADE # 23 ROOT TRAJECTORY

- No deformation of the fan case in the root panel trajectory area
- 1st impact of the root panel in the fan case noticed around 5H45
- From 5H45 to 10H:
 - Evidences of root panel rolling inside the fan case
 - no evidence of sliding.
- Direct measurement of the exiting angle at the A1 flange location : 7-9° (incertitude due to the width of the mark)

➔ 7° < Root fan case exiting angle < 9°

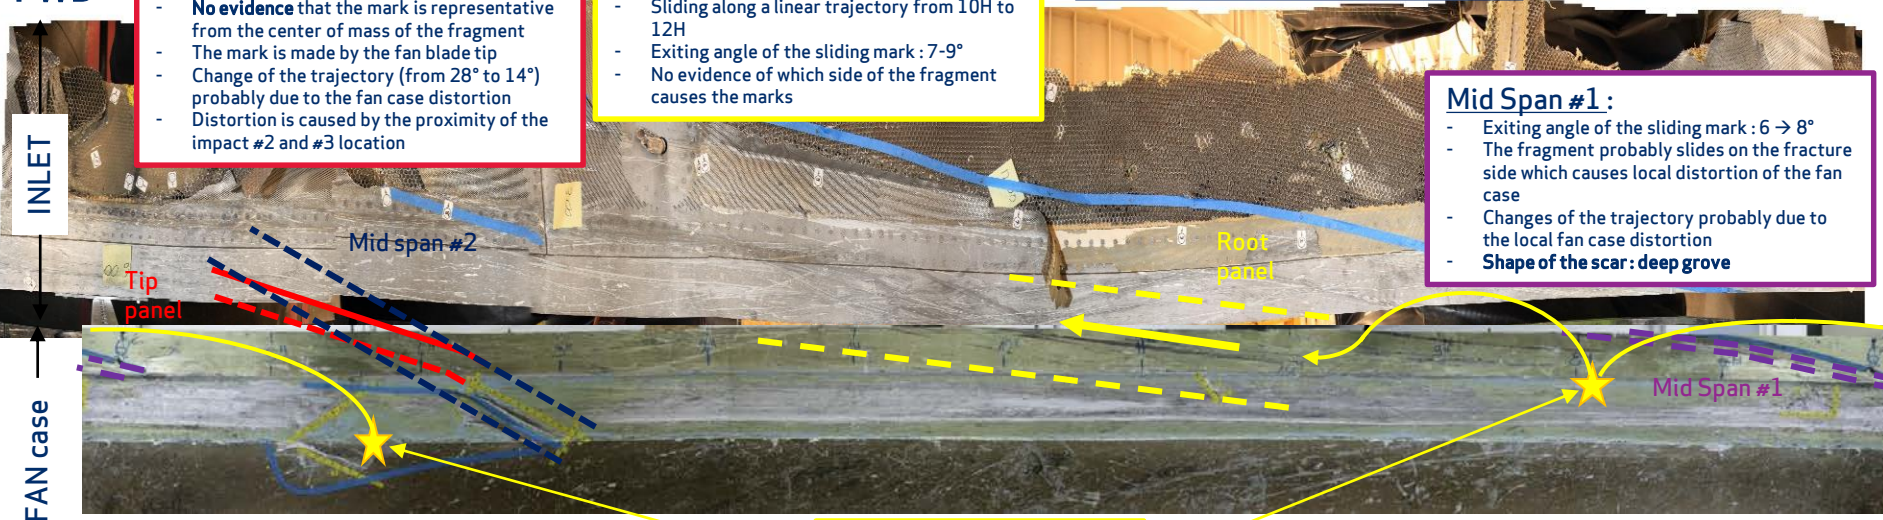
INLET/ FAN CASE PANORAMIC VIEW

Tip panel:

- Exiting angle of the sliding mark : 14°
- **No evidence** that the mark is representative from the center of mass of the fragment
- The mark is made by the fan blade tip
- Change of the trajectory (from 28° to 14°) probably due to the fan case distortion
- Distortion is caused by the proximity of the impact #2 and #3 location

Root panel:

- Rolling from 5H45 to 10H (Evidence of impact at 5H45 and 8H)
- Sliding along a linear trajectory from 10H to 12H
- Exiting angle of the sliding mark : 7-9°
- No evidence of which side of the fragment causes the marks

Mid Span #2 (or more)

- Many evidence of sliding marks at 4H15
- Exiting angle : ≈ 37°

Mid Span #1 :

- Exiting angle of the sliding mark : 6 → 8°
- The fragment probably slides on the fracture side which causes local distortion of the fan case
- Changes of the trajectory probably due to the local fan case distortion
- **Shape of the scar : deep groove**

Impacts from the root panel
