AIRWORTHINESS GROUP CHAIRMAN'S FACTUAL REPORT

DCA16FA217

**CFM CFM56-7B Southwest ESN 874112 Event – Fan Case Analysis dated
January 19, 2017**

CFM56-7B Southwest ESN874112 event FAN CASE ANALYSIS

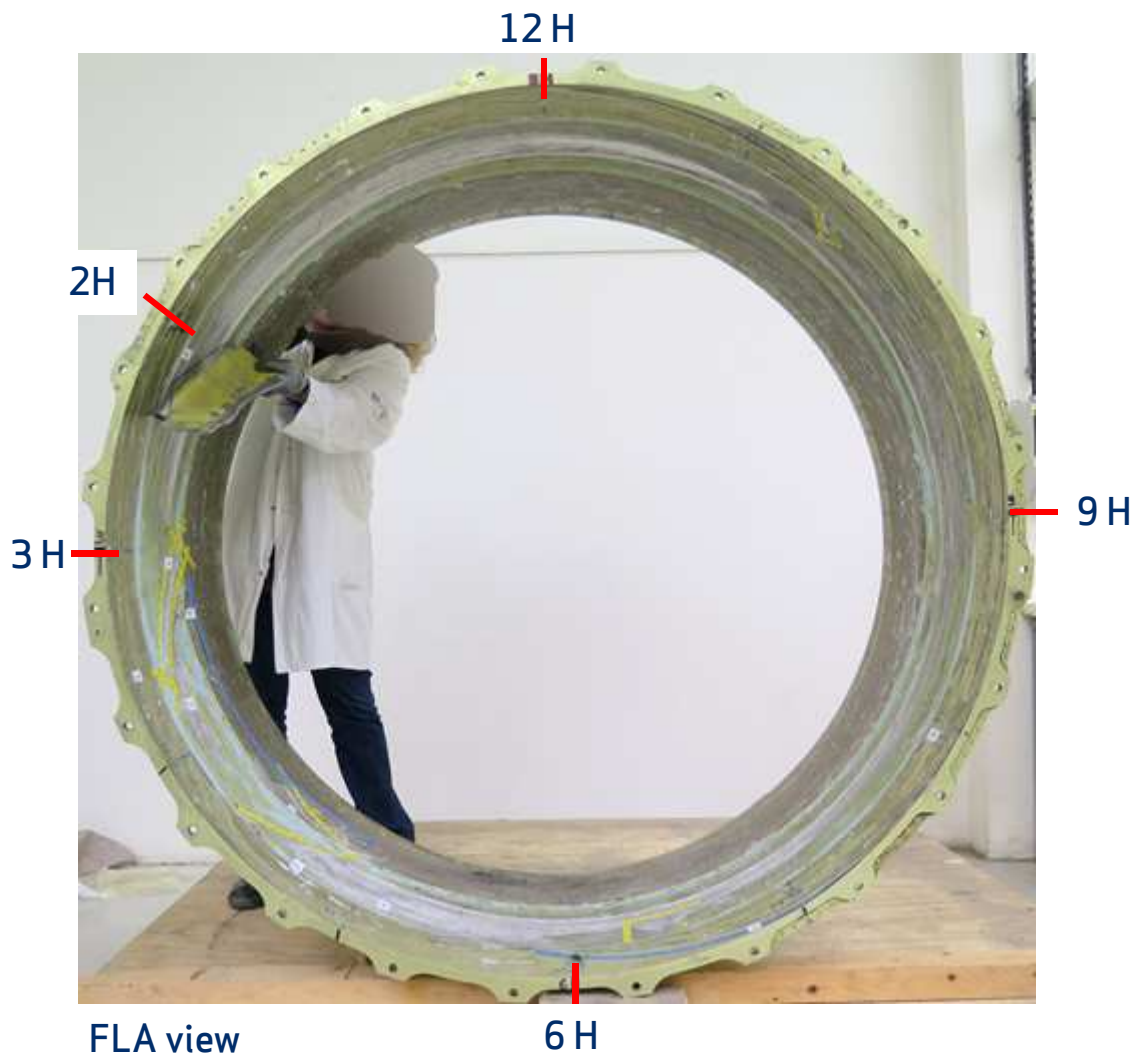
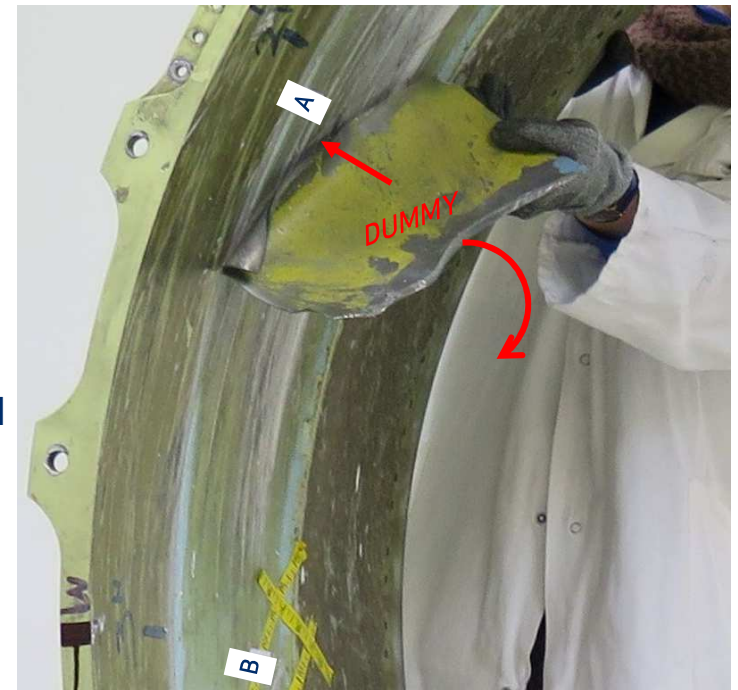
TIP PANEL TRAJECTORY

Tip panel impact 1
1 st contact

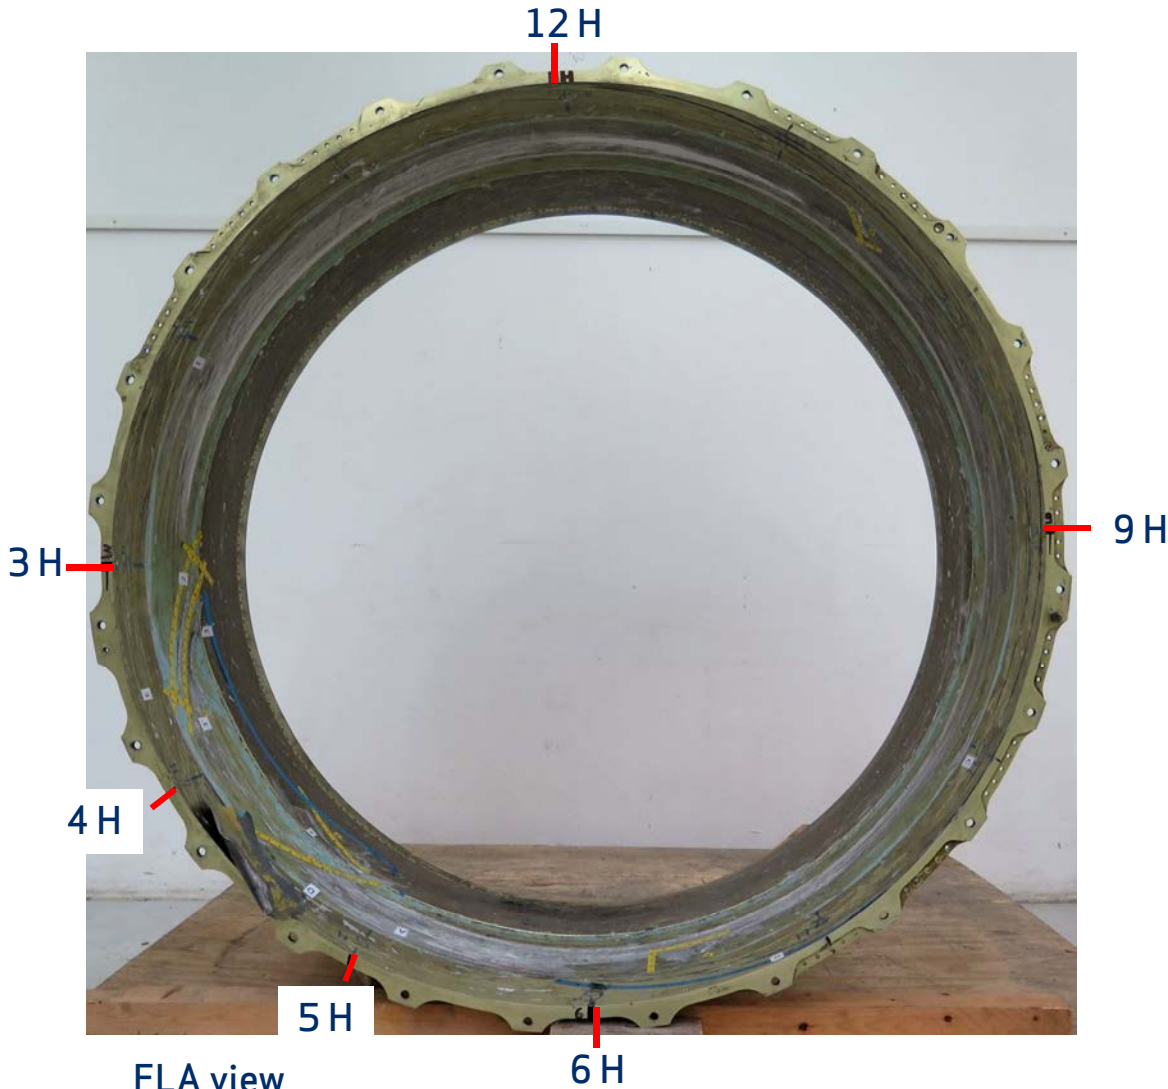
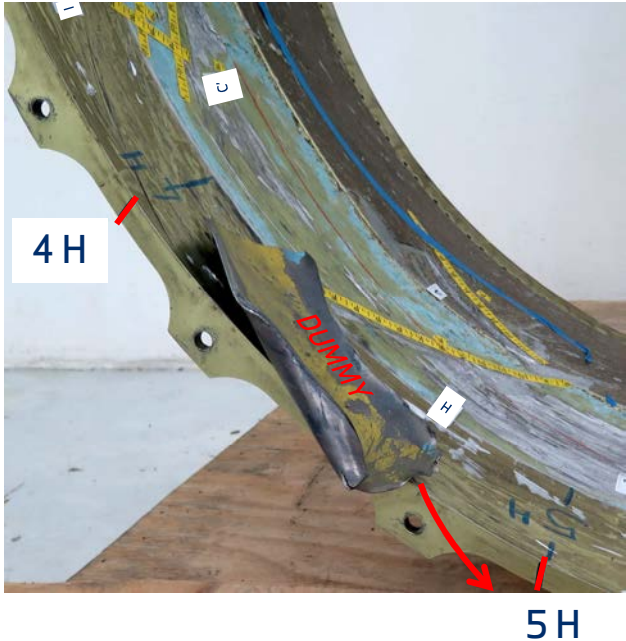
Tip panel was exited between 4H & 5H

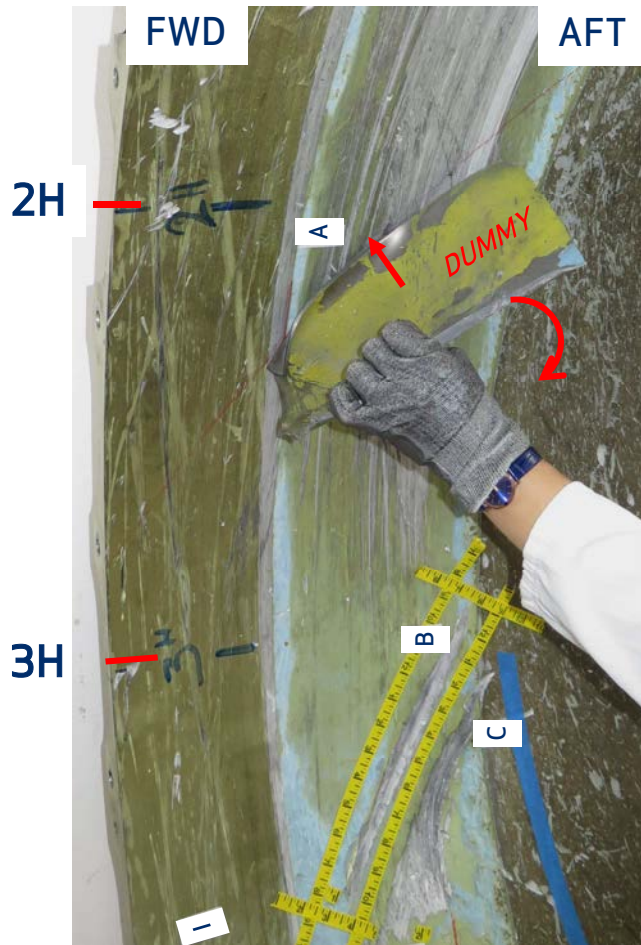
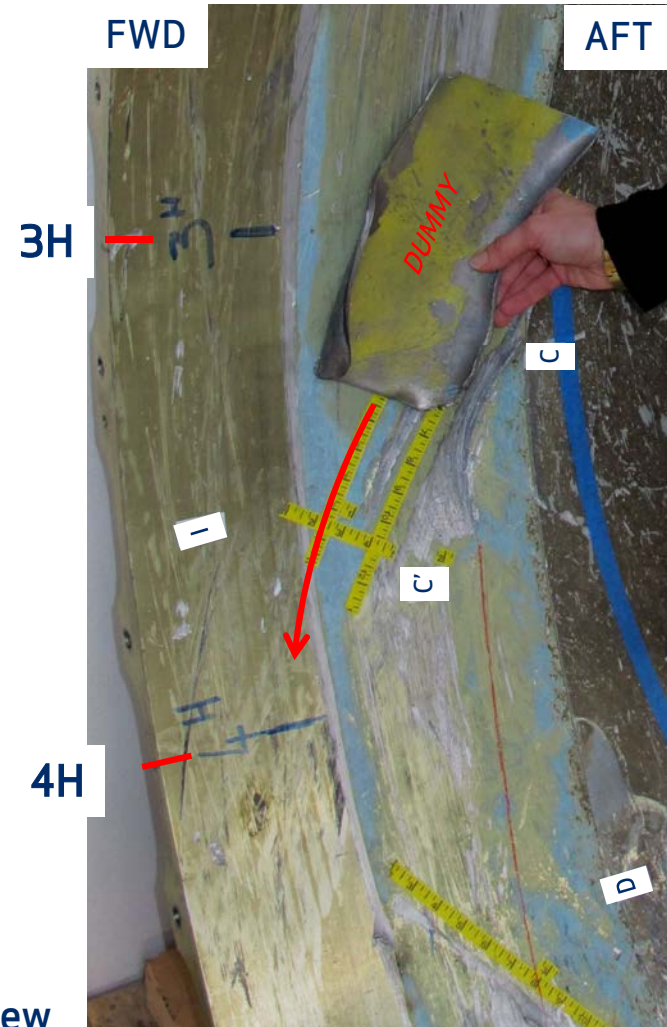
FAN BLADE # 23 TIP PANEL TRAJECTORY

FAN case inner view

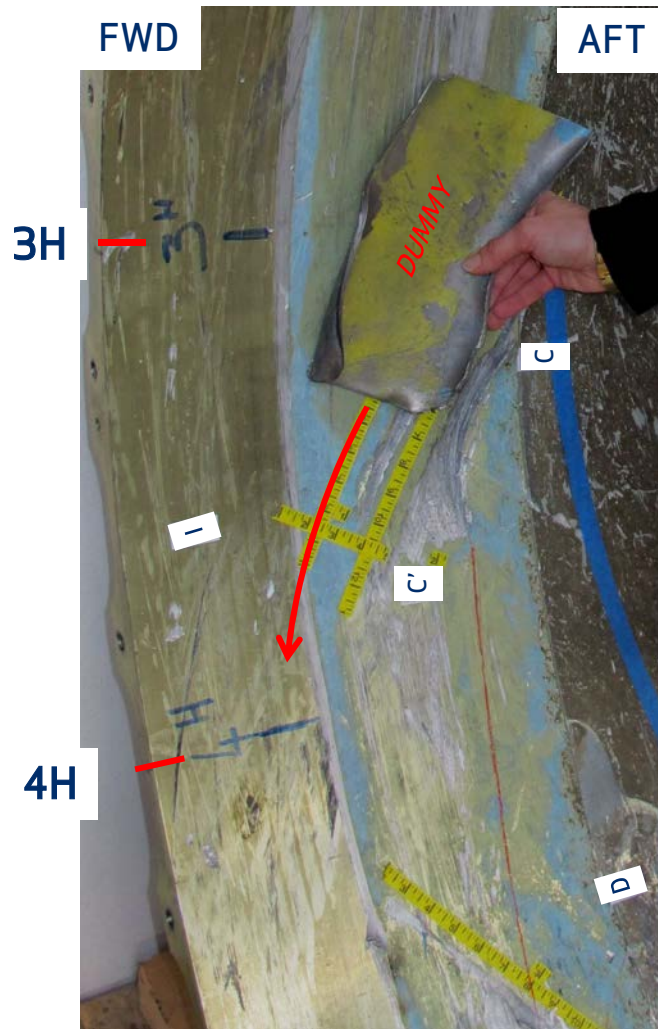
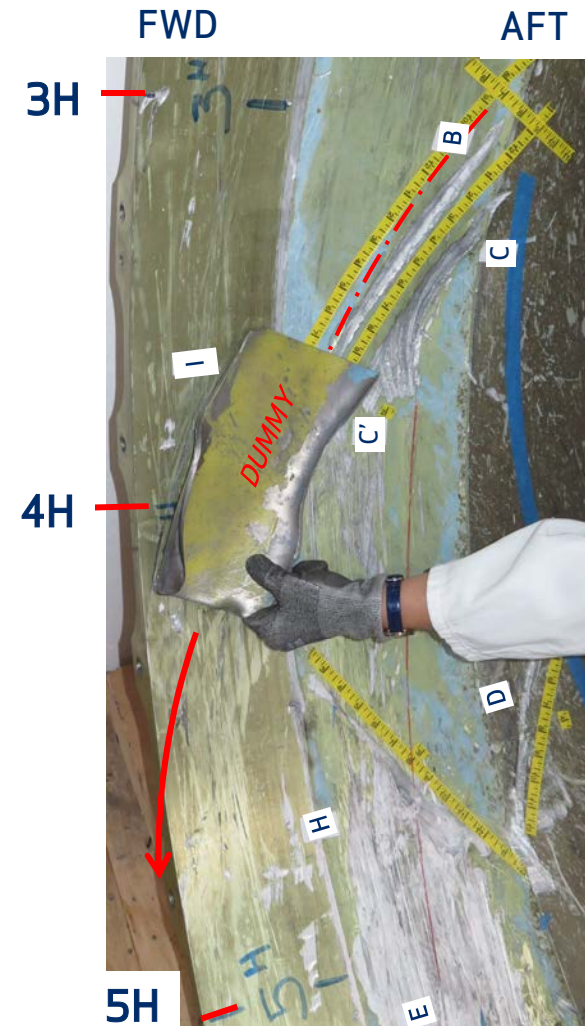
FAN BLADE # 23 TIP PANEL TRAJECTORY

FAN case inner view

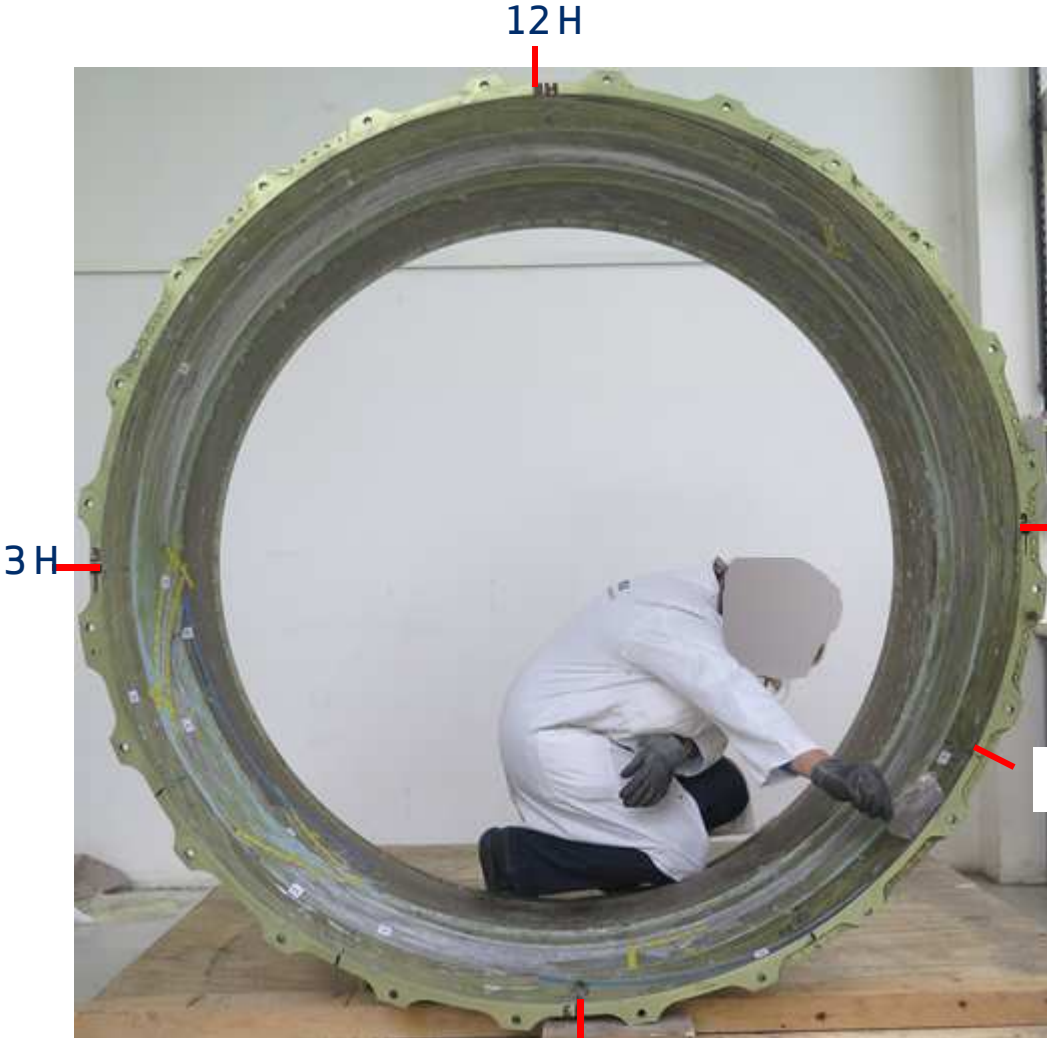
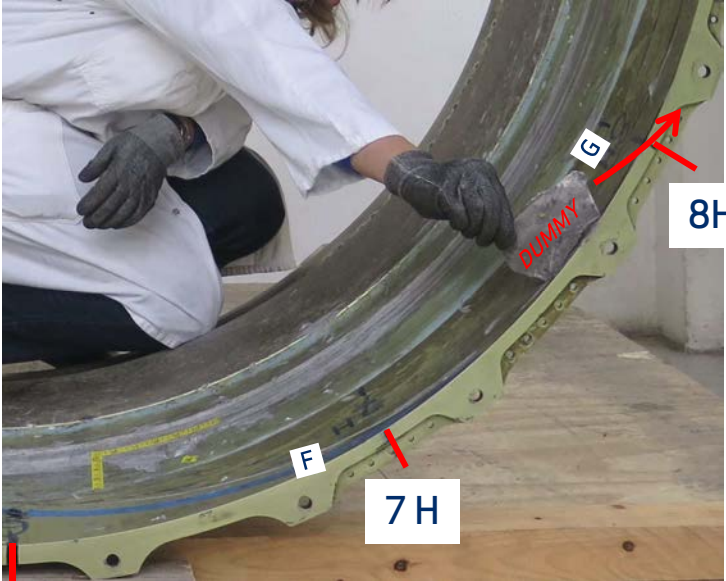
Mid span fragment was exited at 8H

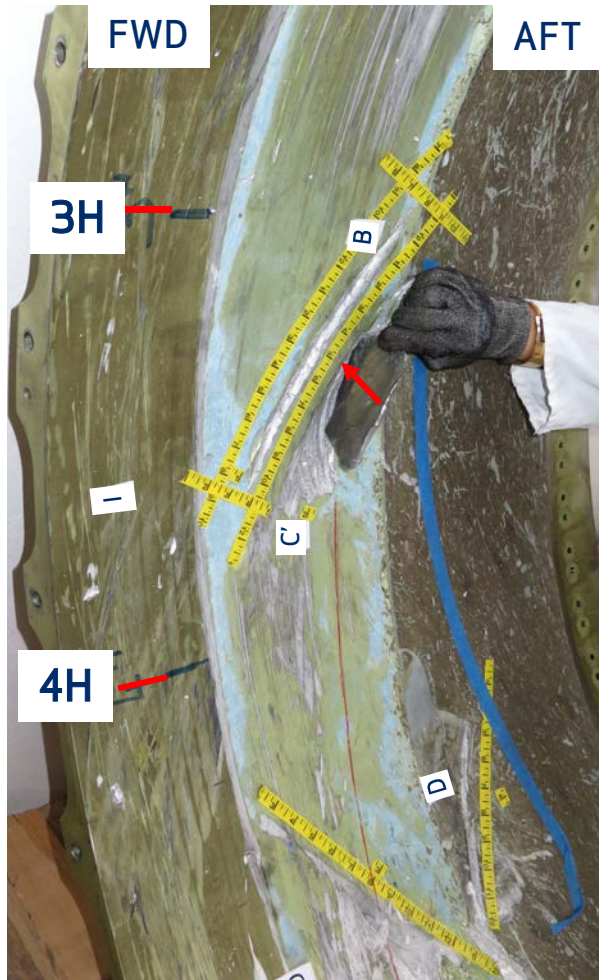
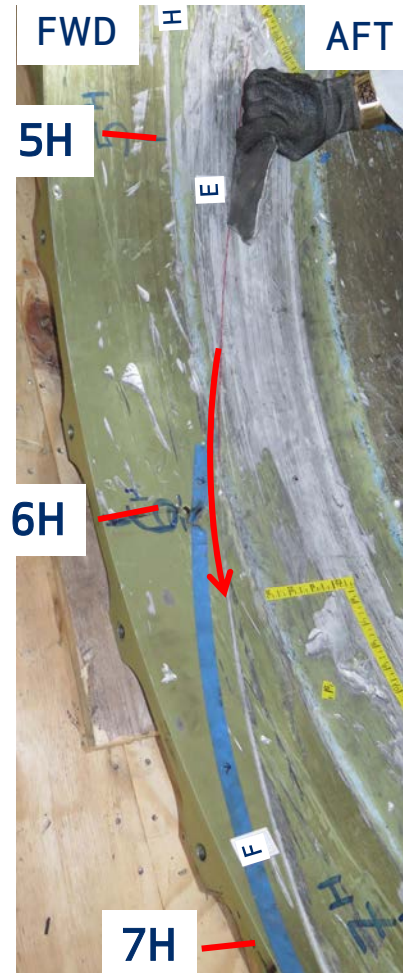
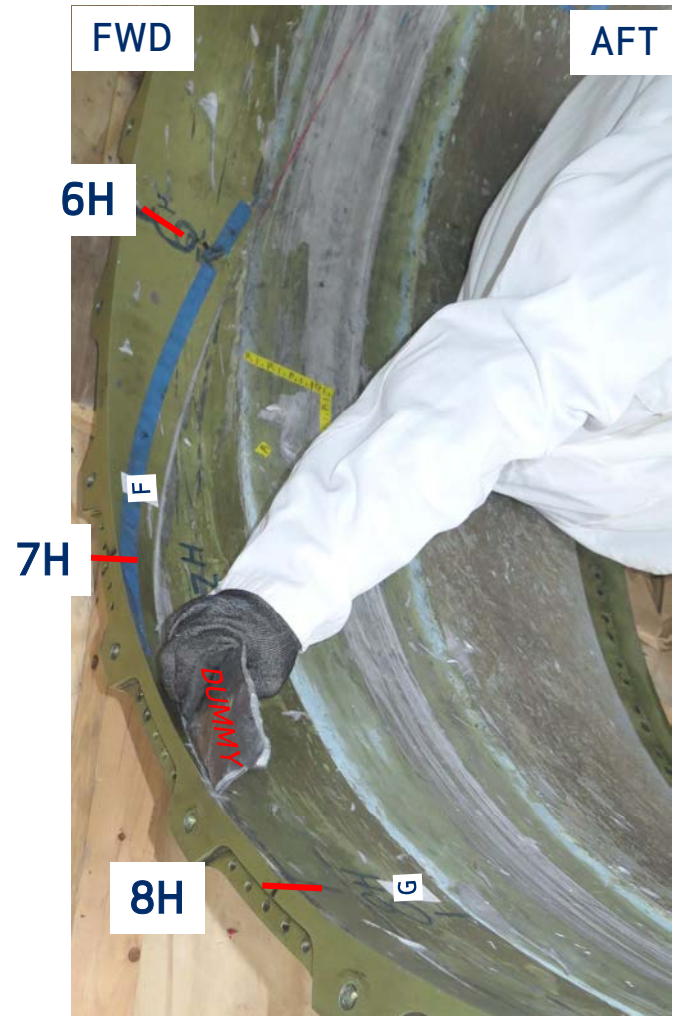
FAN BLADE # 23 MID SPAN FRAGMENT TRAJECTORY

FAN case inner view

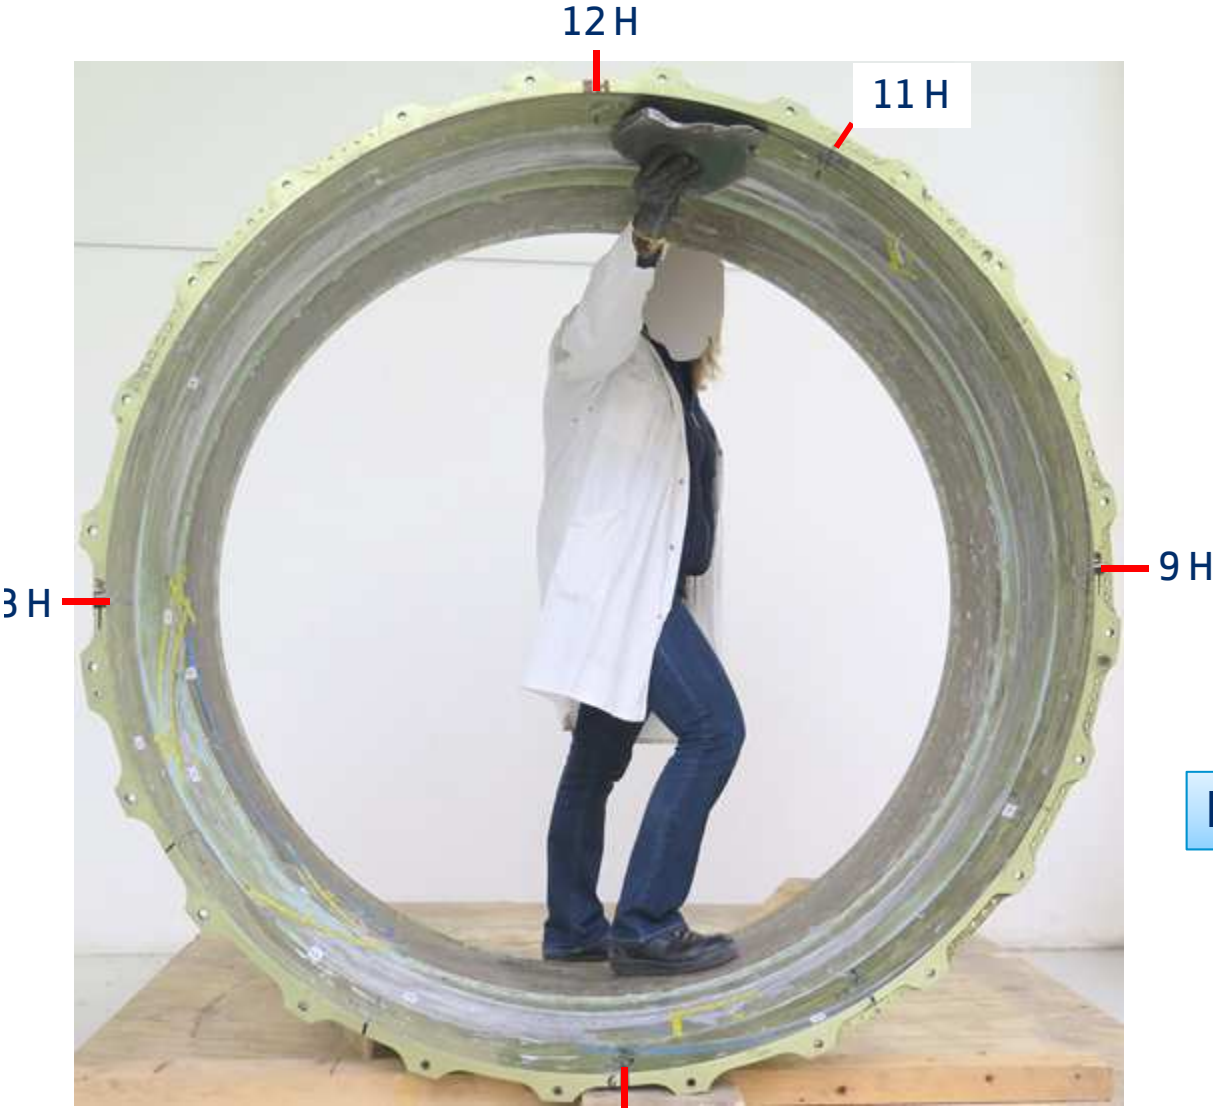
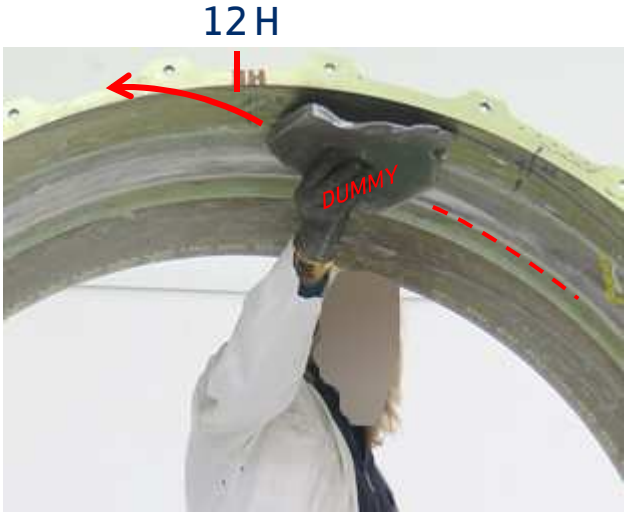
Root blade was exited at 12H

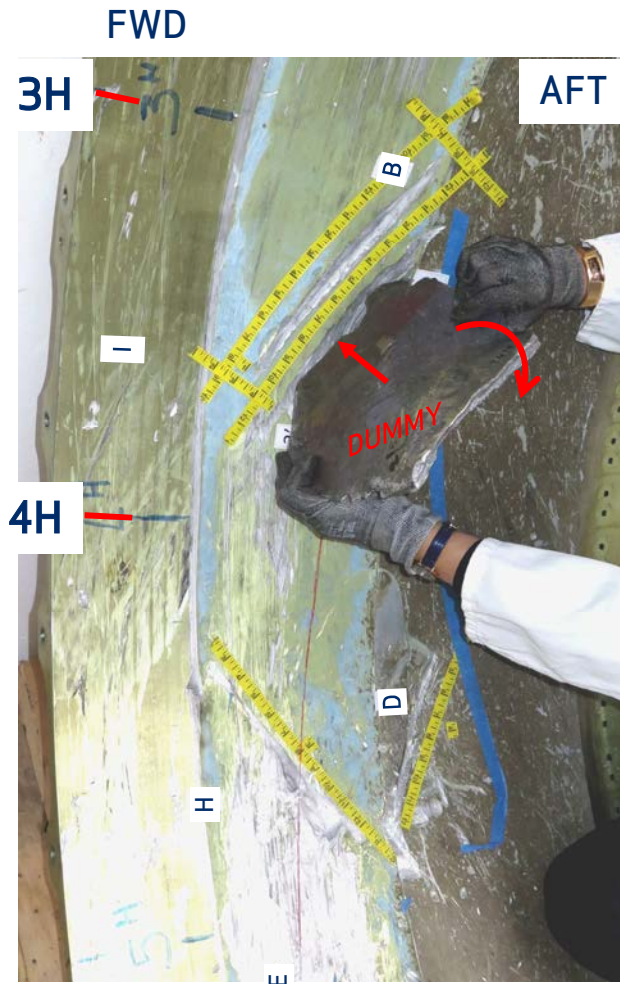
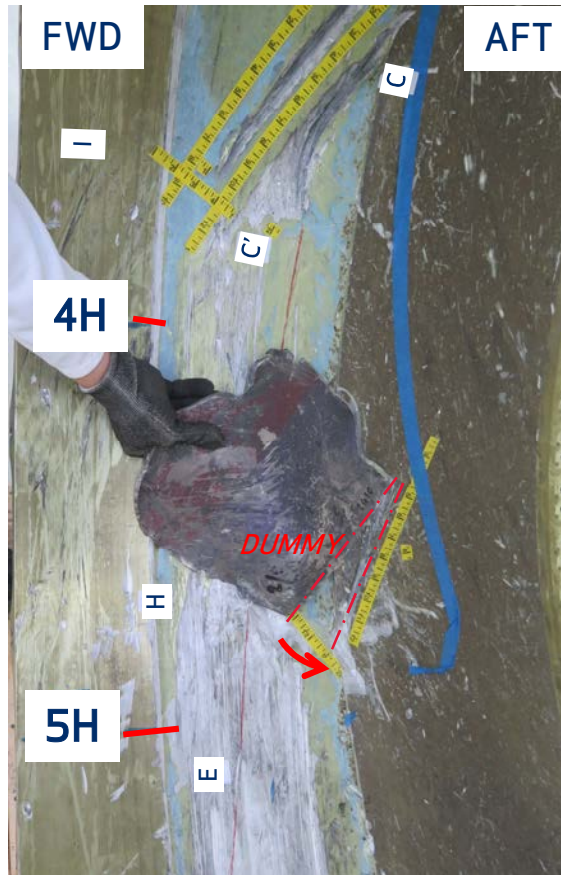
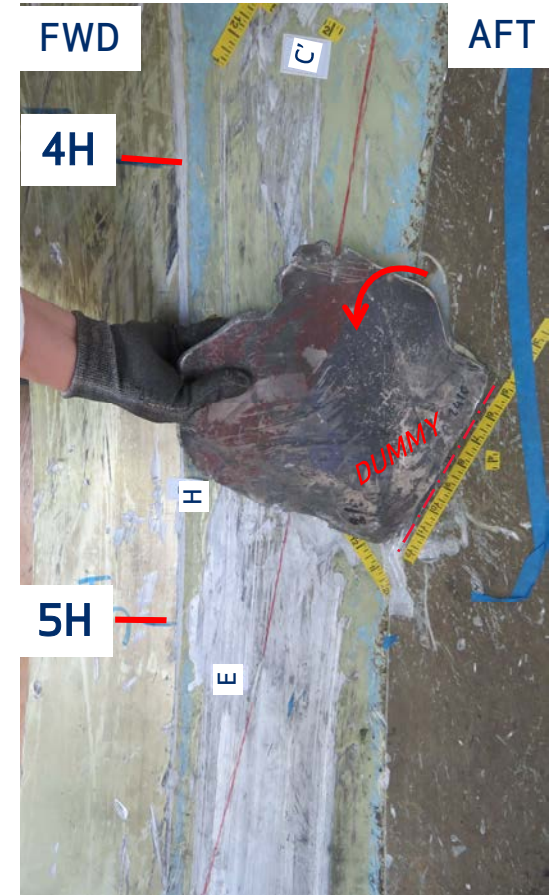
FAN BLADE # 23 ROOT TRAJECTORY

FAN case inner views

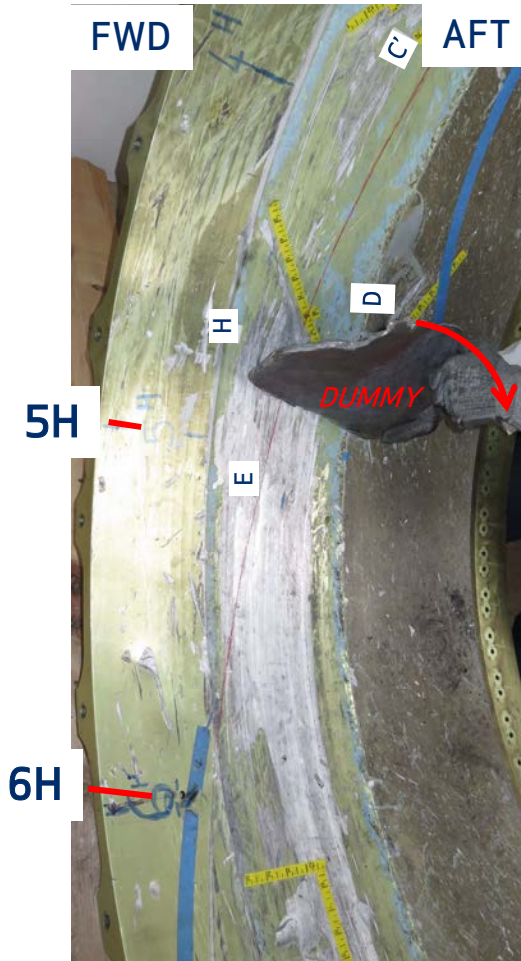
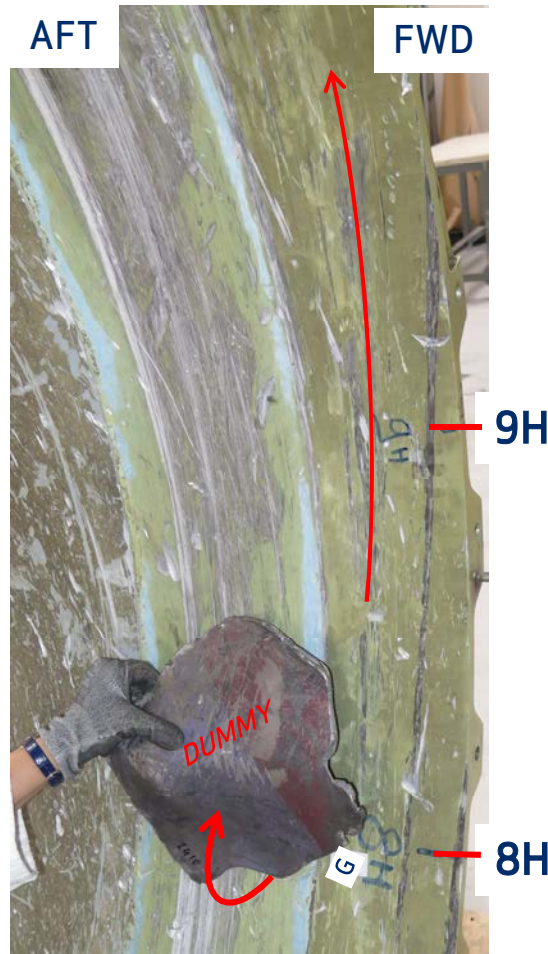
FAN BLADE # 23 ROOT TRAJECTORY

FAN case inner view

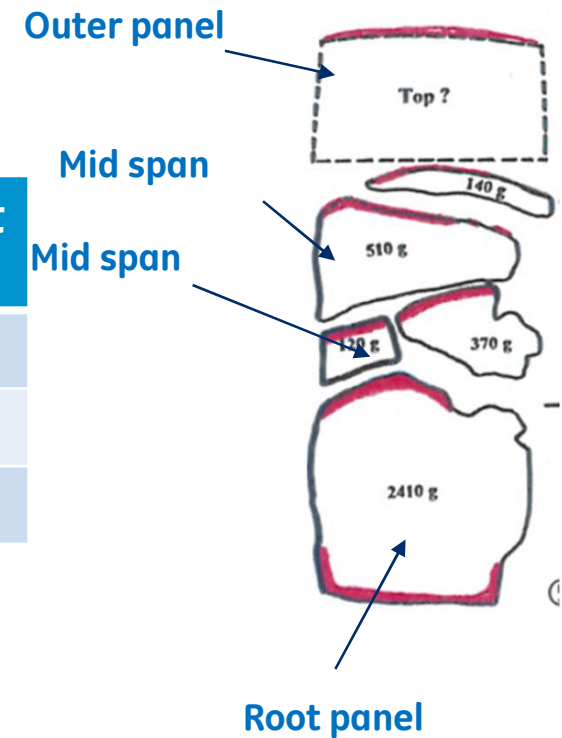
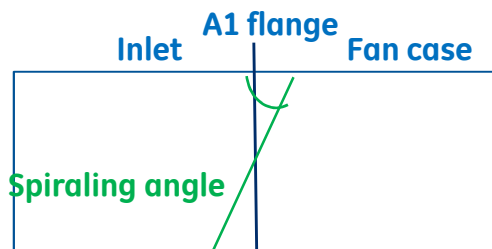
Estimation of ESN874112 fragment angle

Spiraling angle measured on fan case from ESN874112 are below data provided during certification process (15°)
