NATIONAL TRANSPORTATION SAFETY BOARD

AIRWORTHINESS GROUP CHAIRMAN'S FACTUAL REPORT

A. ACCIDENT: ANC10MA068
LOCATION: Near Aleknagik, Alaska
DATE/TIME: August 9, 2010
AIRCRAFT: DeHavilland Canada DHC-3 "Turbine Otter", N455A

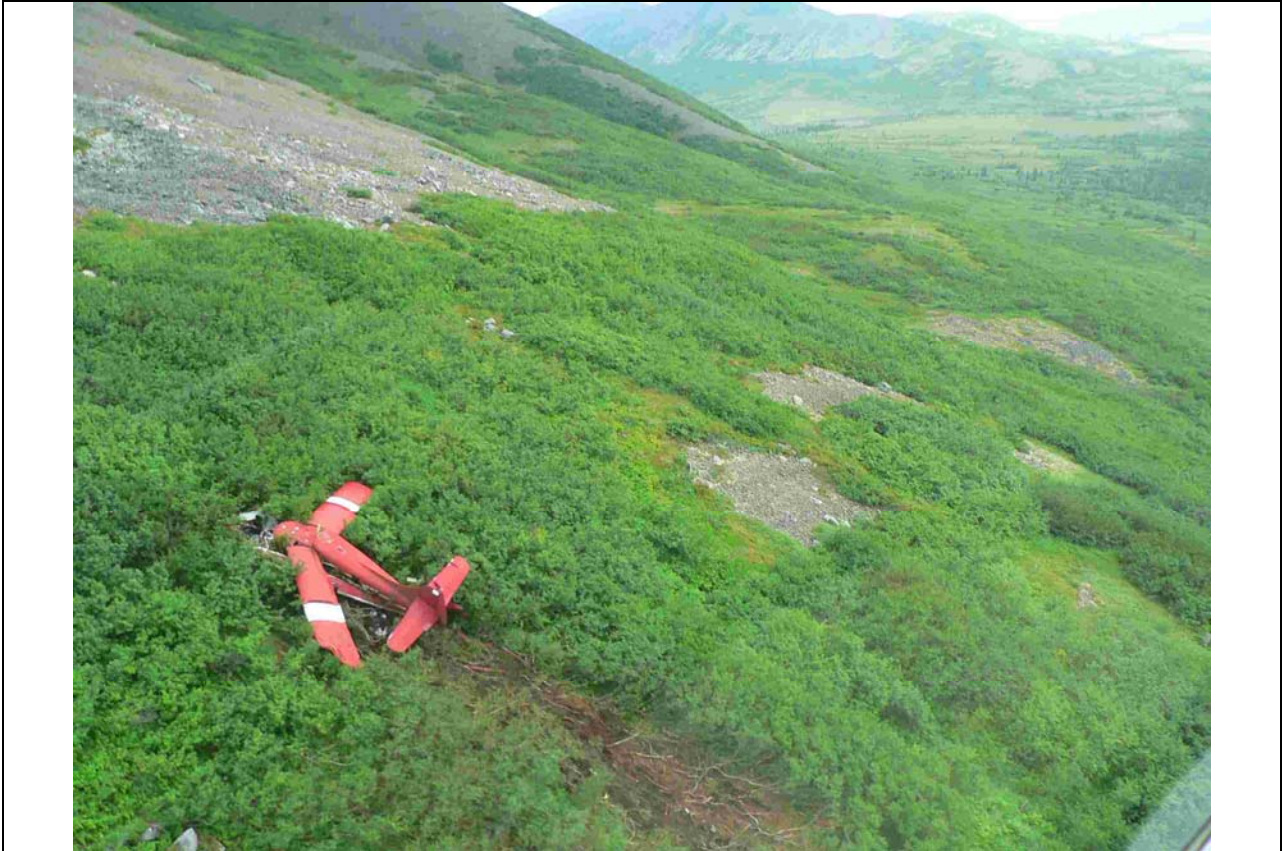
The airplane was found on the western slope of the Muklung Hills. (See Figure 1)

Figure 1. N455A on western slope of Muklung Hills with an unnamed peak at top of the photo. The pass between the Muklung Hills and the unnamed peak is slightly more than a mile wide.

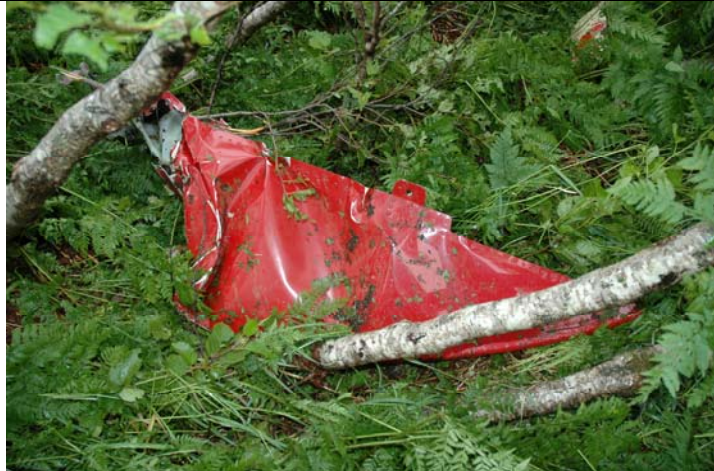
The ventral fin from beneath the airplane tailcone was the first piece of debris and was found near the initial damage to the alder trees. This was prior to where the airplane contacted the ground. The leading edge of the ventral fin had tree strike damage. Debris from the forward tips of the floats was not in the area where the ventral fin from beneath the airplane tail was found in the alders. (See Figures 6, 7 and 8)

Figure 6. Left side of N455A ventral fin, showing impact marks on leading edge (left edge of what is visible).

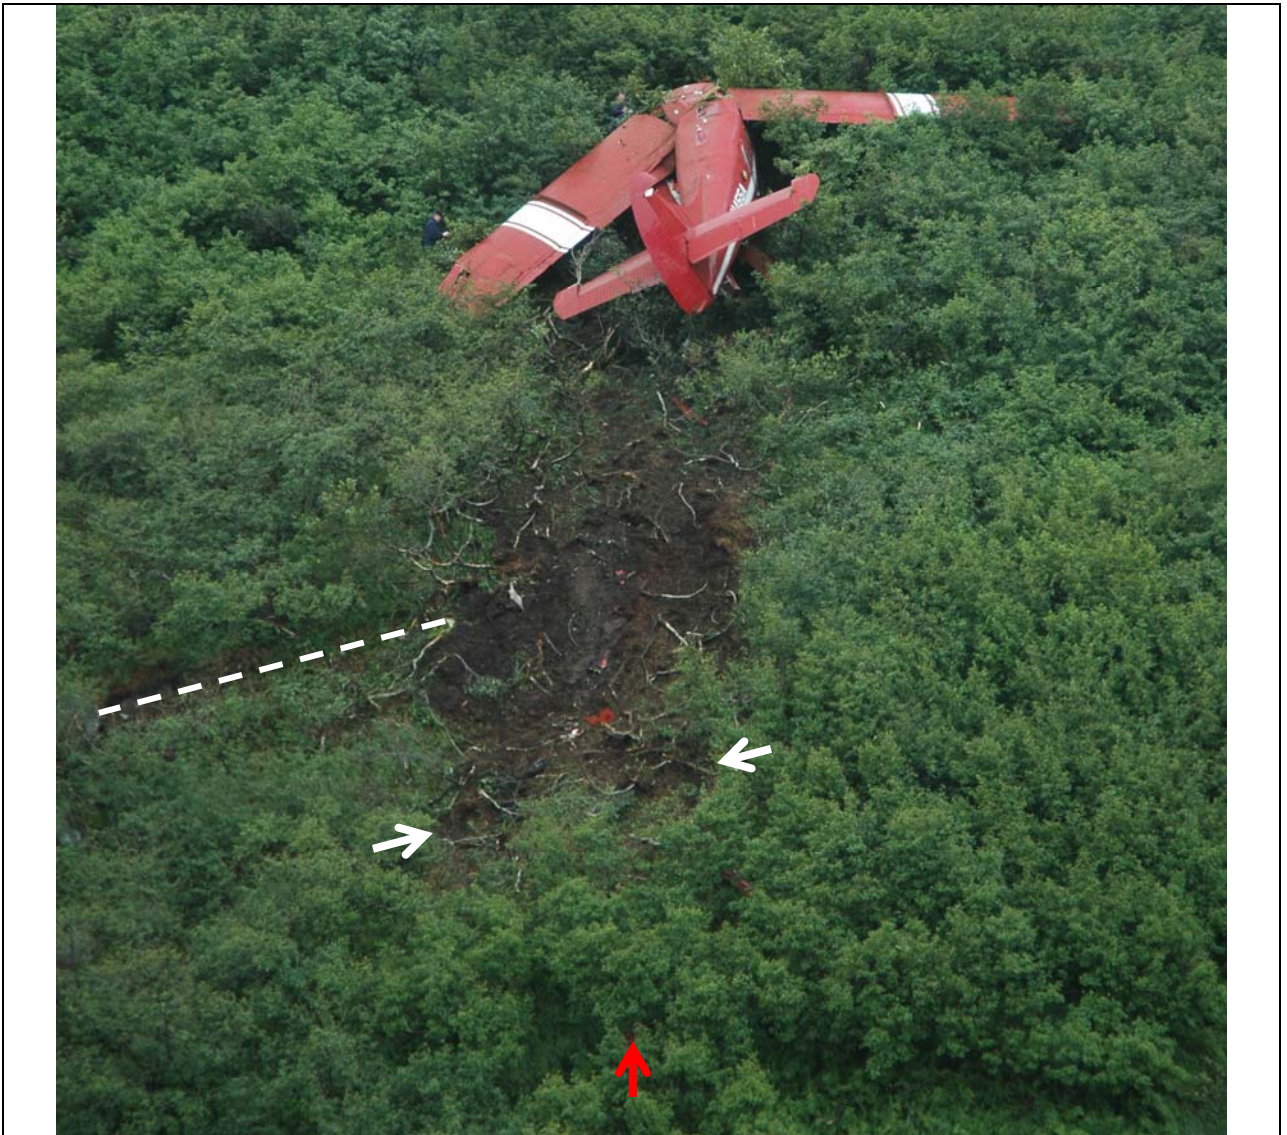
The width of the cut alders and subsequent marks in the ground were found to match the spacing of the floats. (See Figure 10) An imprint in the ground led to the left float and that imprint was the first actual ground contact. The imprint was followed immediately by the left nose wheel. (Most of the right nose wheel stayed with the right float.) The heaviest crush damage on the left float was on the bottom, immediately aft of the nose gear mounting, and the damage to the fuselage at the front left float attach point was diagonally up/aft.

Figure 10. From directly behind the airplane, the small red arrow at the bottom of the photo shows where the first piece of airplane (ventral fin) was found. The white arrows point to the imprints of the floats, the left being the first ground contact. Around the dashed line is a cut in the alders that had the span of the left wing.

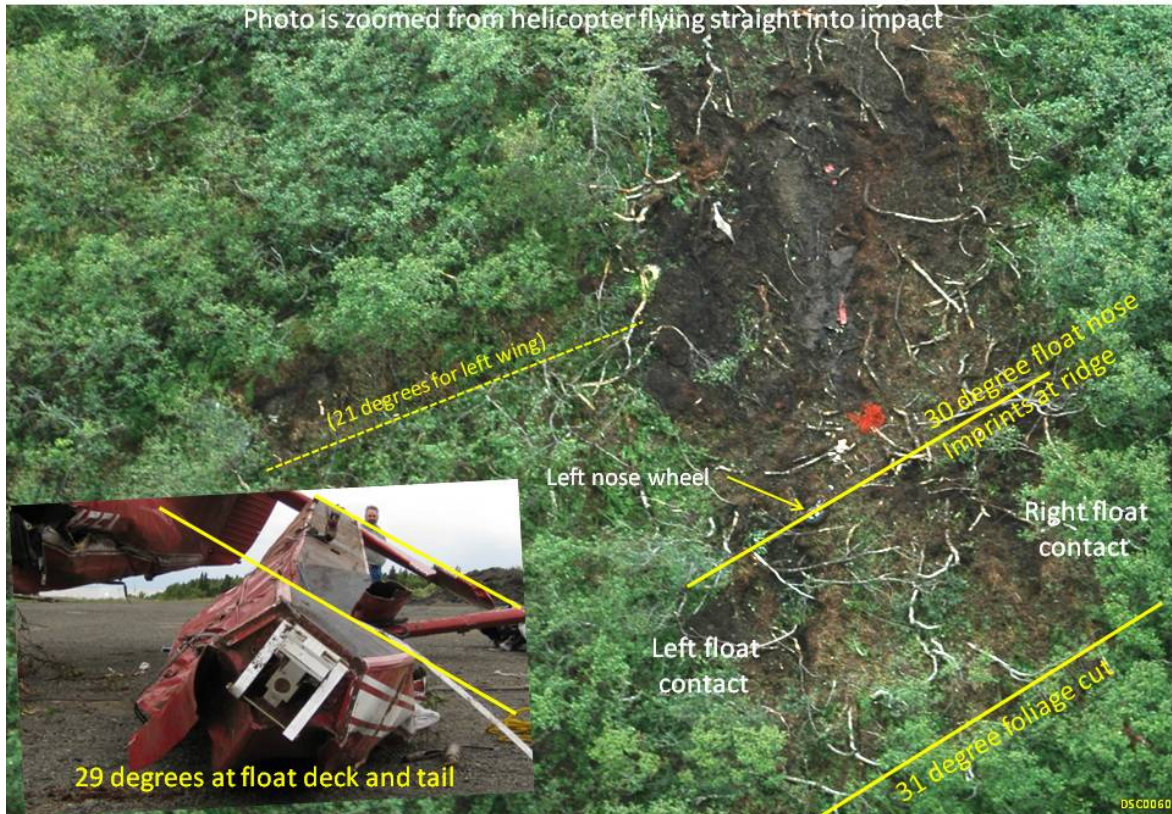
The initial cuts in the alders and roll damage to the floats were found at 29-31 degrees left wing down in bank. (See Figure 11) In pitch, the bottoms of the floats were crushed upward, not the noses. Laying an illustration of the float profiles on a 30 degree line for the measured slope of the hill, the tangent of the damage was at 15 degrees nose up pitch and the heaviest keel twist/crush was between 15-20 degrees, with the rearmost of the keel damage aligning to the 30 degree reference line at about 25 degrees nose up pitch. (See Figure 12)

Figure 11. The above figure shows bank angle damage measurements. The float photo is cropped from Figure 13.

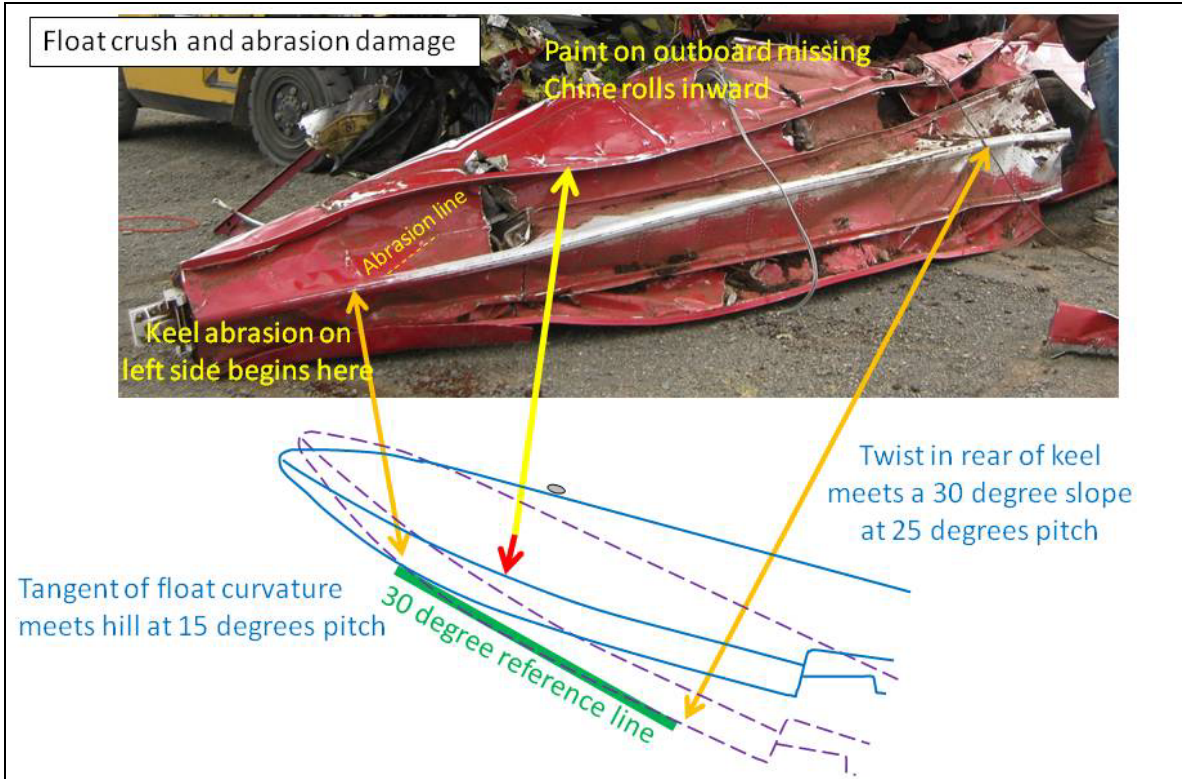
Figure 12. Damage found on bottom of left float, with illustration showing a 30 degree reference line. The heaviest damage is between 15 and 20 degrees pitch, with keel twist extending to about 25 degrees nose up.

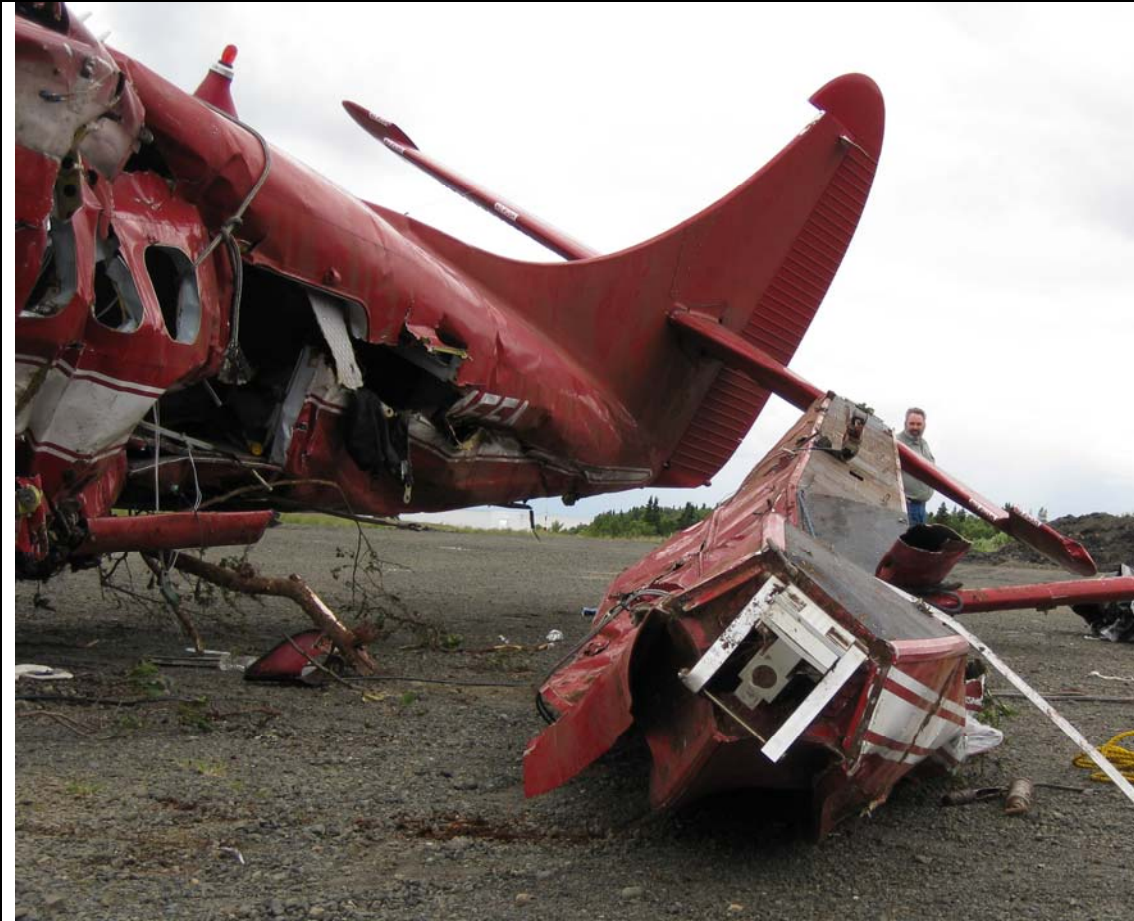
The bottom of the left float was extensively flattened. The forward tip of the float was not as crushed aft into the float body and the nose bulkhead deformation was significantly less than the damage found to the bottom of the float. The forward half of the left float had the outboard (lower left) edge rounded and the float had been bent at the change in bottom contour, known as the “step.” This location was where the main landing gear were located. The set of two main tires were found in the retracted position. (See Figures 13 and 14)

Figure 13. Left float, showing crush from front.

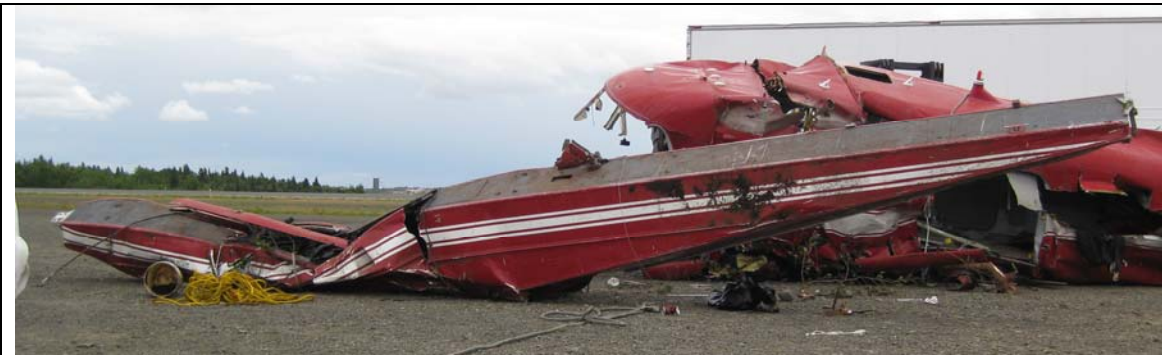
Figure 14. Left float from the left, resting on the crush line

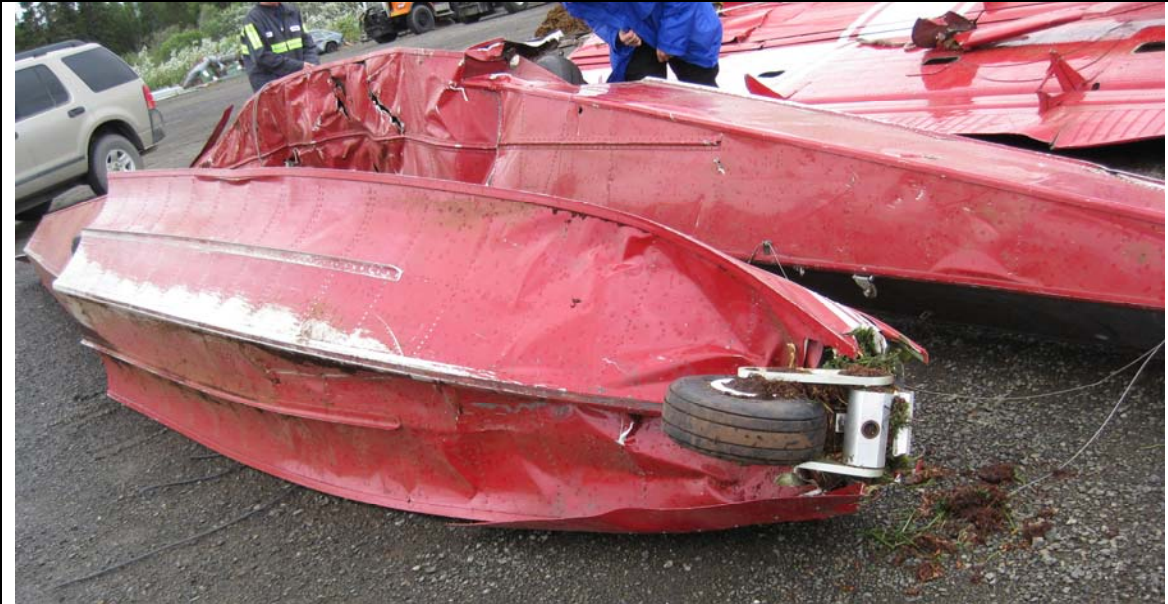
The upward deformation to the right float was limited to the forward portion of the bottom surface, in the immediate area of the nose tire. The nose bulkhead of the right float was crushed aft without sufficient frontal impact to separate the nosewheel. The nosewheel remained attached and had been displaced upward to crush into the bottom surface of the float body. (See Figure 15)

Figure 15. Forward features of the right float. The left float is behind the right float, illustrating the difference in extent of crush damage to the bottom surfaces.

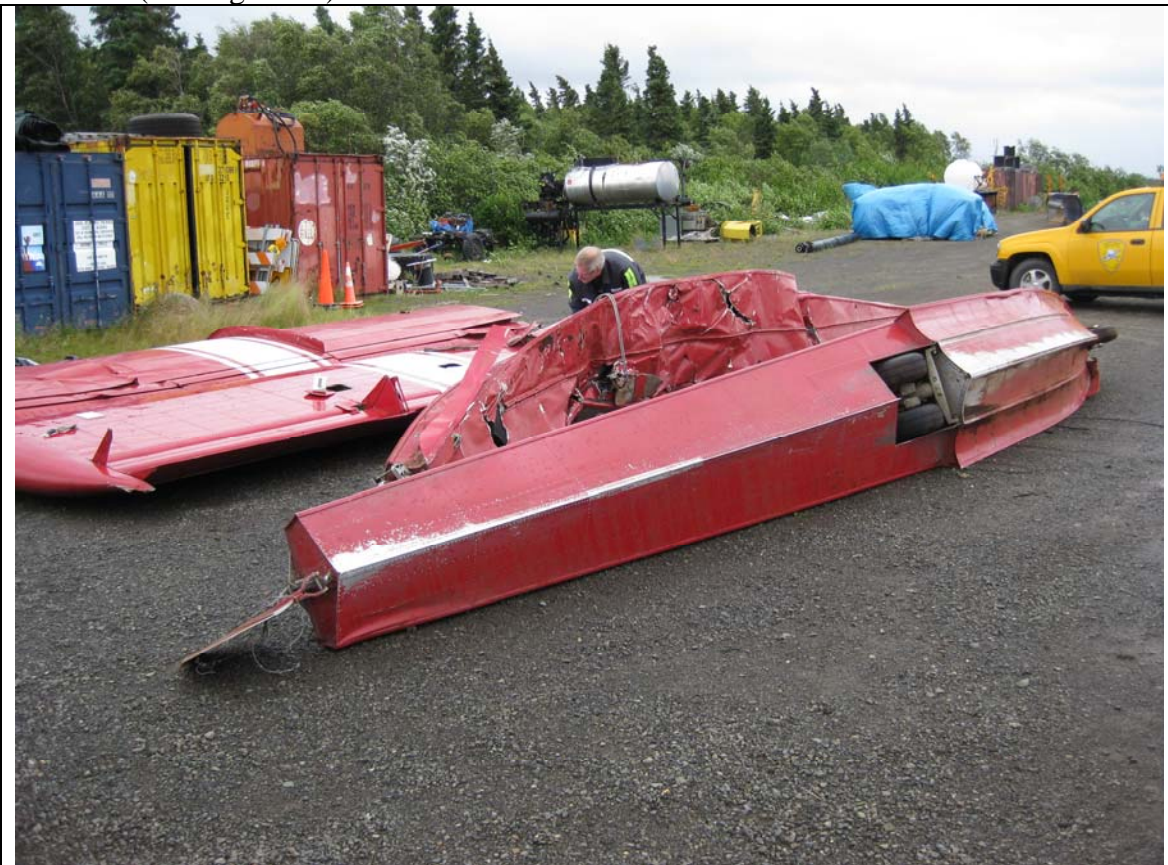
Otherwise the float was significantly less damaged and the water rudder remained attached. (See Figure 16)

Figure 16. Right float appears to be relatively intact when compared to the bottom of the left float (behind the right float).

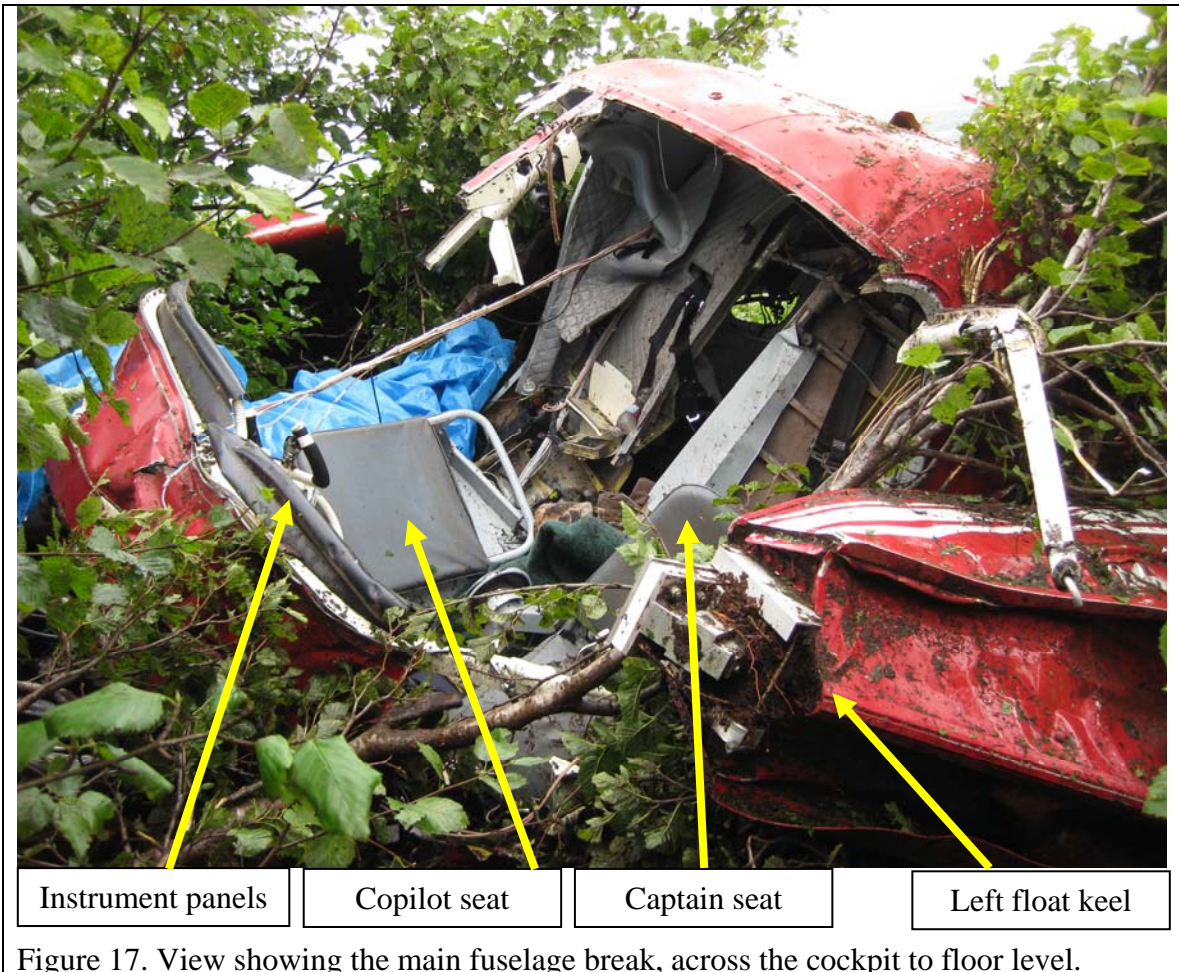
The fuselage had broken at the windshield and down through the cockpit door openings. The instrument panel and engine were loosely held to the rest of the structure by structural remnants at floor level. (See Figure 17) The top of the fuselage had also broken open in the area of the wing spars. (See top of fuselage in Figure 14)

Figure 17. View showing the main fuselage break, across the cockpit to floor level.

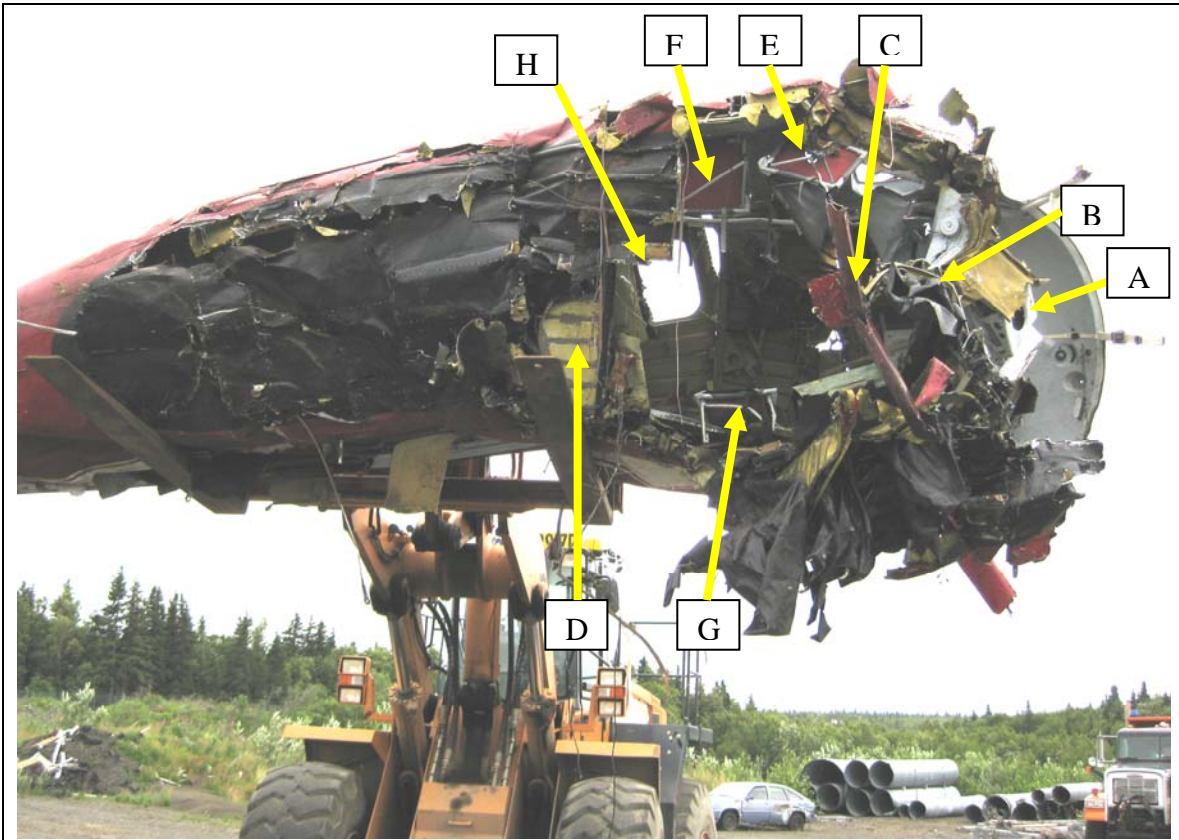
When N455A was to be lifted for recovery, it was learned that little remained of the structure beneath the level of the floor and ahead of the aft bulkhead. The forward cabin floor was completely loose and the fuselage had essentially no remaining integrity. Numerous ratchet straps had to be employed in order to use the left float as a stiffening device for transport. Once at the airport, the ratchet straps were removed and a forklift was used to pick up the fuselage for transport to a hangar. As the fuselage was lifted, the structure hung limply forward and aft of the fork lift, illustrating the lack of remaining integrity to the substructure. (See Figure 19)

Figure 19. Bottom of fuselage when picked up with forklift, showing the lack of structural integrity. Also visible are: (A) Copilot's seat bottom, (B) twisted bottom edge of cockpit/cabin bulkhead, (C) Right forward landing gear attachment fitting, which is on the end of (B), and (D) the aft bulkhead with float attachment fittings. The forward cabin floor has fallen away, exposing (E) the right forward-most cabin seat (#4), (F) right cabin second seat (#6), (G) left cabin second row seat (#5), and (H) the open roof escape hatch.

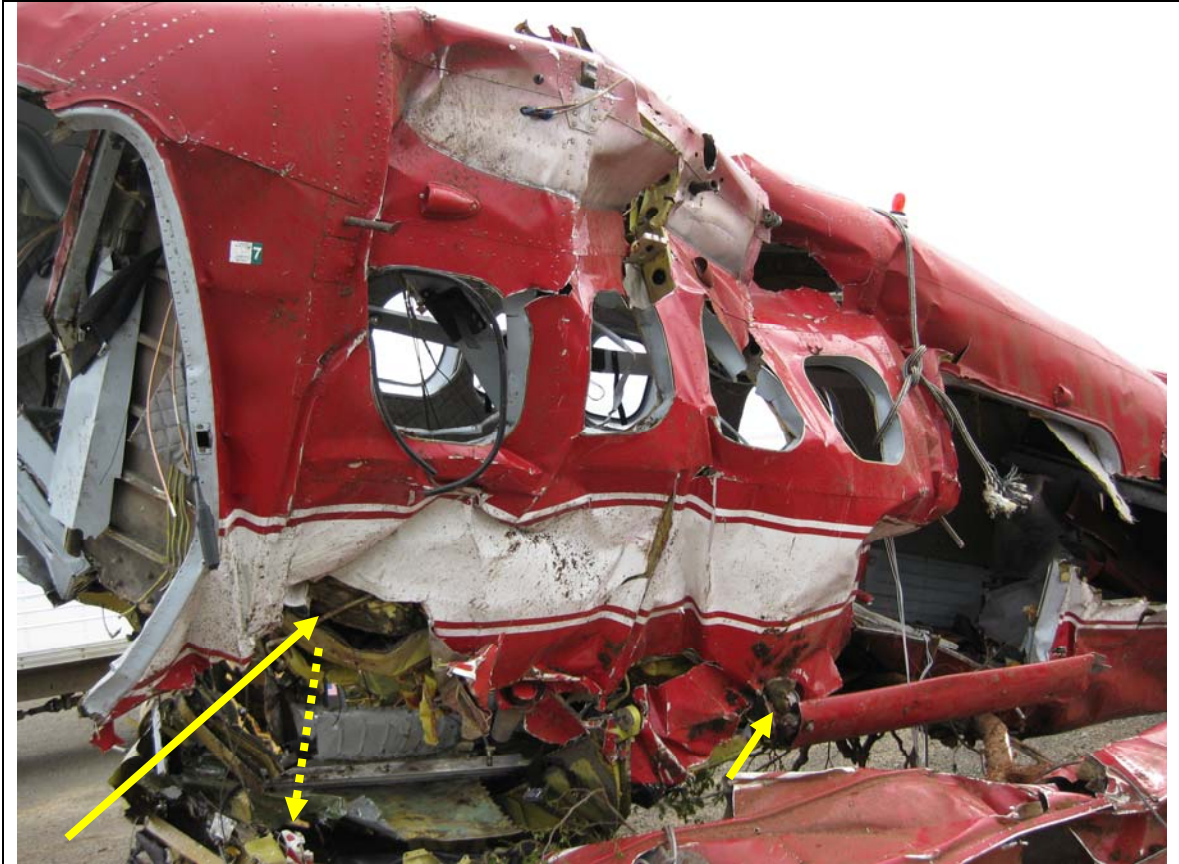
The forward (canted) bulkhead had been extensively torn apart, with the lower structural components either missing or twisted aft. The left end of the forward bulkhead had been above the upwardly hydro formed area of the left float. The upward deformation of the fuselage in the area also upwardly displaced the cabin floor and forward-most left cabin seat. (See Figure 20) The airplane had a post-manufacture modification to strengthen the original design around the landing gear attach fitting and the damage destroyed the reinforced structure.

Figure 20. Damage to left side of the cabin. Arrows point to the approximate displacement of the left float fittings. The aft edge of the cockpit door is normally vertical (above long arrow) and the crush aft of it is how far aft the cockpit/cabin bulkhead had been displaced toward the cabin's left forward-most seat. The seat had been above the head of the long arrow. (As the fuselage was lifted, the forward bulkhead remnant and left forward float attachment fell to the end of the dashed line.) Also visible above the windows is the amount of intrusion into the upper fuselage by the trailing edge of the left wing.

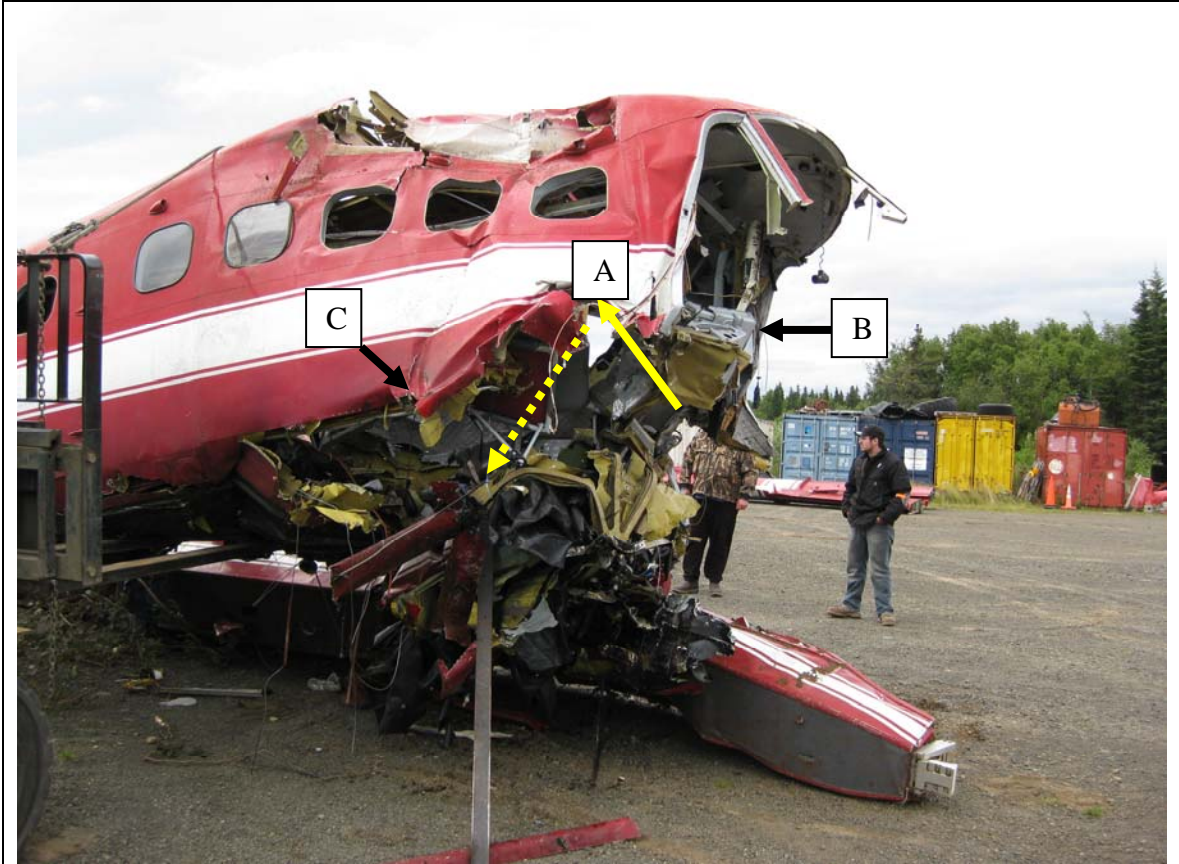
The right end of the forward bulkhead and lower aft portion of the right cockpit door were displaced aft. The float fitting had rotated so that the forward end was outboard. Each of these aspects of the damage reduced the space between the bulkhead that had been the forward cabin wall (aft cockpit wall) and the first passenger seat on the right. (See Figure 21)

Figure 21. Damage to the right side of the cabin. The forward right float fitting was displaced upward and aft (See A), similar to the left fitting, before falling to where indicated by the dashed arrow. (Origin point of solid arrow is approximate.) Aft displacement of the canted bulkhead is visible as crushed structure that is aft of the cockpit door. The copilot seat is (B) ahead of the bottom of the cockpit door frame. The location of the destroyed wing strut fitting structure is visible (C).

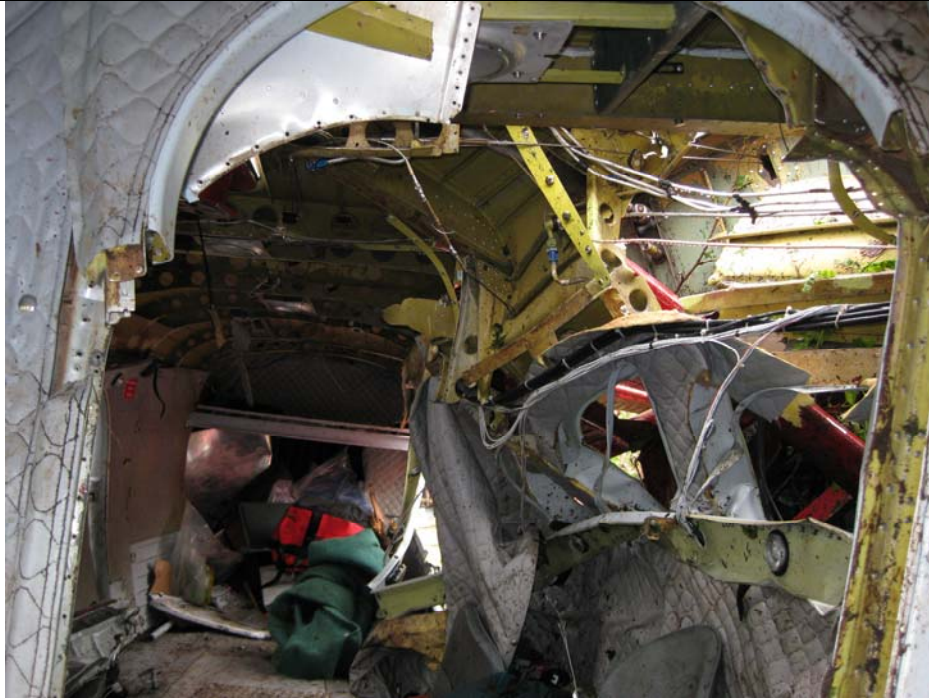
panels. The right wing root and sidewall above the right wing strut fitting intruded to a lesser amount into the upper fuselage structure. (See Figures 22, 23, and 24)

Figure 22. Prior to recovery. The left wall of the cabin can be seen displaced inward, as looking aft from the cockpit.

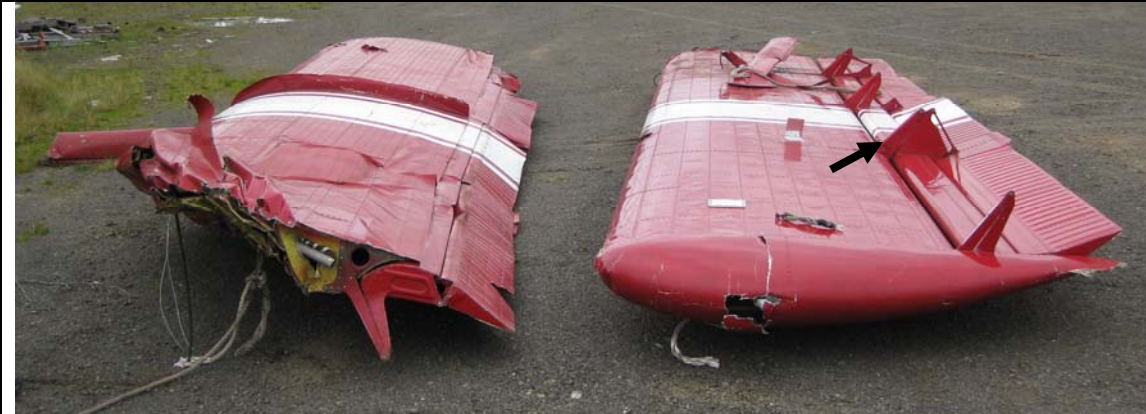
Both wings retained the flaps and ailerons. Each had leading edge impact damage consistent with striking the alder trees at the accident site. The depth of the leading edge damage was enough to break the cover for the landing light in the right wing, but not reach the face of the bulb. The tip of the left wing had a crush line that visually resembled the roll and pitch angles of the bottom of the left float. An alder branch penetrated upward through the gap between the left wing and flaperon.

Figure 25. The upper surface of the left wing and bottom of the right wing, shown respectively from the tip ends. The arrow placed on the right wing shows where a broken control rod was found.

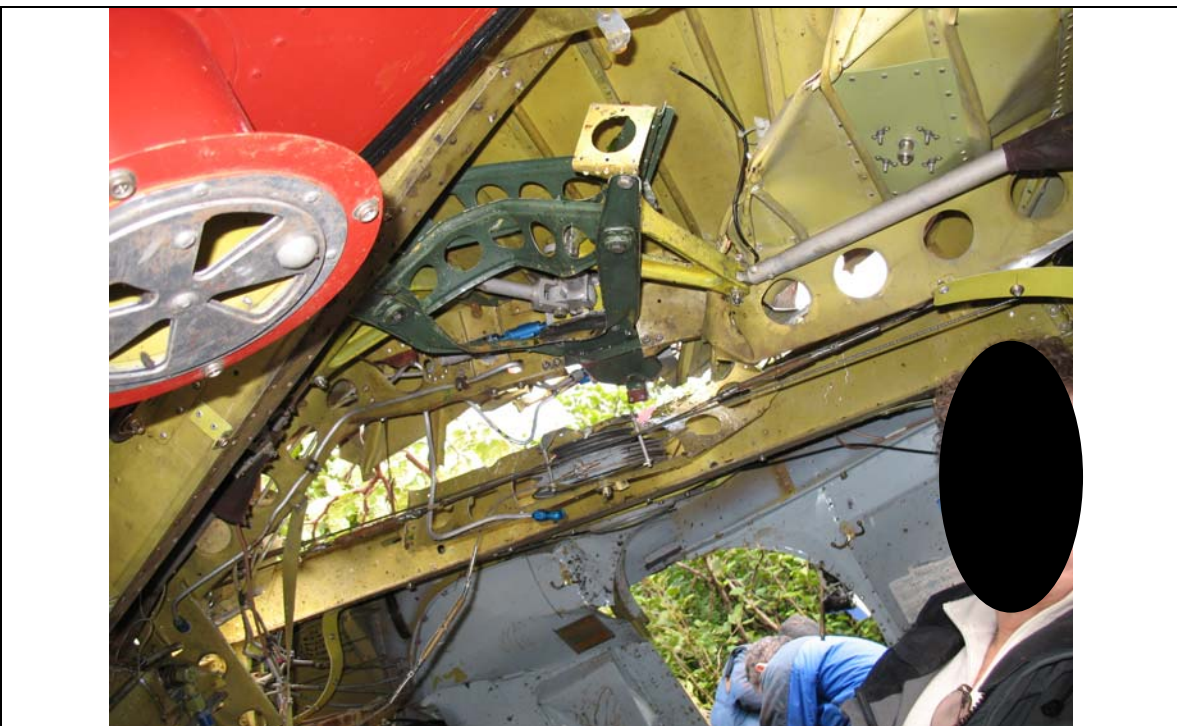
The fuselage carry-through structure for the wing spars was disrupted and the mounting for the hydraulic flap actuator and quadrant had been displaced, trapping the quadrant in the flaps up orientation. A connecting rod for the flap/trim interconnection had broken behind the quadrant. The flap control rods to the left wing had broken at the fuselage wall. (See Figure 26)

Figure 26. Extensive component and structural damage at the fuselage breach near the flap actuator and control quadrant above what had been the cabin ceiling.

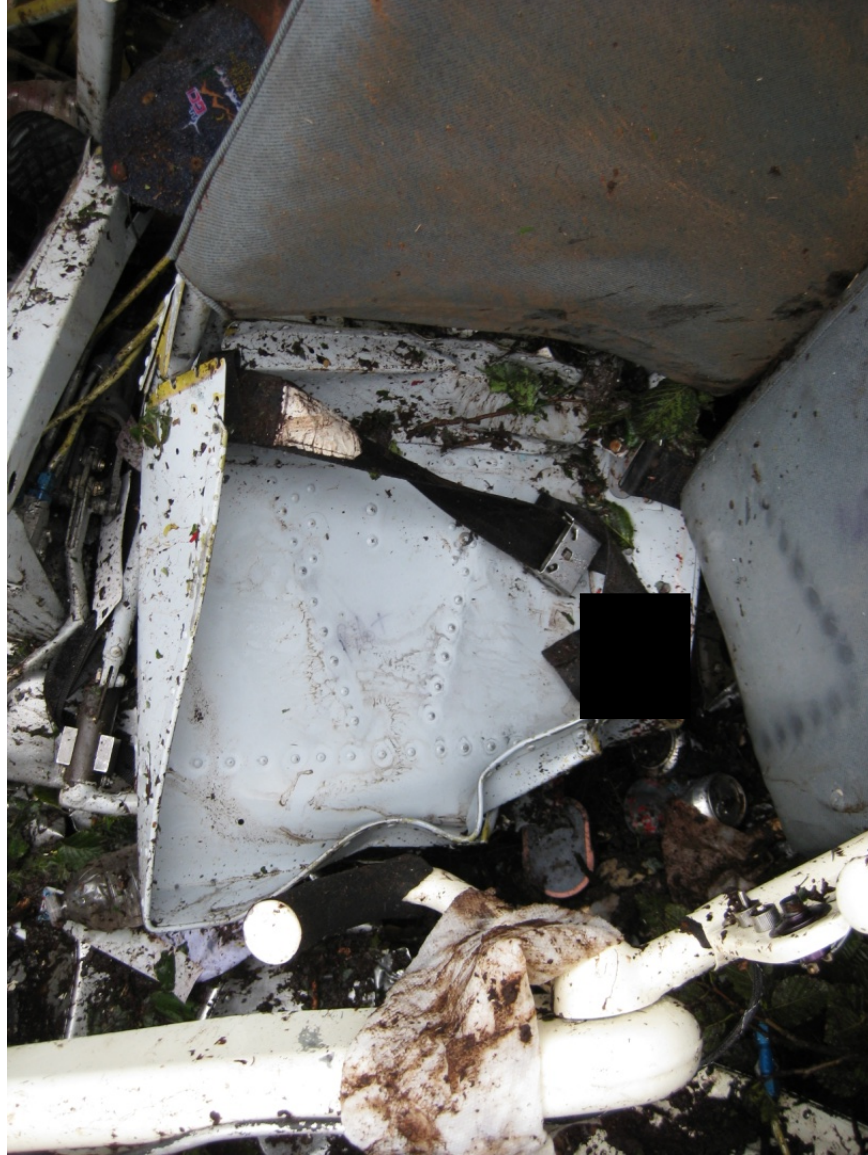
The captain's seat of the accident airplane in general had deformed nose down and to the left. The aluminum seat pan had even further deformation in that direction. Removal of the bottom cushion revealed that the forward left corner of the seat pan had upward/aft impact damage. (See Figure 30) The pan of the seat had twisted on the seat subframe so that the leading edge was toward the left.

Figure 30. Captain seat pan after cushion removal.

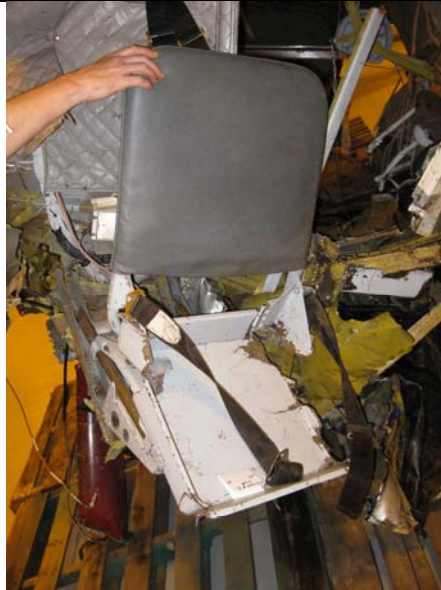
The subframe had bent the floor structure downward, especially toward the front. The copilot's seat had been constructed with a fiberglass pan on a crushable steel subframe. The steel subframe did not have as much crush damage as that found to the captain seat frame. The fiberglass seat pan had broken where the aluminum supports for the backrest attached. The inboard wall of the seatpan had completely broken away. (See Figure 33) A rusty 18 inch pipe wrench was found immediately ahead of the crushable space that had been beneath the copilot seat.

Figure 33. Copilot seat, showing the fractured and missing portions of the seat pan.

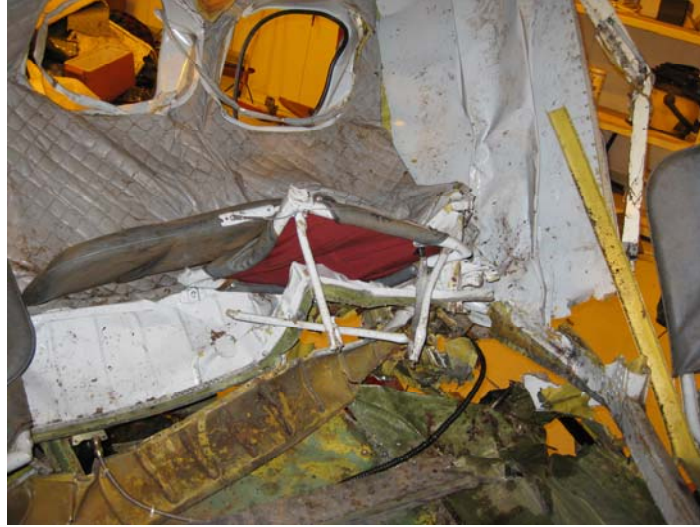
This seat had been above the forward left float fitting and was found up and inward from the original location. The bulkhead in front of the seat had a generalized soft body type of deformation. The lap belts were intact. The seat frame was a welded steel tube assembly that had broken. (See Figure 34)

Figure 34. Seat #3, the forward most left cabin position, showing absence of floor structure and upward deformation beneath the seat.

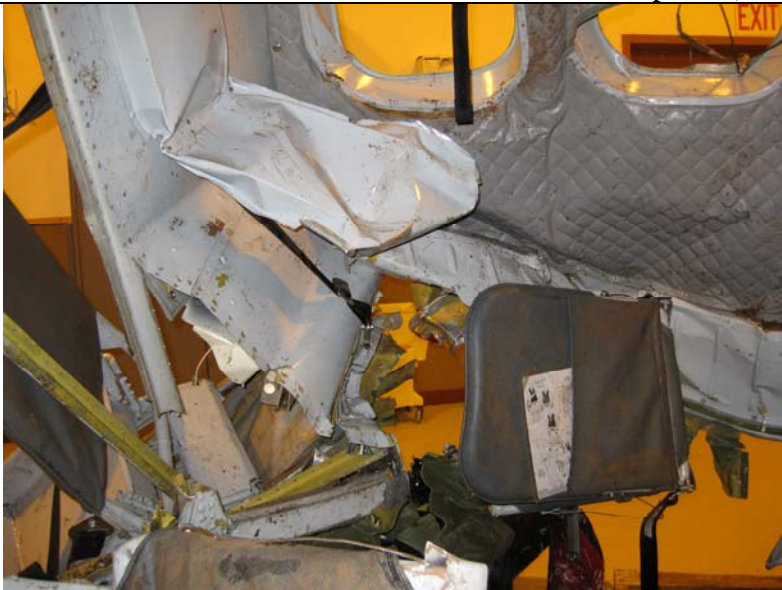
Figure 35. Seat #4, the forward most right cabin position, showing absence of floor structure and upward deformation beneath the seat.

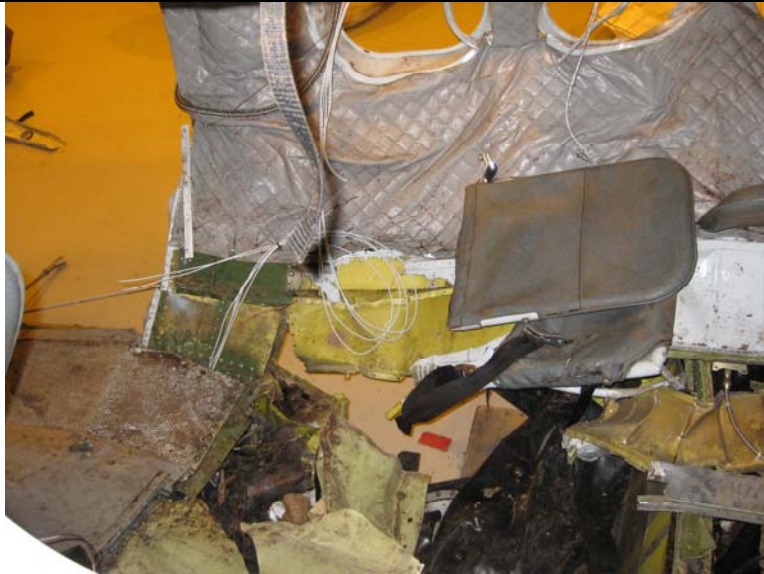
Figure 36. Seat #5, this was the second cabin seat on the left and the photo shows absence of floor structure. Seat #7 had been aft of this seat and fell away during recovery.

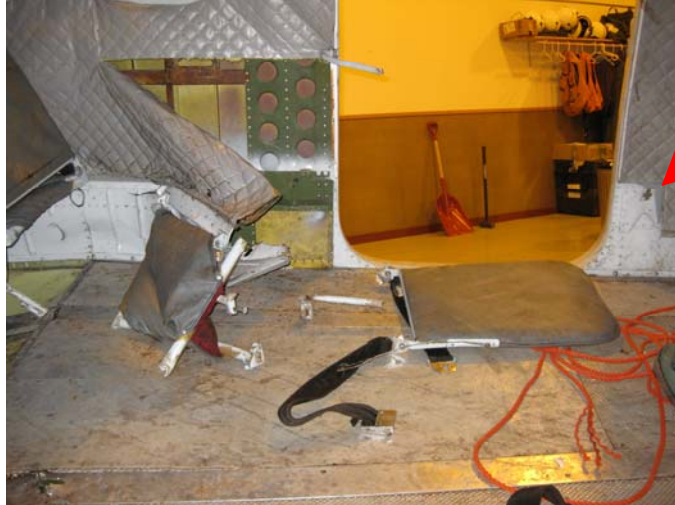
Figure 39. Fragments of seat #9. The arrow points to the broken structure that seat #11 had been attached to.

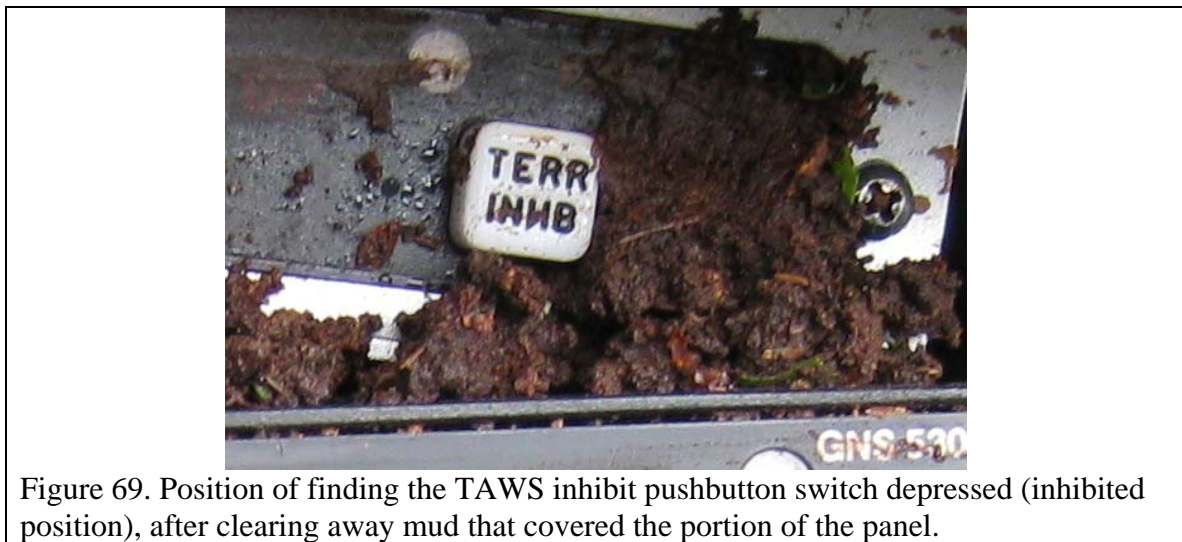
Figure 69. Position of finding the TAWS inhibit pushbutton switch depressed (inhibited position), after clearing away mud that covered the portion of the panel.

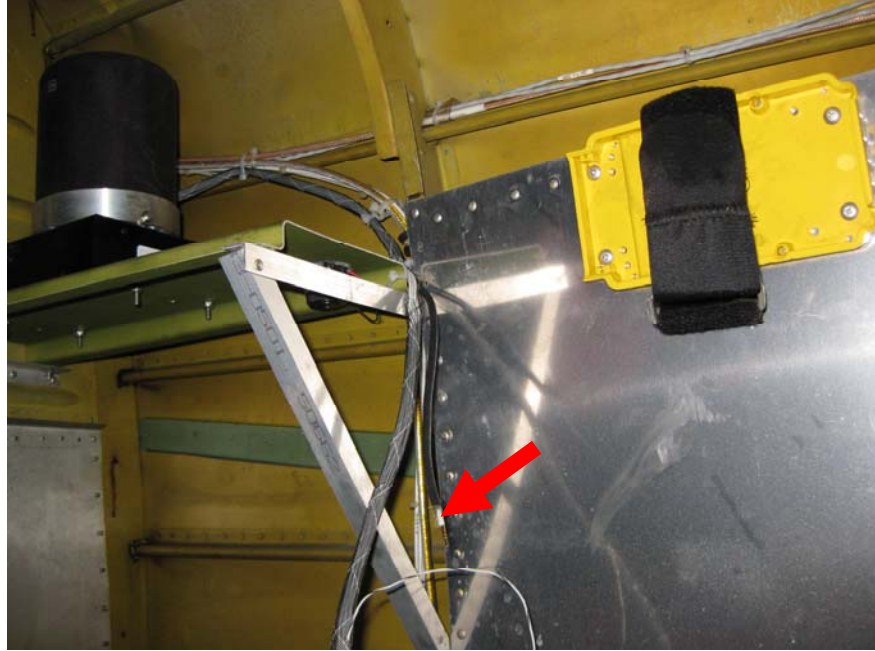
Figure 70. Empty ELT bracket in tail cone. The hook and loop fastening strap closed. To the left is forward in the airplane. The arrow points to the broken antenna connection.

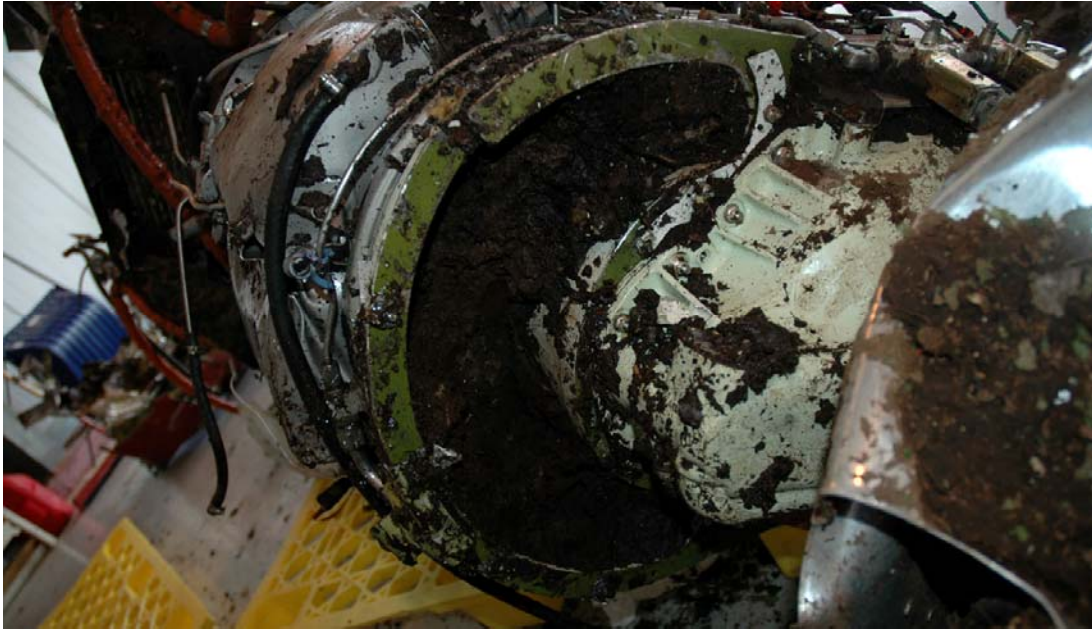
Figure 74. Dirt found in engine inlet

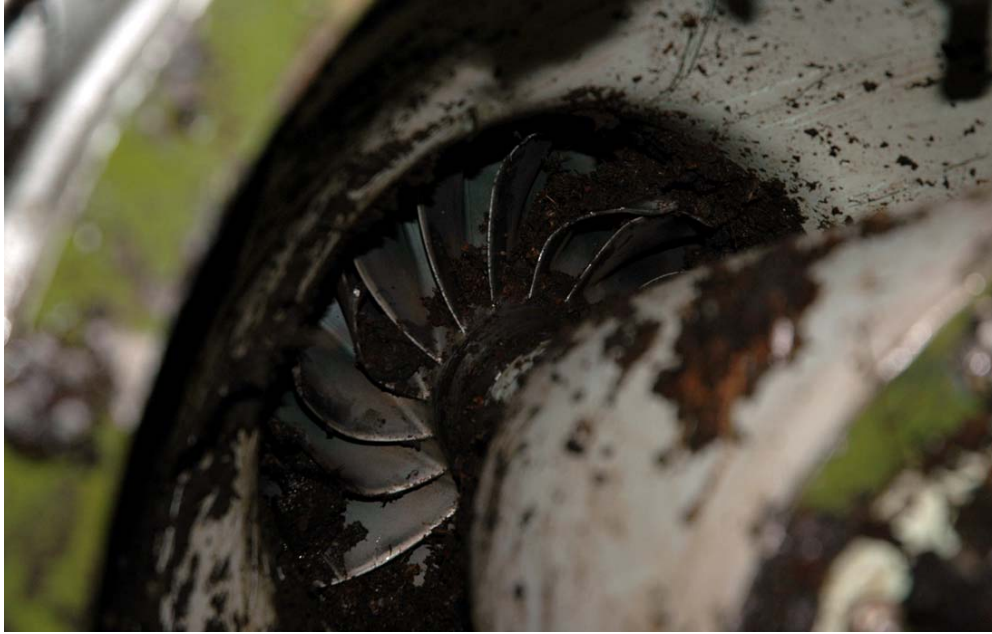
Figure 75. Damage to the first-stage compressor impeller.
