NATIONAL TRANSPORTATION SAFETY BOARD

AIRWORTHINESS GROUP CHAIRMAN'S FACTUAL REPORT

A. ACCIDENT: ANC10MA068
LOCATION: Near Aleknagik, Alaska
DATE/TIME: August 9, 2010
AIRCRAFT: DeHavilland Canada DHC-3 "Turbine Otter", N455A

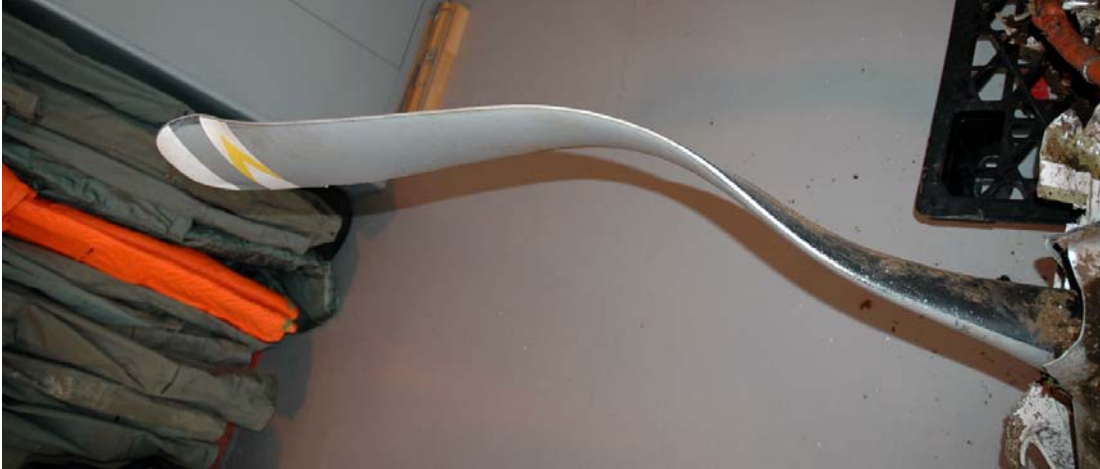
Figure 78. Bending in Propeller Blade, with leading edge toward camera.

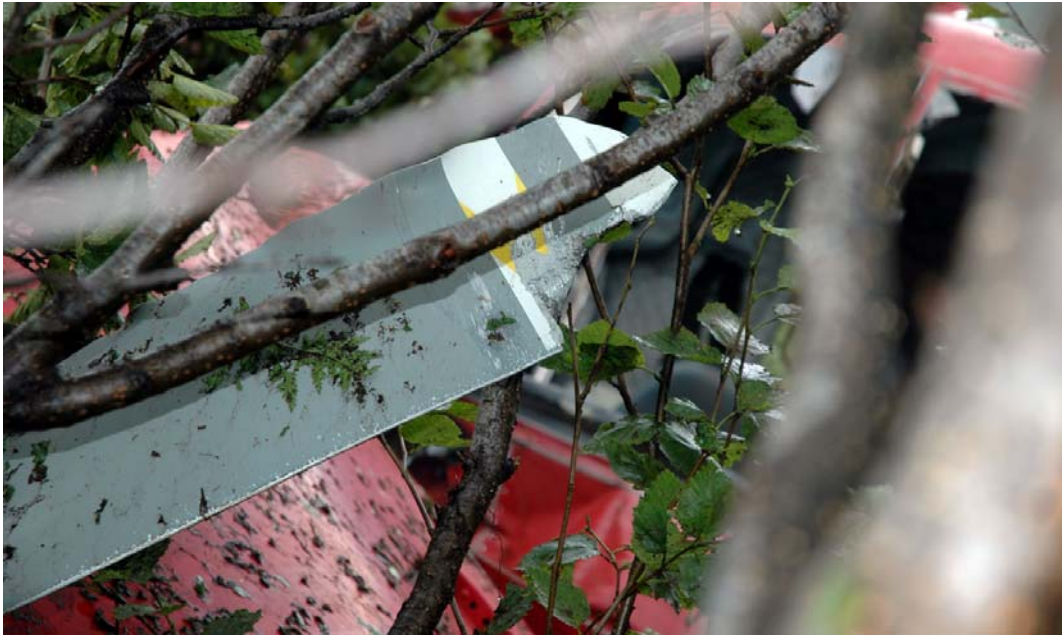
Figure 79. Propeller blade tip damage.

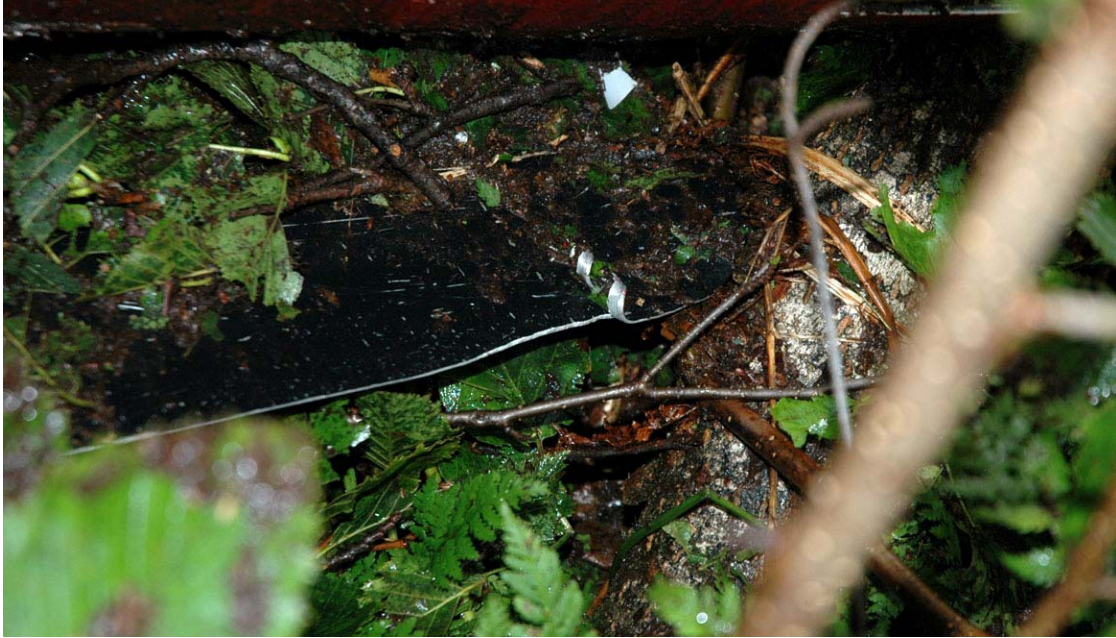
Figure 80. Trailing edge damage to propeller blade.
