NATIONAL TRANSPORTATION SAFETY BOARD
Office of Aviation Safety
Washington, D.C. 20594

Airworthiness Group Chairman's Factual Report of Investigation – Addendum 1

A. ACCIDENT **CEN13FA196**

Location: South Bend, Indiana
Date: March 17, 2013
Time: 1623 Eastern Daylight Time
Aircraft: Hawker Beechcraft Corporation Model 390 Premier 1A,
 N26DK

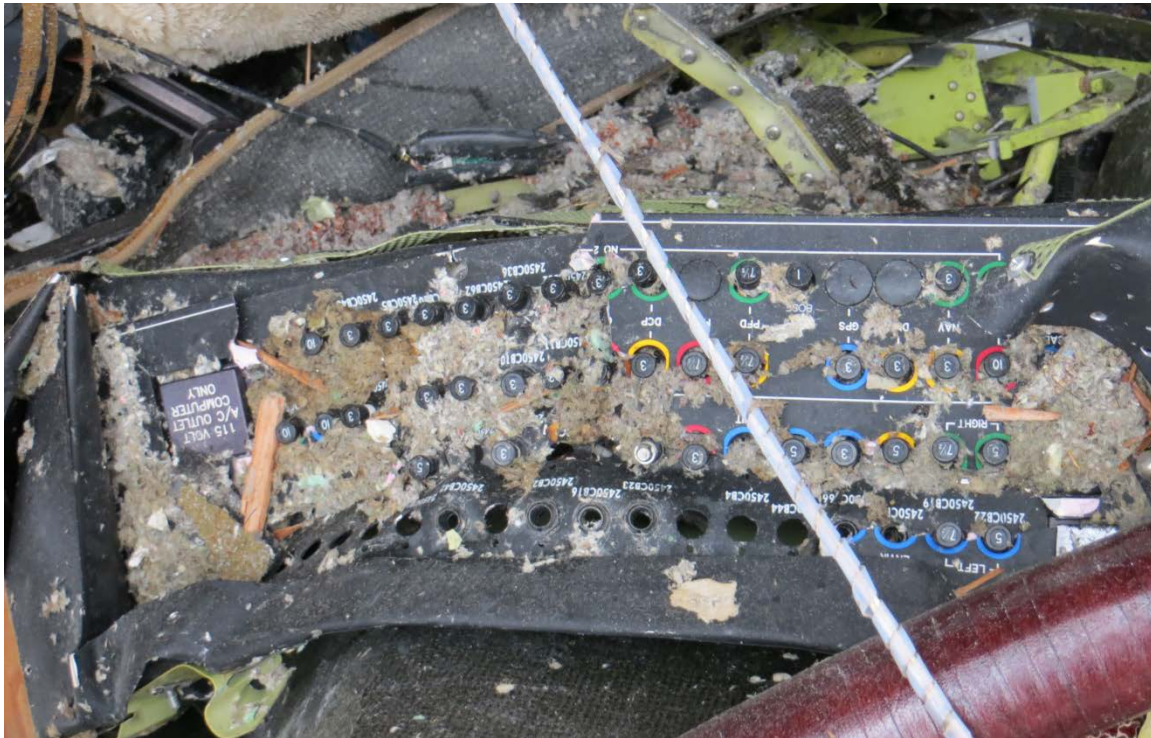
The Copilot's Circuit Breaker Panel was examined. The panel and the cockpit sidewall were separated from the cockpit structure, and the circuit breaker panel top cover and fascia was buckled and was partially separated. The fascia panel contains the circuit breaker nomenclature and the majority of the fascia was missing. There were multiple circuit breakers OPEN and/or physically damaged. (See Figure 1)

Figure 1 - Co-Pilot's Circuit Breaker Panel at Accident Site

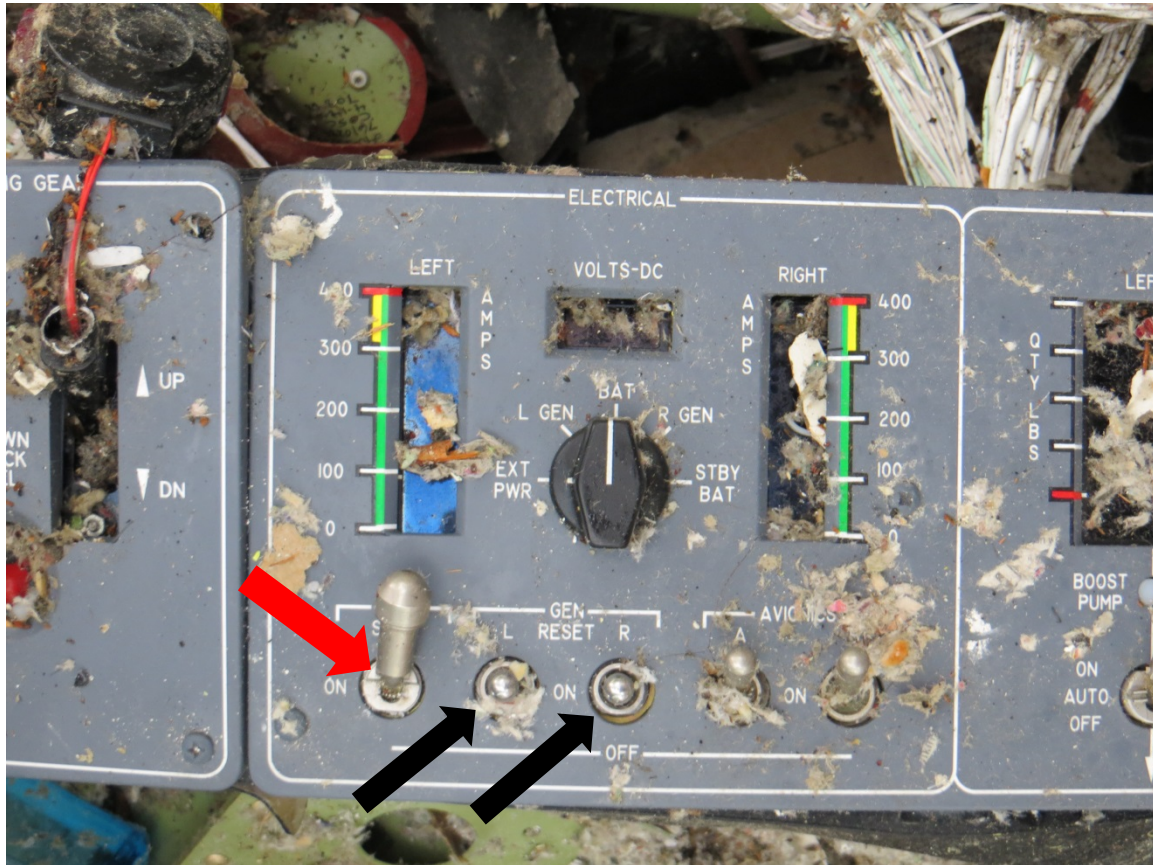
The L and R GEN switches were found in the wreckage. The L and R GEN switches were found in the ON position. See Figure 2.

Figure 2 - Electrical Panel, Including L and R GEN Switches (black arrows) and Standby Battery Switch (red arrow). (Note: Photograph taken at accident site)

The Standby Battery Switch was found in the STANDBY position. See Figures 2 above (taken at the accident site) and Figure 3 (taken after the airplane wreckage was moved to the airplane hangar).

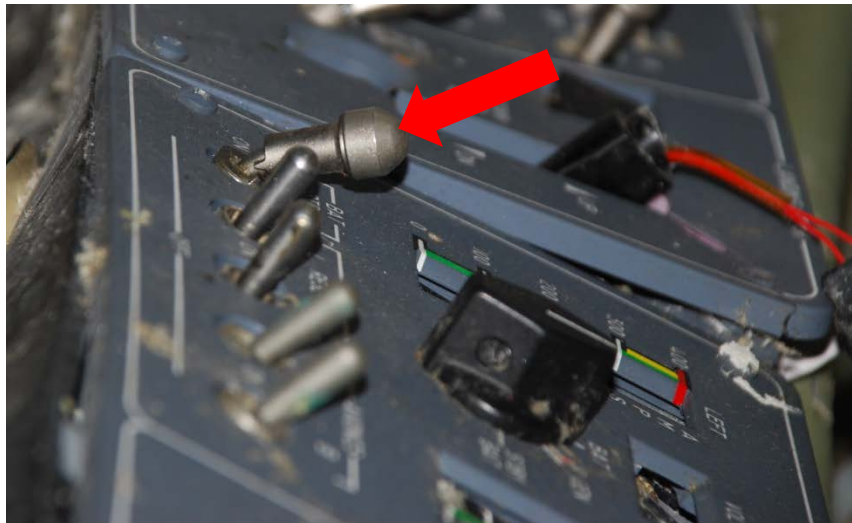
Figure 3 - Standby Battery Switch, After Wreckage Moved to Hangar

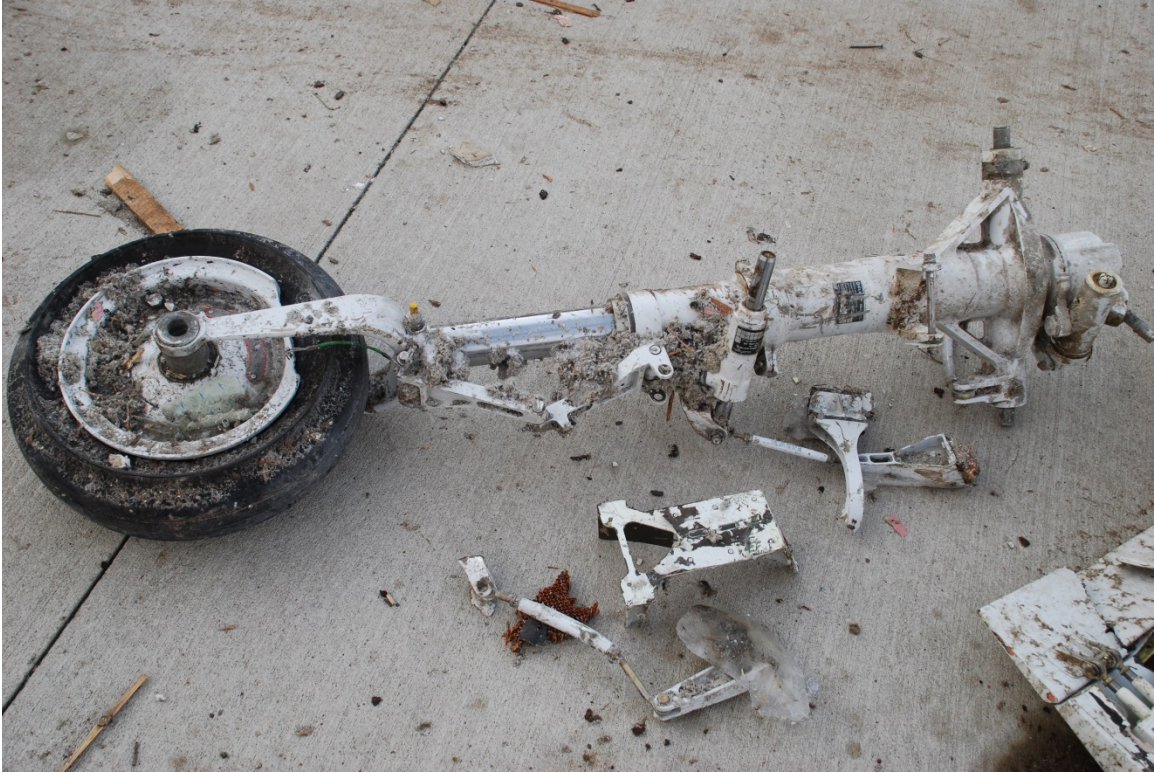
The nose landing gear was found separated from the airframe trunnion. The nose landing gear drag brace separated from the nose landing gear assembly and the airplane structure. The down lock actuator was separated from the drag brace assembly. The down lock "pawl" assembly also separated from the drag brace assembly. The wheel and tire assembly remained attached to the nose landing gear assembly. The wheel assembly exhibited signs of impact damage to a portion of the bead area of the wheel. The nose landing gear doors separated from the airframe and were found among the main wreckage. The nose landing gear actuator separated from the airframe and separated into two pieces with piston portion remaining attached to the nose landing gear assembly. See Figure 4.

Figure 4 - Nose Landing Gear Components at Accident Site

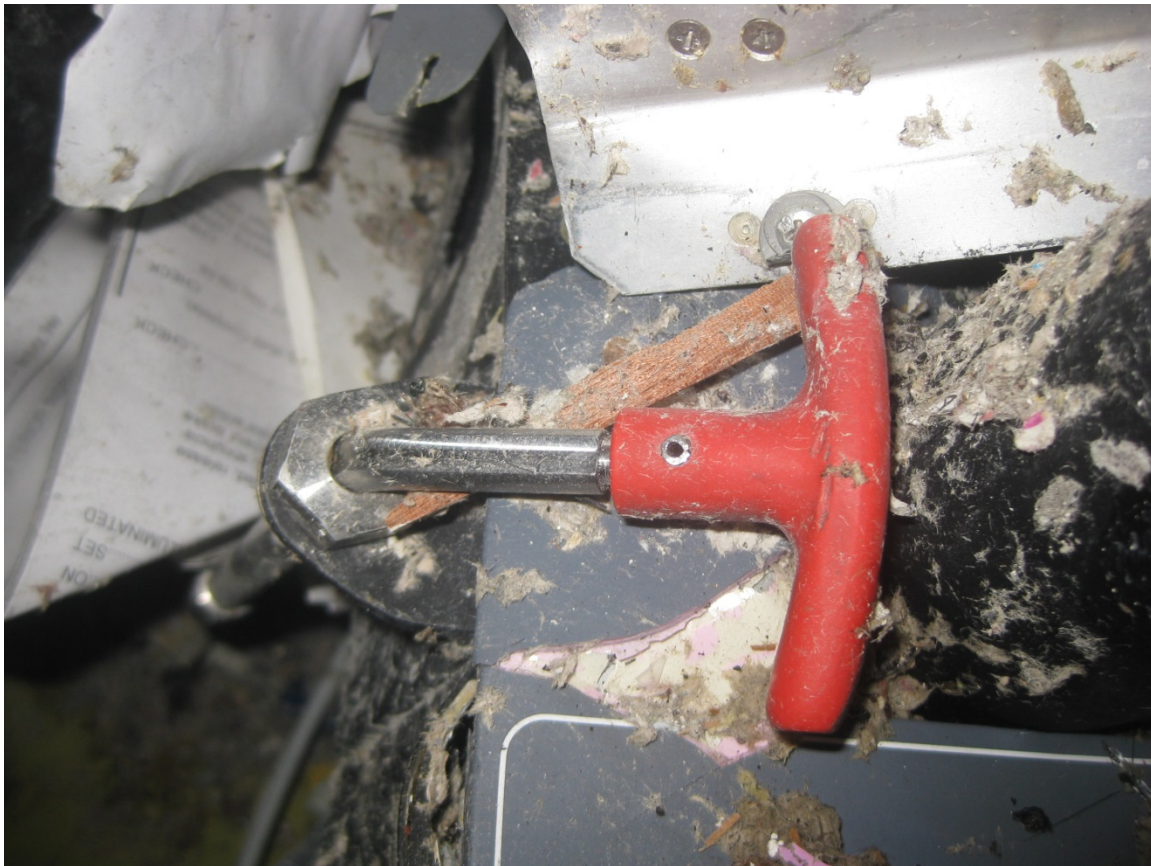
The landing gear alternate extension handle was located in the wreckage. The actuation of the handle was measured at an extended position of approximately 1 ½ inches. See Figure 5.

Figure 5 - Alternate Landing Gear Release Handle

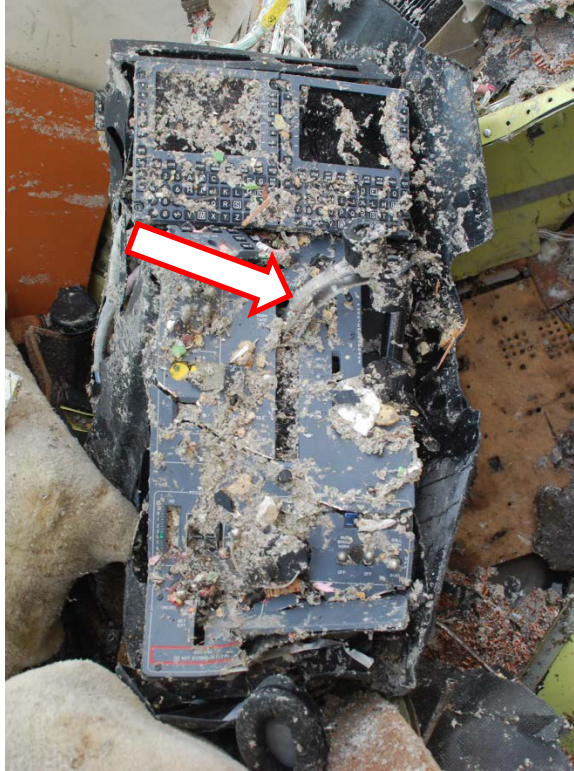
The left and right power (thrust) levers were noted in the NORM TAKE OFF detent. Both levers were bent to the right and forward approximately 45°. The power levers were exercised through normal flight range from NORM TAKE OFF to IDLE. The levers operated smoothly and stopped at both the NORM TAKE OFF and IDLE detents. The cutoff levers were bent due to power lever deformation and could not be moved.

Figure 7 - Center Pedestal and Throttle Quadrant (Arrow points to thrust levers)

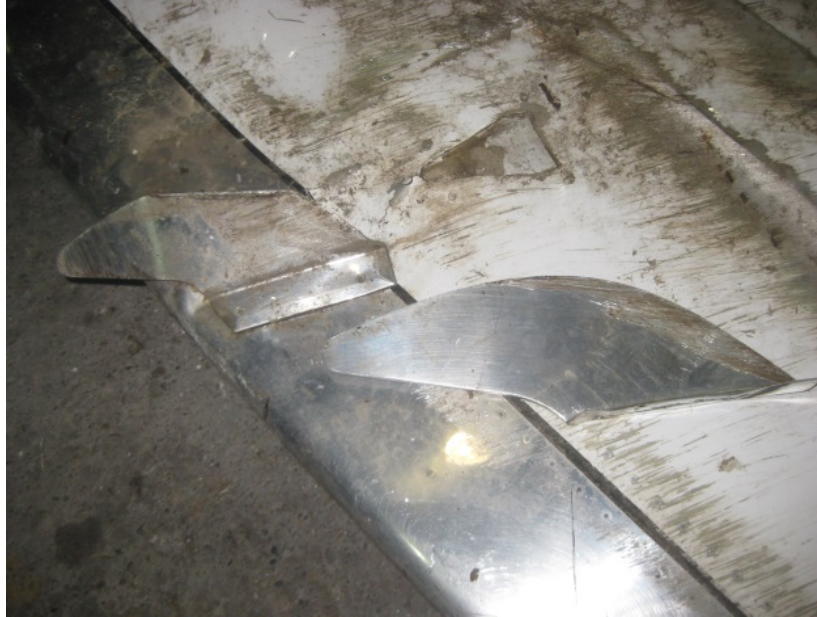
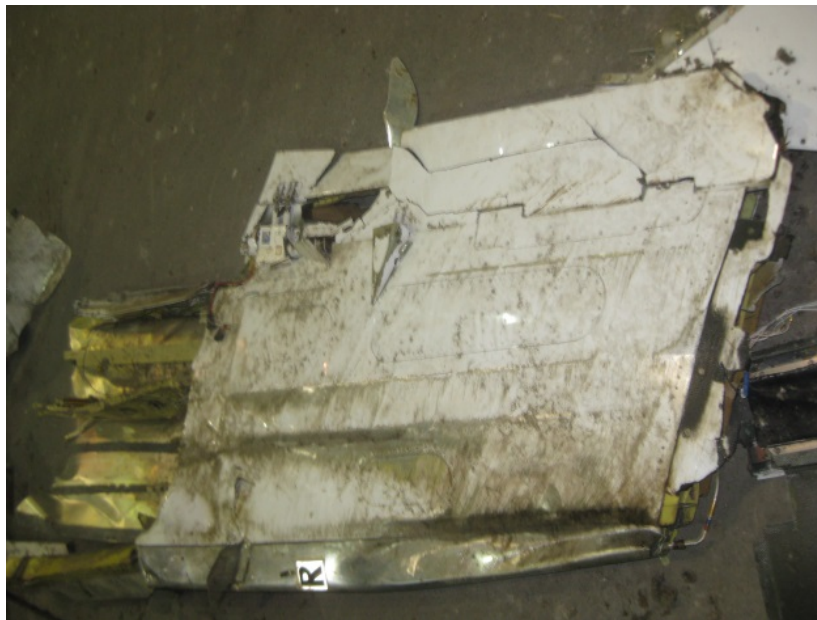
The lower skin of the outboard portion of right wing and the lower skin of the composite wing tip exhibited gouging/scoring consistent with contact with an abrasive surface (See Figures 8 and 9). The marks made by the gouging/scoring were approximately parallel with the chord of the wing and aligned with the longitudinal axis of the fuselage. Abrasion/gouging consistent with that found on the lower outboard skin of the right wing and wing tip was also observed on the lower aft portion of all right wing flap tracks and the aft approximately one third of the wing center keel structure.

Figure 8 - Abrasions on Lower Wing Surface

Figure 9 - Abrasions on Lower Wing Surface
