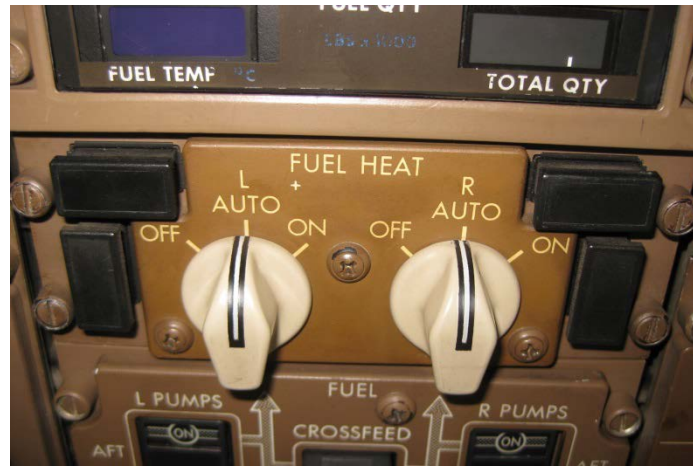
Figure 1 - Fuel Heat Panel

- Fuel Heat AUTO (See Figure 1)

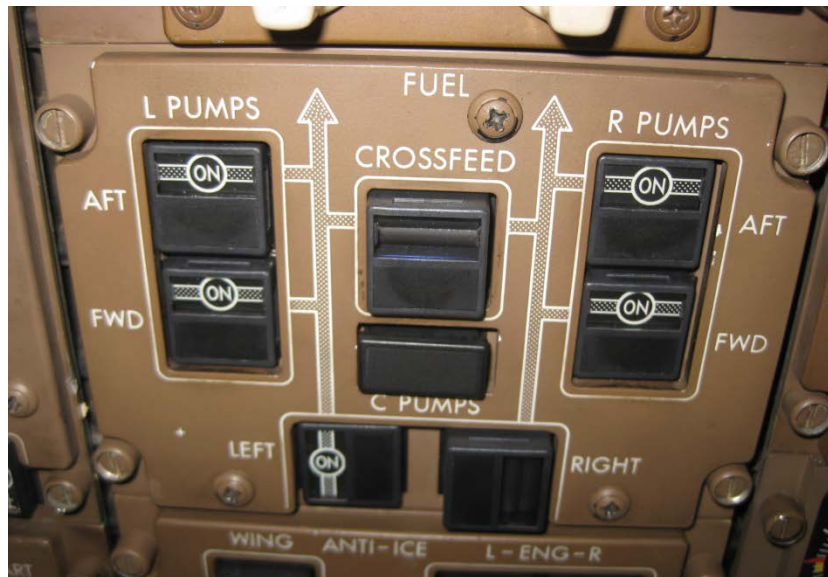
Figure 2 - Fuel System Control Panel

- Fuel System Control Panel ALL PUMPS ON, R CTR OFF (See Figure 2)

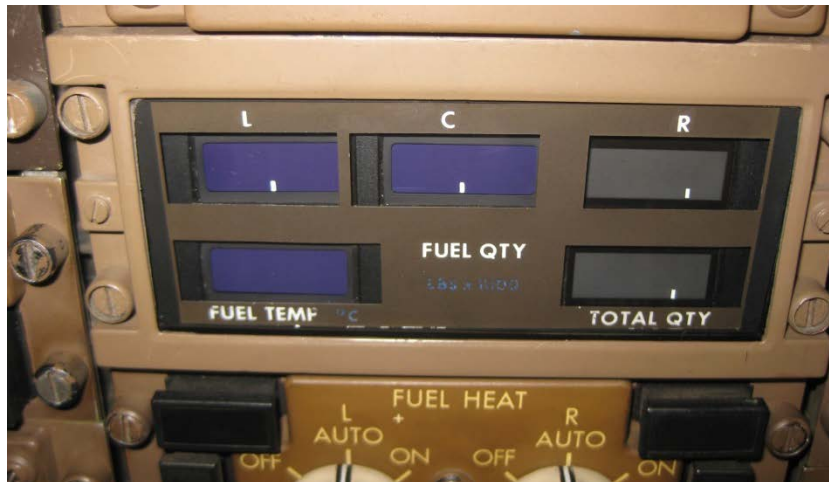
Figure 3 – Electronic Fuel Quantity Panel

The electronic Fuel Quantity Panel did not provide an indication due to no power on the airplane. See Figure 3.

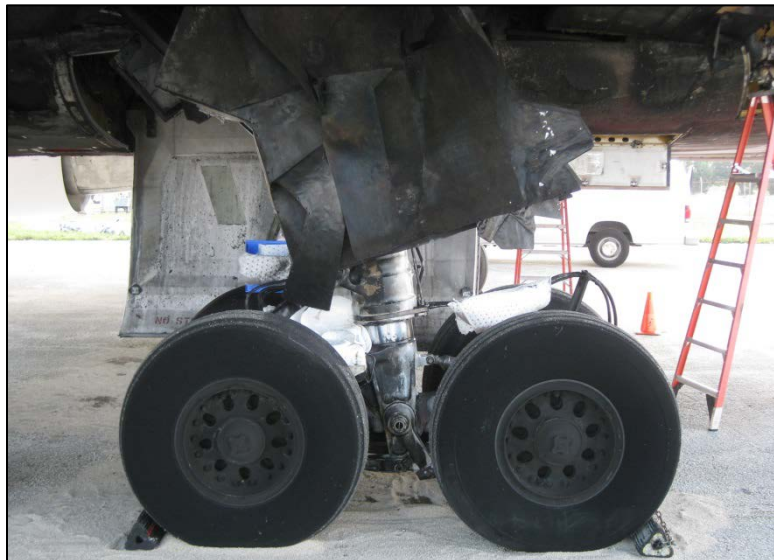
The left main landing gear exhibited thermal damage. The tires, trunnion, and strut structures all exhibited thermal damage. See Figures 6 and 7.

Figure 6 - Left Main Landing Gear, Outboard View. Note thermal damage to tires.

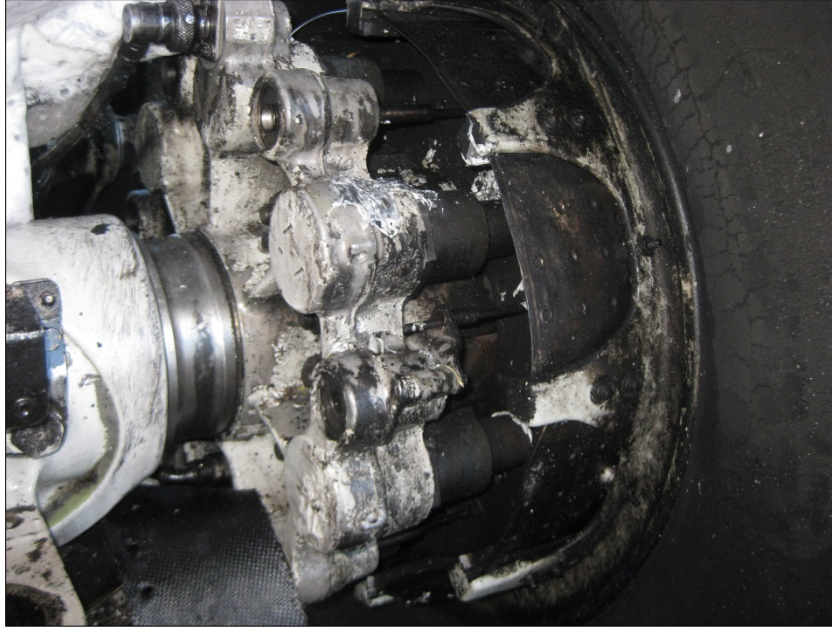
Figure 8 - Close Up View of Left Main Gear Wheel Brake Structure

On the left gear there was heavy soot accumulation over the entire main gear assembly. Paint on the shock strut outboard surface was blistered and peeling adjacent to the truck. The outboard sides of the tires were charred and sidewall markings are no longer visible. The hydraulic line common to the side brace lock actuator was leaking fluid. The thermal fuses common to all four tire/wheel assemblies were intact. See Figure 8.

For each of the wheel brakes there was visible brake wear pin indicator, all within operational limits.

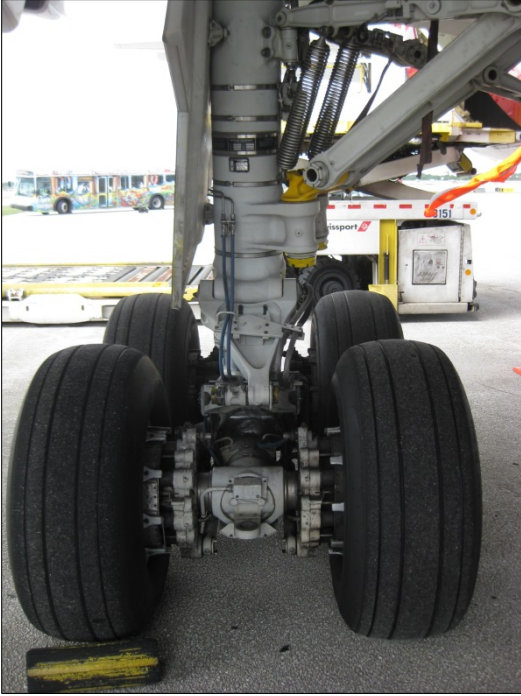
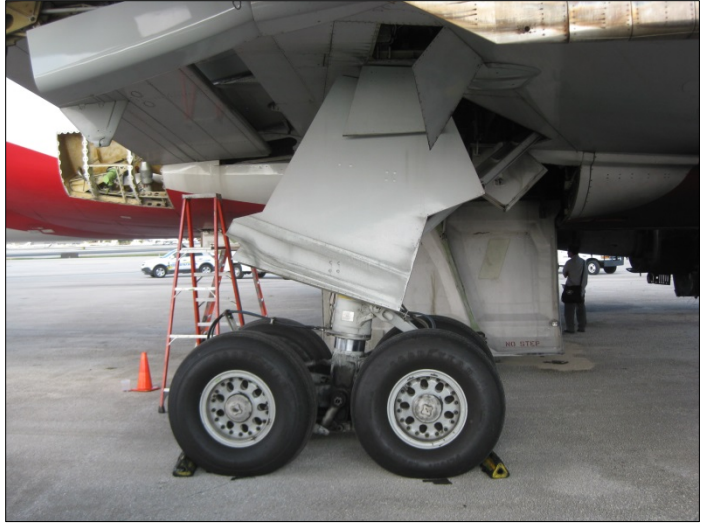
Figures 9a and 9b - Right Main Landing Gear

No thermal or physical damage was noted to the right main landing gear. For each of the wheel brakes there was visible brake wear pin indicator, all within operational limits. See Figures 9a and 9b.

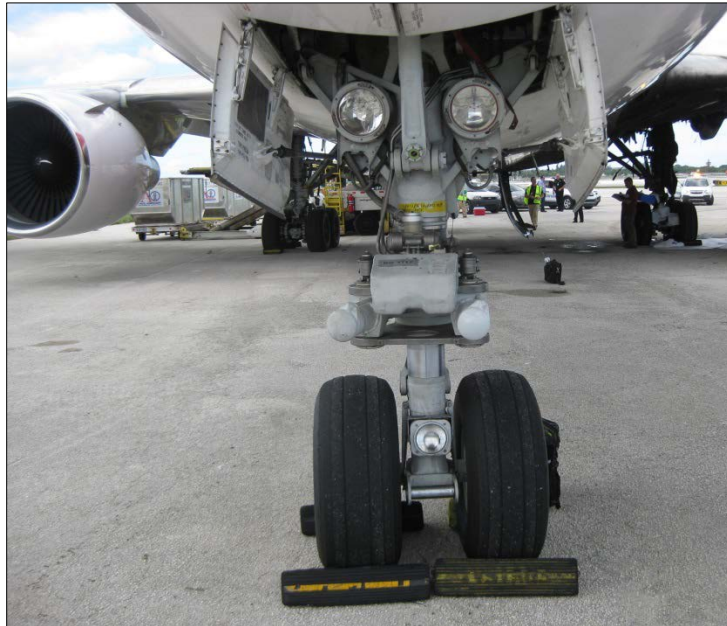
Figure 10 - Nose Landing Gear

No thermal or physical damage was noted to the nose landing gear. See Figure 10.

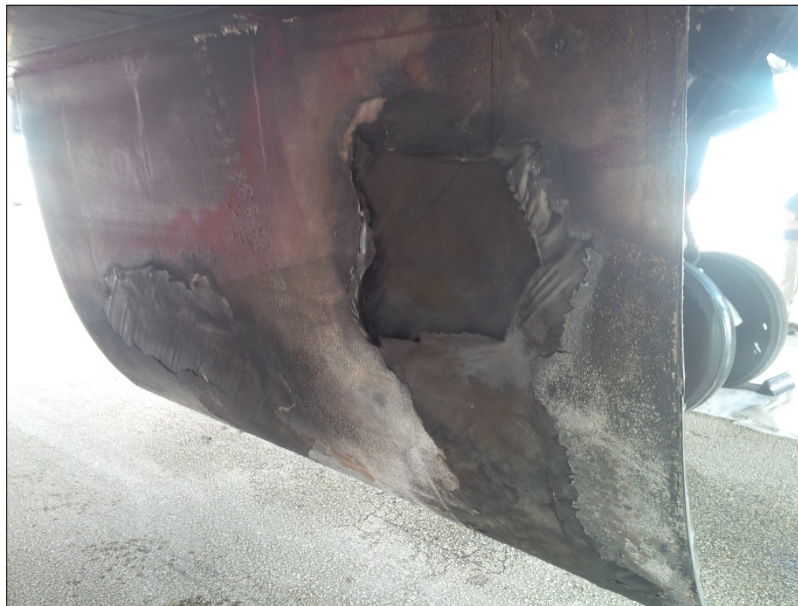
Figure 11 - Left Main Landing Gear Door, Exterior

On the Left Main Landing Gear Door, the paint common to the entire exterior surface was burned and blistered. Two areas in the middle of the panel were noted where the exterior composite plies were delaminated. No penetration of the outer skin panel was evident and no damage was visible on the interior of the panel. See Figure 11.

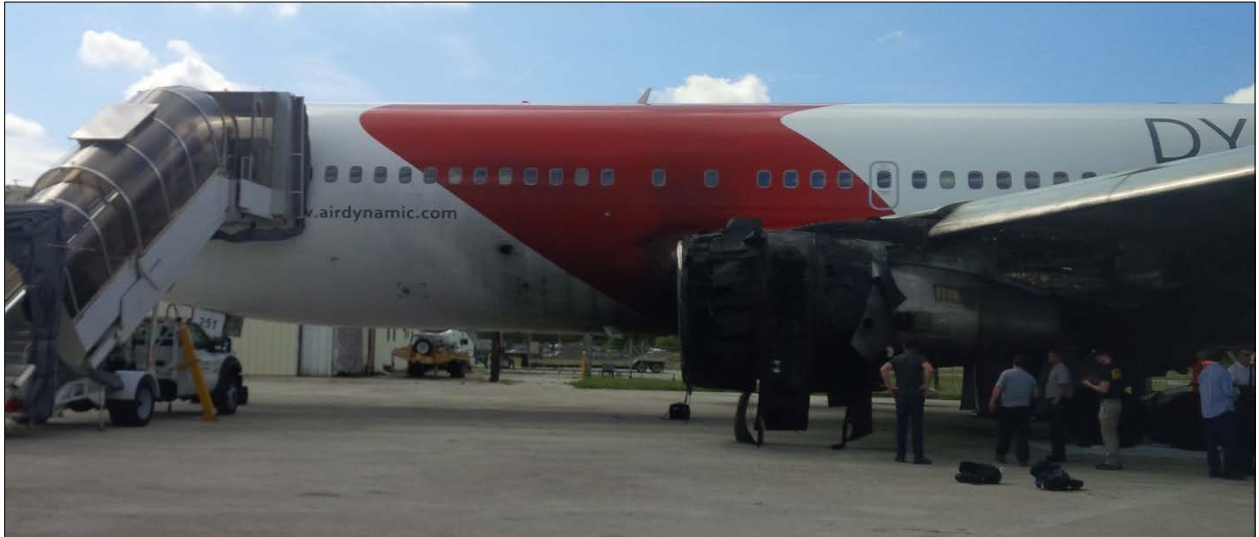
Figure 12 - Forward Left Side of Fuselage

The left side of the fuselage was affected by the fire, while the right side was not. See Figures 12 and 13.

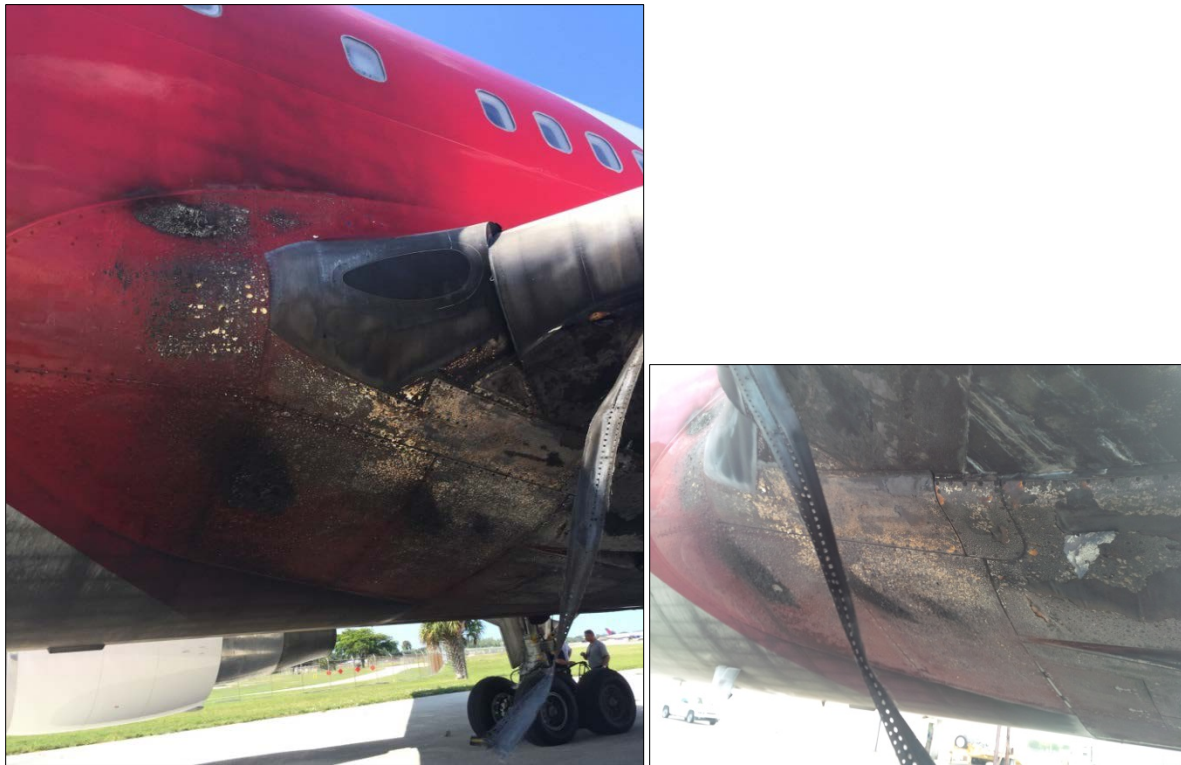
Figures 14a and 14B - Wing to Body Fairing, forward wing area

Paint common to the left side of the wing to body fairing assembly was burned and blistered below the wing. The composite fairing panel exterior plies were delaminated outboard of the left ram air inlet and extended aft to the wing trailing edge. See Figures 14A and 14B.

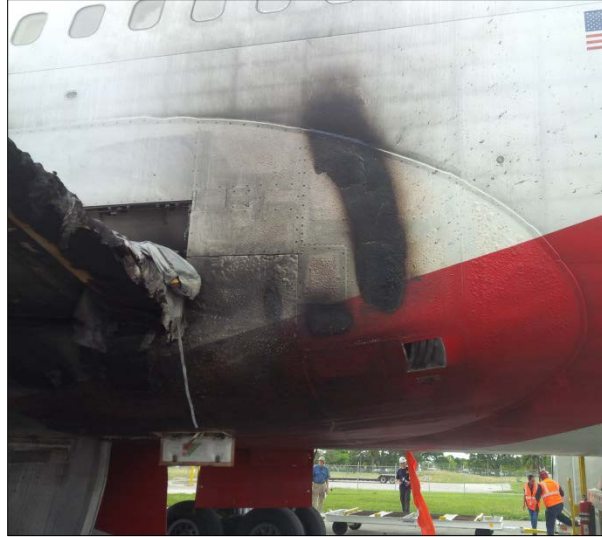
Figure 15 - Wing to Body Fairing in the aft wing area

The area of the fairing panel above the wing was burned and blistered adjacent to the deployed position of the left over wing escape slide. See Figure 15.

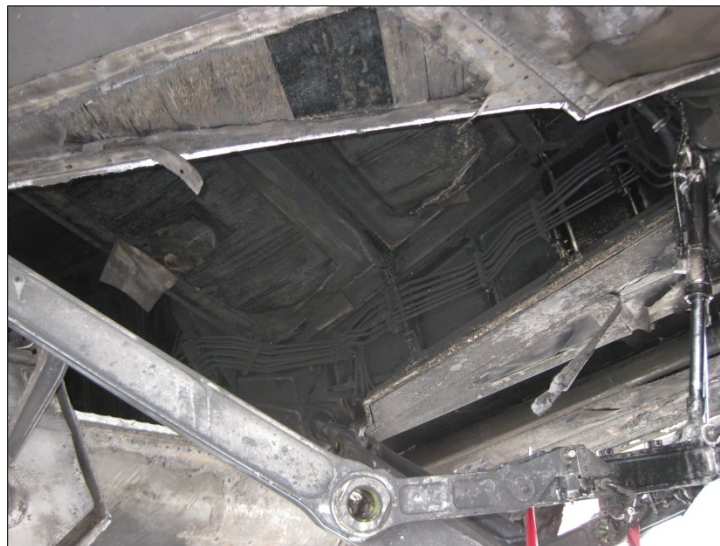
The left wheel well had heavy soot accumulation on all surfaces and components. There was no indication of paint damage common to bulkheads or the pressure deck. The underside of the composite panels between the rear spar and the landing gear support beam was burned and the face sheets were delaminated. The panel cores and upper face sheets were intact. The clamp blocks and clamp cushions common to hydraulic and electrical installations were intact. See Figure 16.

Figure 16 - Thermal Damage to Left Main Gear Wheel Well

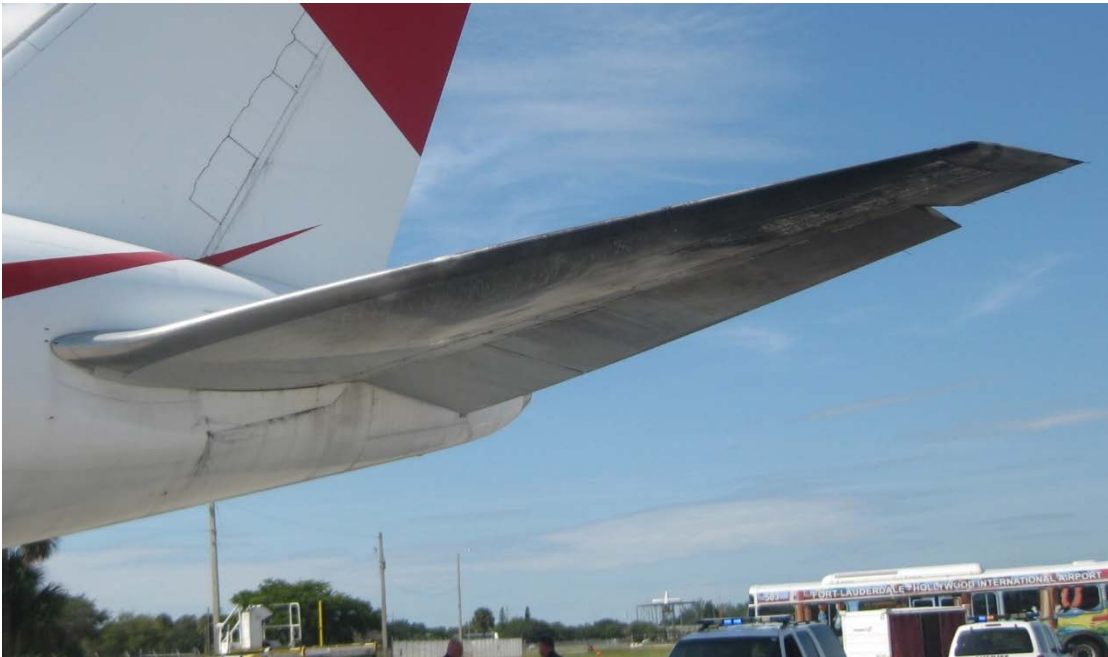
The left stabilizer was sooted and had blistered paint common to the leading edge and the inner spar skin lower surface from tip to approximately 10' inboard of the tip. No evidence of delamination was noted during visual inspection. See Figure 17.

Figure 17 - Sooting on Left Horizontal Stabilizer

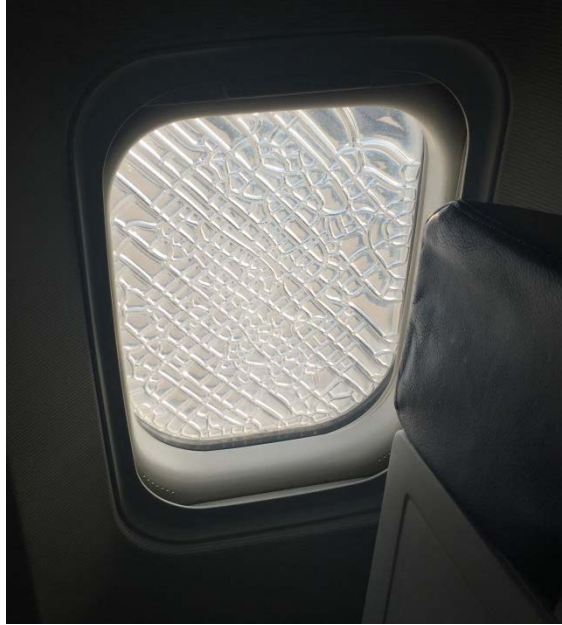
On the left side of the fuselage, passenger windows aft of BSTA 1109 were crazed and exhibited indications of thermal damage. The window in the L2 Door (aft service door) was also thermally crazed. See Figure 18.

Figure 18 - Example of Thermally Crazed Window

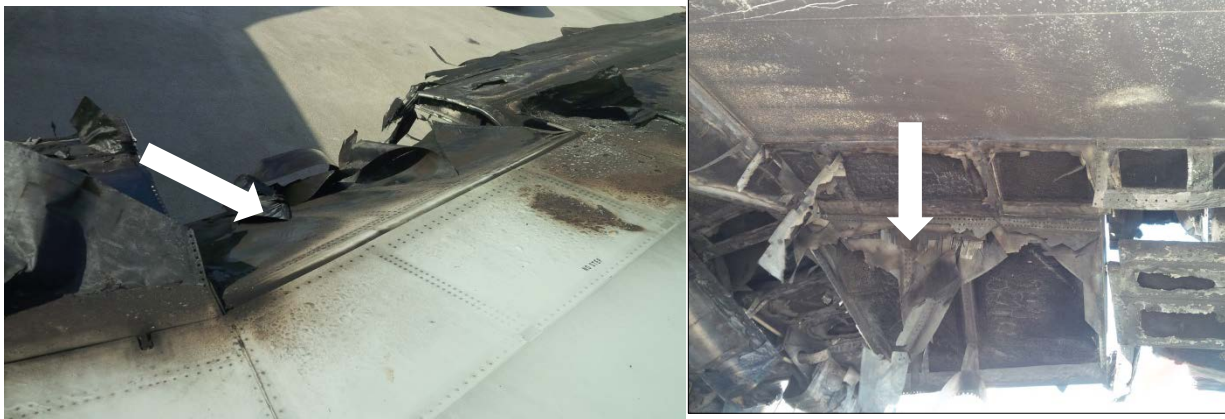
Figure 19A and 19B - Left Inboard Aileron, Top View (19A) and Bottom View (19B)

The inboard flight control surfaces sustained the most damage. The Left Inboard Aileron was thermally damaged, with the skin scorched, delaminated, or consumed. See Figures 19A and 19B.

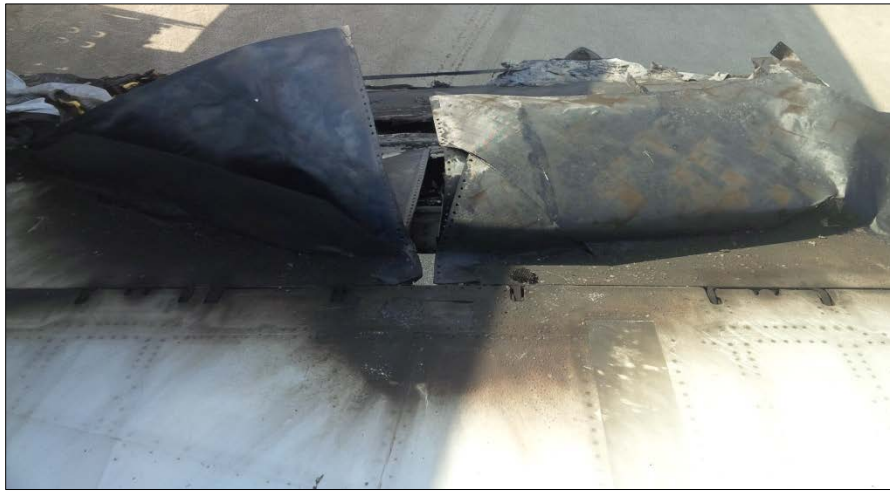
Figure 20 - Spoiler Panels 5 and 6

Spoiler Panels #5 and #6 exhibited thermal damage. The panels were scorched, delaminated, or consumed. See Figure 20.

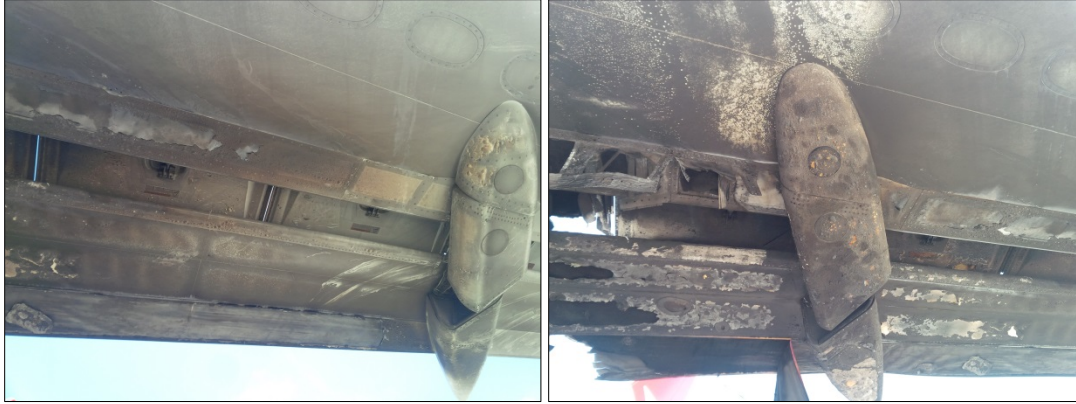
Figure 21A and 21B - Underside of Left Wing, Number 1 Trailing Edge Flap Canoe (Left) and Number 2 Trailing Edge Flap Canoe

Along the trailing edge, the paint on the fixed panels was blistered and peeling from midway between the #1 and #2 flap track fairings inboard to the #2 flap track fairing. Delamination and charred core were common to the exterior surfaces of composite panels aft of engine #1; however, the core and inner face sheets were intact. From the #3 flap track fairing extending inboard to the side of body, the composite panels lower face sheets were burned and delaminated but the panel cores were intact. Both of the left trailing edge flight control surfaces exhibited similar damage. See Figures 21A and 21B.

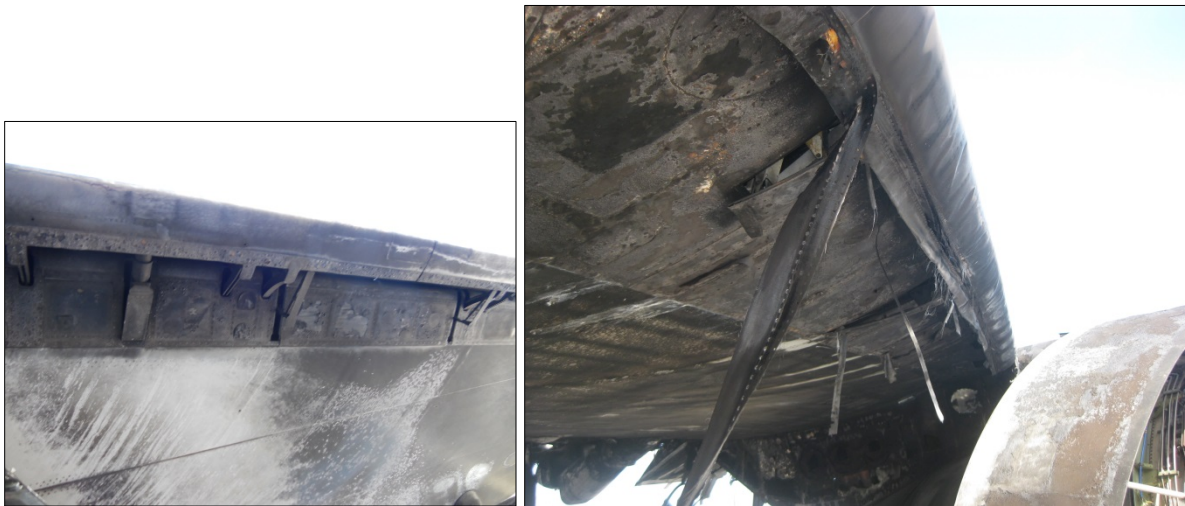
Figure 22A and 22B - Examples of Leading Edge Damage Inboard of #4 Slat (20A) and Inboard of Engine #1 (20B)

Along the leading edge, soot covered the fixed panels extending inboard through the #4 slat. Inboard of the #4 slat, the fixed leading edge composite panels were charred but the exterior surfaces were intact and the panel core was intact. Inboard of engine #1, the fixed leading edge composite panels were charred but the exterior surfaces were intact and the panel core was intact. See Figures 22A and 22B.

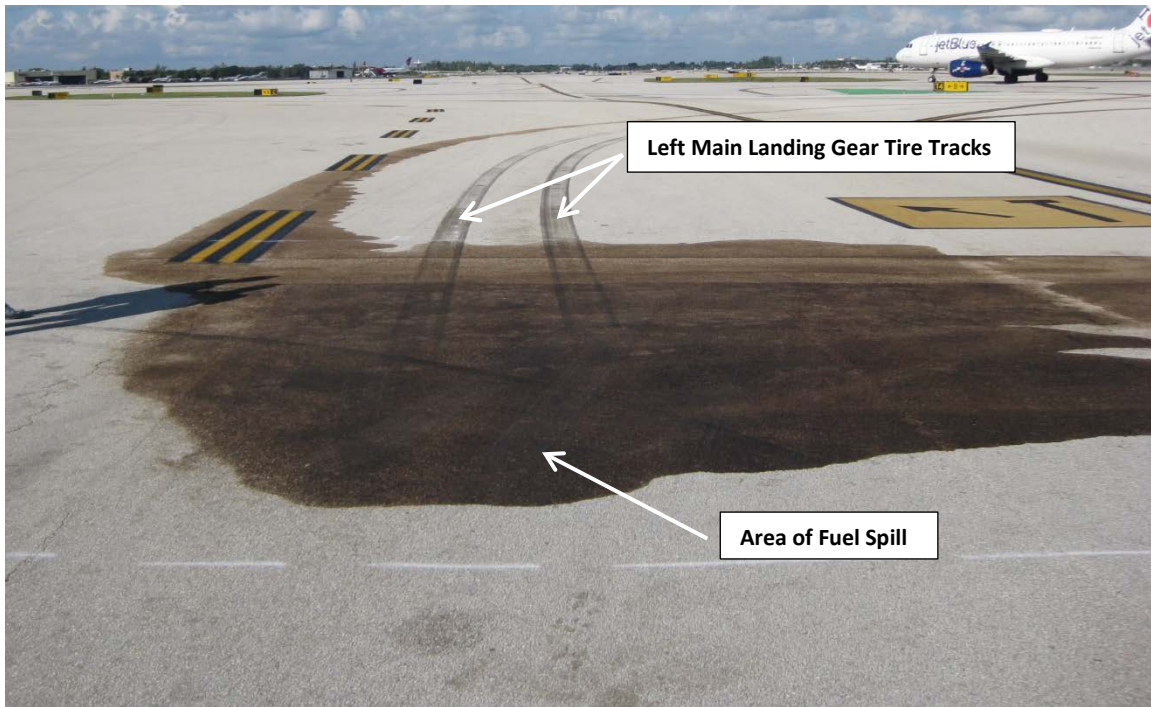
Figure 23 - Area of Fuel Spill and Landing Gear Tire Tracks

Photographs of the airport tarmac and taxiway, in the area where the airplane was pushed back from the terminal boarding gate (E9), showed two black trails from the area of the initial fuel spill. The trails of black material, attributed to the accident airplane's left main landing gear tires, were noted on the airport tarmac and taxiways from the position where the airplane's engines were started after pushback from Gate E9, in the area of spilled fuel to the location of the airplane at the time of the accident. See Figure 23.

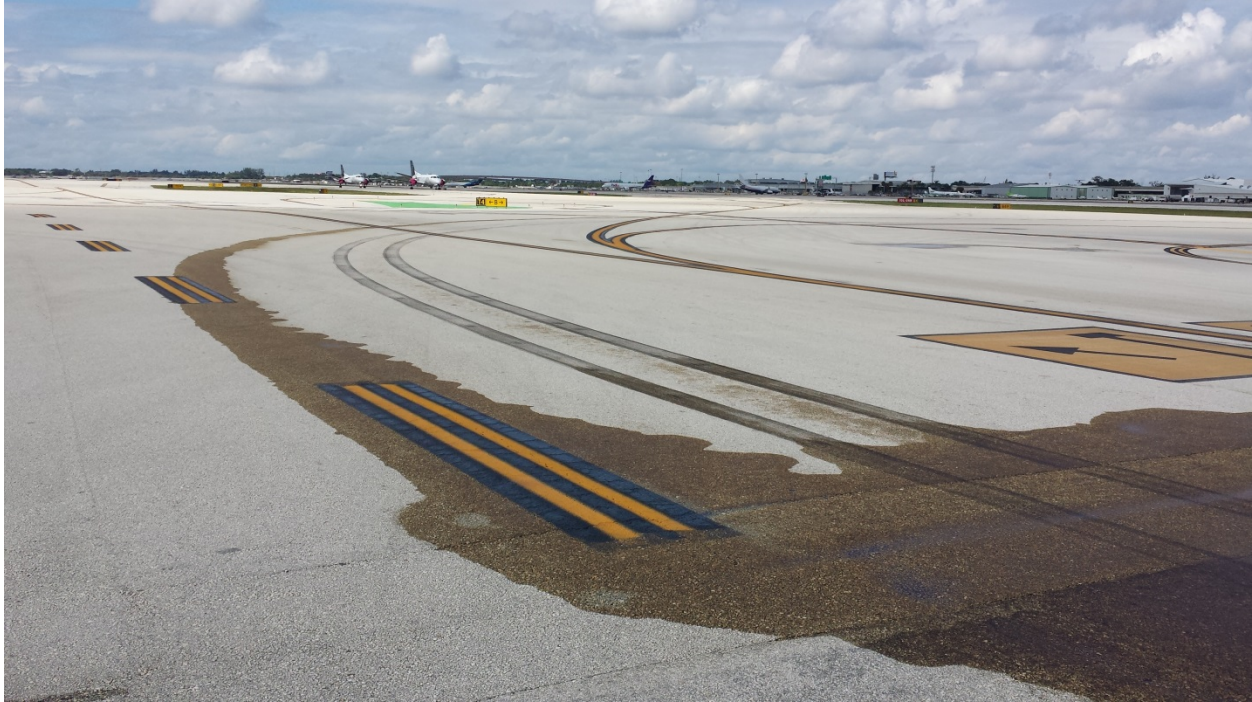
Figure 24 - Fuel Spill and Landing Gear Tire Tracks

A continuous fuel stain from the engine start location to the evacuation site was observed. The length of the stain was approximately 1,000 yards and its width was approximately 15", although the width varied along the fuel path on the taxiway. There was also a continuous tire scrub mark coming from the left main landing gear outboard tires that ran parallel to the fuel stain. The position of the fuel stain relative to the tire mark was consistent with the lateral spacing between the outboard tires and the engine centerline. See Figure 24.

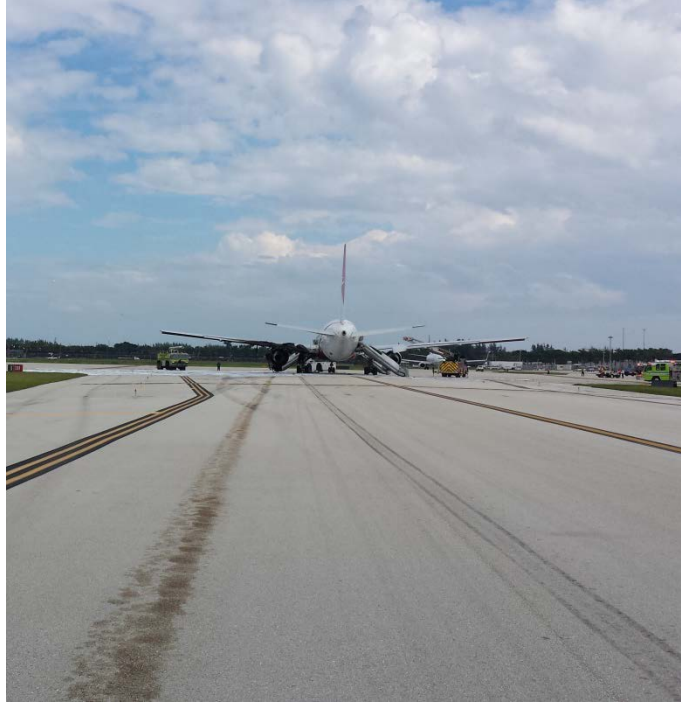
Figure 25 - Fuel Spill and Tire Tracks Leading to Final Airplane Position

The aircraft position at the time of the incident and evacuation was approximately 365 feet east of the ILS hold line at the east end of Taxiway Bravo. See Figure 25.
