NATIONAL TRANSPORTATION SAFETY BOARD

AIRWORTHINESS GROUP CHAIRMAN'S FACTUAL REPORT

ERA13MA139

Location: Thomson-McDuffie Regional Airport, Thomson, Georgia
Date: February 20, 2013
Time: 8:06 PM EST
Aircraft: Beechcraft 390 Premier 1A, N777VG

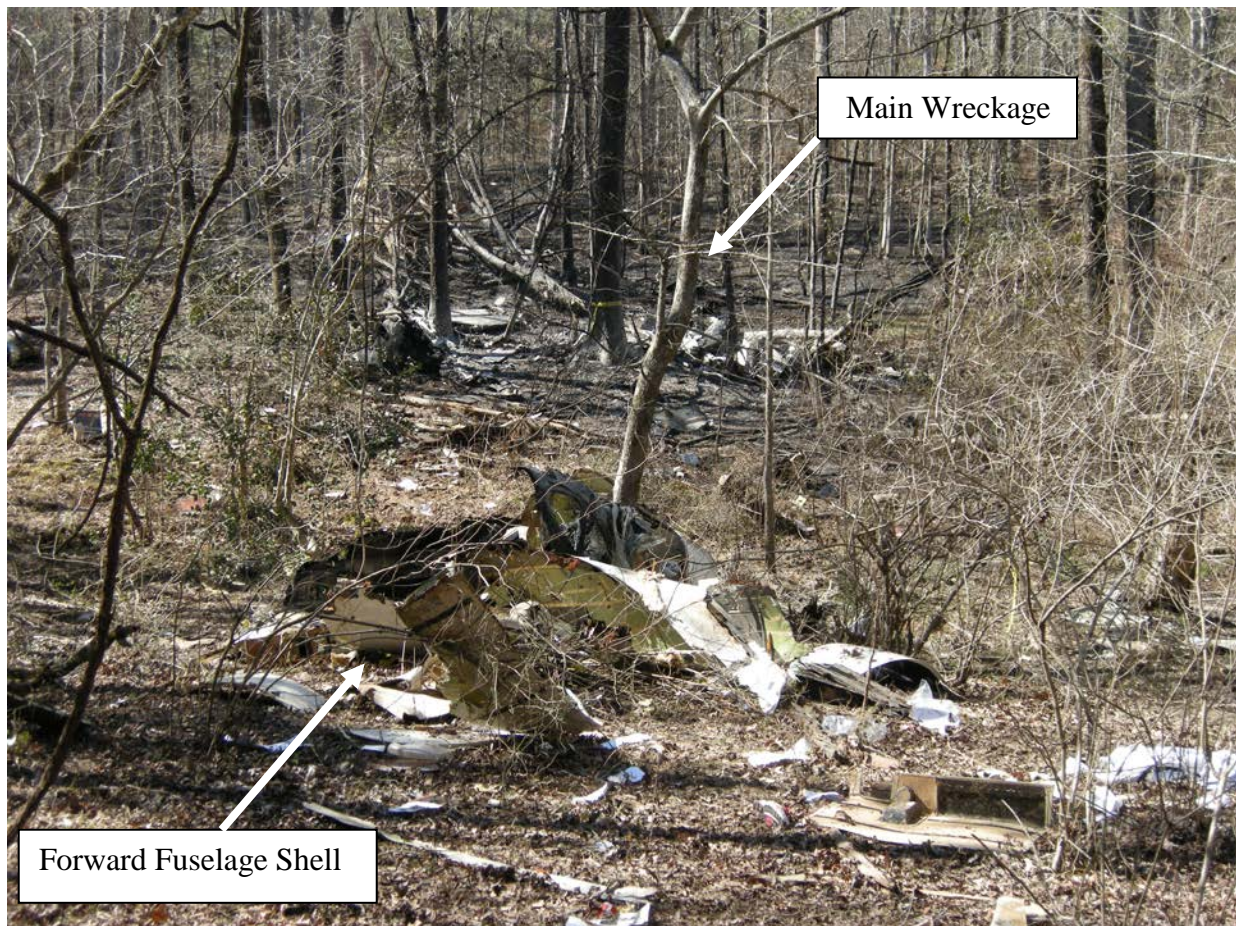
Figure 1: Accident Site with Forward Fuselage Wreckage in Foreground and Center Wing Area/Empennage Wreckage in Background

The aircraft impacted a utility pole that was approximately 72 feet tall and was located approximately 1835 feet from the runway 28 threshold. The airplane struck the pole approximately 58 feet above ground level and sections of the pole and attached power lines were found along the debris path. The ground in the immediate vicinity of the impacted pole was burned and charred. Remnants of the left main landing gear outboard door and the outboard tip of the left elevator were found relatively close to this pole. The wreckage debris path was oriented from west to east on an approximate magnetic heading of 085°. The left wing was completely severed about 13 feet inboard from the wing tip and exhibited no fire damage. The wing section was located approximately 320¹ feet past the utility pole and just to the right of the debris path.

Various fragments of the airplane structure were found along the debris path to the main wreckage site located approximately 925¹ feet from the pole in a densely wooded forest. Multiple trees were severed in the impact zone. A large tree (approximately 2 feet in diameter at the base) was uprooted and severed about 35 feet up from its base. The main wreckage consisting of the center wing section, a portion of the right wing, main landing gear, baggage compartment, ELT rack, and empennage came to rest against a tree line formed by a small service trail approximately 50 feet past the base of the uprooted tree. The main wreckage was severely damaged by fire and contained melted aluminum and burnt composite. An approximately 13 foot section of the forward fuselage shell containing portions of the radome, nose avionics compartment, cockpit, and cabin was damaged by fire and came to rest about 60¹ feet beyond the main wreckage. The right engine was found to the right side of the debris path between the main wreckage and the forward fuselage shell. The left engine was severed into two sections with the compressor, turbine, and exhaust portion located in a pond to the left of the debris path. A large portion of the ground in the vicinity of the accident site was charred and burned by fire. See Figure 1.

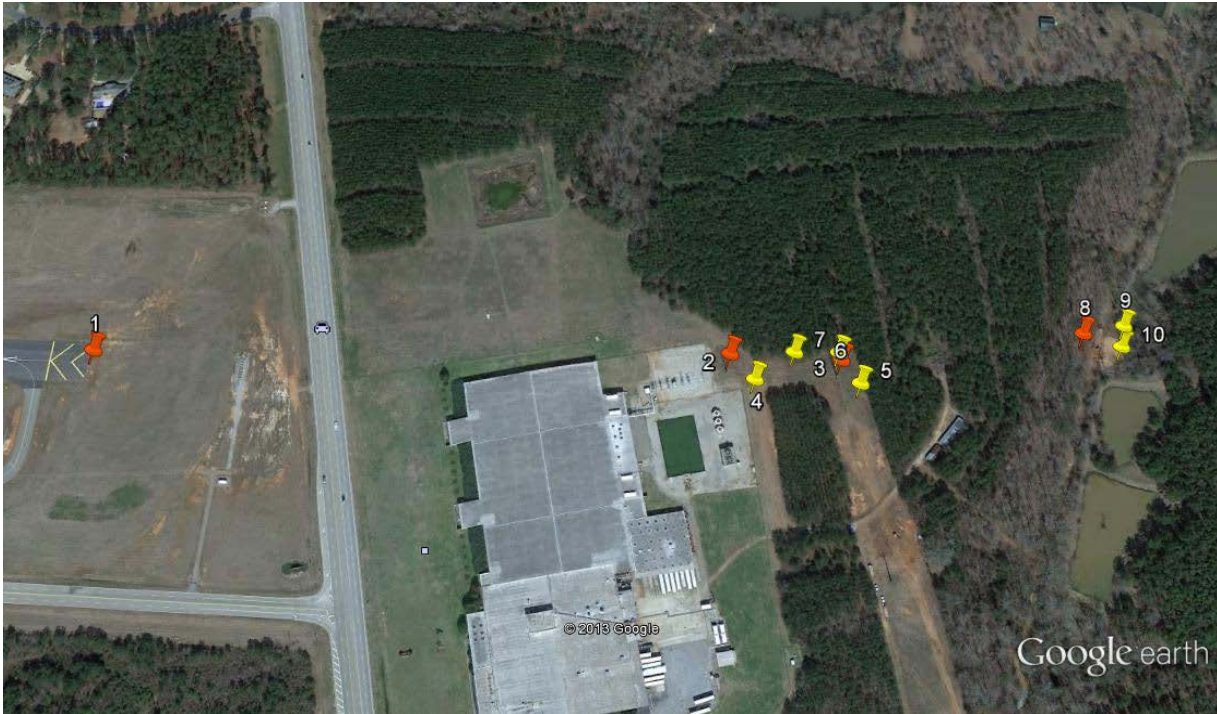
Figure 2: GPS Points of Interest for the Accident Location

- Waypoint 1: 33.529355,-82.507608 Runway 10 End of Pavement
- Waypoint 2: 33.529332,-82.502596 Power Pole Struck By Airplane
- Waypoint 3: 33.529294,-82.501719 Corner Power Pole
- Waypoint 4: 33.529155,-82.502411 Tip of Left Elevator
- Waypoint 5: 33.529133,-82.501582 Section of Left Outboard Wing with Aileron
- Waypoint 6: 33.529342,-82.501736 Flap Actuator (P/N: 390-381402-17; S/N G0471)
- Waypoint 7: 33.529339,-82.502092 Spoiler Panel (P/N: 391-130004-0001; S/N: 0086)
- Waypoint 8: 33.529509,-82.499735 Base of Uprooted Tree Separated 35 Feet Above Ground Level
- Waypoint 9: 33.529573,-82.499381 Left Engine Compressor and Turbine Section (In Pond)
- Waypoint 10: 33.529422,-82.499430 Forward Fuselage Shell

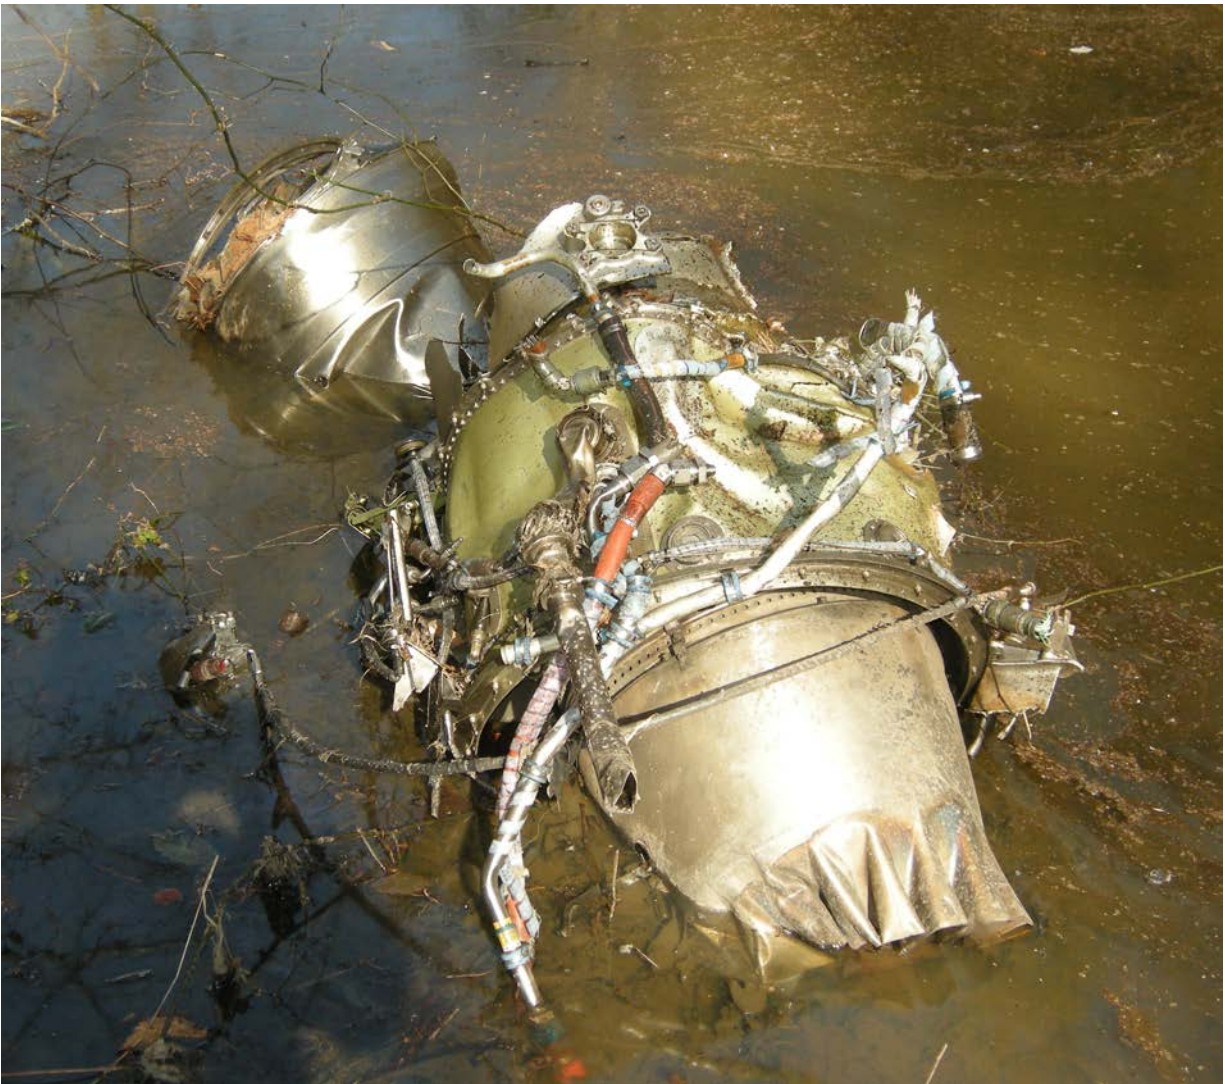
Figure 4: Left Engine

The left engine separated from the aircraft and pieces were distributed along the debris path. The engine exhaust casing was found just to the left of the main wreckage containing the empennage and was separated from the compressor, turbine and exhaust sections which were located in a pond just to the left of the main debris field. See Figure 4. The compressor/nose section separated at the impeller area and the tie shaft broke from impact forces. A few sections of separated fan blades were discovered at the wreckage scene. Vegetation and tree material were imbedded into the first stage compressor and case. The compressor and turbine were damaged to the point of no rotation. See the Powerplant Group Chairman's Factual Report for details of the engine teardown and examination. The report can be found in the public docket for this accident.

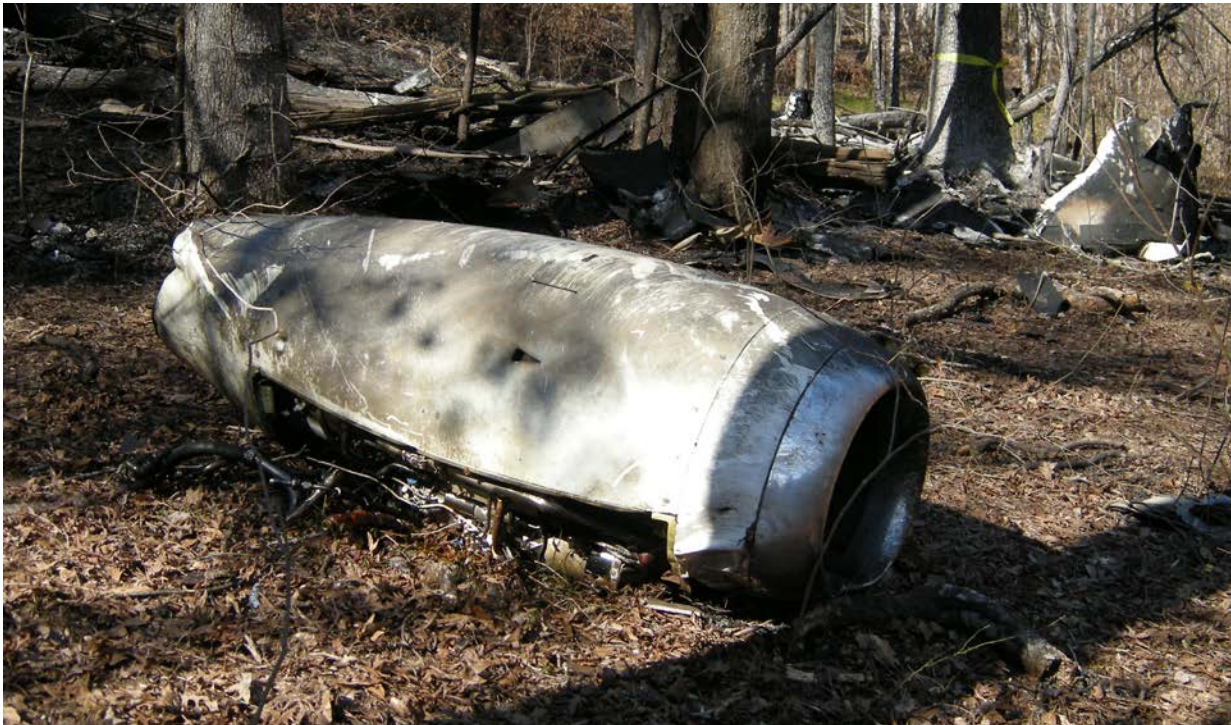
Figure 5: Right Engine

The right engine was found intact between the main wreckage and the forward fuselage shell on the right side of the debris field. See Figure 5. The engine was verified to be the Number 2 engine per aircraft build records and by examination of the engine mounts. The inboard side of the exterior of the engine, the fuselage attachment area, and the bottom side of the inlet area contained various degrees of damage. There were vegetation and carbon materials in the inlet area downstream of the first stage compressor. The engine shaft (compressor and turbine) rotated freely. Nicks were identified on some of the fan blade leading edges and scraping/gouging was identified on the inside of the engine inlet shroud in the plane of fan blade rotation. See the Powerplant Group Chairman's Factual Report for details of the engine teardown and examination. The report can be found in the public docket for this accident.

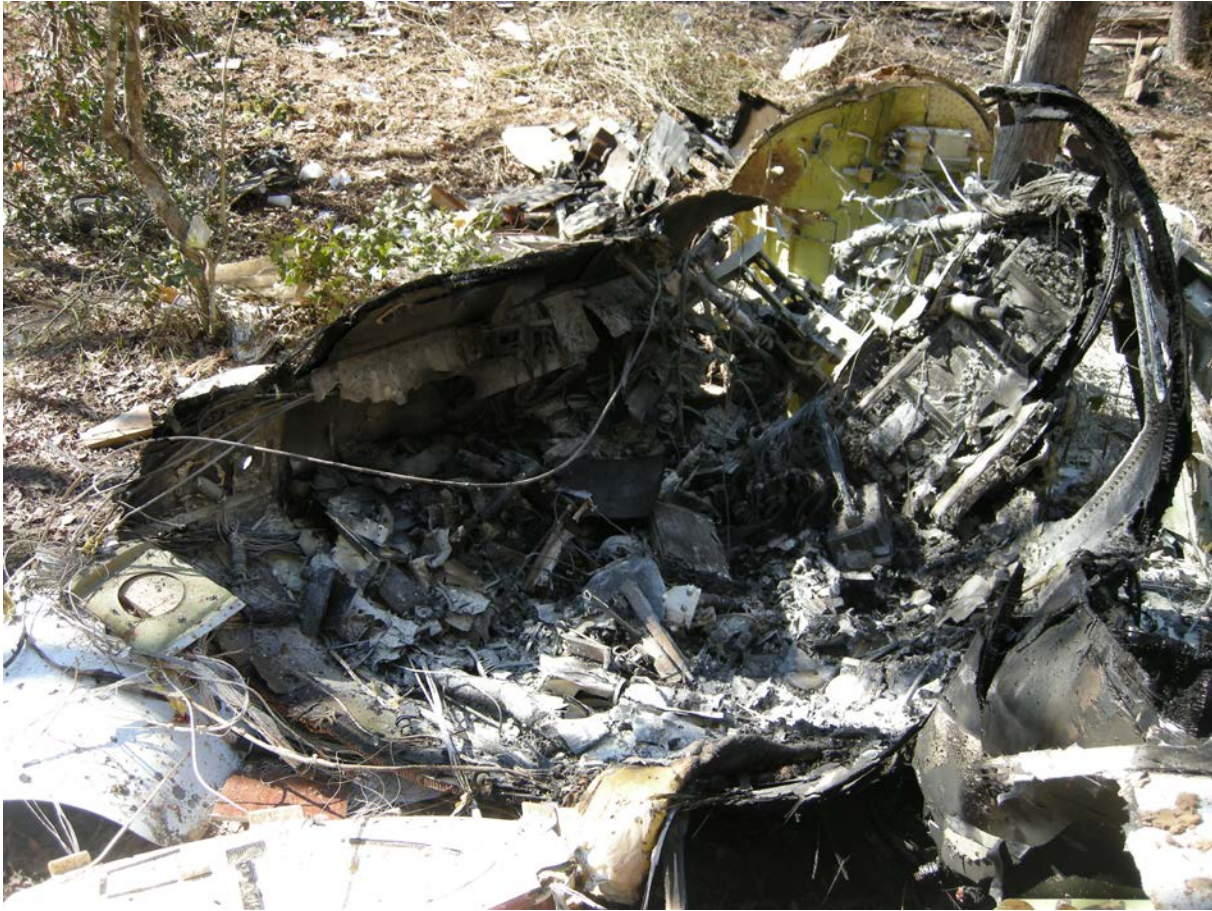
Figure 6: Flight Deck

The flight deck was mostly destroyed by fire (See Figure 6). The remaining glass on the following standby flight instruments was removed and the following parameters were recorded:

Standby Altimeter: 980 feet, no altimeter setting visible
Attitude Indicator: 135° right bank, pitch could not be determined
Airspeed Indicator: 269 knots, barber pole at 322 knots

Most switch positions could not be determined due to the damaged condition of the flight deck. The Stabilizer, Left Windshield, and Right Windshield switches on the Ice Protection Subpanel were in the off position. The flaps handle was in the 10 degree detent. The landing gear handle was found in the gear down detent with the J-hook engaged on the handle. The roll trim switch was found in the "NORM" position. The lift dump switch was not found.
