NATIONAL TRANSPORTATION SAFETY BOARD

AIRWORTHINESS GROUP CHAIRMAN'S FACTUAL REPORT

ENG11IA047

Operator: ExpressJet Airlines
Location: Moline, IL
Date: August 29, 2011
Time: 12:36 CDT
Airplane: EMB 145 XR, N27152

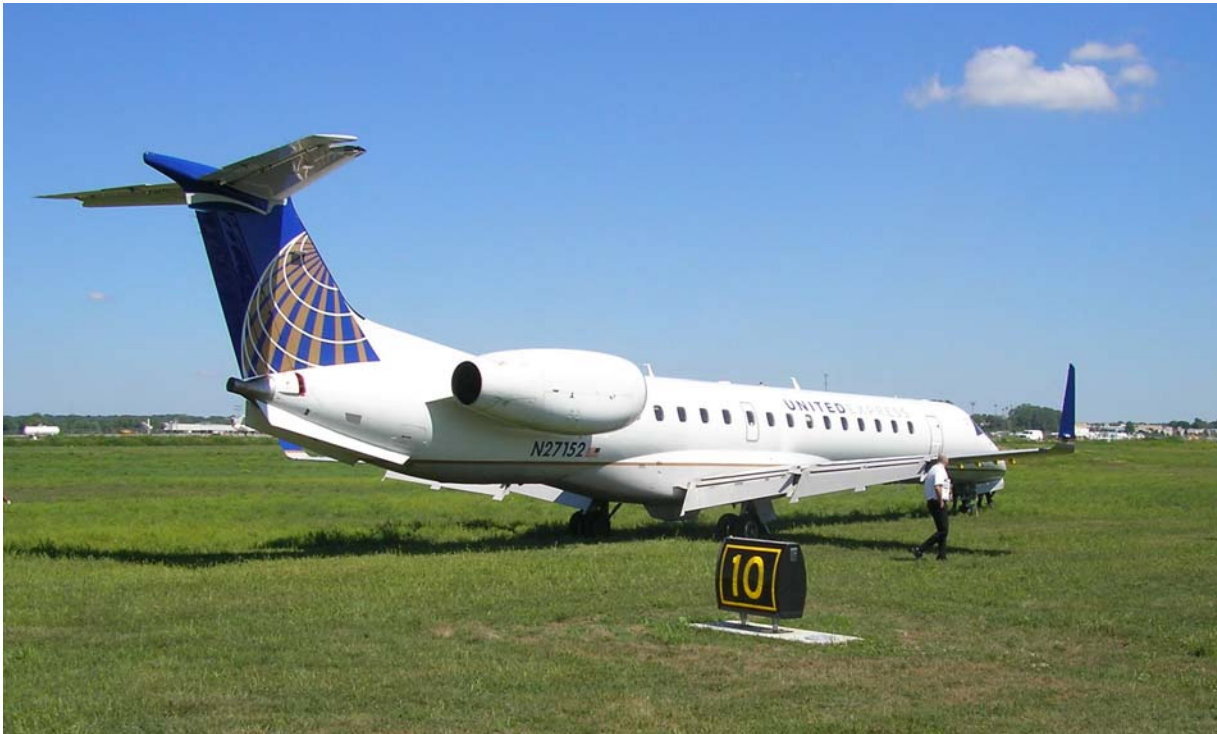
Figure 1: Aircraft Condition Following Runway Departure

The aircraft hit a taxiway sign, crossed taxiway Echo, and came to rest in the grass with the nose wheel approximately 144 ft from the runway edge (see Figure 1). The aircraft had multiple skin tears on the left and underside of the fuselage. There were also numerous dents on the left side of the fuselage. The outboard wheel fairing for the right main gear was damaged. The nose wheel doors had identical gouges on the leading edges. The nose wheel drag brace pin was bent and the nose wheel landing lights were broken. Initial photos taken by the MLI airport police show the nose wheels were turned to the left after the aircraft came to a stop (see Figure 2).

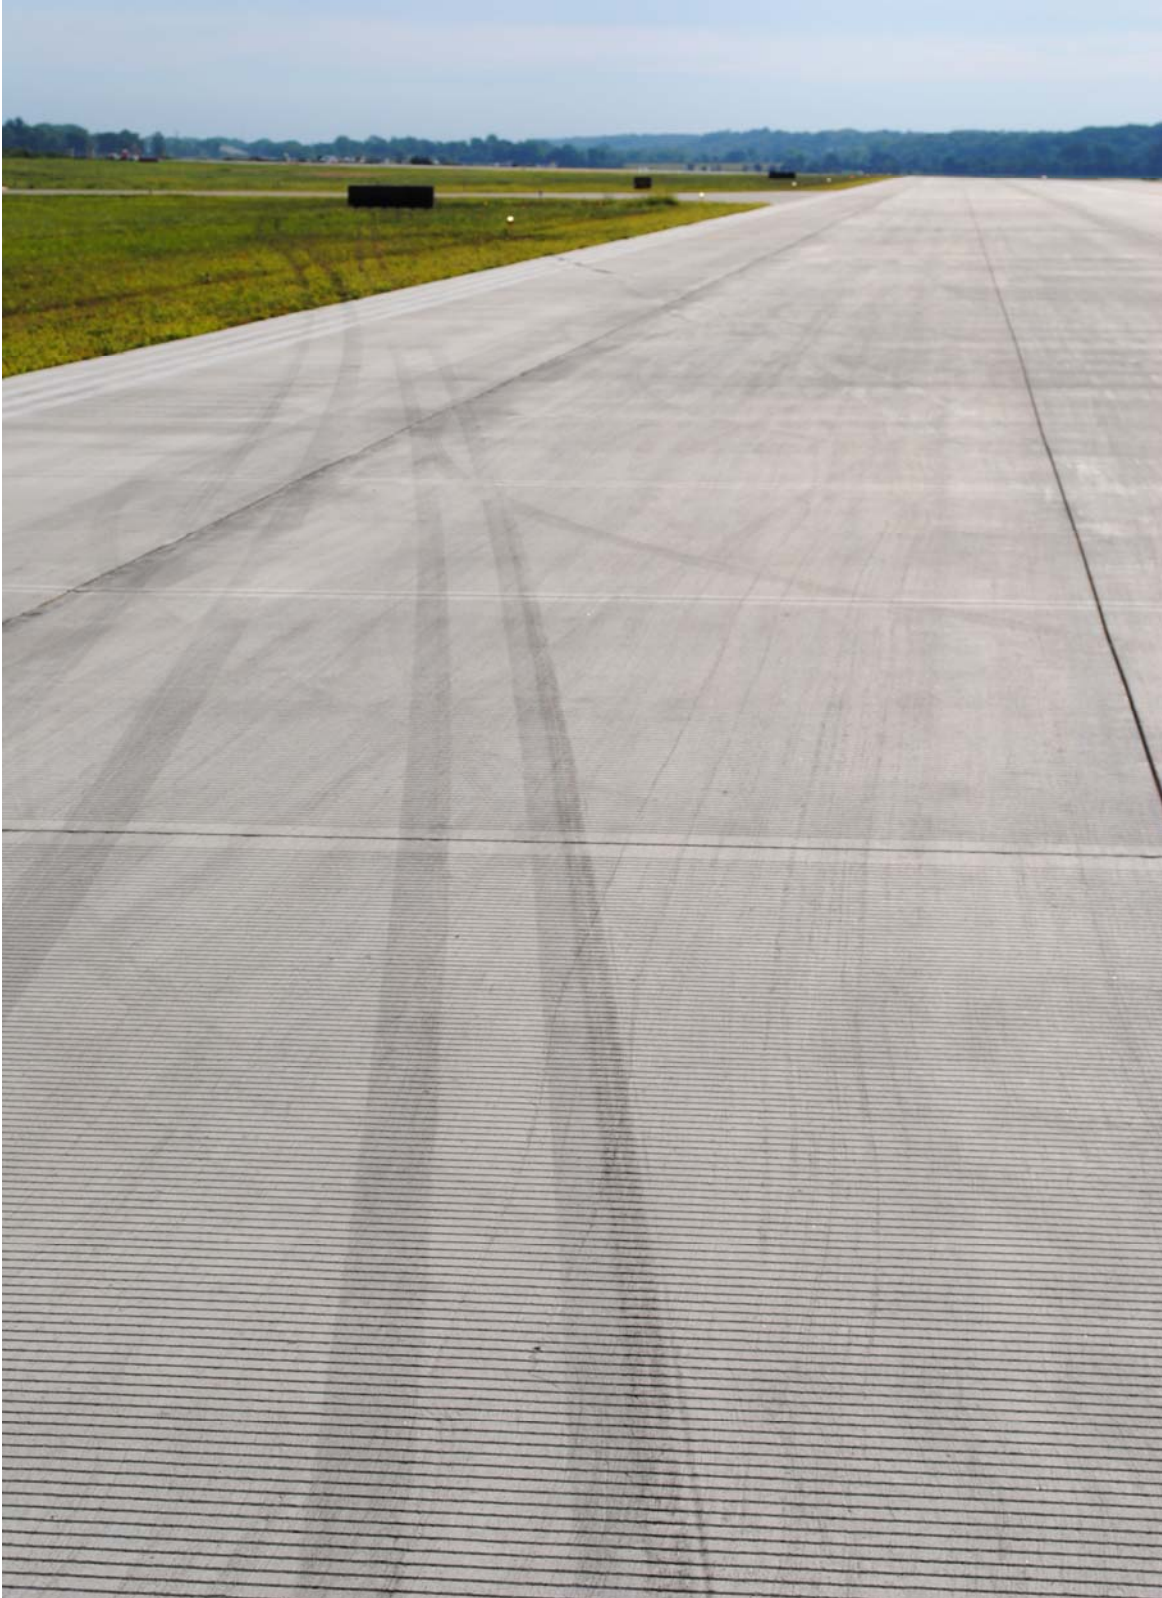
Figure 3: Tire Marks On Runway and Grass

The runway was grooved. The nose tires, left main tires, and right main tires all deposited faint but identifiable witness marks on the runway throughout the initial uncommanded left turn (see Figure 3). Other tire marks were identified on the runway prior to the left turn and after runway departure on the grass (see Figure 4 for tire marks in grass). The following approximate measurements related to the tire marks were obtained by on-scene personnel using a measuring wheel:

- First identifiable mark on runway to first departure point off runway was 393'11" (Left Main)
- Runway departure edge to taxi sign echo was 293'1" (Left Main Wheel)
- Runway departure edge to taxi light prior to echo was 387'8" (Left Main Wheel)
- Runway departure edge to near side of taxiway echo was 398'4" (Left Main Wheel)
- Runway departure edge to far side of taxiway echo was 483'4" (Left Main Wheel)
- Runway departure edge to final stop was 676'8" (Left Main Wheel)

- Left main wheel stopped even with 2000' distance remaining marker
- Nose wheel stop to runway edge was 143'7"
- Runway departure edge to Nose Wheel Stop was about 732'
