**NATIONAL TRANSPORTATION SAFETY BOARD**  
**Office of Aviation Safety**  
**Washington, D.C. 20594**

**AIRWORTHINESS GROUP CHAIRMAN'S FACTUAL REPORT**

**NTSB No: CEN15MA290**

Operator: Air Methods Corporation  
Aircraft: Airbus Helicopters AS350 B3e, Registration N390LG  
Location: Frisco, Colorado  
Date: July 3, 2015  
Time: 1339 mountain daylight time

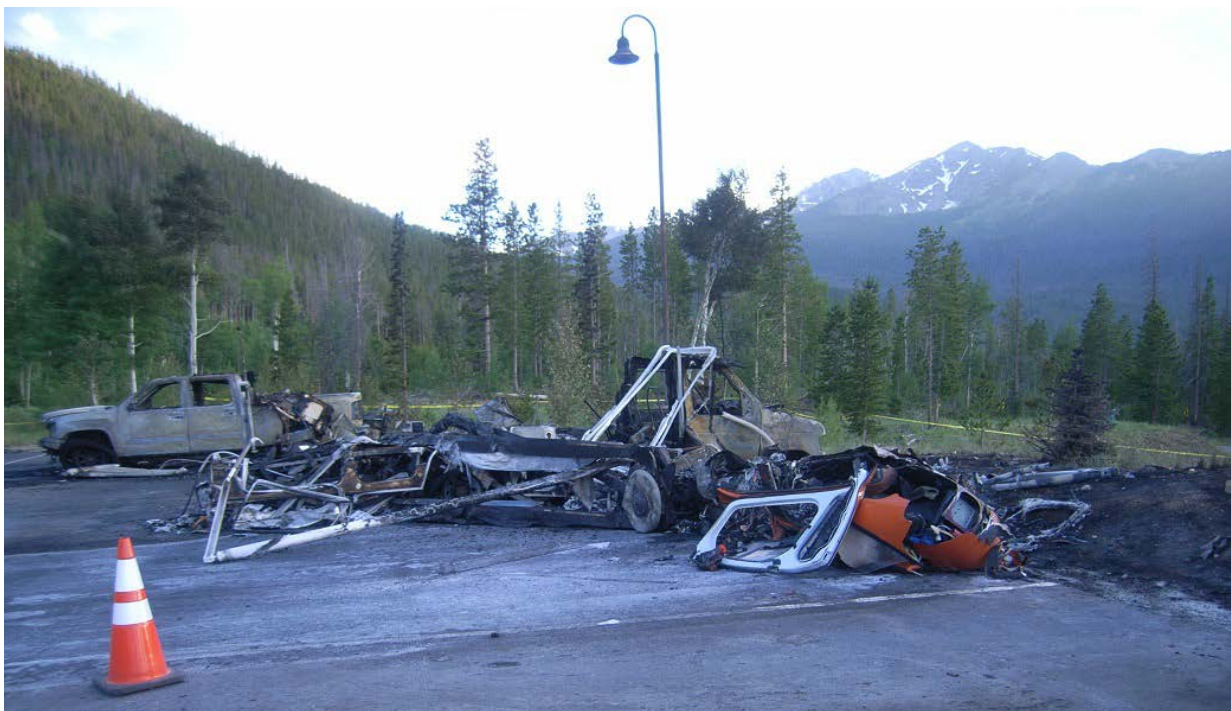
**Photo 1. The main wreckage site.**

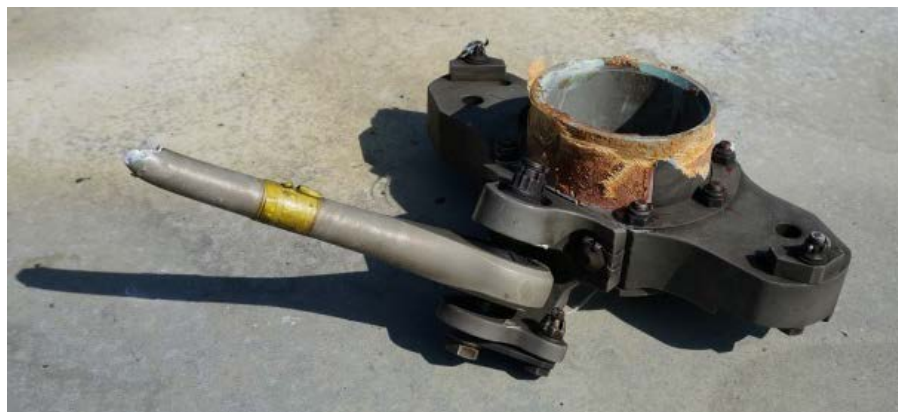
**Photo 3. The recovered 'yellow' pitch change link attached to the blade horn and boss weights. (Photo courtesy of AMC)**

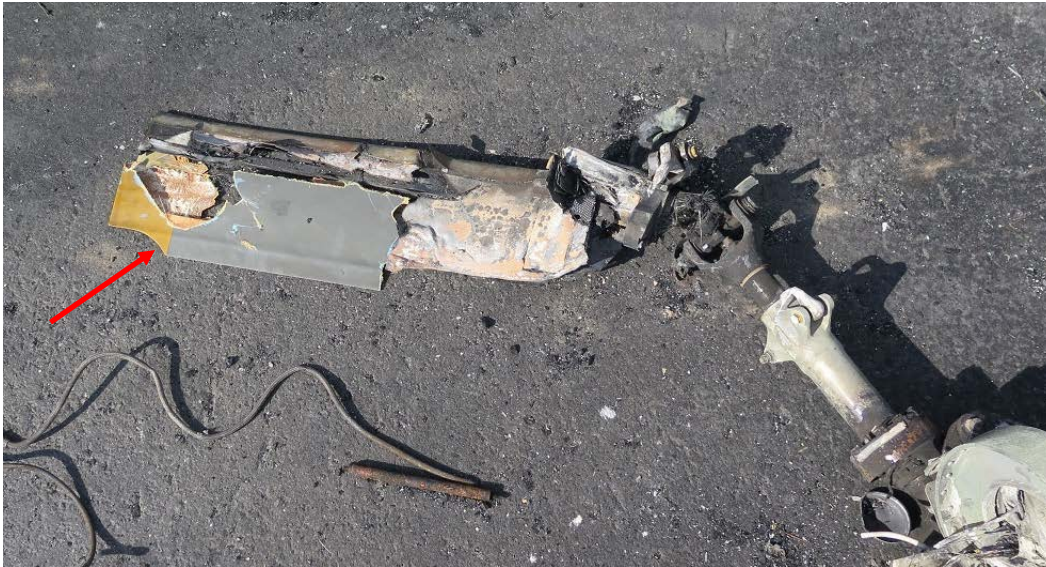
Both tail rotor blades were recovered at the accident site. The 'red' tail rotor blade was fractured at its root end and exhibited heat distress, but remained partially attached to the tail rotor hub. The balance weights of the 'red' blade remained in the blade tip end. An outboard portion of the 'red' blade's afterbody was found away from the main wreckage and did not exhibit heat distress (**Photo 4**). The 'yellow' tail rotor blade was fractured at its rod end and exhibited evidence of heat distress. The 'yellow' blade was found within debris adjacent to the second RV.

**Photo 4. The 'red' tail rotor blade afterbody laid next to the 'red' tail rotor blade. A red arrow points to the afterbody. (Photo courtesy of AHI)**

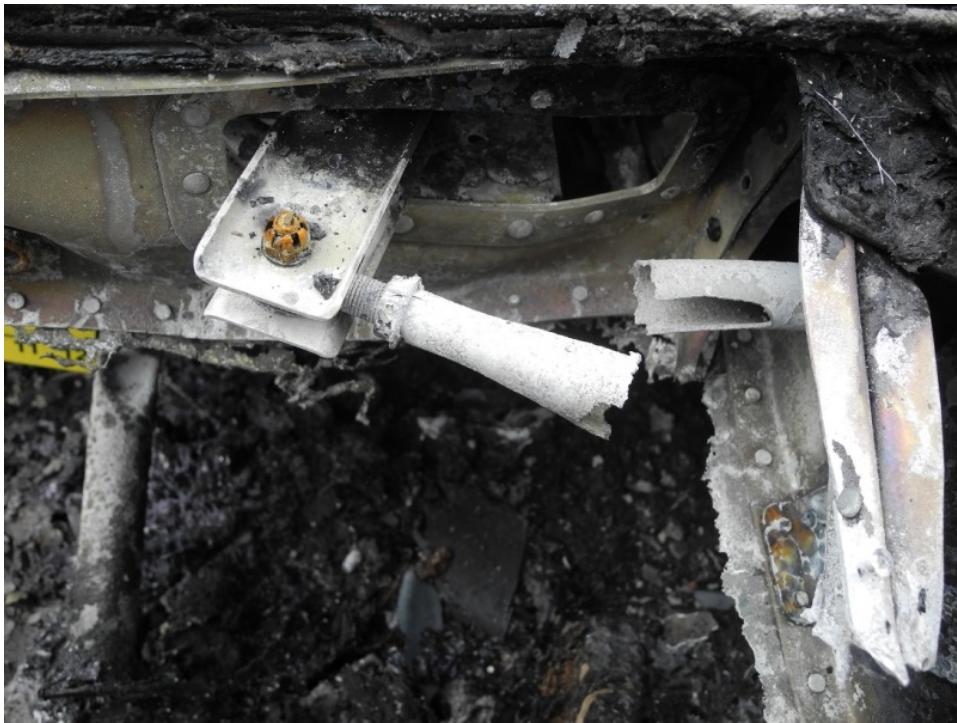
**Photo 5. Fractured and heat distressed push-pull tube for the right pedal.**

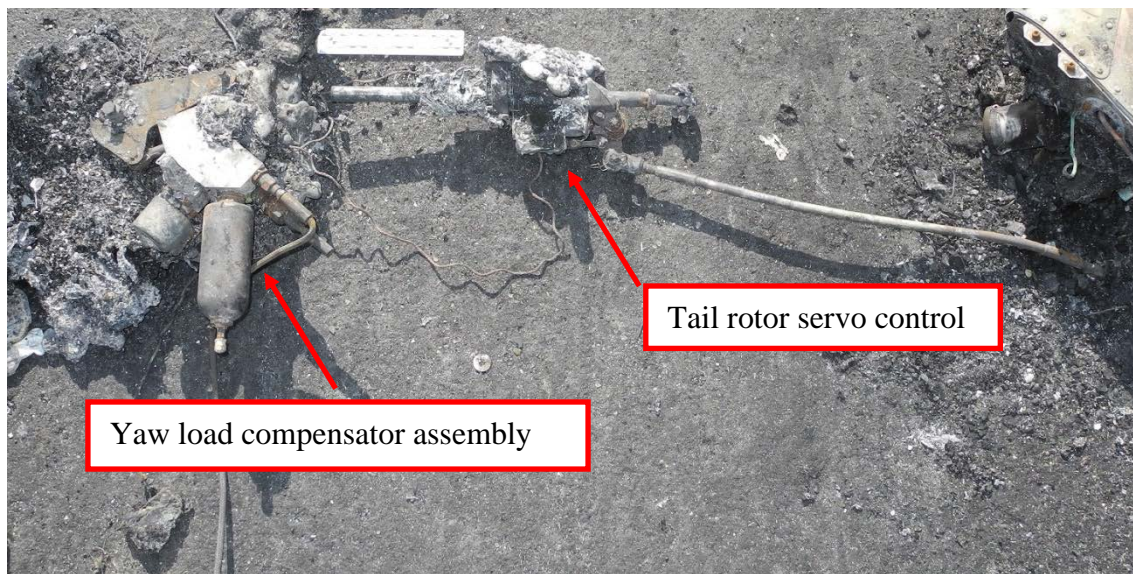
The tail rotor servo control and yaw load compensator were found loose in the main wreckage (**Photo 6**). The tail rotor servo control rod end was not attached to the tailboom structure, but the attaching hardware and resolidified molten aluminum was found within the rod end. Resolidified molten aluminum was found around the servo control body, while the aft end of the piston was exposed. The aft end of the input rod remained connected to the servo control with its associated attaching hardware. Attaching hardware remained installed on the forward end of the input rod, and the input rod tube exhibited a slight curve. The yaw load compensator, yaw load compensator accumulator, ACCU TEST electrovalve, and compensator lever were found as a single assembly, with resolidified molten aluminum surrounding the body of the assembly. Hydraulic lines remained attached to the yaw load compensator assembly but exhibited thermal damage. Attaching hardware was observed where the assembly body and the compensator lever are mounted to the tailboom structure. The compensator lever remained attached to the yaw load compensator piston with its respective attaching hardware. Additionally, the attaching hardware for connecting the compensator lever to the compensator connecting link remained within the compensator lever, but the compensator connecting link was consumed by the postcrash fire.

**Photo 6. The yaw load compensator assembly and the tail rotor servo control recovered from the wreckage.**

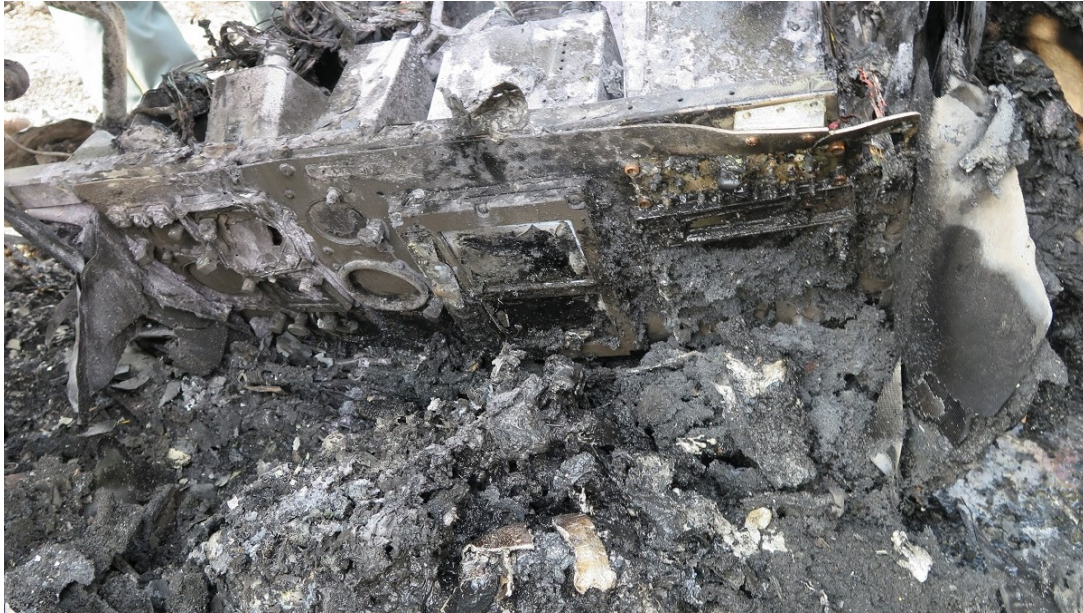
**Photo 7. Cockpit instruments exhibiting heat distress.**

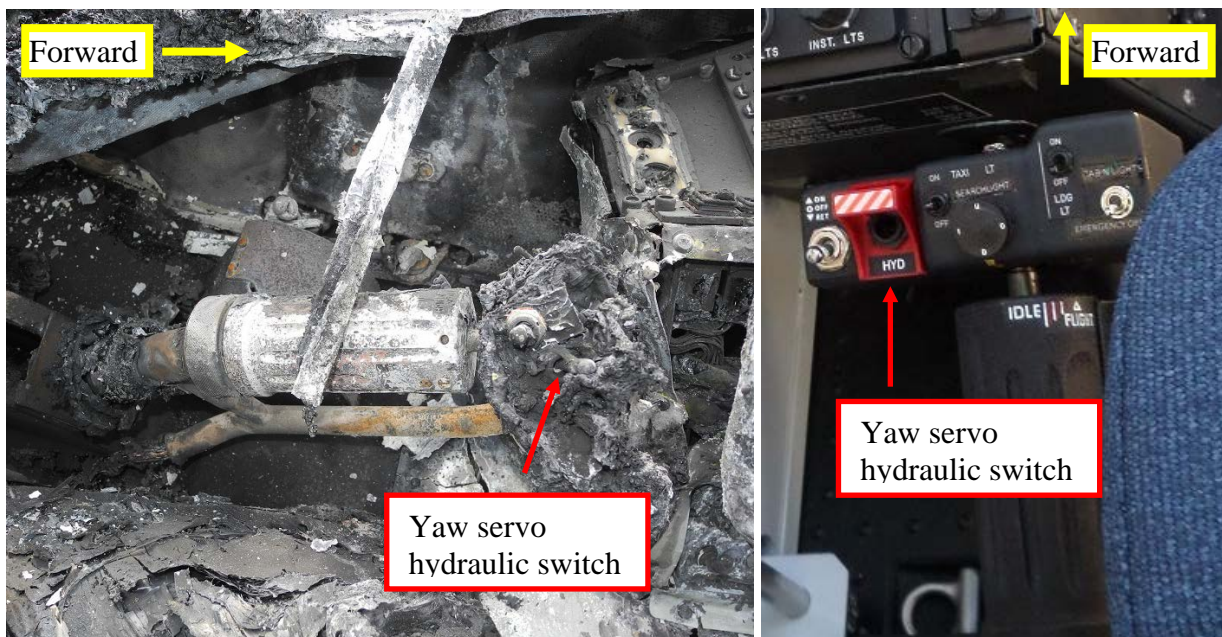
**Photo 8. Collective stick with the control block from the accident helicopter at the accident site (left) and from a photograph prior to the accident (right, courtesy of AMC).**

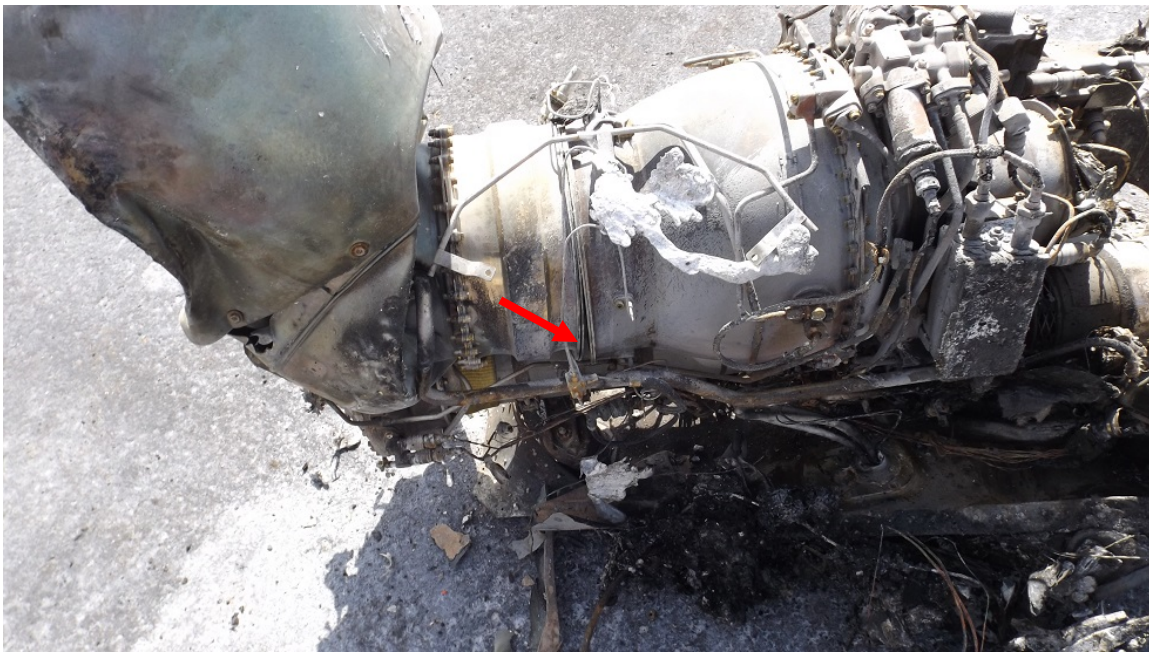
**Photo 9. The right side of the engine after extraction from the main wreckage. The exhaust duct was observed to be deformed upward. The red arrow points to the partially separated flanged connection between the free turbine case and the gas generator case. (Photo courtesy of Turbomeca)**

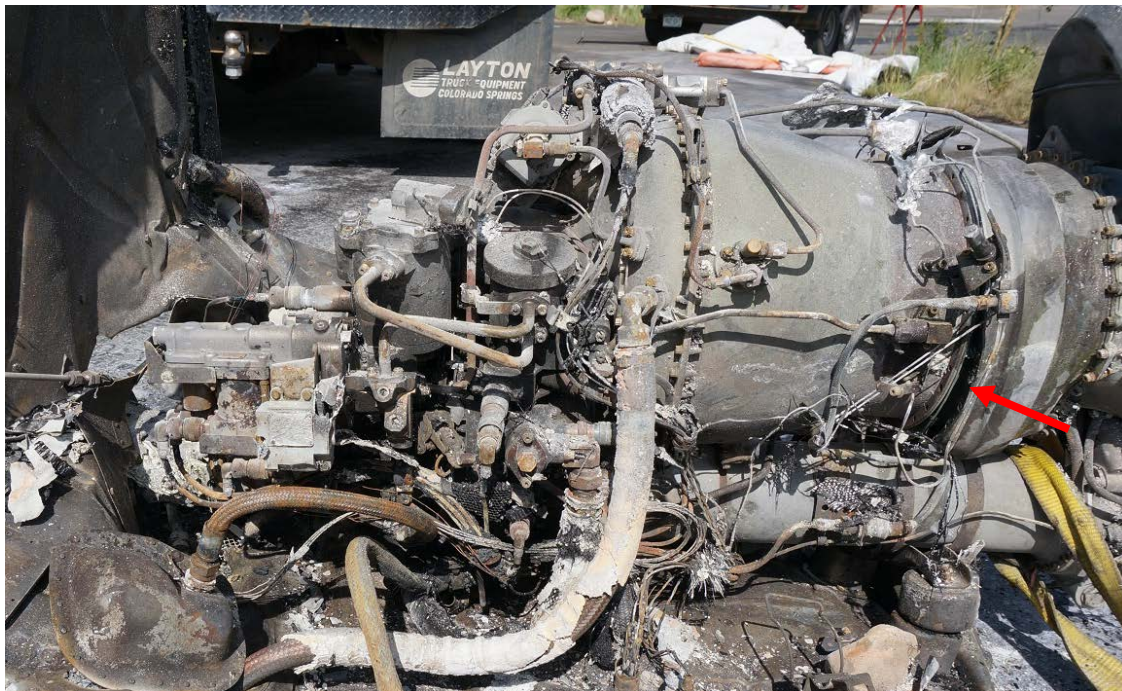
The engine, still attached to the engine deck via the engine rear mounts, was found at the main wreckage site laying on its right side. The overall external surfaces of the engine exhibited heat distress. The engine air inlet duct was consumed by the postcrash fire, but remnants remained attached to the flange adjacent to the axial compressor. The air inlet filter frame and the filter were found aft of the main transmission and exhibited evidence of heat distress. The engine exhaust duct was deformed upward (**Photo 9**). The flanged connection between the free turbine case and the gas generator case was observed to be partially separated (**Photo 10**).

**Photo 10. The left side of the engine after extraction from the main wreckage. The red arrow points to the partially separated flanged connection between the free turbine case and the gas generator case. (Photo courtesy of AMC)**

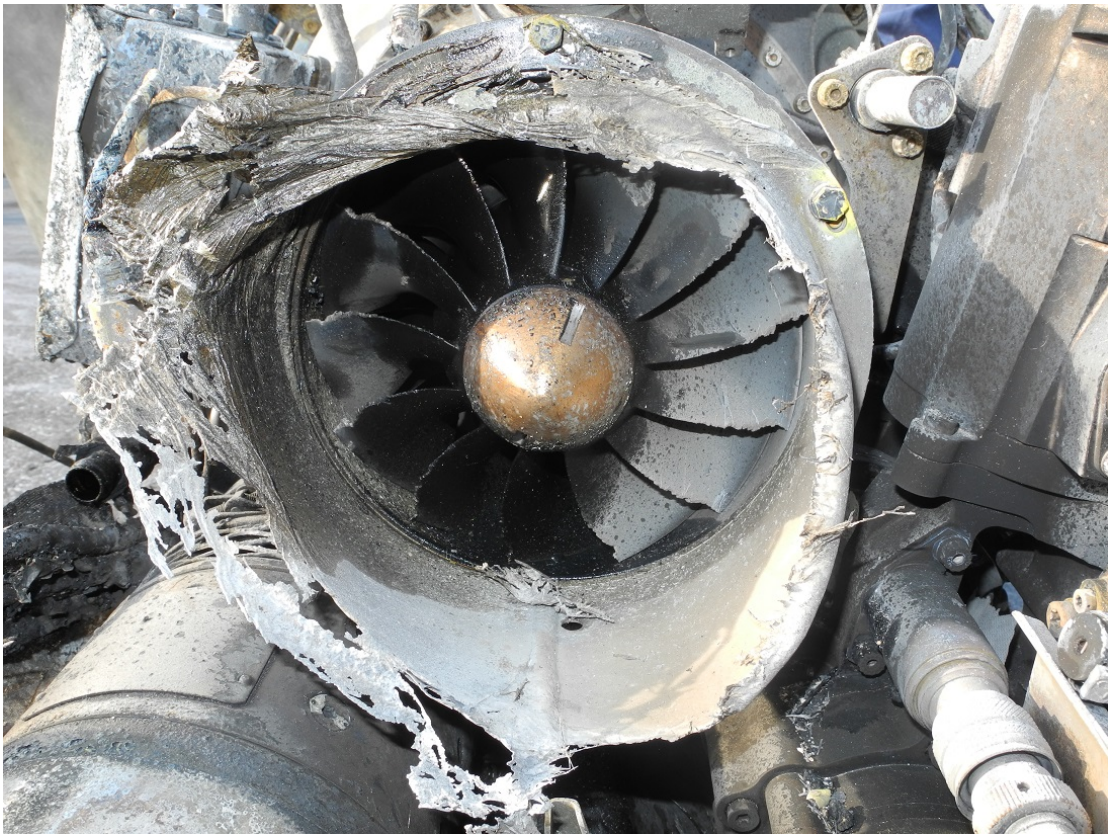
The leading edges of the axial flow compressor blades exhibited evidence of hard body impact damage (**Photo 11**).<sup>7</sup> The gas generator<sup>8</sup> could not be manually rotated. All free turbine blade roots exhibited overload fractures consistent with blade shedding (**Photo 12**).<sup>9</sup> The reduction gearbox was removed and inspection of the input pinion slippage mark<sup>10</sup> was offset in the tightening (torque) direction by about 0.04 inches (**Photo 13**). The forward ends of the splines of the reduction gearbox splined nut exhibited abnormal wear on both the drive and non-drive contact surfaces. The outboard ends of the high pressure (compressor) turbine blades exhibited a rough appearance and material loss of about one quarter of their span length. The free turbine nozzle guide vanes exhibited heat distress and exhibited deformation on its left side.

**Photo 11. Axial compressor blade leading edges exhibiting evidence of hard body impact damage.**

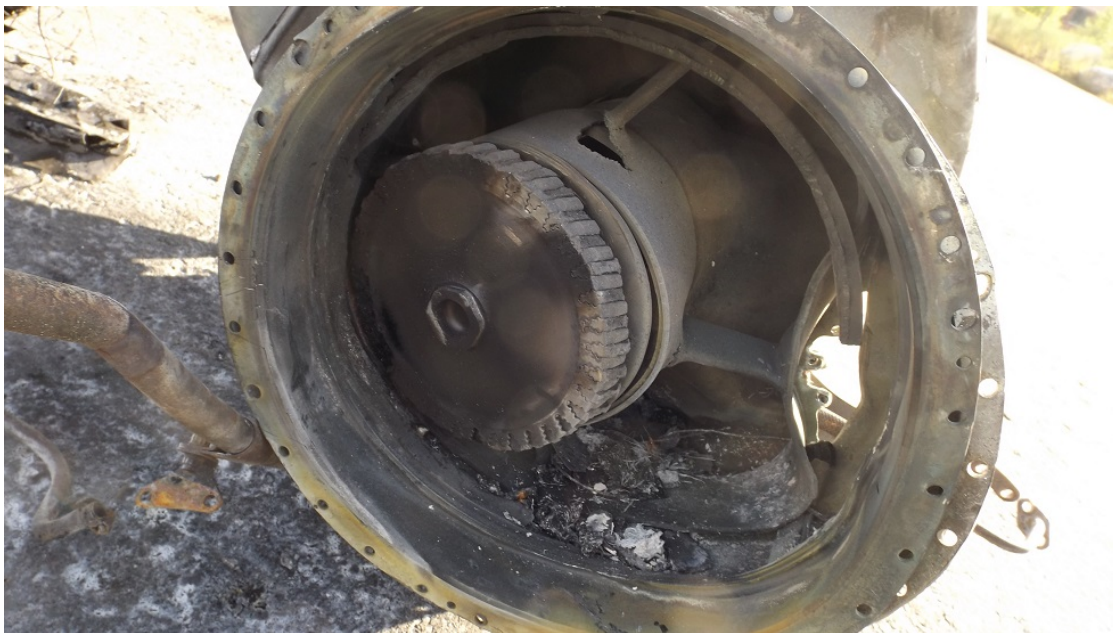
**Photo 12. Free turbine rotor exhibiting evidence of blade shedding (module was removed from engine). (Photo courtesy of Turbomeca)**

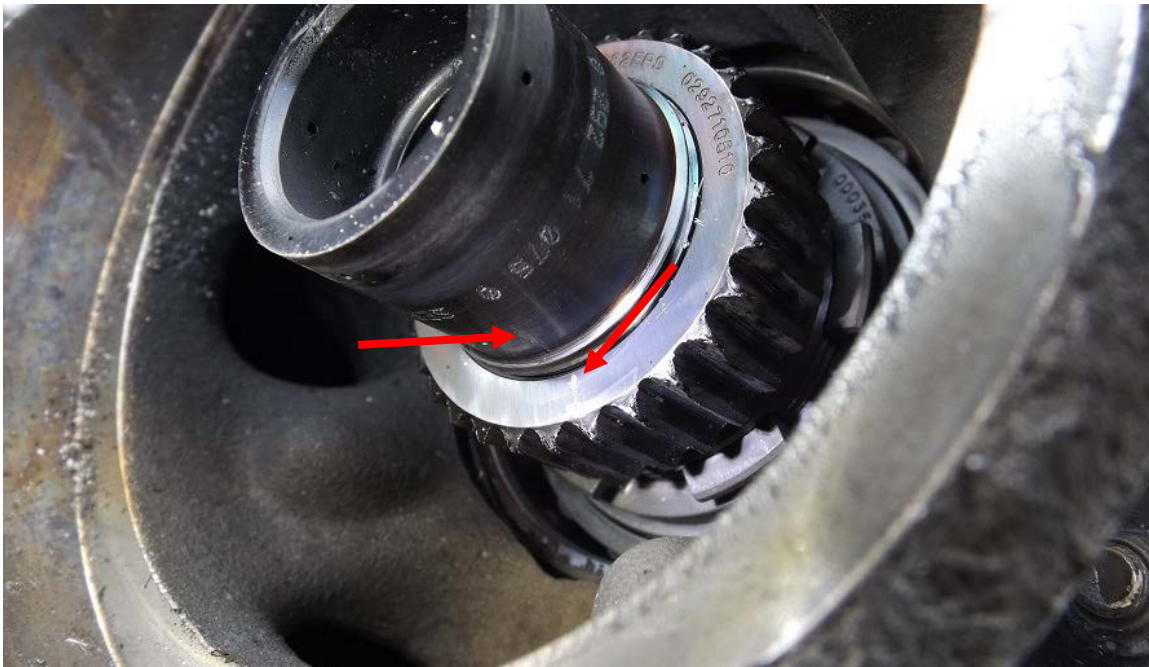
**Photo 13. Red arrows point to the two index marks on the reduction gearbox splined nut and input gear. (Photo courtesy of Turbomeca)**

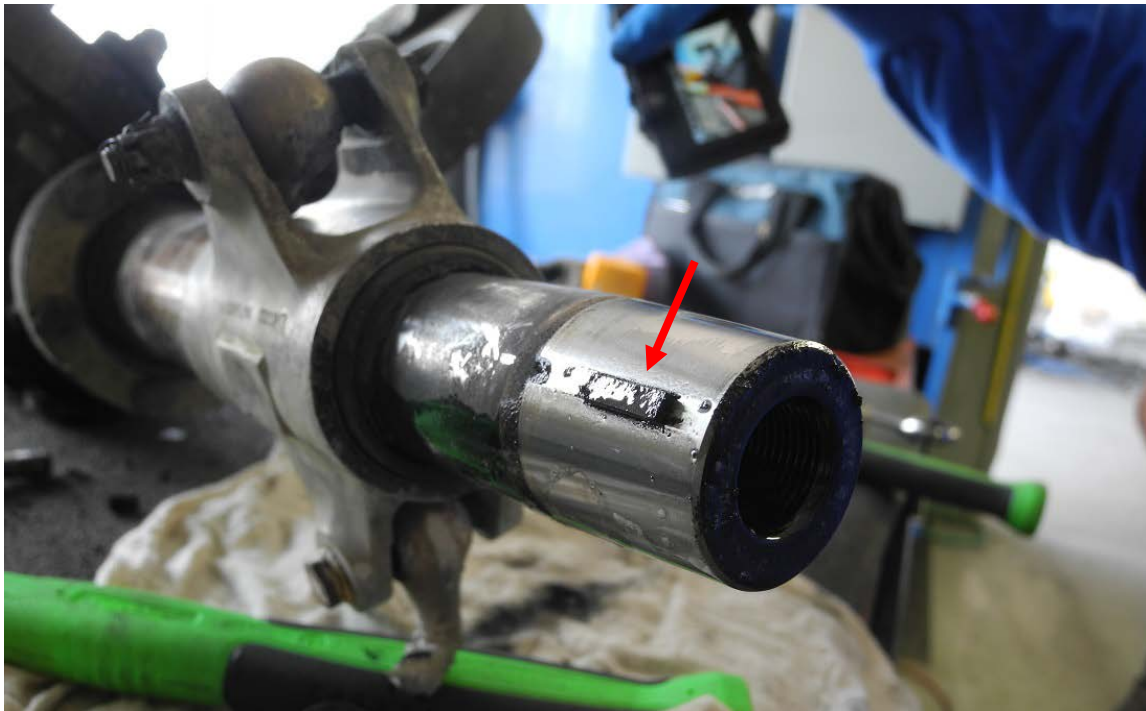
The tail rotor hydraulic isolation valve and solenoid were not found in the recovered wreckage. The tail rotor head was disassembled from the tail gearbox output shaft. The output shaft key (also known as the "woodruff key") was found intact (**Photo 14**).

**Photo 14. Output shaft key (red arrow) on the tail gearbox output shaft.**

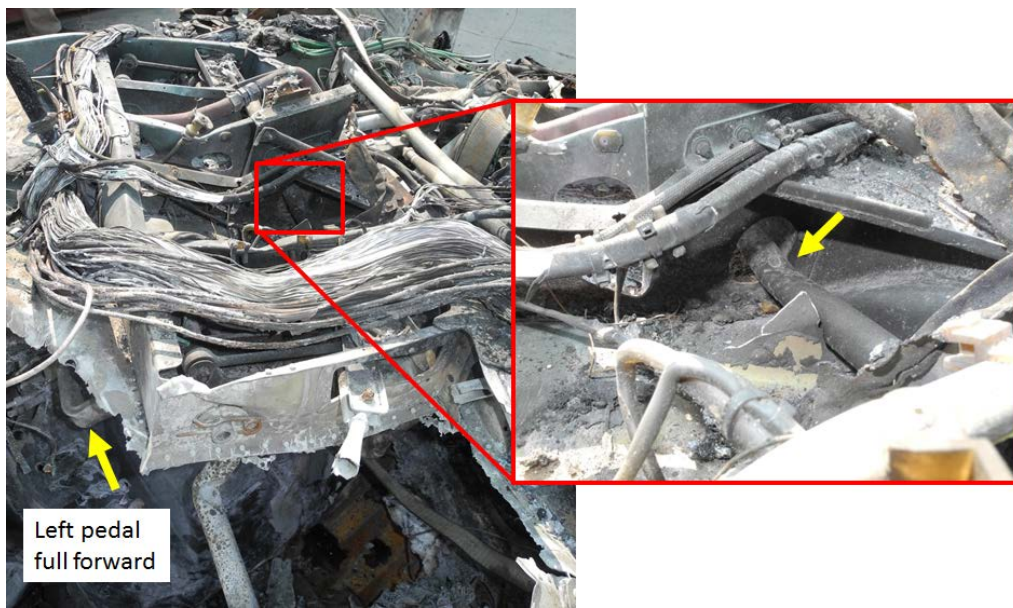
The push-pull tube was found in its normally installed location in the wreckage. Continuity of control was confirmed between the left and right pedal mounts. The push-pull tube was found to have a dent in the upward direction, about mid-length of the push-pull tube. The dent was observed to be near this cutout. When the left pedal was manually moved to its full forward position, the dent on the push-pull tube moved laterally to the right side of the helicopter (**Photo 15**). When the right pedal was manually moved to its full forward position, the dent on the push-pull tube moved laterally to the left side of the helicopter. Furthermore, near the right pedal full forward position, the dent on the push-pull tube lined up with the sheet metal cutout within the floor structure (**Photo 16**).

**Photo 15. Dent on the lateral push-pull tube (yellow arrow in the inset photo) when the left pedal was placed fully forward.**

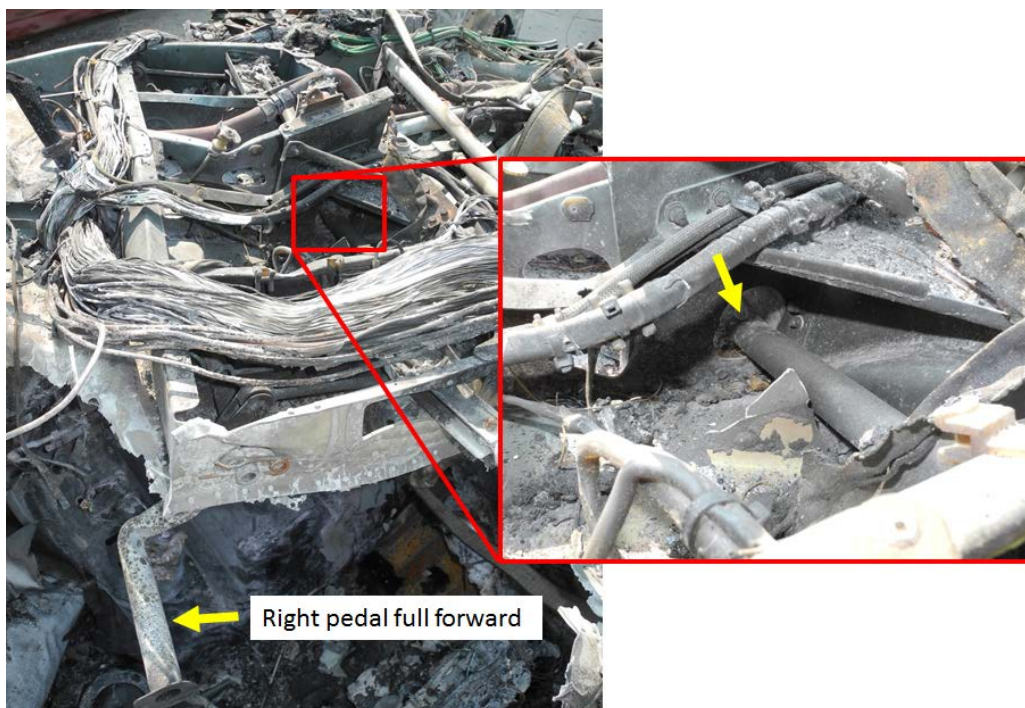
**Photo 16. Dent on the lateral push-pull tube (yellow arrow in the inset photo) when the right pedal was placed fully forward.**
