NATIONAL TRANSPORTATION SAFETY BOARD
Office of Aviation Safety
Washington, D.C. 20594

AIRWORTHINESS GROUP CHAIRMAN'S FACTUAL REPORT

NTSB No: DCA16FA199

Operator: Bell Helicopter Textron Incorporated
Aircraft: Bell Helicopter 525, Registration N525TA
Location: Italy, Texas
Date: July 6, 2016
Time: 1148 central daylight time

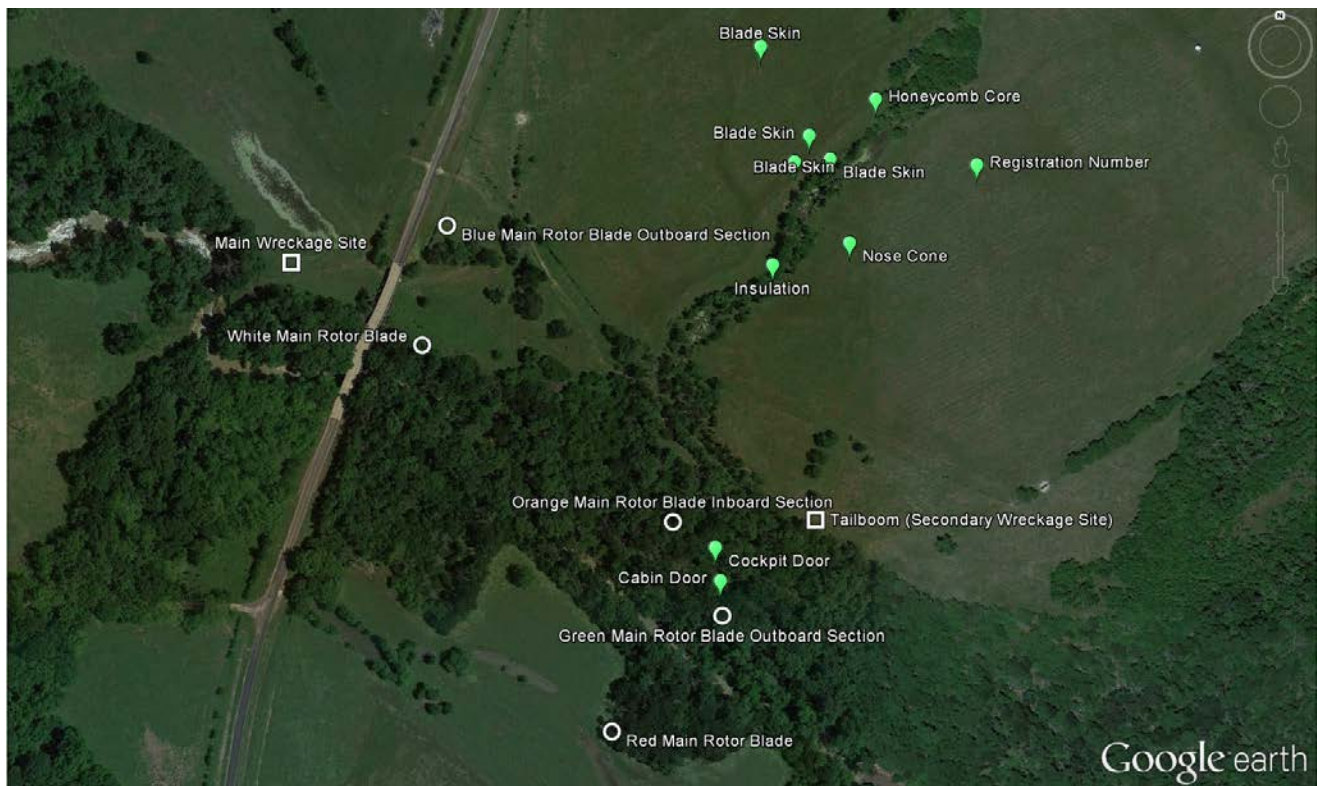
On July 7-8, 2016, members of the Airworthiness Group convened at the accident location to document the wreckage. The wreckage was distributed into two distinct areas (**Figure 1**). The first distinct area was the main wreckage site, comprising an impact crater, remnants of the main fuselage, cockpit, main transmission and main rotor hub, two of the five main rotor blades, the forward portion of the tail boom, and both engines. There was evidence of a postcrash fire at the main wreckage site. The wreckage debris path at the main wreckage site, about 200 feet in length, was oriented about 315 degrees magnetic (**Figure 2**). The second distinct area (the secondary wreckage site), about 1,300 feet southeast of the main wreckage site, comprised the aft portion of the tail boom. The aft portion of the tail boom contained the tail rotor drive system, intermediate gearbox (IGB), tail rotor gearbox (TRGB), and tail rotor. Three of the five main rotor blades were found separate from the main and secondary wreckage sites (**Figure 3**). Various pieces of forward cowlings, cockpit frames, and cabin doors were found in a debris path between the main and secondary wreckage sites. Additionally, lightweight debris, such as insulation and main rotor blade skin pieces, was found scattered to the northeast of the debris path between the main and secondary wreckage sites¹, with the furthest piece being found about 1,520 feet away from the debris path between the main and secondary wreckage sites.

Figure 1. The location of the main wreckage site, secondary wreckage site, and selected items from the wreckage debris field.

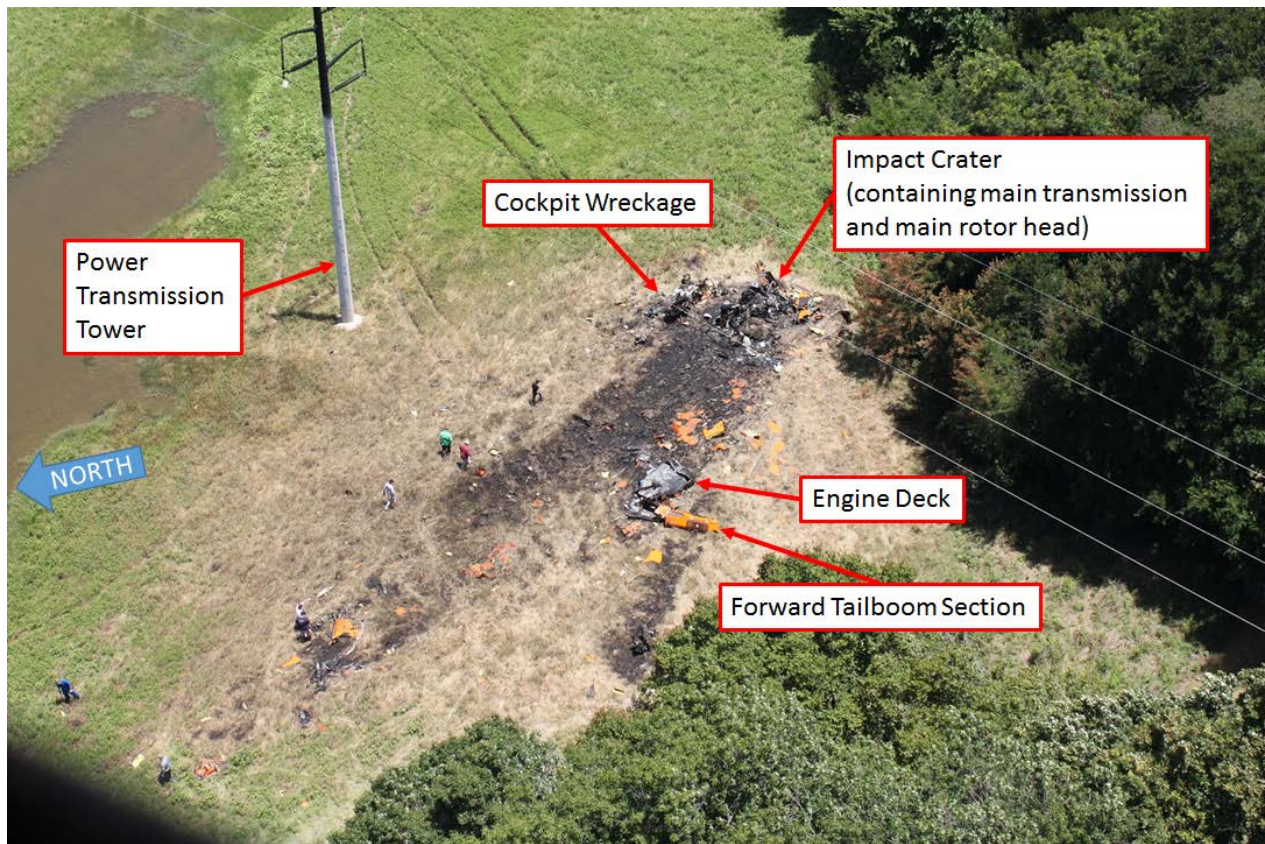
Figure 2. Aerial view of the main wreckage site.

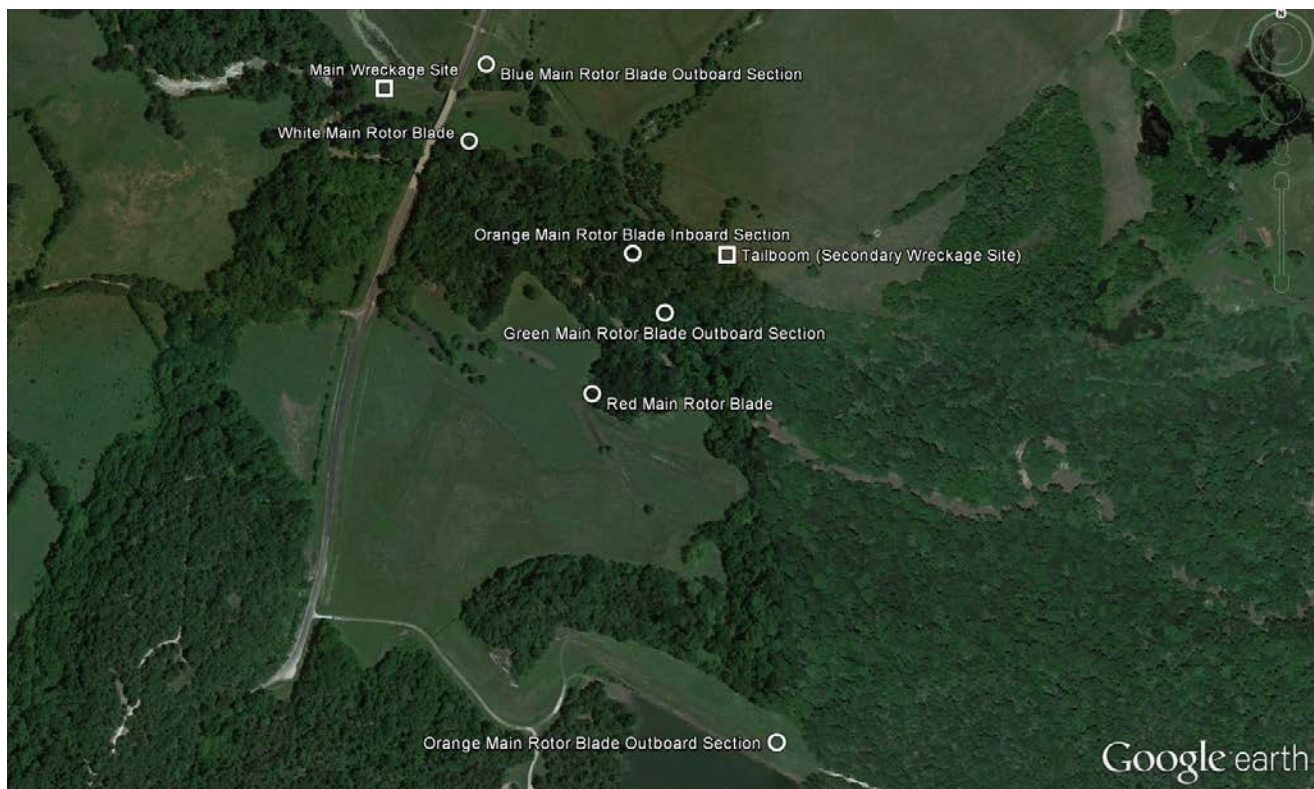
Figure 3. The location of main rotor blade sections.

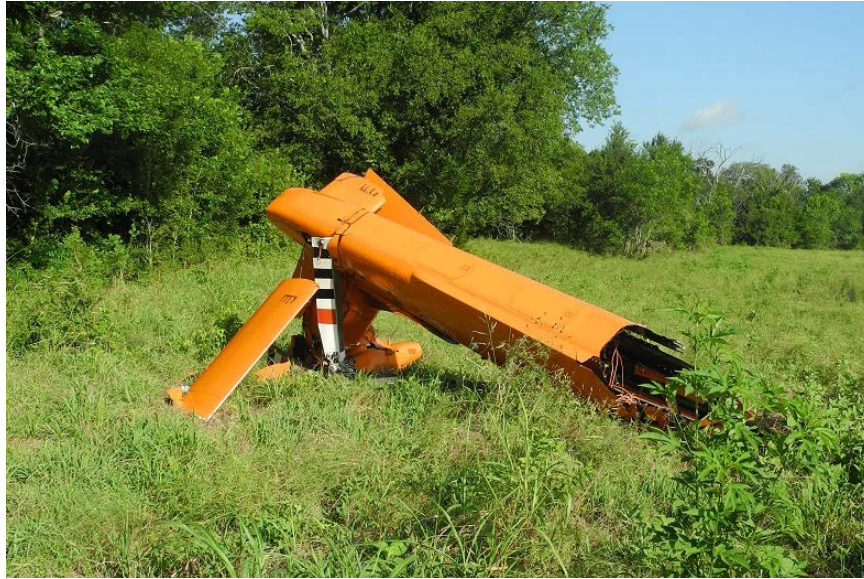
The aft portion of the tail boom was found resting partially inverted, with the tail rotor head and one tail rotor blade fully embedded into the ground (**Figure 4**). The aft portion of the tail boom exhibited an angled cut line at its forward end consistent with main rotor blade contact (**Figure 5**). On the top surface of the tail boom, the cut line was located

about fuselage station (STA) 480.² At the bottom surface of the tail boom, the cut line was located about STA 542.5.

Figure 4. The aft portion of the tail boom.

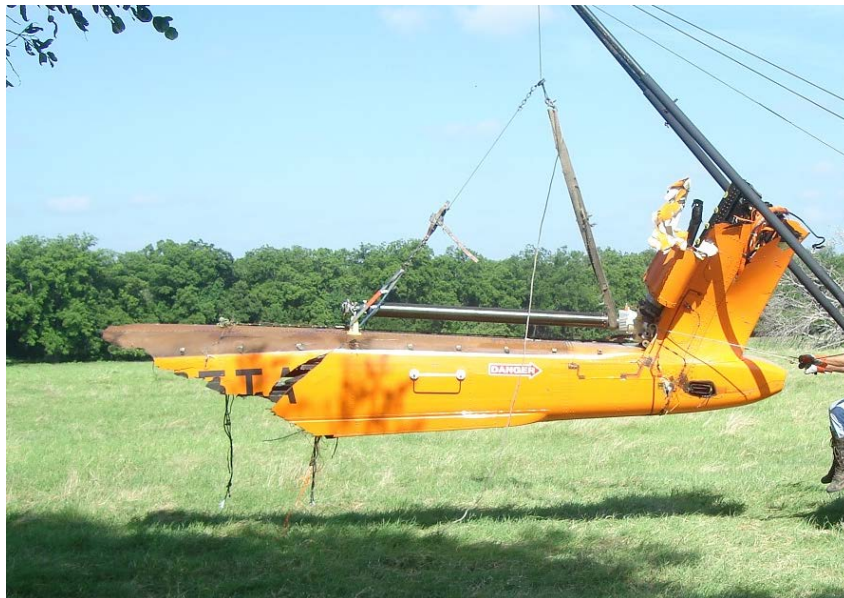
Figure 5. Angled cut line at the forward end of the aft section of the tail boom. (photo courtesy of GE Aviation)

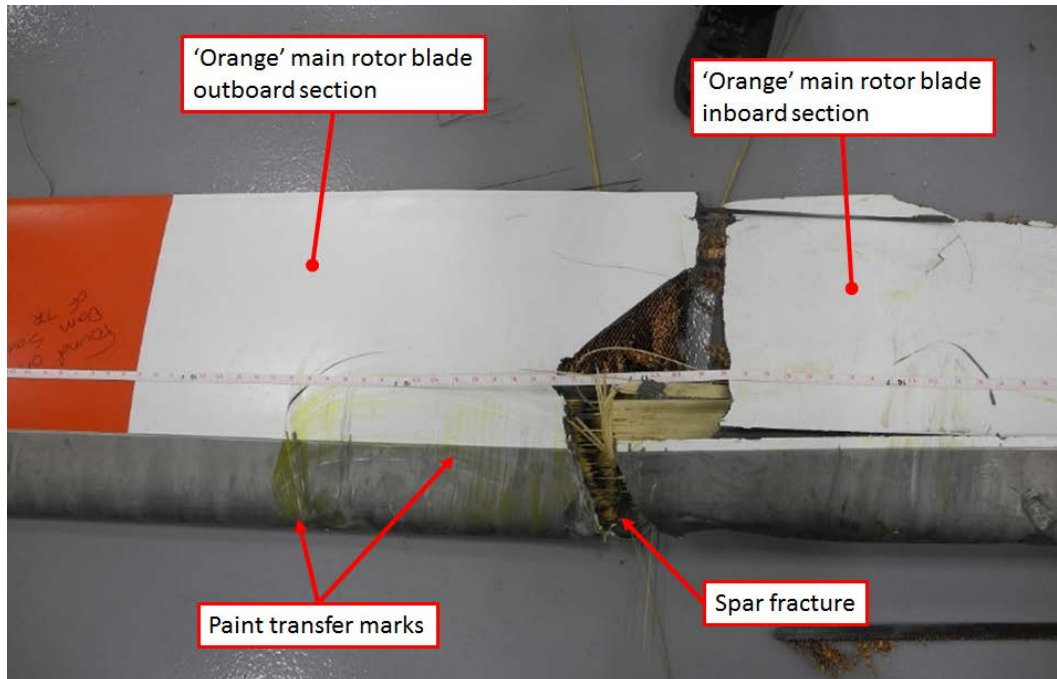
Yellowish-orange paint transfer marks was observed on the leading edge surfaces in the area of RSTA 204, where the blade fractured into its two distinct [inboard and

outboard] pieces (Figure 6). The yellow-colored paint transfer was similar in color to the yellow-colored primer found on portions of the airframe. The spar exhibited a significant impact mark and a broomstrawed appearance at RSTA 204. Additional orange paint transfer marks were observed on the leading edge surfaces along various RSTAs of the inboard section. Gouge marks into the lower blade surface were observed between RSTA 64 and 74, with the gouge increasing in depth toward the trailing edge. Damage to the blade afterbody was observed between RSTA 153-204. Outboard of RSTA 204, on the outboard section of the blade, no significant damage was observed.

Figure 6. Damage signatures observed near RSTA 204 on the 'orange' main rotor blade.

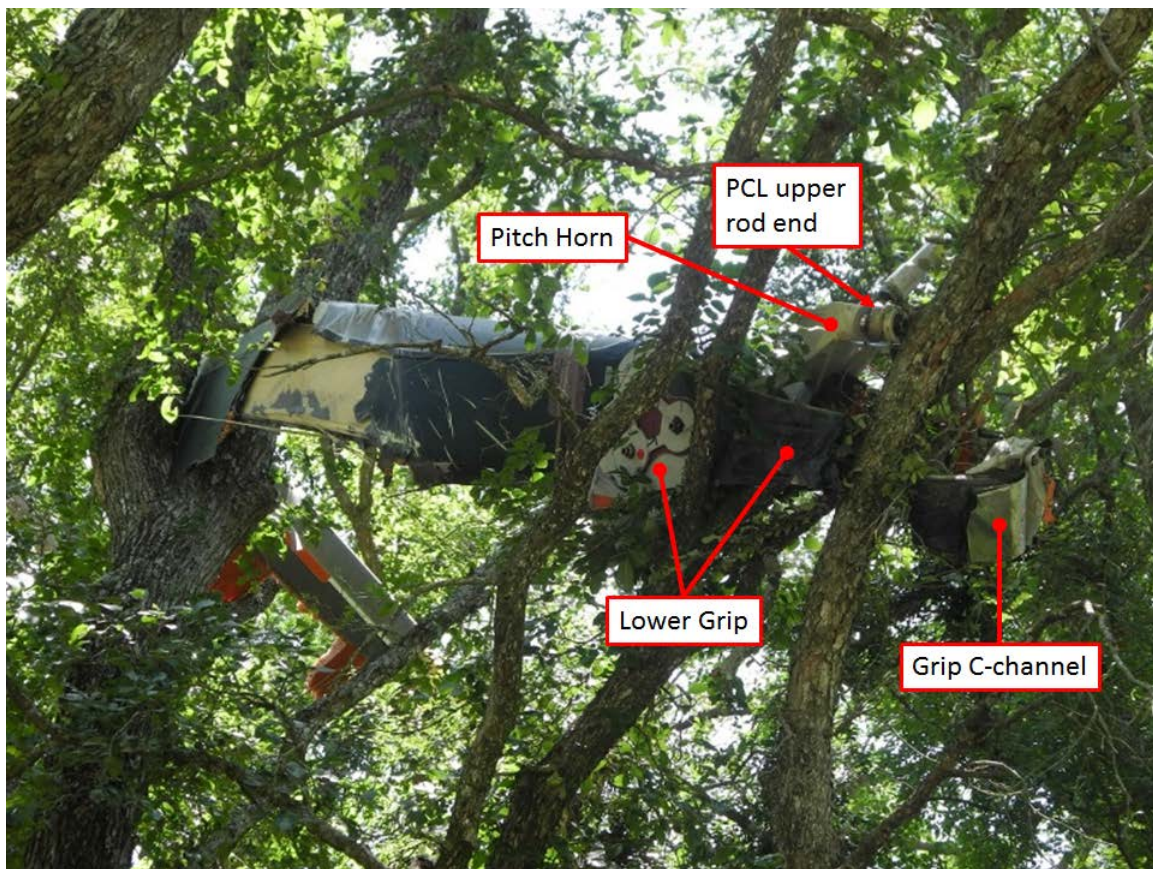
The 'red' main rotor blade, comprising the entire blade airfoil, pitch horn/damper attachment fitting, and grip, was found embedded in a tree about 1,400 feet southeast of the main wreckage site (Figure 7). The blade airfoil remained attached to the grip via three blade retention bolts. The grip fractured near the lower end of the C-channel. The interior surface of the upper portion of the grip was fractured adjacent to the pitch horn/damper attachment fitting. The sheared droop stop attachment bolt shank was observed within the grip, but the droop stop was not attached. The blade tip weight package remained installed.

Figure 7. 'Red' main rotor blade embedded in a tree.

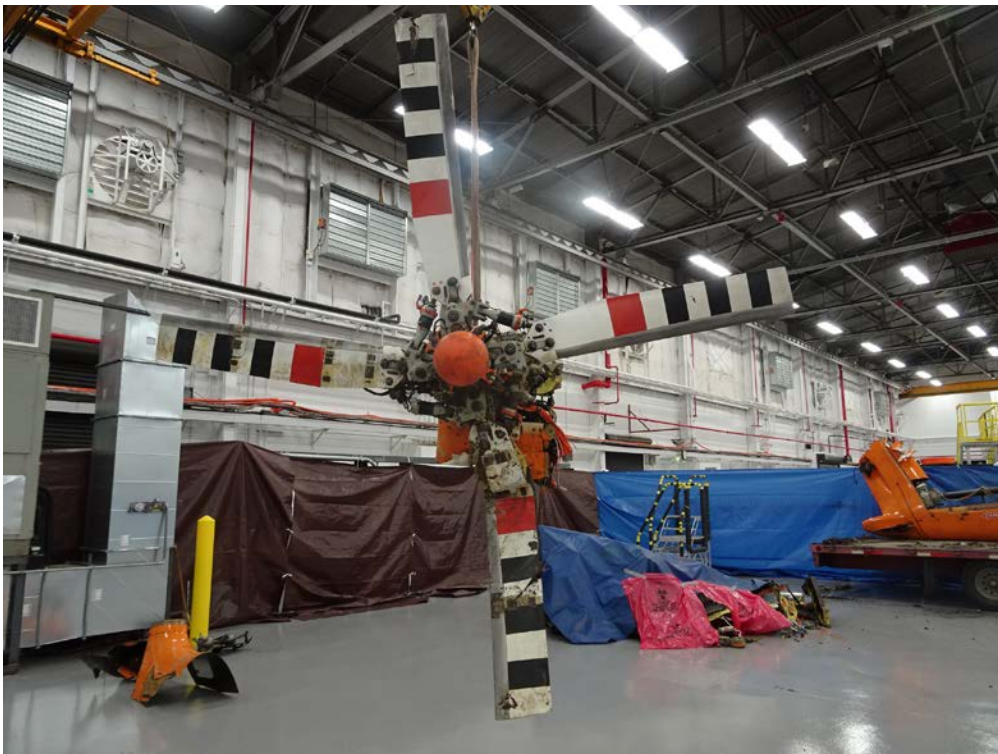
The tail rotor head remained attached to the TRGB (**Figure 8**). The hub exhibited no evidence of cracks or fractures. Its outer surfaces exhibited scuffing and caked dirt. All four damper attachment fittings, dampers, CF bearings, and grips were present. The crosshead and slider remained installed. All attaching hardware was secured and did not exhibit evidence of looseness.

Figure 8. The recovered tail rotor head with all four tail rotor blades attached. (Photo courtesy of Bell Helicopter)

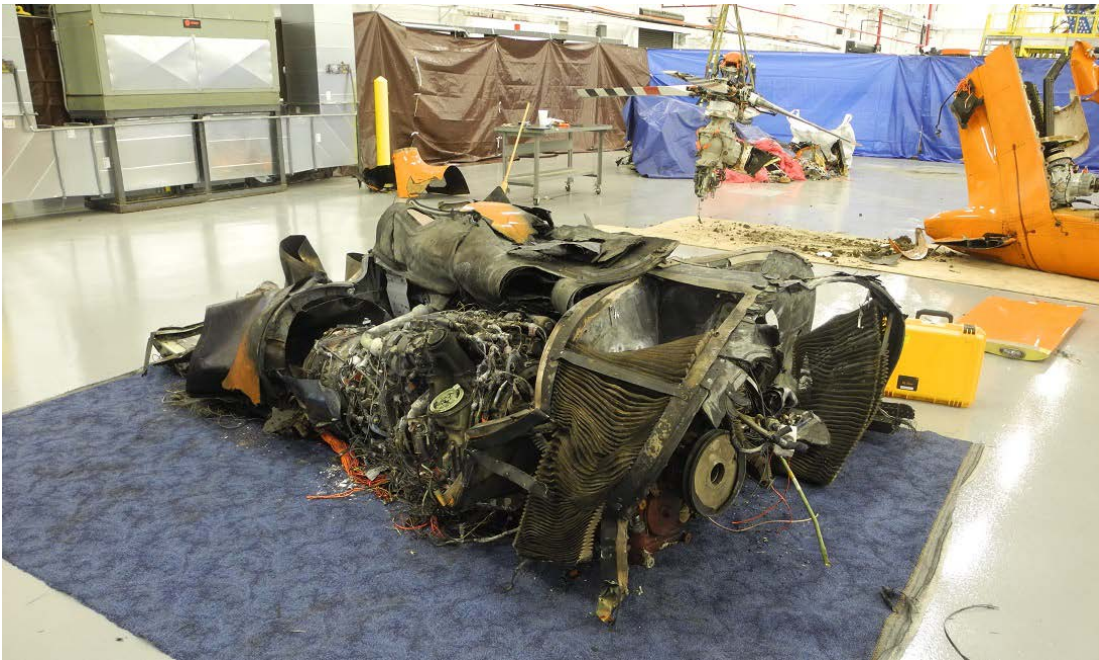
Both engines remained installed on the engine deck and exhibited thermal distress from exposure to the postcrash fire (**Figure 9**). The APU was not observed on the engine deck and was not recovered. Both inlet barrier filters remained with the engine deck but were separated from their normally installed location. Both engine fairings remained installed to the engine deck but exhibited thermal damage. All engine casings remained attached to each other with no evidence of anomalous damage. The stage 1 and 2 vanes of both engines appeared to be in the closed position. For both engines, the anti-icing valve actuator rod was in the fully retracted position and the fuel metering unit actuator rod was in the fully extended position. For both engines, manual rotation of the engine core was attempted but unsuccessful. No evidence of the case crushing against the rotors was observed in the areas viewable via borescope. For both engines, the stage 4 power turbine blade sets did not exhibit evidence of damage.

Figure 9. The recovered engine deck.

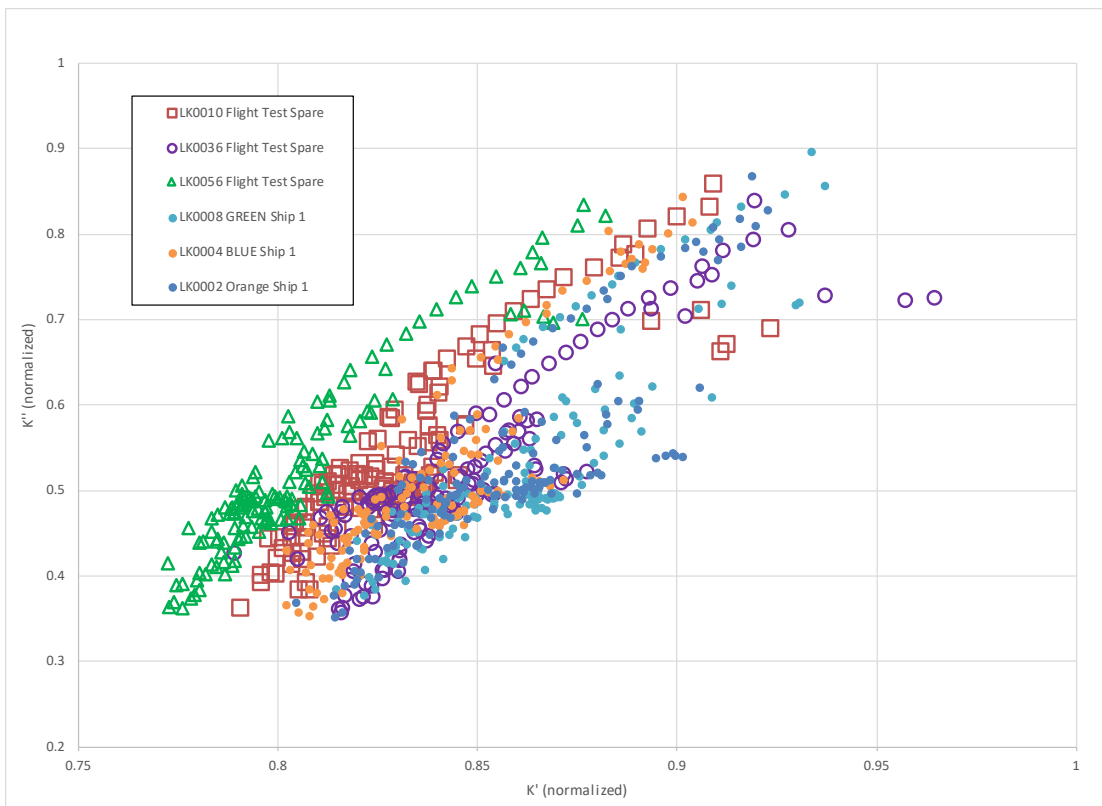
During the static bench test, displacement in both tension and compression resulted in acceptable values for all three accident tail rotor dampers tested. Dynamic testing of all three accident dampers did not reveal evidence of anomalous response behavior. **Figure 10** shows the stiffness and damping result comparison between the accident and exemplar dampers from the dynamic bench test using ATP conditions. **Figure 11** shows the stiffness comparison between the accident and exemplar dampers from the dynamic bench test replicating the conditions of the accident flight. **Figure 12** shows the damping comparison between the accident and exemplar dampers from the dynamic bench test replicating the conditions of the accident flight.

Figure 10. Comparison of the stiffness and damping results between accident and exemplar tail rotor dampers using ATP conditions.

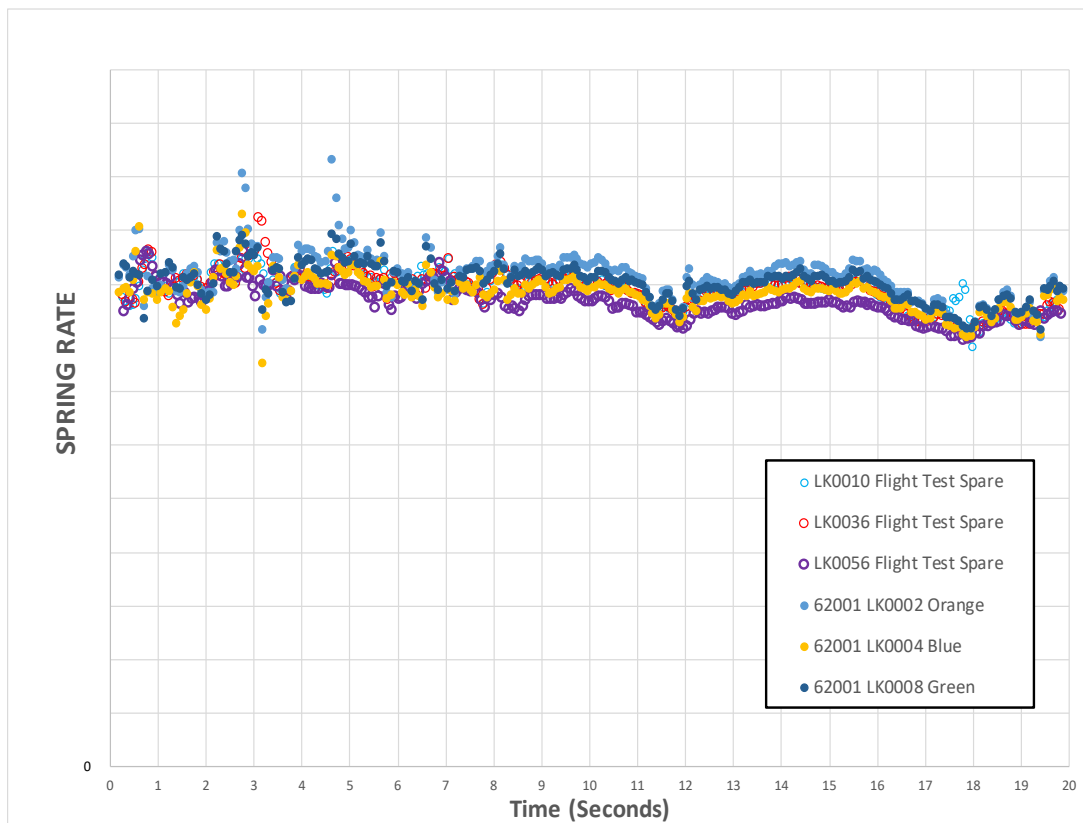
Figure 11. Comparison of the stiffness results between accident and exemplar tail rotor dampers using simulated accident flight conditions.

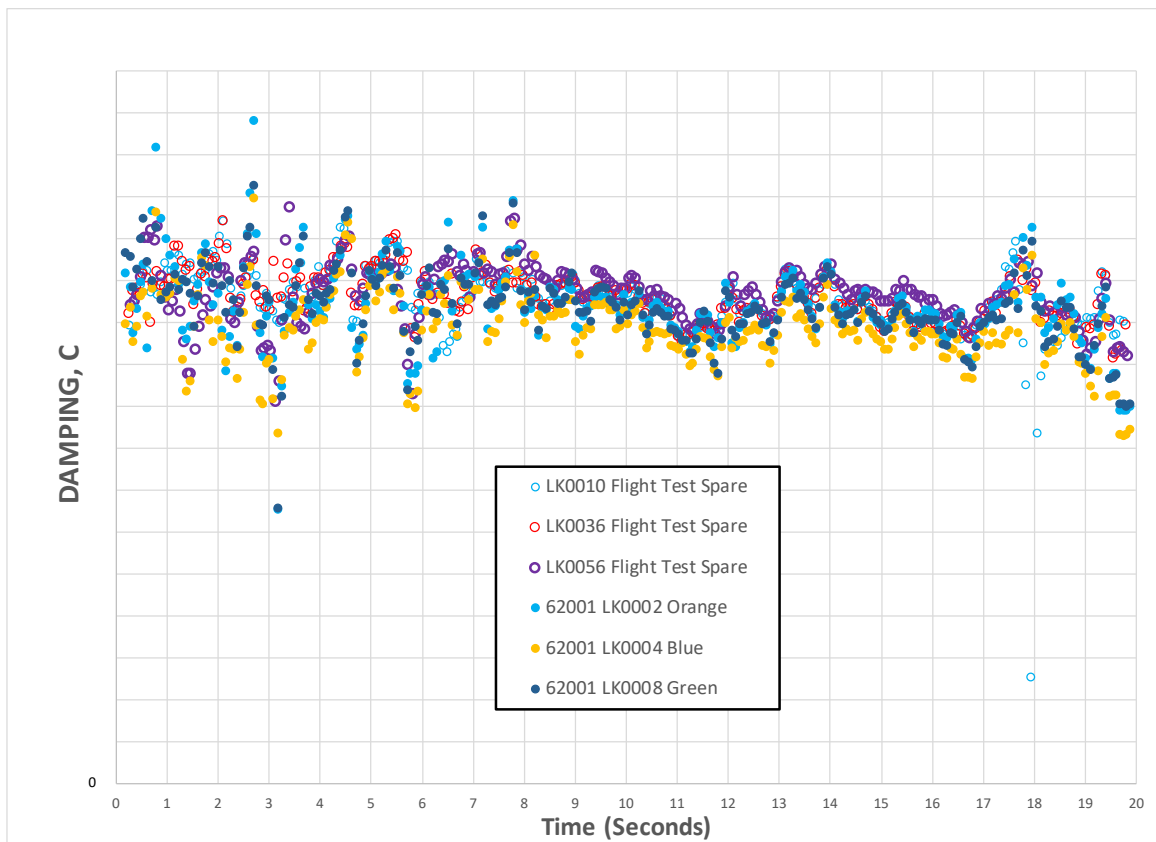
Figure 12. Comparison of the damping results between accident and exemplar tail rotor dampers using simulated accident flight conditions.
