NATIONAL TRANSPORTATION SAFETY BOARD
Office of Aviation Safety
Washington, D.C. 20594

AIRWORTHINESS GROUP CHAIRMAN'S FACTUAL REPORT

NTSB No: ERA16FA311

Operator: AAR Airlift Group
Aircraft: Sikorsky S-61N, Registration N805AR
Location: Palm Bay, Florida
Date: September 6, 2016
Time: 1340 eastern daylight time

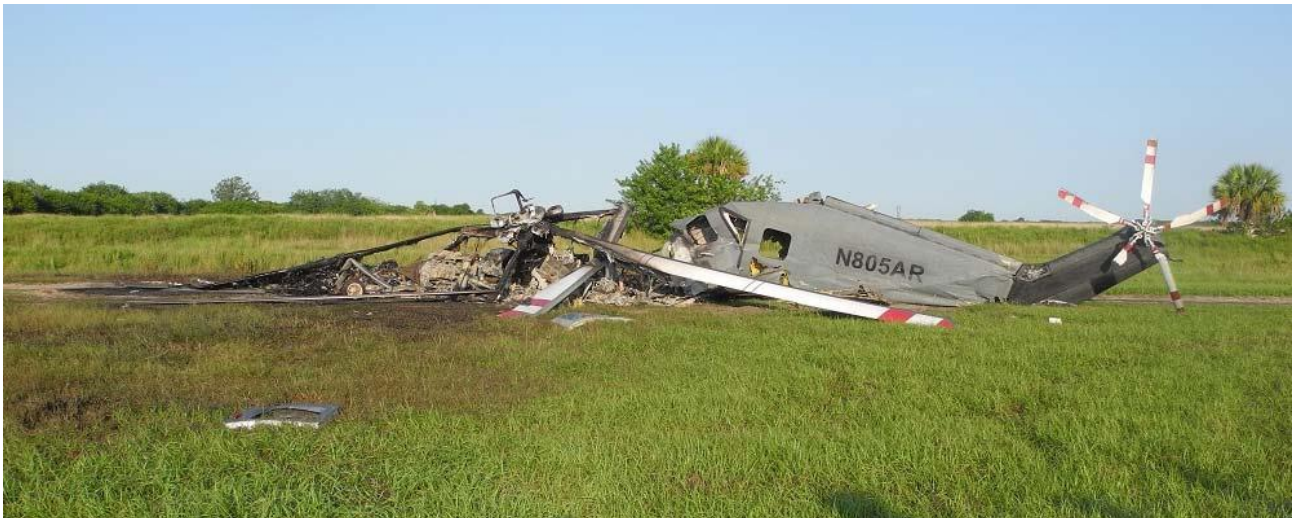
The helicopter came to rest upright with a heading of about 190 degrees magnetic (**Figure 1**). The majority of the airframe forward of the tail boom was consumed by the postcrash fire. The cabin was partially consumed by the postcrash fire and the lower fuselage (normally housing the fuel tanks) had crushed from ground impact. The left side of the tail boom remained attached to the aft end of the main fuselage and did not exhibit evidence of thermal damage. The forward portion of the right side of the tail boom exhibited thermal damage. The horizontal stabilizer remained attached to the vertical fin. The trailing edge of the horizontal stabilizer tip end exhibited distortion, but the remainder of the horizontal stabilizer exhibited no anomalous damage. The underside of the tail boom and vertical fin attachment area exhibited wrinkling of the skin and crush damage consistent with ground impact. The tail rotor driveshaft covers remained installed from the aft portion of the main fuselage up to the vertical fin. The tail rotor driveshaft covers forward of the tail boom were thermally damaged and partially consumed by the postcrash fire.

Figure 1. The accident helicopter.

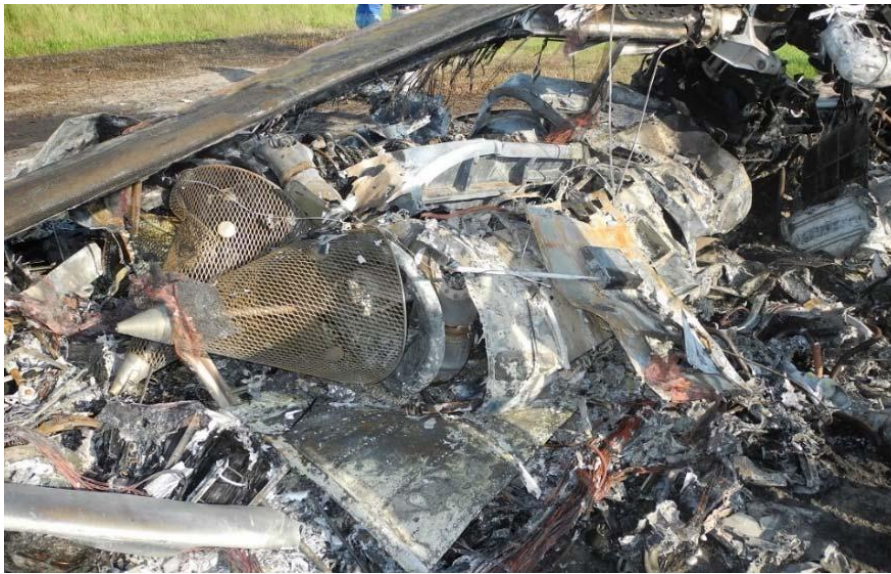
The two engines remained installed on the engine deck (located forward of the main gearbox). The resting position of the engine deck was about one foot lower than the resting position of the main gearbox. As mentioned in section 2.3 of this report, both engines were mechanically disconnected from the main gearbox due to separation of the aft end of their respective high speed shafts from main gearbox. The conical engine inlet screens were found loose near their normally installed position (**Figure 2**). No evidence of significant blockages was observed on the conical screens. The engine control levers were found loose in the cockpit wreckage, precluding determination of lever position, and exhibited thermal damage (**Figure 3**).

Figure 2. The engines and conical inlet screens at the accident site (No. 2 engine partially viewable).

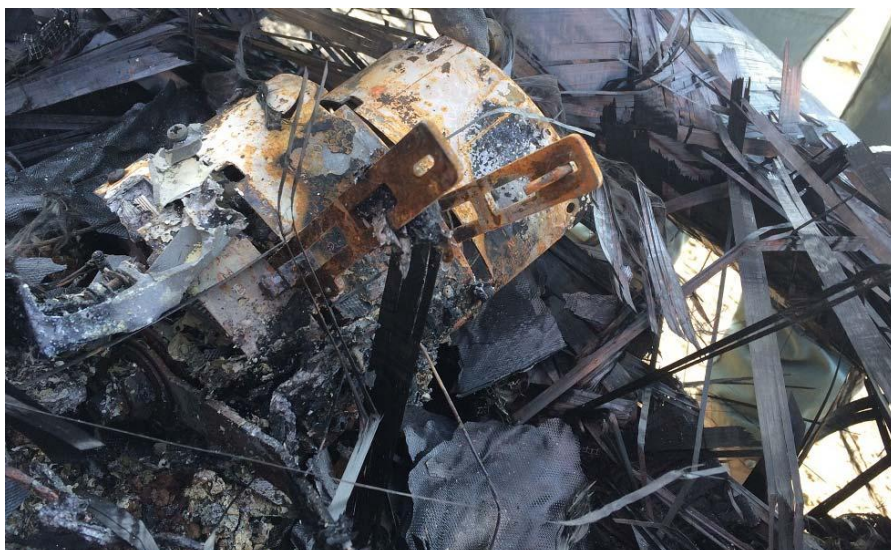
Figure 3. The engine control levers found on scene.

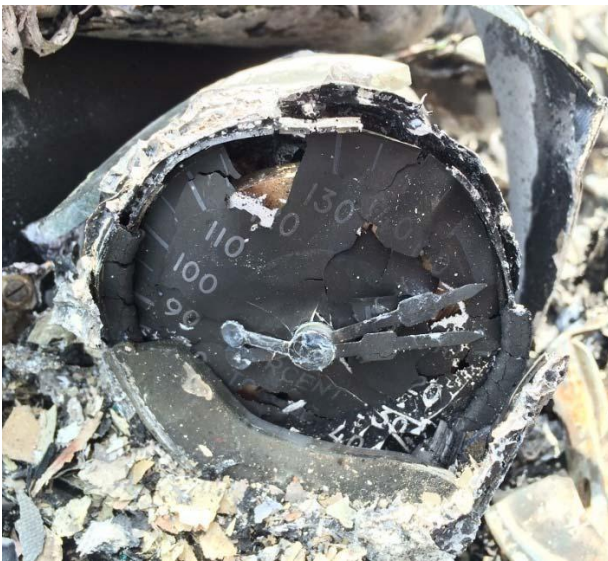
The majority of cockpit instruments found at the accident site were unreadable due to impact and thermal damage. The percent torque gauge within the cockpit exhibited thermal damage and soot deposits, and its two needles were deformed in the forward direction. The two needles for the cockpit torque gauge were labeled “1” and “2”; needle “1” indicated about 0% and needle “2” indicated about 8% (**Figure 4**). The percent torque gauge mounted on the exterior of the helicopter for the left-seated pilot exhibited minor thermal distress. The two needles for the externally-mounted torque gauge were labeled “1” and “2”; needle “1” indicated about 34% and needle “2” indicated about 9% (**Figure 5**).

Figure 4. Cockpit engine torque gauge.

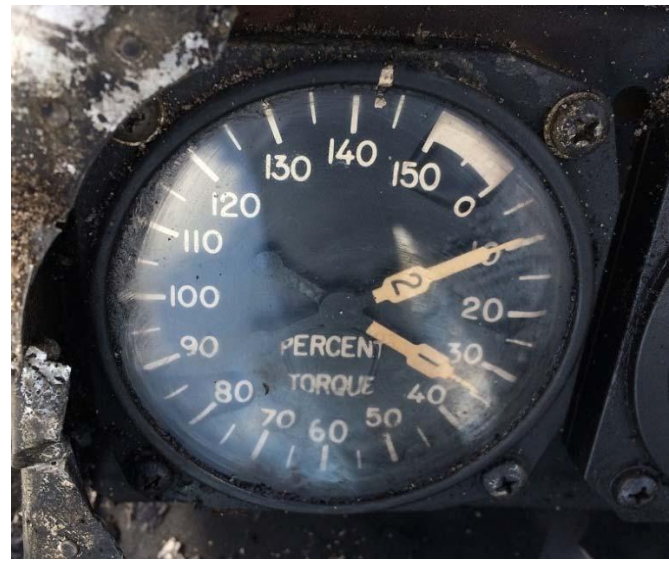
Figure 5. Exterior-mounted engine torque gauge.

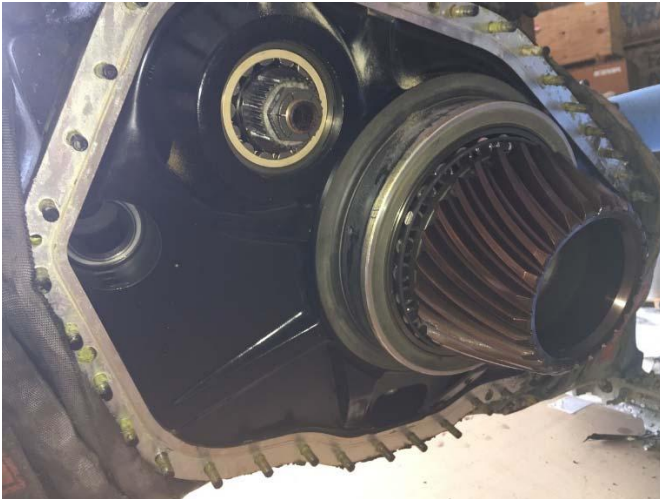
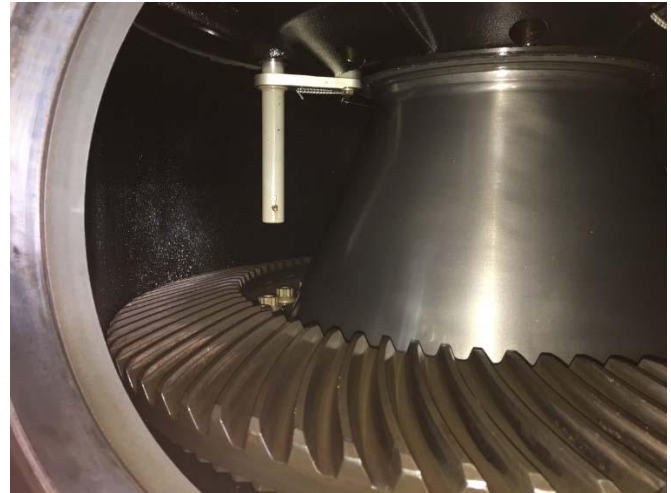
revealed the main bevel gear and the main bevel input pinion (**Figures 6 and 7**). The gear teeth for the main bevel gear and the main bevel input pinion exhibited no evidence of anomalous damage. Separation of the front cover from the input housing revealed both FWU assemblies (**Figure 8**). Both input coupling retaining nuts were found to be hand tight, however both FWU assembly nuts did not exhibit evidence of looseness when removed. Manual rotation of the right FWU in the direction of normal drive resulted in engagement of the ramp-roller clutch; rotation in the freewheeling direction resulted in disengagement of the ramp-roller clutch. Manual rotation of the left FWU resulted in freewheeling motion in both directions of rotation. No anomalous damage was observed on the splines and gear teeth seen within the interior of the input housing during removal of the FWUs.

Figure 6. Main bevel input pinion.

Figure 7. Main bevel gear.

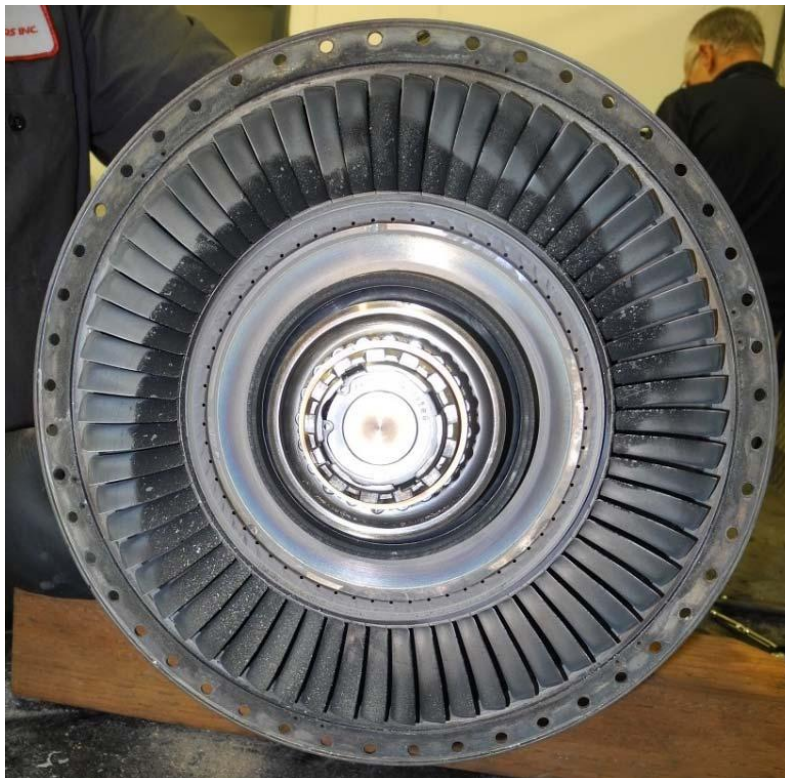
Removal of the power turbine rotor from its case revealed the power turbine blade dampers (located between the root end of the blades) were not flush to the forward surface of the rotor hub. The tip end of several blades exhibited slight curling near the leading edge. The second stage turbine rotor was removed and its blades exhibited no anomalous damage or erosion (**Figure 11**). All blades were present, and both sides of the blades exhibited evidence of soot deposits. The turbine disk exhibited thermal discoloration; the disassembly technicians stated that based on their experience the discoloration was typical of in-service use. The labyrinth seals, forward and aft cooling plates, and the coupling shaft between the first stage and second stage turbine rotors exhibited no anomalous damage. The honeycomb static seal on the inner diameter of the second stage turbine nozzle exhibited no anomalous damage. The second stage turbine nozzle and the first stage turbine shroud remained within the first stage turbine case when the case was removed. Four witness marks consistent with static (non-moving) first stage turbine blade contact with its shroud was observed on the 3 o'clock position of the shroud. A surface stain in the shape of static (non-moving) blades was observed on the 1 o'clock position of the shroud.

Figure 11. The second stage turbine rotor from the No. 1 engine.

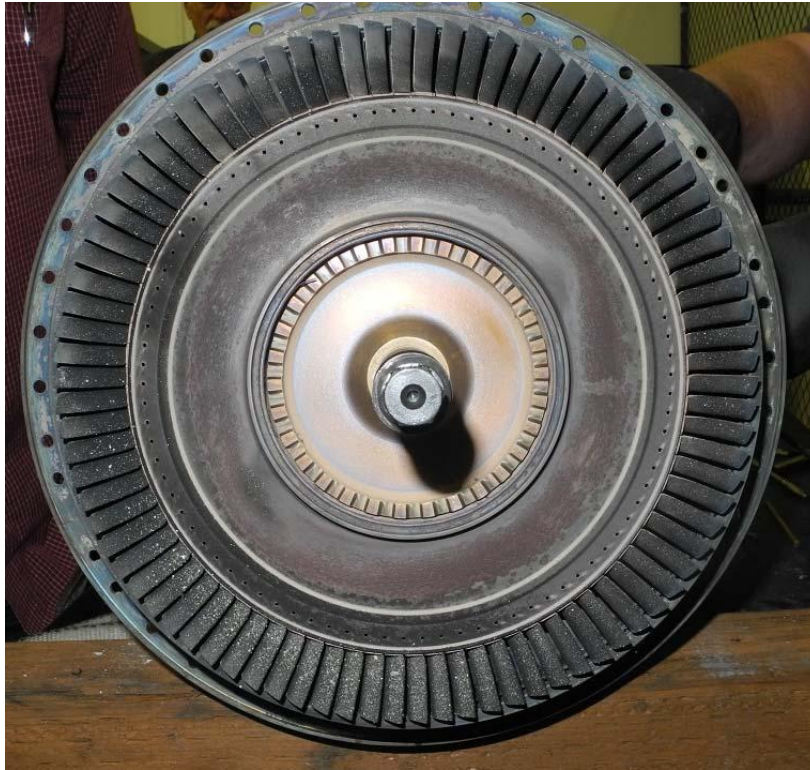
The first stage turbine rotor was removed and its blades exhibited no anomalous damage or erosion (**Figure 12**). All blades were present, and both sides of the blades exhibited evidence of soot deposits, with heavier soot deposits observed on the blades around the 12 o'clock position. The curvic coupling teeth, the forward and aft cooling plates, and the first stage nozzle exhibited no anomalous damage. The turbine forward shaft, providing drive from the gas generator turbines to the compressor, exhibited no anomalous damage. The turbine shaft bolt was removed and its threads did not exhibit anomalous damage.

Figure 12. The first stage turbine rotor from the No. 1 engine.

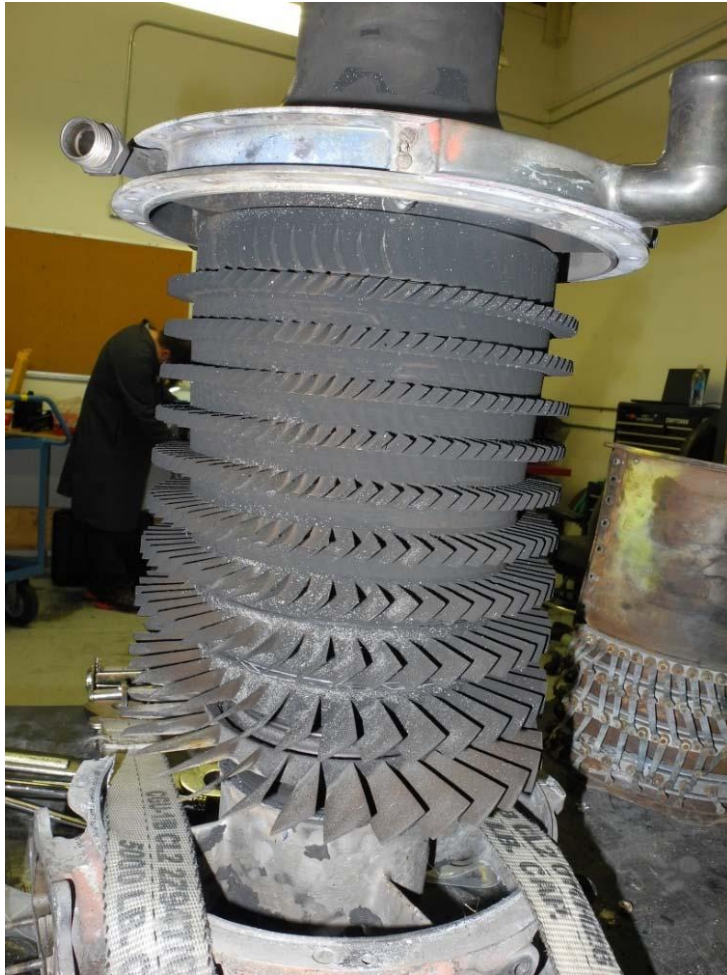
Figure 13. Compressor rotors from the No. 1 engine.

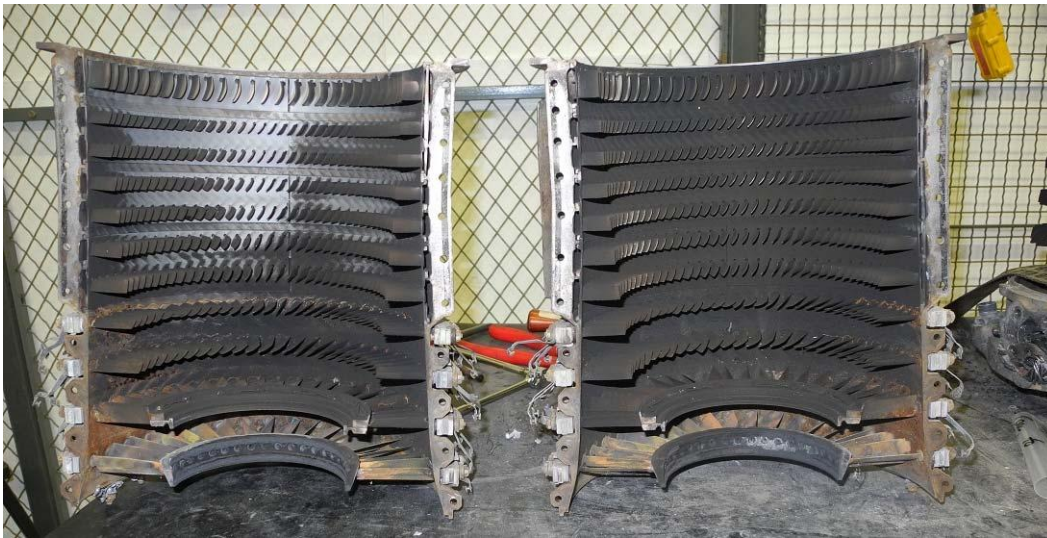
evidence of anomalous damage. Soot deposits were observed on the IGV, VGV, and the six stages of stators (**Figure 14**). From the 3 o'clock to the 6 o'clock region, the three stages of VGV tips were scored in the area between the second, third, and fourth stages. Impressions of the stator vanes were observed on the soot deposits on the compressor spool surfaces. Very light impressions of the last two stages of the VGV were observed on the soot deposits on top of the spool surfaces, but impressions of the first stage of VGV and the IGV were not observed on the soot deposits on the compressor spool surfaces.

Figure 14. Compressor case halves from the No. 1 engine.

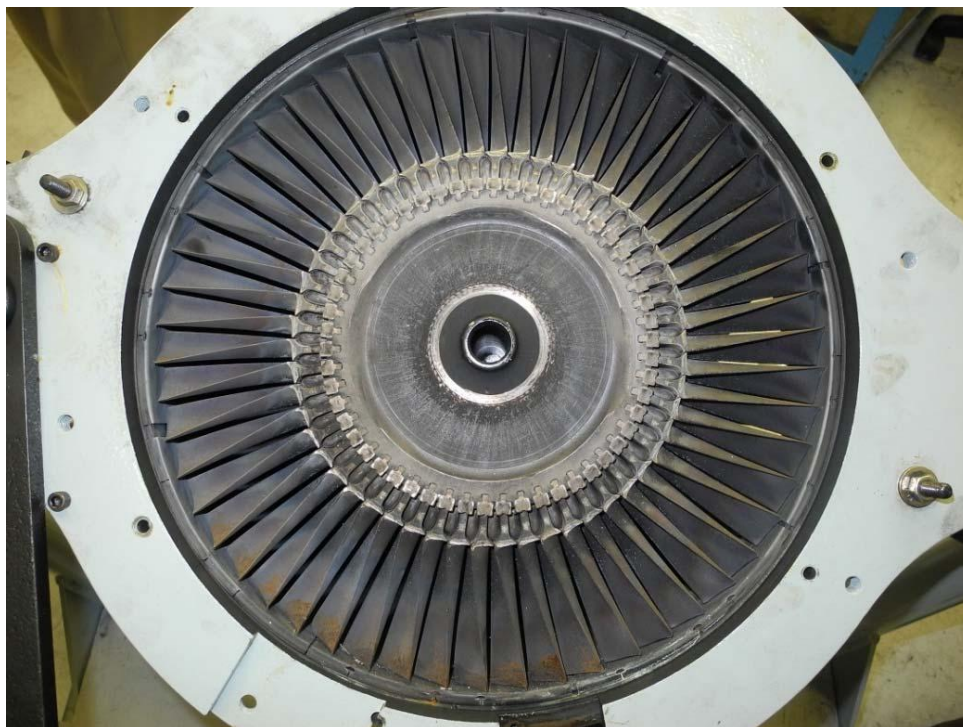
The torque tube was removed from the exhaust case, revealing the high speed shaft which remained attached to the power turbine flange via flexible disc coupling (also known as a Thomas coupling). The flexible disc coupling did not exhibit evidence of splaying or opening of the coupling laminates. The power turbine and the high speed shaft could not be rotated, precluding disassembly of the exhaust case. The No. 5 bearing housing was shifted, within the exhaust case, about 3/8 inches forward at the 9 o'clock position and 1/8 inches forward at the 3 o'clock position. The power turbine blades did not exhibit evidence of anomalous damage or severe erosion; the blades exhibited discoloration and the surfaces exhibited a rough appearance in areas that were not coated with soot (Figure 15). The power turbine accessory drive was stuck within the exhaust casing. The oil supply tube to the power turbine bearings exhibited deformation at the rotor hub-side.

Figure 15. The power turbine rotor from the No. 1 engine.

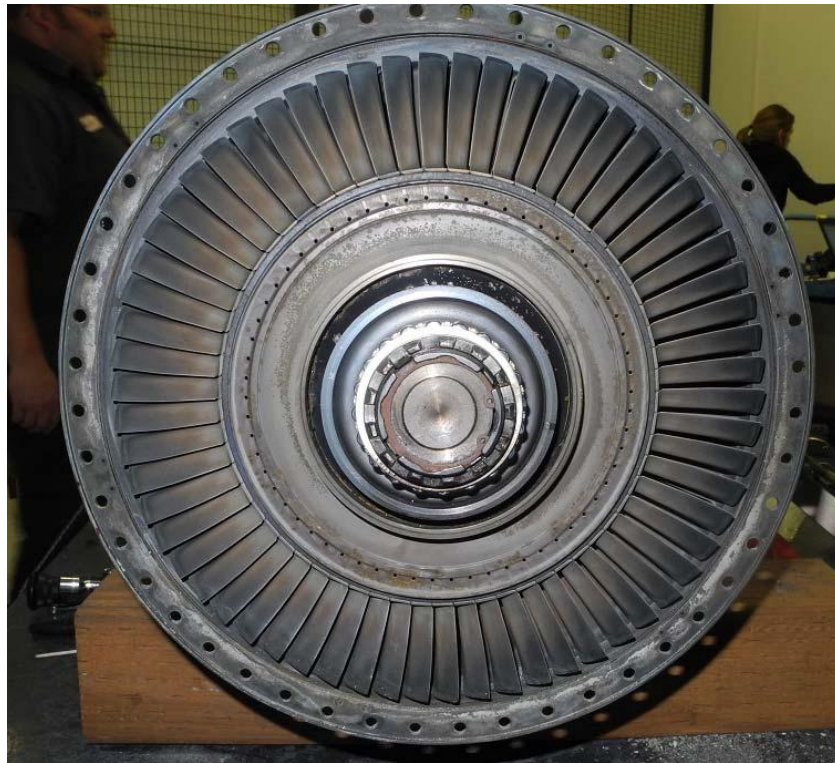
The second stage turbine case and third stage nozzle were removed from the core engine. The second stage turbine shroud showed no evidence of rubbing or blade contact marks. The second stage turbine blades exhibited no evidence of anomalous damage (**Figure 16**). Soot deposits were observed on the blades near the 6 o'clock position, but the remainder of the blades did not exhibit evidence of soot deposits. An orange-colored residue was observed near the 6 o'clock position of the labyrinth oil seal. The second stage turbine rotor was removed; two blades exhibited evidence of small curls at their tips, but no other anomalous damage was observed. All blades remained retained within the turbine wheel. The honeycomb static seal exhibited no anomalous damage.

Figure 16. The second stage turbine rotor from the No. 2 engine.

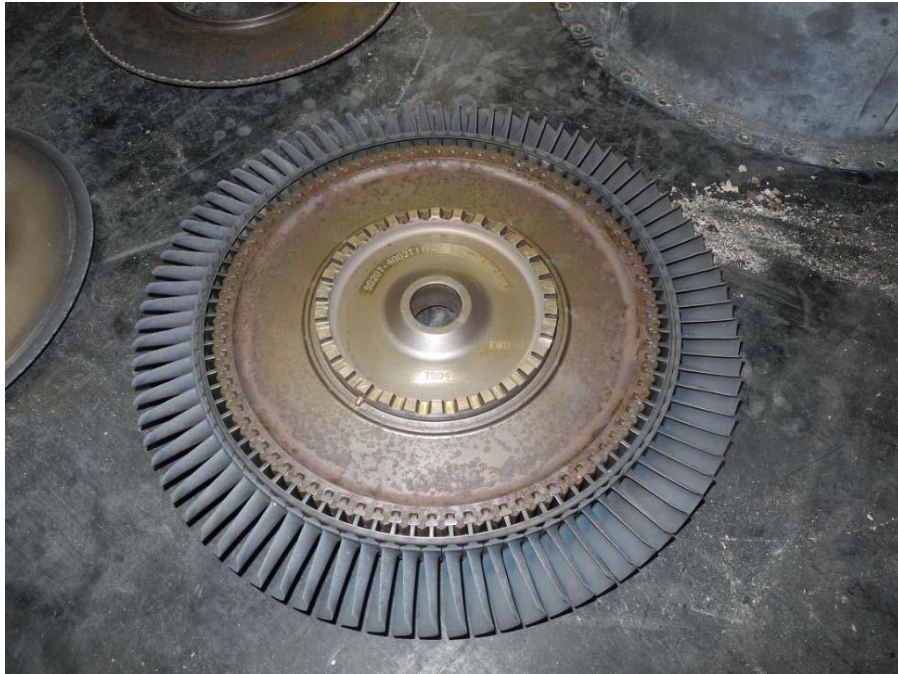
cracks were measured to be about 3/8 inch in length.⁷ The first stage turbine blades did not exhibit anomalous damage (**Figure 17**). Corrosion was observed on the first stage turbine wheel and its forward and aft cooling plates. The turbine forward shaft curvic coupling and the forward splines of the shaft exhibited no anomalous damage. The forward rotating labyrinth seal exhibited debris, overlaid on its surface, of a dull-gray color and crystallized appearance. On the surfaces of the forward stationary seal, which contacts the forward rotating labyrinth seal, debris of a jade-green color. The turbine shaft bolt shank exhibited corrosion. Additionally, the first stage turbine case exhibited corrosion on its internal walls. The first stage nozzle exhibited no anomalous damage. The turbine shaft bolt was removed and its threads exhibited no anomalous damage. The aft third of the length of the bolt exhibited corrosion.

Figure 17. The first stage turbine rotor from the No. 2 engine.

⁷ According to SEI-183, the rejection threshold for nozzle vanes is three cracks, no larger than 3/8 inch long, and with no danger to material breaking away.

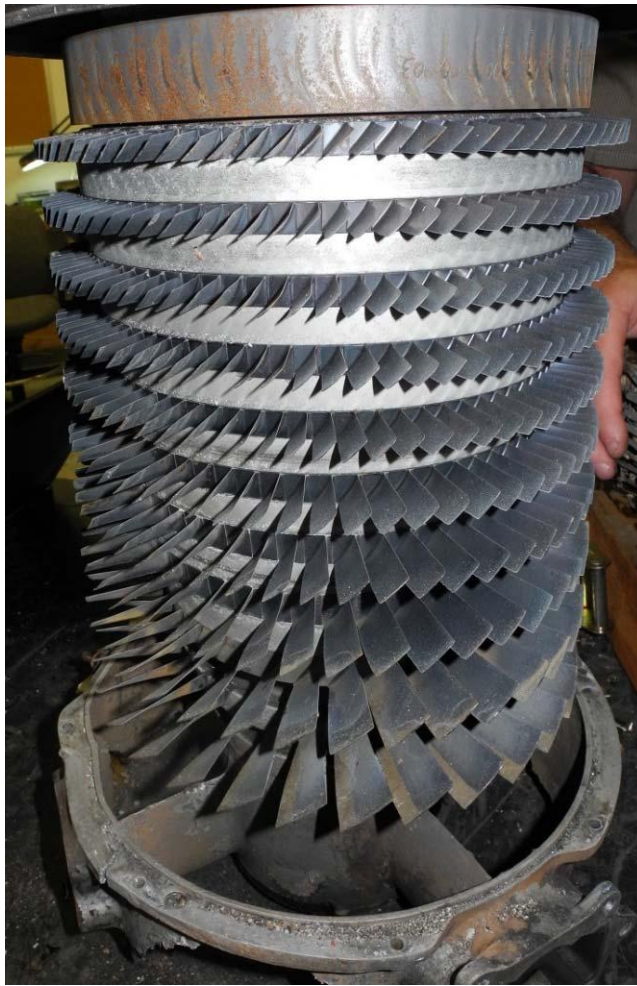
Separation of the compressor case halves revealed all 10 stages of the compressor rotors (**Figure 18**). Slight bending deformation in the direction opposite of normal rotation was observed on several compressor blades from various stages. Corrosion was observed on the vanes of the IGV and all three stages of the VGVs (**Figure 19**). The spool face for the third stage VGV, between compressor stages 3 and 4, exhibited evidence of rubbing; corresponding rub marks were observed on 7 of the vanes on the third stage VGV. The rubbing on the spool face was of negligible depth and could not be measured with calipers. Additionally, the spool face between compressor stages 5 and 6 exhibited evidence of rubbing of negligible depth. The remaining 6 stages of stators did not exhibit anomalous damage.

Figure 18. Compressor rotors from the No. 2 engine.

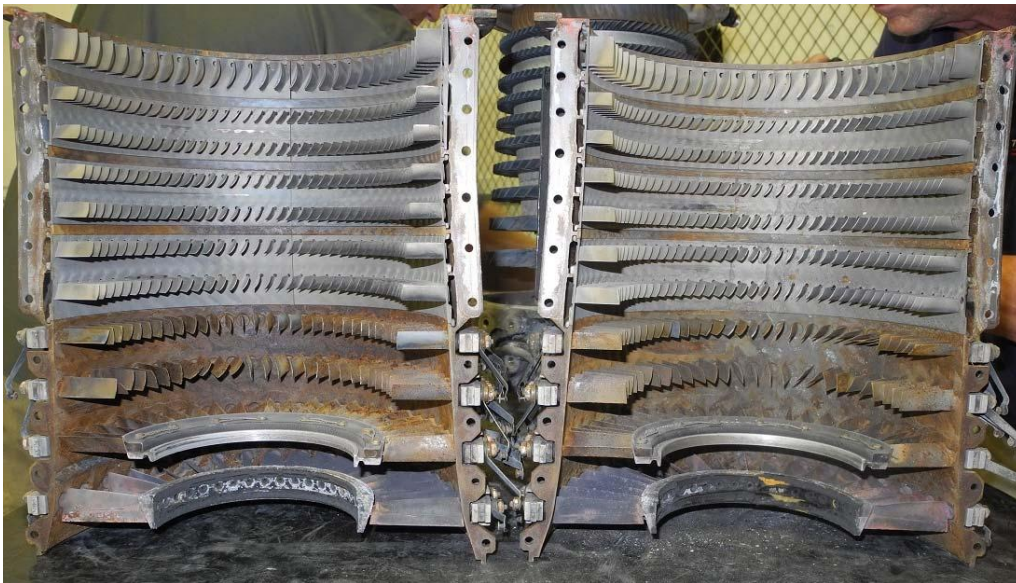
Figure 19. Compressor case halves from the No. 2 engine.

On the bottom compressor case, there was evidence of rubbing between all stages of the stators, VGV, and IGV. The depth of the rub marks between stages 3 and 4 of the VGV was measured, using calipers, to be about 0.003 inches. On the bottom compressor case, rubbing was

observed between the 6 o'clock to 7 o'clock position for the first 8 stages of compressor rotors; rubbing was observed between the 6 o'clock to 9 o'clock position for the 9th stage compressor rotor.

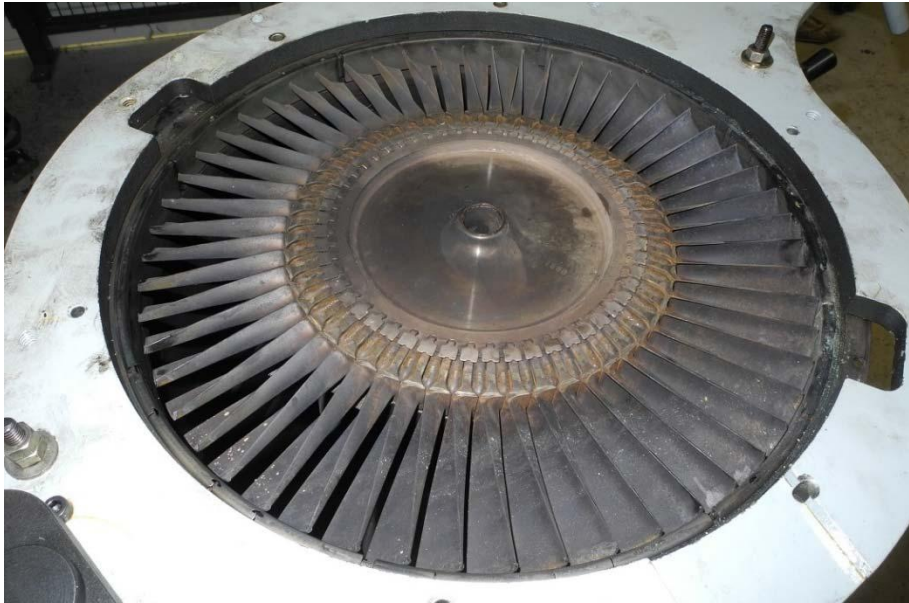
The torque tube was removed from the exhaust case, revealing the high speed shaft which remained attached to the power turbine flange via flexible disc coupling. The flexible disc coupling did not exhibit evidence of splaying or opening of the coupling laminates. All power turbine blades were present (Figure 20). At the leading edge tip ends of the power turbine blades exhibited impact damage with material curled both in the direction of normal rotation and opposite the direction of normal rotation (Figure 21). Power turbine accessory drive was manually rotated and continuity of drive was visually confirmed. The power turbine accessory drive's square-shaped driver did not exhibit anomalous damage and its shear point remained intact. The oil supply tube to the power turbine bearings exhibited slight bending deformation.

Figure 20. The power turbine rotor from the No. 2 engine.

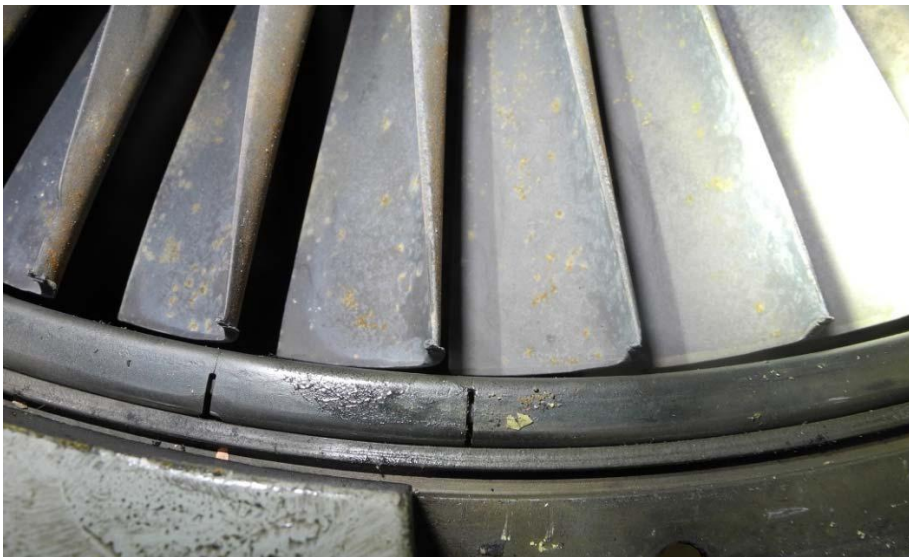
Figure 21. Damage observed on the leading edge tip ends of the power turbine blades from the No. 2 engine.

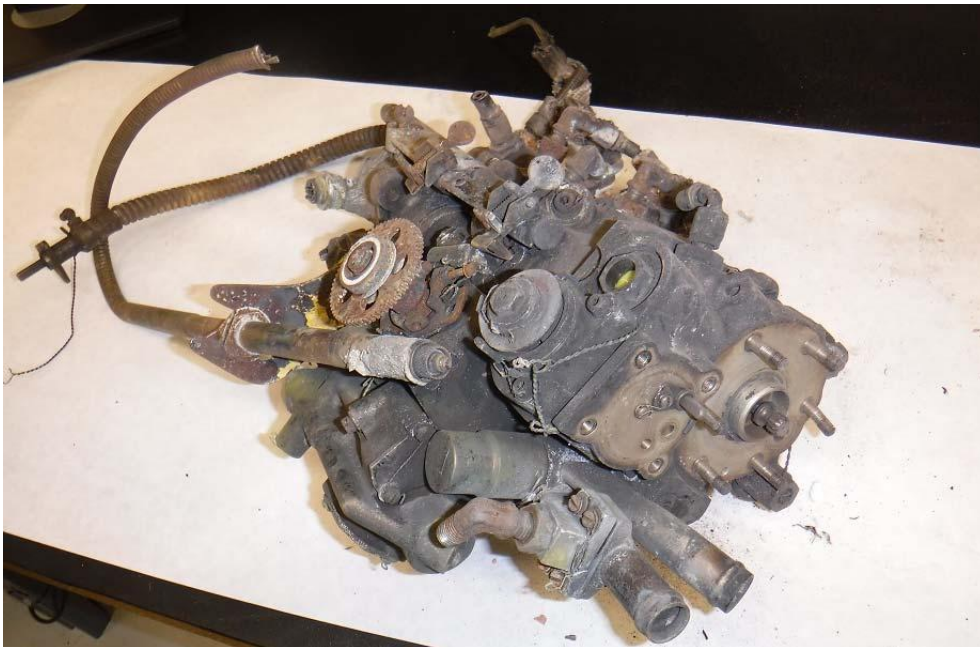
Soot was present on the exterior of the fuel control housing (**Figure 22**). There was no evidence of cracks, fractures, or melting of the housing. The retaining clip for the pressure relief valve (PRV) housing was fractured at one of its ends, but lockwire remained attached to the fractured retaining clip end. Lockwire was present on the bolts securing the PRV housing to the fuel control. The fuel density adjustment dial tab was bent upward and the tab was offset from the dial hard stop by about 40 degrees. The PRV dial was at the JP-5 setting.

Figure 22. The No. 1 fuel control prior to disassembly.

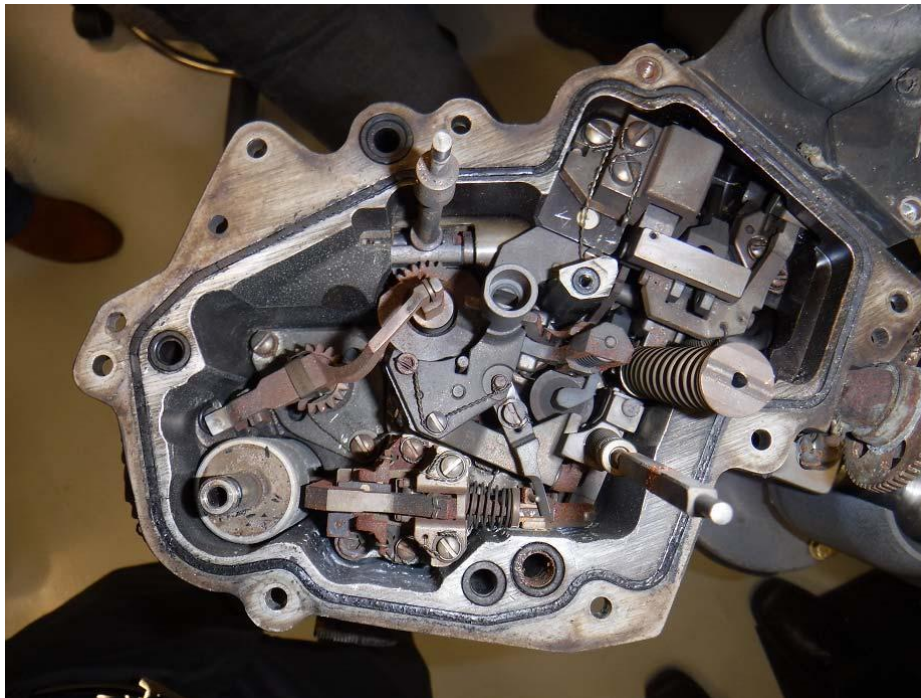
The cover of the fuel control was removed, revealing the internal components of the fuel control (**Figure 23**). Generally, corrosion was visible throughout the surfaces of the internal components, but the visible components did not exhibit fractures or disconnection. All components exhibited freedom of movement except for the three-dimensional (3D) cam and the Ng governor gear. According to the disassembly technician, the internal configuration and condition of the fuel control appeared typical aside from the corrosion and thermal damage. The 3D cam was approximately at the ground idle position. The rack gear which rotates the 3D cam was found to be positioned to the end of the rack gear consistent with elevated temperatures.¹¹ The compressor discharge pressure (P3) bellows was vacuum tested and successfully held a vacuum for 1 minute.

Figure 23. The internal components of the No. 1 fuel control after removal of the cover.

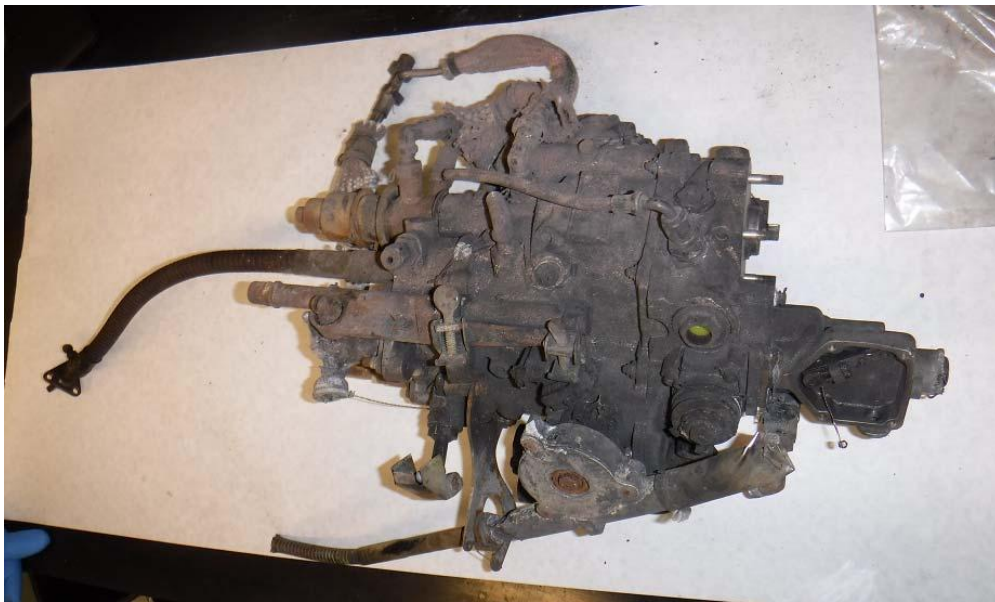
Soot was present on the exterior of the fuel control housing (**Figure 24**). There was no evidence of cracks, fractures, or melting of the housing, but several of the external bosses exhibited small dents. The retaining clip for the PRV housing was intact and lockwire was present on the bolts securing the PRV housing to the fuel control. The fuel density adjustment dial tab was not bent and the tab was offset from the dial hard stop by about 40-45 degrees. The PRV dial was at the JP-5 setting.

Figure 24. The No. 2 fuel control prior to disassembly.

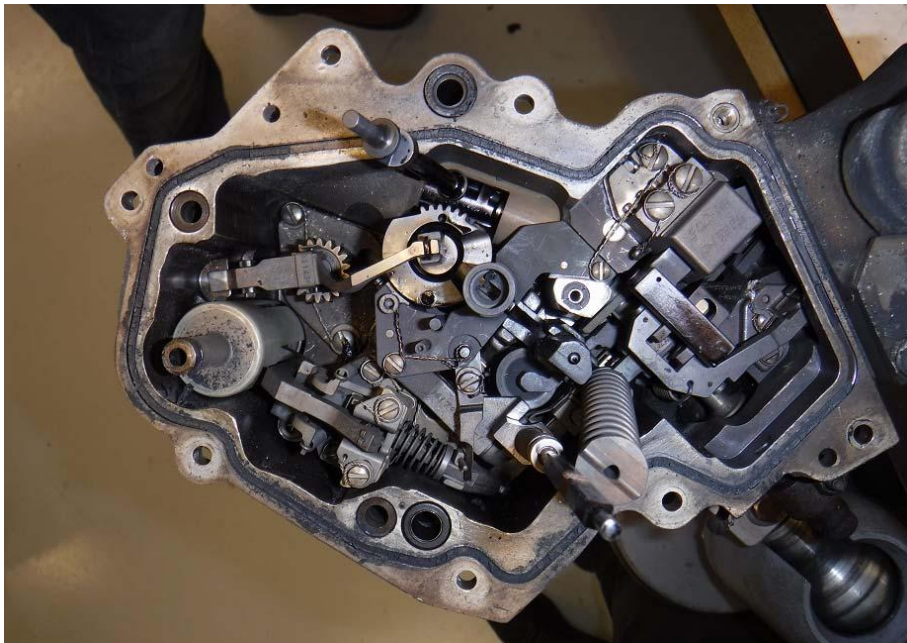
The cover of the fuel control was removed, revealing the internal components of the fuel control (**Figure 25**). Generally, the surface condition of the internal components did not exhibit corrosion to the extent observed on the No. 1 fuel control. The internal components did not exhibit fractures or disconnection. All components exhibited freedom of movement. According to the disassembly technician, the internal configuration and condition of the fuel control appeared typical to those seen at overhaul. The 3D cam was at a relatively higher axial position compared to the 3D cam of the No. 1 fuel control.¹² The 3D cam was also positioned about mid-travel on its rack gear. The P3 bellows was vacuum tested and successfully held a vacuum for 1 minute.

Figure 25. The internal components of the No. 2 fuel control after removal of the cover.

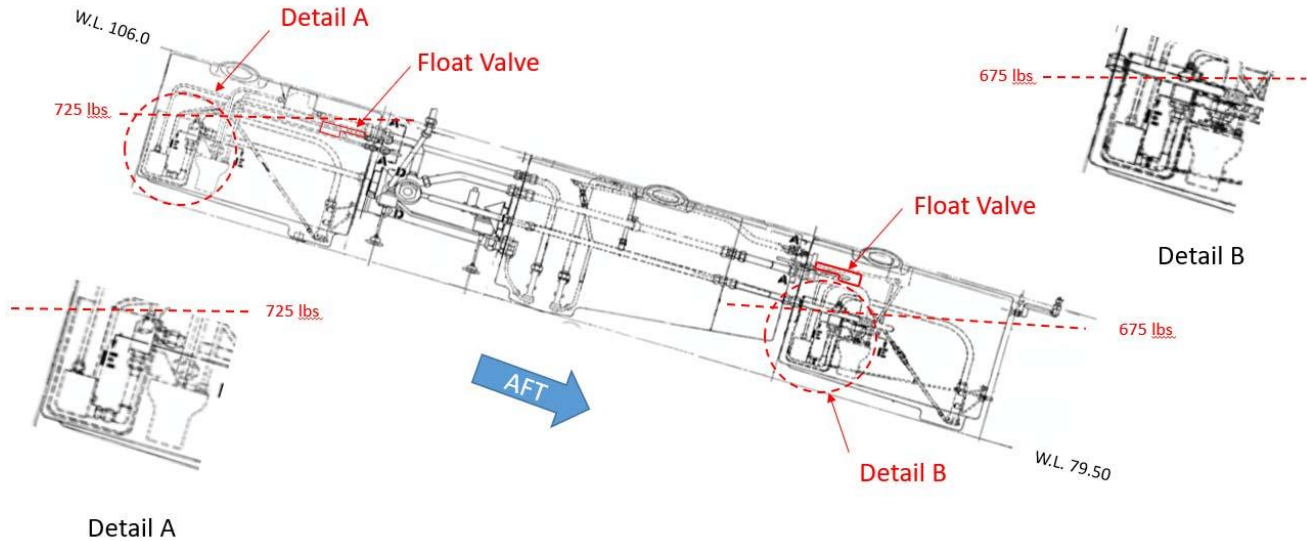
during the accident flight¹⁴ and assuming a scenario where no fuel was transferred from the center tank to the forward and aft tanks to produce the lowest estimated fuel levels, fuel quantities of 725 pounds and 675 pounds were estimated to be in the forward and aft tanks, respectively, at the time of the accident. With the helicopter at a 15 degree positive pitch (nose-up) attitude, the fuel level within the forward and aft tanks was estimated to partially cover the top-aft edge of the collector can (Figure 26).

Figure 26. Estimated fuel level within the forward and aft tanks with a 15 degree positive pitch attitude.
