NATIONAL TRANSPORTATION SAFETY BOARD
Office of Aviation Safety
Washington, D.C. 20594

AIRWORTHINESS GROUP CHAIRMAN'S FACTUAL REPORT

NTSB No: CEN19FA072

Operator: Viking Aviation, Inc.
Aircraft: Bell 407, Registration N191SF
Location: Zaleski, Ohio
Date: January 29, 2019
Time: 0650 eastern standard time

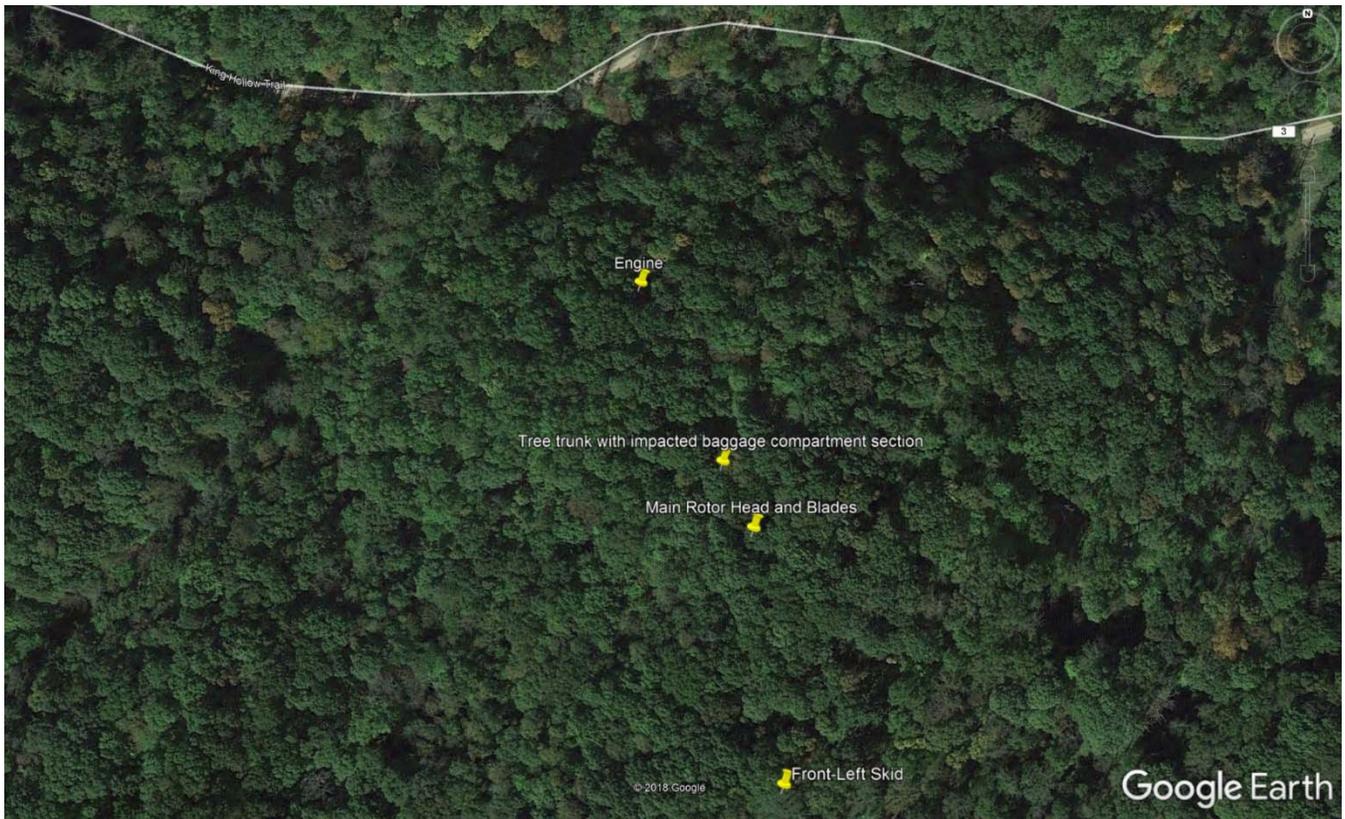
The wreckage and debris path extended horizontally about 600 feet downslope on a heading of 345° magnetic (**Figure 1**). A portion of the front-left skid tube was found at the start of the wreckage path, followed by the main rotor hub and blades, tail boom and tail rotor, cockpit and cabin (main fuselage), and the engine and transmission deck (**Figure 2**). Broken tree branches, about 30 ft agl, were observed near the front-left skid tube. The elevation of the wreckage area ranged from 850 to 980 feet above msl. There was no evidence of a postcrash fire, but a strong smell of fuel was reported by first responders when the wreckage was first discovered.

Figure 1. Overview of the wreckage debris distribution.

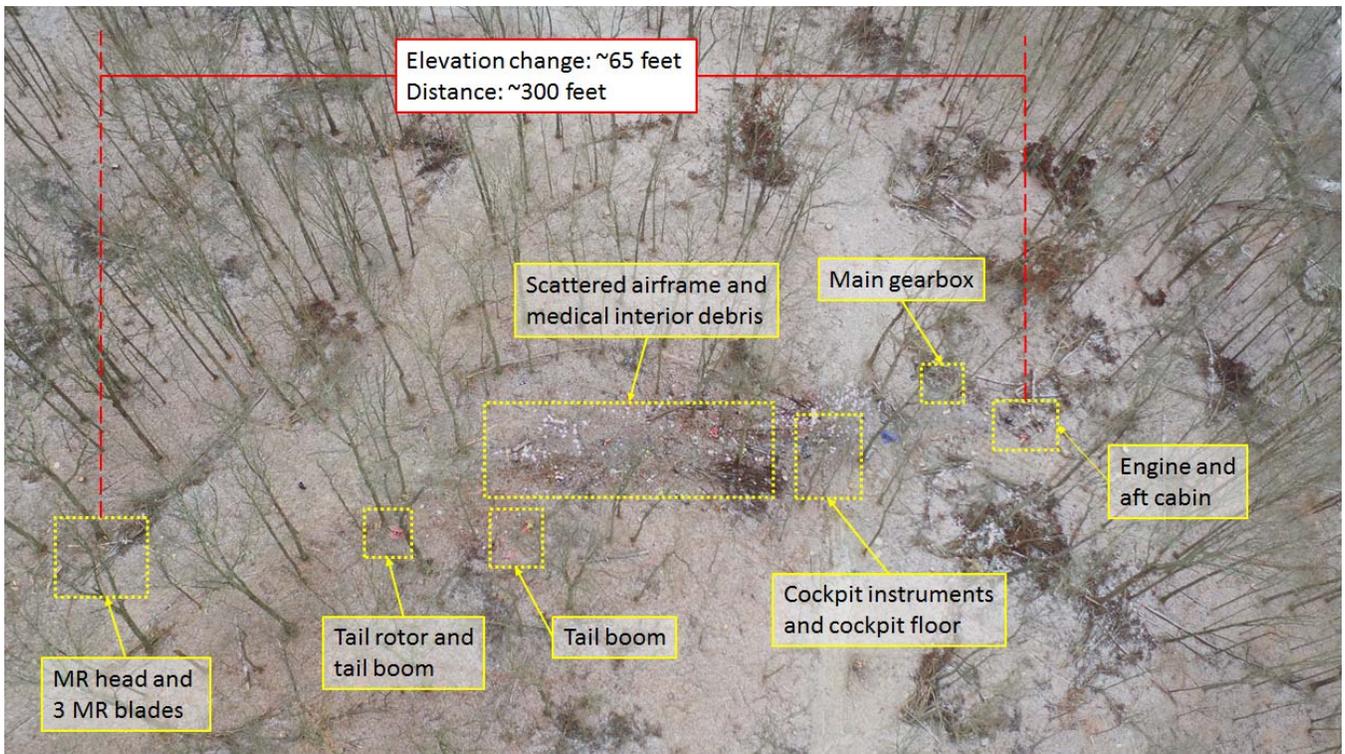
Figure 2. Detailed wreckage debris distribution from the main rotor head and main rotor blades to the engine and aft cabin. (photo courtesy of Ohio State Highway Patrol, edited by NTSB)

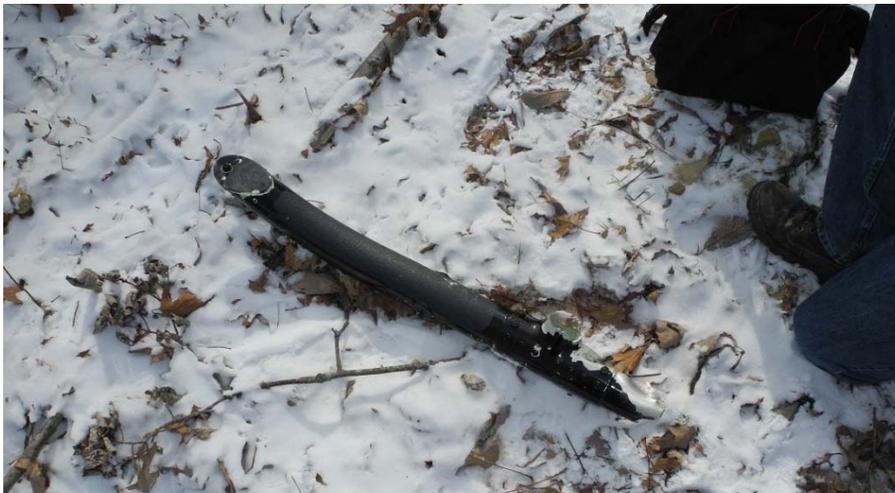
The airframe exhibited significant fragmentation. The remnant skid pieces were separated from the main fuselage and found in the debris trail. The left-front skid tube was found at the start of the wreckage path (**Figure 3**). Both forward and aft skid cross tubes were found separate from each other.

Figure 3. The left-front skid tube.

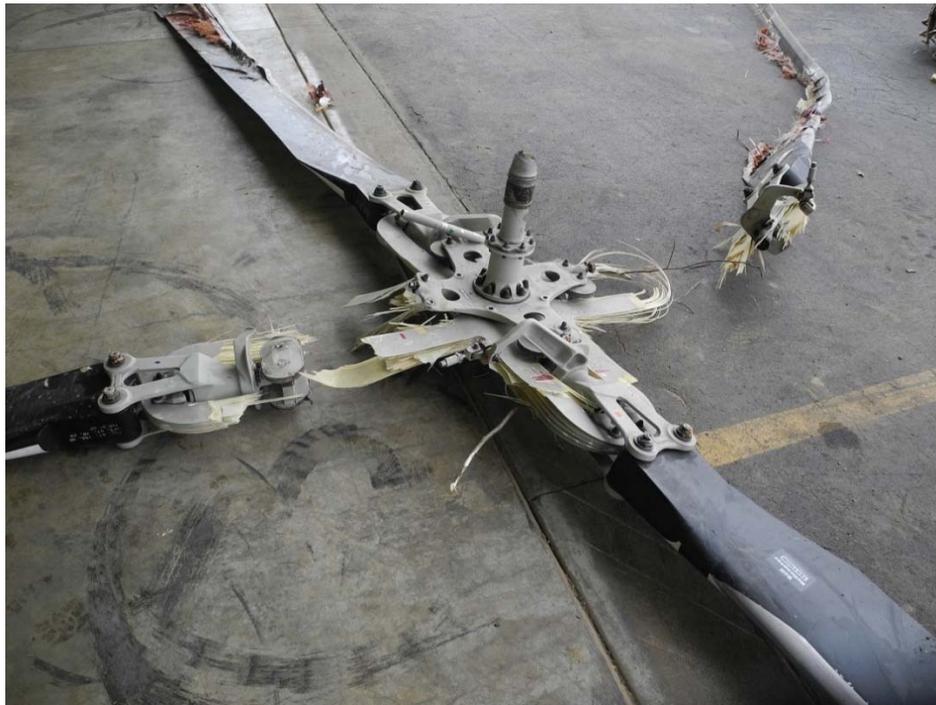
The main rotor hub was found downhill of the left-front skid piece. The main rotor hub contained the yoke, the upper and lower plates, and a portion of the main rotor shaft (**Figure 4**). The 'orange', 'green' and 'blue' main rotor blades, found adjacent to the main rotor hub, contained multiple fractures that exhibited a broomstrawed appearance. Major

portions of the blade afterbody was separated on the 'orange', 'green' and 'blue' main rotor blades. Pieces of main rotor blade skin and core material were found distributed in the debris field near the main rotor hub. The 'orange' and 'green' blades and pitch horns remained attached to their respective grips, which remained attached to the yoke via their elastomeric thrust bearing. The upper portion of the 'orange' PCL remained attached to its pitch horn. The 'green' PCL remained attached to its pitch horn. The 'green' PCL rod was present down to the threaded connection for the lower spherical bearing. The 'blue' blade and pitch horn remained attached to its grip, but the pitch horn was fractured at the horn arm. The 'blue' grip was separated from the yoke at the main rotor hub, but a remnant piece of the yoke was still attached to the grip via its elastomeric thrust bearing. The 'red' main rotor blade assembly was found within a tree near the main rotor hub. The 'red' blade and pitch horn remained attached to its grip. The 'red' grip was separated from the yoke at the main rotor hub, but a remnant piece of the yoke was still attached to the grip via its elastomeric thrust bearing. The upper portion of the 'red' PCL remained attached to its pitch horn. The 'red' main rotor blade contained multiple fractures that exhibited a broomstrawed appearance. Major portions of the blade afterbody was separated on the 'red' main rotor blade.

Figure 4. The recovered main rotor head and main rotor blades.

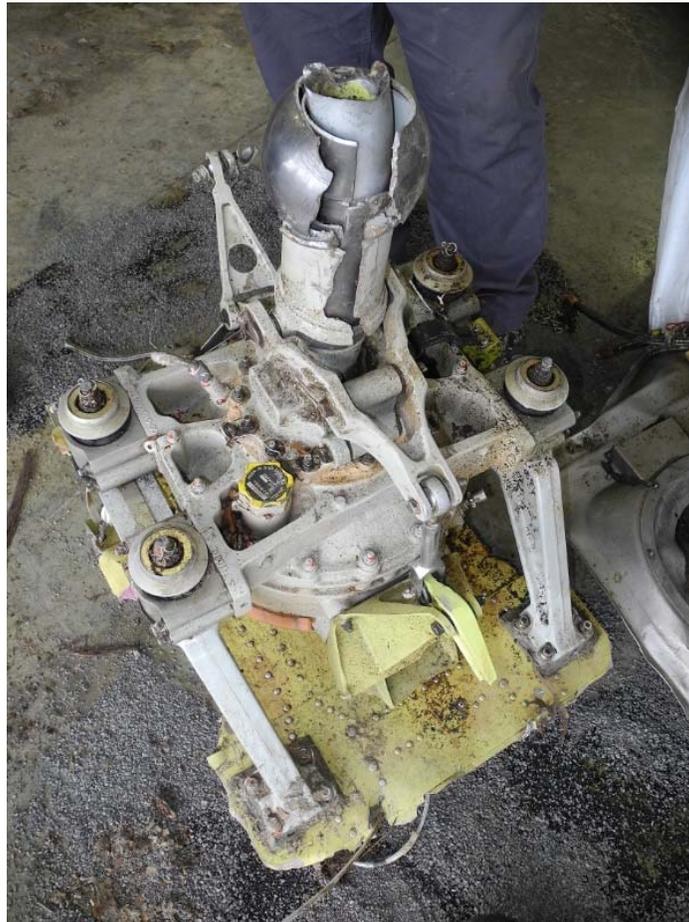
The main transmission pylons remained attached to the airframe and the main transmission remained attached to its pylons (**Figure 5**). The forward Kaflex coupling for the engine-to-transmission drive shaft remained attached to the input flange. The forward flange of the engine-to-transmission drive shaft remained attached to the forward Kaflex coupling but the remainder of the shaft was not found. The forward flange fracture surfaces exhibited signatures consistent with overload. The main rotor shaft remained installed within the main transmission but exhibited a fracture corresponding to the fracture observed on the main rotor head wreckage. The fracture surfaces exhibited signatures consistent with overload. Cracking of the main transmission housing was observed near the lower-right mount. The forward lower-left main transmission chip detector was slightly loose; removal of the chip detector showed no evidence of metallic chips. The main rotor shaft chip detector was not present. Manual rotation of the main transmission input flange resulted in a corresponding rotation of the main rotor shaft.

Figure 5. The recovered main transmission with pylons and airframe attached.

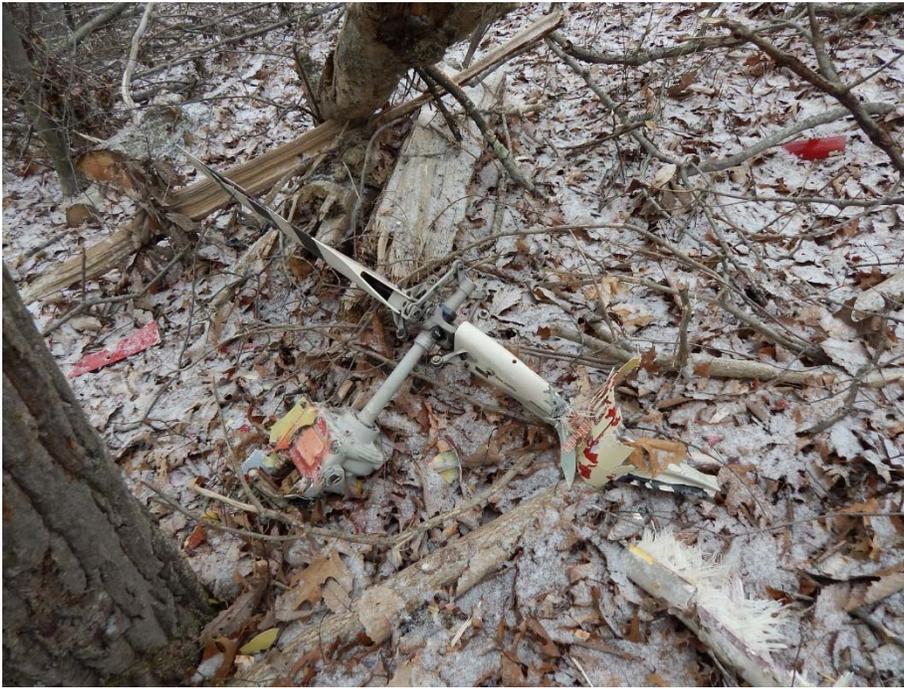
Both tail rotor blade roots remained attached to the tail rotor hub ([Figure 6](#)). One of the two tail rotor blades, identified in this report as the “unmarked” tail rotor blade, exhibited impact damage on its leading edge. About two-thirds of the outboard section of the unmarked tail rotor blade was separated. A fractured section of the unmarked tail rotor blade leading edge was found next to the tail rotor and exhibited a broomstrawed appearance; the afterbody was not present on the fractured section. The second tail rotor blade, which had a green-colored sticker at the blade root and on its PCL, was whole and exhibited opening of its trailing edge near its outboard end. The flap stop for the unmarked tail rotor blade was fractured and separated. The flap stop for the ‘green’ tail rotor blade was deformed but still attached.

Figure 6. The tail rotor and tail rotor gearbox at the accident site. (photo courtesy of Ohio State Highway Patrol)

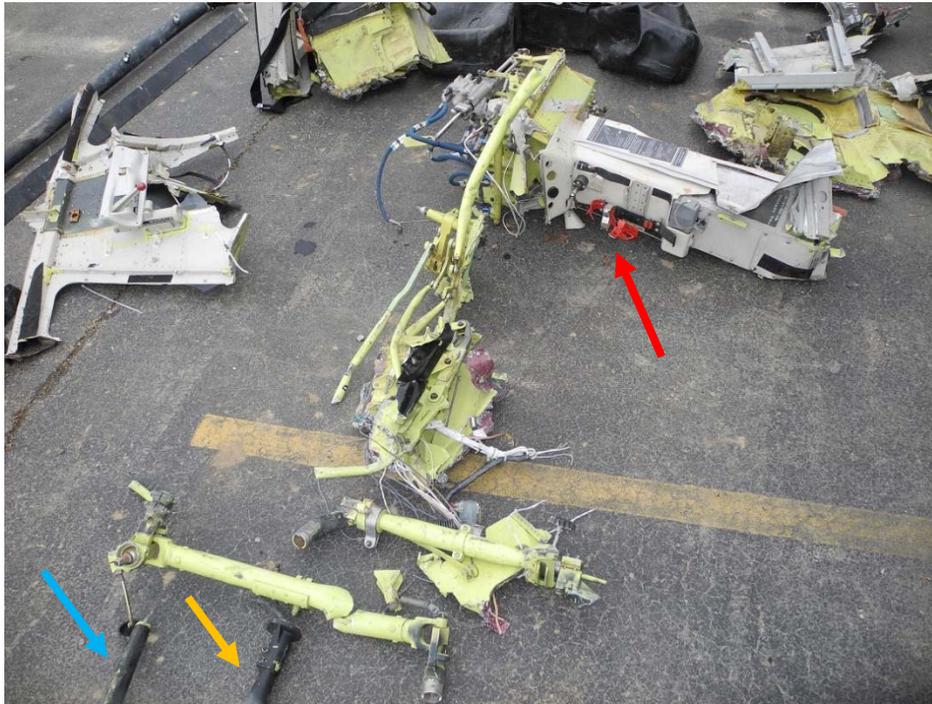
Continuity of the push-pull tubes was established from the hydraulic actuator inputs through the broom closet⁶ but were fractured at their lower rod ends normally connected to the mixing unit (**Figure 7**). The three main rotor hydraulic actuators remained installed in a separated section of airframe. All input linkages remained installed to all three main rotor hydraulic actuators. The airframe mount to the piston of the left hydraulic actuator was fractured but the mounts for the right and center hydraulic actuators were whole. The aft mounts for the hydraulic actuators remained attached to the support assembly. The data plate for the right main rotor hydraulic actuator was not present.⁷ The data plate for the left and collective main rotor hydraulic actuators were present and showed S/N HR012 and HR011, respectively.

Figure 7. The recovered flight controls. The red arrow points to the broom closet structure with the main rotor hydraulic actuators to the left of it. The blue and orange arrows point to the cyclic and collective, respectively.

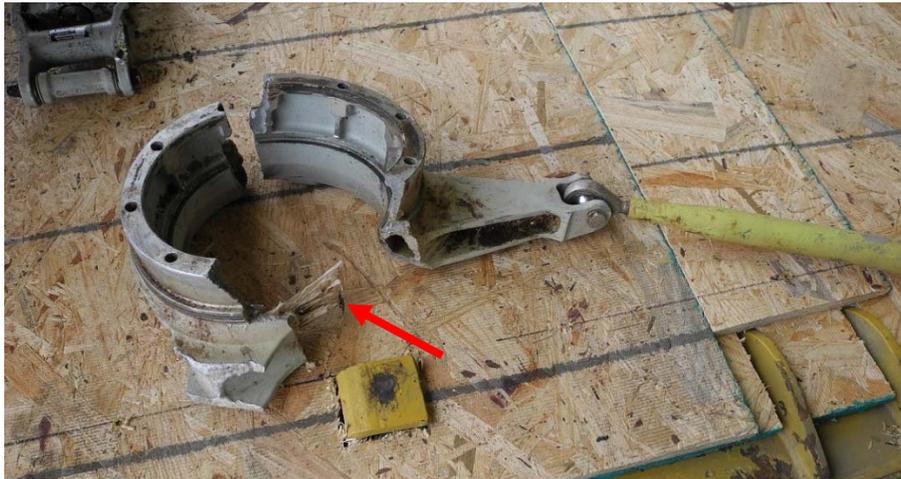
The stationary swashplate was fractured and two large pieces of stationary swashplate were recovered (**Figure 8**). One piece contained the left control arm with a fractured portion of a control tube rod end connected to it. The second piece contained a portion of the right control arm but the outer portion of the arm was fractured, with pieces of wood embedded in the right control arm.

Figure 8. The two pieces of the stationary swashplate. The red arrow points to embedded wood on the right control arm.

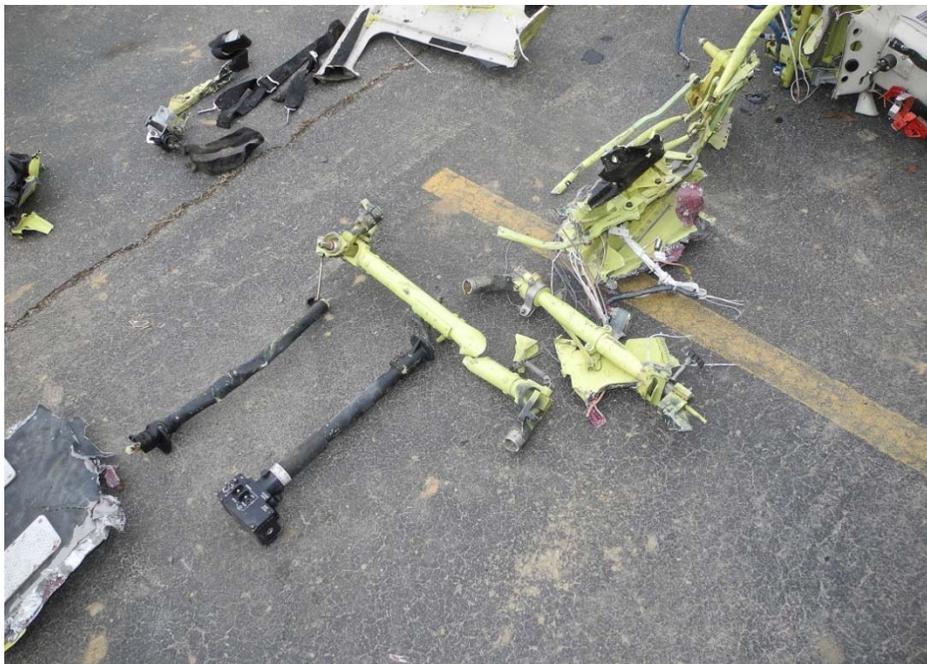
The cyclic and collective controls were recovered separated from their mounts (**Figure 9**). The pilot collective control-mounted engine twist grip control was found between “FLY” and “95” (**Figure 10**). The pilot cyclic mount was found installed on the cyclic jackshaft and its friction knob remained installed. The friction knob mount exhibited a gap. The cyclic jackshaft was fractured in two pieces, with each piece containing the left and right cyclic mounts. The pilot collective mount remained installed on the collective jackshaft. The left collective mount was fractured and separated.

Figure 9. The recovered cyclic, collective, and their respective jackshafts.

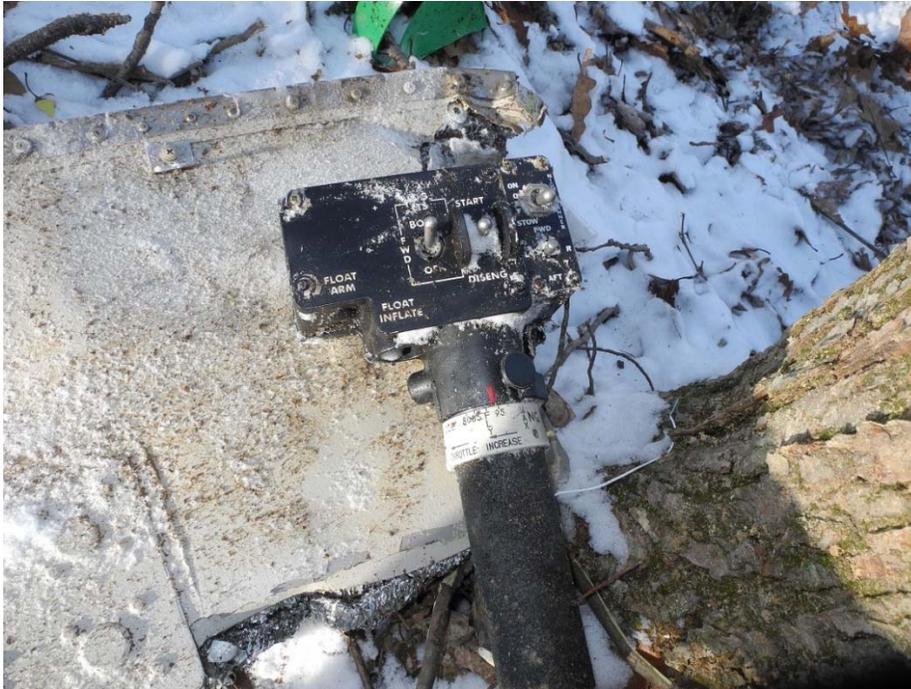
Figure 10. The pilot collective control-mounted engine twist grip control.

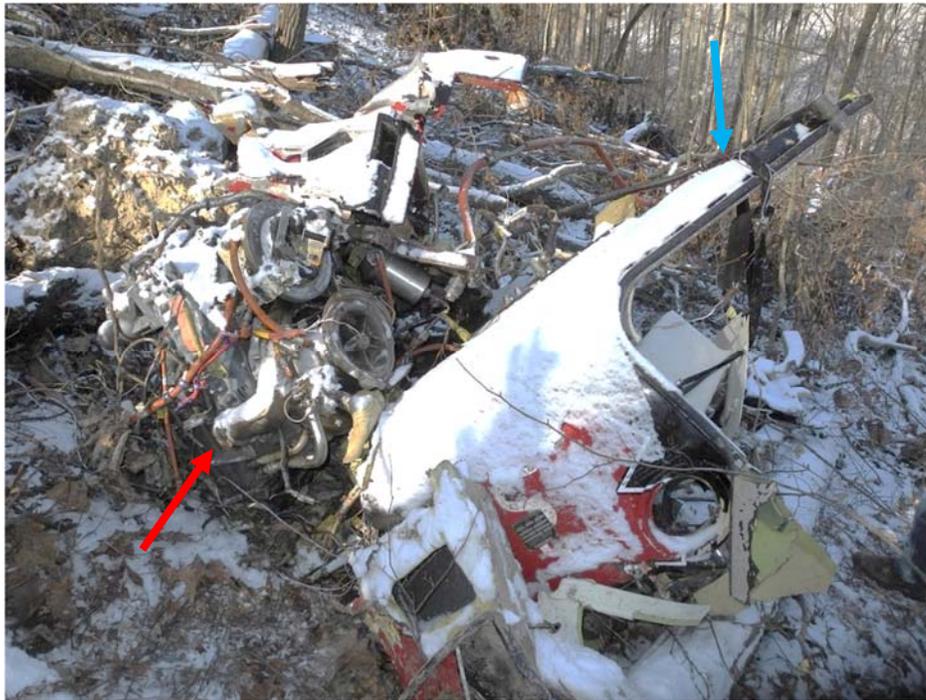
The engine was found resting inverted on the aft cabin structure (**Figure 11**). The left, right, and bottom engine mounts remained attached to the engine but its linkages to the airframe were fractured. Several of the first stage compressor blades exhibited leading edge tip curls. The deformation was consistent with soft body foreign object debris (FOD) ingestion.¹¹ The outer combustion case and the compressor discharge tubes were separated from the engine and found about 20 feet downhill of the engine. The exhaust remained attached to the engine but exhibited crushing deformation. The engine accessory gearbox remained attached to the engine. The engine accessories remained attached to the accessory gearbox. The inlet guide vanes remained attached and did not exhibit deformation. When the compressor was rotated by hand, the starter generator also rotated, confirming continuity of the gas producer turbine-to-compressor (N1) drivetrain. Rotation of the power output shaft resulted in rotation of the power turbines, confirming continuity of the power turbine-to-pinion gear (N2) drivetrain. There was no evidence of binding on either the N1 or the N2 drivetrain. The upper and lower magnetic chip detectors were removed and exhibited no ferrous debris. Residual oil from the engine exhibited a clean appearance with a bright tan coloration. The ECU was found in the wreckage debris path and was retained for data extraction. (See section 3.0 of this report.)

Figure 11. The engine (red arrow) and aft cabin (blue arrow) at the accident site.

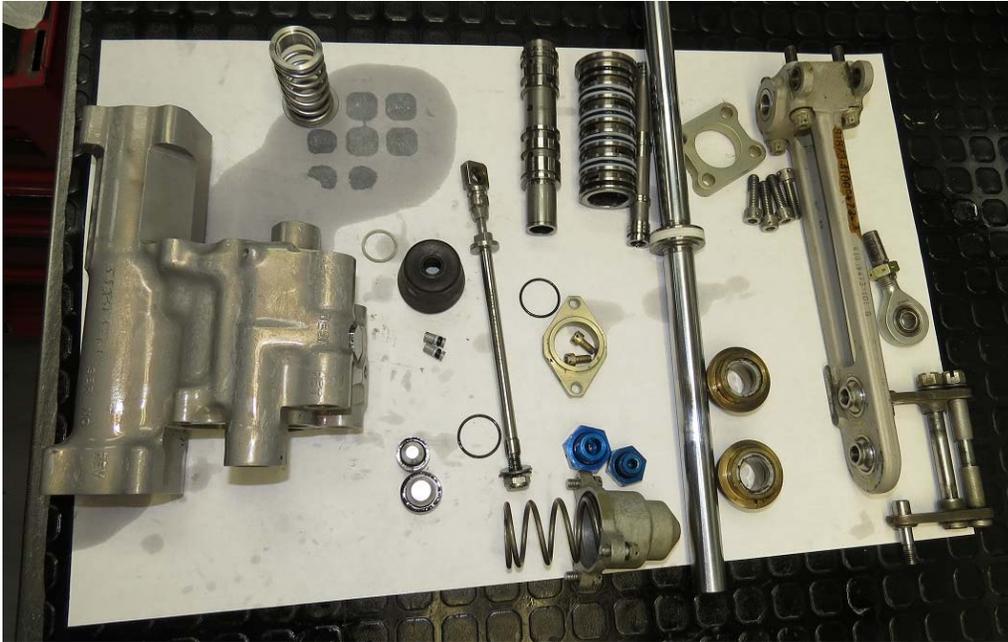
The input lever was removed and did not exhibit anomalous damage. The piston rod end (still containing its spherical bearing), jam nut, and locking key were removed. The rod end threads exhibited no anomalous damage. The housing output end and end cap were removed to facilitate removal of the piston. Residual hydraulic fluid exited the housing as the piston was removed. The piston's external surfaces were shiny in appearance with a visible crosshatch pattern¹⁸ on its surface except in certain areas containing typical service wear. The piston seal was present and intact. The dynamic seals and scraper seals were intact on the end glands. Debris was visible only on the exterior side of the scraper seal. The o-ring and backup ring on the end glands were intact. The cylinder bore had no anomalous damage and exhibited a clean appearance.

The MCV cover and spring were removed, revealing the MCV. There was no residual hydraulic fluid within the MCV cover. The servo spool was removed from the MCV. The lands on the servo spool and bypass spool exhibited no evidence of anomalous damage and their o-rings were intact. The o-ring and backup rings on the sleeve were intact. The sleeve and its bore exhibited no anomalous damage.

The sequence valve and back-to-back check valve were removed and their components, including their respective o-rings and backup rings, exhibited no anomalous damage. The filter (screen) on the pressure port exhibited no evidence of blockage or debris. The differential relief valve was removed and the valve components, including o-rings, did not exhibit anomalous damage. Debris, with the appearance of wood, was embedded within the threads on the outside of the differential relief valve cap. The inlet

Figure 12. The completed disassembly of the right main rotor hydraulic actuator. (photo courtesy of Woodward)

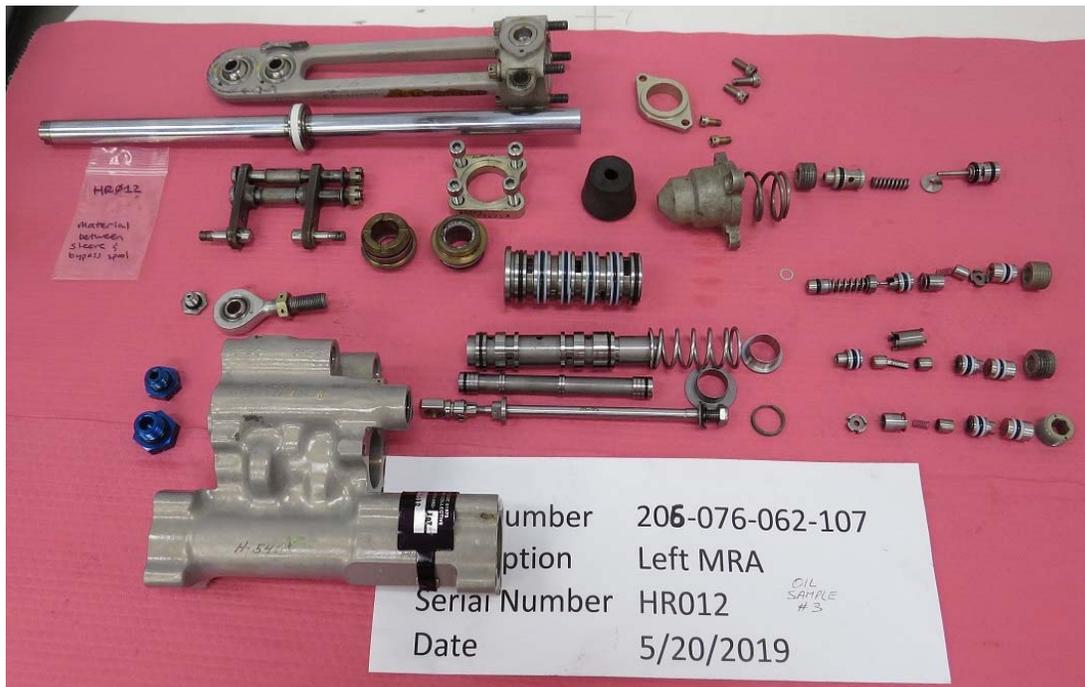
During the manual operation test (Paragraph 40.3), the actuator moved in the extend direction at 60 pounds, above the maximum allowable of 26 pounds. During the sequence valve leakage test (Paragraph 40.13), the pressure port leaked about 4.4 cc per minute; no more than two drops are allowed at the pressure port. There was no evidence of leakage from the return port during this test. During the thermal relief valve test (Paragraph 40.15),

the cracking pressure was about 240 pounds per square inch (psi); the allowable cracking pressure was 125 to 200 psi. During the servovalve check (Paragraph 40.5), the bypass stroke in the retract direction was 0.010 inches, below the minimum of 0.011 inches. The actuator met the requirements for the remaining tests within Paragraph 40 of the AT&IP. At the conclusion of the AT&IP, the manual operation test (Paragraph 40.3) was performed again to determine if the manual operation forces would change after the dynamic leakage test was performed; there was no change from the initial results of the manual operation test.

The MCV cover and spring were removed; no hydraulic fluid was visible within the cover. An orange-colored material, similar in appearance to torque stripe material, was seen on the exterior end face between the sleeve and the bypass spool, on the input-lever side of the sleeve. The pilot input and shaft assembly were removed and exhibited no anomalous damage. The o-rings and backup rings on the sleeve had no anomalous damage. The sleeve and its bore exhibited no anomalous damage. The servo and bypass spools were removed from the sleeve, neither of which exhibited anomalous damage. The o-rings on the servo and bypass spools were intact.

Figure 14. The completed disassembly of the left main rotor hydraulic actuator. (photo courtesy of Woodward)

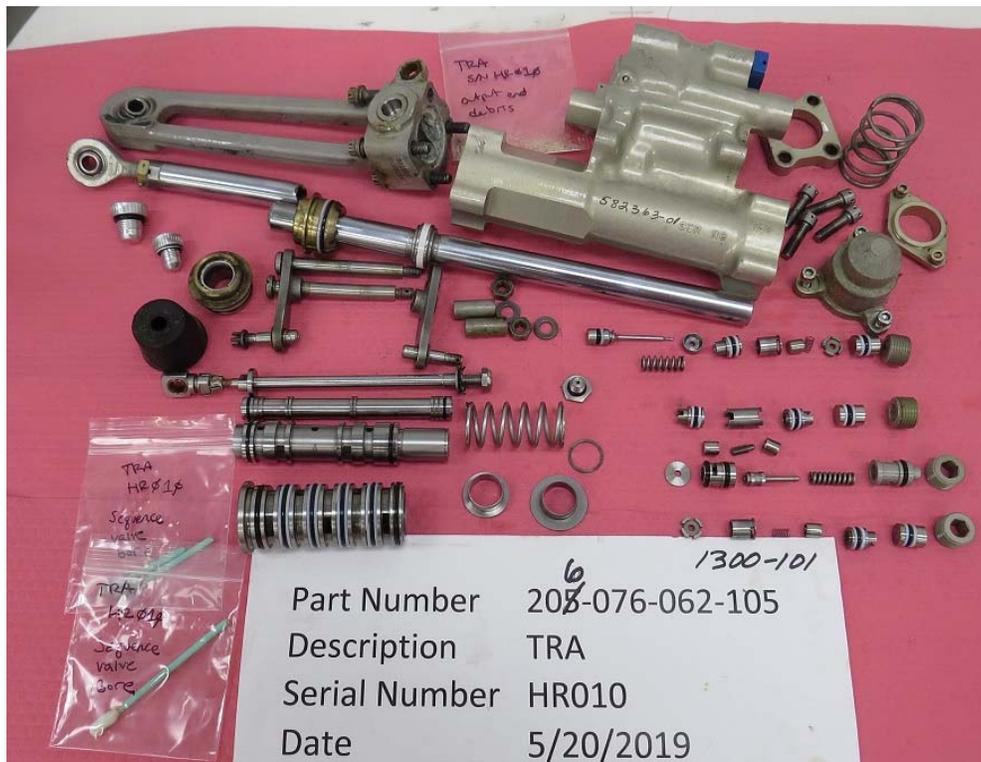
The input lever was removed via tapping the screws using a hammer. The input links exhibited bending deformation. The output end was removed, revealing a white-colored powder consistent with aluminum oxide (corrosion byproduct) at the piston

interface. The end cap was removed, revealing a brownish-colored residue on the exterior surface of the end gland. The piston rod end (containing its spherical bearing) remained installed with the piston and exhibited a slight bend at its threaded connection. The jam nut, locking key, and cotter pin remained installed. The remainder of the piston within the actuator was removed. The end gland on the rod end side of the piston could not be removed due to the fractured piston. The fracture surfaces of the piston exhibited signatures of overload. The end gland on the output side was removed from the piston. Both end glands exhibited evidence of corrosion on their external surfaces but their o-rings and backup rings were intact. The dynamic seal of the output-side end gland showed no anomalous damage. The piston seal was present and intact. The external surfaces of the piston exhibited a shiny appearance with a visible crosshatch pattern on its surface except in certain areas containing typical service wear. Residual hydraulic fluid was collected during removal of the piston and exhibited a bright red coloration. The piston bore exhibited no anomalous damage.

The MCV cover and spring were removed; no hydraulic fluid was visible within the cover. Torque stripe material was found on the surface between the sleeve and the bypass spool, on the input lever side of the sleeve. The o-rings and backup rings on the sleeve were intact. The sleeve and its bore exhibited no anomalous damage. The servo spool and bypass spool were removed from the sleeve. The servo spool lands and the bypass spool exhibited no anomalous damage. The o-rings on both the servo spool and bypass spool were intact.

The sequence valve was removed but its plunger and seat were stuck within the valve bore. The plunger and seat were removed using pliers; the tip of the plunger was damaged during removal but the remainder of the plunger and the seat had no anomalous damage. After removal of the valve, a small piece of black material and residual hydraulic fluid were found in the sequence valve bore and collected using a q-tip. The remainder of the sequence valve components had no anomalous damage. The back-to-back check valve retaining plug remained installed but was not tight when removed from the actuator housing. The back-to-back check valve components, including its o-rings, did not exhibit anomalous damage. The plug for the differential relief valve remained installed but was not tight when removed from the actuator housing. The differential relief valve was removed and its components, including its o-rings, exhibited no anomalous damage. The inlet check valve retaining plug remained installed but was not tight when removed from the actuator housing. The inlet check valve was removed and the poppet cage exhibited radial chatter marks on its end face that mates to the spring retainer. The remaining components from the inlet check valve, including its o-rings and backup rings, did not exhibit anomalous damage. The filter on the pressure port showed no evidence of blockage and was clear of debris.

Figure 15. The completed disassembly of the tail rotor hydraulic actuator. (photo courtesy of Woodward)
