# **NATIONAL TRANSPORTATION SAFETY BOARD**

## **AIRWORTHINESS GROUP CHAIRMAN FACTUAL REPORT**

**ACCIDENT:** CEN10FA443

**AIRCRAFT:** Hawker Beechcraft Model 390, N6JR

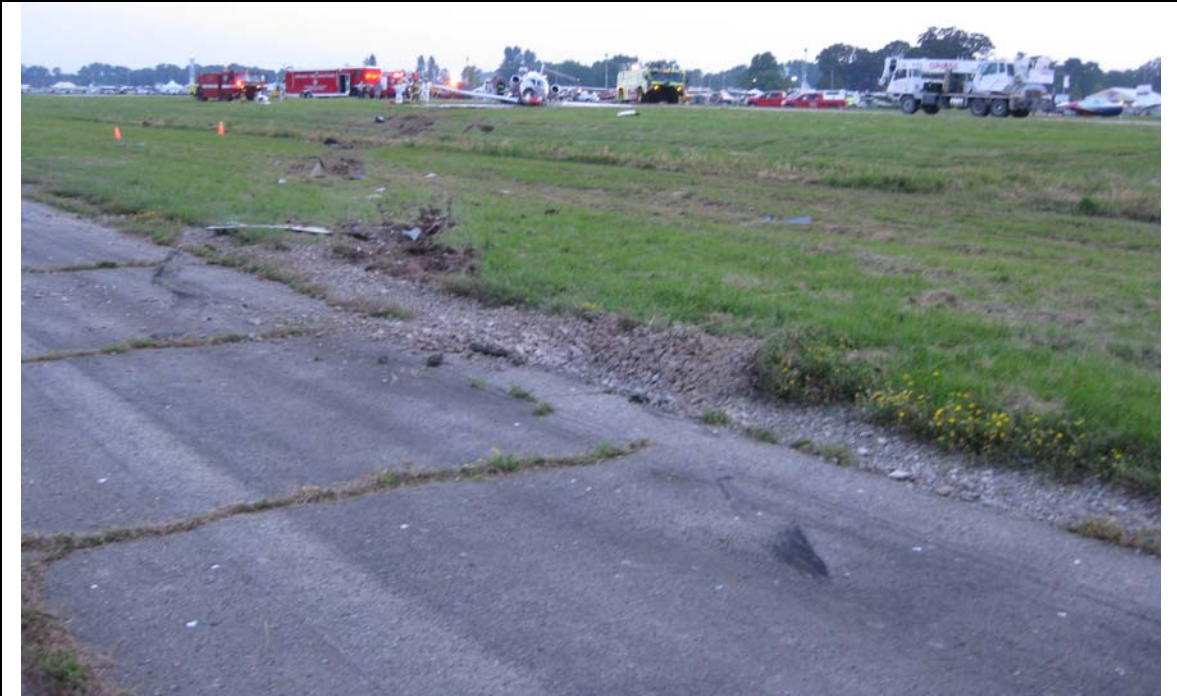
A fragment of carbon fiber from the right wing tip was the first fragment of airplane and was found in the first ground contact mark. (See Figure 1) This contact point was located two to three feet from the west edge of a closed runway 18/36 and at the beginning of ground scars leading through the grass toward the resting airplane. The closed parallel runway (18/36) is to the west of the main north/south runway.

Figure 1. View toward the airplane from left and right main landing gear tire marks. The first point of ground contact by the wingtip was at the right edge of the photo and is not visible in this view.

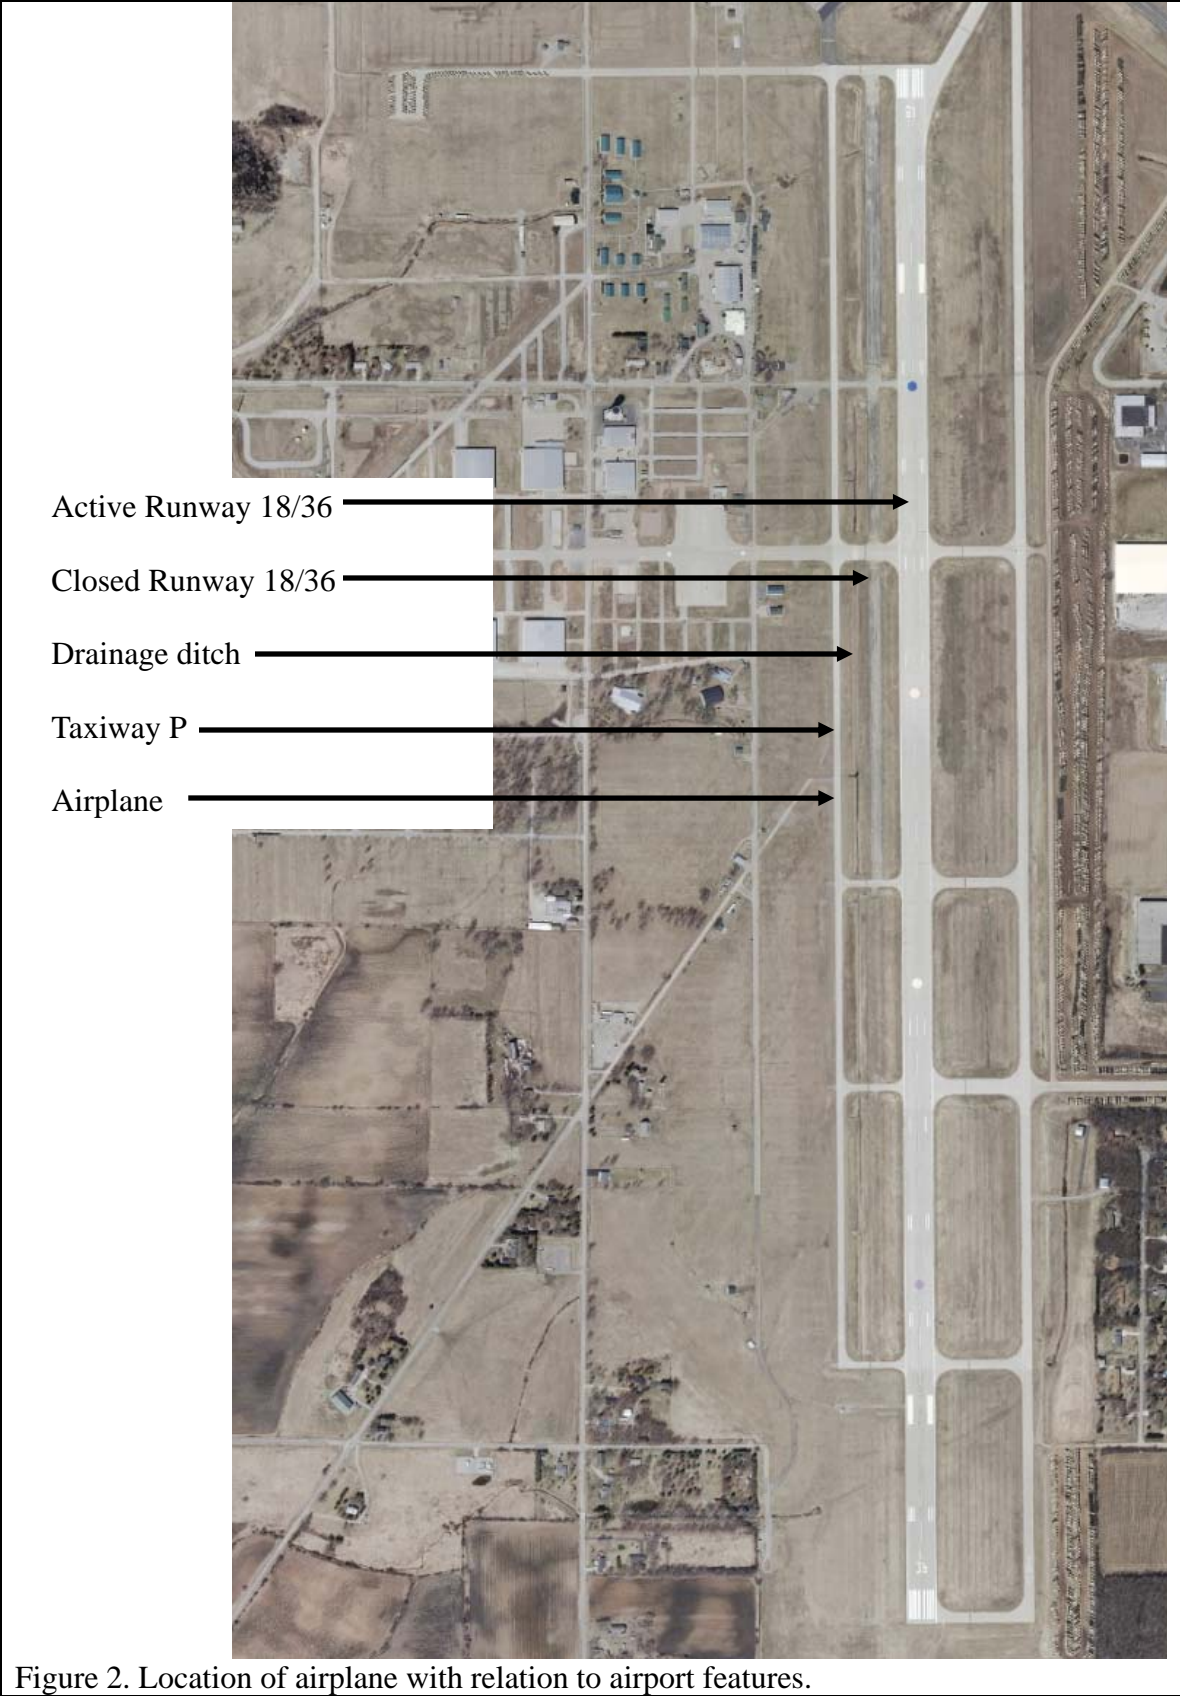
A WAAS-enabled GPS and TotalStation® survey equipment used by the Winnebago County Sherriff's Department provided positional data about the debris trail.<sup>2</sup> The location of the first fragment and ground contact was about 4,300 feet from the southern end of the pavement for the main runway that the airplane had been traveling toward. (See Figure 2)

Figure 2. Location of airplane with relation to airport features.

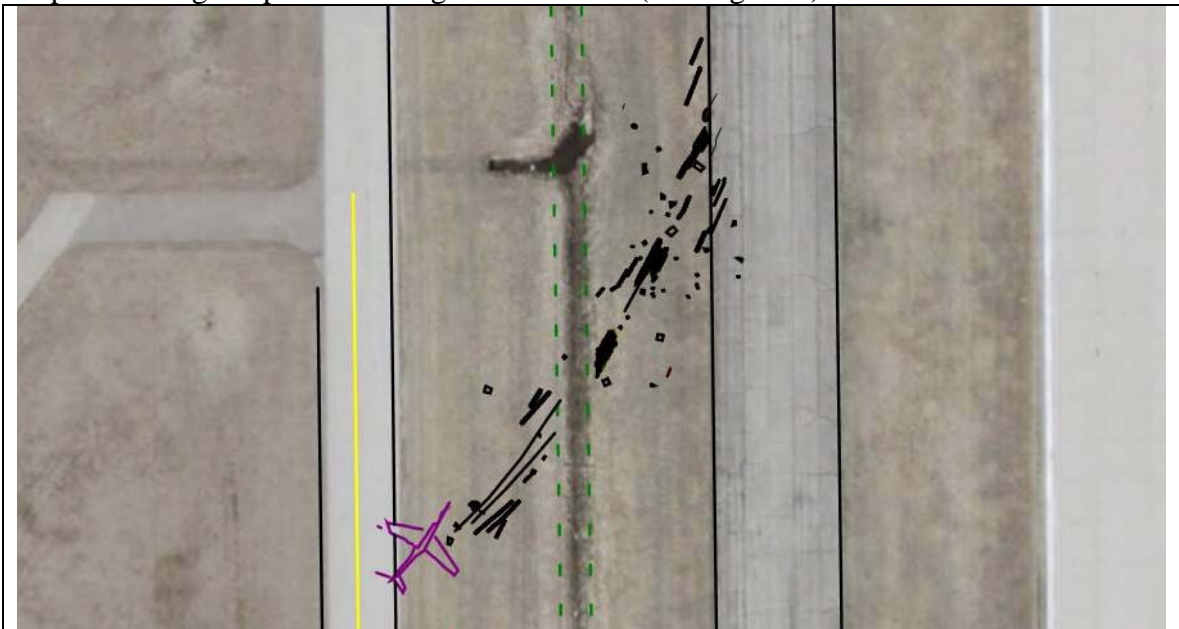
The heading of ground scars from the initial impact was 215 degrees. The southwest path of the ground markings and debris from the closed runway led through a low drainage ditch, up a short embankment, and to edge of Taxiway P. Photographs showed that the taxiway had been in use at the time by at least two Cessna 170 airplanes. The accident airplane came to rest in the grass on the east edge of the taxiway, with the nose of the airplane facing the point of first ground contact. (See Figure 3)

Figure 3. Total Station data superimposed upon aerial photo of the airport. The pavement of the active runway is the right edge of the photo and the airplane faces northeast, toward the first marks at the edge of the closed runway 18/36. The tail of the airplane is at Taxiway P. The dashed vertical green lines denote a water-filled drainage ditch. See Appendices for additional detail.

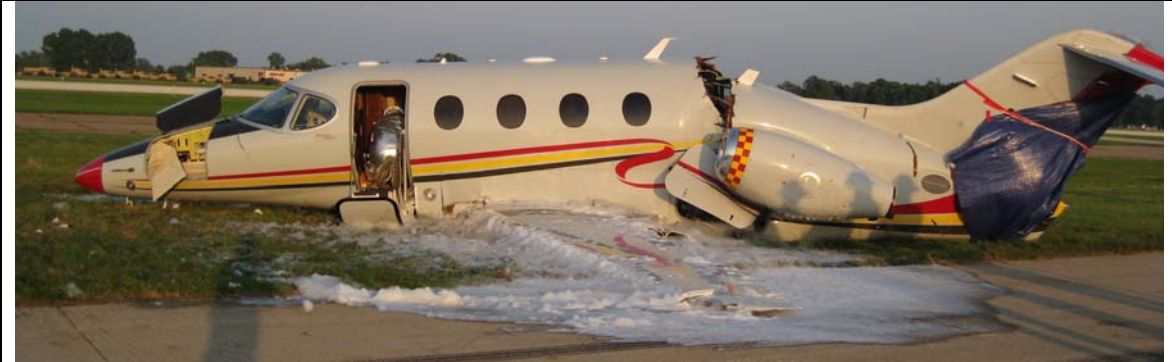
The airplane was found laying on the belly and left wing. Attached to the airframe were the engines, nose radome, tail position light, and left wing tip. No evidence of fire was found. (See figures 4 and 5)

Figure 4. Left side of airplane.

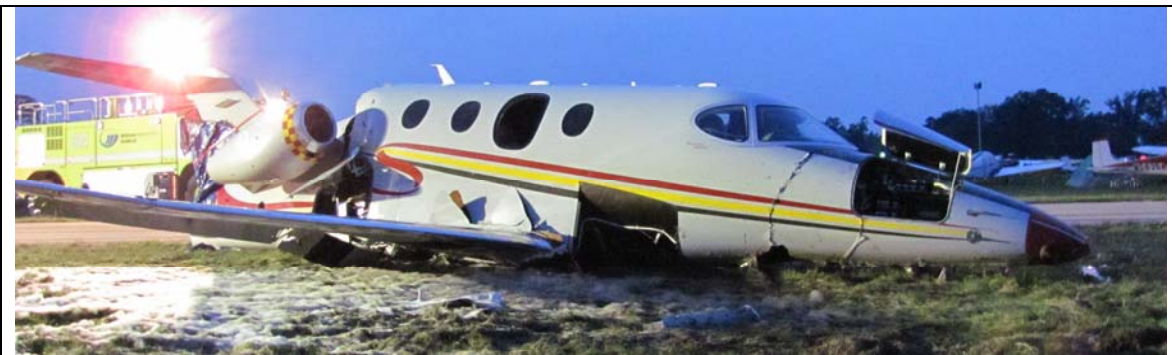
Figure 5. Right side of airplane.

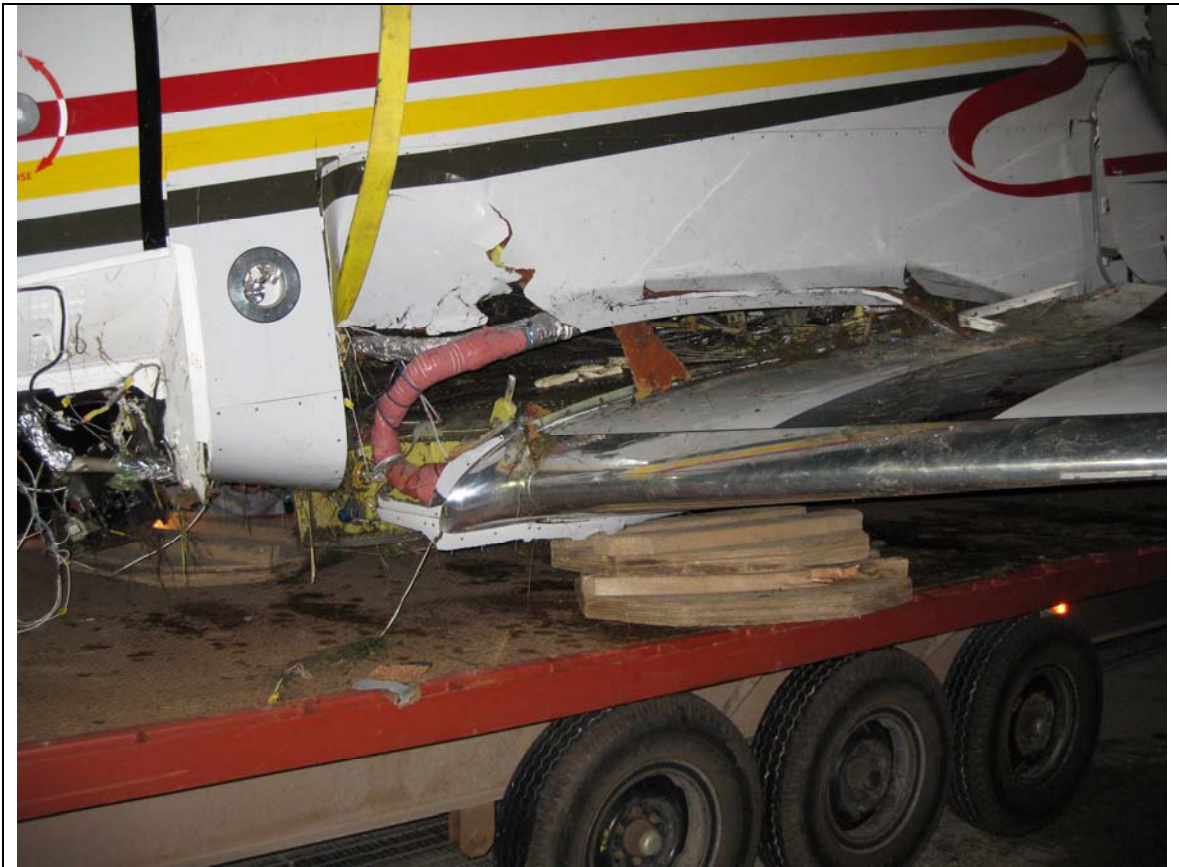
The structural mounting of the fuselage to the wing had been four metal links. The forward two links were visible from the exterior and both were found broken. The fuselage tube was found resting on the wing center section. When the fuselage was lifted with a crane for removal from the grass, the forward edge of the wing hung about a foot lower than normal from the fuselage. (See Figure 6) The bottoms of the wings had scrape marks and black embedded asphalt marks that was similar to the closed runway. (The primary Oshkosh north/south runway is concrete.)

Figure 6. Separated leading edge of left wing root beneath fuselage. (Nose is to the left)

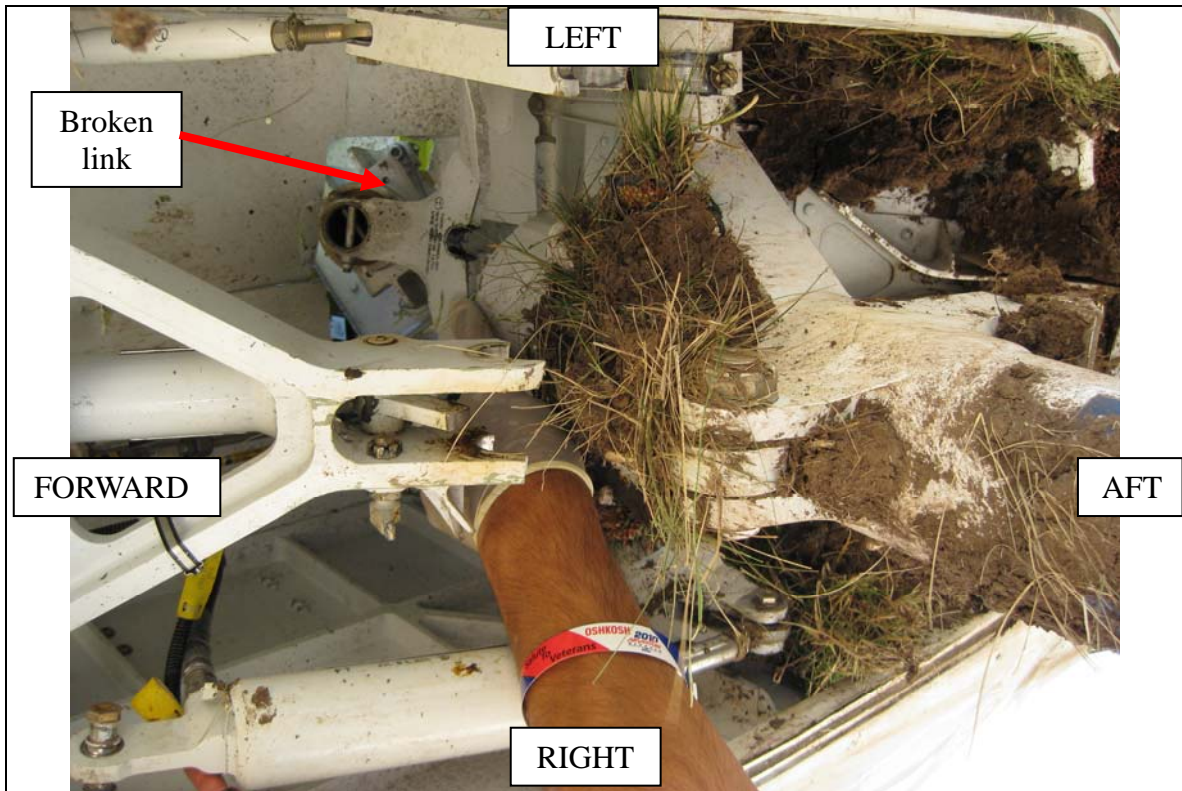
The rudder was found to move freely by hand and the rudder pedals were used to move the rudder fully to the right. Moving toward left from the full right position, the control cables went slack at the break in the fuselage near the engines and disruption of the cable path was found. Holding the cables to account for the broken fuselage, the pedals stopped before reaching the centered position, such that the right pedal remained slightly forward of the left pedal. Further examination found the pedals connected indirectly to the nose steering link assembly at the top of the broken nose landing gear. The steering assembly had broken through the structure of the nose landing gear box and the impeded travel was the stopping point of the rudder pedal movement. (See Figure 7)

Figure 7. Arrow points to the nose steering link assembly broken at the top of the nose landing gear structure. View looks upward.

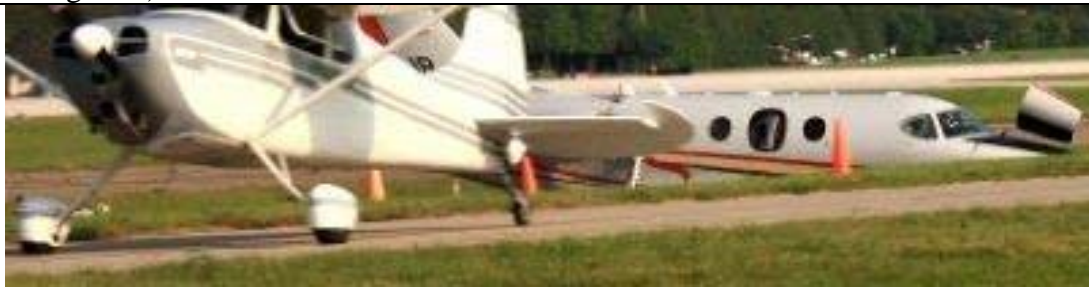
Photos show the overwing exit from the right side of the airplane was closed in flight and open after the initial ground contact. (See Figure 8) The hatch was found inside of the cabin, on the left side second passenger seat, with the latch in the stowed orientation. (See Figure 9)

Figure 8. Cropped section of photo shows the overwing escape hatch opening during the impact sequence.

Prior to this accident, Hawker Beechcraft received reports about opening of overwing exits during ground operations. The hatches are held firmly shut by pressurization during flight. Company review into the previous openings resulted in Premier 1A Communiqué #27, dated August 2010. The communiqué points out that revision A30 of the Premier Airplane Maintenance Manual provides additional rigging instructions.

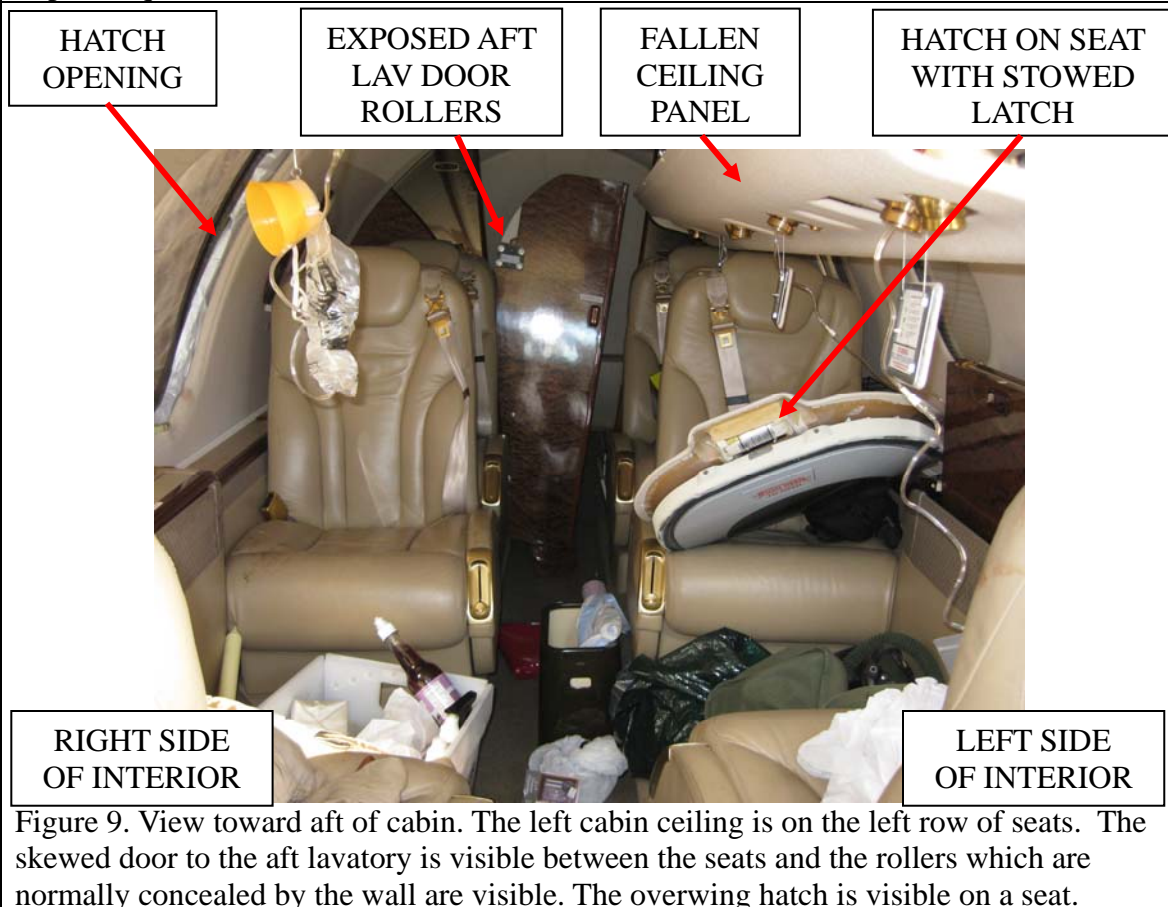
Figure 9. View toward aft of cabin. The left cabin ceiling is on the left row of seats. The skewed door to the aft lavatory is visible between the seats and the rollers which are normally concealed by the wall are visible. The overwing hatch is visible on a seat.

The left cabin ceiling had fallen into the occupiable head space of the left cabin seats. (See Figure 9)

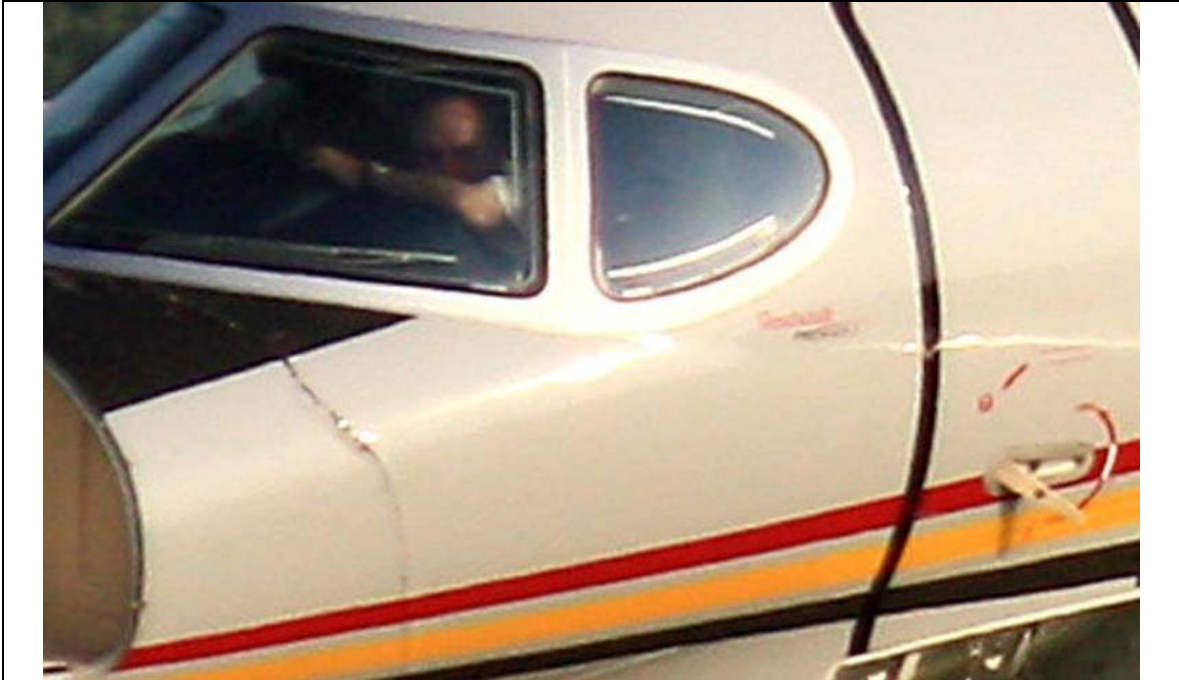
Detailed examination of exterior photos in the impact sequence showed the cockpit interior through the windshield. The male occupant of the captain seat can be seen with an arm stretched forward of his shoulder. The person in the first officer seat is not similarly visible. (See Figure 10)

Figure 10. Cropped section of an attached photo that shows the airplane colliding with the drainage ditch, showing the captain's arm stretched forward of the shoulder. The person in the first officer seat is not similarly visible. Also shown are displacement of the main cockpit door handle and a fuselage fracture near the forward pressure bulkhead.

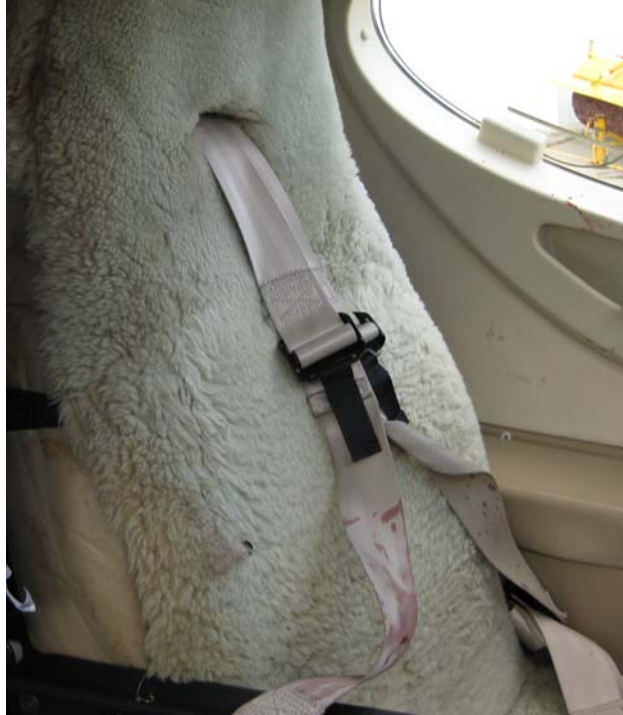
The shoulder harness set for the seat of the captain was found to be locked, so that neither strap would extend further when lightly pulled. Each of the harness straps for the captain was brought to the belt buckle and the extensions were about correct to pass over a pilot's shoulders. (See Figure 11)

Figure 11. Shoulder harness of captain seat.

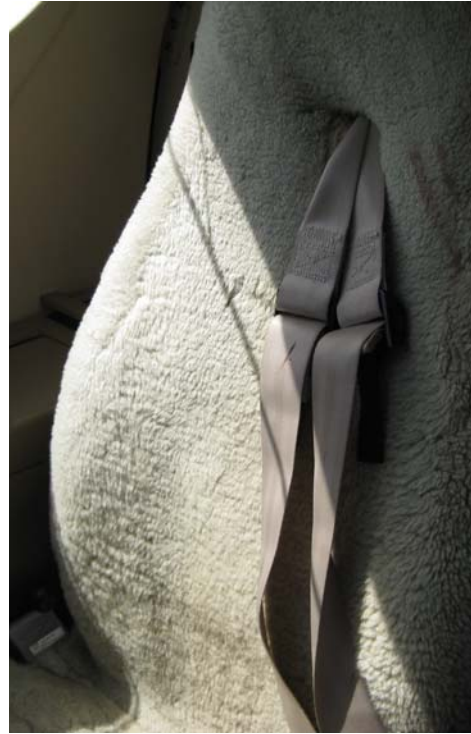
The shoulder harness on the side of the first officer was not locked, the straps had a fold that was not creased into the material, and the buckles were inverted from a usable orientation. (See Figures 12) None of the shoulder harness sets were disassembled to examine for stretch marks in the webbing.

Figure 12. Shoulder harness of first officer seat.

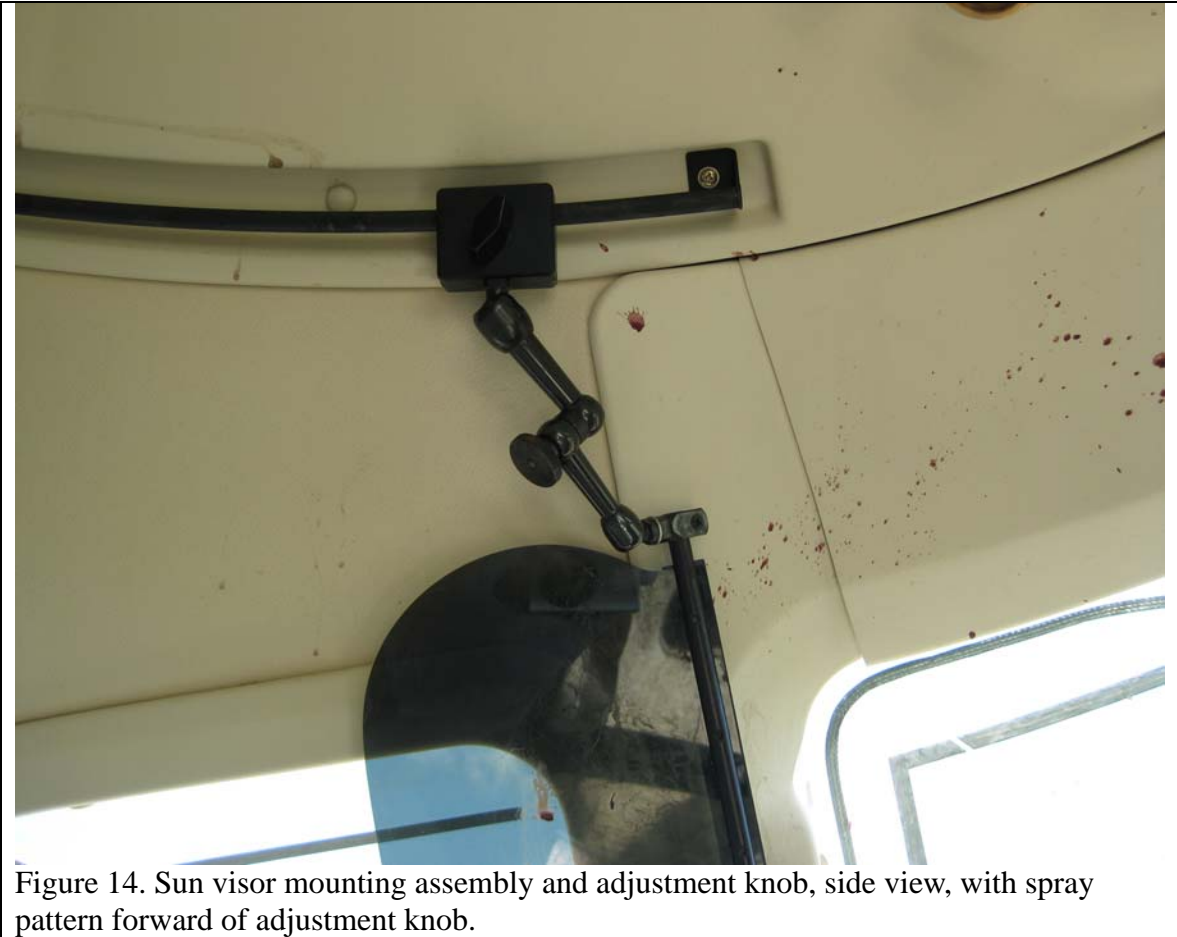
The sun visor assembly was found oriented vertically, along the aft edge of the window pillar. Blood distribution had silhouetted the visor in the position where it was found. The round adjustment knob for the pilot's sun visor was the highest point at which blood was found. Radiating from this point was a pattern down and forward. (See Figure 14)

Figure 14. Sun visor mounting assembly and adjustment knob, side view, with spray pattern forward of adjustment knob.

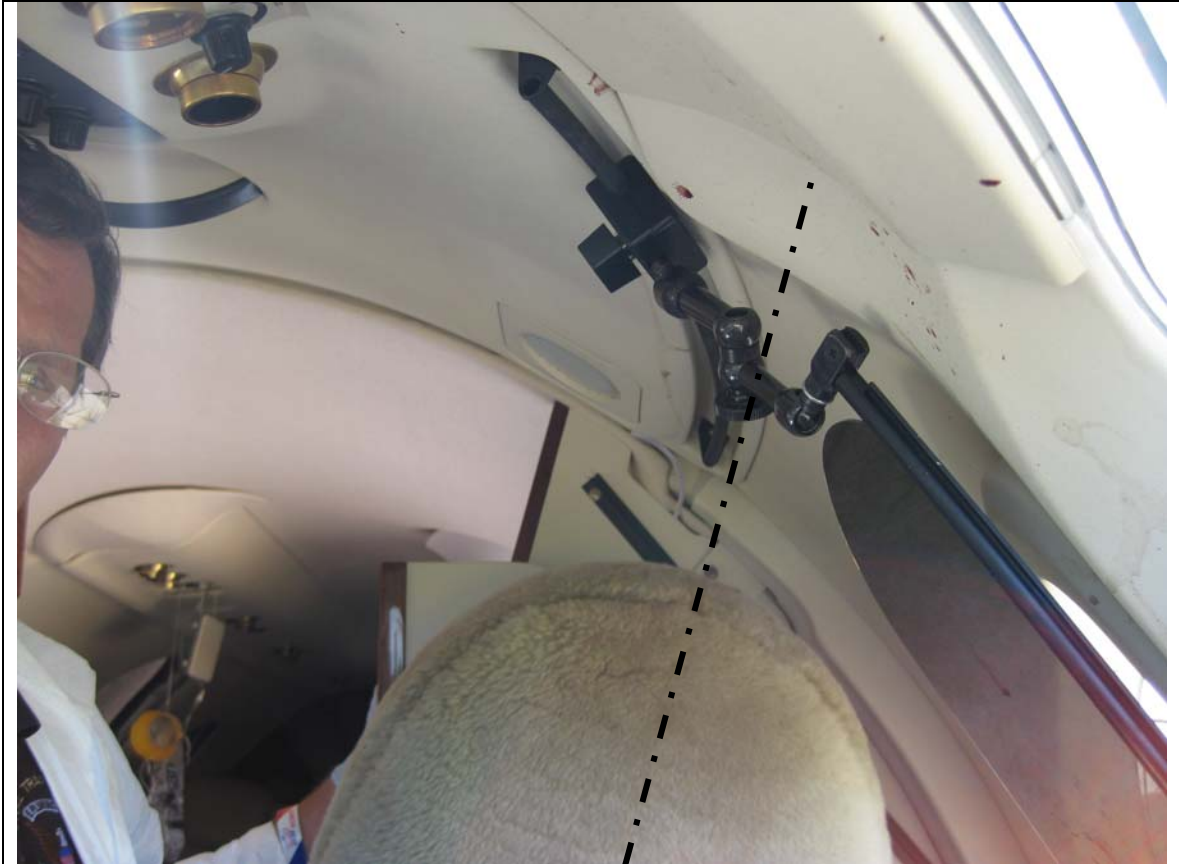
At the head position found with the shoulder harnesses and seat adjustment, the sun visor mounting assembly and adjustment knob was approximately in front of the pilot's forehead, near the hairline and above the left eye. (See Figure 15)

Figure 15. Sun visor mounting assembly and adjustment knob, as viewed aft and from above the centerline of the control yoke. The photo is slightly rotated and the dashed line has been added to provide vertical orientation, as copied from the door frame.
