----- AIRWORTHINESS GROUP CHAIRMAN'S FACTUAL REPORT -----

Location: Las Vegas, Nevada
Date: September 8th, 2015
Time: About 1627 PDT
Aircraft: Boeing 777-200
Serial Number: 29320
Registration: G-VIIO

3. SUMMARY

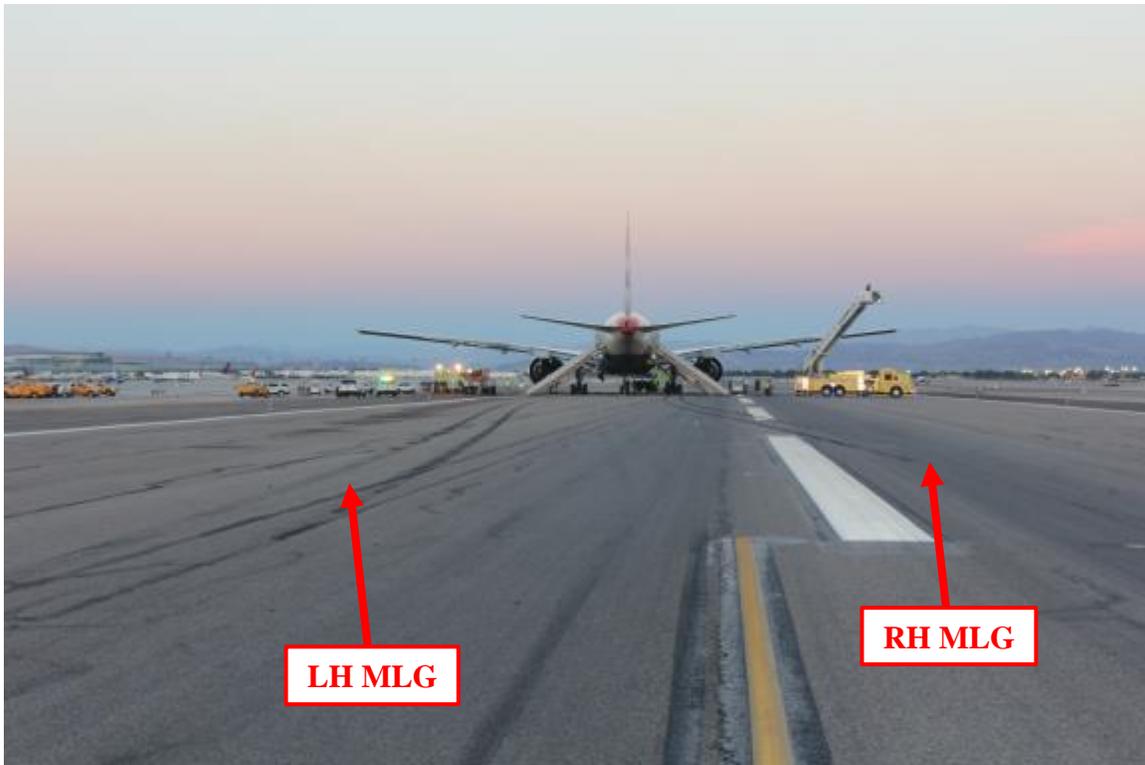
Skid marks were visible, see Figure 4, on the runway surface from both of the main landing gear assemblies and extended approximately 700 ft. from the aircraft's final resting place.

Figure 4 - MLG skid marks on RWY 7L

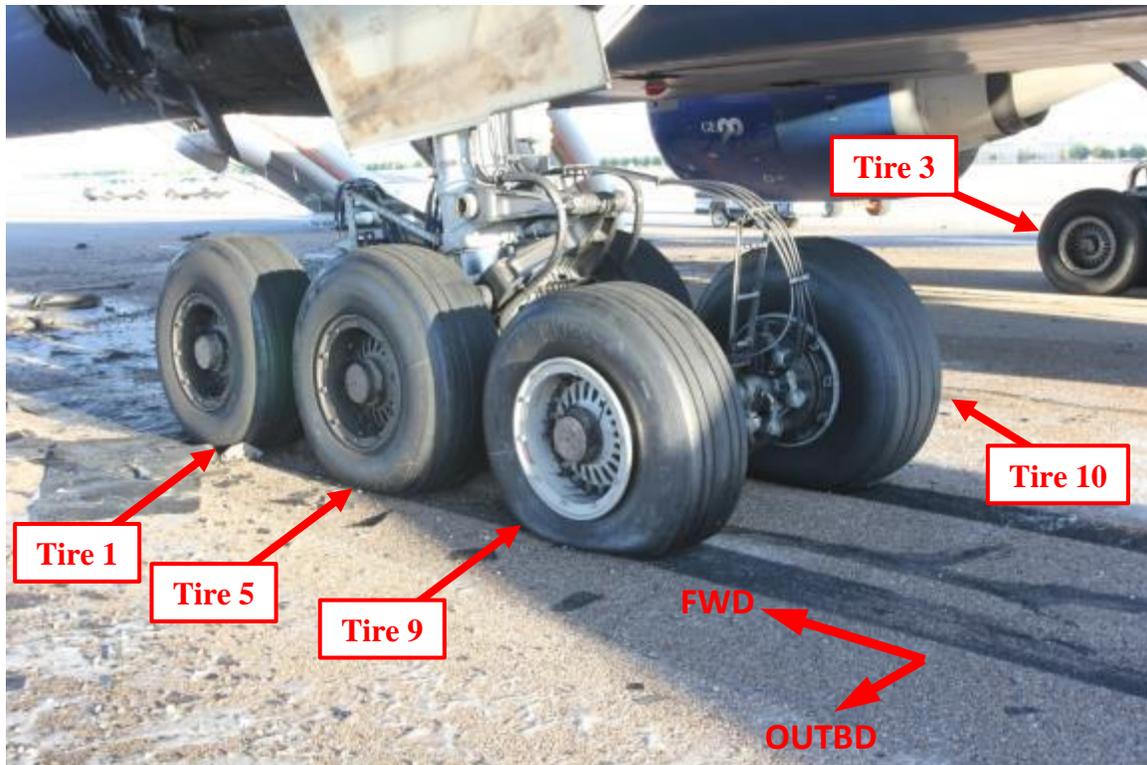
The aft-most tire on the outboard left hand main gear, referred to as tire 9, was found deflated, see Figure 5.³

Figure 5 - LH main gear as found after aircraft stopped, tire 9 is deflated

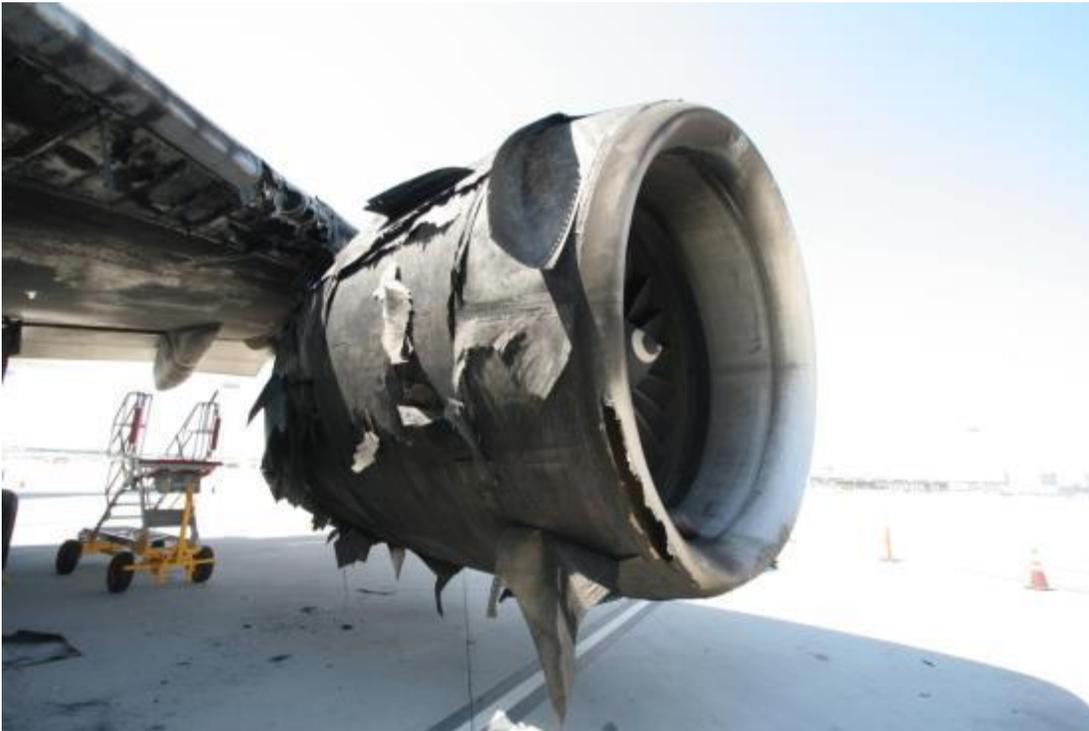
On the left engine the cowling was thermally damaged from the 4 o'clock position (just below the pressure relief port) to the 12 o'clock position (engine mounting strut) as viewed from the front. The degree of this thermal damage was more extensive in between the 6 and 12 o'clock positions (inboard side of the engine) causing the composite cowling to delaminate, see Figure 14. The aluminum leading edge of the cowling was partially melted along the 7 – 8 o'clock position. Once the cowling was removed it was evident that the interior of the engine was not nearly as thermally damaged as the exterior and primarily

had sooting on some surfaces but no significant thermal degradation to the components. It was discovered that the main fuel supply line had been severed at the engine.

Figure 14 - Inboard side of left engine.

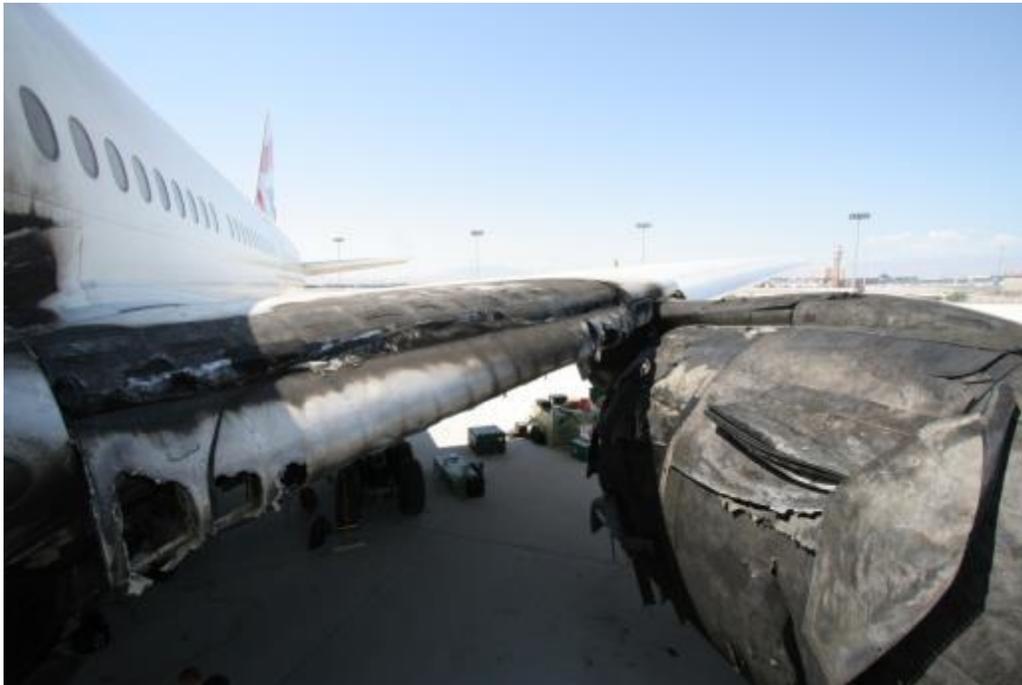
The left wing sustained thermal damage in the area between the left engine and the fuselage. There was no evidence of engine debris impacting or penetrating the left wing structure. The aluminum slat in this area was melted on the inboard and outboard ends but remained intact in the middle section, see Figure 15. The aluminum Krueger flap adjacent to the strut was charred and damaged. The aluminum strakelet exhibited areas of buckling, cracking and portions of missing material, see Figure 16. The composite lower fixed leading edge panels were thermally damaged and exhibited delamination of the external plies, see Figure 17. Their cores were still in place but had suffered thermal degradation. The composite flap track fairing exhibited charred and blistered paint along its lower portion. The aluminum/composite fuel tank access doors on the inboard portion of the wing (inboard of the engine) were weeping gasket grease from beneath the clamp ring, see Figure 18. There was no evidence of fuel leakage from the wing tank. The interior side of the composite lower fixed leading edge panels exhibited thermal degradation in the areas near the slat. The thermal degradation diminished towards the front spar. The composite upper fixed leading edge was charred all the way out to the strut, see Figure 19. The wing surfaces outboard of the strut, both the top and bottom, did not exhibit any damage from the fire. Examination of the aluminum front spar did not reveal any adverse thermal effects. The composite panel mounted to the shock strut of the left main landing gear exhibited blistering of the paint and some delamination of the outer plies.

Figure 15 - Thermal damage to slat and top surface of fixed leading edge of the left wing.

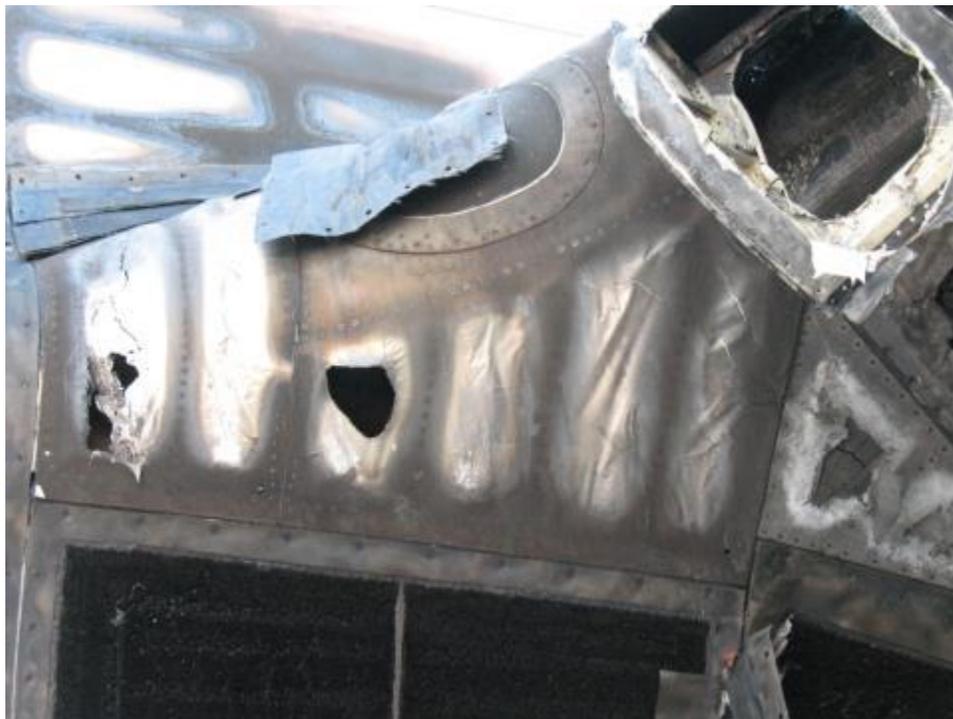
Figure 16 - Close-up view of thermal damage to strakelet.

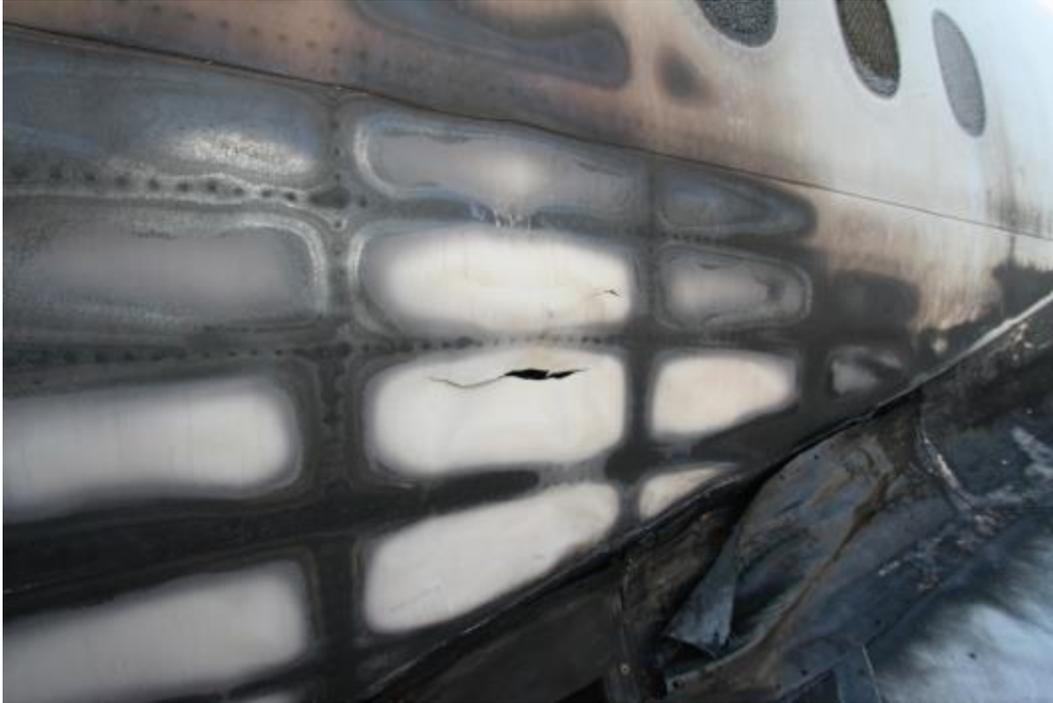
The fuselage skin exhibited thermal damage in the form of missing and charred paint from frame station (FS) 867 to FS 993 and stringer 15 to 30. The center of this thermally damaged region exhibited buckling and some cracks in the skin, the longest being approximately 12 inches long, see Figure 20 and Figure 21. These cracks in the skin coincided with the area of most severe thermal damage to the wall panels in the interior of the aircraft. There were 13 thermally crazed windows on the fuselage extending from the L2 door back to FS 1119. There was no evidence of engine debris impacting or penetrating the left side of the fuselage structure.

Figure 20 - Thermally damaged fuselage skin exhibiting cracks.

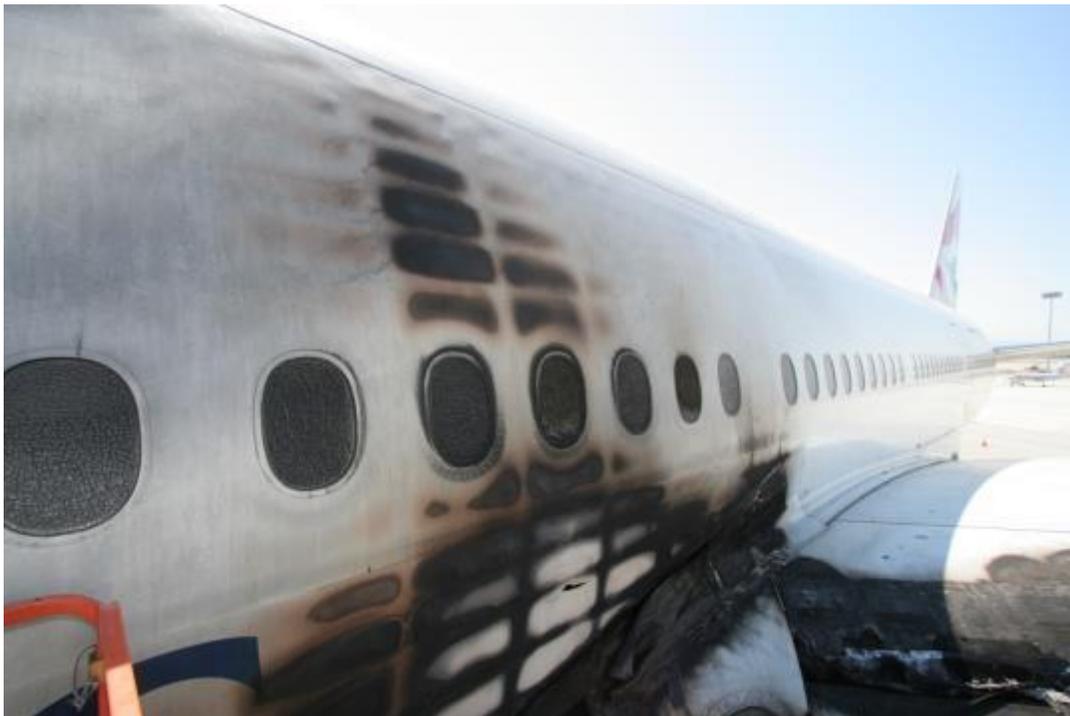
Figure 21 - Thermally damaged fuselage skin and thermally crazed windows.

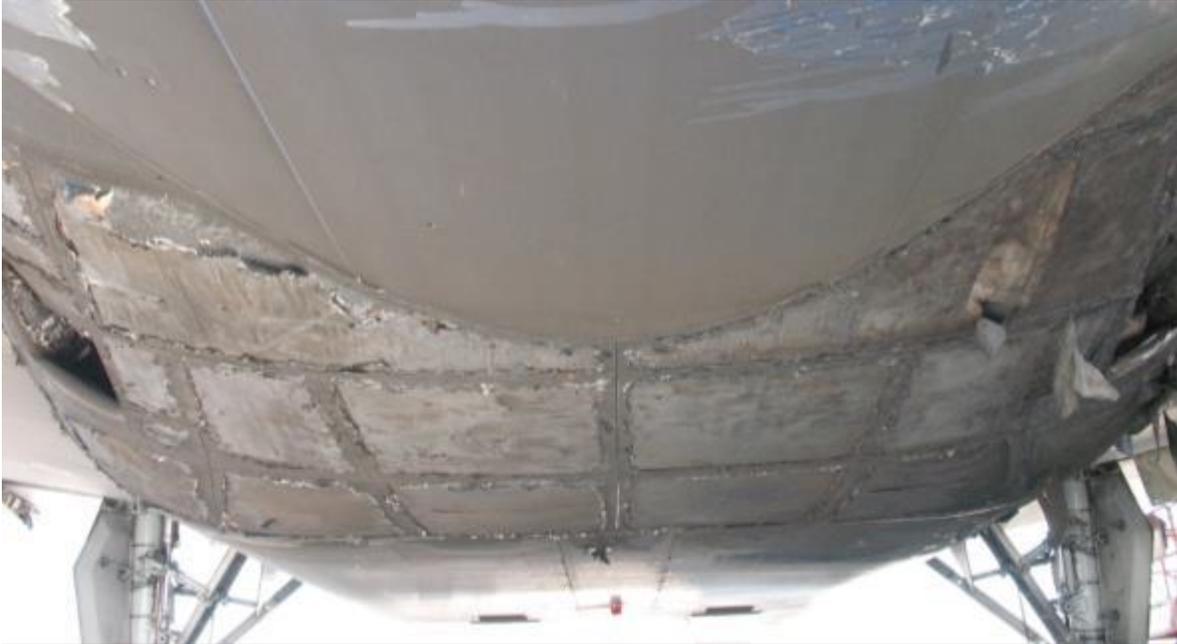
Figure 23 - Thermally damaged composite panels on the belly of the aircraft in the area of the wing to body junction. Photo taken looking aft.

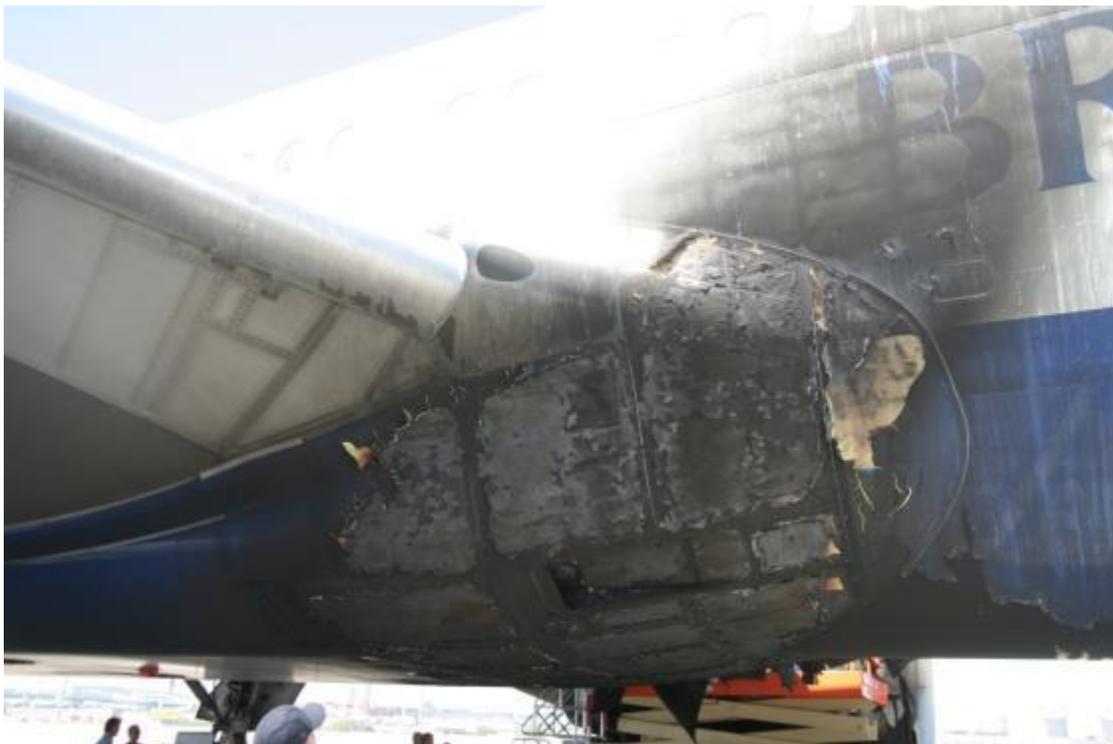
Figure 24 - Thermal damage on the right side wing to body fairing.

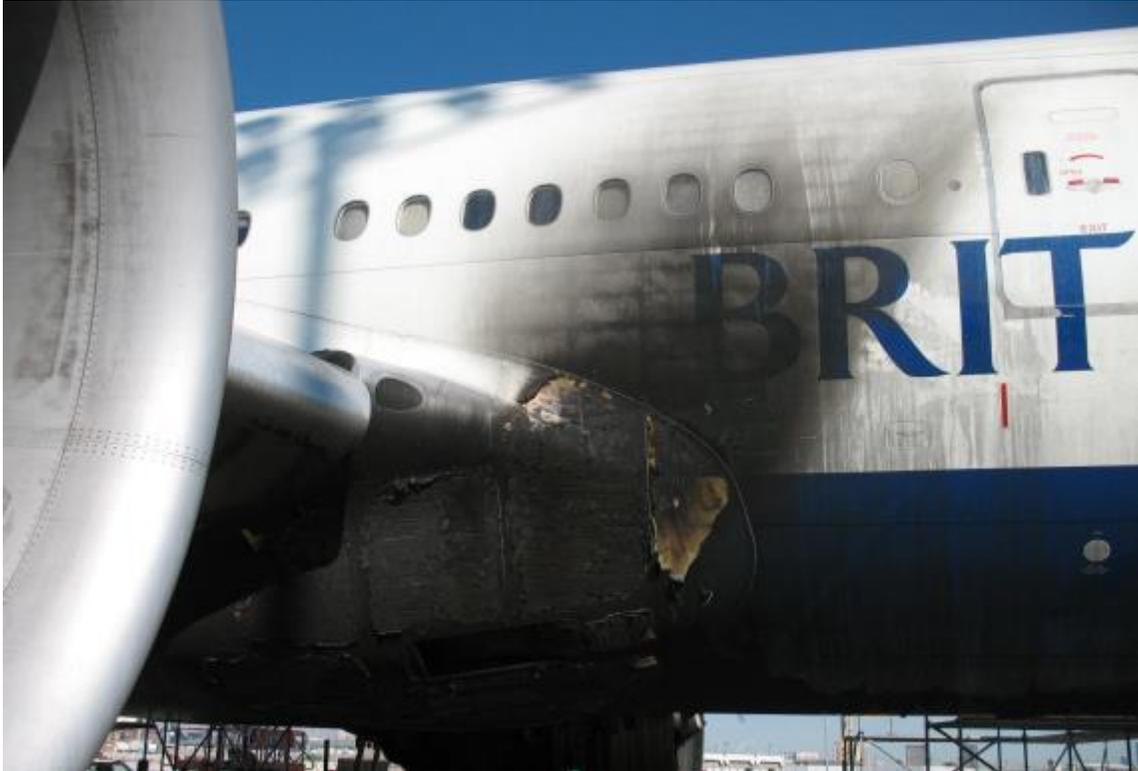
On the right side of the aircraft above the wing to body fairing the fuselage was sooted. Buckling that created a tactile waviness to the aluminum skin was found in the area from FS 867 to FS 909 in between stringers 27 – 30, see Figure 25. Two of the windows above this area exhibited thermal crazing.

Figure 25 - Sooting and thermal damage to right side fuselage.

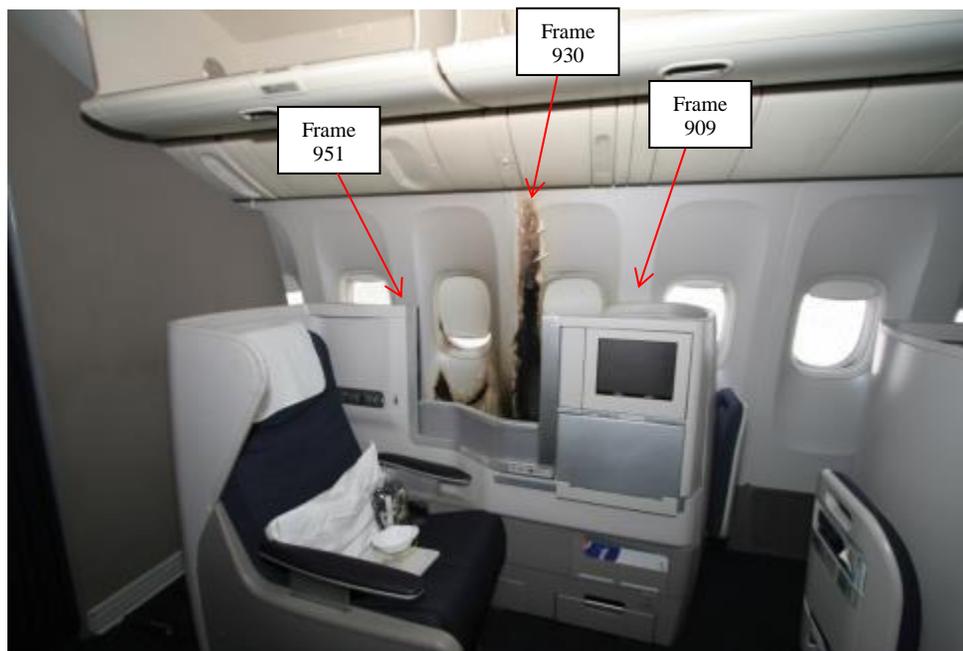
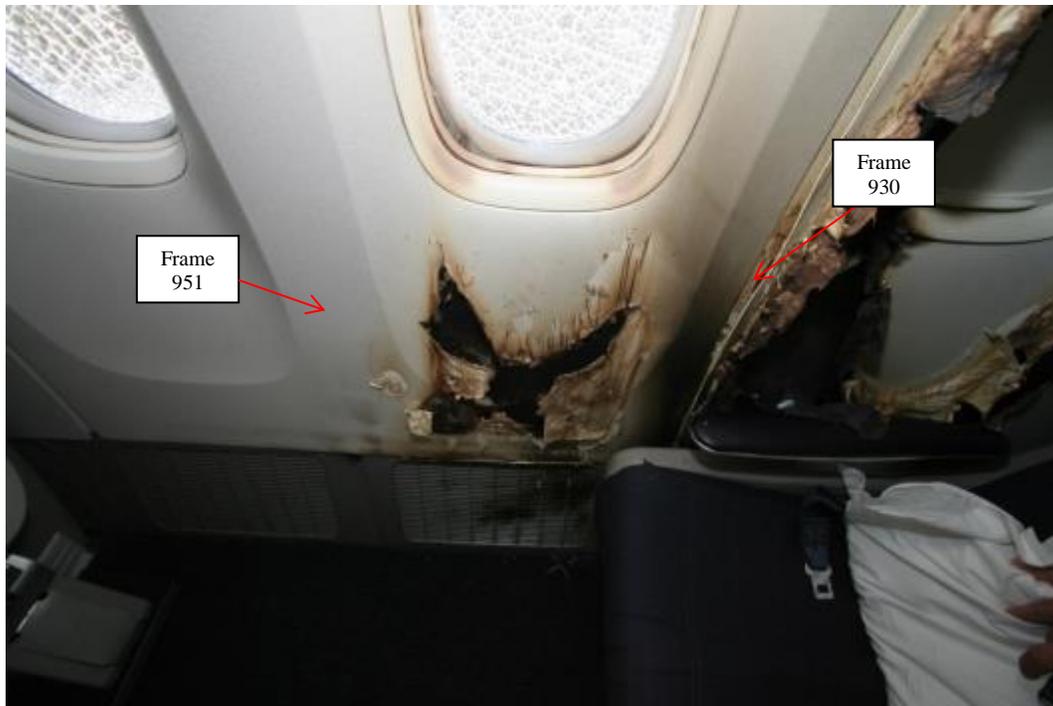
The thermal damage to the interior cabin was confined to the wall panels at the location of seat 11A, see Figure 26. The thermal damage consisted of blistering and charring of the decorative face sheet on the wall panels. There was no soot on any surfaces adjacent to the thermally damaged areas. The damage was consistent with thermal decomposition and charring and not flaming combustion on the inboard surfaces of the damaged panels. The seat adjacent to the charred wall panel did not sustain any thermal damage. The majority of the charring to the panels was concentrated in between frame 909 and frame 951. The most severe damage was in between frame 909 and frame 930 where charring was observed from the vent grill at the floor and extended up to just below the passenger service unit (PSU). In between frame 930 and frame 951 the charring extended from the vent grill at the floor to just below the window, see Figure 27.

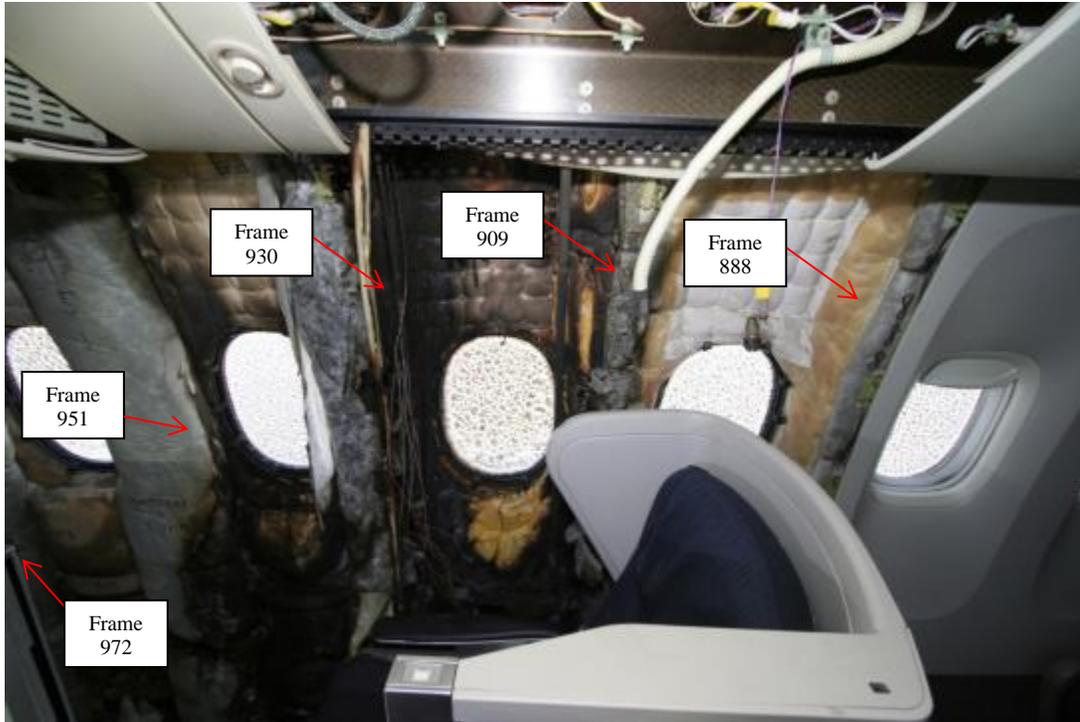
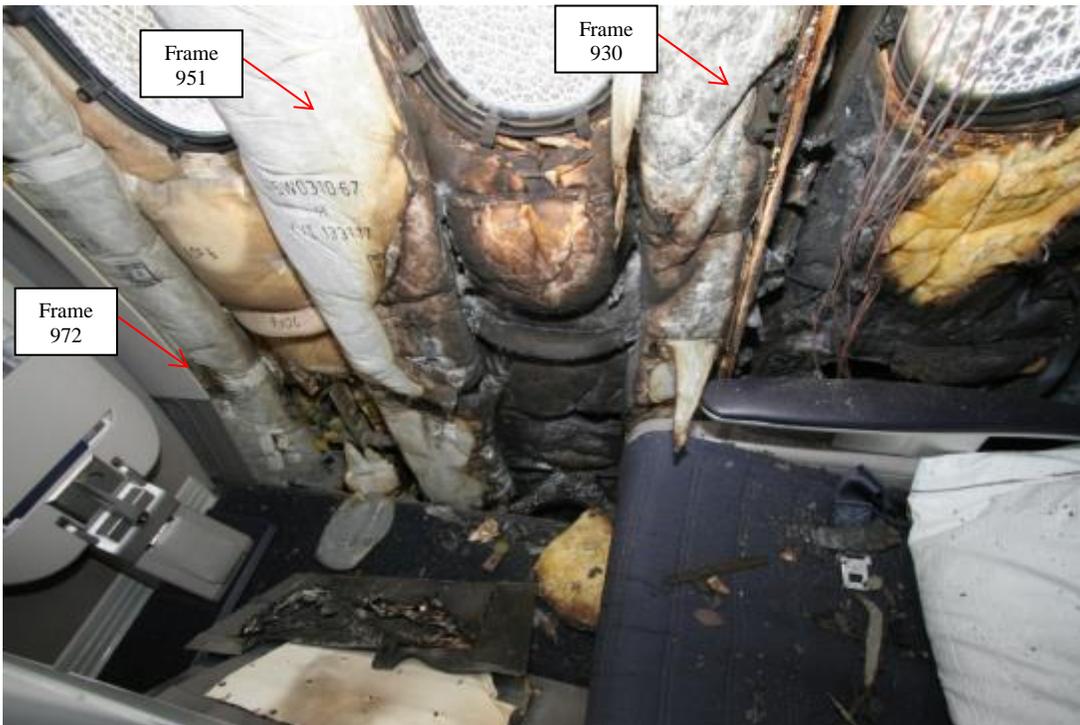
The wall panels were removed to document the damage to the inboard side of the insulation behind them. This exposed the thermal acoustic insulation from the floor level up to the PSU, see Figure 28 and Figure 29

In between frame 888 and frame 909 the damage to the insulation was located at floor level and extended up the insulation covering frame 909 to the height of the top of the window. The damage consisted of melted and missing insulation vapor barrier film.

In between frame 909 and frame 930 the damage extended from the floor level up to the PSU and filled the width of the bay. This damage consisted of missing insulation film and blackened glass batting.

In between frame 930 and frame 951 the damage to the insulation extended from floor level up to the bottom of the window and covered the width of the bay. The damage consisted of missing insulation film and charred glass batting. Above the damaged portion, the insulation had some soot on the film mostly on the side nearest frame 951.

In between frame 951 and frame 972 the damage to the insulation extended from the floor level and up about 12 inches. The damage consisted of missing insulation film and some charring near frame 951.

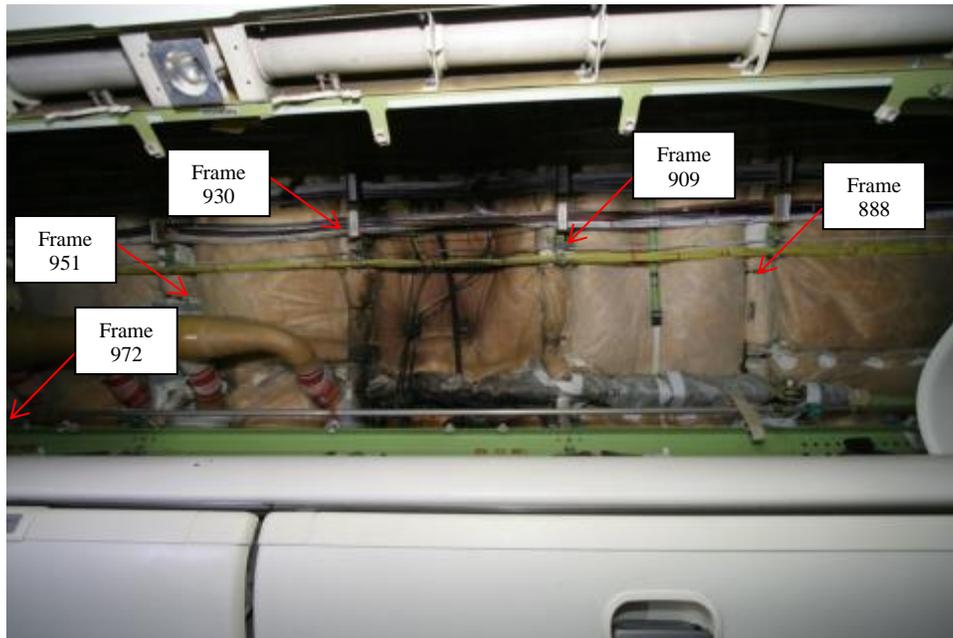
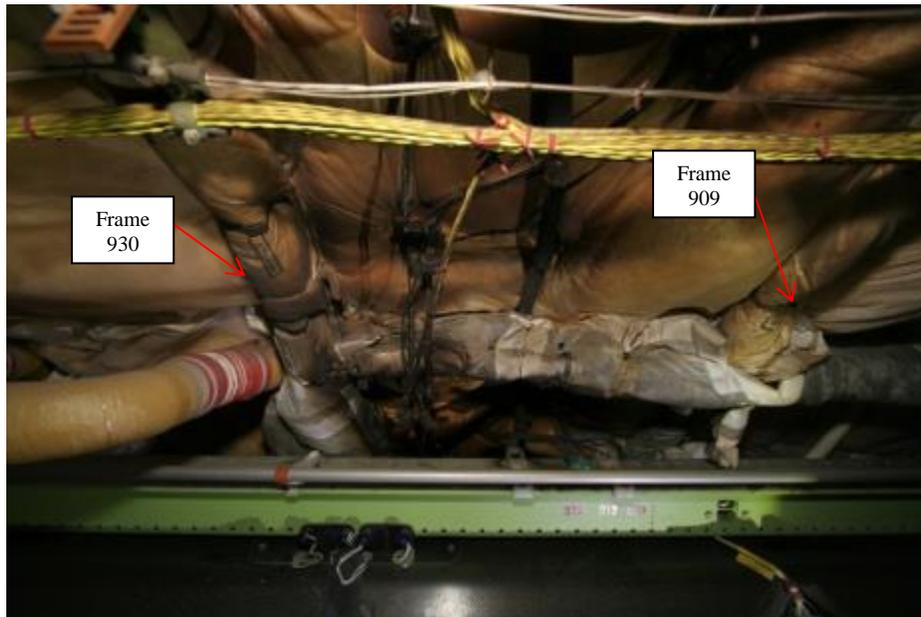
and frame 930. This damage consisted primarily of discolored insulation film and small areas of missing film, see Figure 30 and Figure 31

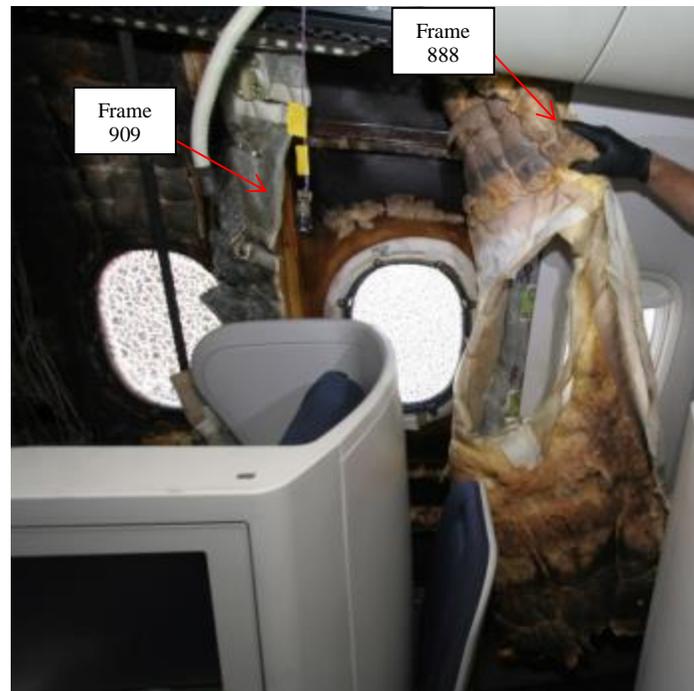
In between frame 888 and frame 909 the thermal damage to the insulation was more severe on the outboard side than on the inboard side. The primer on the fuselage skin was charred behind the insulation, see Figure 32.

Figure 32 - outboard side of insulation between frames 888 and 909.

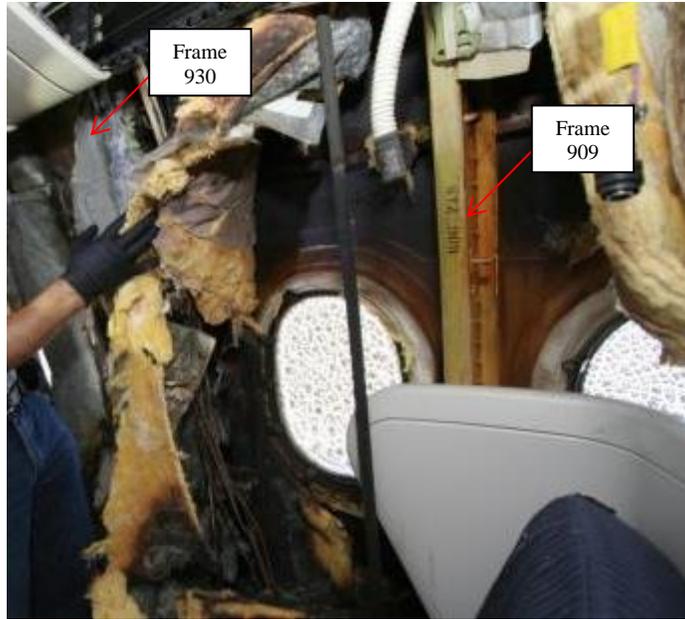
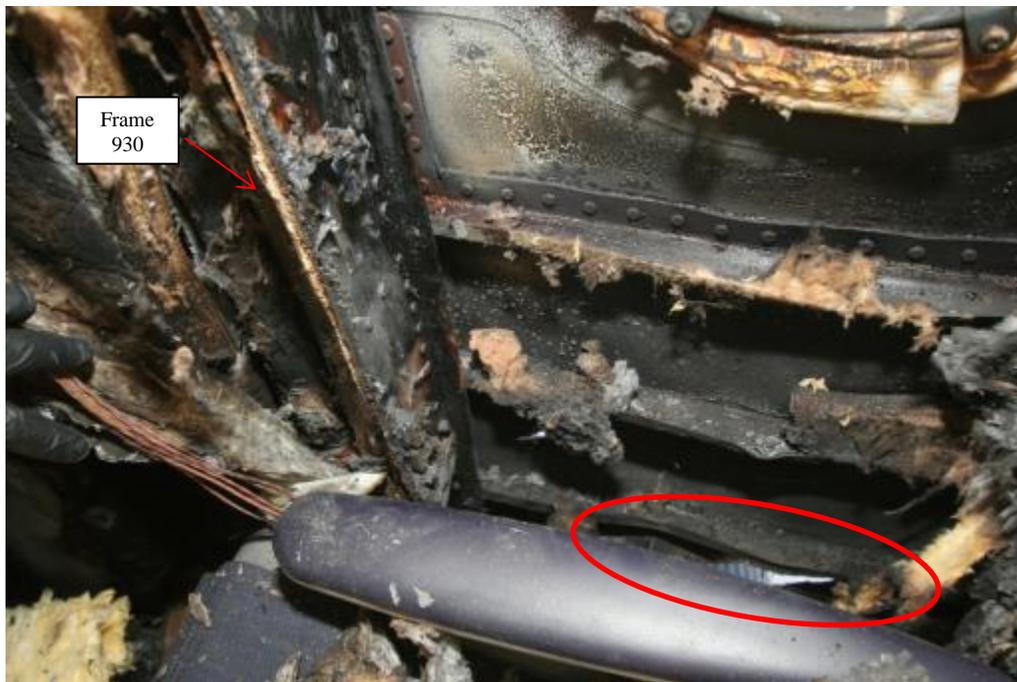
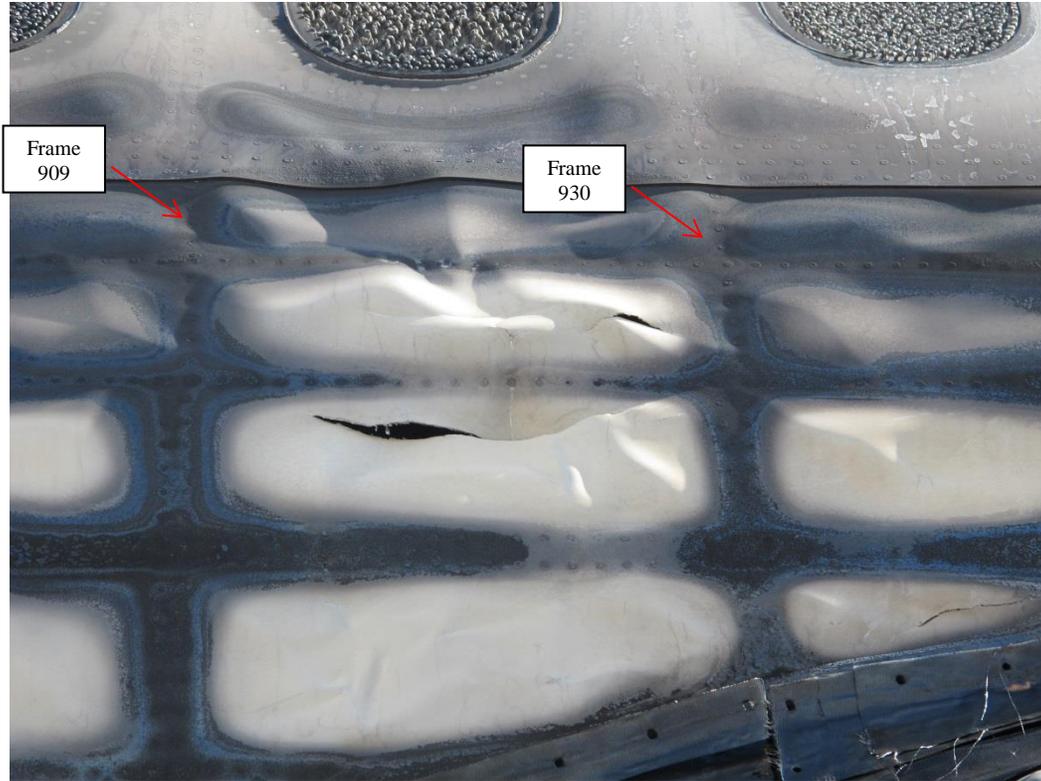
In between frame 909 and frame 930 the thermal damage to the insulation along the lower portion up to the window was similarly damaged on both the outboard side and the inboard side, see Figure 33. From the window and up, the thermal damage to the insulation was more severe on the inboard side. In this frame bay there was a bundle of wires extending vertically along the side of frame 930 and the thermal damage seemed to coincide with this wire chase. The primer on the fuselage skin was charred behind the insulation in the entire frame bay. There was a split in the fuselage skin visible at floor level and included some buckled stringers just above the floor, Figure 34. From the outboard side, the visible edges of the split were bright and soot was not present, see Figure 35.

Figure 34 - Split in the fuselage skin near floor level between 909 and 930

Figure 35 - Outboard side of skin split between frames 909 and 930.

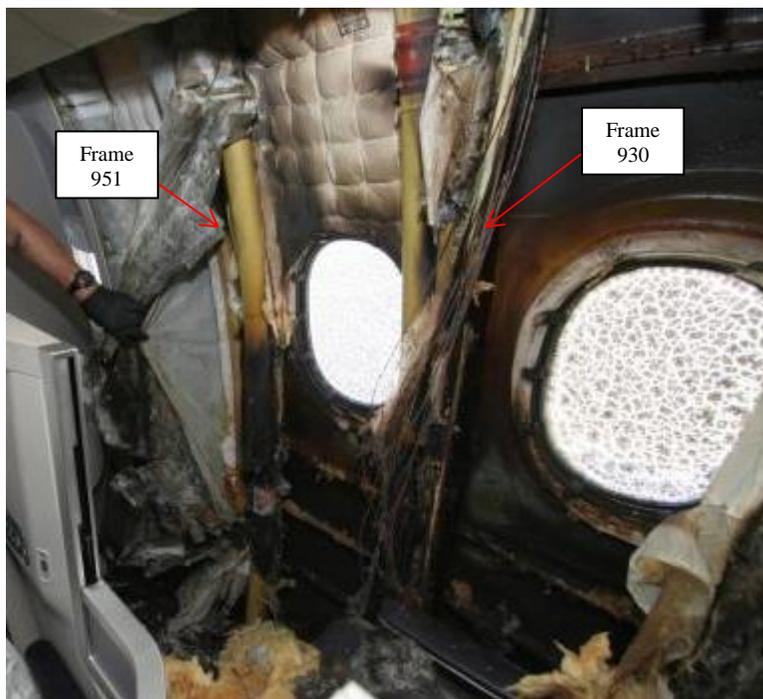
In between frames 930 and frame 951 the outboard side of the insulation above the window level was not severely damaged and exhibited some discoloration. In this frame bay two ducts were oriented vertically, one adjacent to frame 930 and one adjacent to 951. These ducts were charred and friable below the window level, Figure 36. The insulation below the window level was also charred on the outboard side. The primer on the fuselage skin in this frame bay was charred.

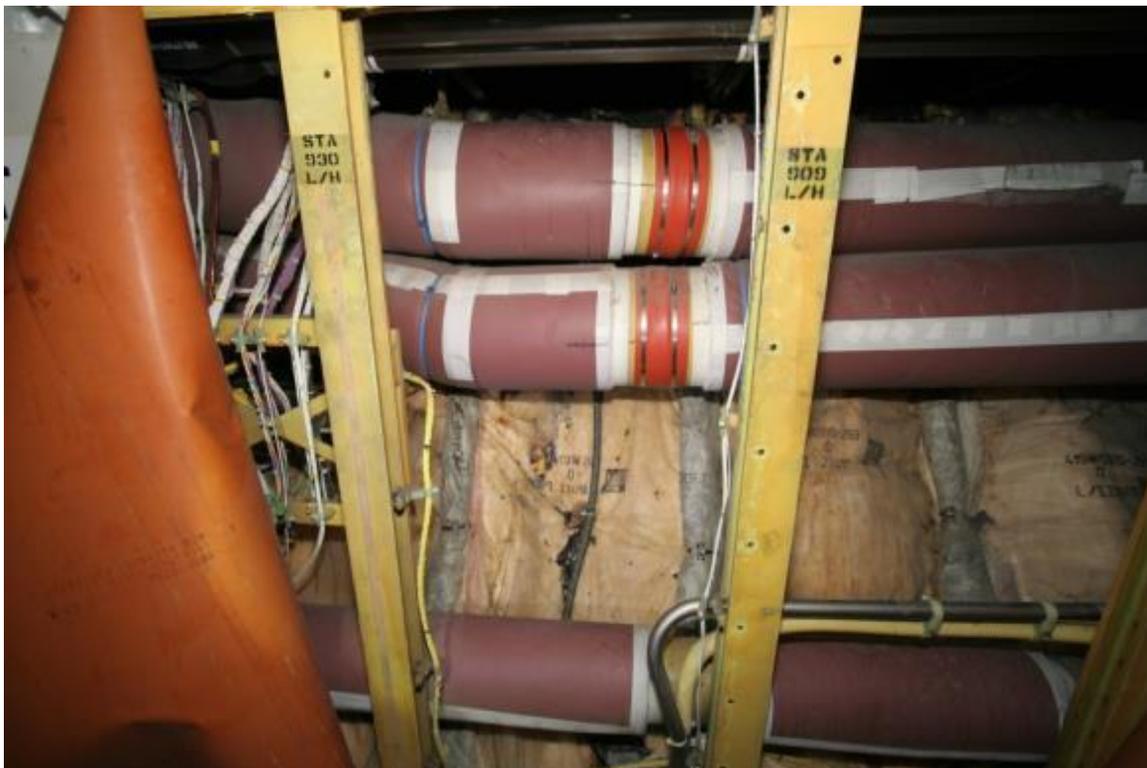
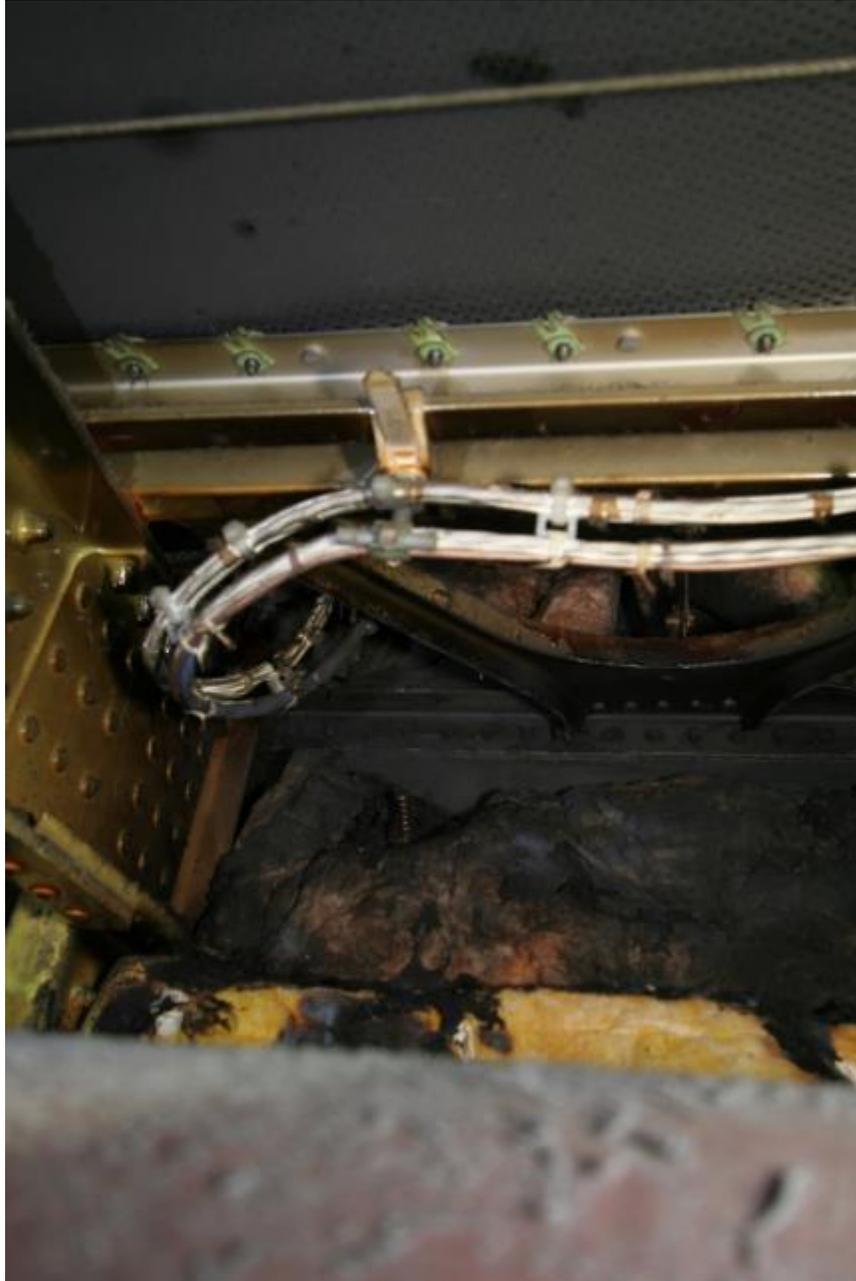
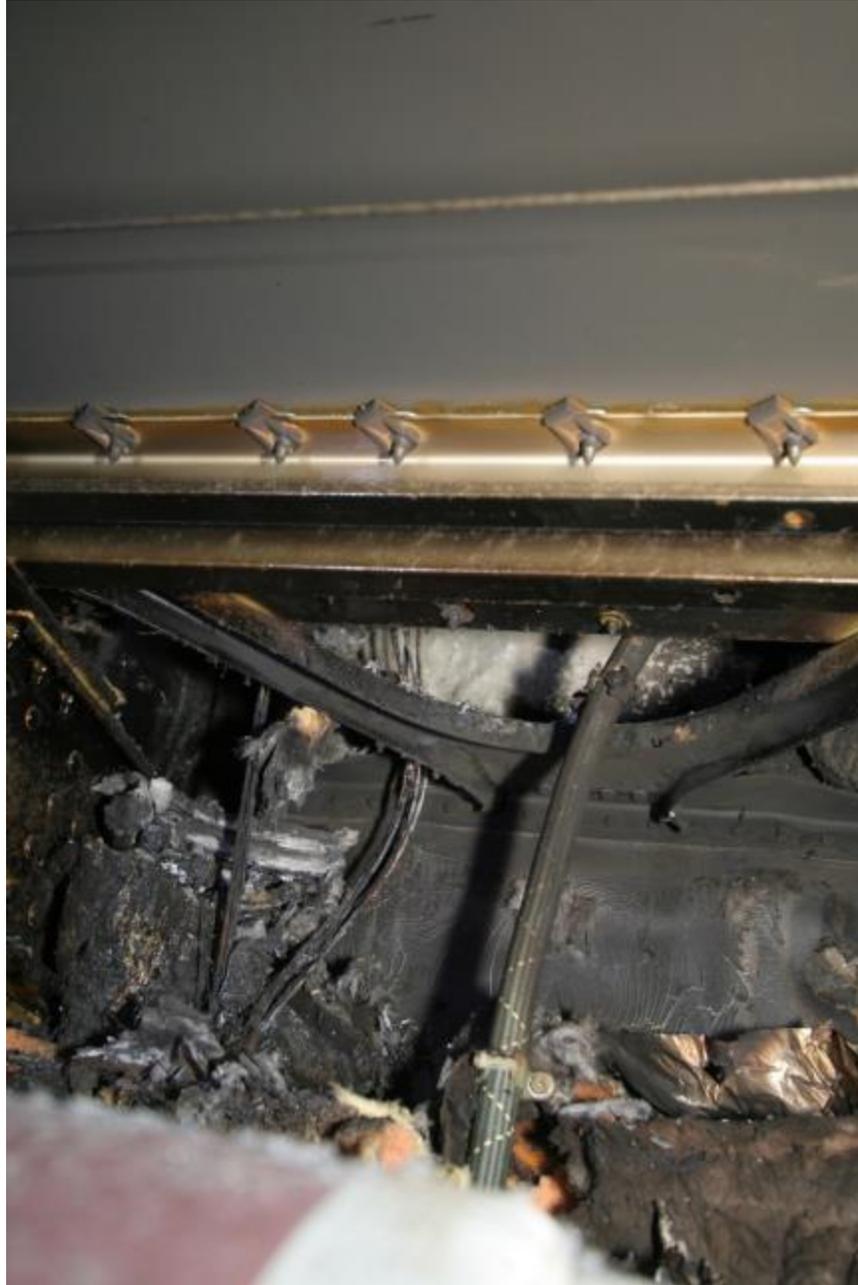
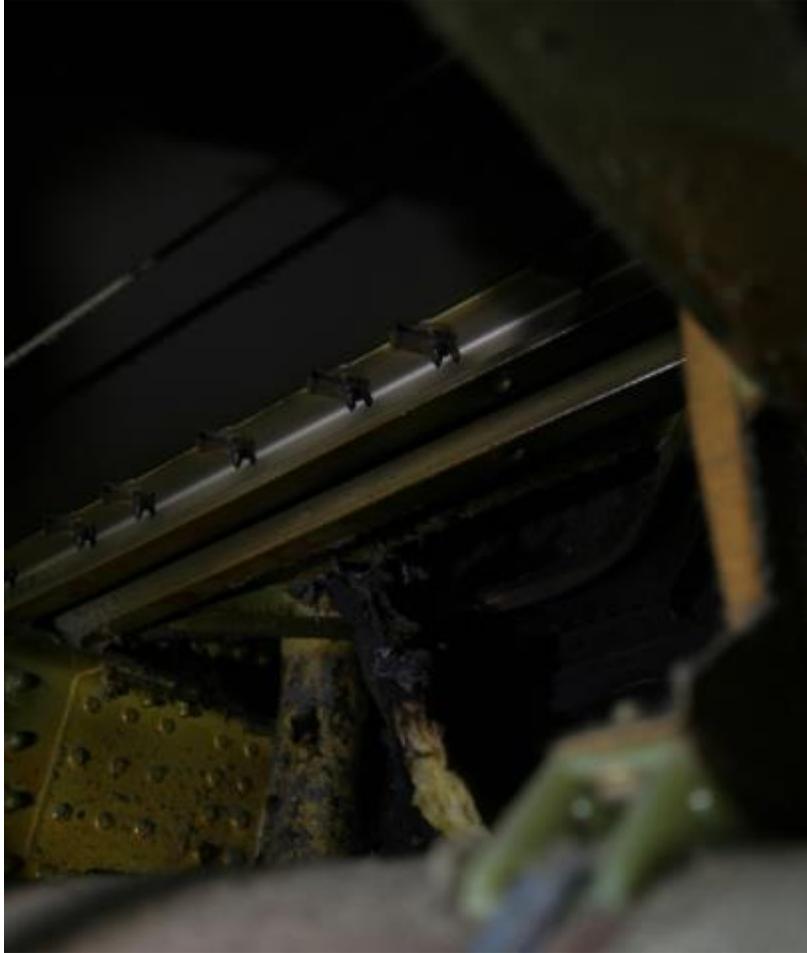
The cargo liners were opened between frames 888 and 940 to reveal the area inboard of the external fire damaged area see Figure 37 through Figure 40. The following observations were made:

- Between frames 867 and 888 the insulation just below the floor (~6") was discolored and a small area of the film was melted.
- Between frames 888 and 909 the insulation just below the floor (~8") was charred and the film shrank back.
- Between frames 909-930 there were small areas on the lower section of the blanket with burned film due to drips. The insulation blanket just below the floor (~8") was charred.
- Between frames 930 and 951 the insulation blanket was charred (6") just below the floor, and approximately 12" of the film shrank back.

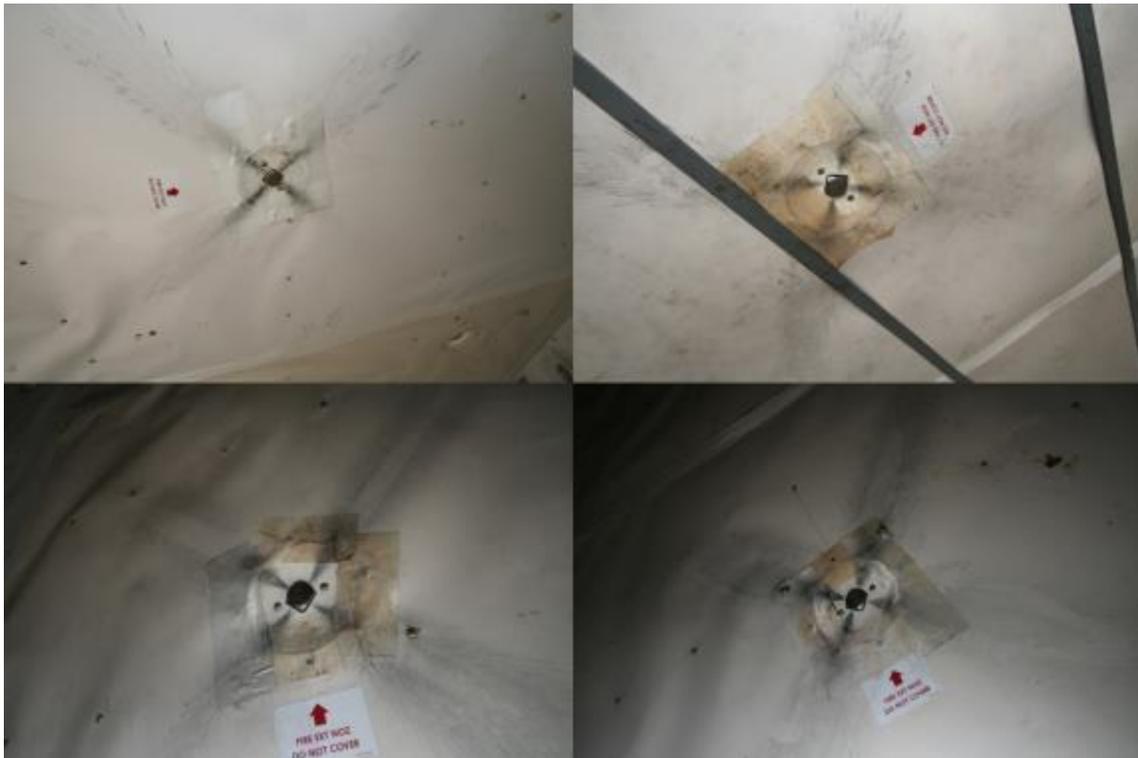
The cargo compartment and liners looked normal, no soot or thermal damage was evident. The ceiling liners did have spray pattern stains locally around the Halon discharge nozzles which is not unusual after a discharge.

The four halon discharge ports in the ceiling liners did have spray pattern stains locally around the Halon discharge nozzles, see Figure 43.

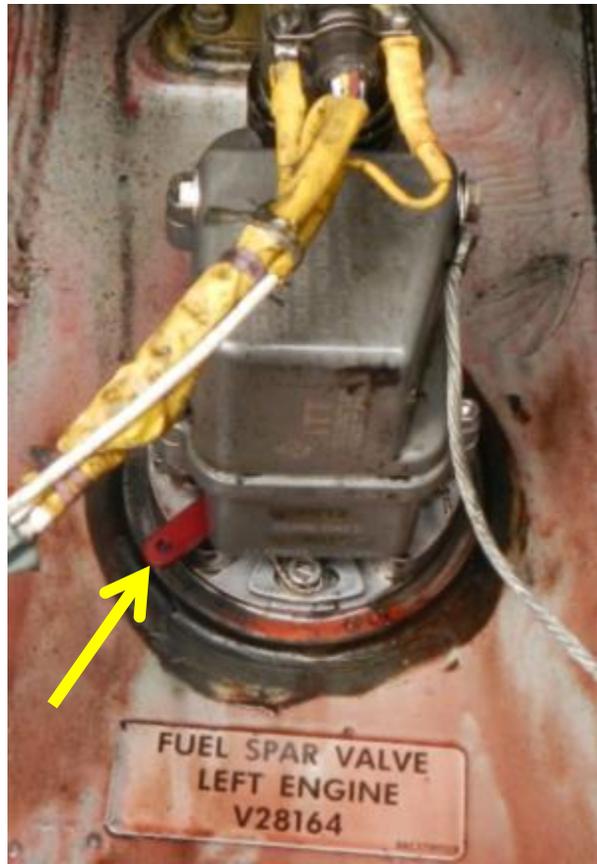
The position of the left main spar valve was verified by a visual inspection of the valve's position indicator on the rear spar of the wing. The left main spar valve was in the closed position. Fuel was not found leaking from the severed main fuel feed line. Information regarding the severed main fuel feed line can be found in the Powerplants Group Chairman's Factual Report.

Figure 46 - Left Engine Fuel Spar Valve in Closed Position
