----- AIRWORTHINESS GROUP CHAIRMAN'S FACTUAL REPORT -----

Location: Las Vegas, Nevada
Date: September 8th, 2015
Time: About 1627 PDT
Aircraft: Boeing 777-200
Serial Number: 29320
Registration: G-VIIO

3. SUMMARY

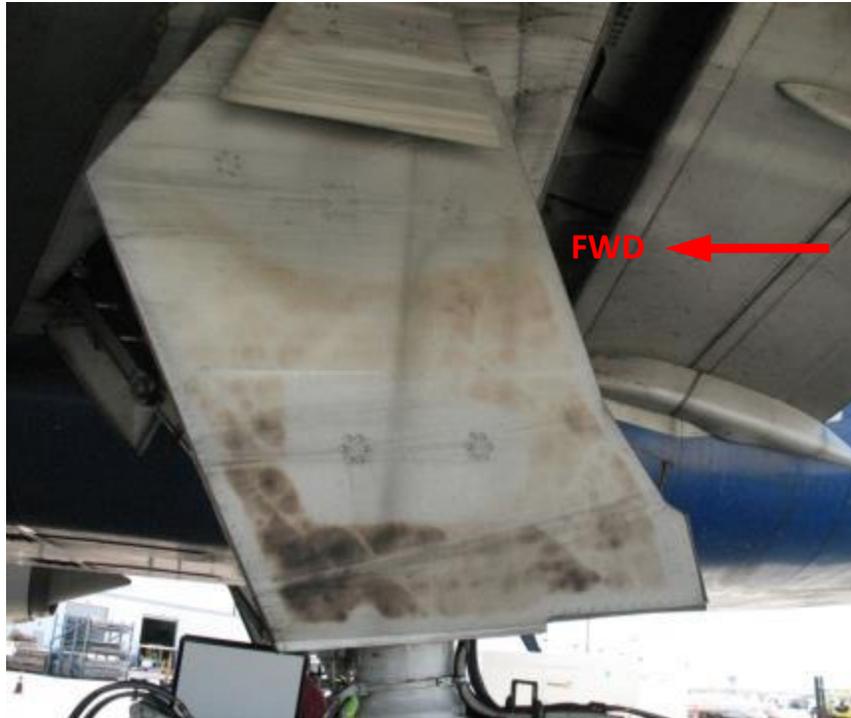
The shock strut mounted panel on the LH main gear had paint blisters and large delaminated areas.

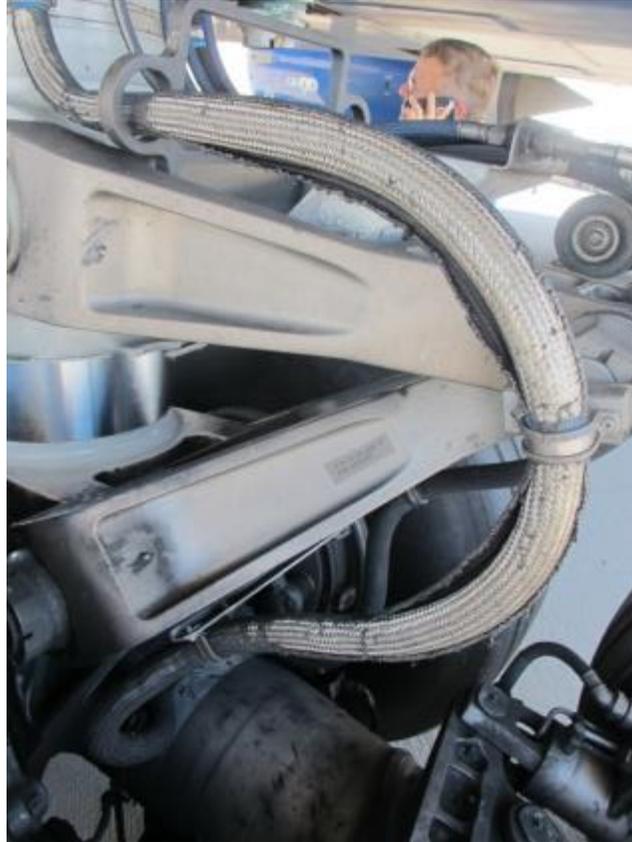
The outer braid of multiple landing gear hydraulic hoses was melted on the outboard facing side only. Areas shielded by the tires and strut-mounted panel showed no signs of heat damage including the forward or inboard areas of the gear or gear systems.

Figure 48 - Area of melted outer hose braid on LH main landing gear

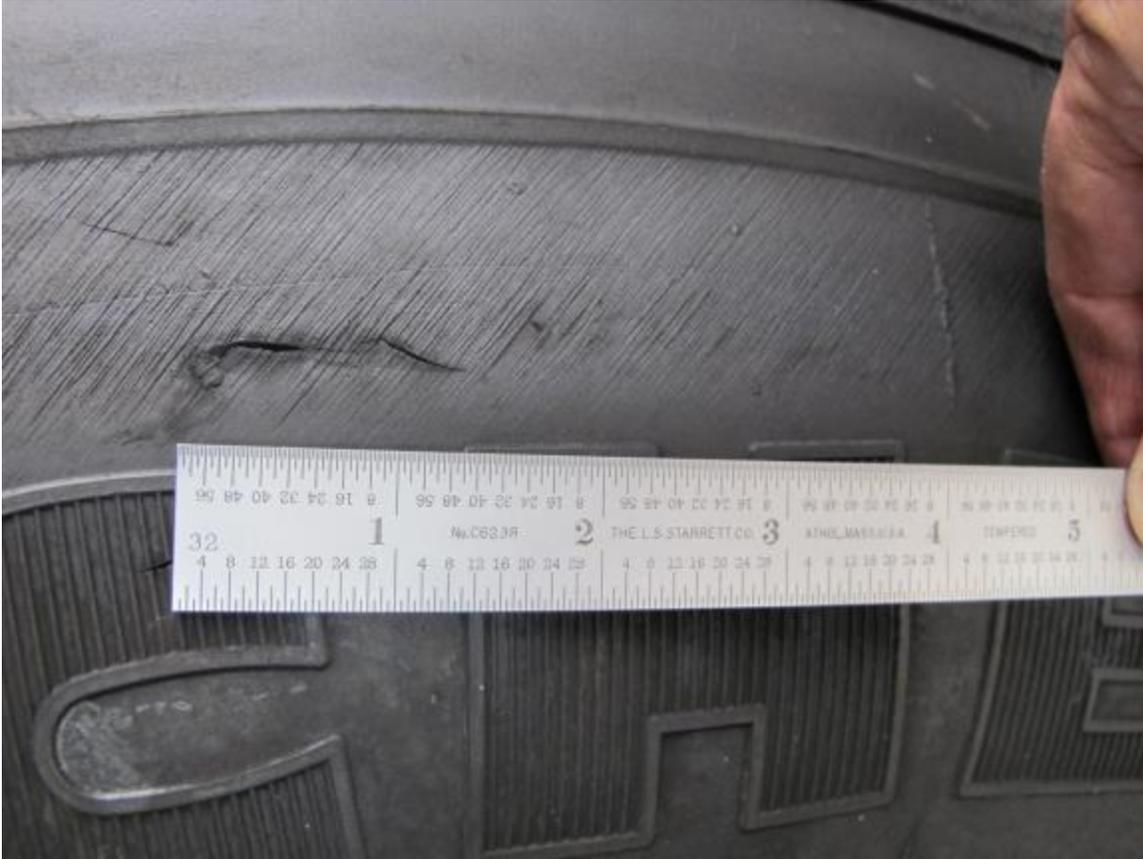
The sidewalls of the main landing gear tires were inspected and a side wall cut was also found in the outboard sidewall of tire 5, see Figure 53. The total length of the cut was approximately 1.25 inches.

Figure 53 - Cut found in the outboard side of tire 5

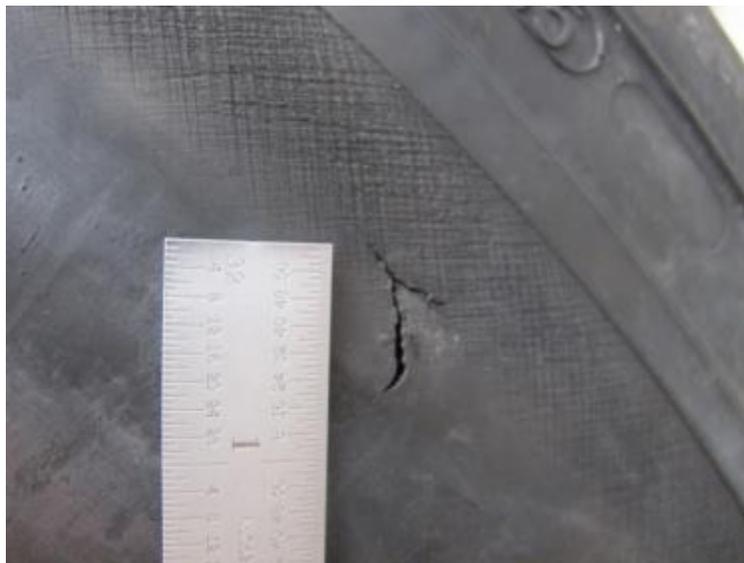
On tire 9, a “vee” shaped cut was seen on the sidewall of the outboard side of the tire. One arm of the “vee” was measured at approximately 0.75 inches and the other arm of the “vee” was measured at approximately 0.375 inches, Figure 54.

Figure 54 - "Vee" shaped cut in sidewall of tire 9

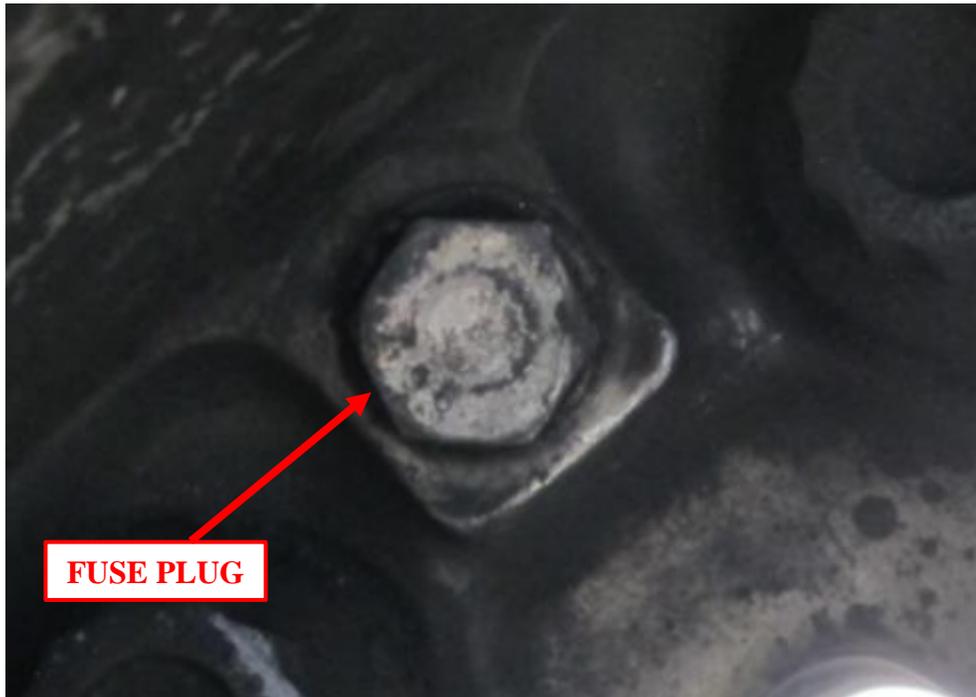
Tire 9 was removed to allow for inspection of the thermal fuse plugs. Four thermal plugs were installed on the inner portion of the wheel hub. The four fuse plugs were removed and visually inspected and did not appear to be fused open, see Figure 55. During the removal of one of the fuse plugs, the fuse plug broke in the wheel rim, but the fuse plug showed no signs of activation.

Figure 55 – Typical fuse plug condition
