Beechcraft Letter Regarding Aileron Components Examination

Subject: Beechcraft Corporation Model 390, Serial Number RB-226, Registration N26DK,
accident in South Bend, Indiana on March 17, 2013

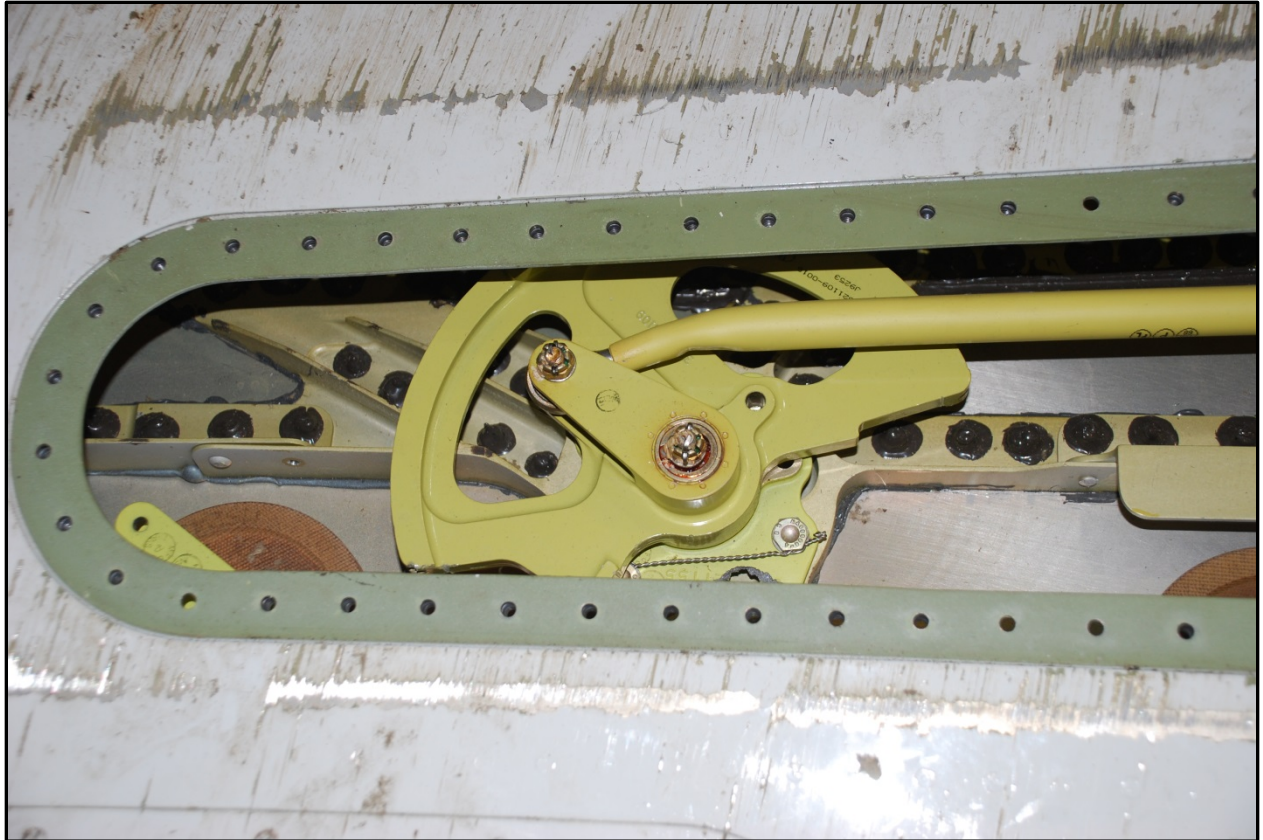
Figure 1: Aileron Bellcrank Assembly before Removal

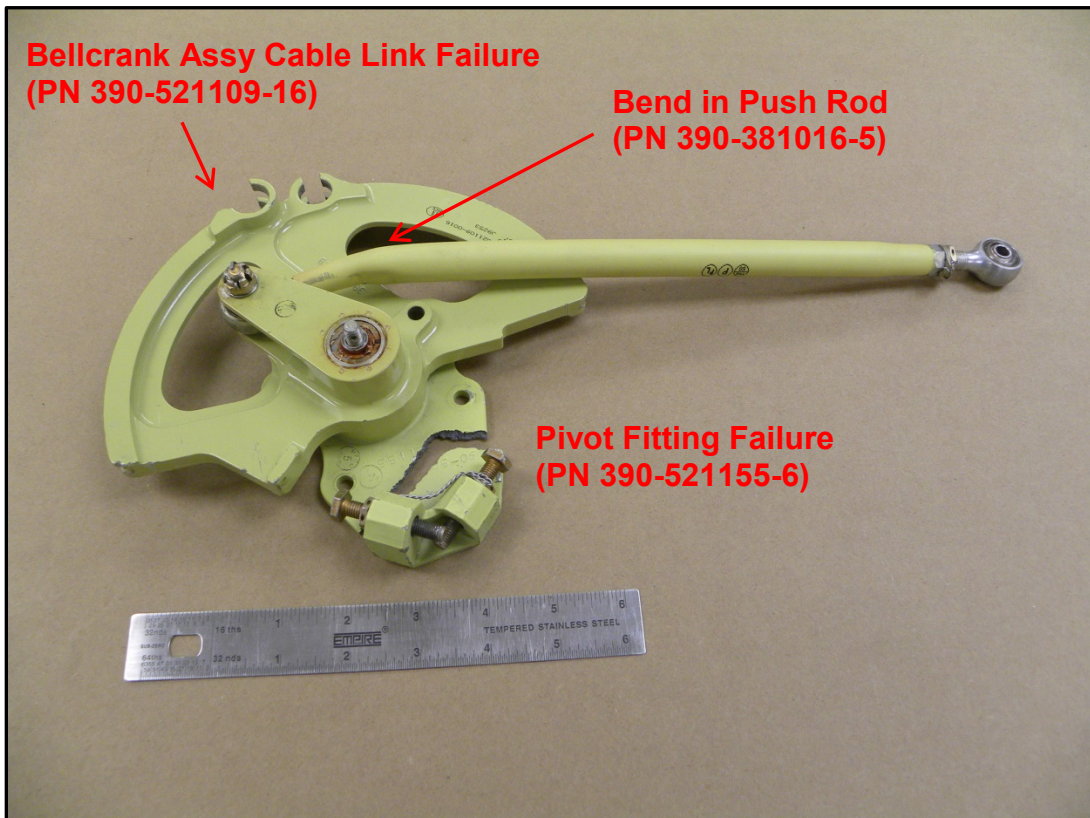
Figure 2: Bellcrank Assembly as Received

The assembly presented three different areas of separation. Figure 2, above, displays the parts as received by the lab with each area noted. The bolts in the pivot fitting serve as physical stops for the bellcrank assembly's rotation. Visual inspection of the fitting showed that the bellcrank made an impact with the left-side bolt. As shown in Figure 3, the bellcrank itself also showed signs of impact from the same bolt. The right-side bolt showed no signs of impact or wear. Figure 4 is the underside of the pivot fitting where it buckled under compression near the bolt opposite the impact. Once the fitting had completely fractured, the cable continued to pull on the bellcrank causing the push rod to bend as shown in Figure 2. Finally, the cable broke loose from the bellcrank. Figure 5 shows the cable link failure. Both fracture faces, on the pivot fitting and on the bellcrank, are clean; consistent with the entire assembly failing collectively and recently.

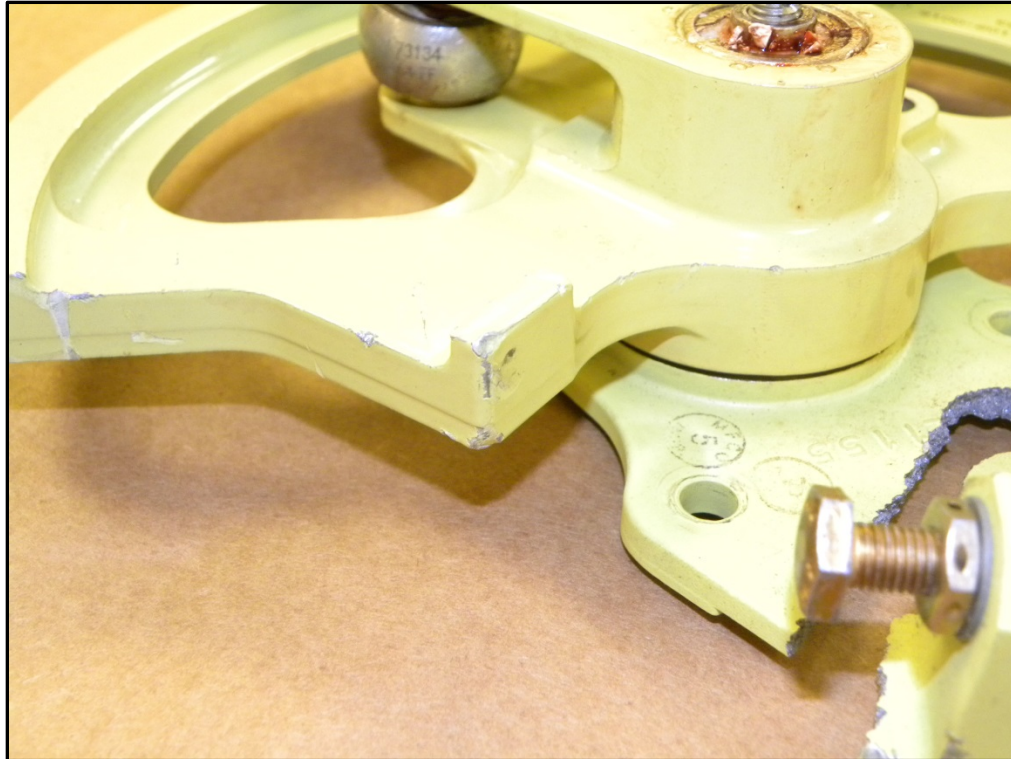
Figure 3: Impact Zone on -16 Bellcrank

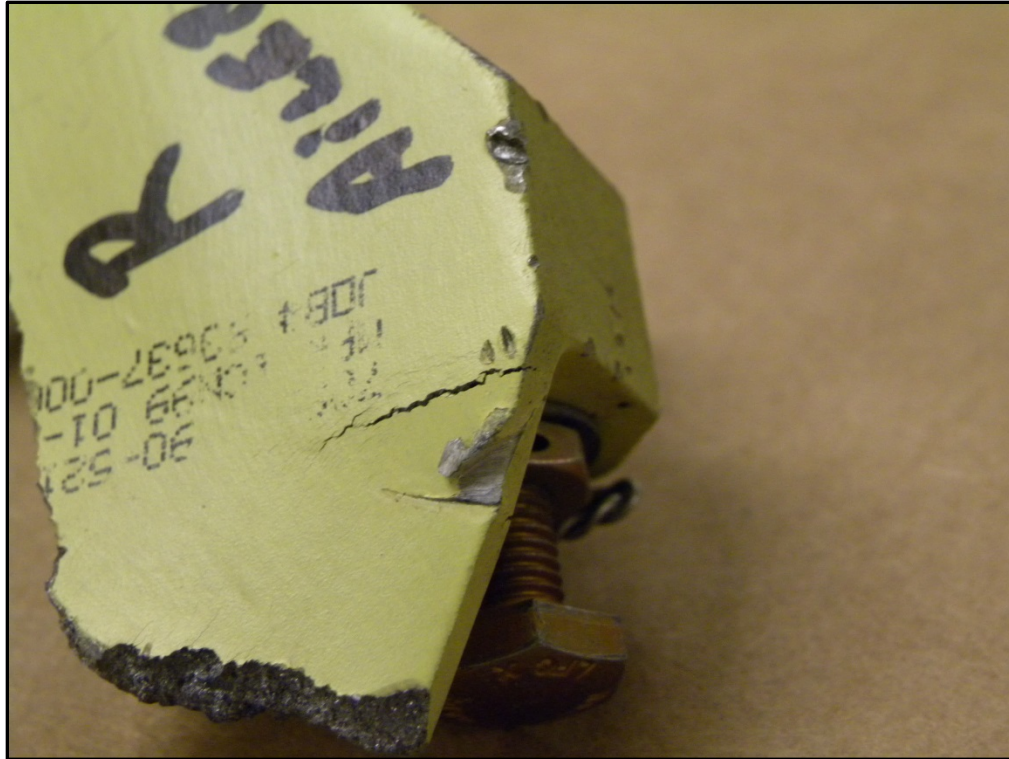
Figure 4: Fracture Under -6 Pivot Assembly from Buckling

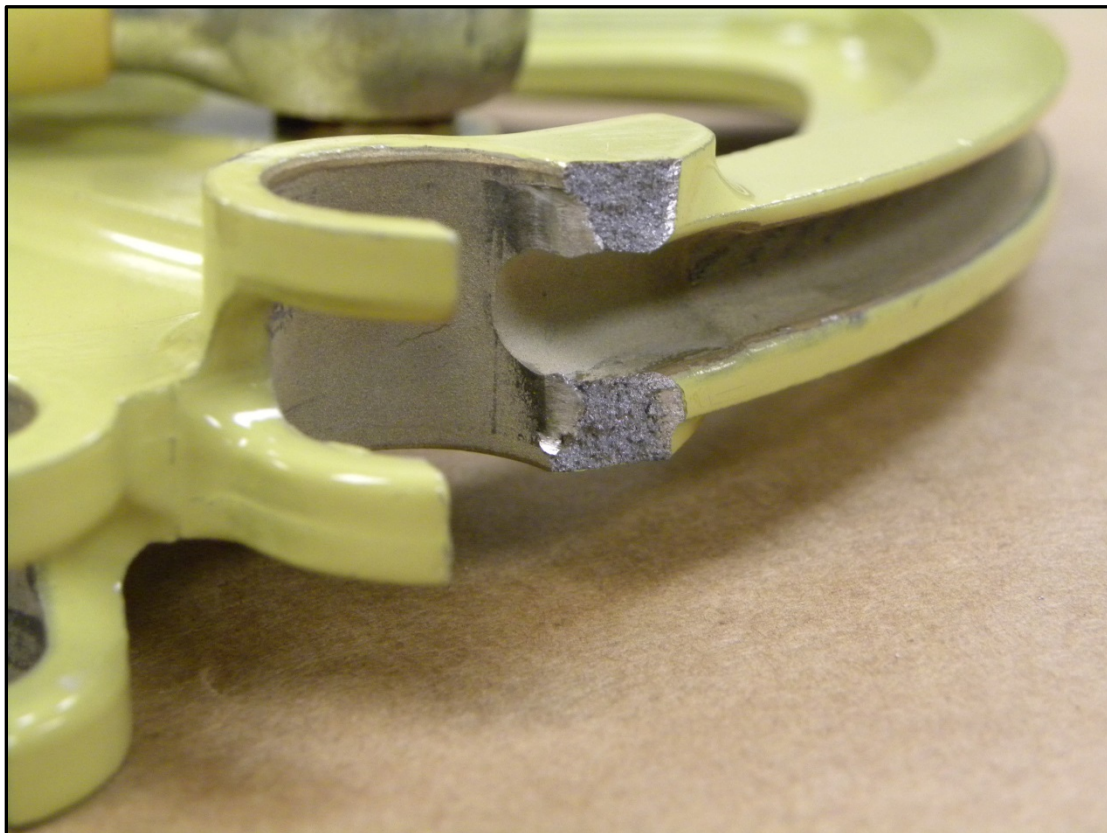
Figure 5: Cable Link Failure on -16 Bellcrank

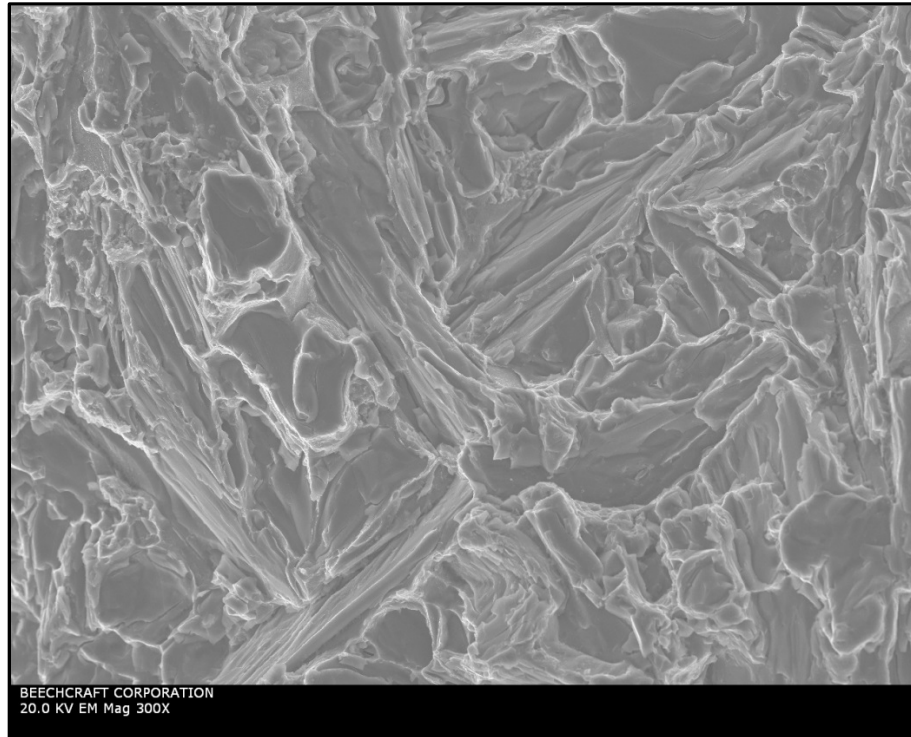
After the initial visual inspection, the fracture surfaces were examined using a Scanning Electron Microscope (SEM). Figure 6 displays the fracture face of the pivot fitting at 300X. This image shows a fracture surface common to overload on castings. The cable link failure was also examined (Figure 7) and was found to have similar characteristics of overload.

Figure 5: Pivot Fitting Fracture Face at 300X

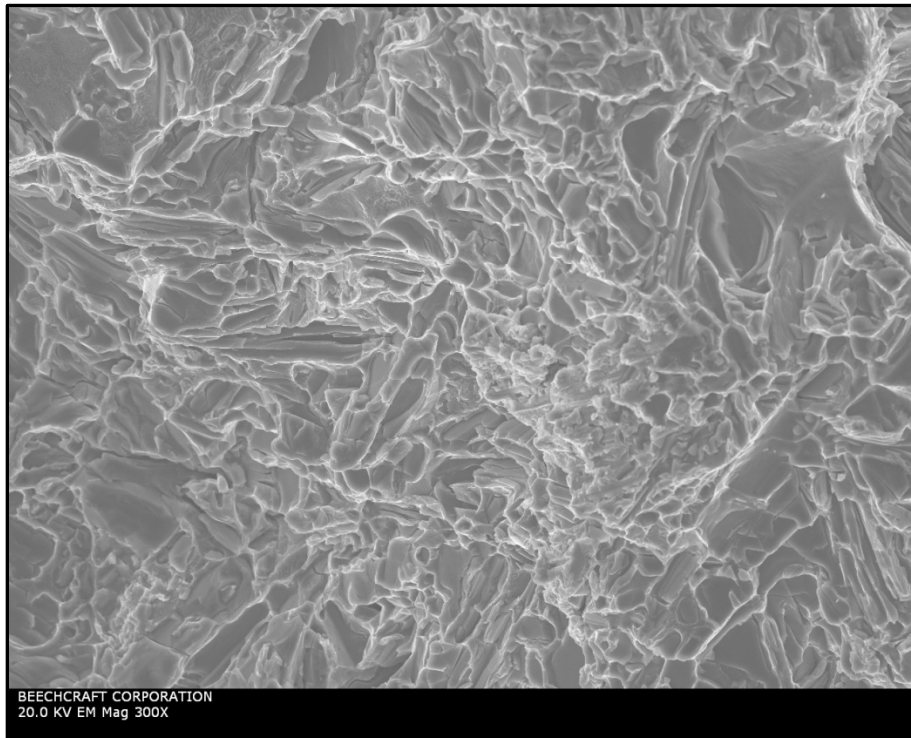
Figure 6: Cable Link Fracture Face at 300X
