ATTACHMENT 5

Moog Report Regarding Spoiler Control Unit Circuit Card Examination

Subject: Investigation of SCU 233700-109 S/N 0218 (HBC PN: 390-384011-0019)

On March 17, 2013, a Hawker Beechcraft model 390 (Premier IA) business jet, registered N26DK, collided with residential structures at the South Bend Regional Airport (KSBN), South Bend, Indiana.

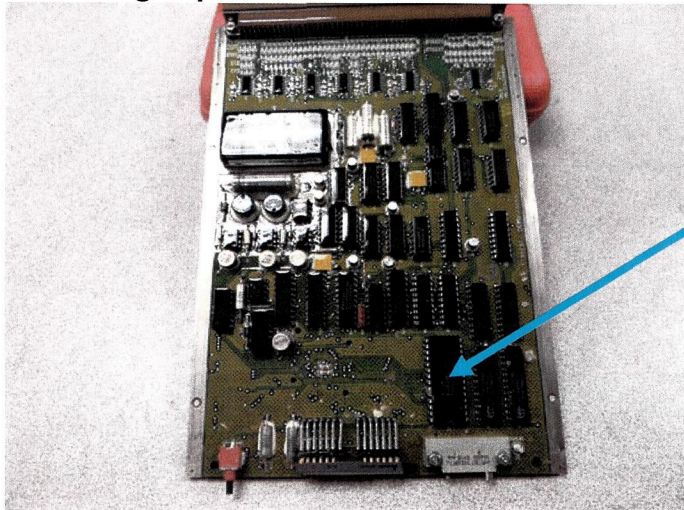
BIT / Diagnostics Board PN: 233498-001 from SCU S/N: 0218

The NTSB contacted Moog and sent pictures of the BIT / Diagnostics board (PN: 233498-001) that they removed from the ECU unit, S/N 0218. Moog did not know they were going to open the unit and remove the cards. There appeared to be no damage to the board.

U3 – NV RAM
memory chip
