Rockwell Collins CRASH INVESTIGATION REPORT FOR THE FMC-3000

AIR-13-05

LOCATION: South Bend Regional Airport, Indiana

AIRCRAFT TYPE / TAIL: Beechcraft Premier 1A / N26DK SN: RB-226

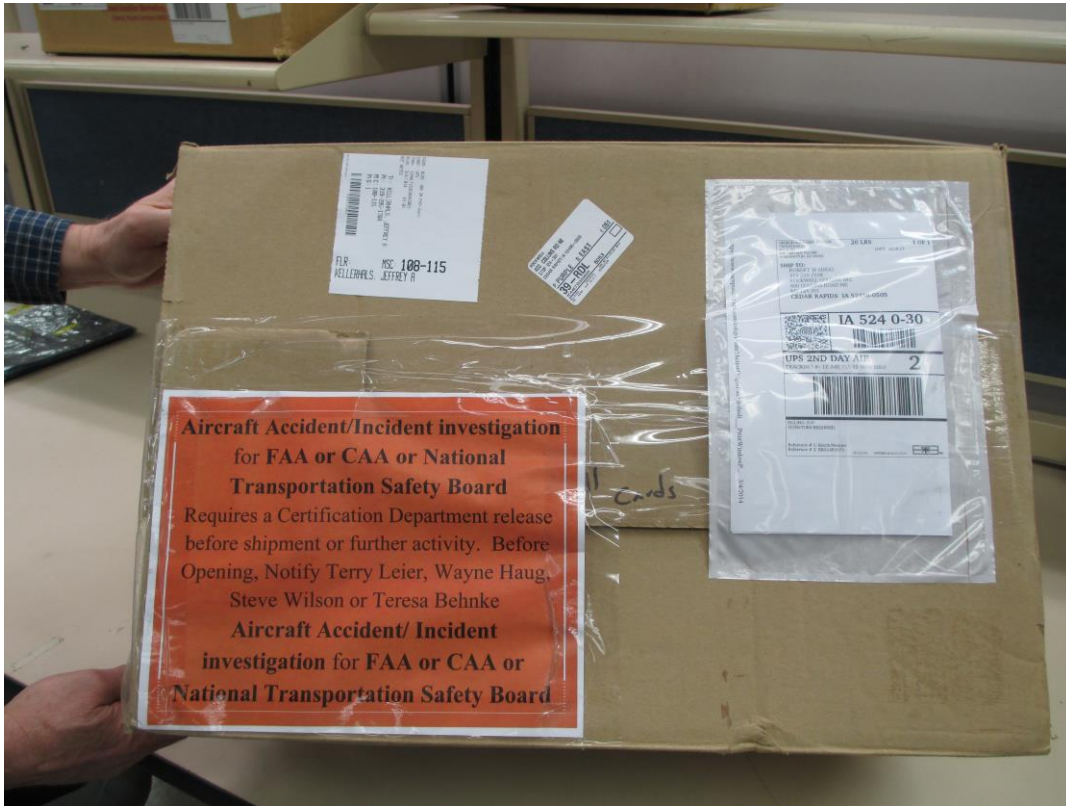
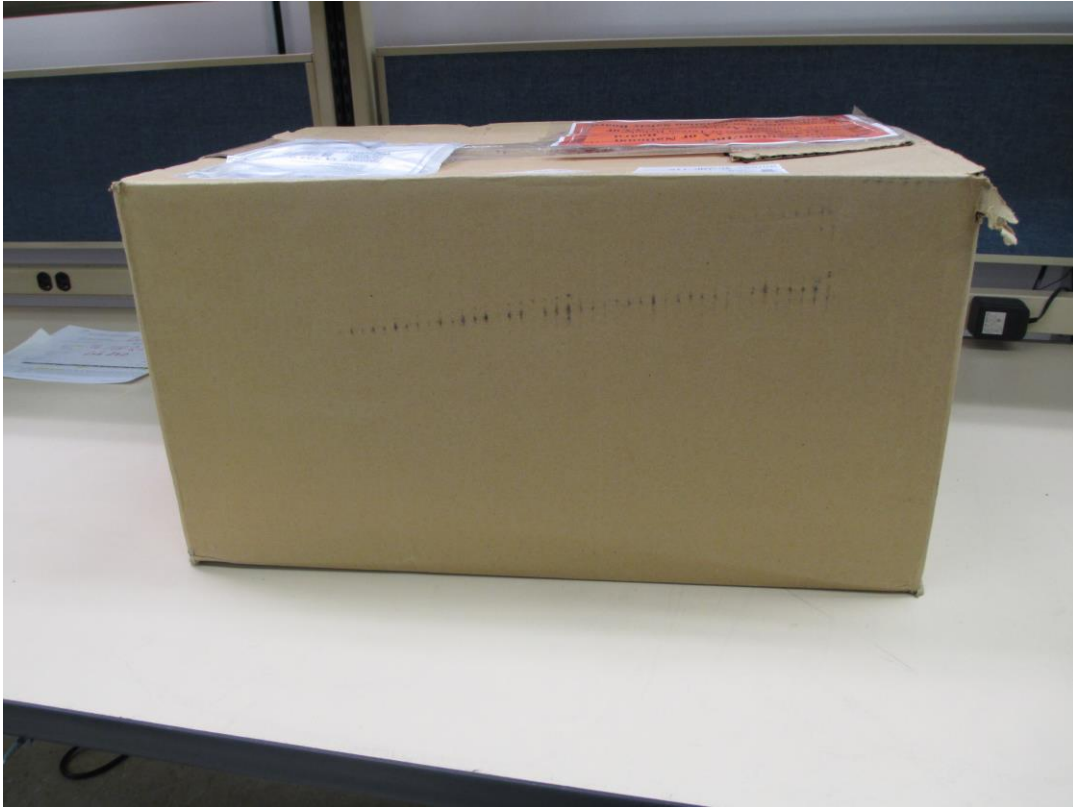
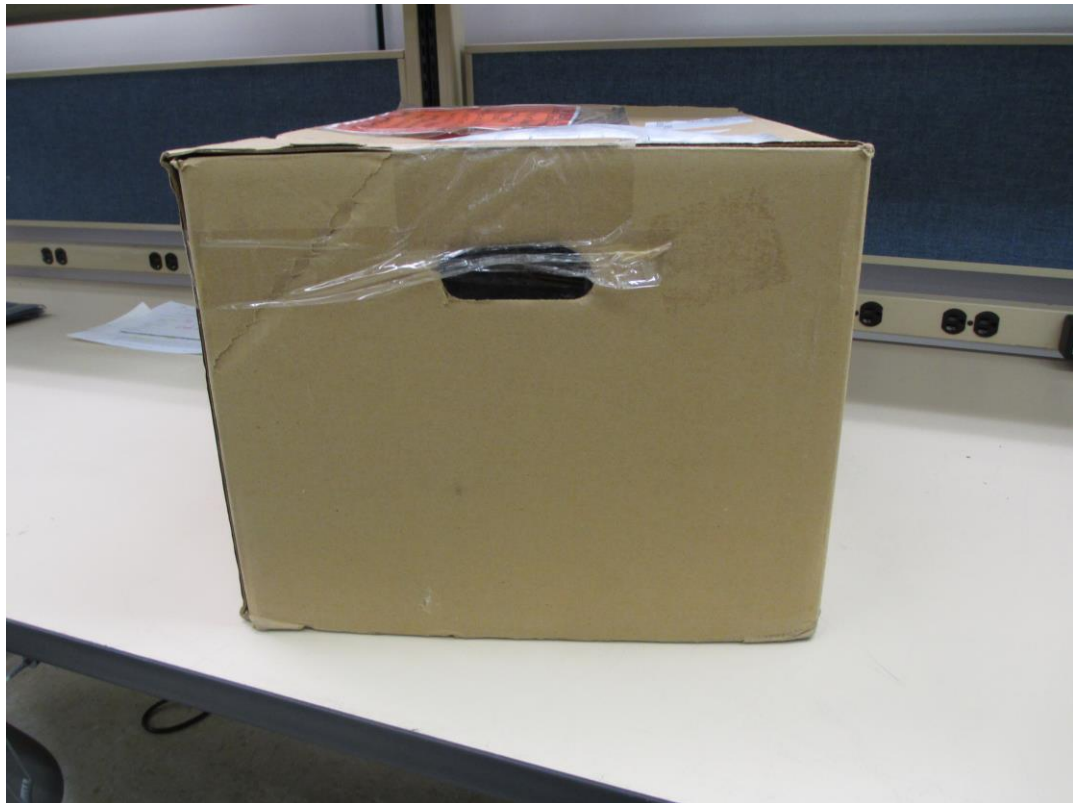
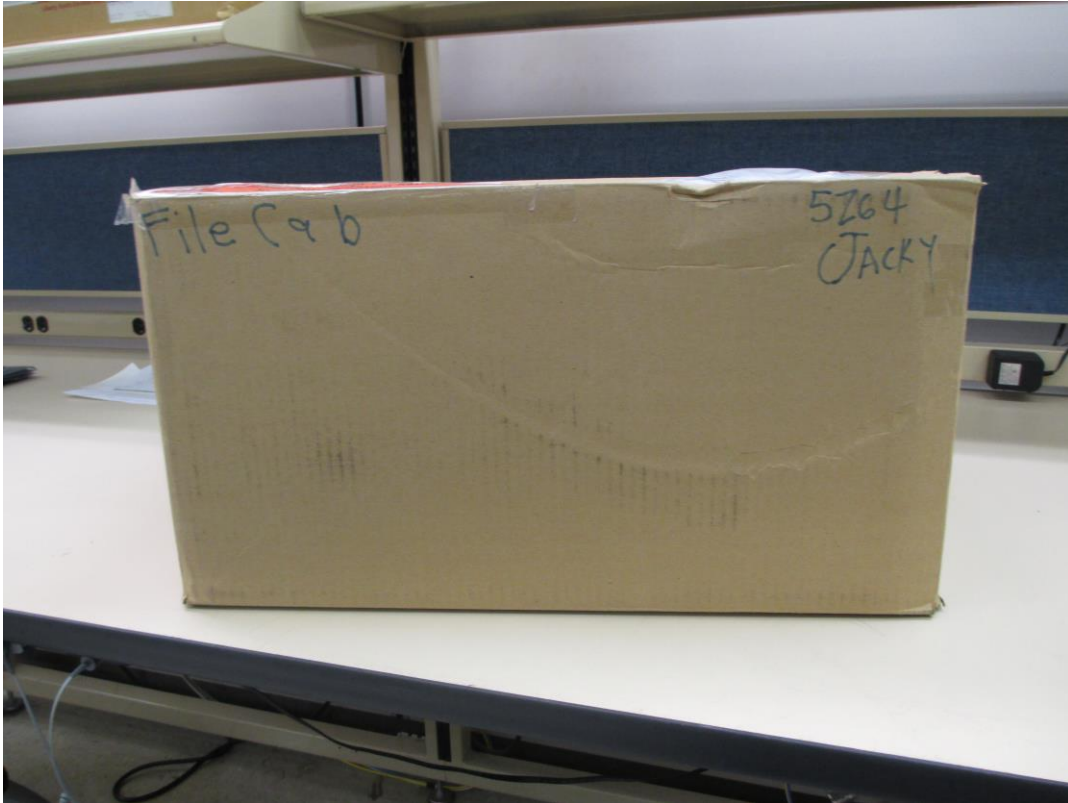
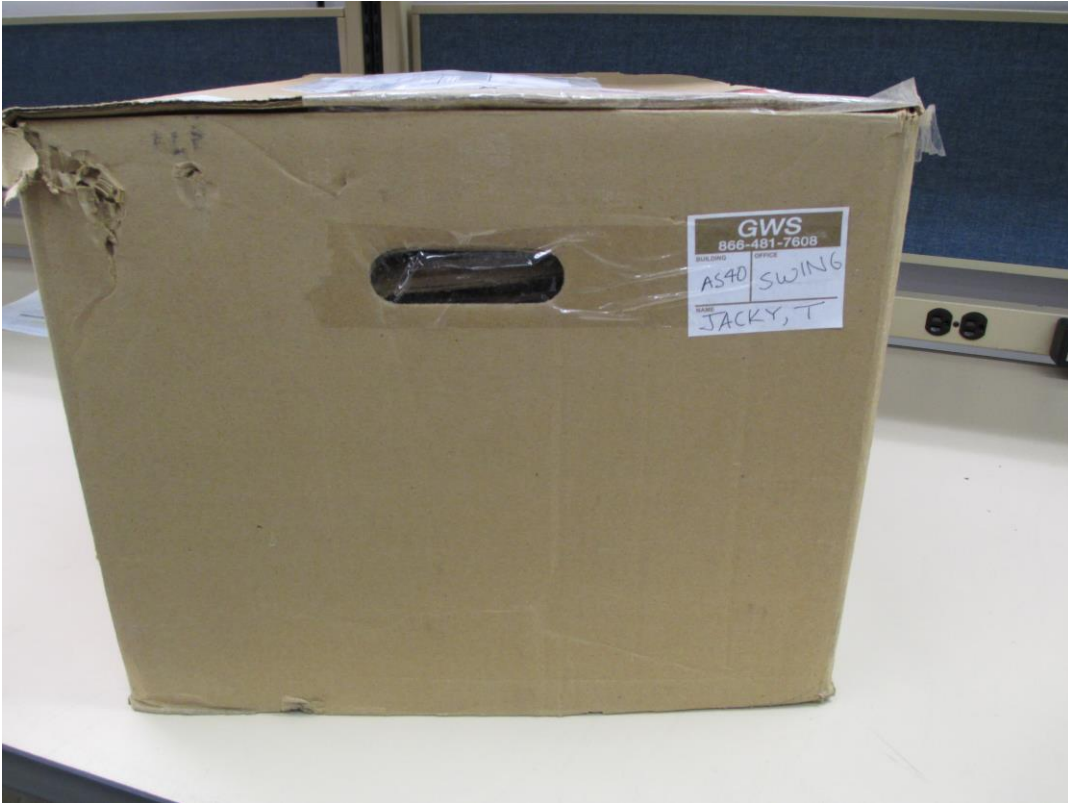
- a. Examine shipping container for any trace of abnormal smell or odor.
 - i. Shipping container in good condition.
- b. Examine condition of the shipping container that houses the FMC-3000 for signs of wear & tear or any physical damage.
 - i. Minor damage noted. Minor damage did not translate to any internal damage to units.
- c. Examine shipping container for signs of liquid spills or contamination on the container's surfaces.
 - i. No signs of liquid spills or contamination.

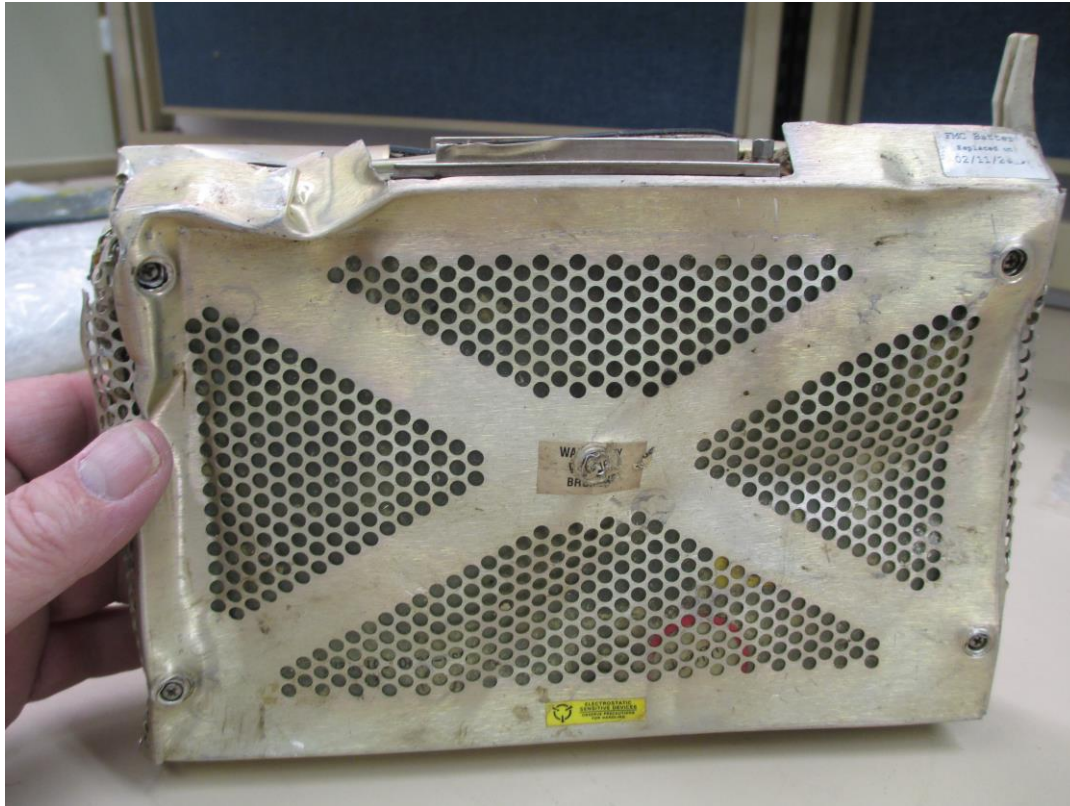
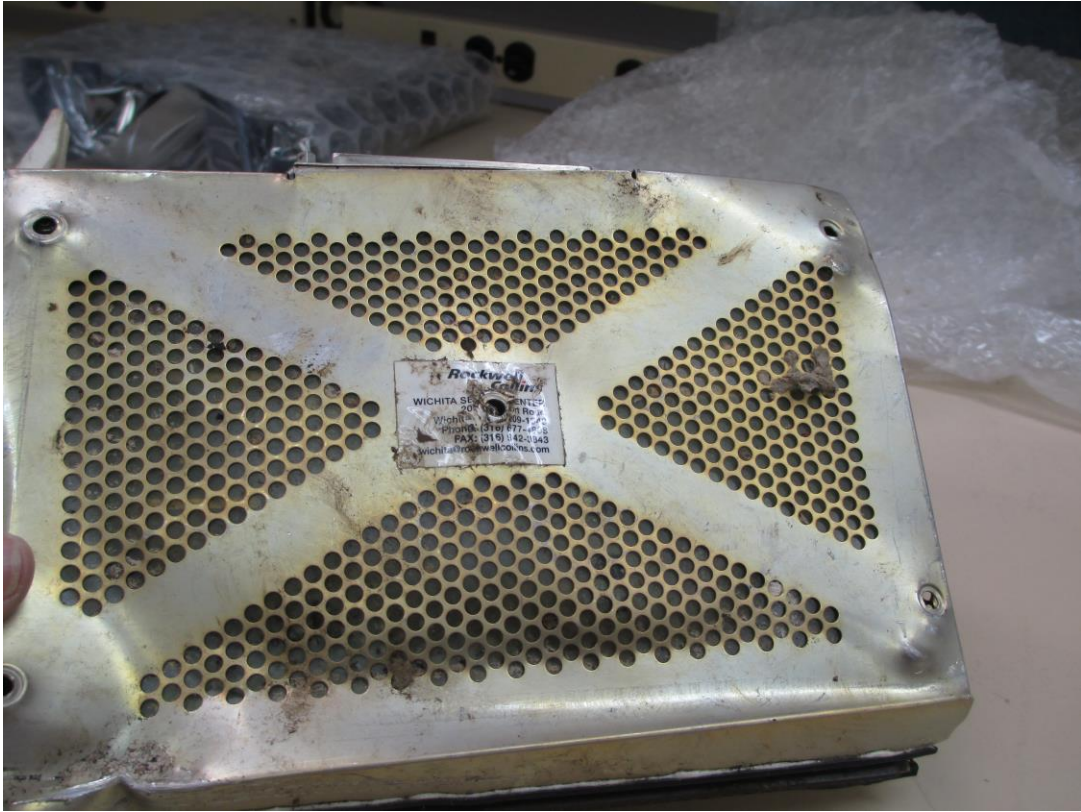
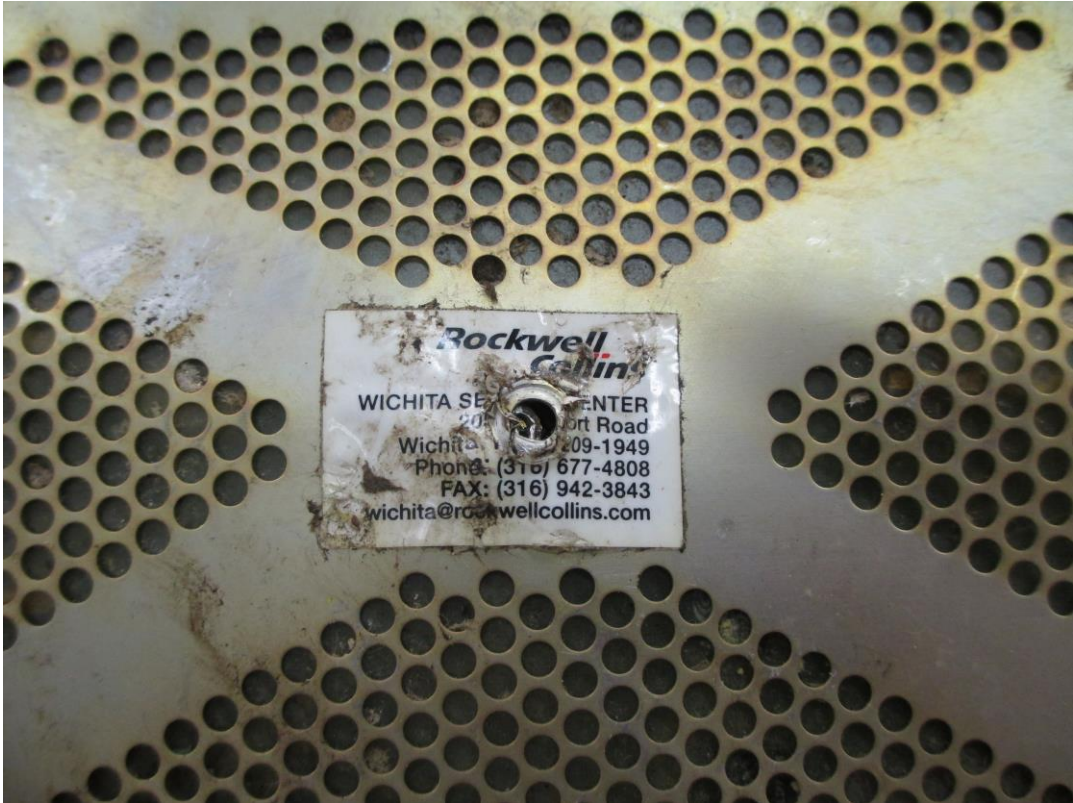
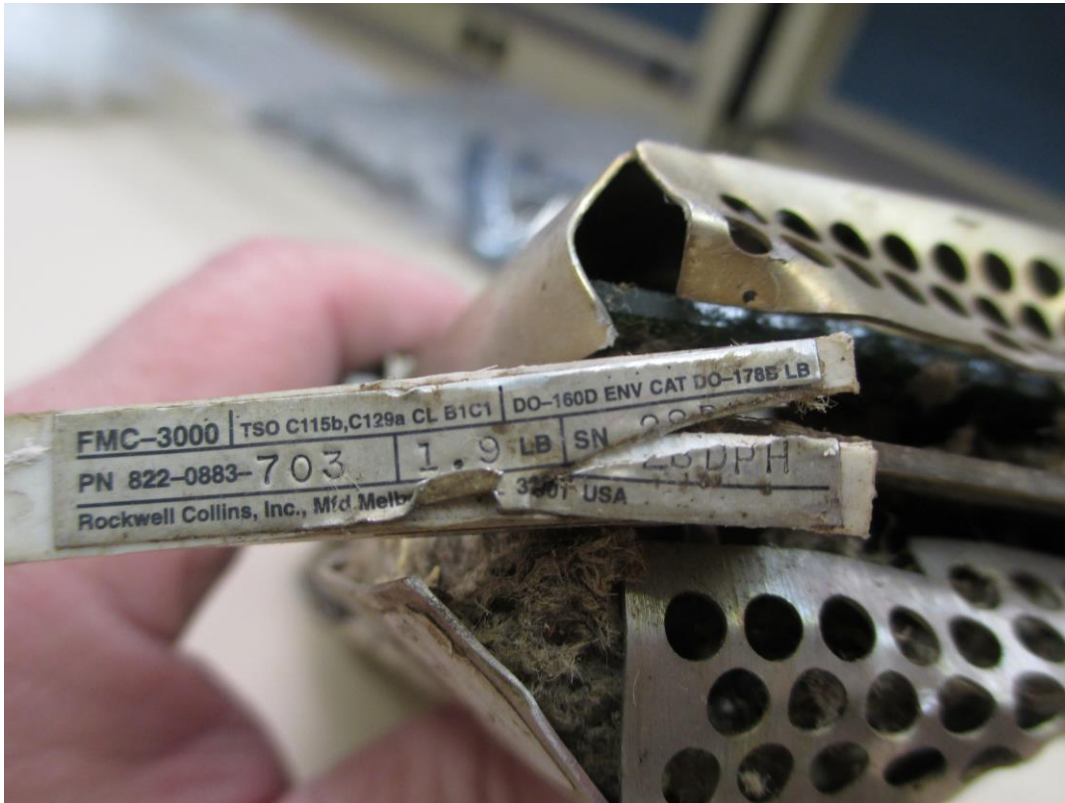
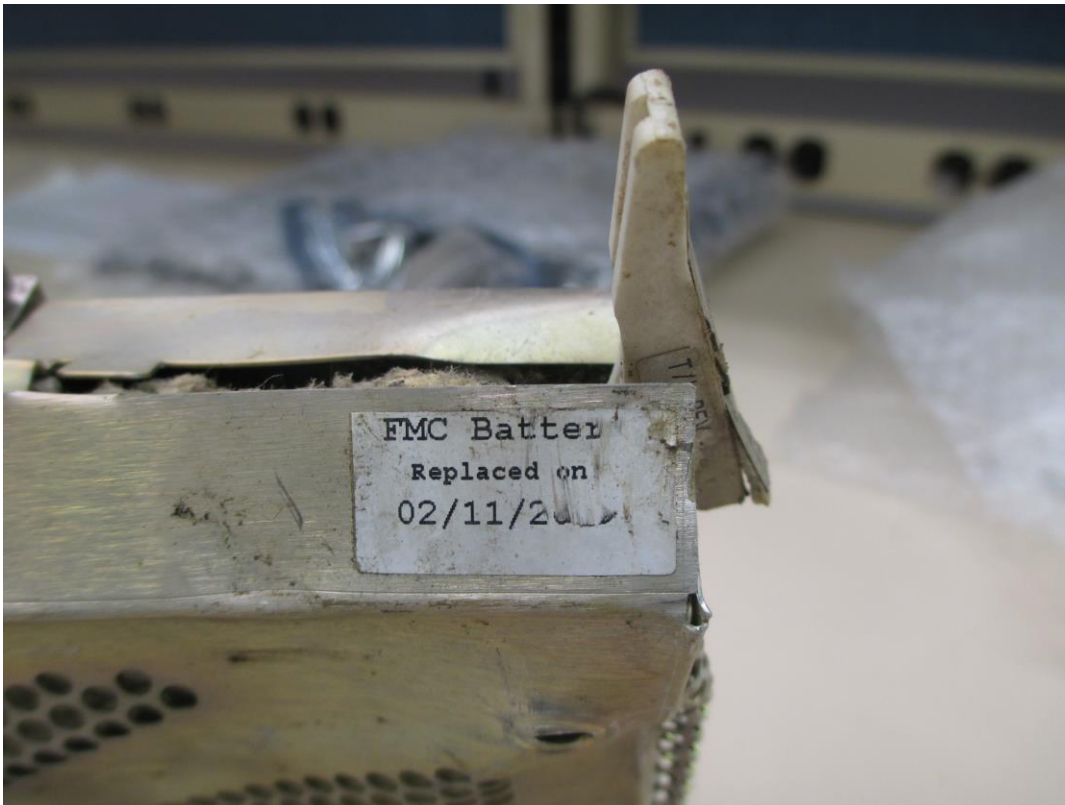
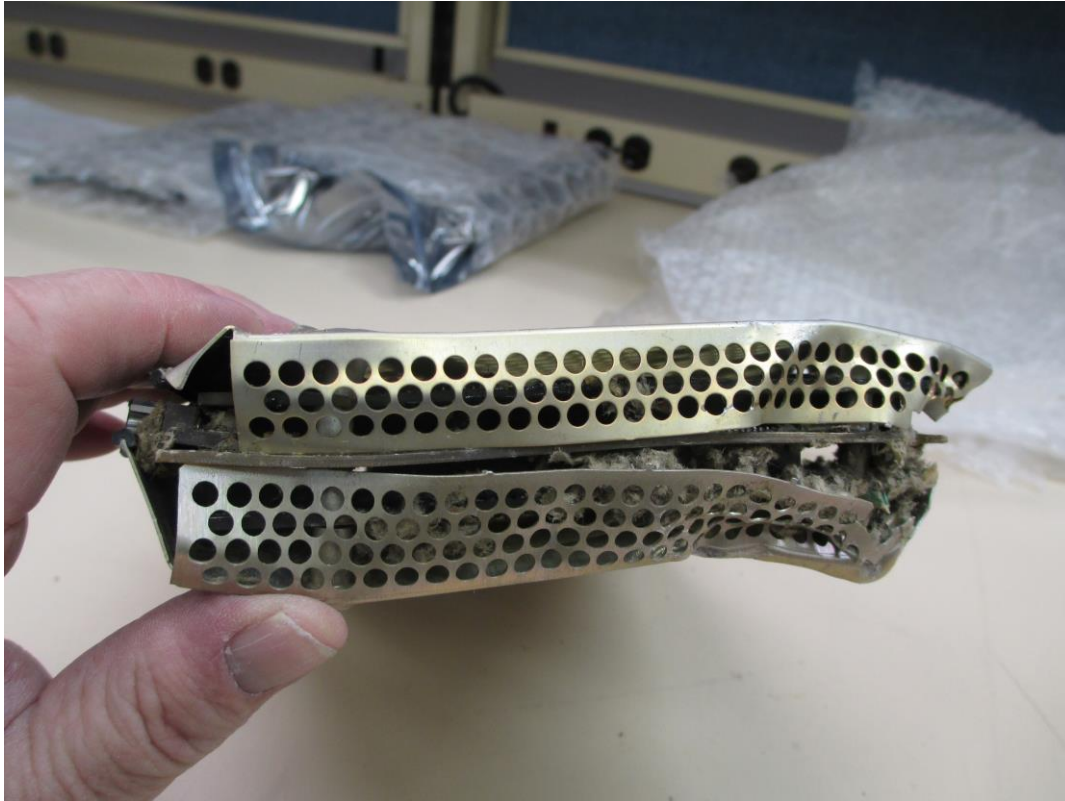
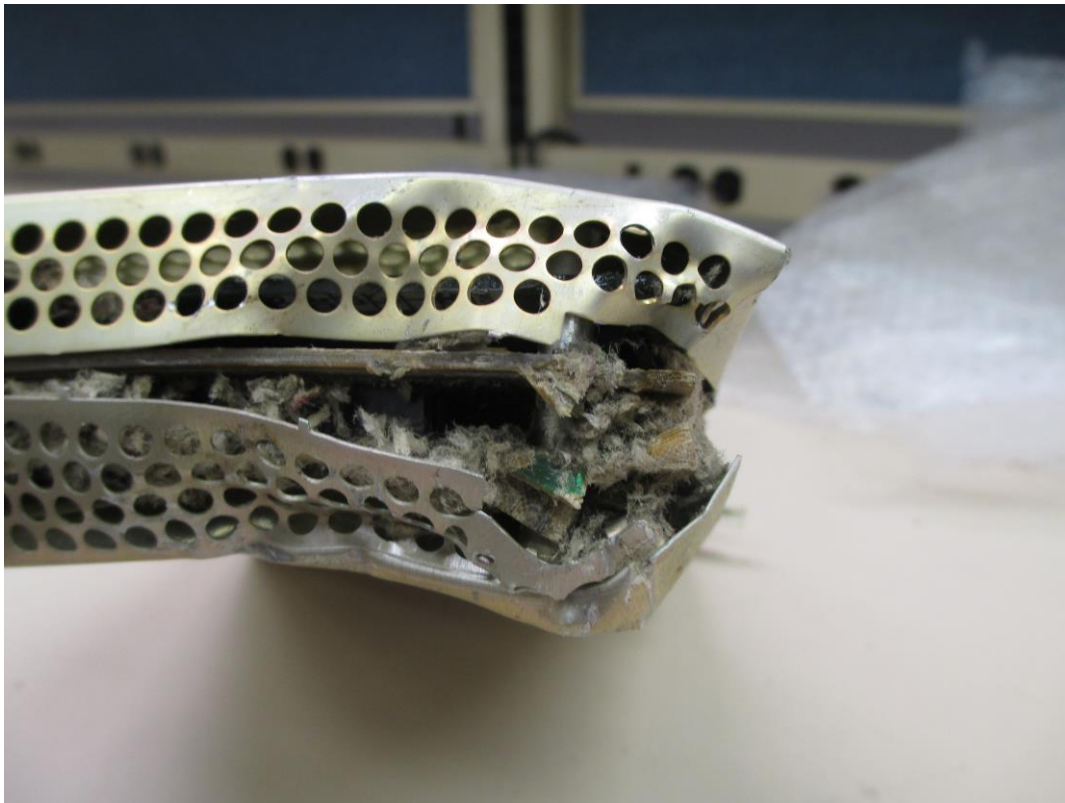
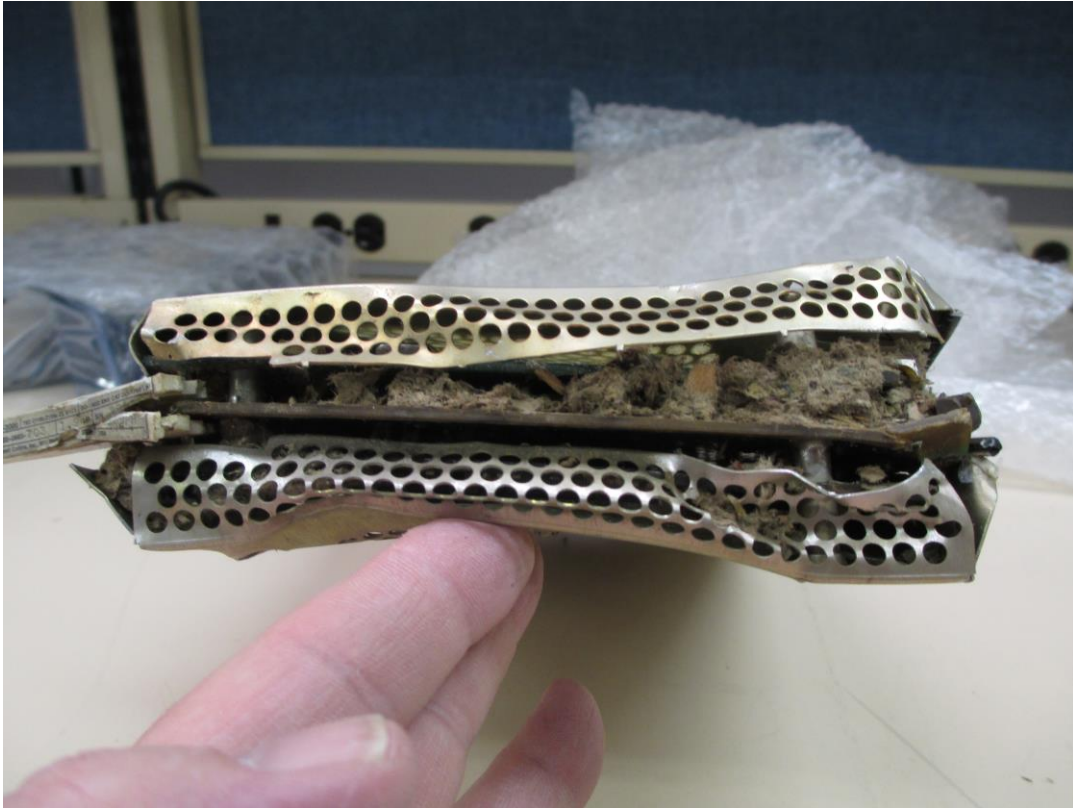
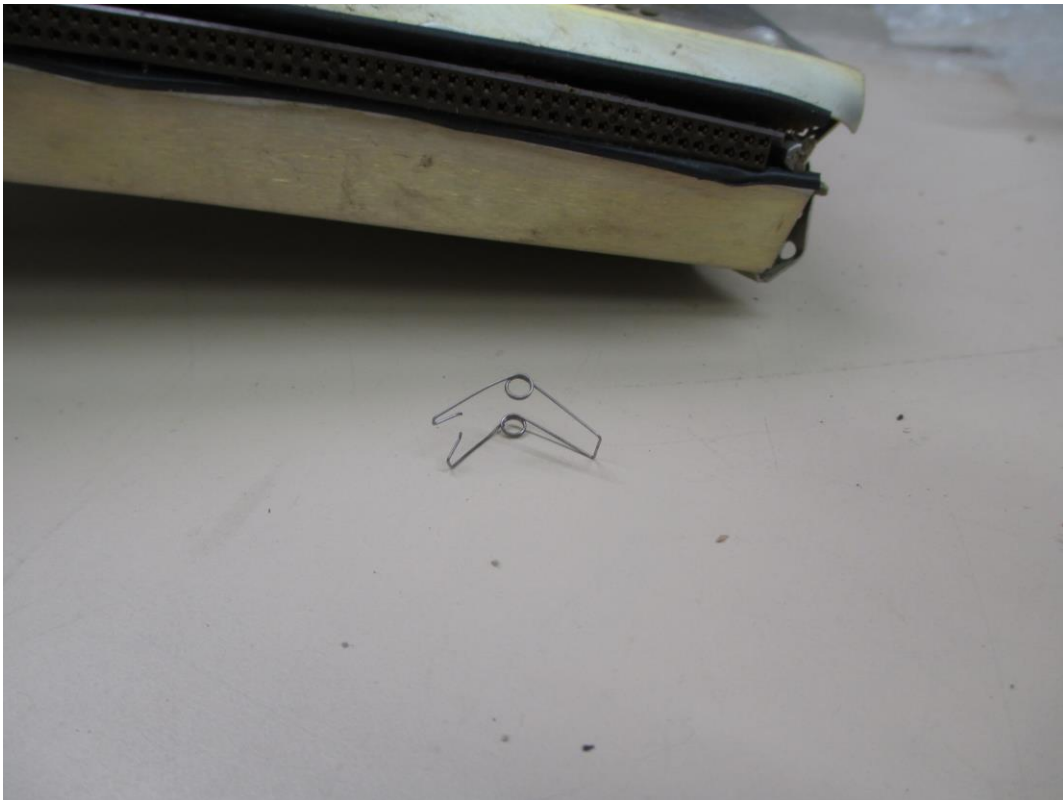
SN 28DPH was removed from its shipping box. Initial visual inspection showed extensive damage to the exterior covers and some foreign material was inside the unit. The top and bottom covers were able to be removed from the unit without removing the cover screws. The cover screws on one of the covers were pulled through and were not holding the cover onto the CCA assembly. Applying a little pressure to the second cover allowed for the cover screw to detach from the cover.

The Center standoff was bent so a vice grip was used to aid in the removal of the damaged standoff. Reference Figure 3 through Figure 15.

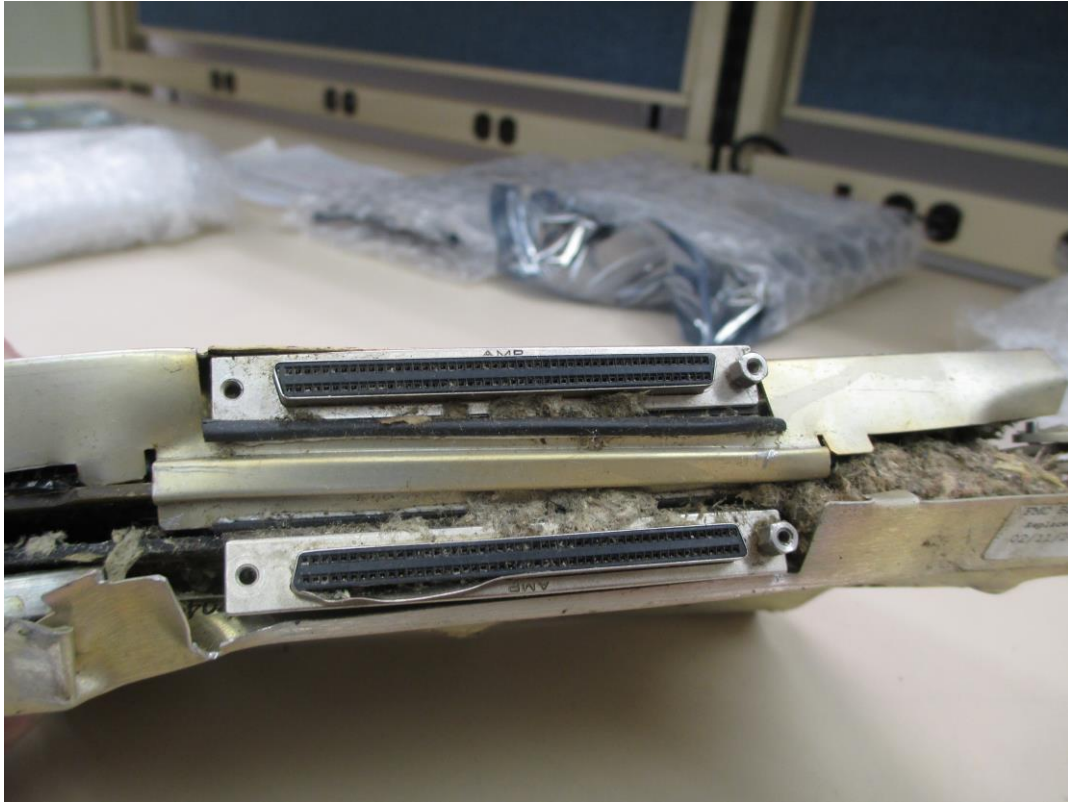
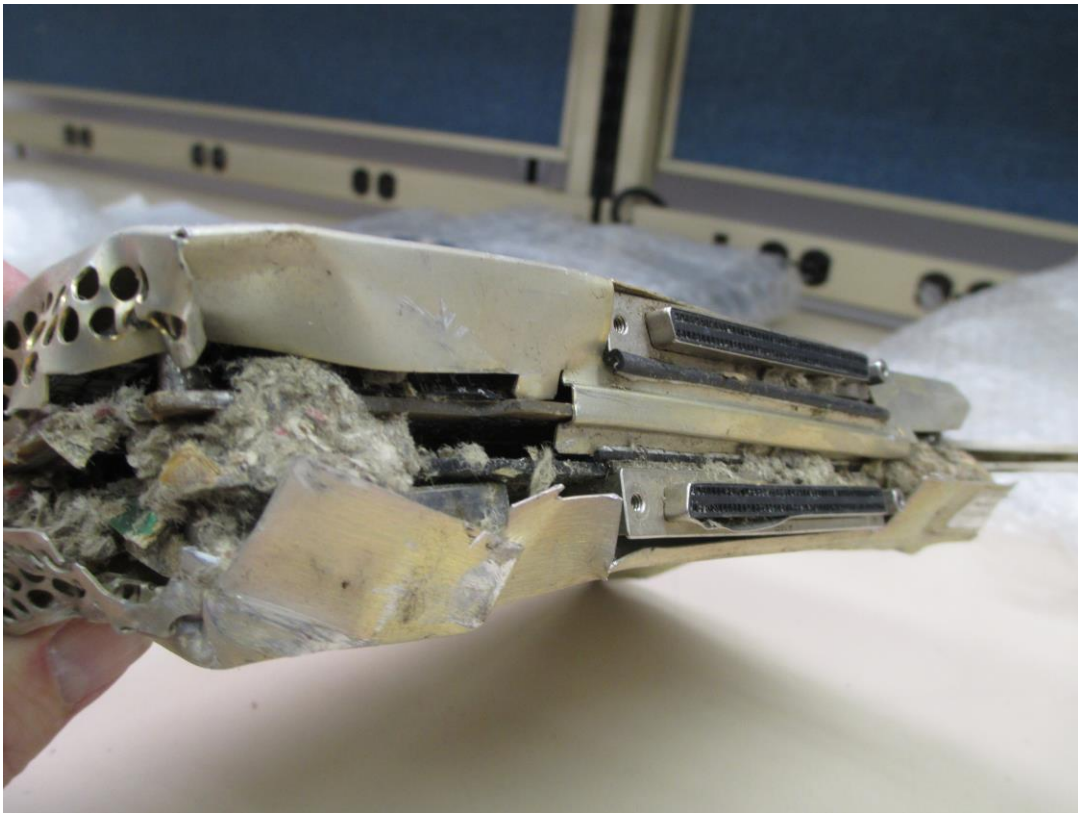
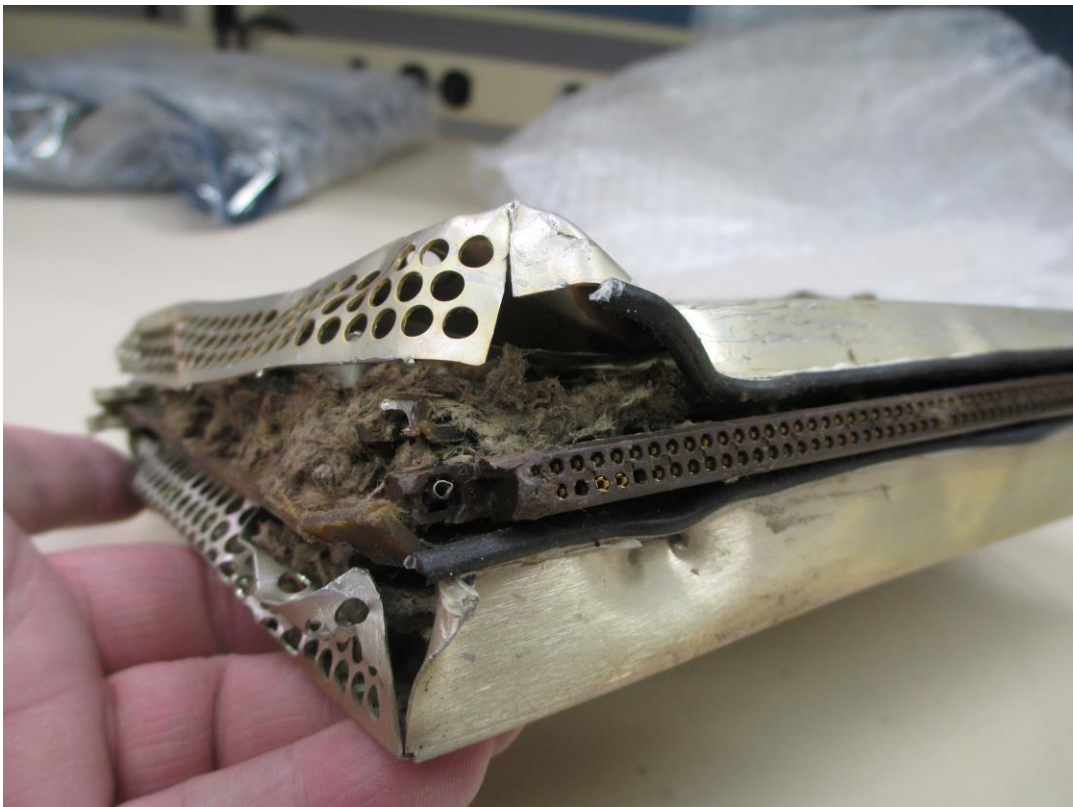
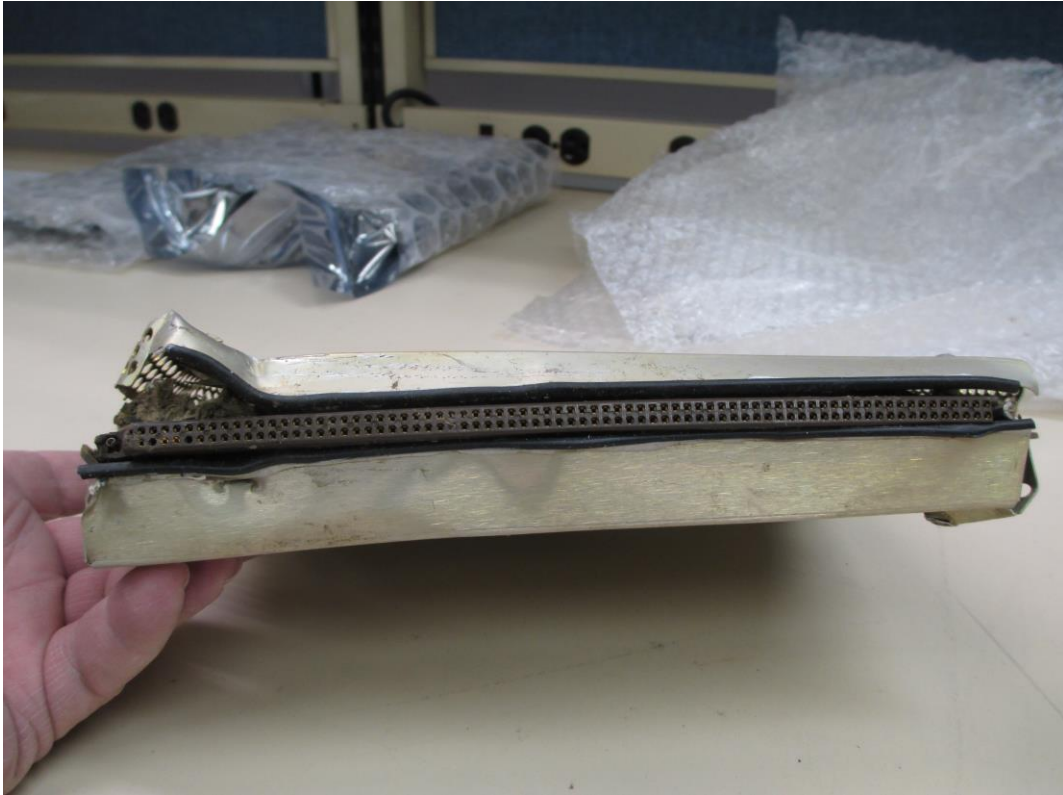
- a. Take photos of the FMC-3000 from all sides to show condition of the FMC-3000 being received. Include close-up photos of the ID tag(s) and its warranty seal.
 - i. See Figure 14 through Figure 26 in Appendix A.
- b. Examine the FMC-3000 exterior for any possible damage or scratches, any sign of overheating, corrosion, liquid spill or discoloration. Note, record and photograph findings.
 - i. Initial visual inspection showed extensive damage to the exterior covers and some foreign material was inside the unit. See Figure 14 through Figure 26 in Appendix A.
- c. Inspect the external connectors and check for ESD protection. Look for any signs of damages in the connector shells and pins for liquid spill, corrosion, overheating and discoloration. Note, record and photograph findings.
 - i. Figures 21, 22, 24 and 25 show that there is some damage to the A1 CCA connector.

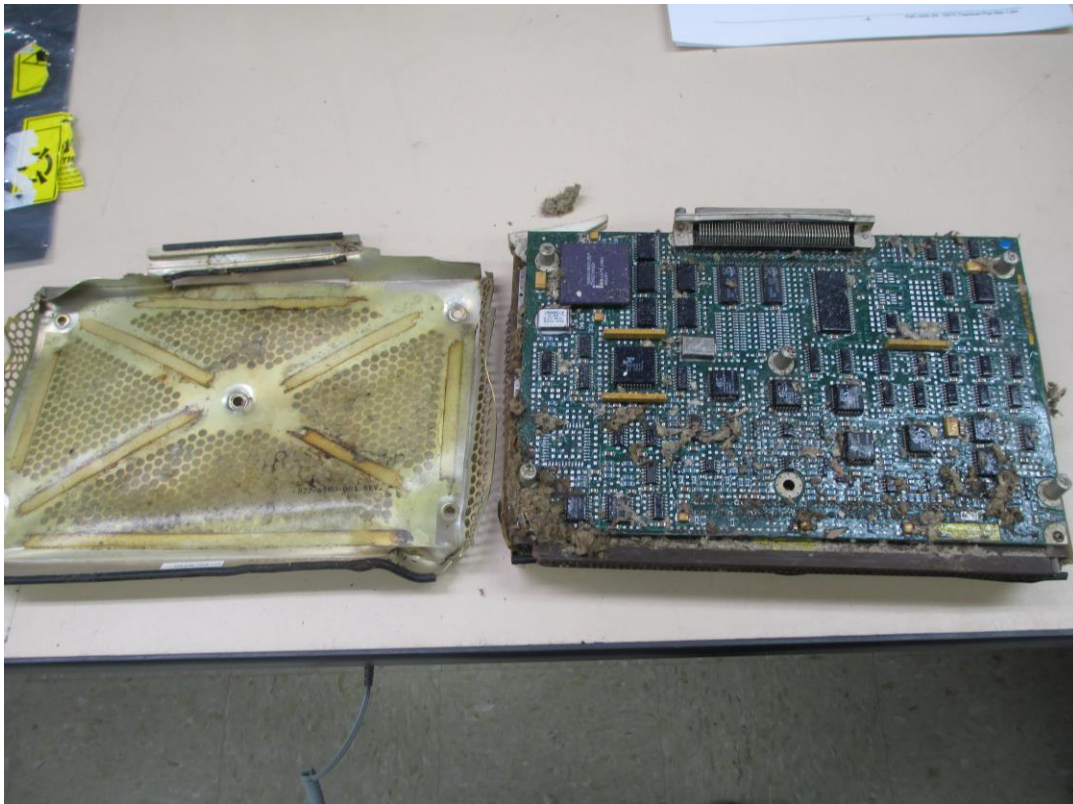
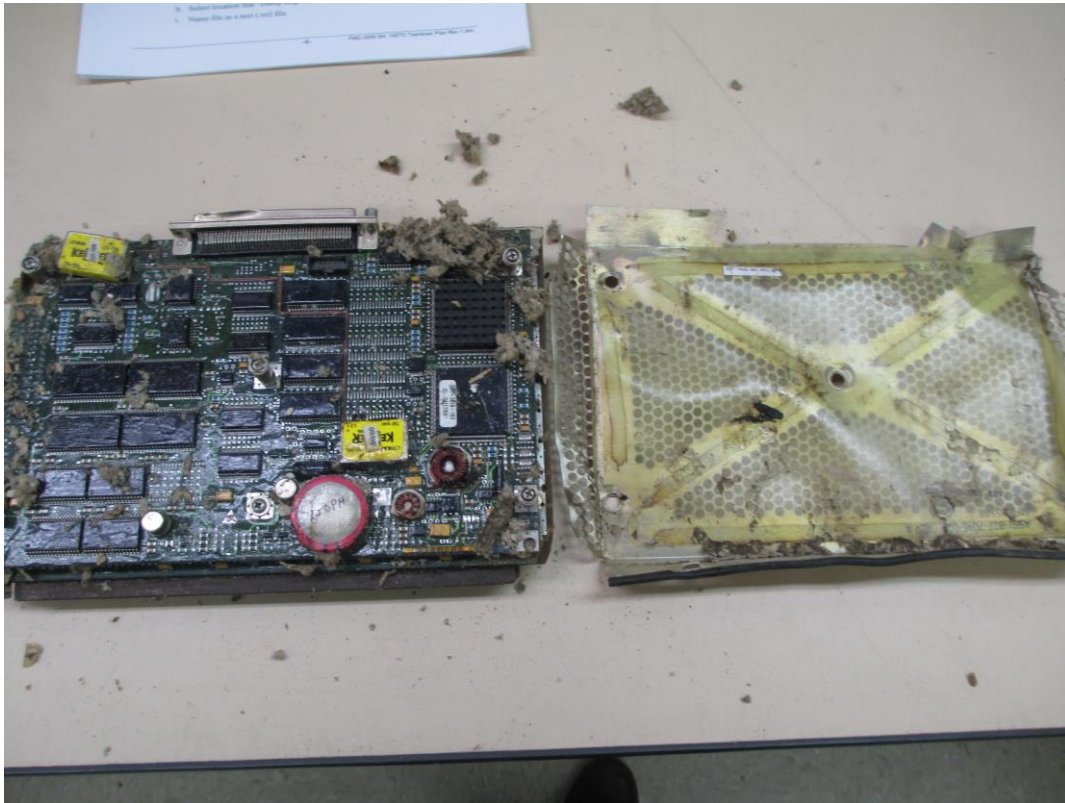
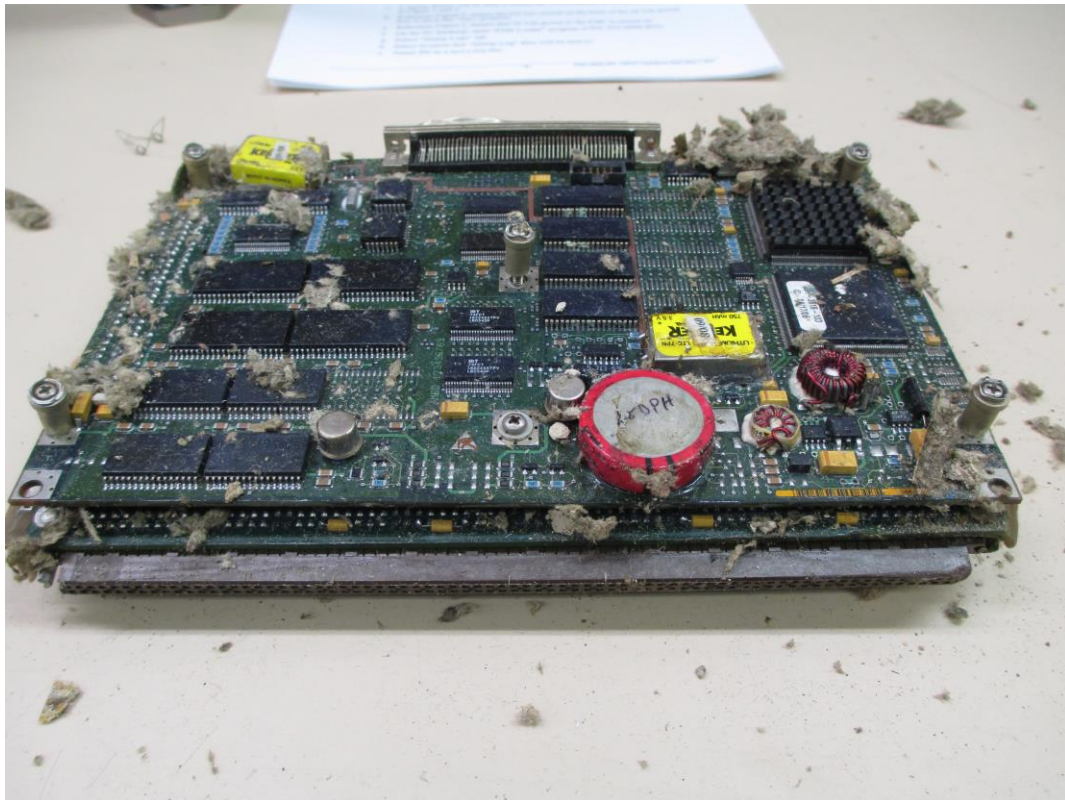
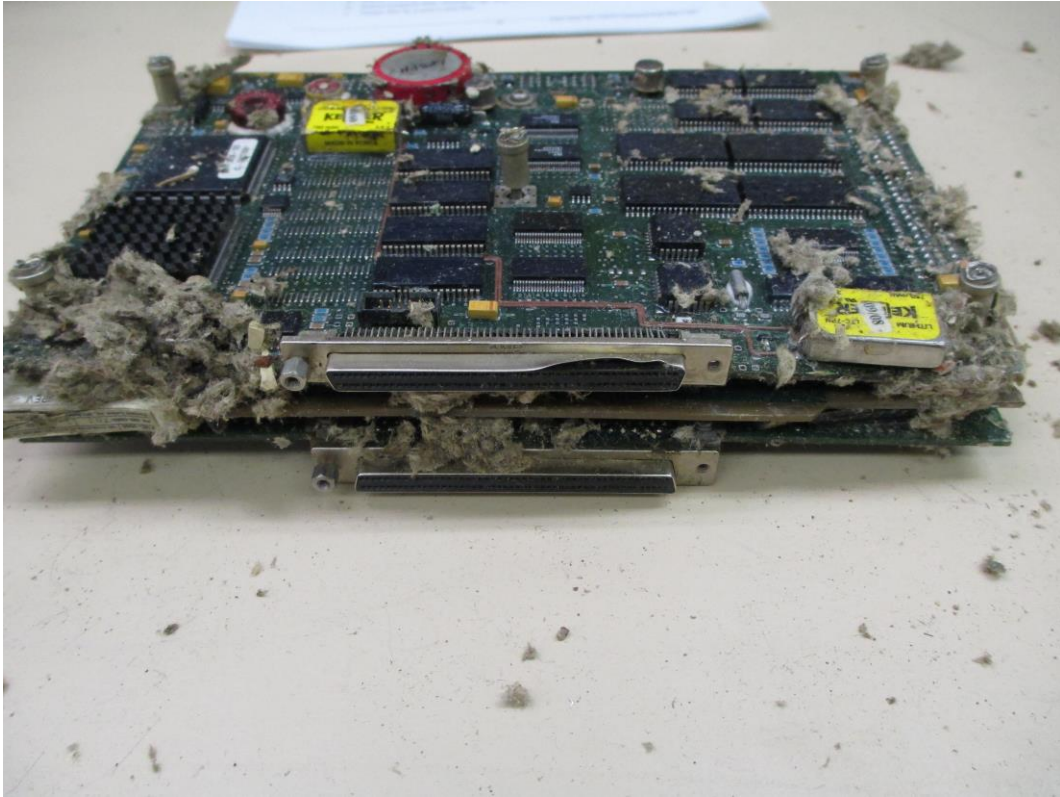
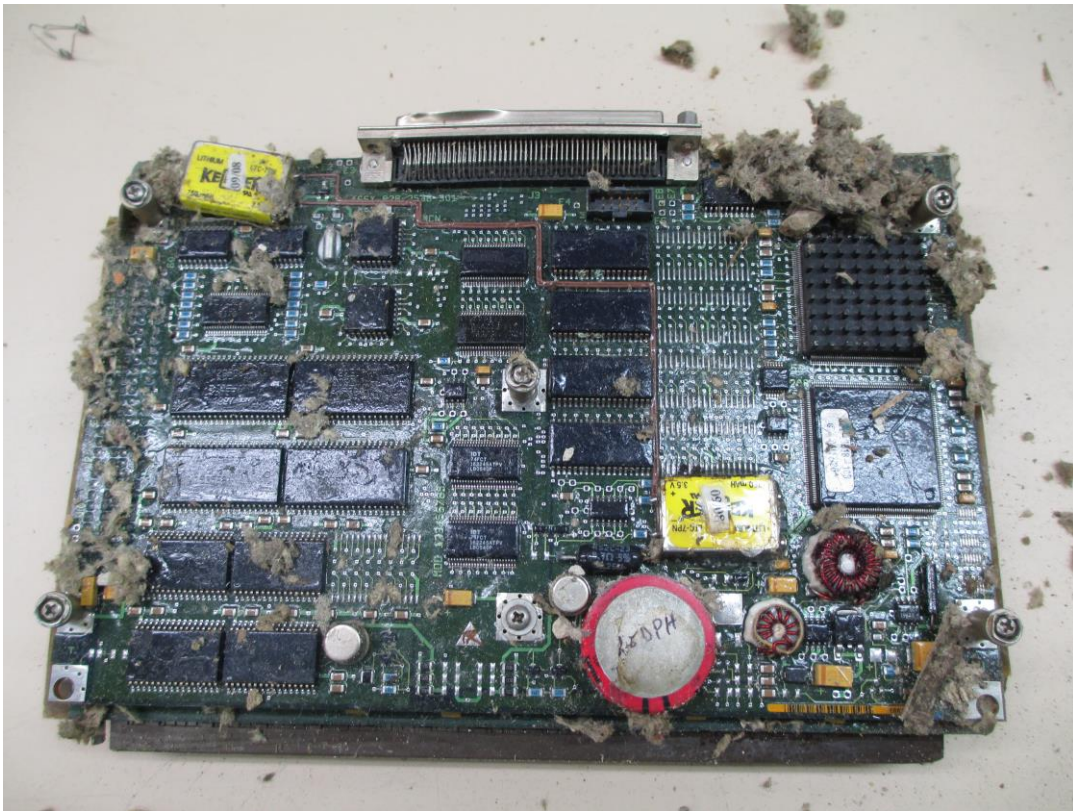
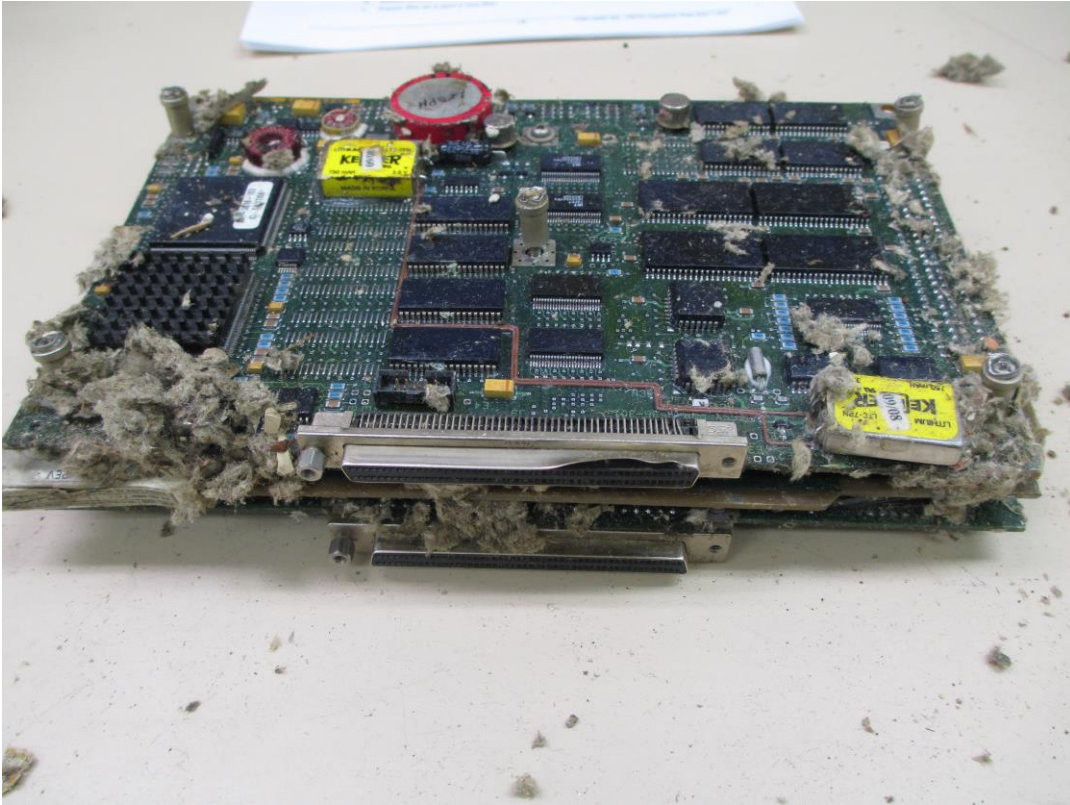
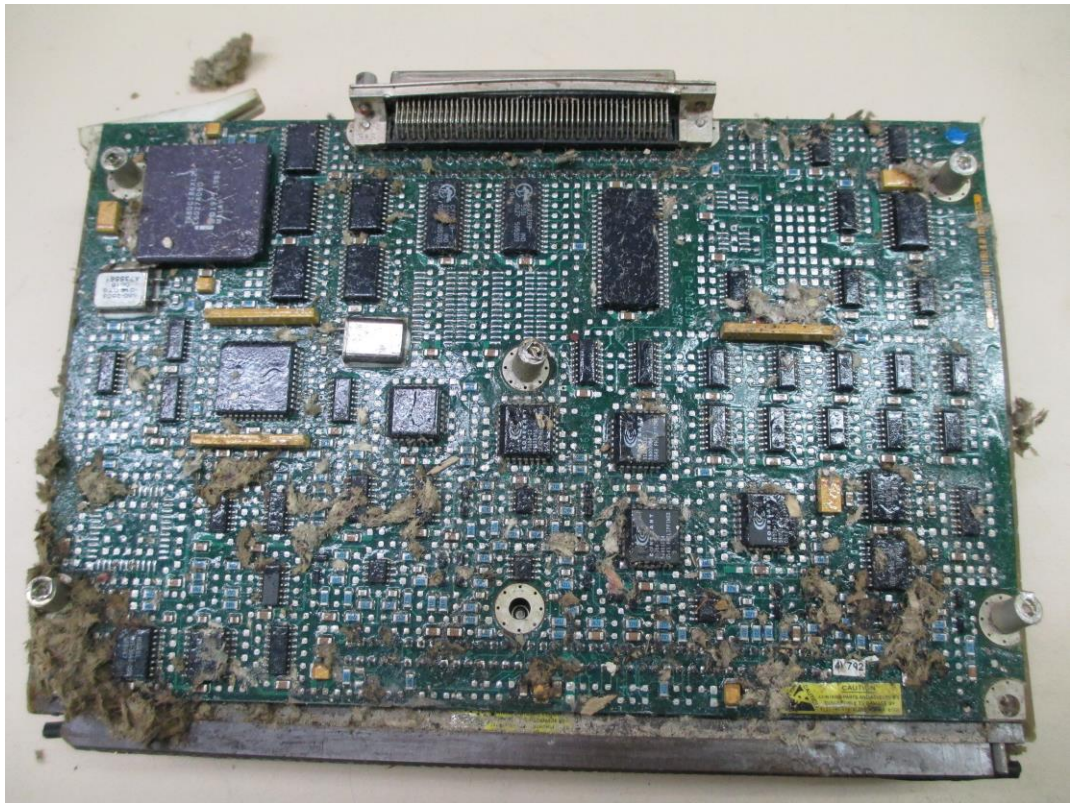
- a. Figure 27 through Figure 33 show considerable damage on the circuit card assemblies and the NVRAM batteries. It was decided to measure the NVRAM battery voltage to determine if downloading the NVRAM data would be viable. Battery voltage read 0Vdc. NVRAM data is not recoverable, further teardown on the unit is not necessary therefore teardown was stopped.

Upon removal of the covers it was determined that the foreign material seen in the unit was insulation from the house that the aircraft crashed into. There was also considerable damage observed on the circuit card assemblies.

Due to the extensive damage and the condition of the NVRAM batteries it was decided to measure the battery voltage to determine if downloading the NVRAM data would be viable. Battery voltage read 0Vdc. NVRAM data is not recoverable. Further teardown of the unit is not necessary. Teardown stopped

Upon removal of the covers it was determined that the foreign material seen in the unit was insulation from the house that the aircraft crashed into. There was also considerable damage observed on the circuit card assemblies. Due to the extensive damage and the condition of the NVRAM batteries it was decided to measure the battery voltage to determine if downloading the NVRAM data would be viable.
